PROJECT REPORT

**Evaluating The Longevity and Condition of the Geotextiles
Used in The Past in Geo-Infrastructures Constructed
with Recycled Concrete Aggregate**

April 2022

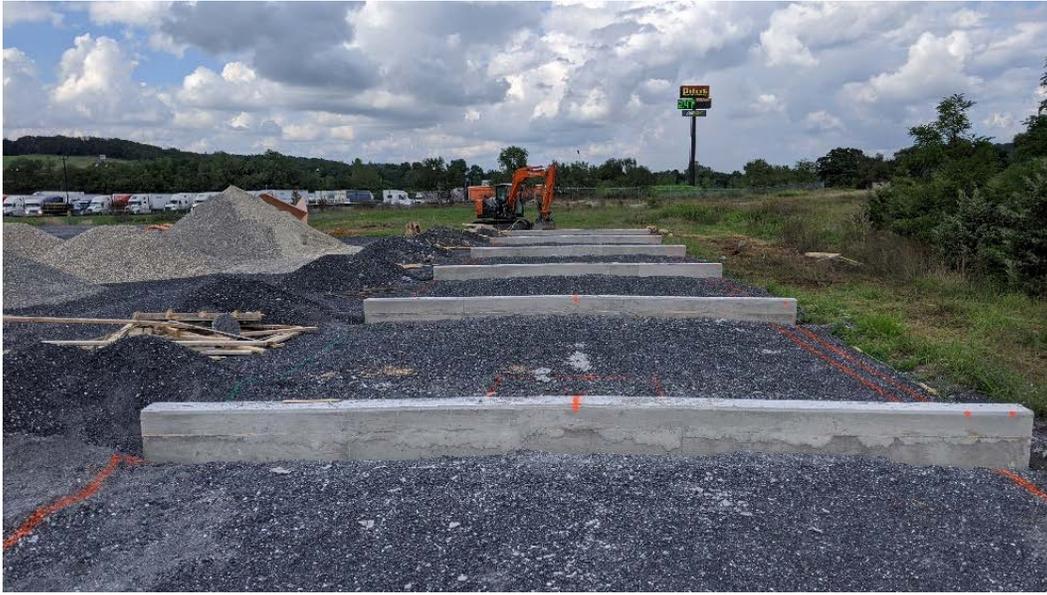
Figure 3. Installed section dividers

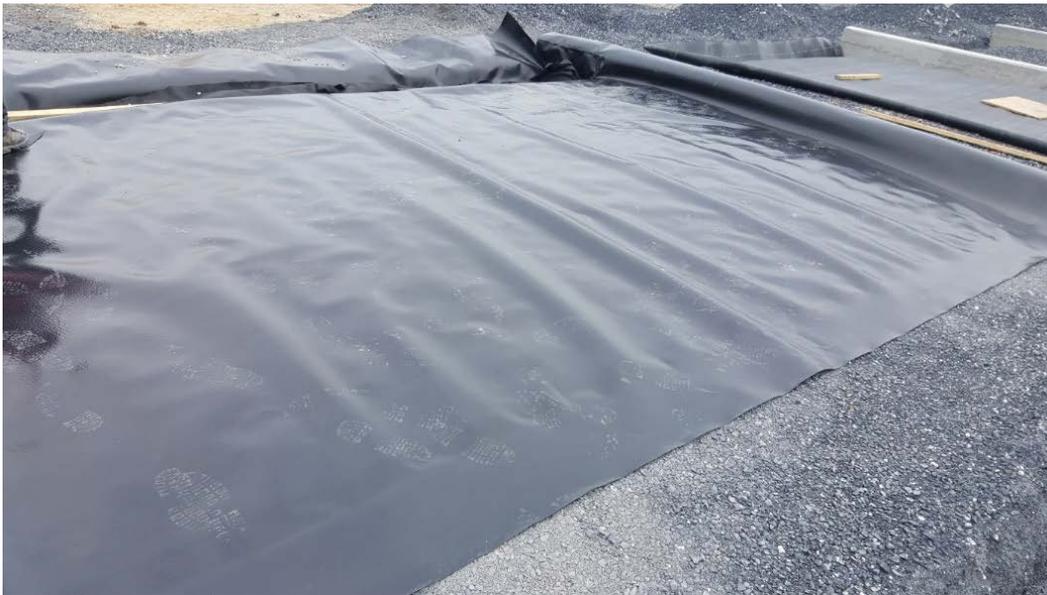
Figure 4. Installation of the 40 mil HDPE geomembrane liner

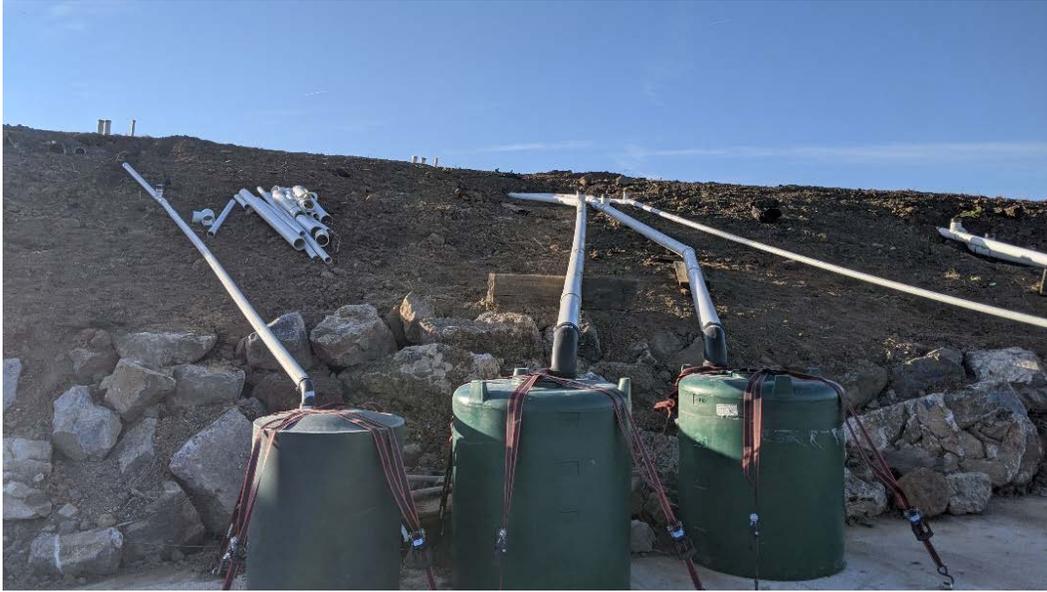
Figure 7. Collection tanks connected to underdrains (two 100-gallon tanks) for each side

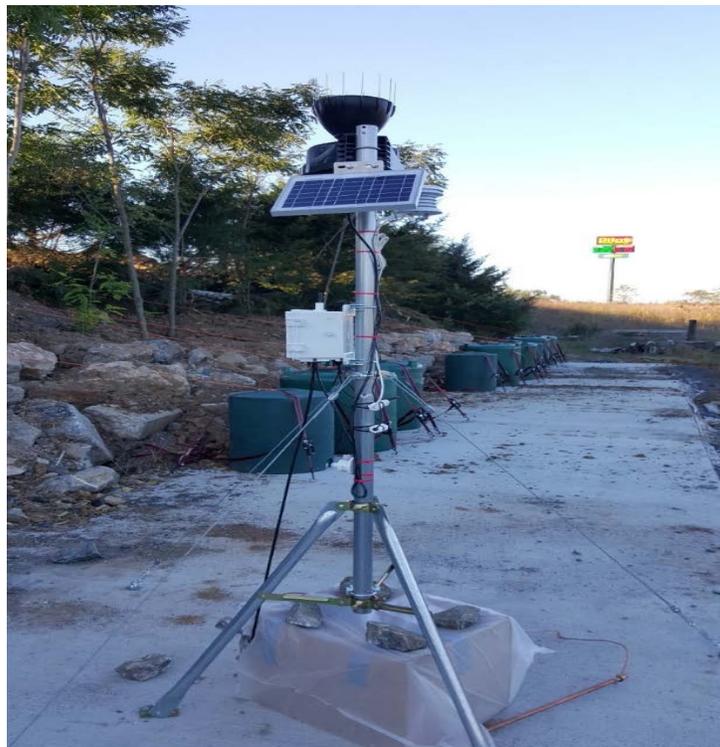
Figure 8. Installed weather station at the test site

A weather station was installed at the site to collect the meteorological data (Figure 8). The weather station consisted of a temperature/relative humidity sensor, a Davis rain gauge, a barometric pressure sensor, and a water level sensor. The weather station is connected to a 3G remote monitoring station that enables researchers to monitor and download data remotely.

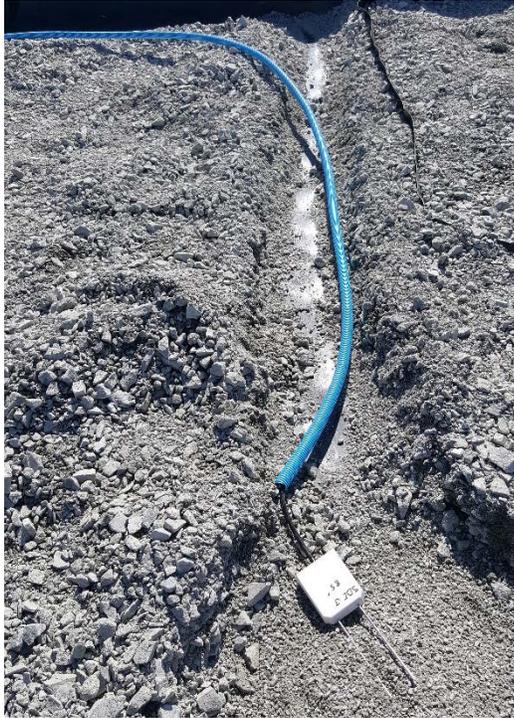
Figure 9. Installation of volumetric moisture content sensor within the base course

Volumetric moisture content sensors were installed at the center of each section (Figure 9) and connected to the data logger (Figure 10) to monitor the seasonal changes in the moisture content and temperature within the base course material. In order to be able to observe any clogging, deposition of any residue, or any other damages to the drainage pipes, pipes and outlets are monitored using a borescope at the time that geotextile samples are exhumed for clogging analyses.

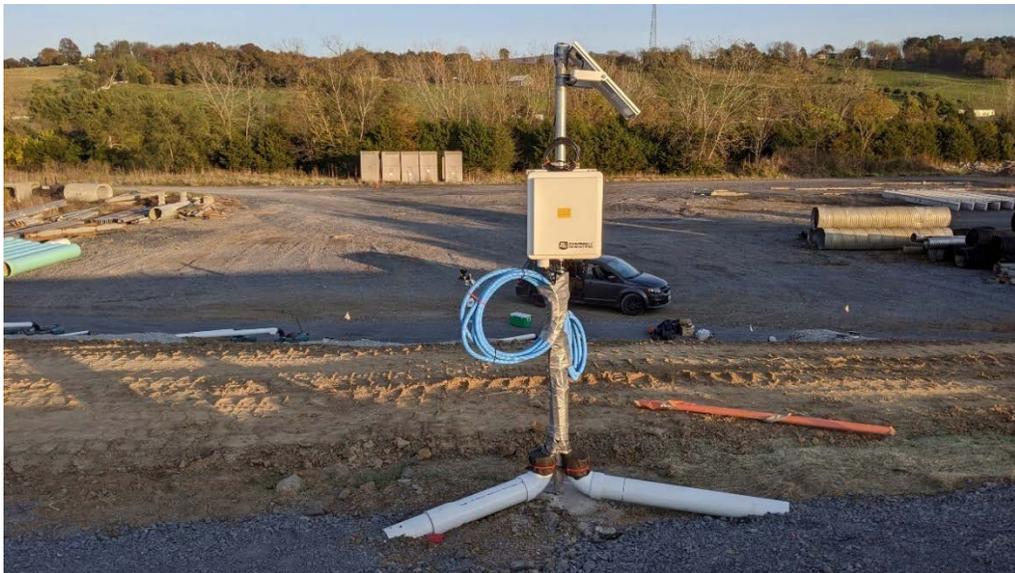
Figure 10. Data logger pole for all volumetric moisture content sensors

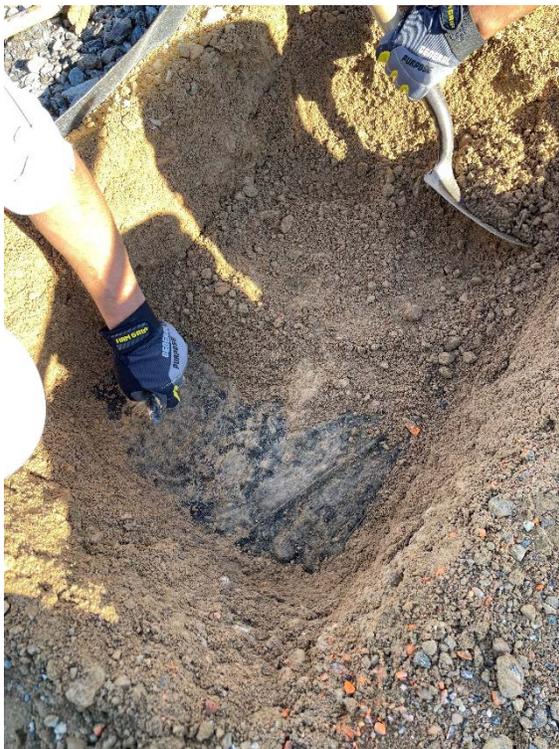
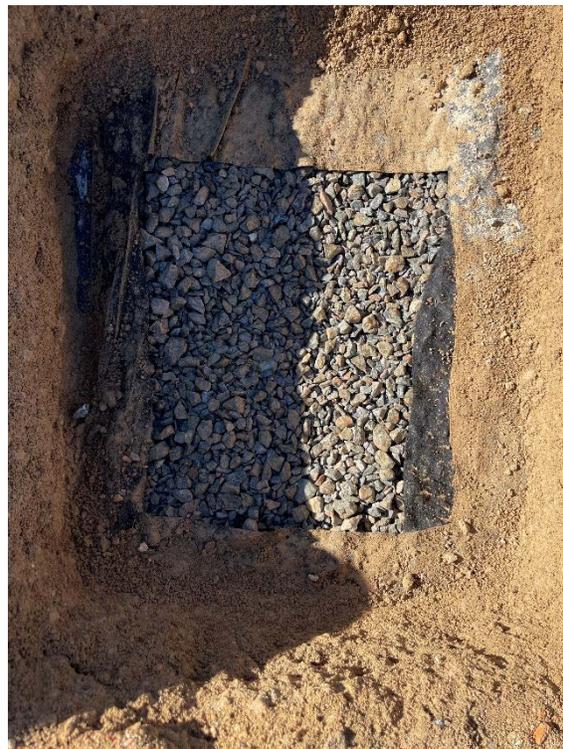
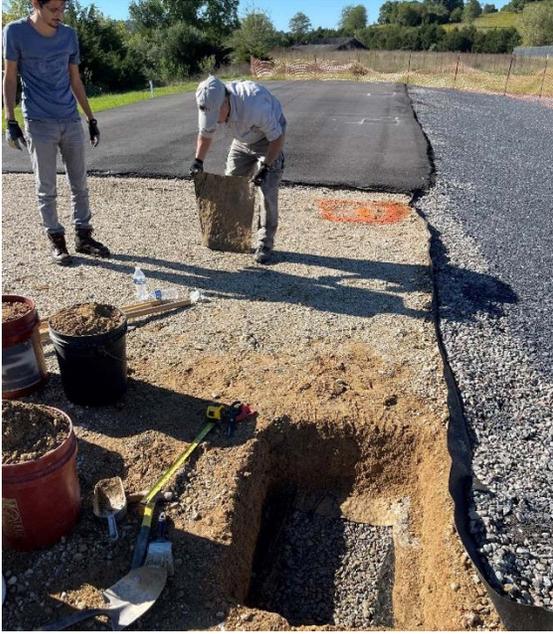
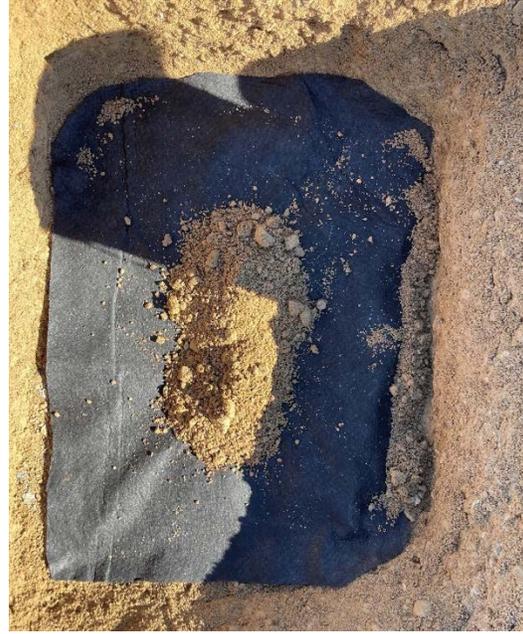
Figure 11. Process of (a) removing base material over the geotextile using a brush, (b) exposed base course aggregate, (c) the exhumed geotextile and (d) placement of the new geotextile while maintaining a minimum of 6-inch overlap with the old geotextile

- 1- Marking the location of geotextile sampling on the base material
- 2- Removal of base course until the geotextile is exposed
- 3- Carefully brushing the top of the geotextile and cutting a square sample
- 4- Covering the sampling spot with new geotextile including a minimum of 6-inch overlap
- 5- Replacing the base course material and compacting it (using hand tamping and vibratory plate).

Exhumed samples are preserved and transported to the GMU laboratory for further investigations. Figures 11 and 12 show geotextile exhuming process.

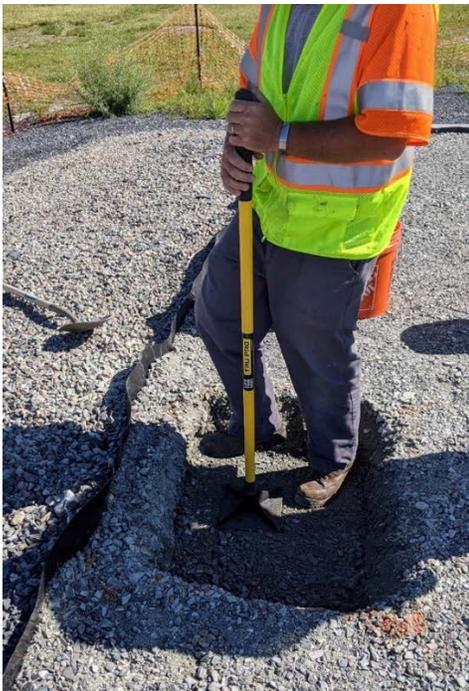
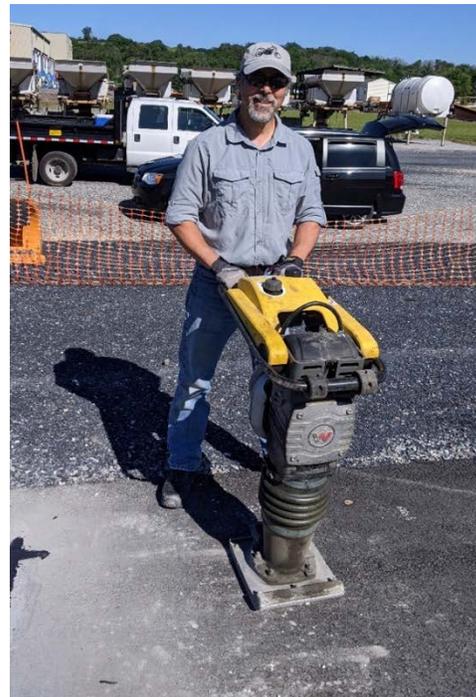
Figure 12. Compaction of the new material placed over the exhumed geotextile with (a) hand tamping and (b) with jumping jack

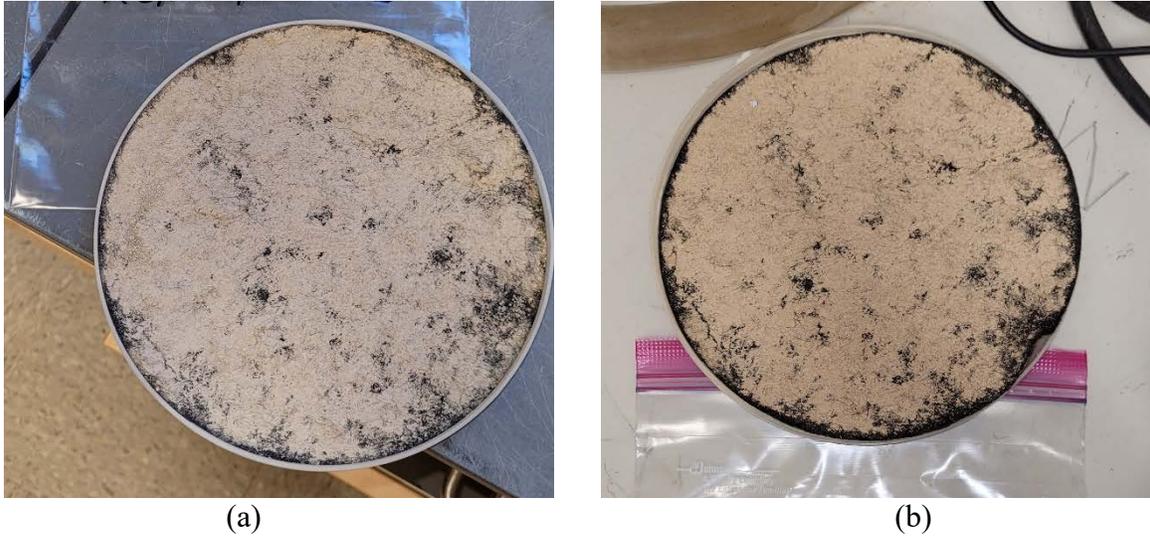
Figure 13. Appearance of the geotextile sample exhumed from unpaved RCA section after 9 months (a) before and (b) after permittivity test

The permittivity of virgin and exhumed geotextiles were determined following the procedures listed in ASTM D4491. Geotextile samples were initially air-dried prior to laboratory analysis. A circular sample was cut off from the larger sample (Figures 13 and 14) and was soaked for a minimum of 24 hours. Then they were placed into the permittivity test chamber. Tests were started with an applied head of 10 mm until flow was stabilized. After which applied head was increased in 10 mm increments to measure the permittivity of the samples at higher flow discharges.

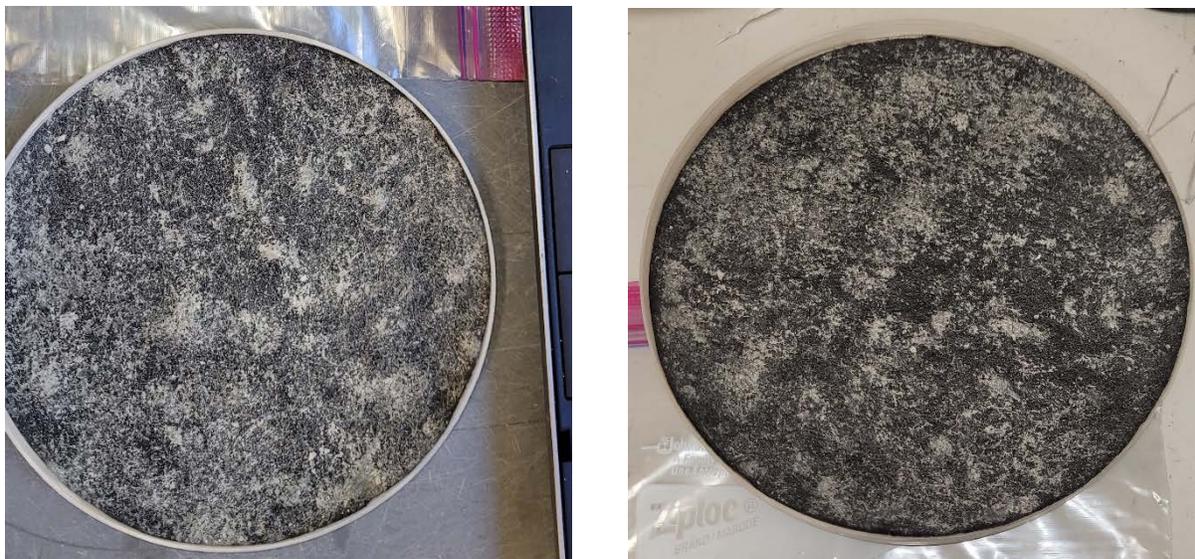
Figure 14. Geotextile sample exhumed from unpaved V.A. section after 9 months (a) before and (b) after permittivity test

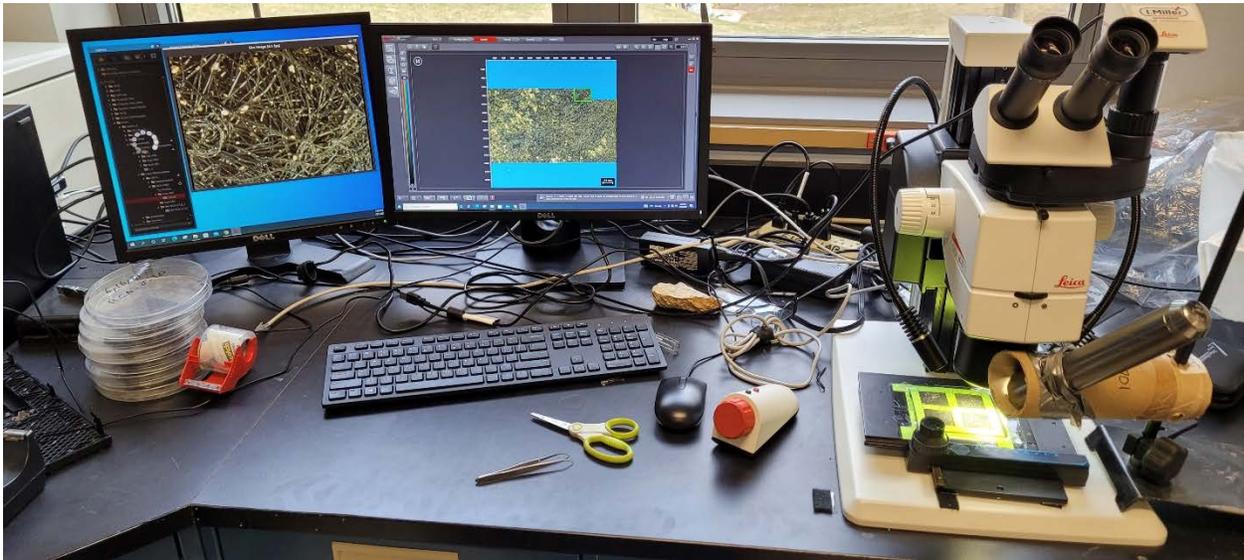
Figure 15. Leica M125 C microscope with a built-in 5 MP HD digital camera with a geotextile sample under analysis

The microscopic imaging was conducted using a Leica M125 C microscope with a built-in 5 MP HD digital camera (Figure 15). Continues microscopic images with a small overlapped area on each consecutive picture were taken from a point of interest with a magnification of 40 on both sides of the sample and images were stitched together using Leica LAS EZ software to create a larger image. In order to quantify the percentage of the areas covered with crystals, these large images were then analyzed using Leica LAS X software. This process allowed the surface area covered with precipitate deposition to be identified and quantified based on the calculated unit surface of various areas. Average values and standard deviations for both sides of the same geotextile specimen are reported in this report.

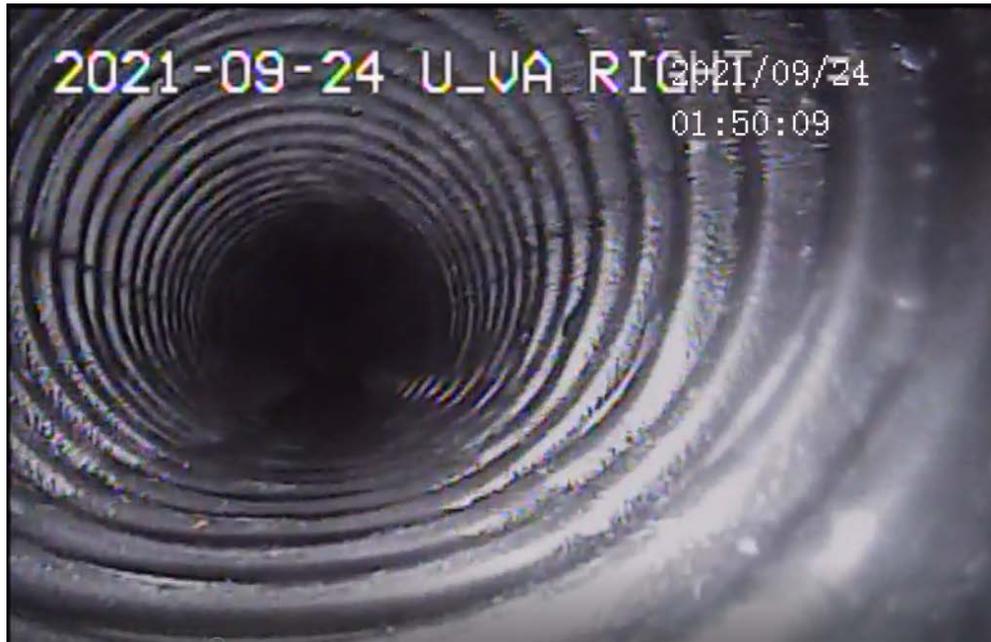
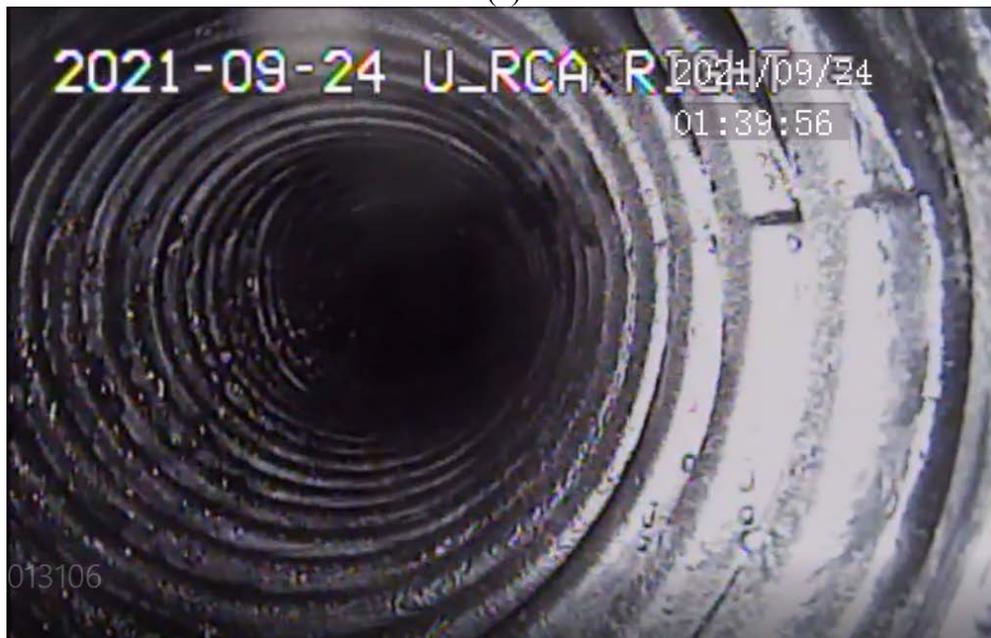
Figure 20. Example images from borescopic observations of drainage pipes (a) perforated pipe in the left edg drain of the paved RCA section and (b) PVC outlet pipe of the same drain

Figure 20 shows examples of the images taken from drainage pipes and outlets of the test pads when geotextile samples were exhumed. Based on the recorded images and videos from the borescopy, any type of deposition or damage within the drainage pipes was not observed by the researchers.
