**NDOT Research Report**

**Report No. 701-18-803 TO 6 Part 2**

**TPF-5(358)  
PART 2 - WILDLIFE BARRIERS: THE  
EFFECTIVENESS OF ELECTRIFIED BARRIERS  
TO KEEP LARGE MAMMALS OUT OF FENCED  
ROAD CORRIDORS**

**September 2022**

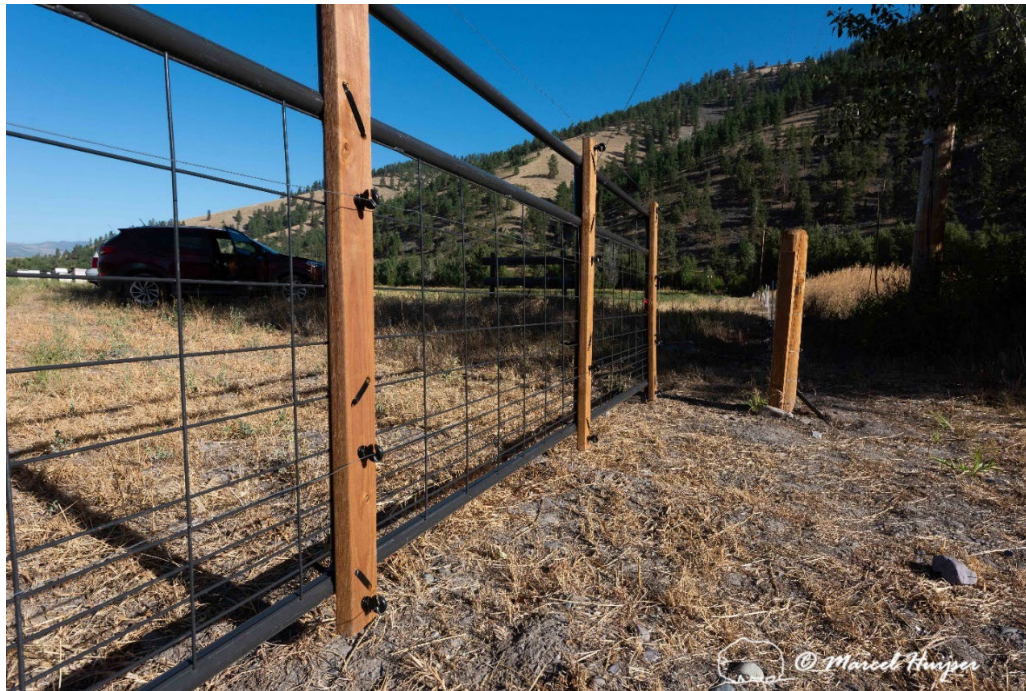
**Figure 5: The electrified swing gate (16' (4.88 m) wide, 4'6" (1.37 m) tall, about 7" (18 cm) gap between ground and bottom of gate). The wires were mounted at 6" (15 cm), 1'7" (48 cm), 3'2" (97 cm), and 4'7" (140 cm) above the ground.**

The researchers evaluated 5 different electrified barrier designs at 4 access points in 2020 and 2021 (Table 2, Figures 5-9). In addition, the swing gate at access point 2, and the drive-over mat at access point 3 were monitored from 23 May 2022 until 25 Sep 2022. The drive-through bump-gates were originally installed at 2 access points, but 1 of them was modified in 2020. The drive-over wires barrier was replaced by a drive-over mat in 2021 (Table 2).

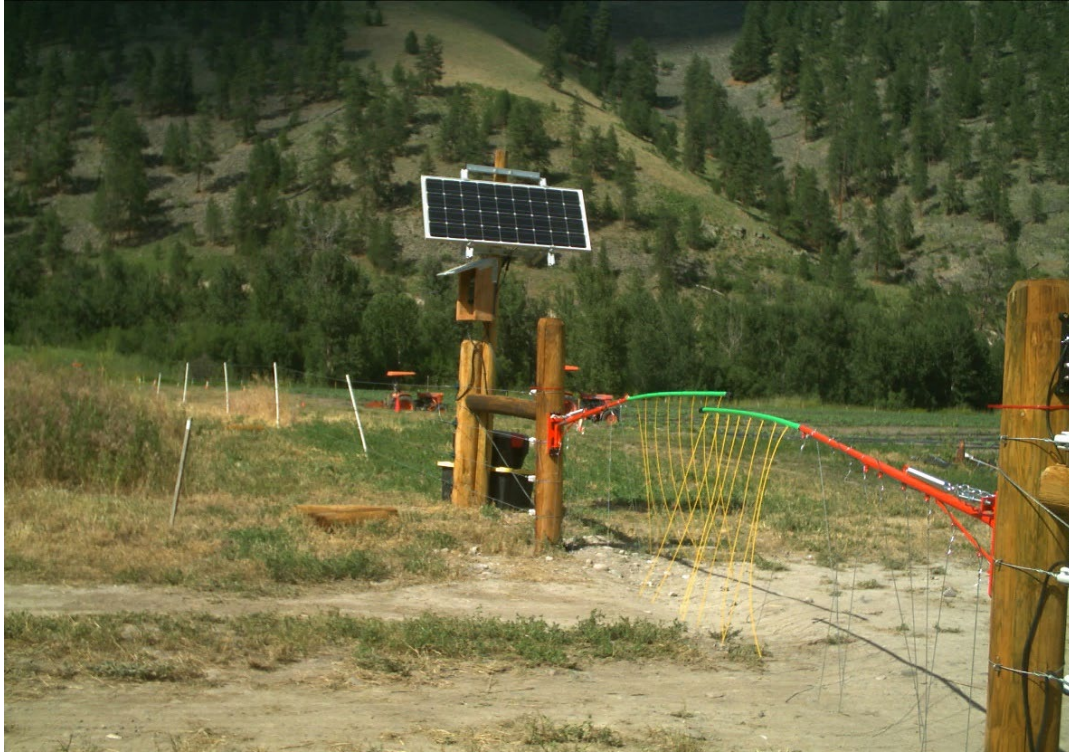
**Figure 6:** A drive-through bump gate (not modified) (about 16' (4.88 m) wide, about 3' (91 cm) tall), with vertical electrified wires. The orange horizontal pole is metal and carries current. The green horizontal part is fiberglass and does not carry current.

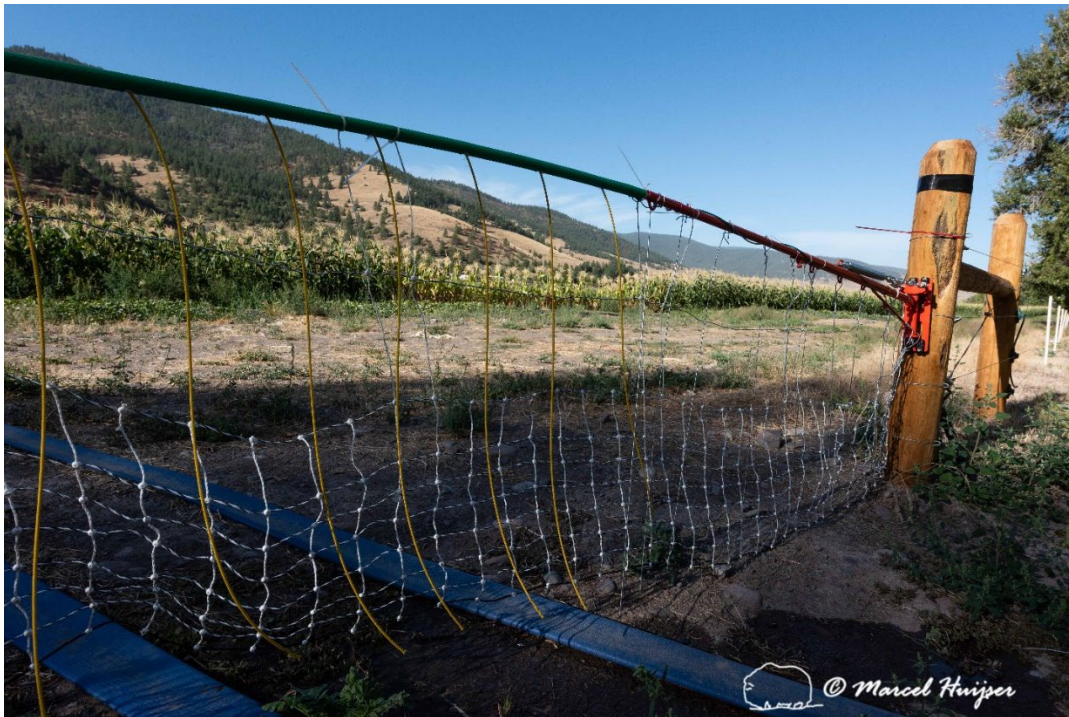
**Figure 7:** A modified drive-through bump gate (with conductive netting) (about 16' (4.88 m) wide, about 3' (91 cm) tall), with vertical electrified wires and custom conductive netting (about 2' (61 cm) high) attached.

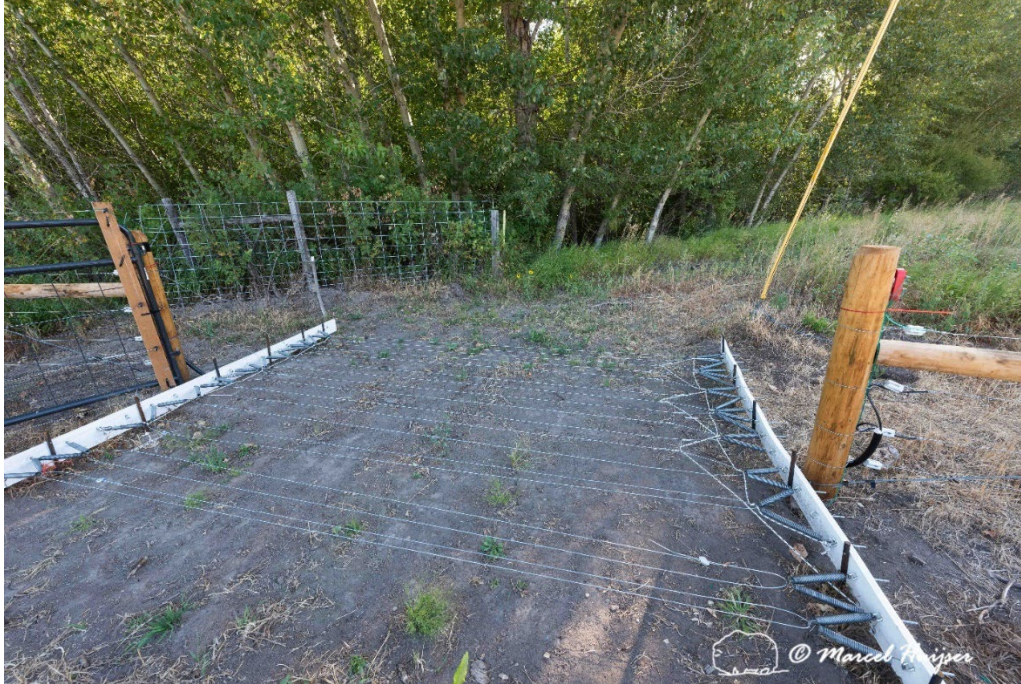
Figure 8: The drive-over wires, about 14'3" (4.34 m) wide (post-post) and 10'2" (3.10 m) long. The 18 drive-over wires are about 7" (18 cm) above the ground and the gaps between the wires vary between 5-12" (13-30 cm). There are "side-board" wires that angle toward the ground from the post along the sides of the barrier to reduce the likelihood of an animal bypassing the drive-over wires. However, these "side-boards" do not cover the full length of the barrier.

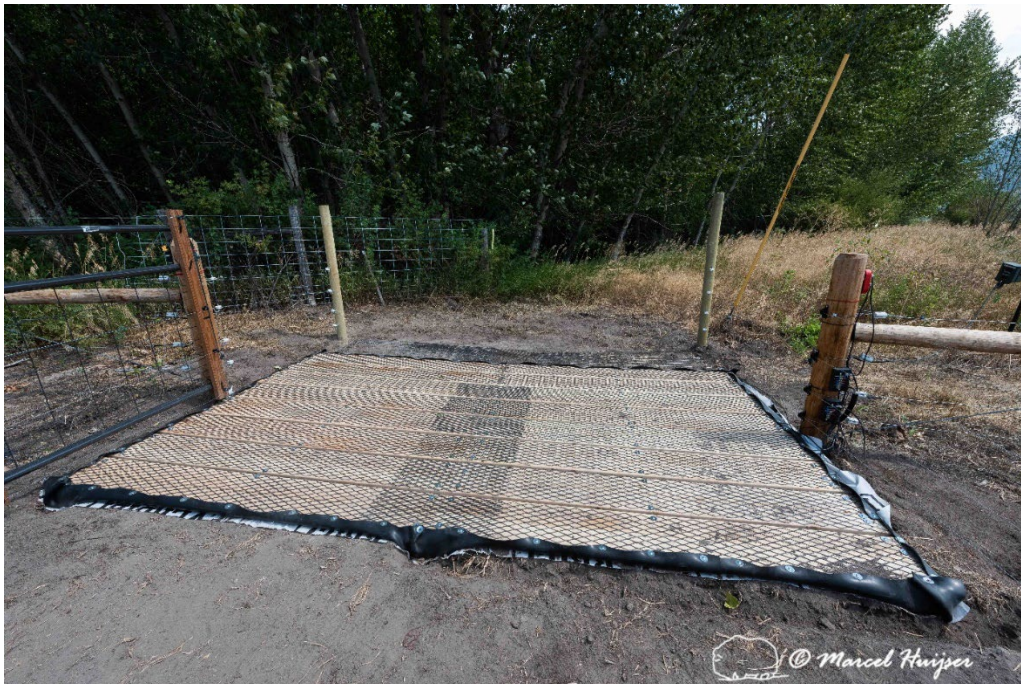
Figure 9: The drive-over mat about 14'3" (4.34 m) wide (post-post) and about 10' (3.05 m) long. On the far side, the habitat side, there is metal mesh on the ground, connected to a grounding rod (about 2 ft (61 cm) wide). This is followed by 8 sections of 10-11" (25-28 cm) wide expanded metal sheeting (alternating positive and negative (ground)) mounted on wooden planks. This drive-over mat is powered by its own solar panel, battery and energizer.

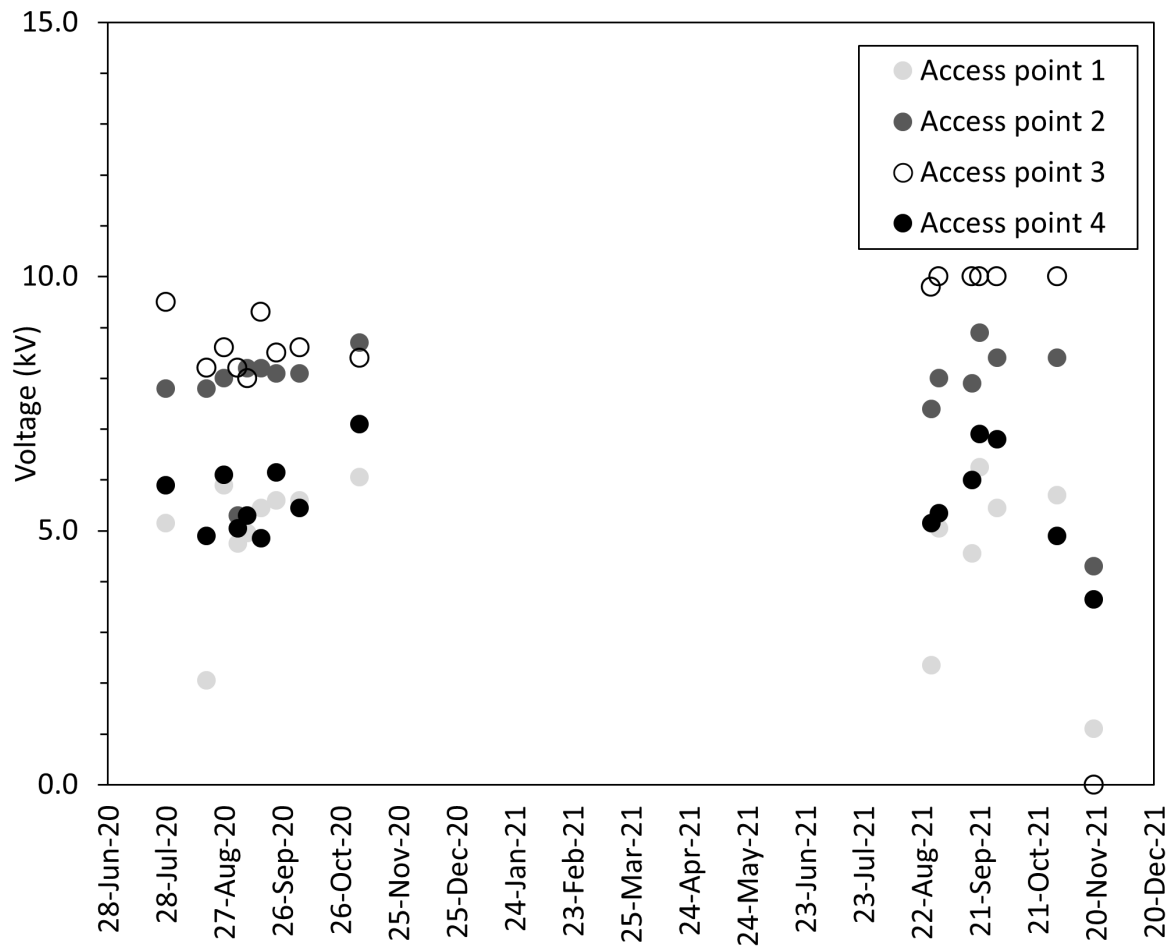
Figure 11: The voltage on the four access points wires for each date that measurements took place during the harvest season in 2020 and 2021.

In general, the voltage on the fence and at access points 2 and 3 was almost always 7-10 kV. However, the 2 bump gates (access point 1 and 4) usually had lower voltage (usually between 4-6 kV), suggesting higher resistance of the materials or a short or voltage leak. The overall drop in voltage at the end of November in 2021 was most likely the result of shorter days (not enough daylight to recharge the batteries) and lower temperatures (reduced capacity of the batteries).

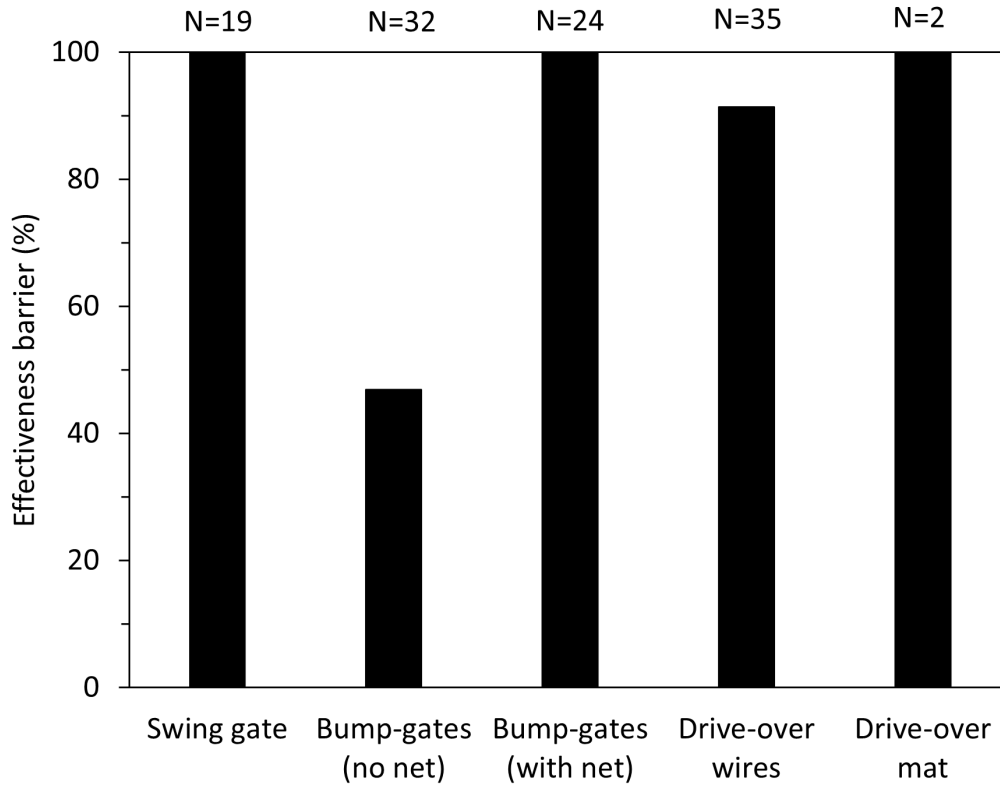
Figure 12: The effectiveness of the different barrier types in keeping black bears out of the melon patch.

above the ground (Figure 12). All 3 intrusions involved a bear bypassing most of the wires by coming in or leaving from the side (Figures 14-16).

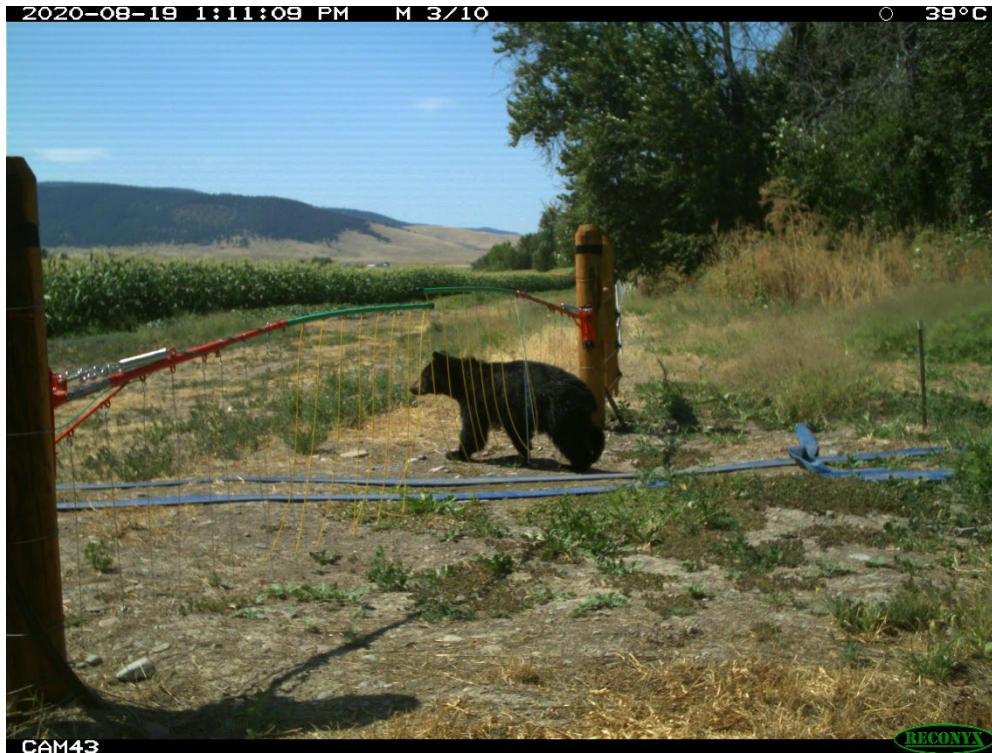
Figure 13: Black bear accessing the melon patch at a bump gate at access point 4, entering in between the vertical electrified wires. The black bears tended to choose the location where the space between the vertical wires was widest, at the transition of the orange and green parts of the horizontal pole.

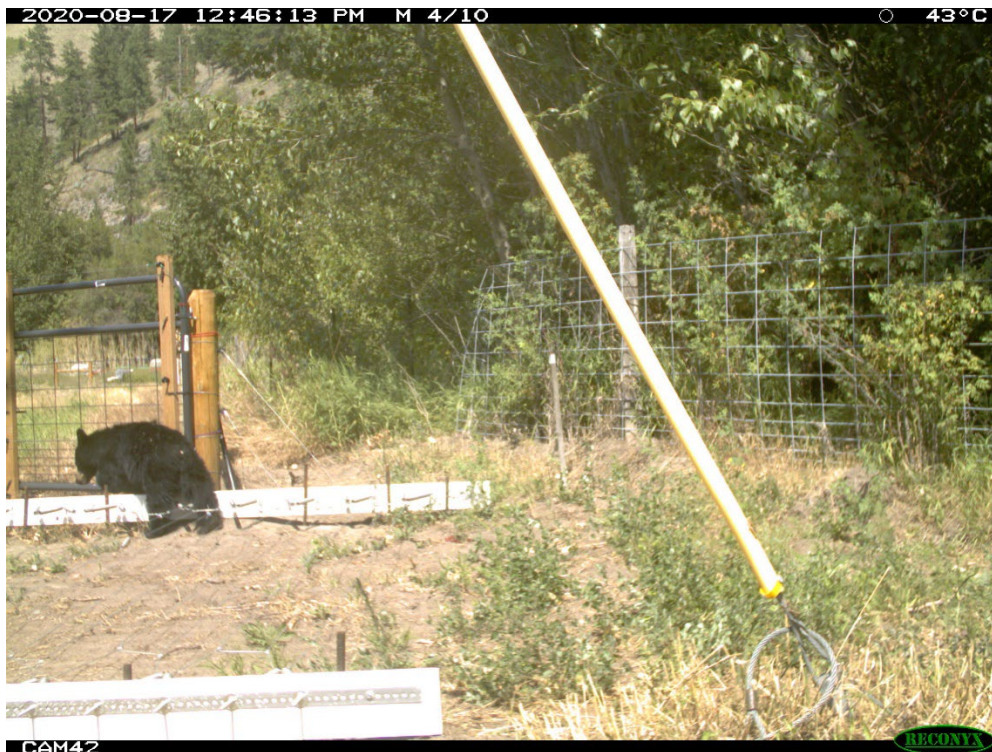
Figure 14: Black bear bypassing most of the wires above the ground and taking advantage of the space between the wires and the electrified gate on the side (1<sup>st</sup> out of 3 intrusions). Note that the electric wires on the side of the barrier (to the right of the bear) only cover the side partially.

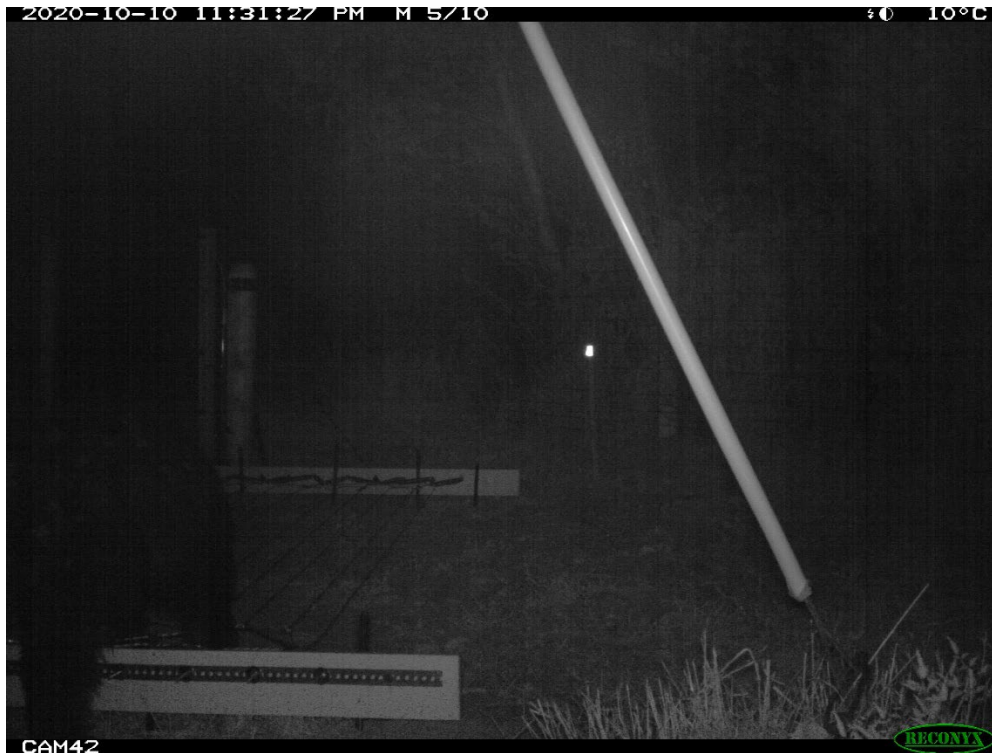
Figure 15: Black bear bypassing most of the wires above the ground by taking advantage of the partial electric fence on the side of the barrier (2<sup>nd</sup> out of 3 intrusions).

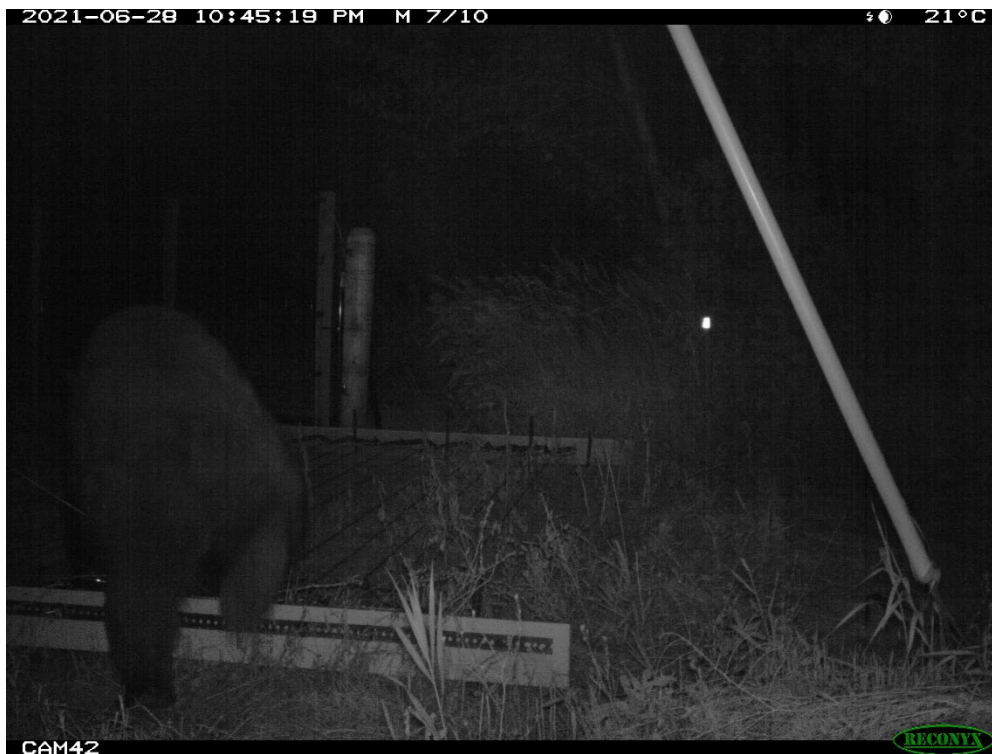
Figure 16: Black bear bypassing most of the wires above the ground by taking advantage of the partial electric fence on the side of the barrier (3<sup>rd</sup> out of 3 intrusions).

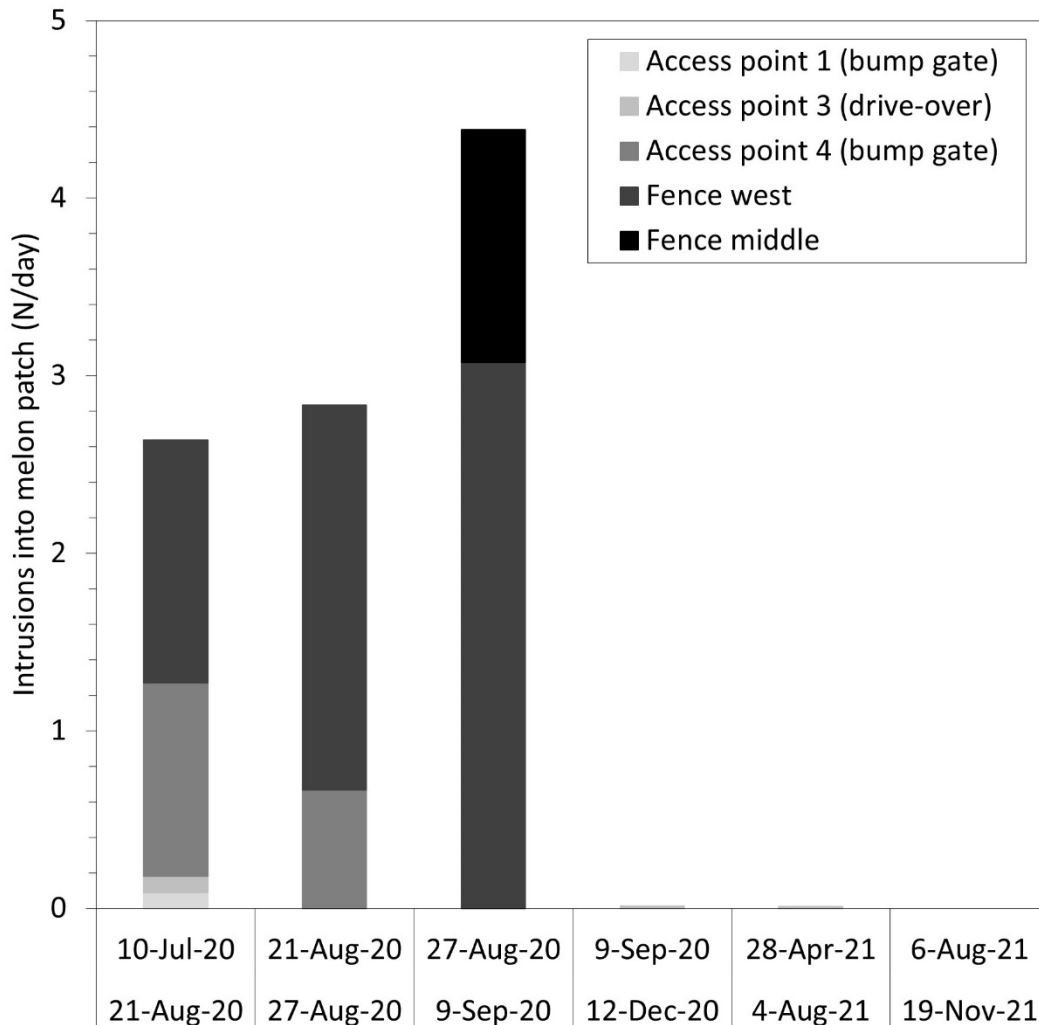
Figure 17: The number of black bear intrusions per day into the melon patch during different periods. Note: No intrusions were reported at access point 2 (swing gate) and “fence east”.

At the 7 locations that were monitored with a camera, the number of black bear intrusions into the melon patch varied between about 2.5 and 4.5 per day during much of the 2020 harvest season (Figure 17). Access point 4, the non-modified bump gate adjacent to the Jocko river, and “fence west” accounted for the vast majority of the intrusions. After conductive netting was attached to the bump gate at access point 4, black bear pressure increased on “fence west”, and also “fence middle” (Figure 18-20). After fence modifications on 9 September 2020, almost no bears were able to enter the melon patch. There were only 2 black bears that entered after that date, and both did so through largely bypassing the drive-over wires at access point 3. The researchers did not have any evidence that black bears entered the melon patch at any other location that was not monitored with a camera. The total number of black bears was highest in August through October (Figure 21). The total number of black bear observations at any of the 7 locations monitored with a camera, regardless of which side of the fence or electrified barriers the bears were on, was 95% lower in 2021 (N=24) than in 2020 (N=527).

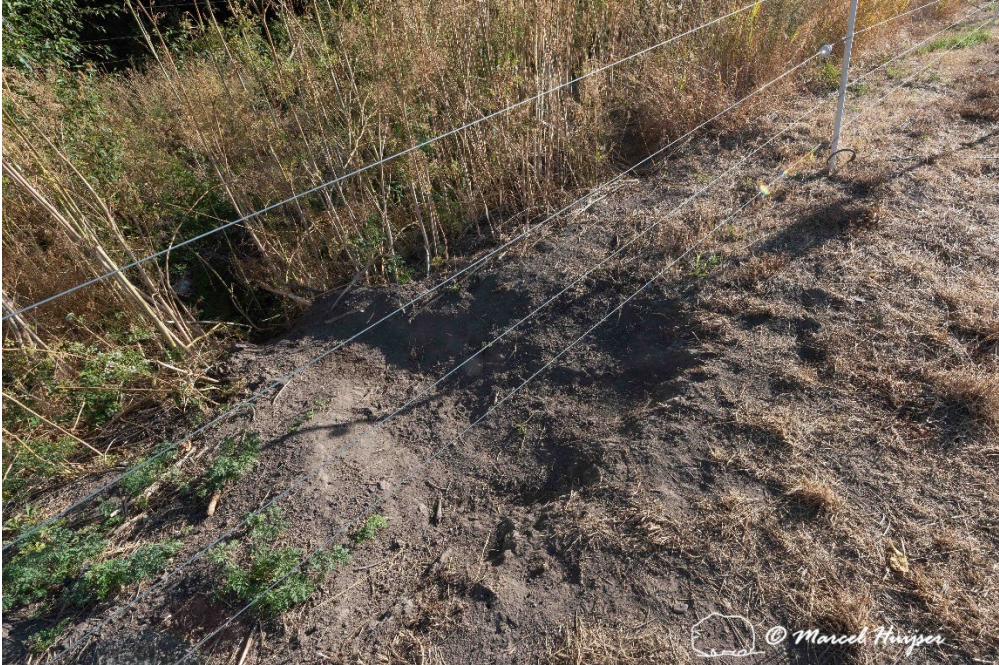
Figure 18: In some places black bears dug under the fence.

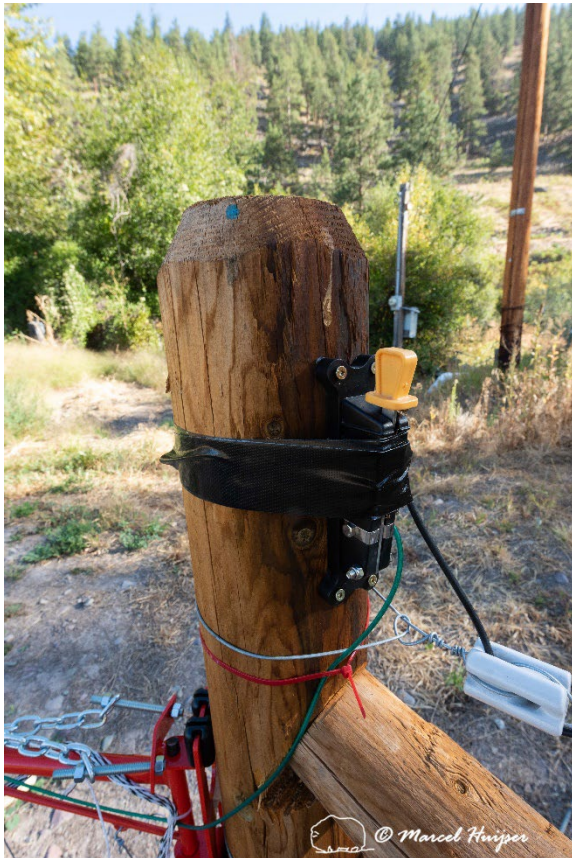
**Figure 22:** Switch at a bump gate taped in the permanently “on” position. Also note the adjustment bolts and nuts for the chain (lower left in image) that allows for the alignment of the horizontal pole.

All 4 vehicle access points had manual switches allowing farm personnel to walk through the electrified barriers without shocking themselves. However, shortly after the electric barriers were activated, the farmer realized that the switches were sometimes accidentally left in the “off” position. From 29 August 2020 onwards, all switches were permanently taped in the “on position” (Figure 22). While relatively inexpensive, the bump gates required custom conductive netting to become a substantial barrier to black bears. The netting is subject to tearing and needs to be adjusted and reattached regularly (e.g. zip-ties). In addition, there are tensioners for the 2 horizontal poles of the bump gates (Figure 22). These also need to be adjusted on a regular basis to ensure that the two horizontal poles align and do not leave a gap in the middle. The horizontal poles are also subject to breaking; one of the poles broke after it got stuck in a bumper or wheel well of a pickup truck (Figure 23).

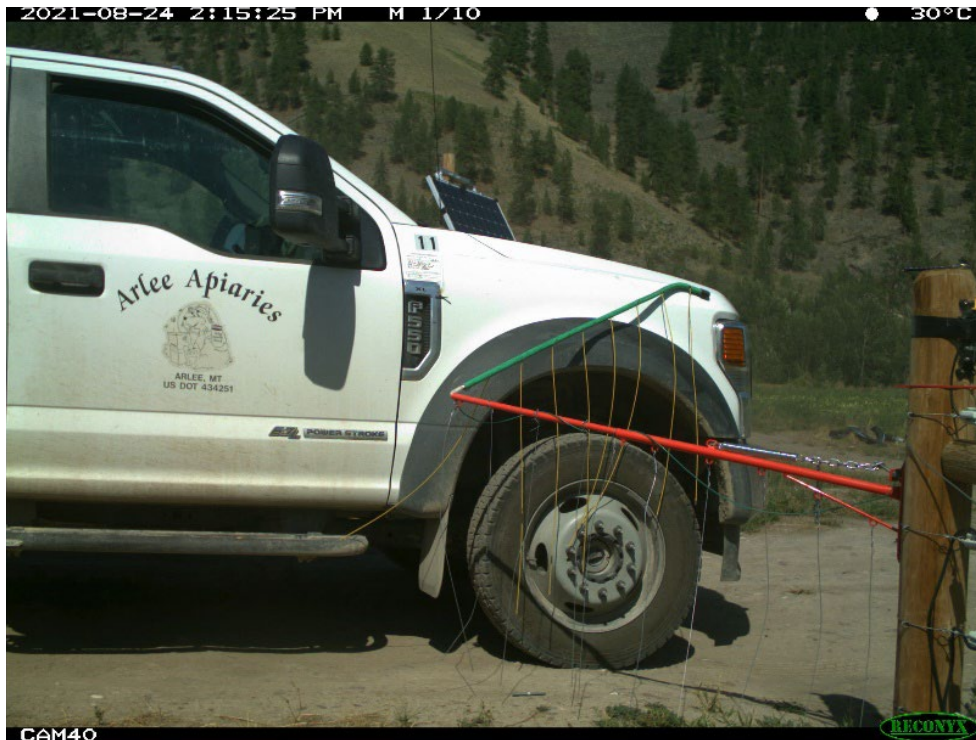
**Figure 23: Broken horizontal pole of a bump gate because of a vehicle passing through.**

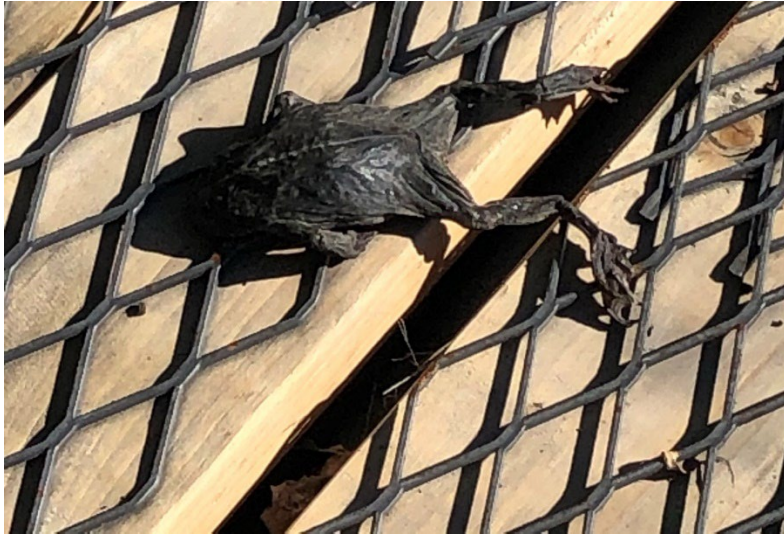
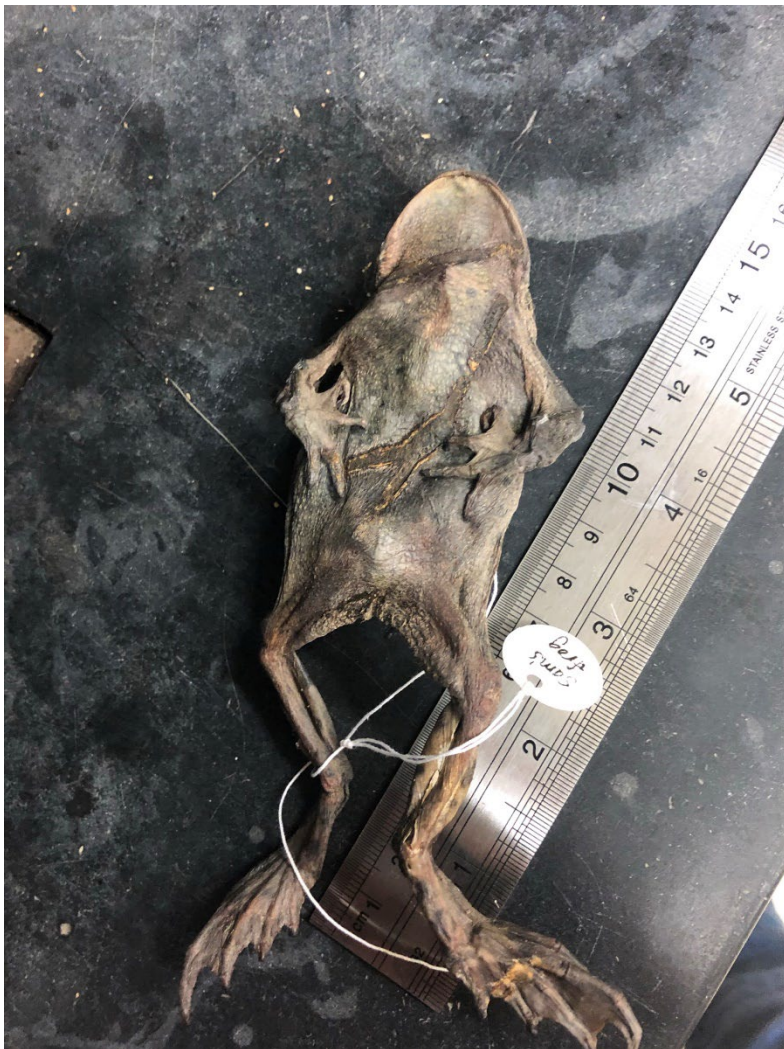
Figure 24: A. Western toad (*Anaxyrus boreas*), presumably electrocuted, on the electrified drive-over mat (Crosstek™). B. Same animal with burn marks from the mat. (Copyright: Samantha Getty).

There were no operation or maintenance issues with the electrified swing gate. A design problem of the drive-over wires barrier was that the side fences were too short. All three intrusions for black bears bypassed most of the wires above the ground by accessing or leaving the barrier from one of the sides. Barriers or “side-fences” that run tight along the full length of the barrier would address this issue and force bears, if they try to access the crop, to walk on top of or in between the wires above the ground for the full length of the barrier. In contrast, the drive-over mat has side barriers that have a tight connection to the mat, and they do run the full length of the mat. Here, no large mammals were able to bypass the mat by coming in from or leaving at one of the sides. The researchers did observe that the drive-over mat may kill amphibians and small mammals. Between 6 August 2021 and 21 November 2021, the researchers found one dead toad and one dead mouse on the mat (Figure 24, 25).

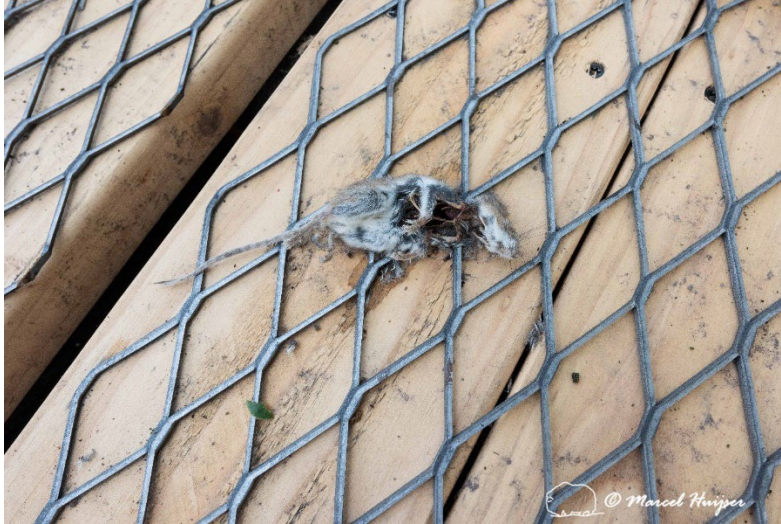
Figure 25: Deer mouse (*Peromyscus maniculatus*), presumably electrocuted, on the electrified drive-over mat (Crosstek™).

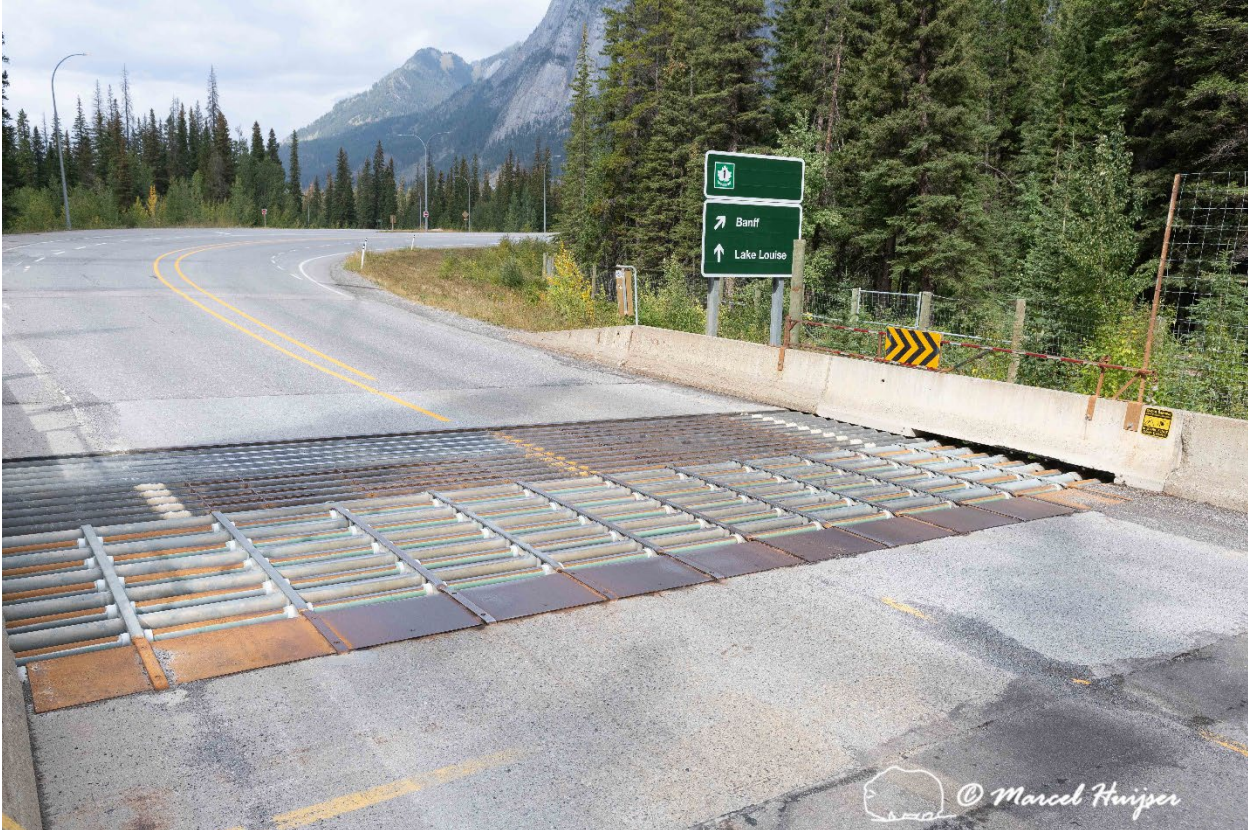
Figure 26: Electrified barrier, Sunshine Road, Banff National Park, Canada.

The barrier was briefly fully operational 8-20 October 2020, but a snowplow damaged the grounding plate as the protective strips had not been installed yet. After that, the damaged grounding plate was removed which meant that the animals were less likely to receive a full shock (variable conductivity of the pavement) or they would only be delivered a full shock after making contact with both a positive and negative bar. The grounding plate was reinstalled (with protective strips) at the end of September 2021 (personal communication Dan Rafla, Parks Canada).

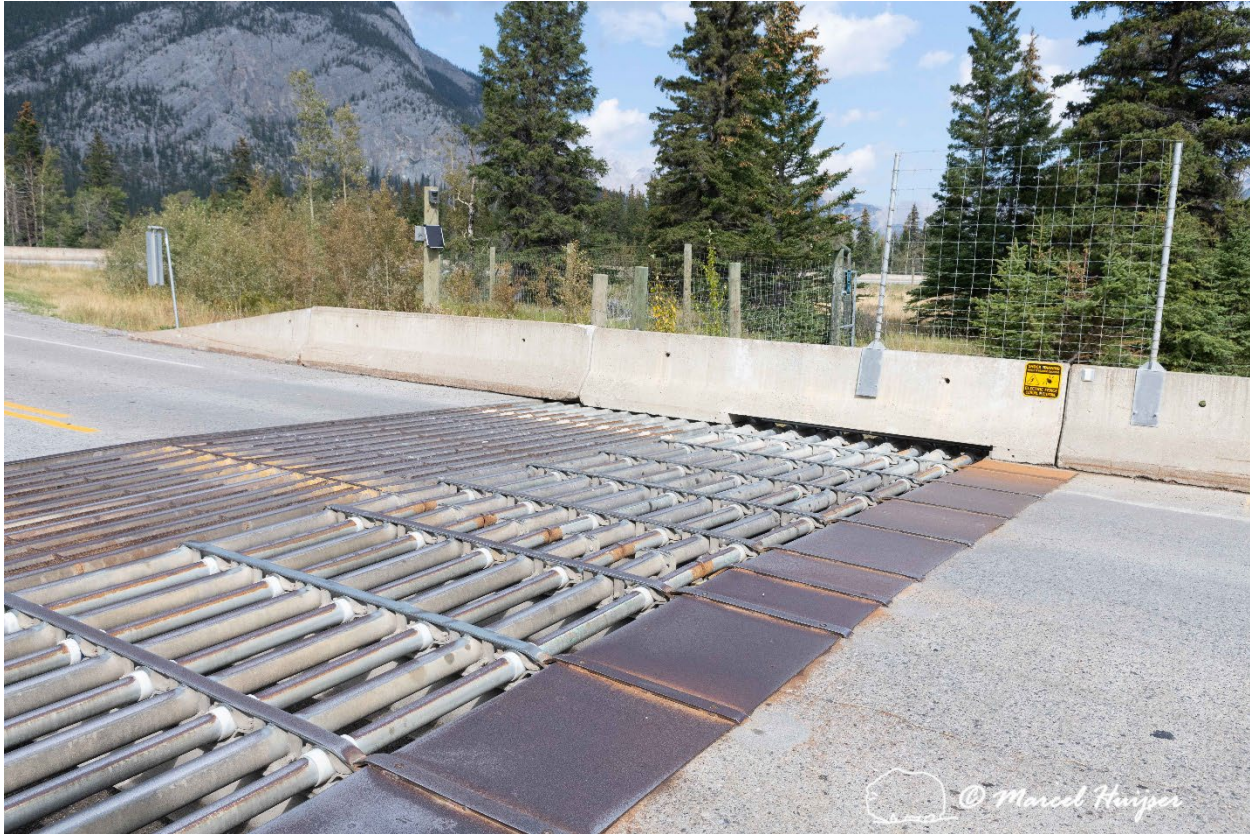
Figure 27: Electrified barrier, Compound Road, Banff National Park, Canada.

The barrier at Compound Road is constructed similar to the one at Sunshine Road (Figure 27). This barrier did not receive a grounding plate (with protective strips) until the end of September 2021 (personal communication Dan Rafla, Parks Canada).

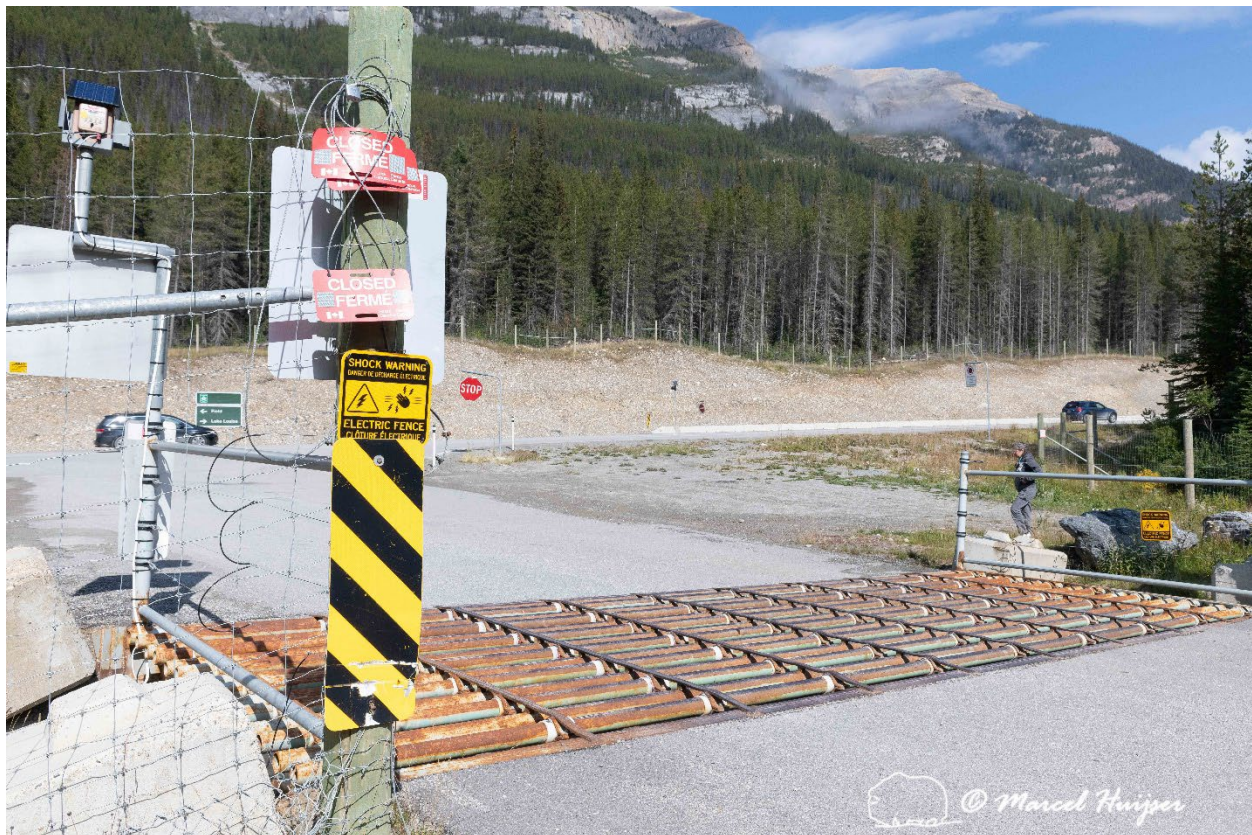
Figure 29: Electrified barrier, Lake O'Hara exit, Yoho National Park, Canada.

This barrier does not have a grounding plate. The Trans-Canada Highway is in the far side of the image. The foreground is the habitat side. This barrier does not have a grounding plate. This barrier has been operational, but the electricity is turned off in winter when most bears are inactive.

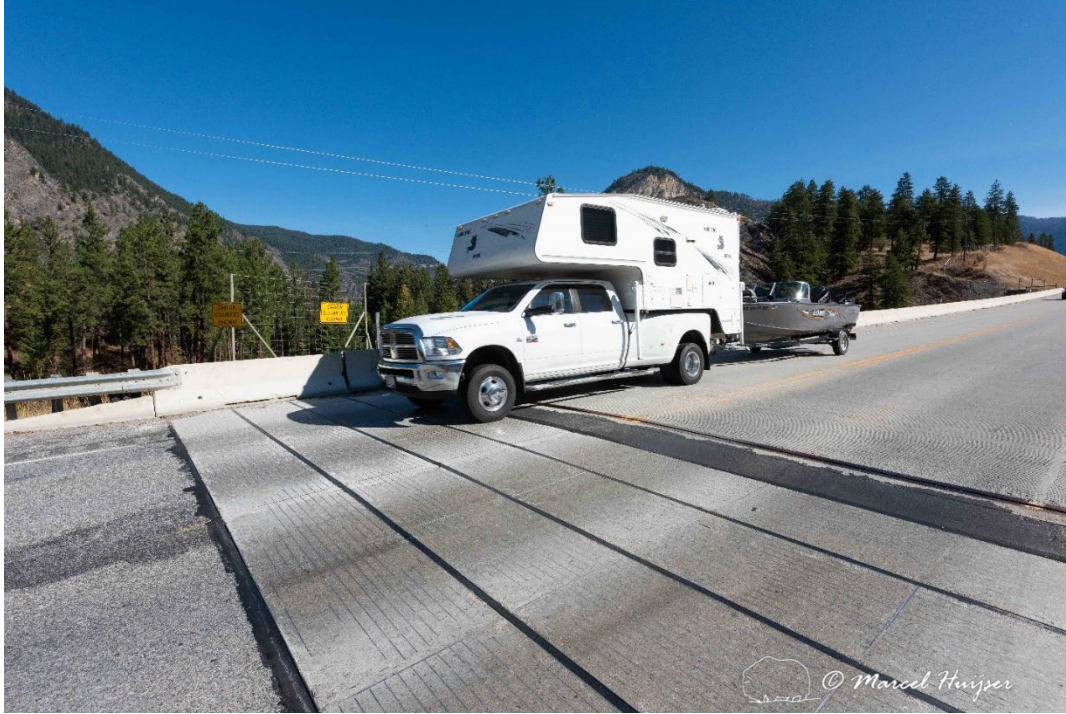
**Figure 31: The electrified barrier at the west fence-end. Note that the bridge directly connects to the electrified barrier.**

ZapCrete™ consists of concrete, conductive materials and insulation materials. The power source is a solar battery system. The dimensions of the electrified barriers are 40 ft x 12 ft (12.2 x 3.7 m) (west end) and 33 x 12 ft (10.1 x 3.7 m) (east end) (personal communication Tim Hazlehurst, CrossTek™ Wildlife Solutions) (Figure 31-34). Each mat is solar-powered and consists of metal strips embedded in concrete. There are 2 pushbuttons at each mat, one for each travel direction. These buttons are for pedestrians and other non-motorized traffic that may be at risk of receiving an electric shock (around 10kV). After the button has been pushed, the power turns off. After about 1 minute the power turns back on automatically. The total cost for two mats across 2 lanes was approximately US\$ 247,000, including materials and labor (about US \$ 123,500 per mat).

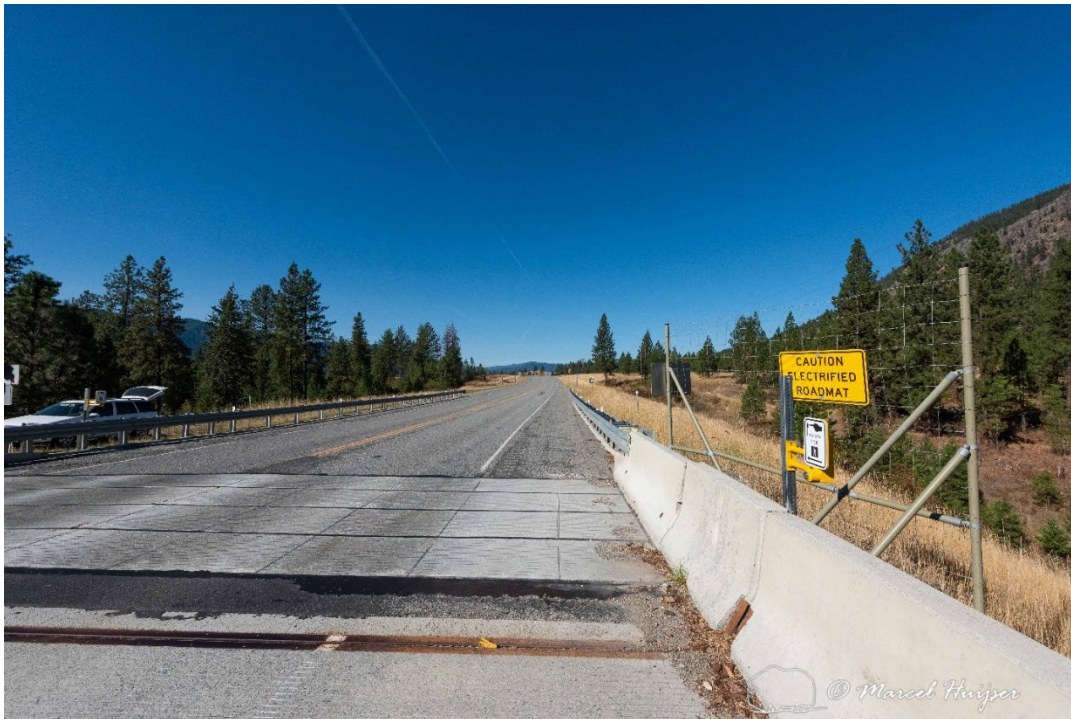
**Figure 32: The electrified barrier at the west fence-end. Note that the bridge directly connects to the electrified barrier.**

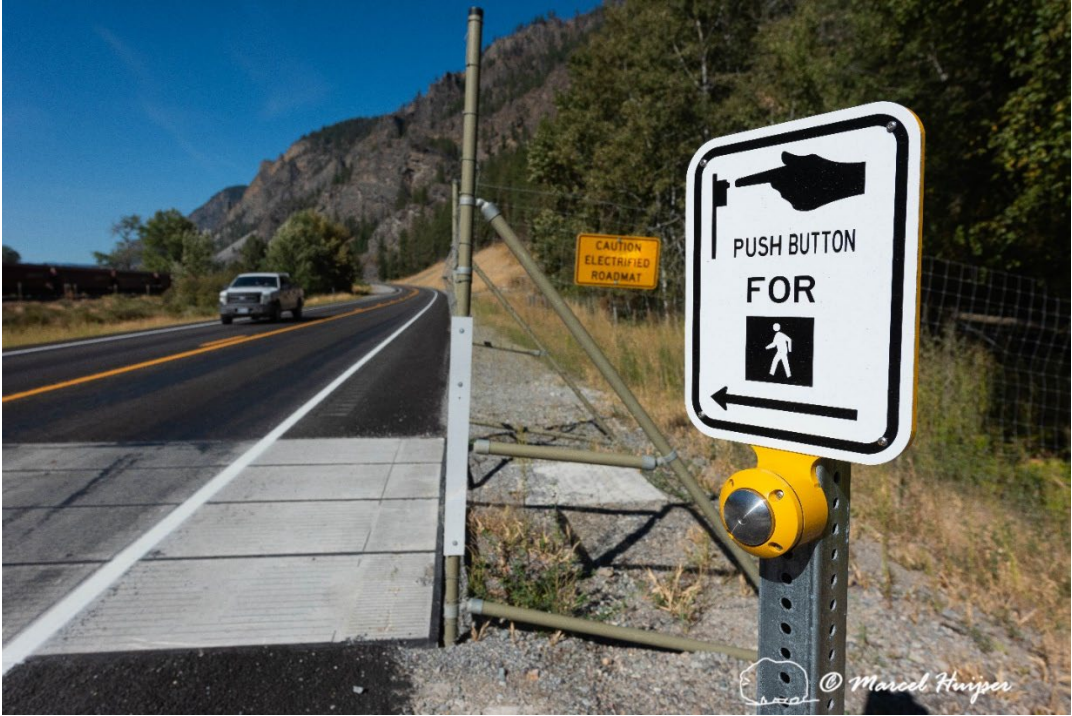
Figure 34: One of the push buttons for pedestrians at the electrified barrier at the east fence-end. There are 2 push buttons; one for each travel direction.

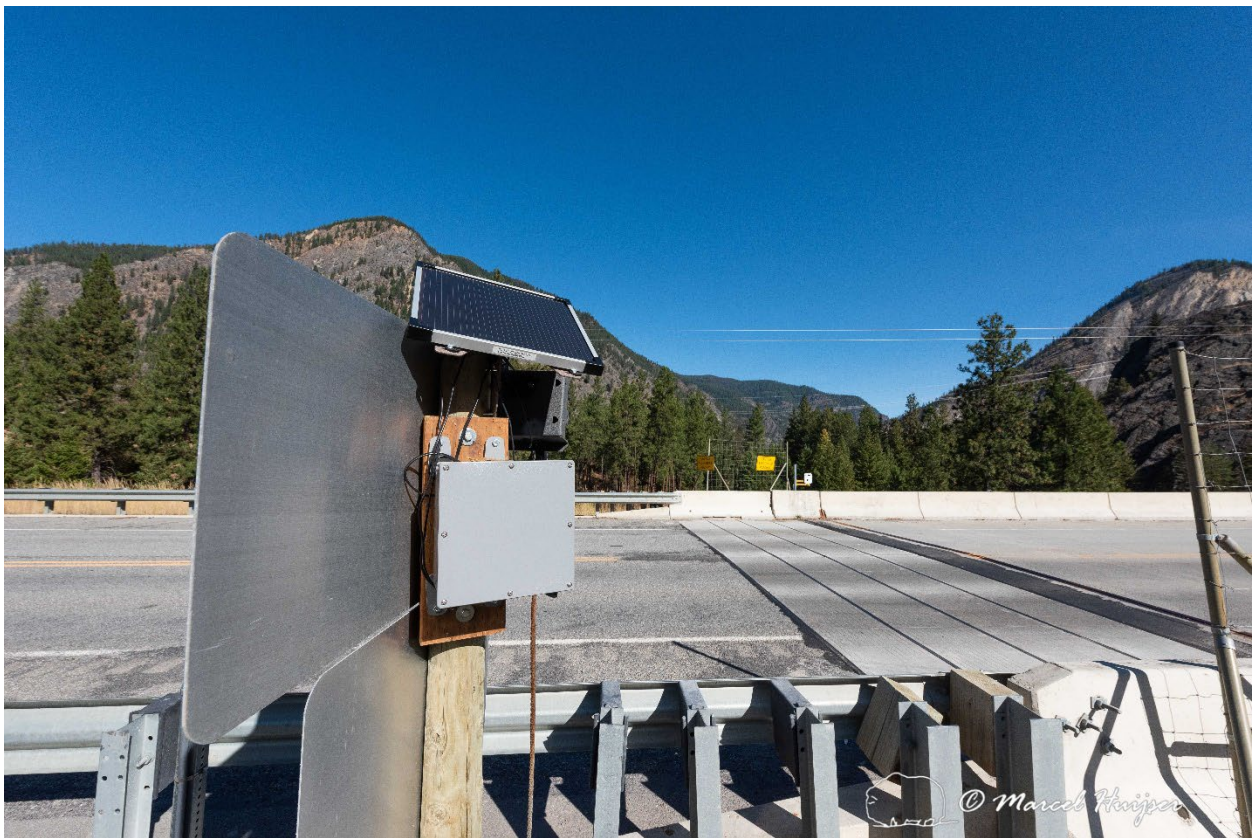
**Figure 35: The camera, battery box and solar panel installed on a sign post behind the sign at the western electrified barrier.**

The west and east electrified barrier each had a trail camera installed (HyperFire 2 Professional Covert IR) (Figures 35, 36). To accommodate the heavy use of the cameras associated with the traffic volume (about 2,000 potential camera triggers per day on average), the cameras were customized with an external power. This allowed the cameras to be powered through a solar panel and associated battery. In addition, high-capacity memory cards (64 GB) were used. The cameras were checked, and the memory cards were exchanged about once a month. The camera at the west fence-end was installed 30 September 2020. The camera at the east fence-end required a new post for which a right-of-way encroachment permit was obtained from MDT on 8 October 2020. The post and camera were installed on 27 October 2020.
