**NDOT Research Report**

**Report No. 701-18-803 TO 6 Part 2**

**TPF-5(358)  
PART 2 - WILDLIFE BARRIERS: THE  
EFFECTIVENESS OF ELECTRIFIED BARRIERS  
TO KEEP LARGE MAMMALS OUT OF FENCED  
ROAD CORRIDORS**

**September 2022**

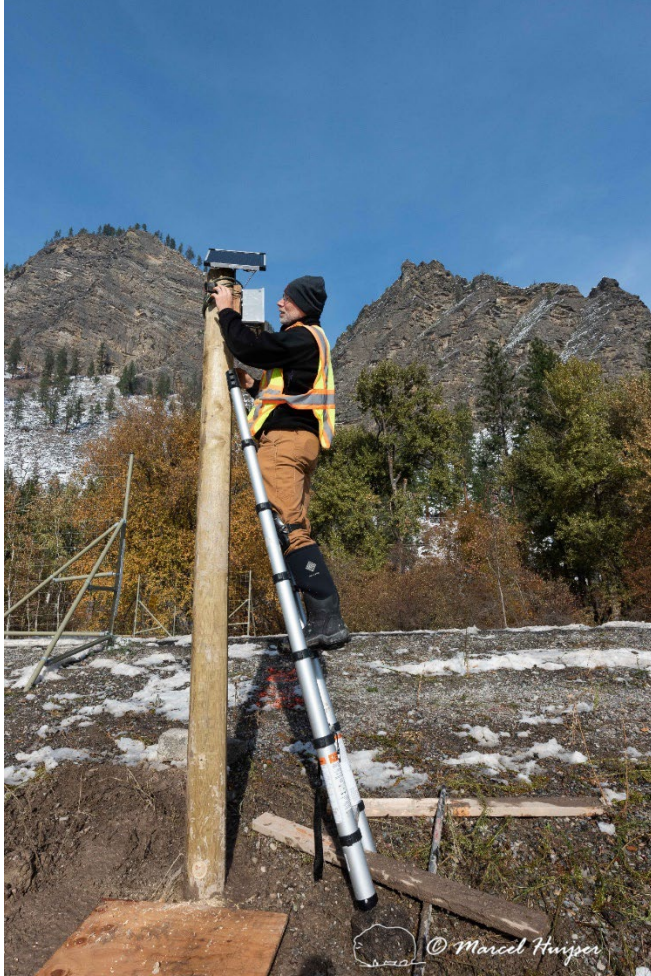
**Figure 36: The camera, battery box and solar panel installed on a designated newly installed post at the eastern electrified barrier.**

The west and east electrified barrier each had a trail camera installed (HyperFire 2 Professional Covert IR) (Figures 35, 36). To accommodate the heavy use of the cameras associated with the traffic volume (about 2,000 potential camera triggers per day on average), the cameras were customized with an external power. This allowed the cameras to be powered through a solar panel and associated battery. In addition, high-capacity memory cards (64 GB) were used. The cameras were checked, and the memory cards were exchanged about once a month. The camera at the west fence-end was installed 30 September 2020. The camera at the east fence-end required a new post for which a right-of-way encroachment permit was obtained from MDT on 8 October 2020. The post and camera were installed on 27 October 2020.

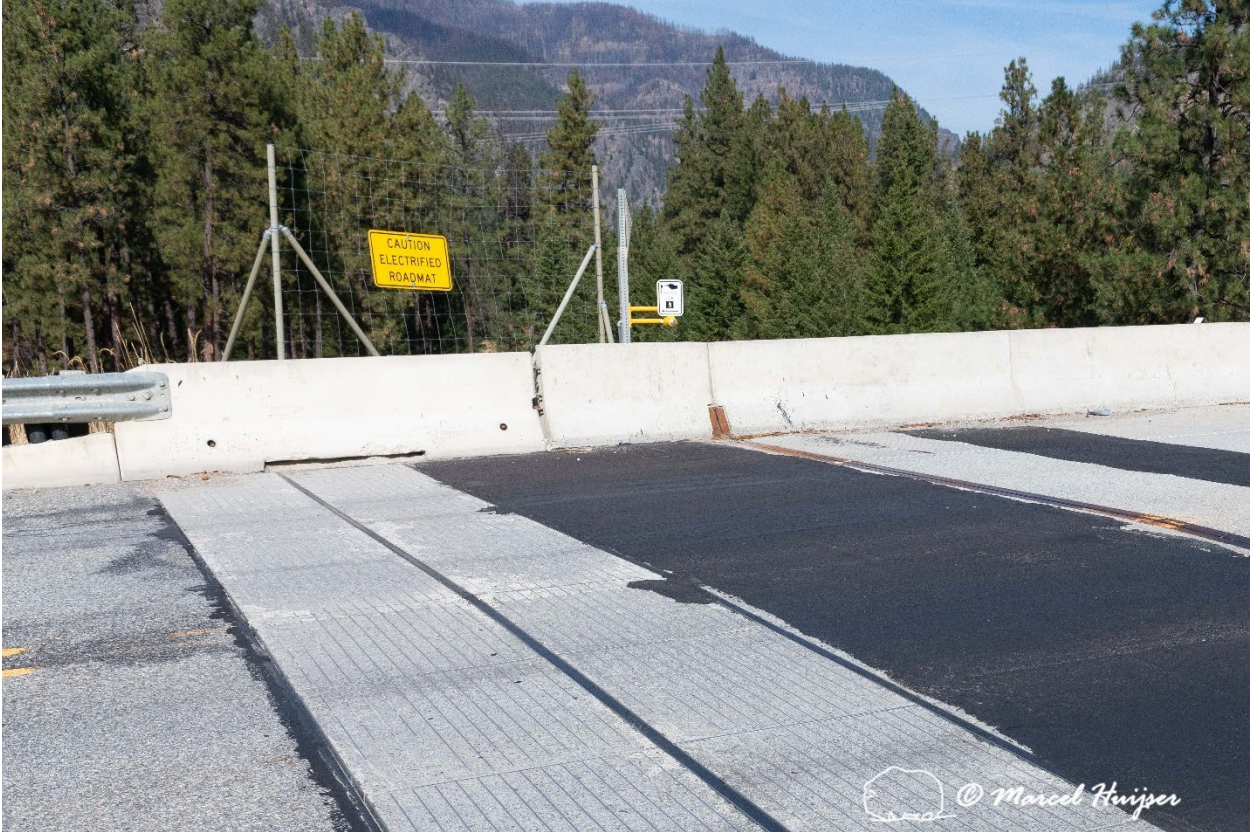
Figure 38: The crumbling concrete at the western electrified barrier was covered in asphalt.

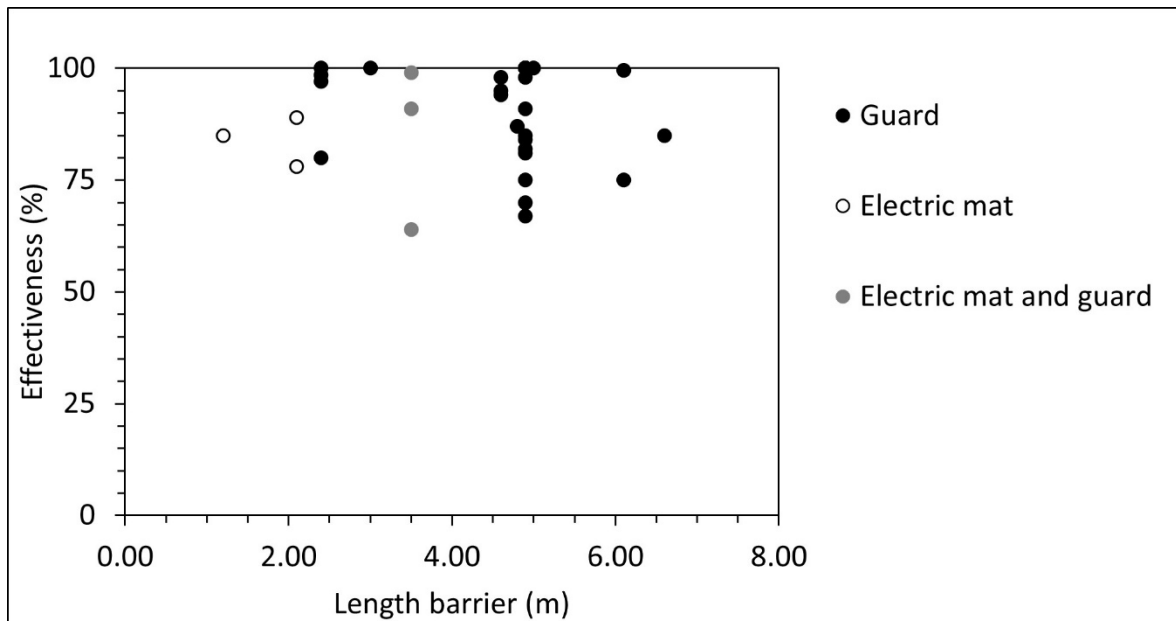
**Figure 39: The effectiveness of different barrier types (guard, electric mat and a combination of an electric mat and guard) in relation to the length of the barrier. Based on Belant et al. 1998; Peterson et al. 2003; Seamans & Helon 2008; VerCauteren et al. 2009; Allen et al. 2013; Clevenger & Barrueto 2014; Cramer & Flower 2017; Gagnon et al. 2020; Honda et al. 2020; Kintsch et al. 2021.**

The researchers plotted the effectiveness of barriers for large ungulates against the length of the barrier (Figure 39). The length is the distance that animals would have to cross to reach the other side of the barrier. Most while most barriers of all types are a substantial barrier (>80%) to large ungulates, there is not a clear relation with the length of the barrier. This suggests that the target species (different large ungulate species) and differences in design and implementation and maintenance may cause substantial variation in the effectiveness of the barriers.
