Progress Report
Fourth Quarter 2007 through First Quarter 2008
Midwest Roadside Safety Facility
Mid-States Regional Pooled Fund Program
March 17, 2008

Pooled Fund Consulting Summary

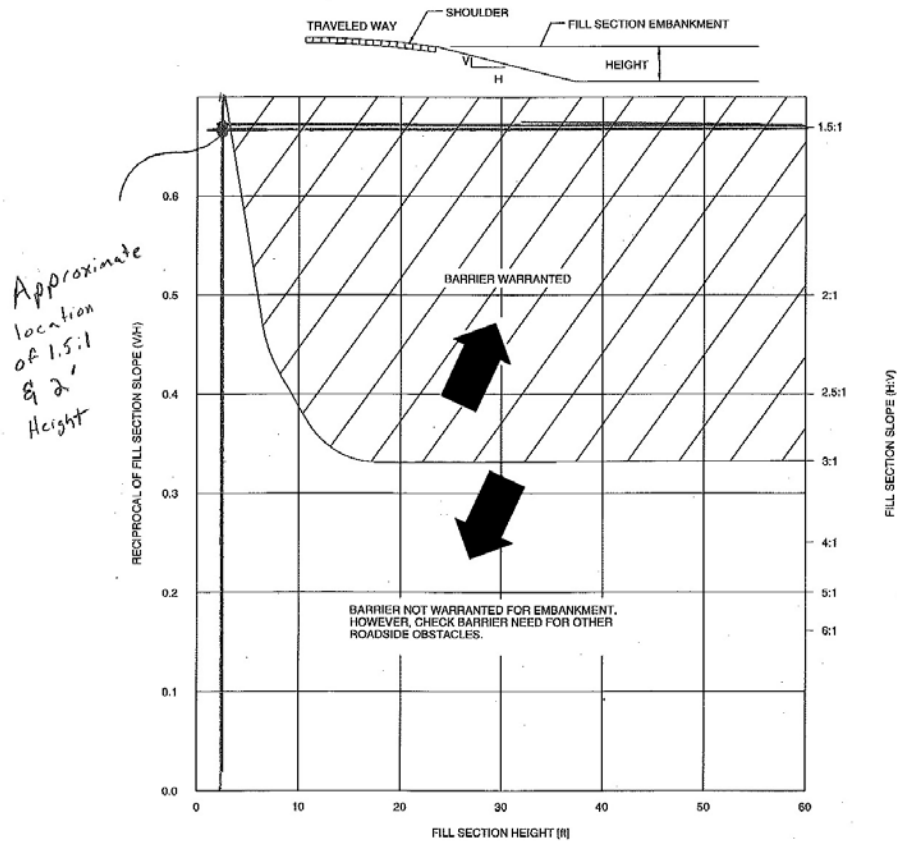
Figure 2. RDG Slope Guidelines

FIGURE 5.1b Comparative risk warrants for embankments [U.S. customary units]

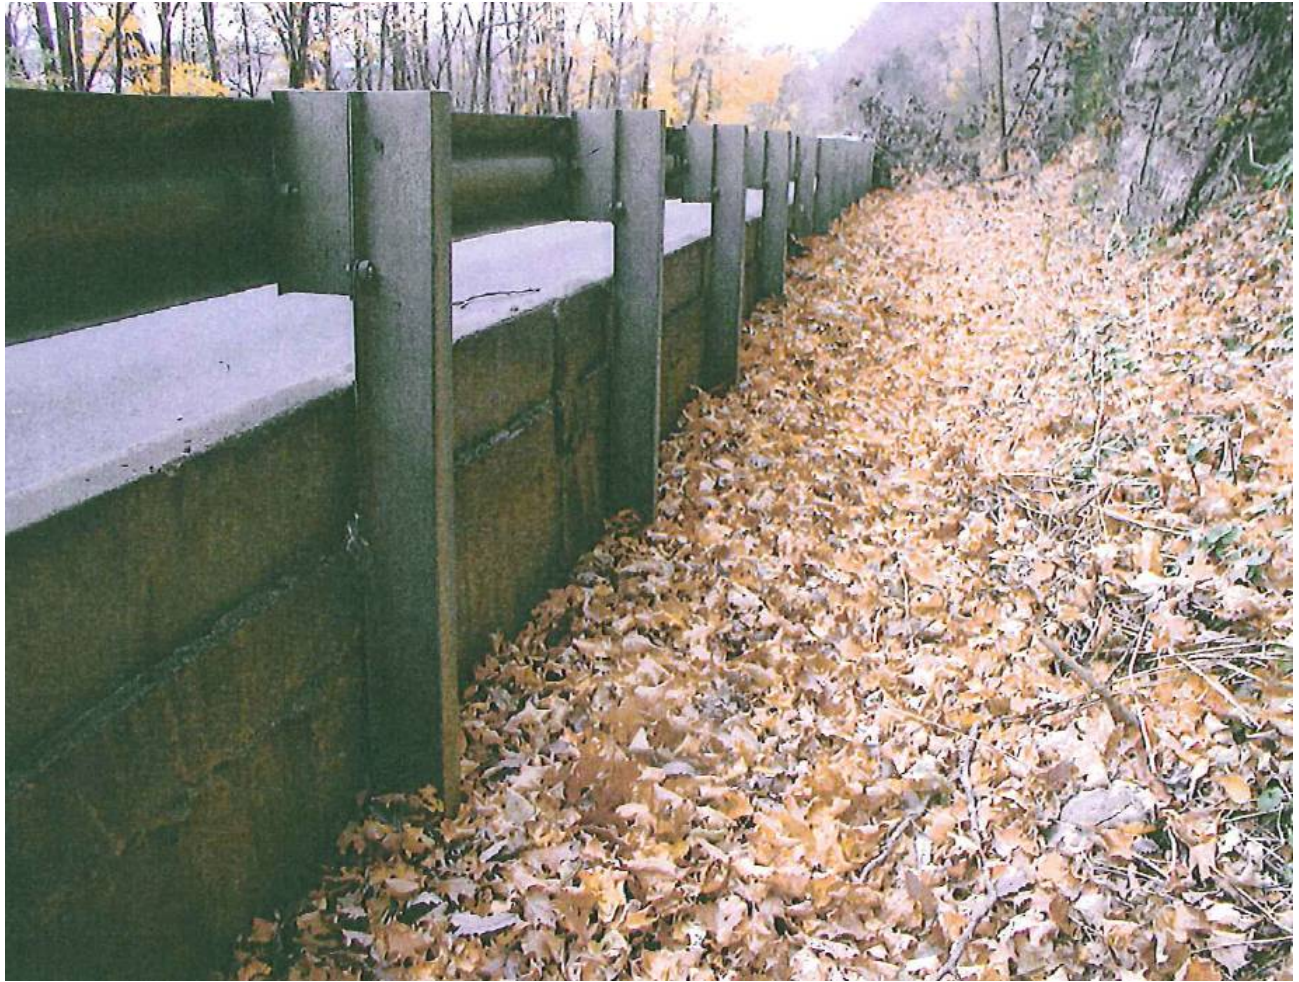
Figure 4. Guardrail Adjacent to Retaining Wall

I am seeking your opinion on how to address this situation. Would you recommend bolting the MGS posts to the wall, as was done previously? Or would we be able to place the posts independent of the wall? Would thrie-beam be appropriate here, or would standard W-beam be sufficient?

At this time, I cannot recommend attaching the MGS to the headwall as our MGS bridge rail project has not been completed. Actually, we are only beginning the Phase I part of that effort in the Year 18 program.

As an alternative you could attach the MGS using an adaptation of the guardrail culvert system that was previously developed for culvert slabs. We discussed this system in the first three topics of the MGS implementation discussions that occurred before I left on medical leave. Did you or Deanna receive those emails? I am not sure as many of the Pooled Fund State members have not commented on the noted topics.

If that option is not possible, then I suggest using a thrie beam bridge railing detail that already has been crash tested. Also, one would then use the asymmetrical w-beam to thrie beam transition section in conjunction with approved transition designs. MwRSF is currently revises details for the transition to exisitng transitions as well.

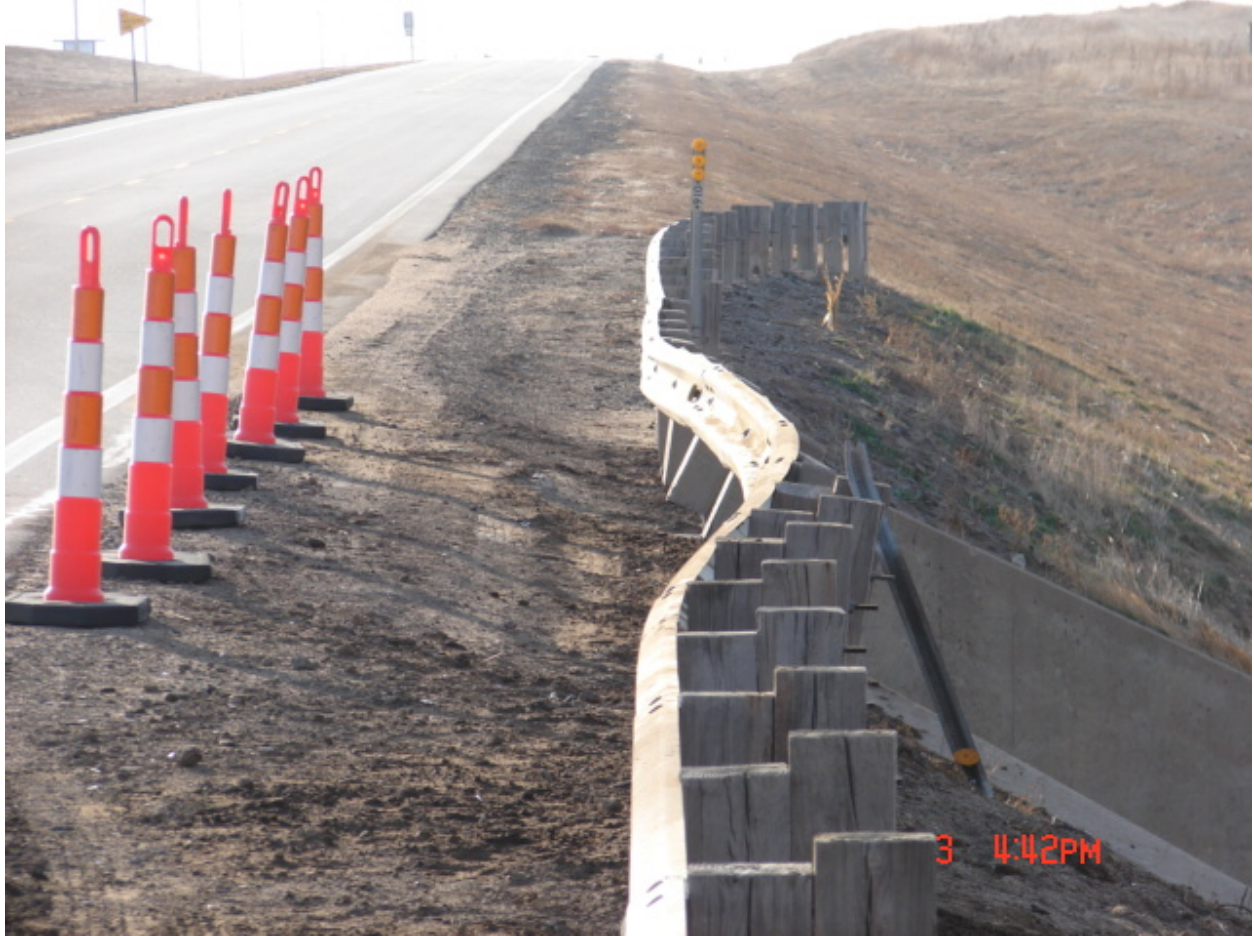
Figure 5. Guardrail Adjacent to Culvert

Bob this is a follow-up to our conversation today regarding the repair of a guardrail on US-56. The existing guardrail is protecting a triple 20'x20' box culvert. The guardrail is non-blocked out on concrete posts. The maintenance repair options we have will result in narrowing of the shoulder or extension of the box culvert to accommodate a low-fill guard rail attachment. Both of these options are not likely for a maintenance activity. Do you know of any designs that allow guardrail posts to be bolted to the outside edge of the culvert headwall? I could not find any details. However Dale said that he found a little info from West Virginia DOT. The sheet is called "Guardrail Installation on Box Culverts and Bridges" I have not had a chance to look at this yet.

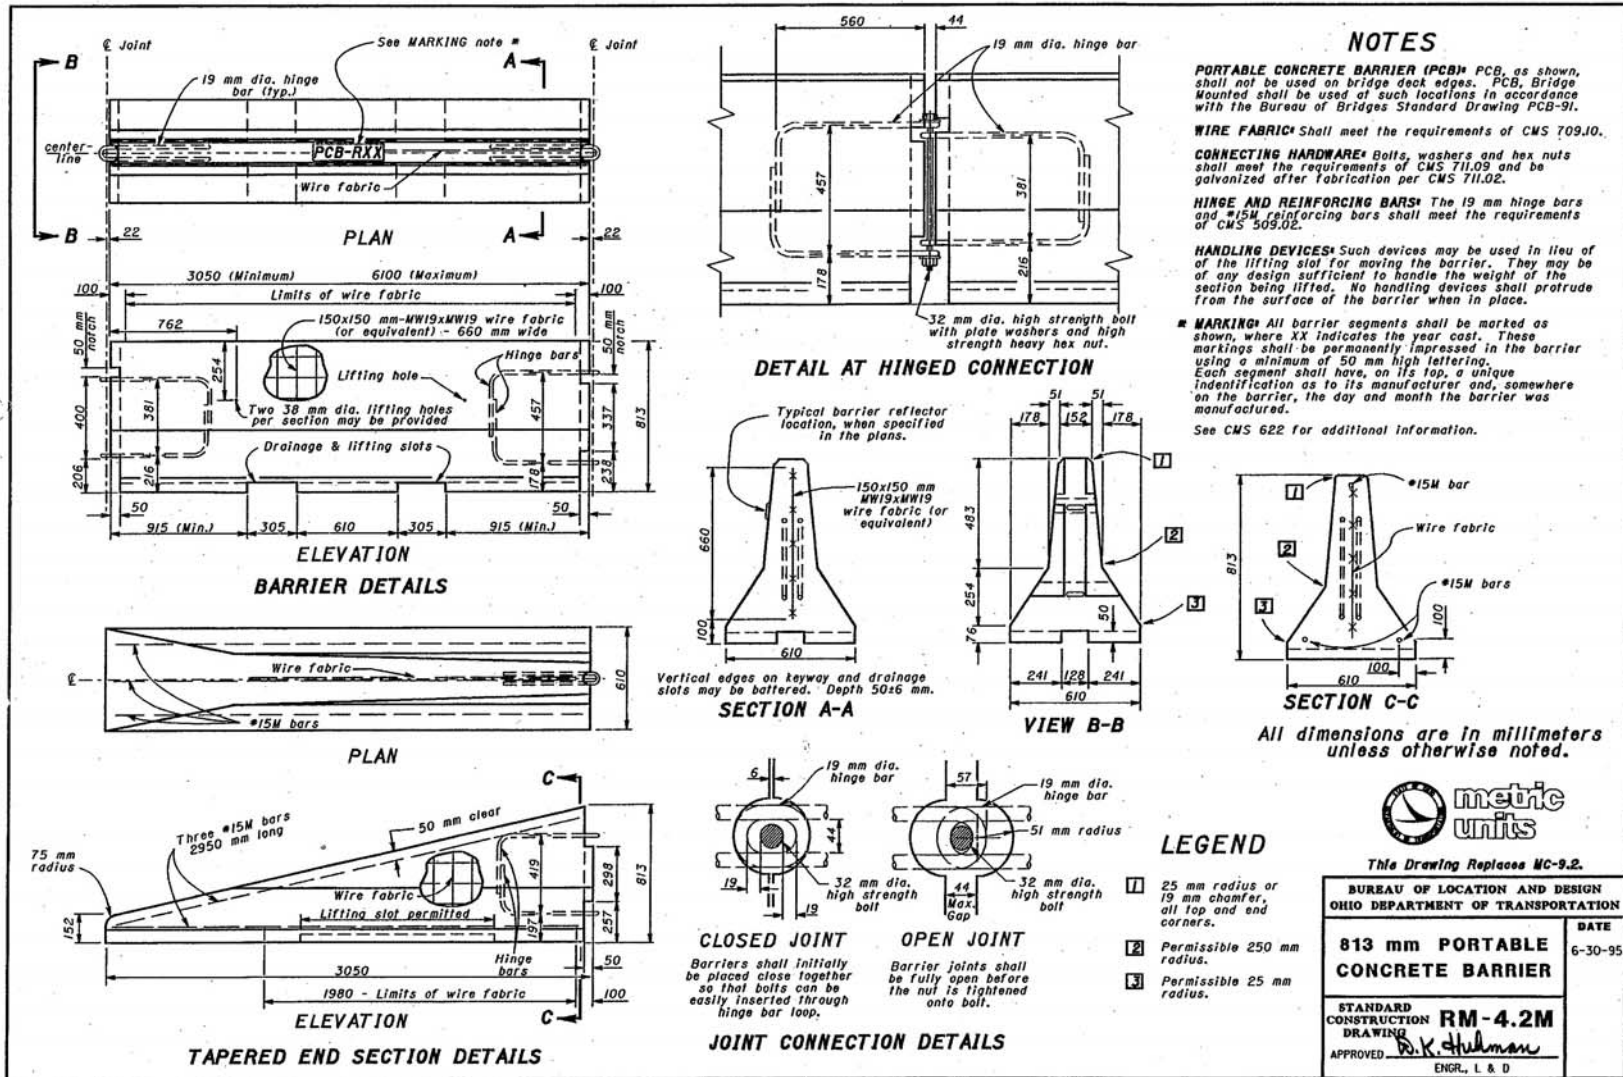
Figure 6. Unreinforced PCB

One addition note on the detail is the tapered end section details. The TL-2 tested tapered end-section has been tested and required a 20' length. Thus, it appears the end section on your detail does not have sufficient length. We would recommend that you use an extended tapered end section if possible.

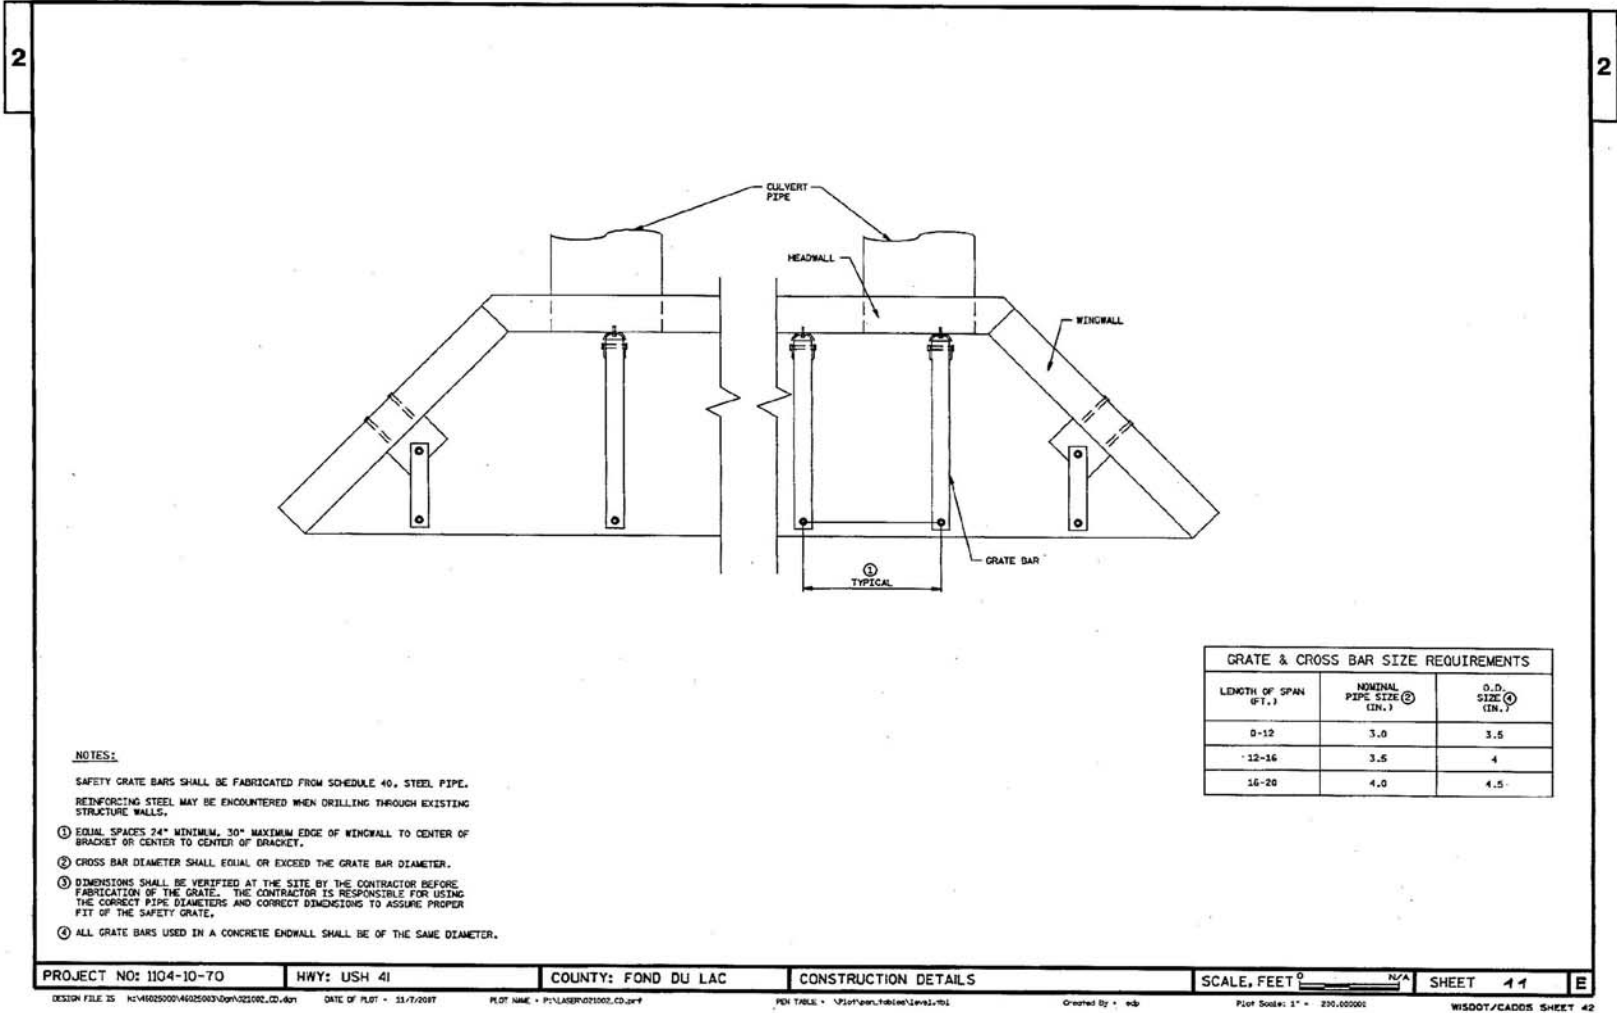
Figure 7. Traversable Culvert Grate

As I looked at the plan, I found out that the designer has developed a special detail to install steel bars to make a box culvert traversable (see attached details). I believe that the safety pipe runner spacing is correct. The inside diameter of the safety pipe runners are slightly over sized.

1. The Schedule 40 pipe listed on your plans is sufficient for allowing the vehicle to transverse the culvert. The table in your plans is developed from testing done at TTI in 1980 and was later adopted as an AASHTO guideline. Furthermore, we conducted a test of the culvert pipes with the largest spacing and size in the table on a 3:1 slope with the 2000P vehicle and the 820C vehicle and found that the specified pipes and spacing were adequate.

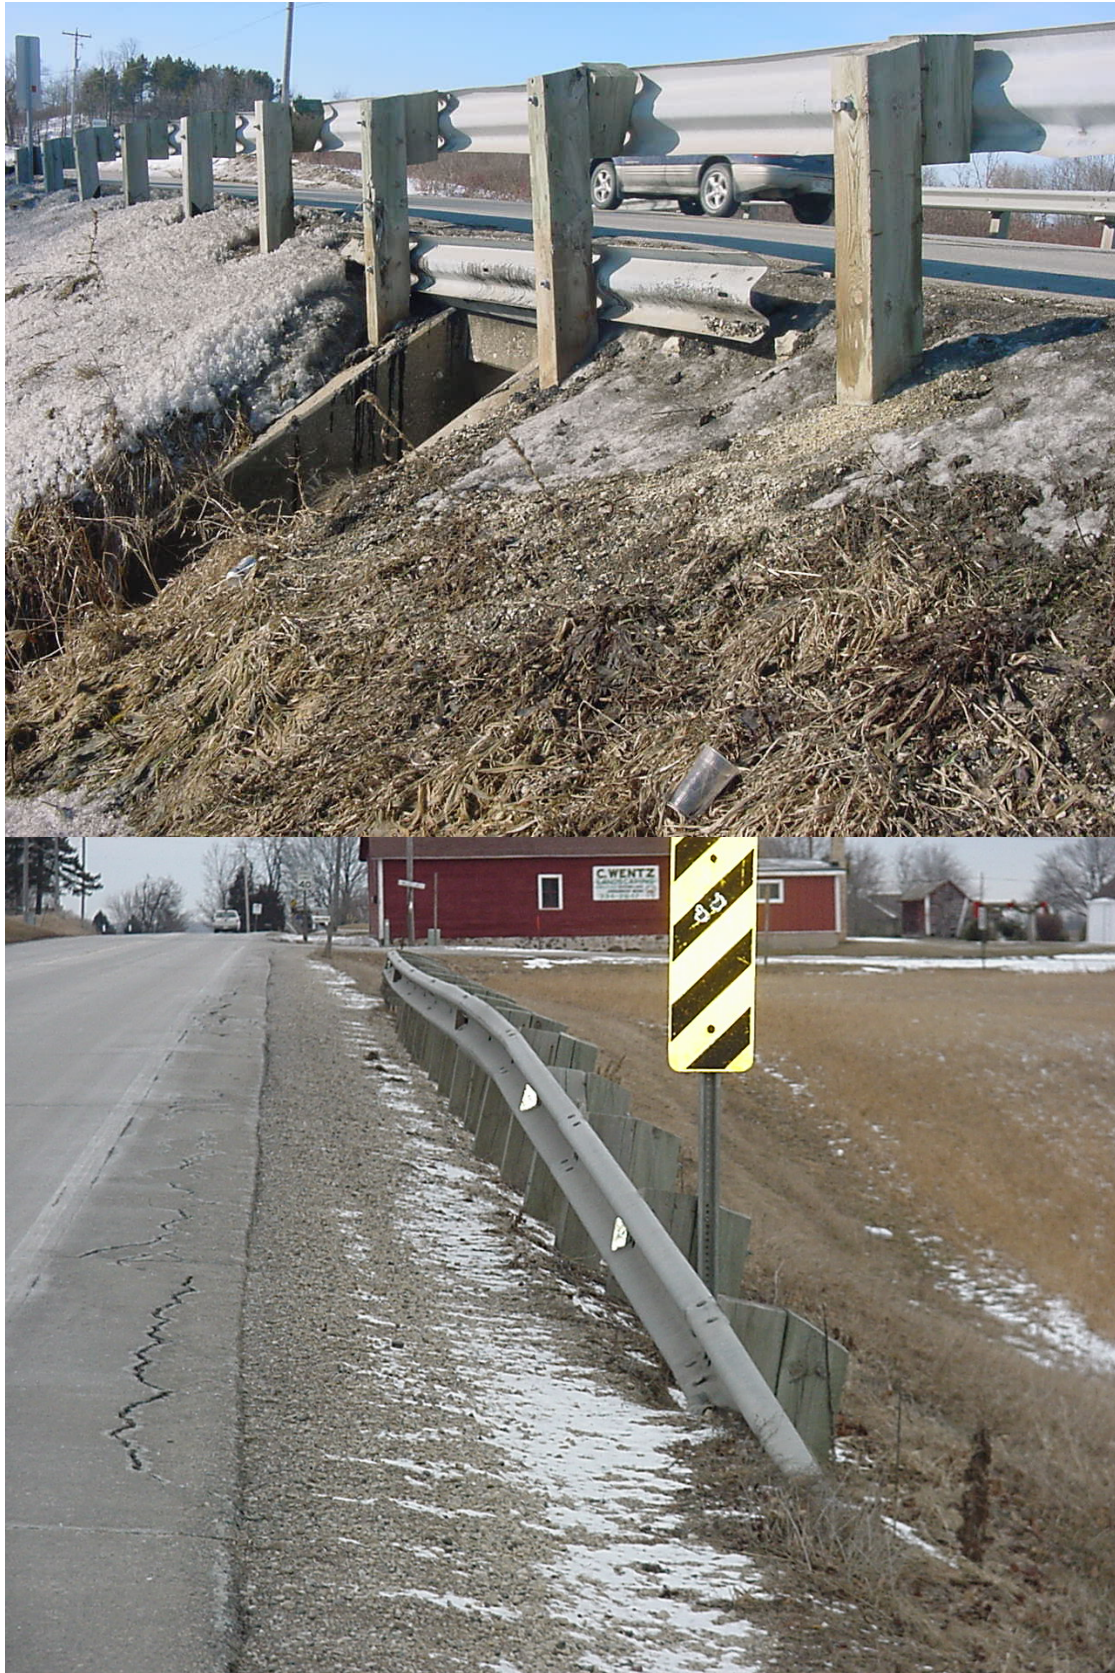
Figure 9. Guardrail on Slope Installation

In the photographs and design details that you provided, discrete W-beam rail segments were shown bolted to the face of guardrail posts both above and below grade and for retaining soil. We do not believe that this practice should be used. In addition, when asphalt overlays are placed in advance of the guardrail without placing new fill behind the posts, the post-soil behavior is altered. An even greater concern is whether the long, wood posts can rotate at the appropriate load without fracturing. In the past, we have developed recommendations for such cases for the Missouri DOT and with using steel posts. This recommendation was based on the best available data and engineering judgment – no testing. I can find that recommendation if you desire it.

In several of your photographs, the guardrail posts are tipped backward. If subsequent work were to occur in these areas, it would be suggested that the guardrail systems be adapted to meet those noted above and that the posts be placed vertical to reduce any tendencies for vehicle climb and override.

Other photographs also reveal the use of buried, turned down end terminals that are not in a back-slope. If modifications are to occur to these guardrail systems, you will need to review the WsDOT policies for replacing these terminals when certain 3R or roadway surfacing activities are scheduled. I assume that WsDOT has a policy on when guardrail terminal upgrades are to occur. Once again, it is highly recommended that you review this policy before doing any work around these terminals to ensure that you follow your long-range implementation plan for certain roadway classifications.

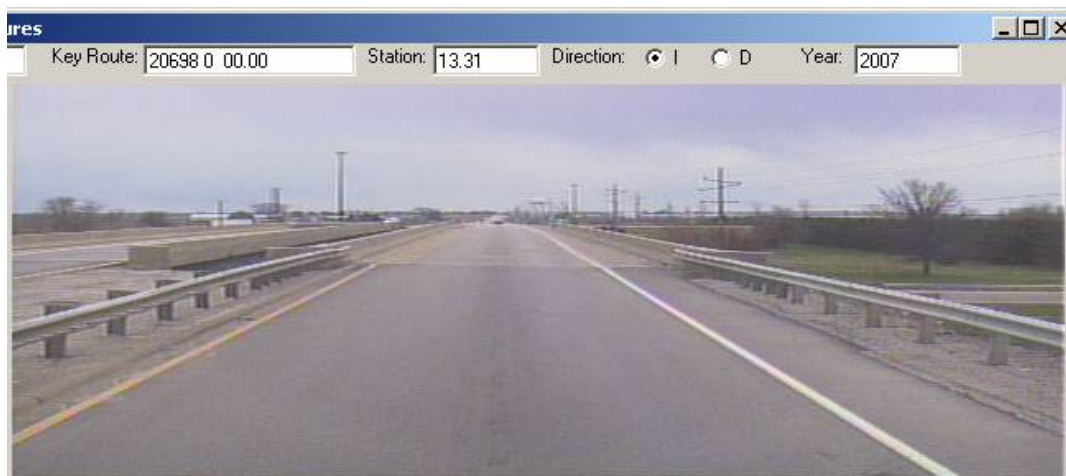
This is the type of bridge parapet/wingwall. The bridge is a Jersey or GM shape. The wing curves away.

We do have reinforcement around the holes for the anchor pins, but it is not as substantial as what is used in the testing of the transition. Ours is #4 bars, where the testing used #6.

There seem to be a couple possibilities – remove and recast the end of the parapet to work with the TCB, or perhaps fabricate a triangular steel shape to bolt to the face of the parapet and provide a connection point and also fill over the curved portion. This latter idea still leaves the question of how to span the back of the joint.

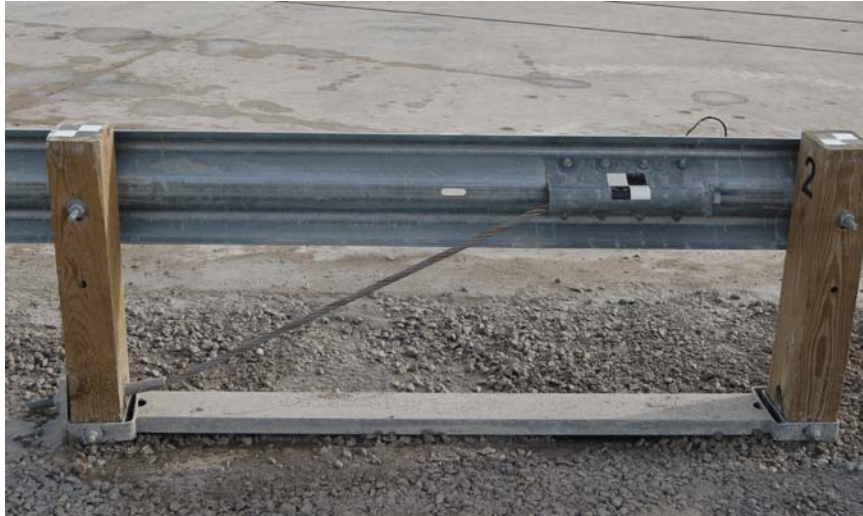
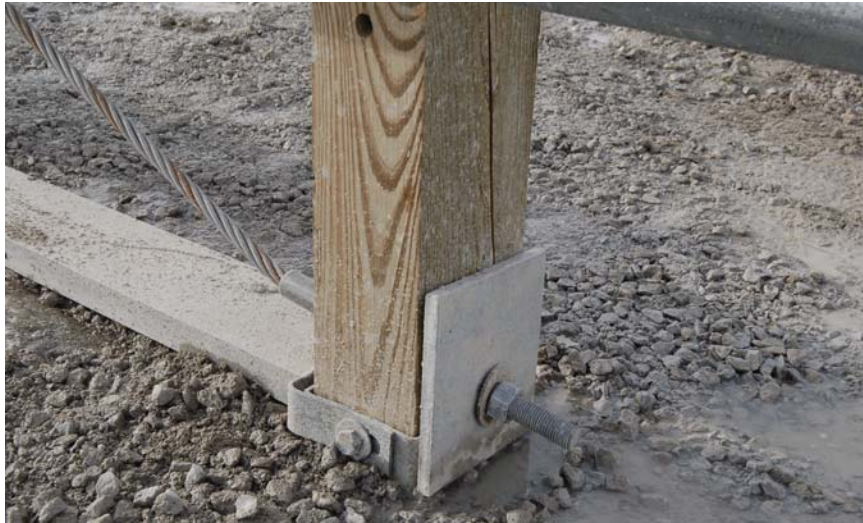
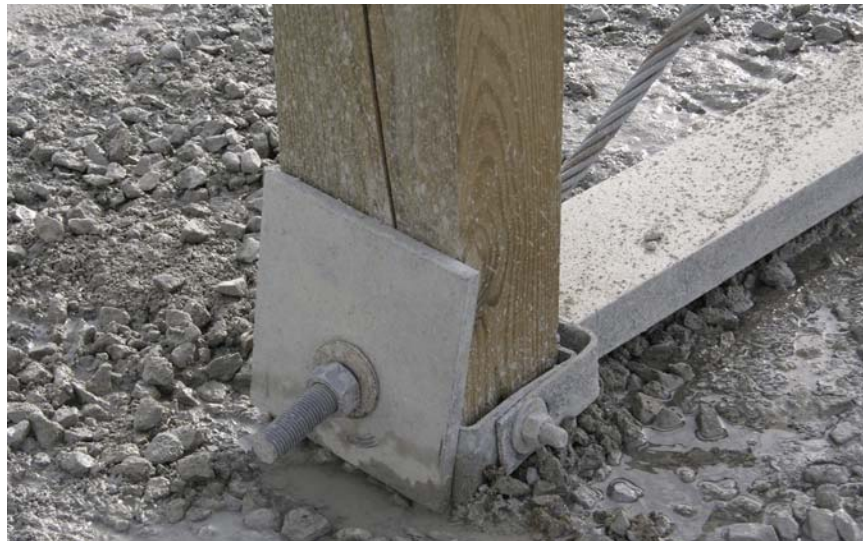
Figure 4. Upstream Anchorage System - Test MWTSP-1

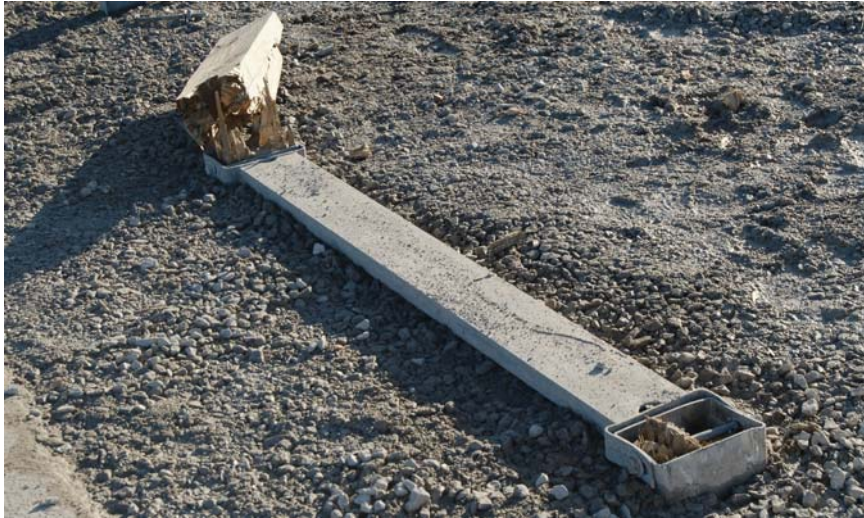
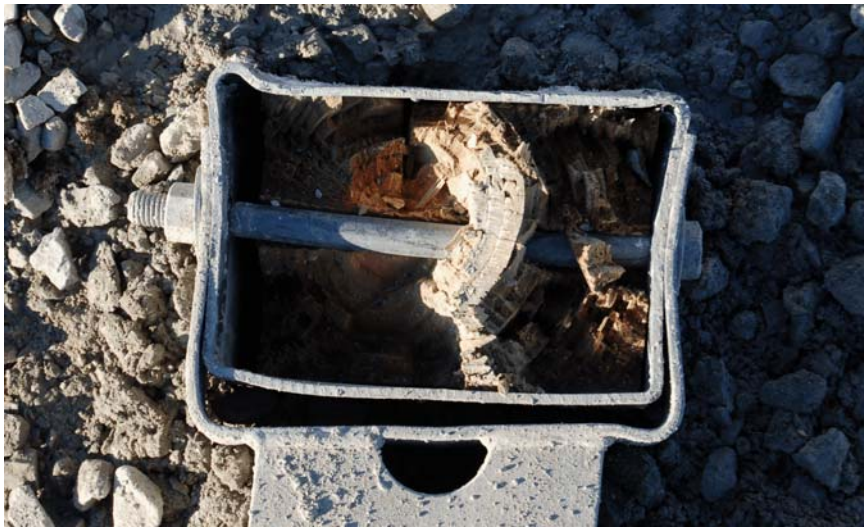
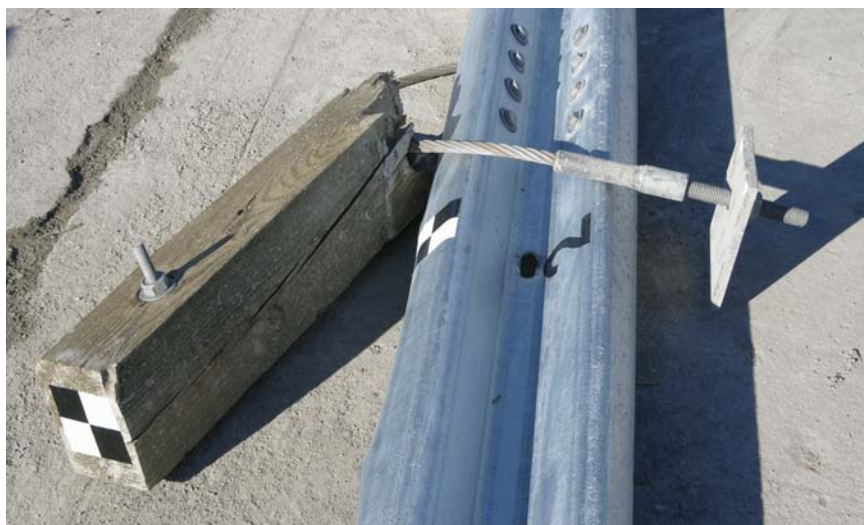
Figure 5. Damage to Upstream Anchorage System - Test MWTSP-1

Following a review of the high-speed videos and damaged barrier hardware, several potential factors affecting the unsatisfactory outcome were observed. First, BCT wood post no. 1 was observed to release due to post fracture. A closer inspection of post no. 1 revealed significant checking through the wide faces of the post along with a critically placed knot on the upstream, back-side corner of the post, just above the steel cable anchor plate. Upon review of the test results, it is believed that the BCT post with checks and a critically-placed knot contributed greatly to the test failure. Second, the steel foundation tube supporting BCT wood post no. 1 was not found to have displaced during the test. This result could have been due to either inadequate load imparted to the foundation tube prior to wood post fracture or a stiffer than normal soil material compacted around the foundation tube. Although an overly stiff foundation tube could increase anchor loading, we believe that this condition would have had only a minor contribution to the failed post and test, since much higher anchor loadings have been observed during prior 2000P tests on the high flare rate MGS designs. Third, Detail K was selected by the States over Detail L due to it being a less costly design (one less steel post) even though it was a more aggressive design. When impacted, Detail K was predicted to result in increased barrier deflection and vehicle pocketing as compared to Detail L. With an increased propensity for vehicle pocketing, combined with greater barrier deflections, it is believed that the selection of the more aggressive design, Detail K, modestly contributed to the failed test. However, it should be noted that FEA modeling of the two modified designs revealed a propensity for

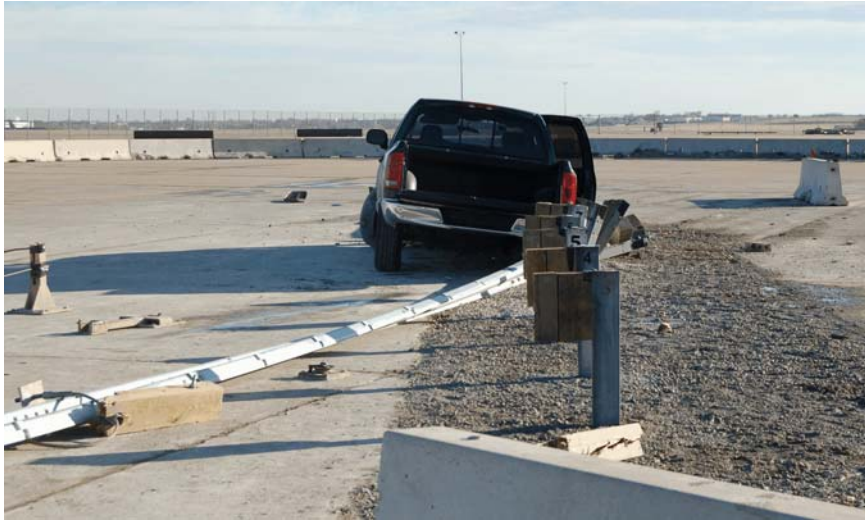
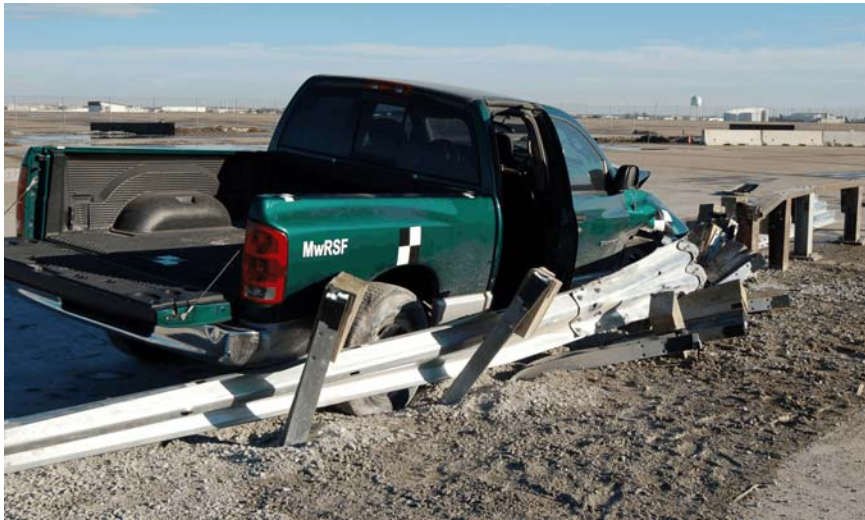
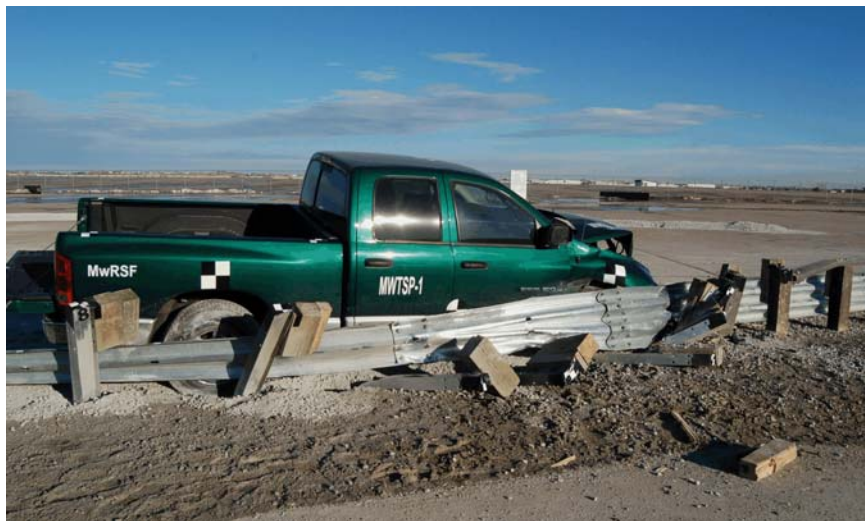
Figure 6. Damage to Approach Guardrail Transition - Test MWTSP-1

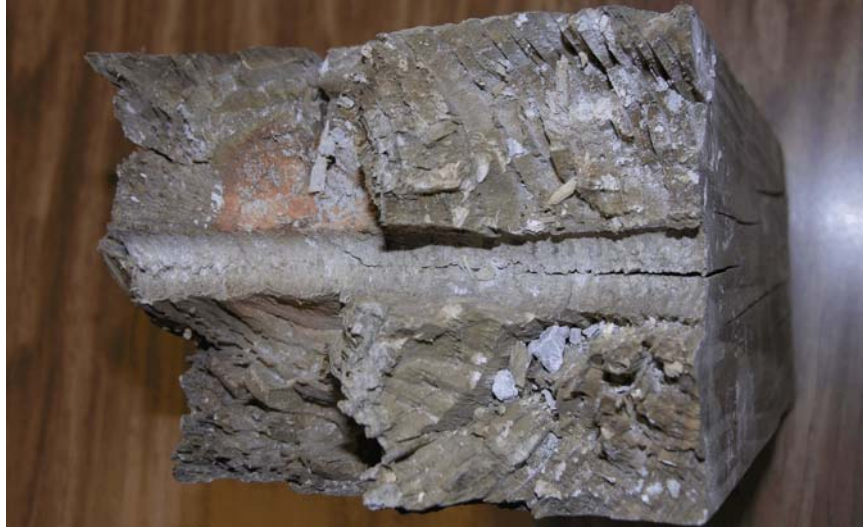
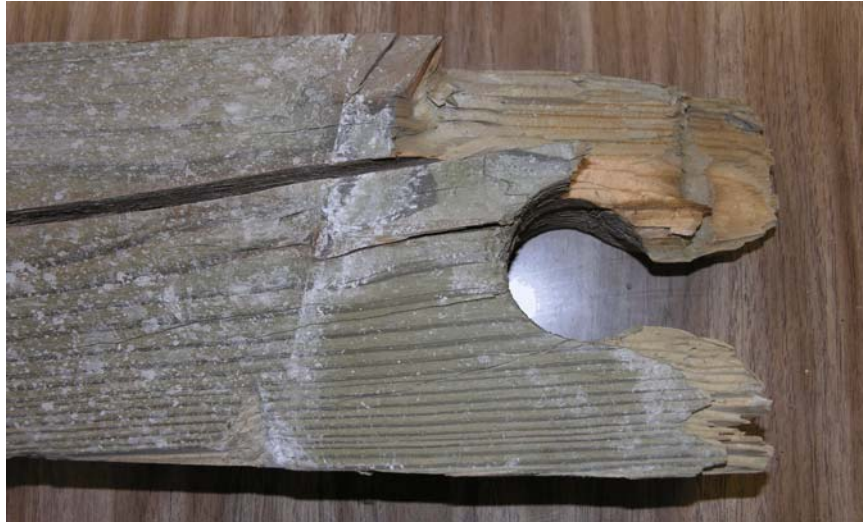
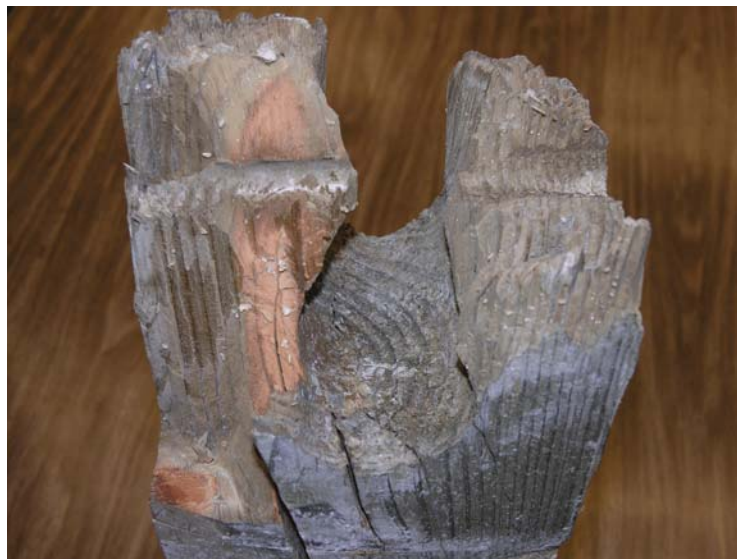
Figure 7. Damaged BCT Wood Post - Test MWTSP-1
