Progress Report
Second Quarter 2008 – April 1 to June 30
Midwest Roadside Safety Facility
Midwest State's Regional Pooled Fund Program
June 20, 2008

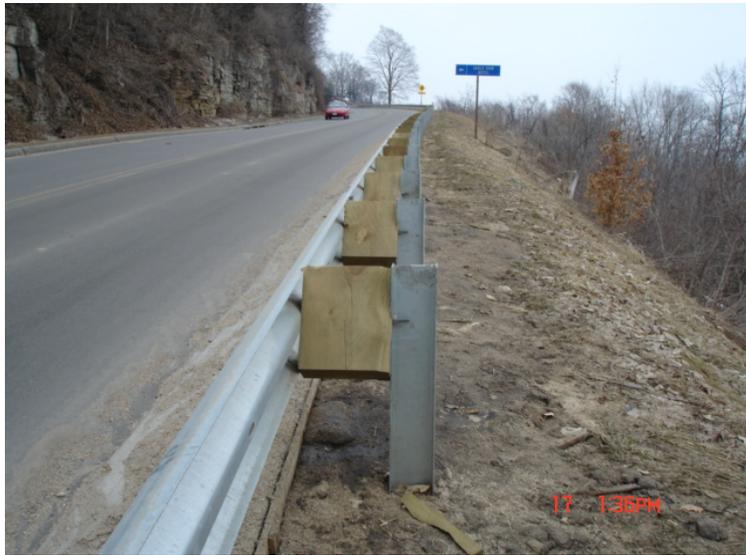
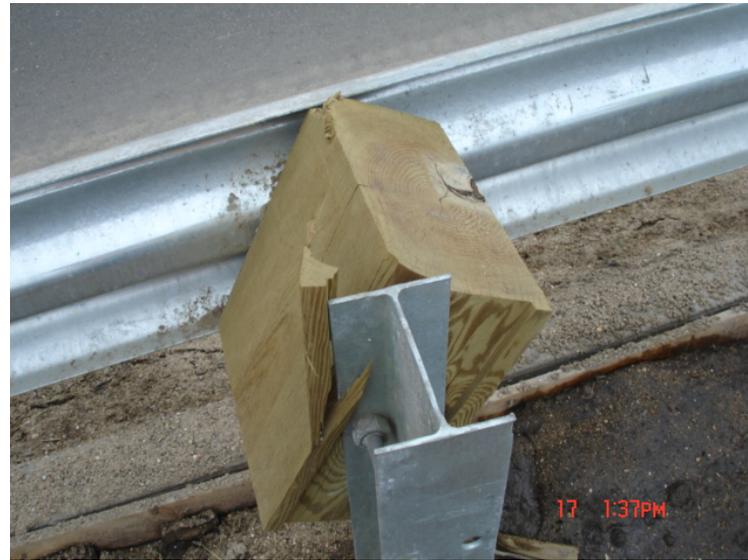
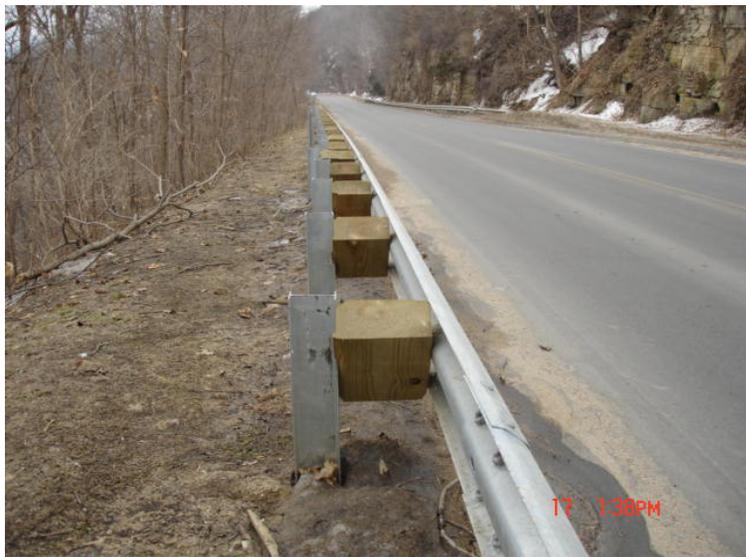
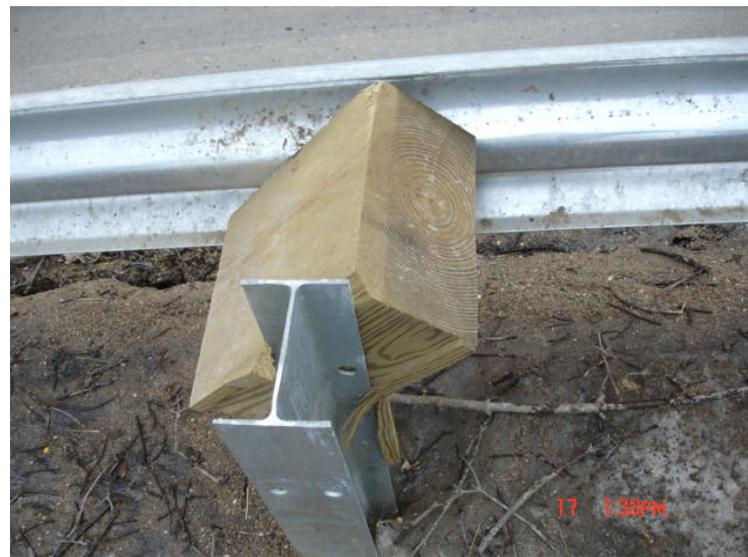
Figure 1. Guardrail blocks on US 52

These are photos of our recently installed MGS system over curb (Figure 1). The plans detailed a 16-d nail into each blockout that apparently wasn't installed.

Had heavy snowfalls all season in this area (and all of Iowa for that matter). Trying to figure out why these blockouts are tipped in this direction, but we're thinking it may be related to snow-removal operations.

My question of the day boils down to repairing this installation. You can see on some of these blockouts, the flange of the post has fractured off portions of the routed channel in the back side of the blockout. Any opinion as to how much of this channel would need to be intact to reuse the blockouts (basically straightening the blockout and placing the nail)?

We agree that this blockout rotation would appear to be caused by snow removal operations. To resolve your blockout issue and eliminate the requirement to field drill holes in the steel flanges, we recommend that you place four (4) nails in the top and bottom corners on both sides and bend the nails over the flanges. The four nails should provide adequate resistance to block rotation, even under snow removal operations. For this solution, you could use 16-d nails, but it may be preferred to use 20-d nails with this alternative. Please note that it would not be necessary to have the post webs on the back of the blockout using this option.

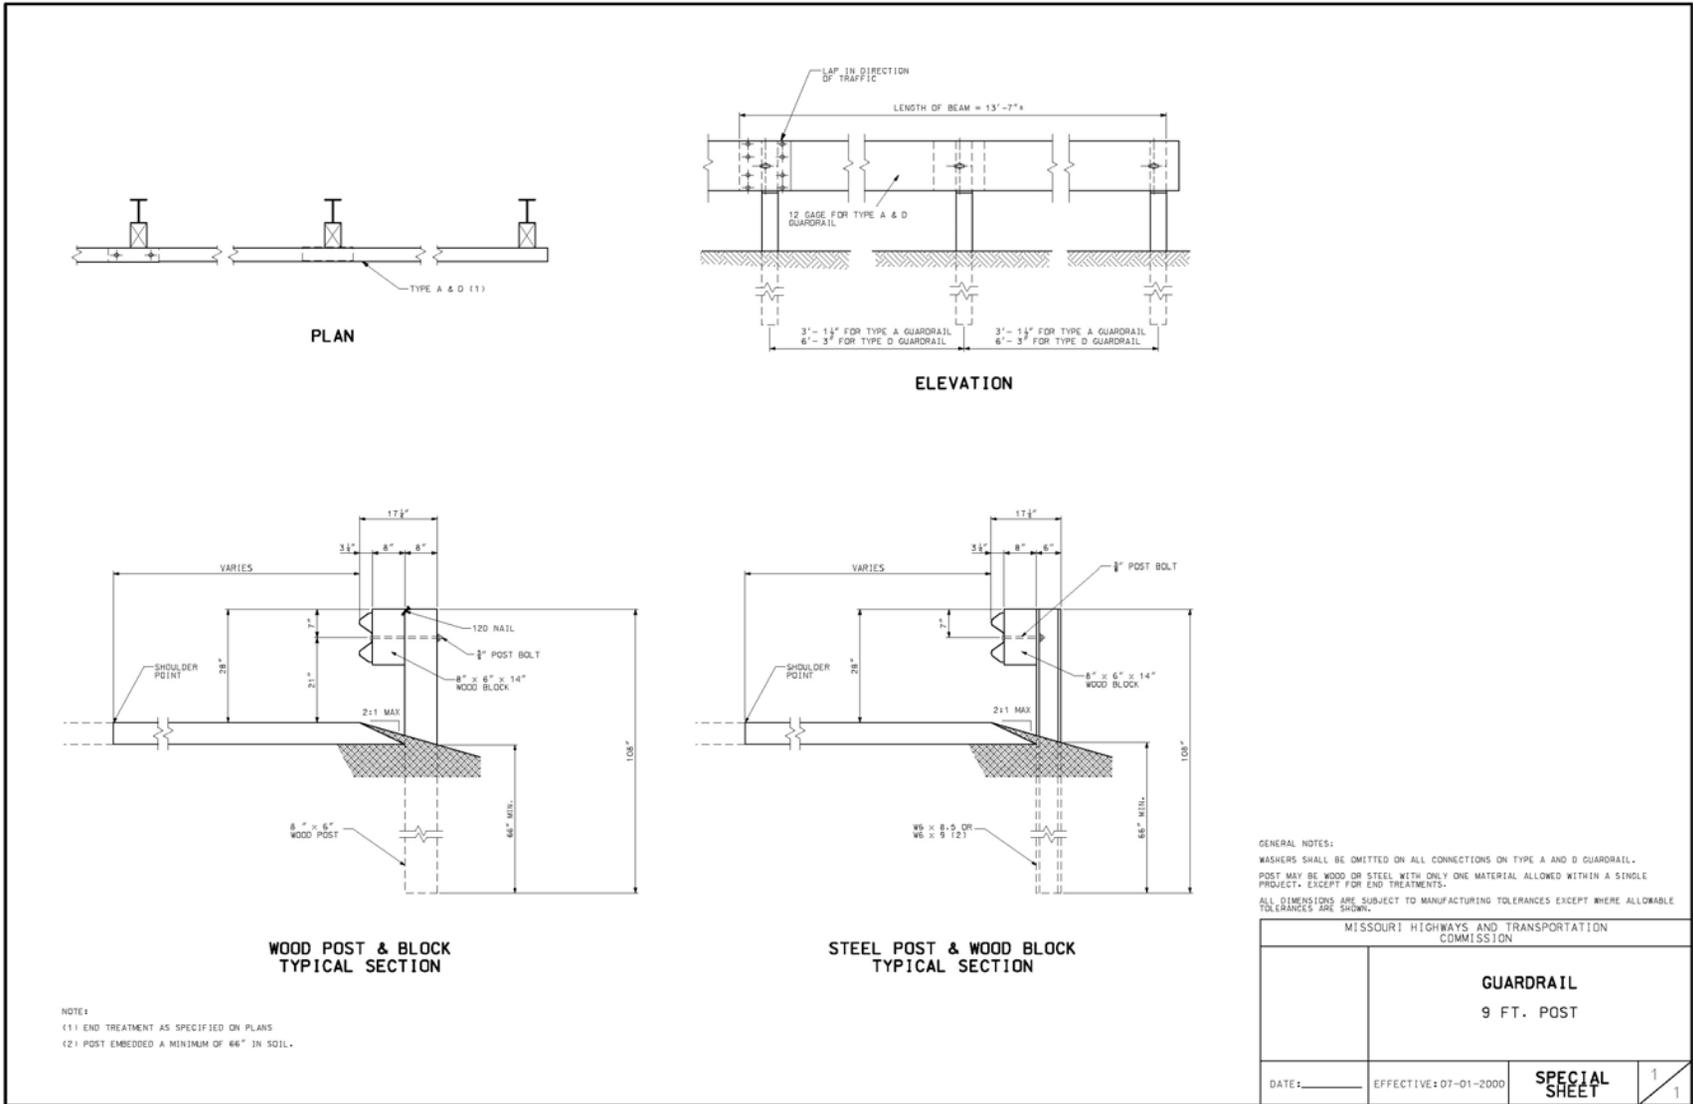
Figure 2. Nine Foot Post Detail

I looked at your schematic of the w-beam guardrail installation on what appears to be a 3:1 slope with a 1:1 or a 2:1 slope behind it. Missouri had a similar issue in the past. We recommended to them that they use 9' posts at ½ post spacing (3'-1 ½"). I have attached the detail they made based on this recommendation.

We would recommend a similar post length and spacing for your installation.
