Guidelines for Designing Bridge Piers and Abutments for Vehicle Collisions

State Pooled fund Study: TPF-5(106)
Panel Meeting
April 14, 2009
Texas Transportation Institute

Phase 1a Literature Review & 1c Accident Survey

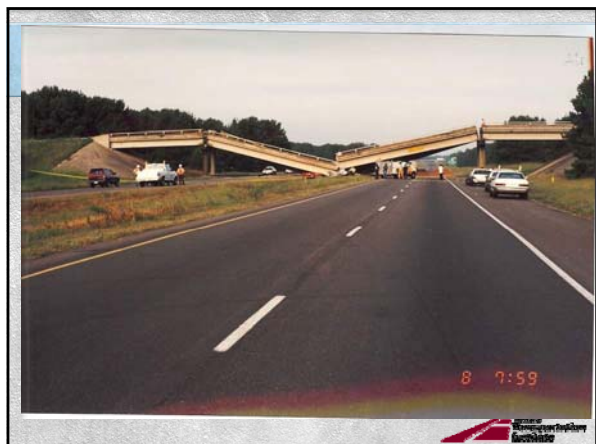
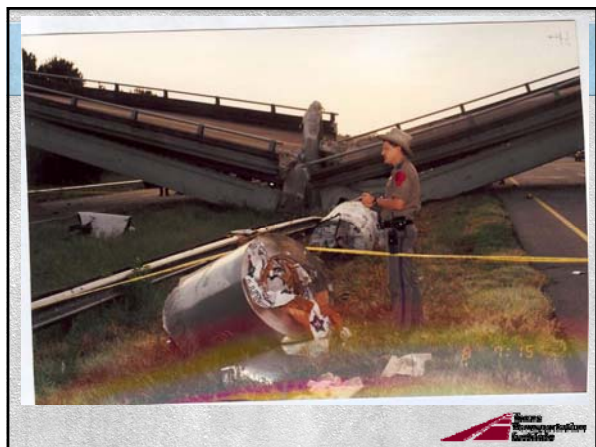
Accident #1: Semi Tractor-Trailer Crash
FM 2110 Bridge Over I-30,
Texarkana, TX, August 8, 1994
80,000 lbs. @ 65 mph w/
30-inch Pier

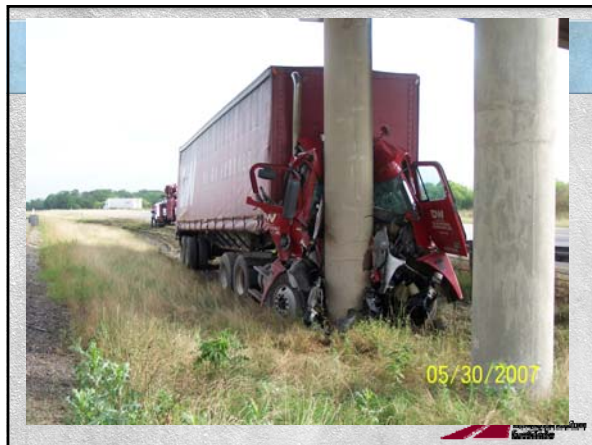
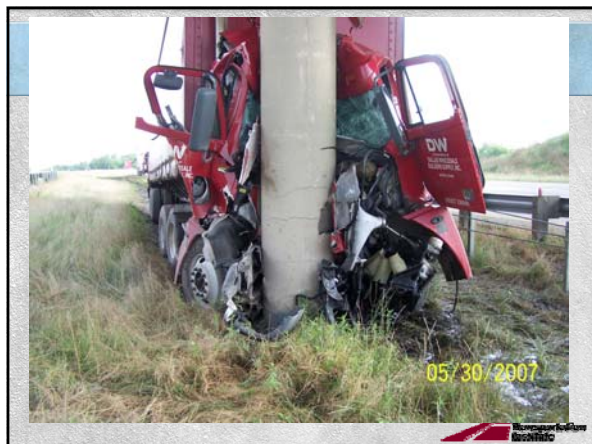
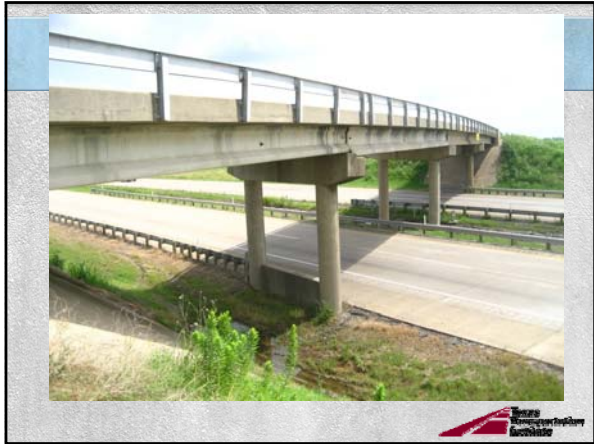
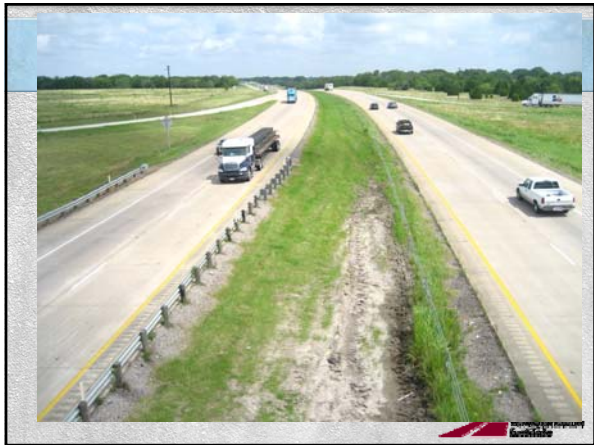
Accident #2: Semi Tractor-Trailer
Crash
FM 3041 Bridge Over I-45,
Corsicana, TX, May 30, 2007
<80,000 lbs., est. 65 mph w/
30-inch Pier

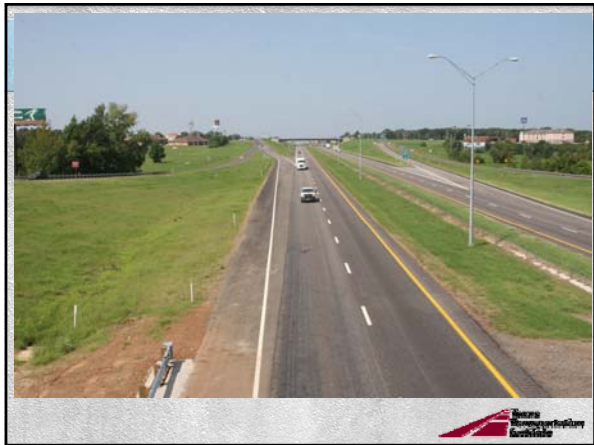
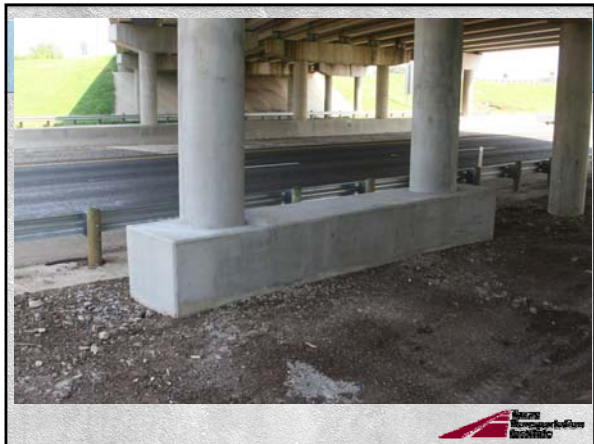
Accident #18: Semi Tractor-
Trailer Crash
FM-1401 Bridge Over IH-30,
Mount Pleasant, TX,
May 29, 2008
Approx. 80,000 lbs., est. 65
mph w/
30-inch Pier
