EVALUATION OF 0.7 INCH DIAMETER CARBON FIBER REINFORCED POLYMER PRETENSIONING STRANDS IN PRESTRESSED BEAMS

MICHIGAN DEPARTMENT OF TRANSPORTATION
OHIO DEPARTMENT OF TRANSPORTATION
NORTH CAROLINA DEPARTMENT OF TRANSPORTATION
MAINE DEPARTMENT OF TRANSPORTATION

Nabil F. Grace, PhD, P.E., Project Investigator
Mena Bebawy, PhD, P.E., Co-Project Investigator

Mar. 31st, 2022

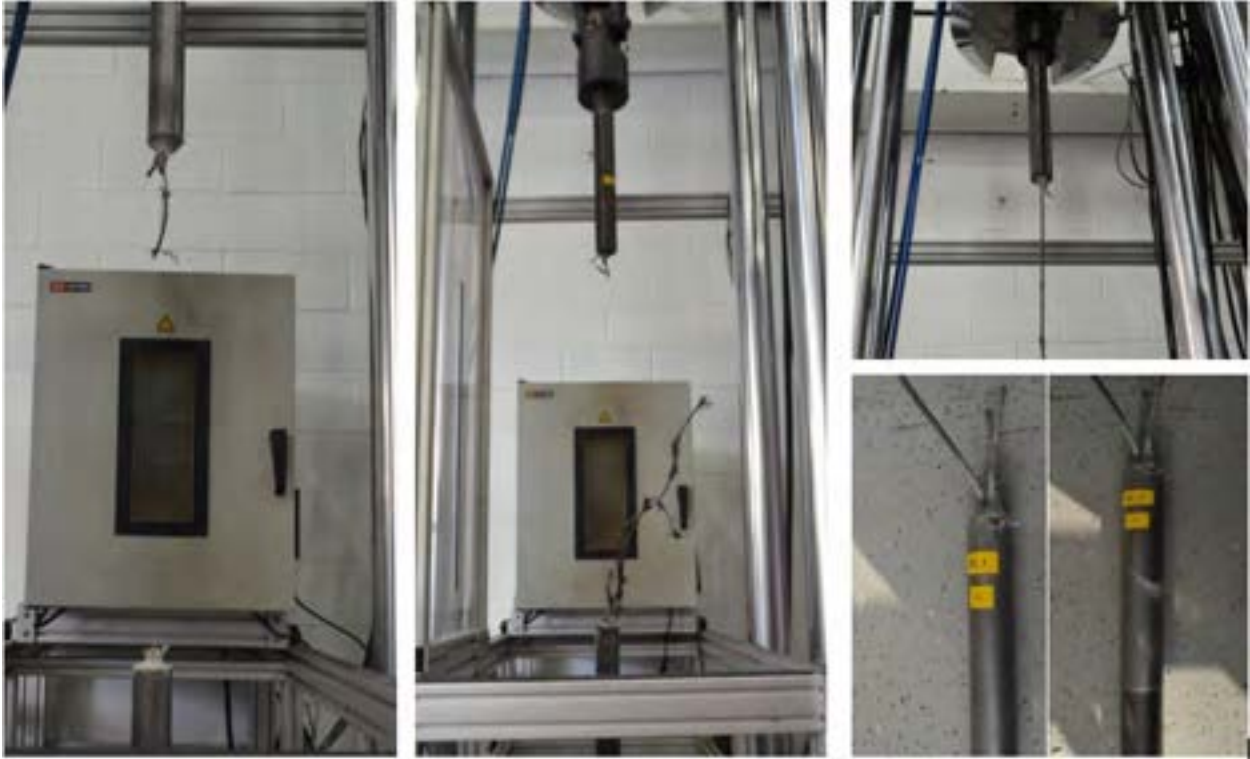
Figure 2.4-7 Typical failure mode of CFCC specimens with sleeve type anchorage

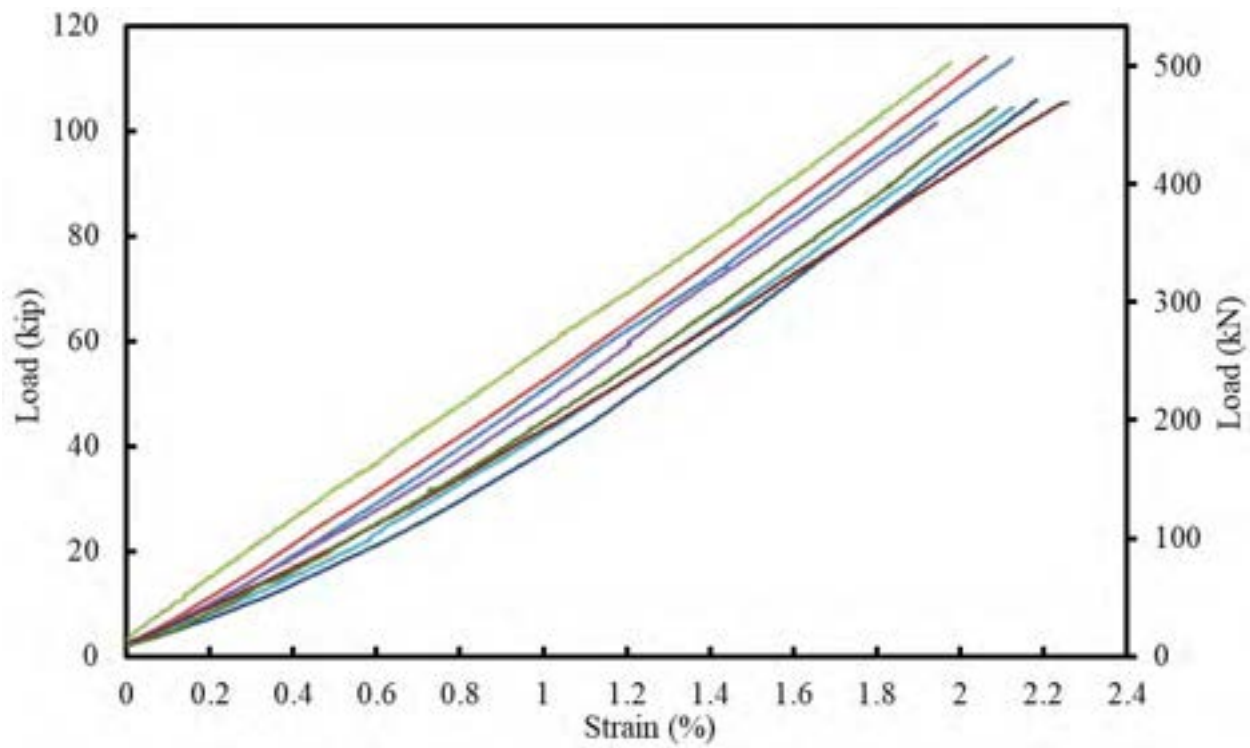
Figure 2.4-8 Load-strain curves for CFCC specimens tested under uniaxial tension

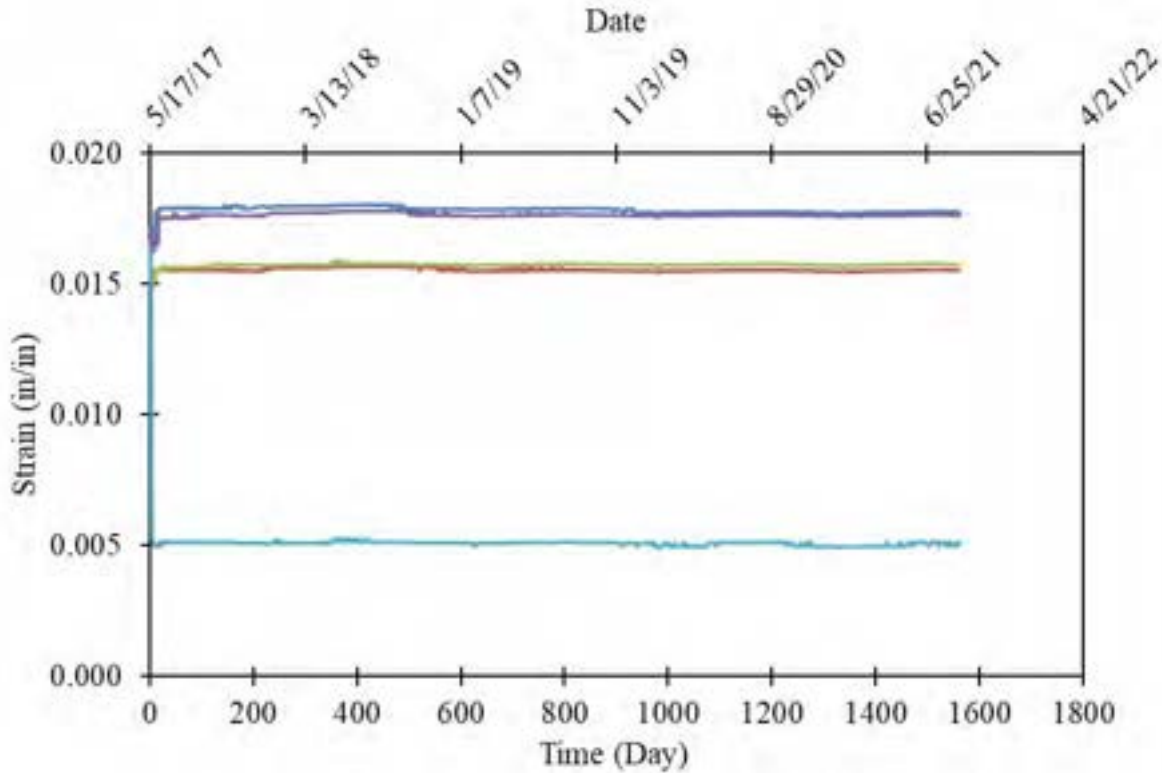
Figure 3.2-12 Strain vs. time of 0.7" CFCC specimens with 85 % load ratio

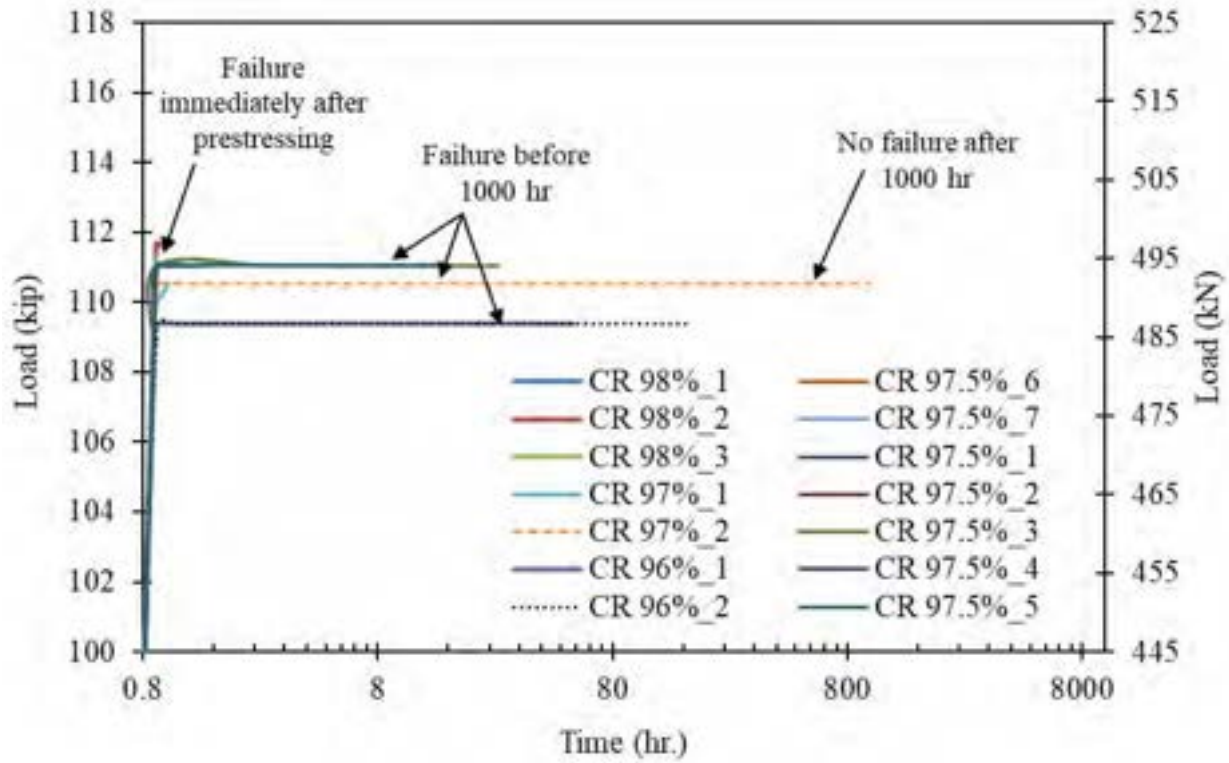
Figure 3.2-13 Load vs. logarithmic time for 0.7" CFCC specimens

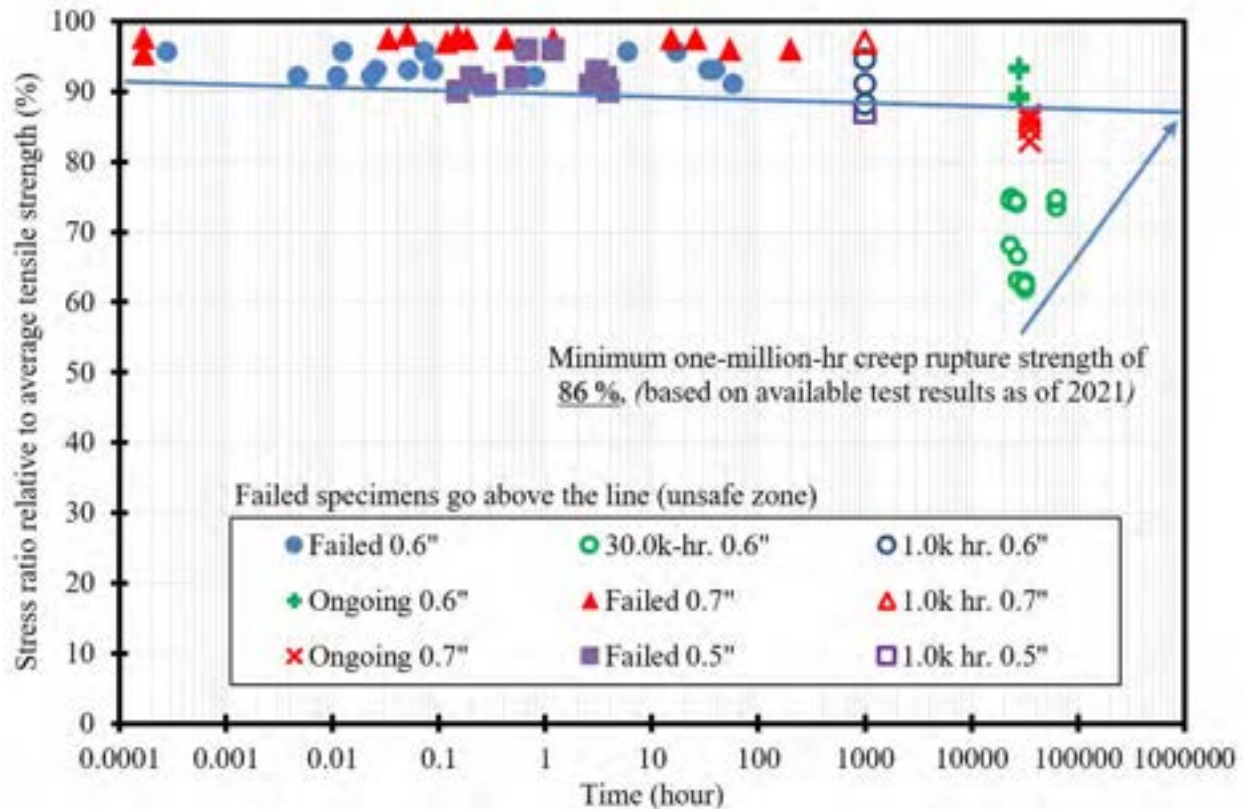
Figure 3.2-15 Lowest estimate for one-million-hour creep-rupture strength based on available test results to date

Based on available test results at the time of writing this report, the minimum one-million-hour creep-rupture strength for CFCC strands cannot be less than 86 % of the average tensile strength. For instance, for 0.7" CFCC strands with average tensile strength of 113.9 kip (507 kN), the lower bound for one-million-hour creep rupture strength is approximately 98.6 kip (439 kN). In other words, 0.7" CFCC strands can be safely loaded to its guaranteed strength of 78.7 kip (350 kN) for 114 years (one-million hour) without experiencing creep rupture. Using the value of 86 %, a creep rupture strength can be estimated for different diameters of CFCC, based on their established average tensile strength.

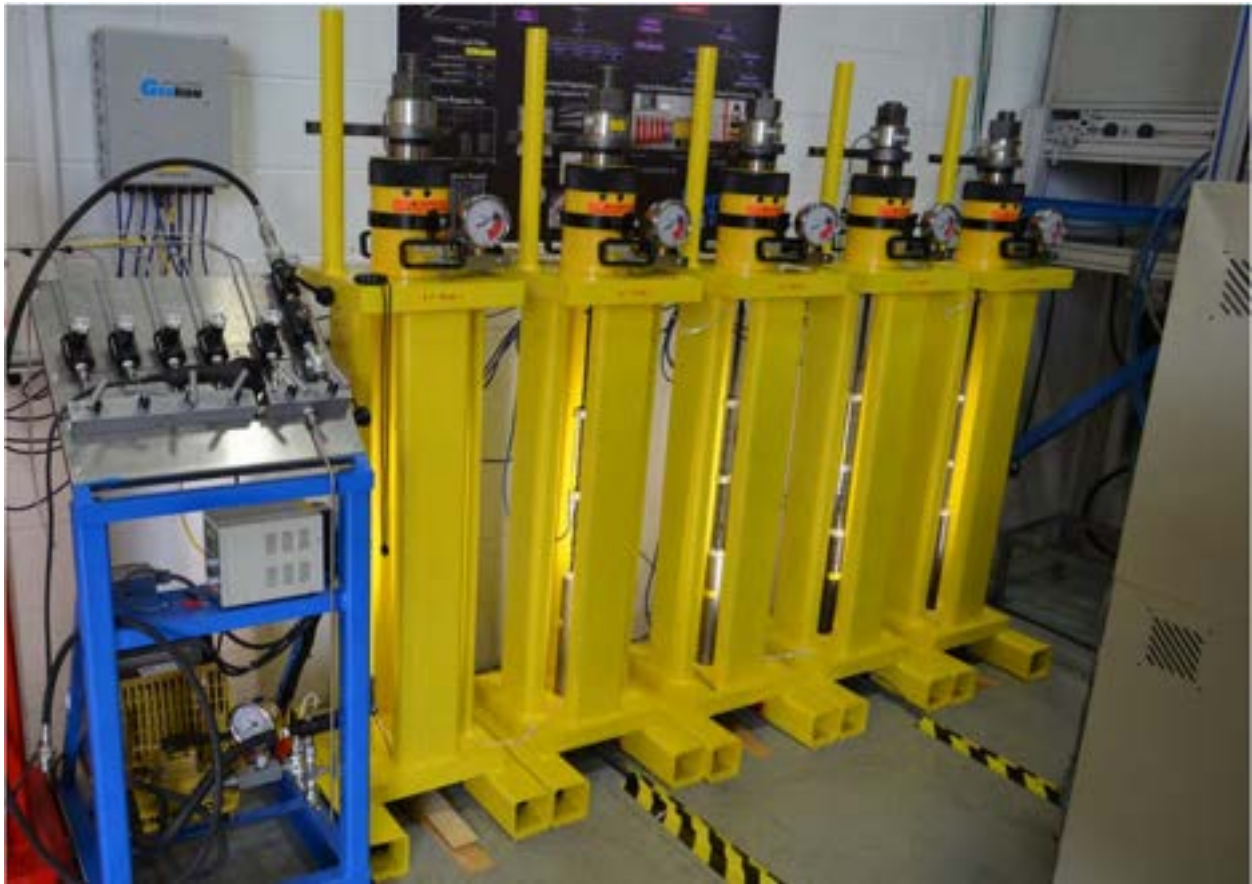
Figure 3.3-1 Test setup for evaluating relaxation of CFCC strands

As shown in Figure 3.3-1, CFCC specimens were connected to a hydraulic pressure system with load cells at one end (dead end) and fastened at the other end (live end) by a high strength steel nut and washer. Prestressing force was applied at the live end through a hydraulic jack at a rate of 2 kip/min (8.9 kN/min). The relaxation of the CFCC strands is calculated by recording the loss in force monitored through the load cells and the pressure gage of the hydraulic system (Figure 3.3-2), while the change in the strain was recorded using Geokon vibrating wire strand meters attached to the strands (Figure 3.3-3). The load cells and the strand meters are connected to a data acquisition system that captures and stores the data continuously.

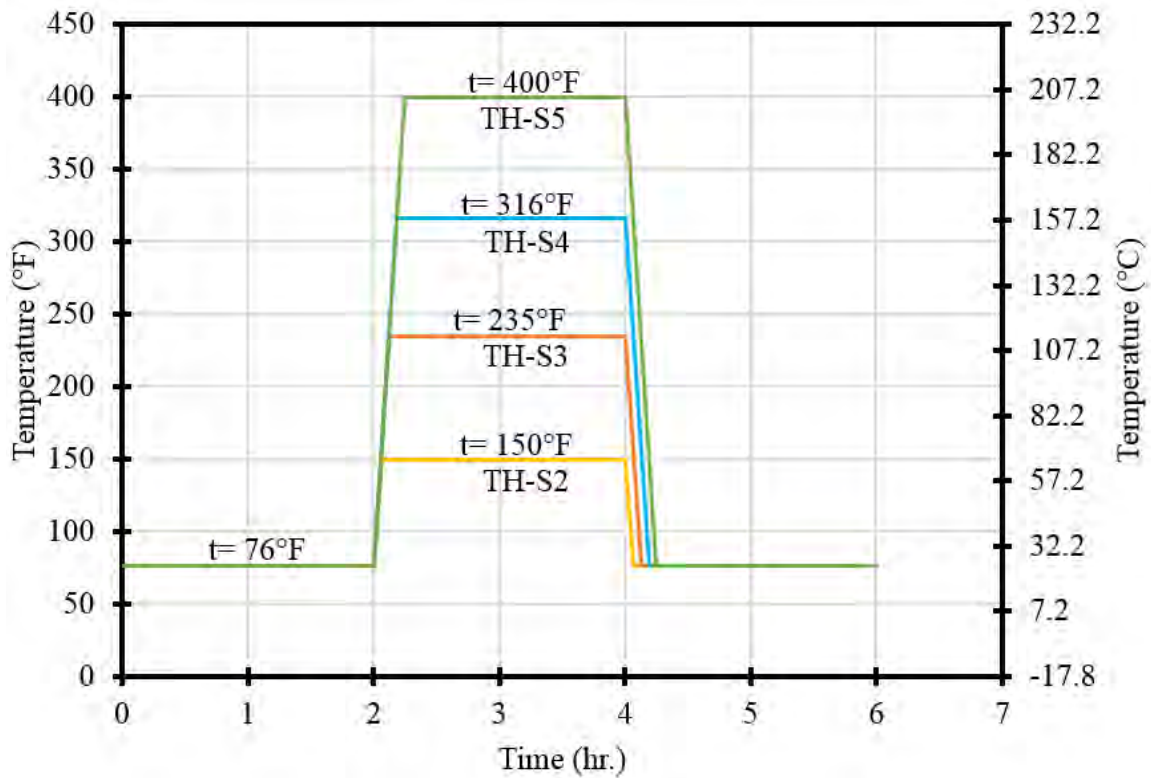
Figure 3.3-15 Temperature profiles for heat relaxation specimens in Phase II

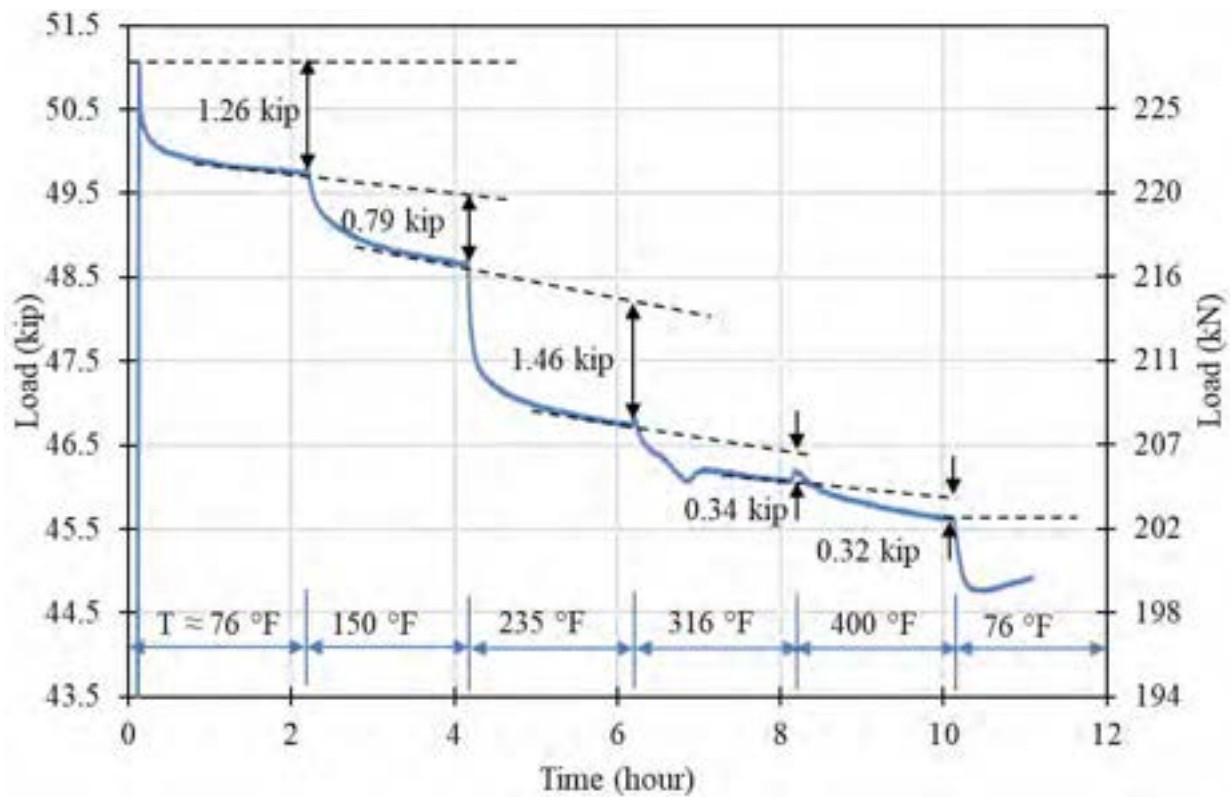
Figure 3.3-20 Load vs. time for TH-S5 in Phase I of thermal testing

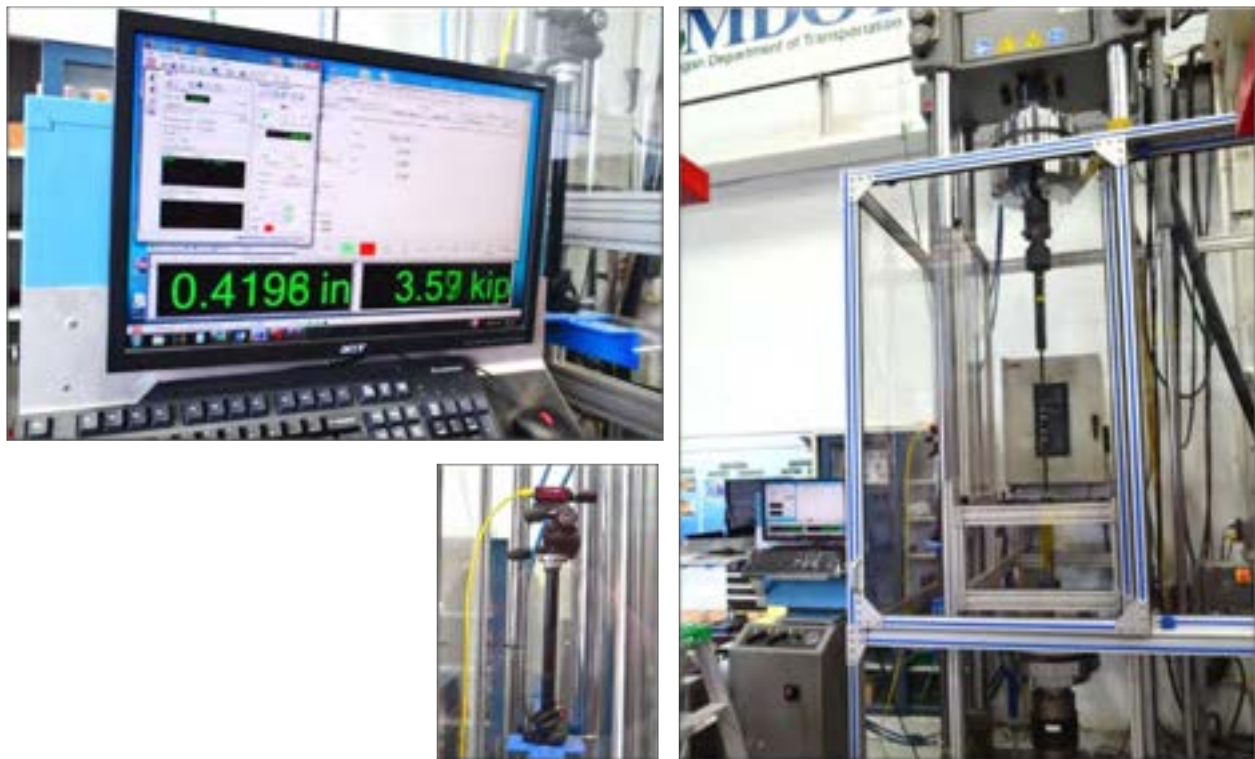
Figure 3.3-25 Uniaxial testing of CFCC specimens in Phase III

Figure 3.3-25 and Figure 3.3-26 show the testing and failure of the test specimens in Phase III. Test results are also presented in Table 3.3-2. The ambient uniaxial tensile test of the four previously-heated test specimens revealed an average breaking load of 113.4 kip (504 kN), which is slightly higher the breaking load of the non-heated test specimen. The average elastic modulus from the uniaxial tensile tests of the four previously heated test specimens was calculated as approximately 23,728 ksi (163 GPa), which is also slightly higher than the elastic modulus of the non-heated specimen. No noticeable physical difference was observed during the test for between the first specimen (non-heated) and the rest of the specimens. Table 3.3-2 also lists earlier test results of 0.6" CFCC specimens (Grace et al. 2019) and test results showed a similar pattern.

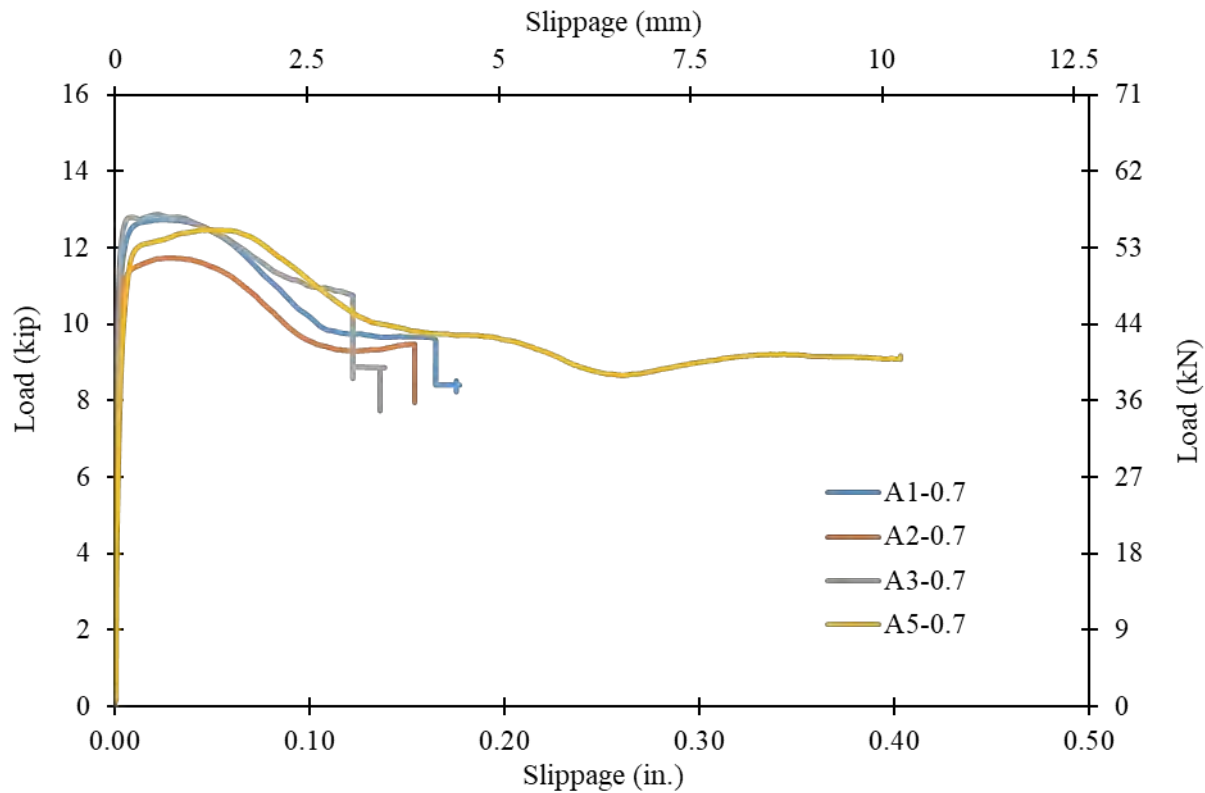
Figure 4.2-9 Load vs. slippage of pullout test specimens with 0.7" CFCC strands

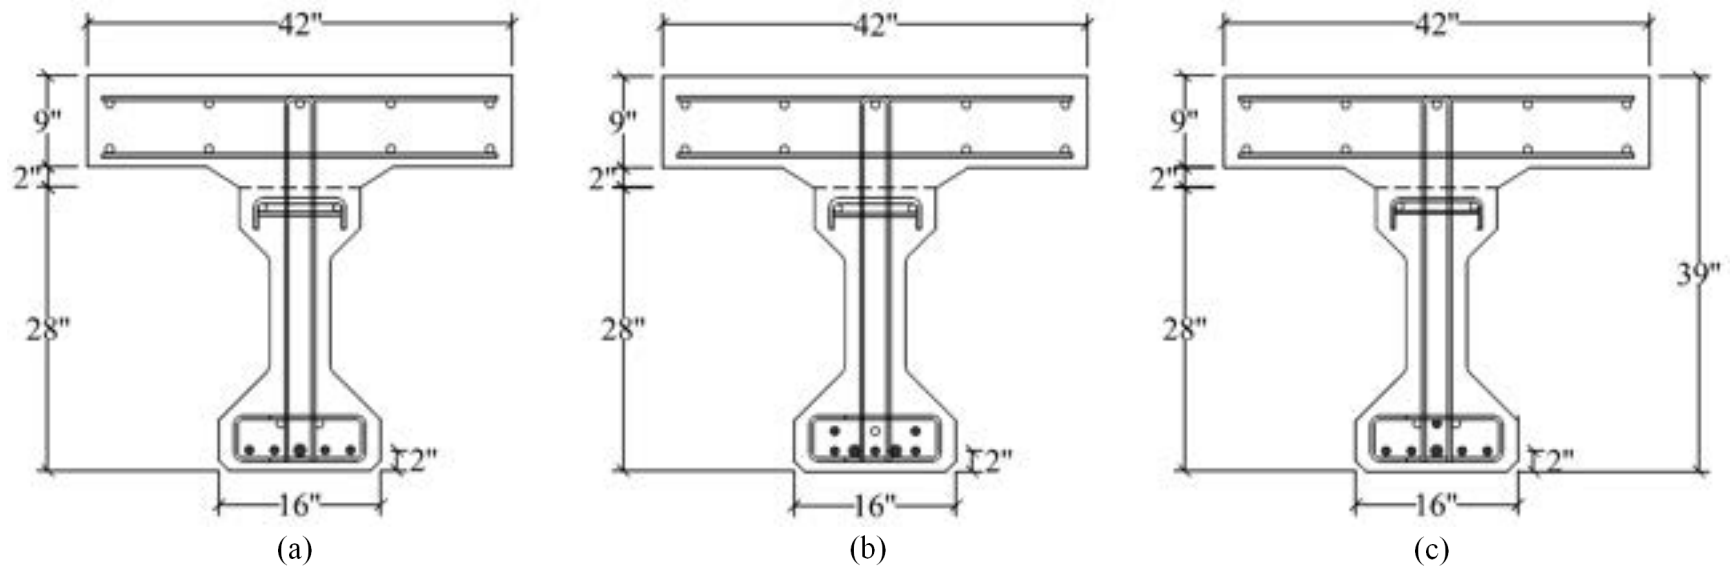
Figure 5.2-2 Cross-section details of AASHTO I-beams; (a) Beam C0.7, (b) Beam C0.6, (c) Beam S0.6 (1 in. = 25.4 mm)

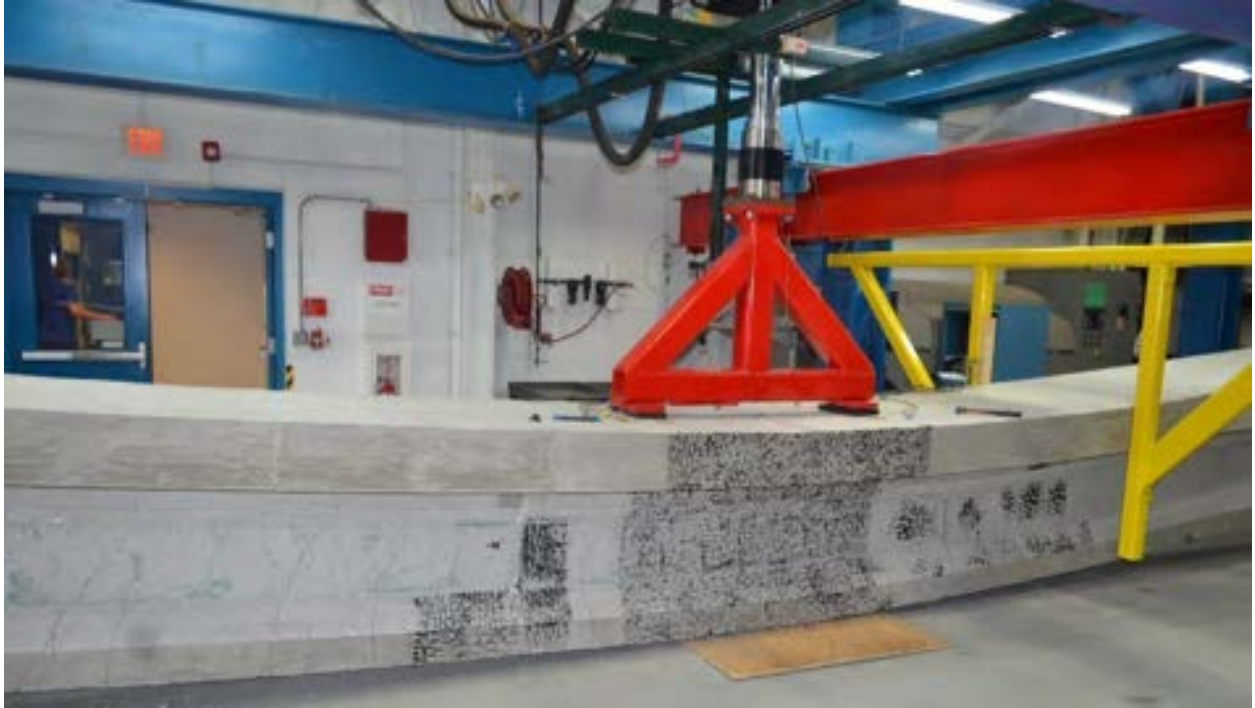
Figure 5.5-3 Tension failure of Beam C0.7

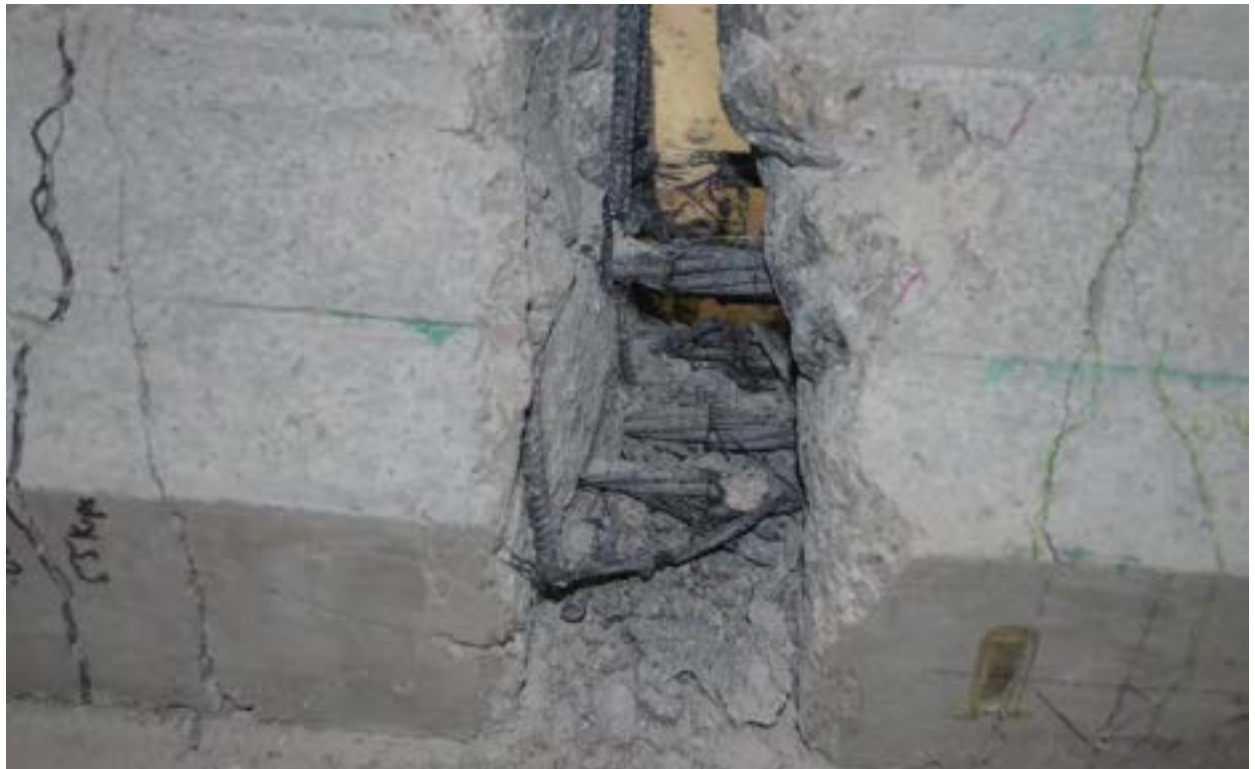
Figure 5.5-4 Rupture of CFCC strands at failure of Beam C0.7

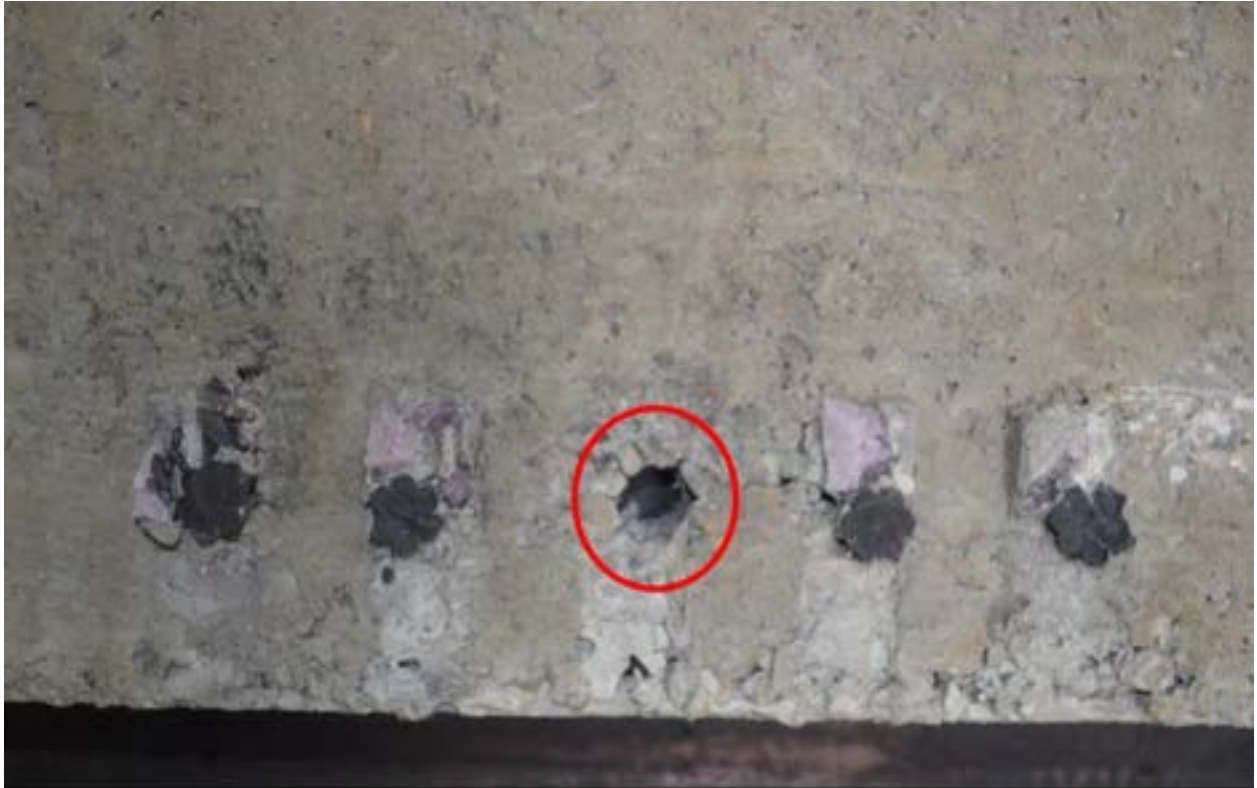
Figure 5.5-5 Slippage of partially debonded CFCC strands prior to failure of Beam C0.7

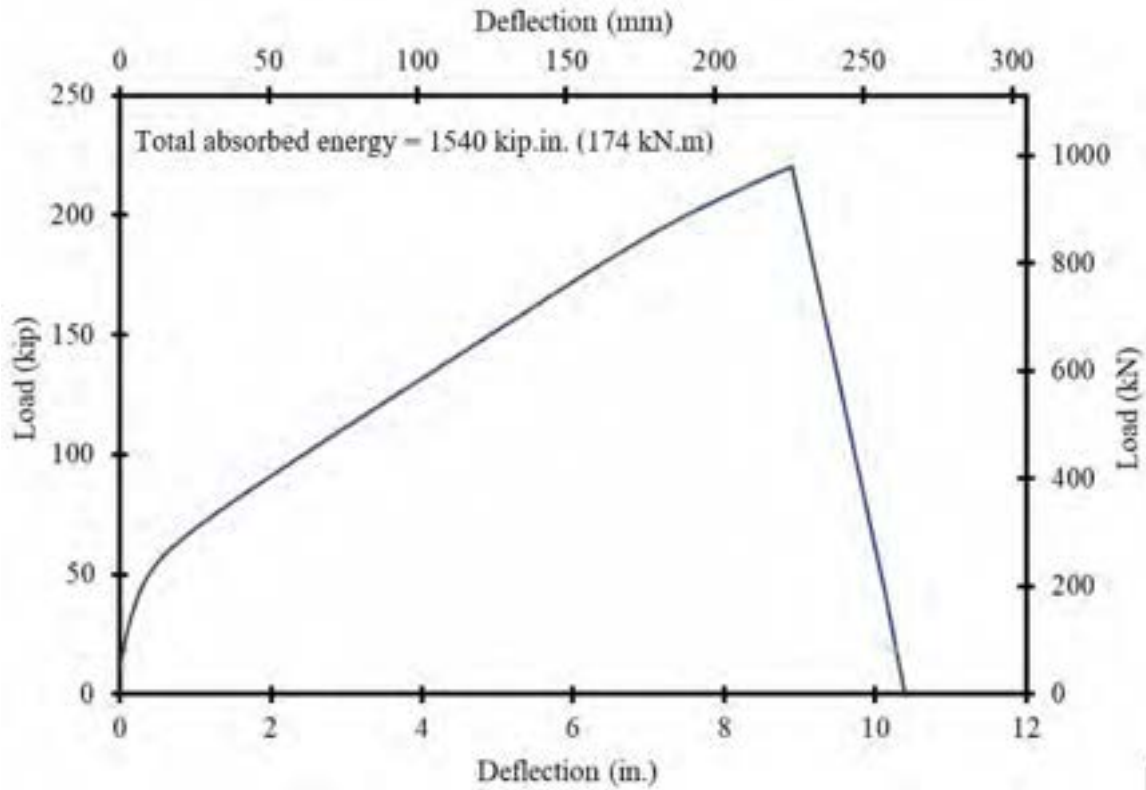
Figure 5.5-7 Energy absorption capacity of Beam C0.7

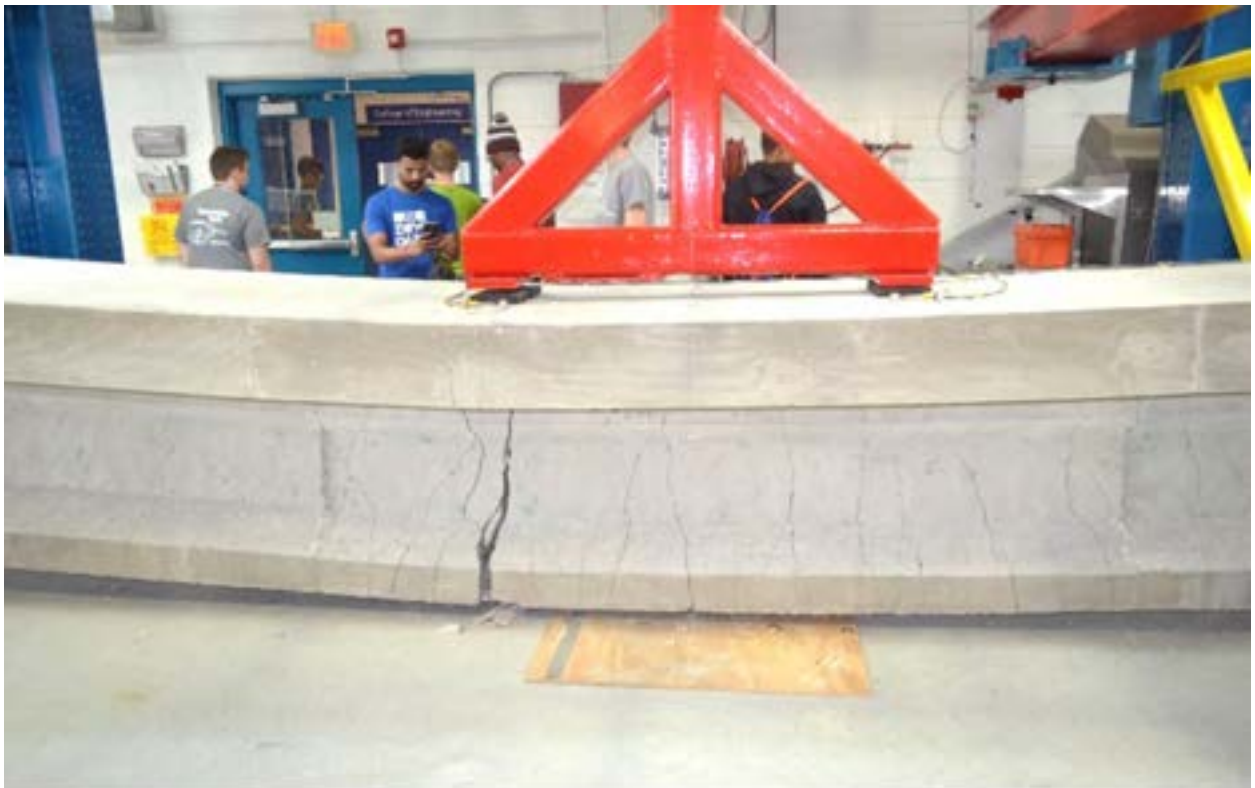
Figure 5.5-10 Tension failure of Beam C0.6

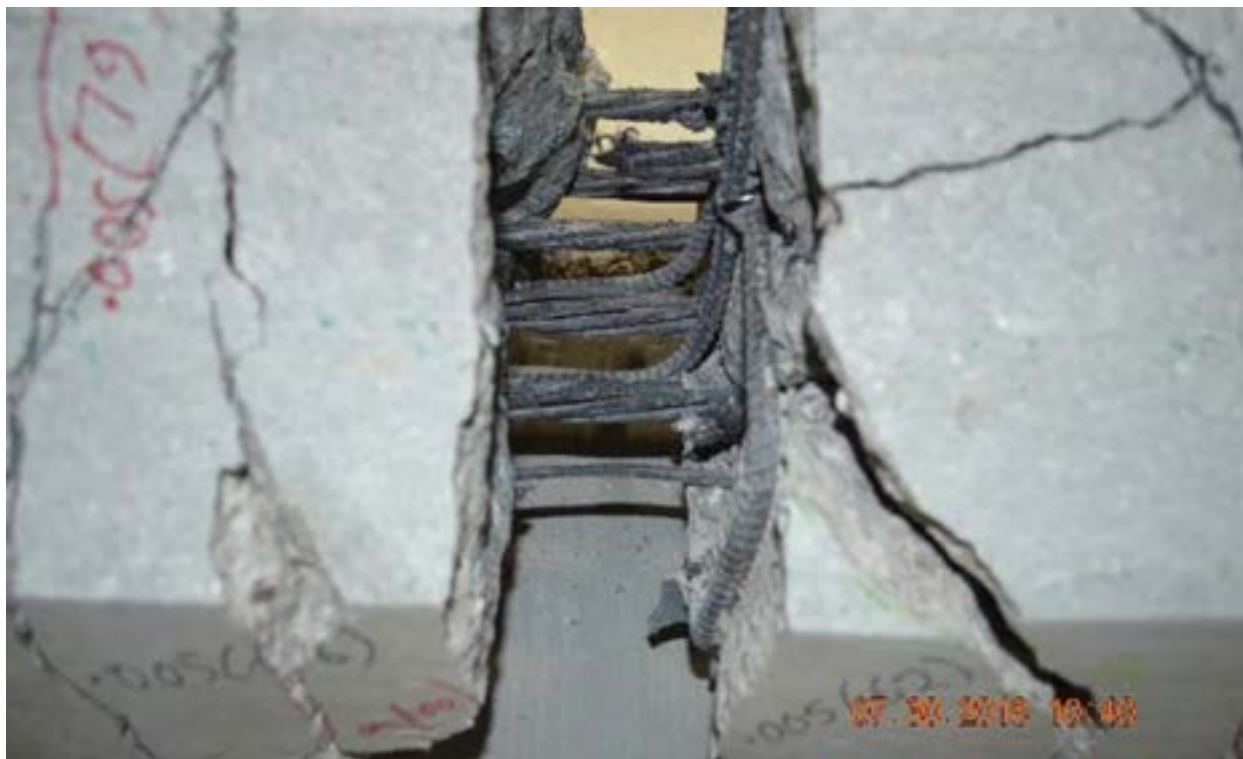
Figure 5.5-11 Rupture of CFCC prestressing strands at failure of Beam C0.6

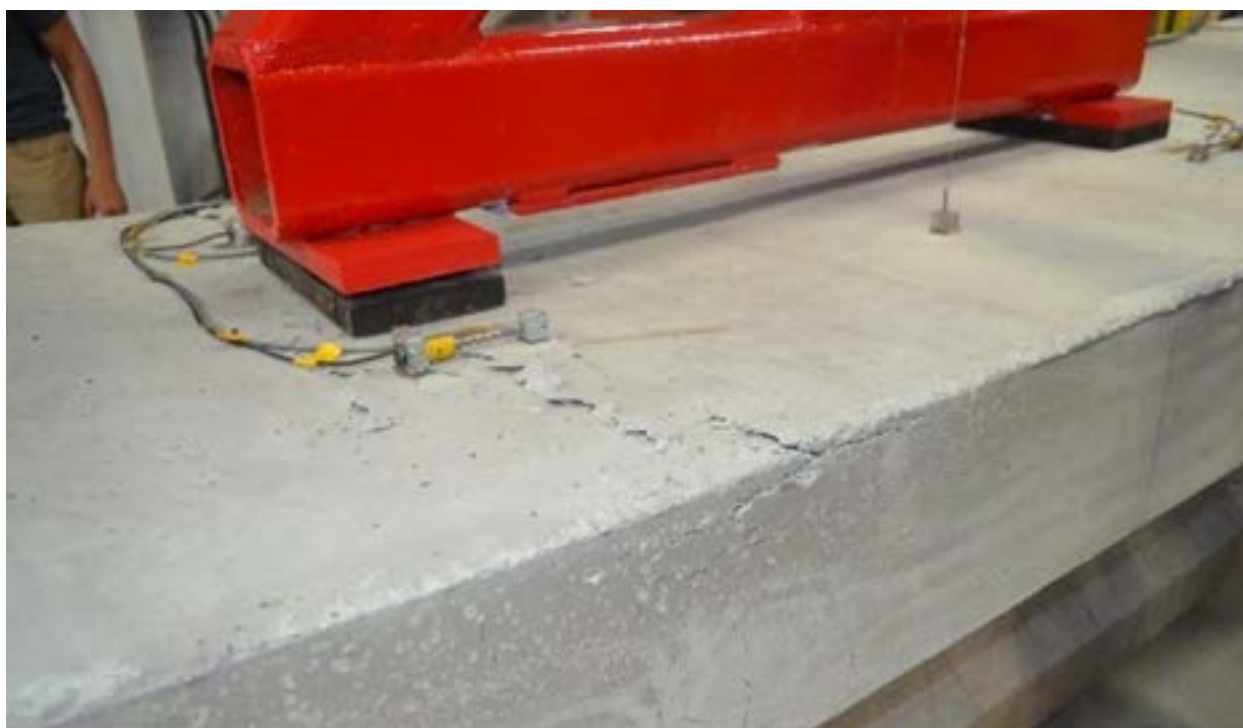
Figure 5.5-12 Spalling of concrete at the top surface of the deck slab at failure of Beam C0.6

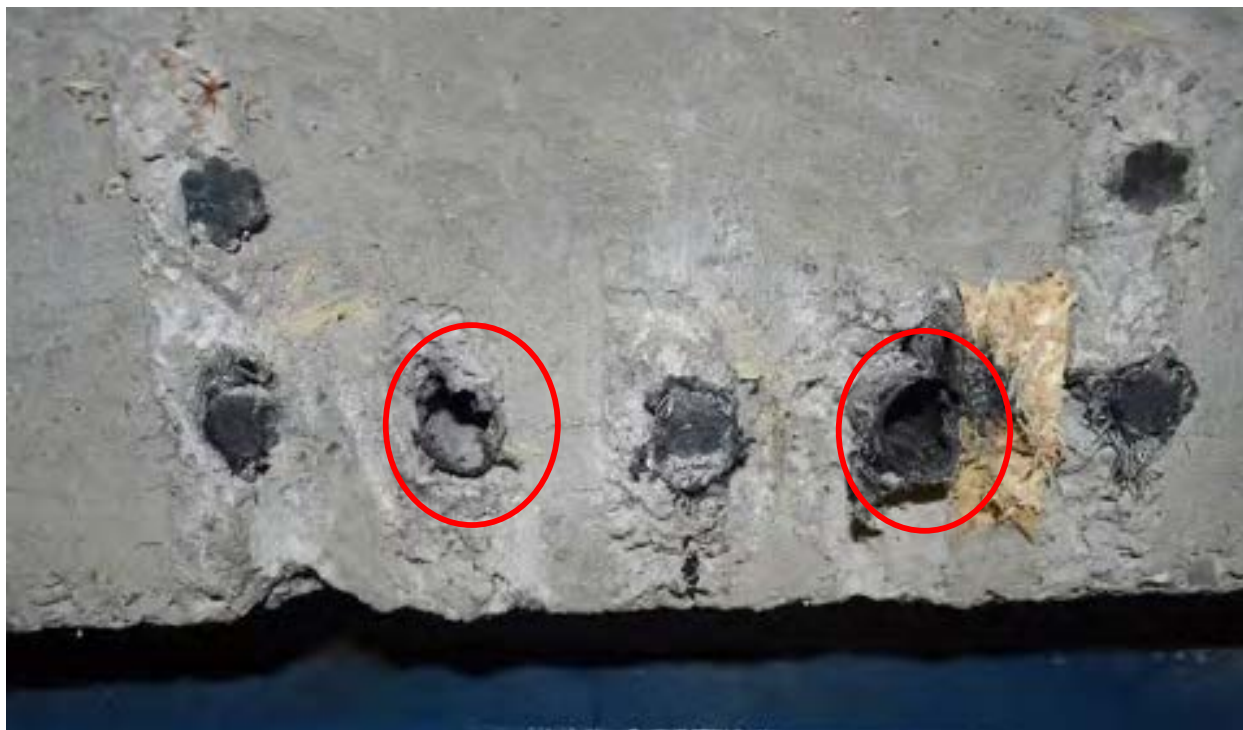
Figure 5.5-13 Slippage of partially debonded stands prior to failure of Beam C0.6

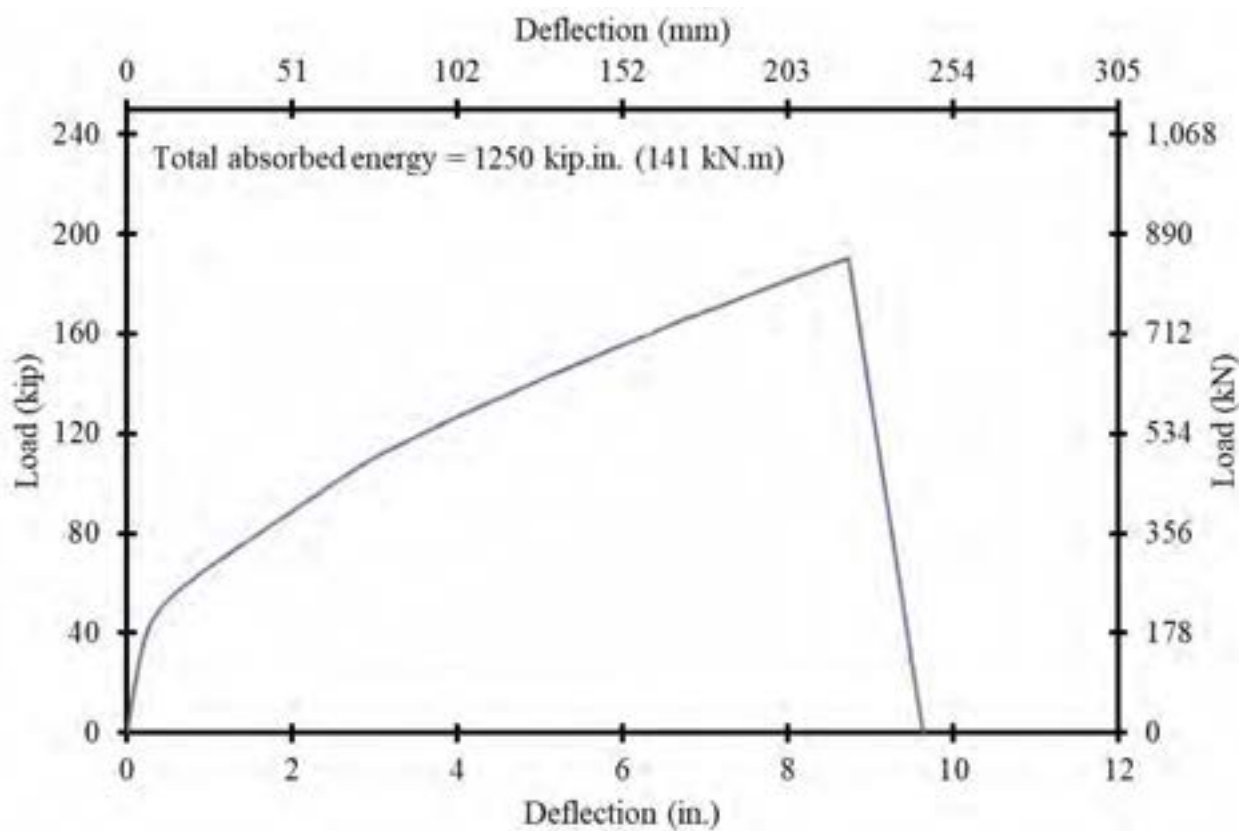
Figure 5.5-14 Energy absorption capacity of Beam C0.6

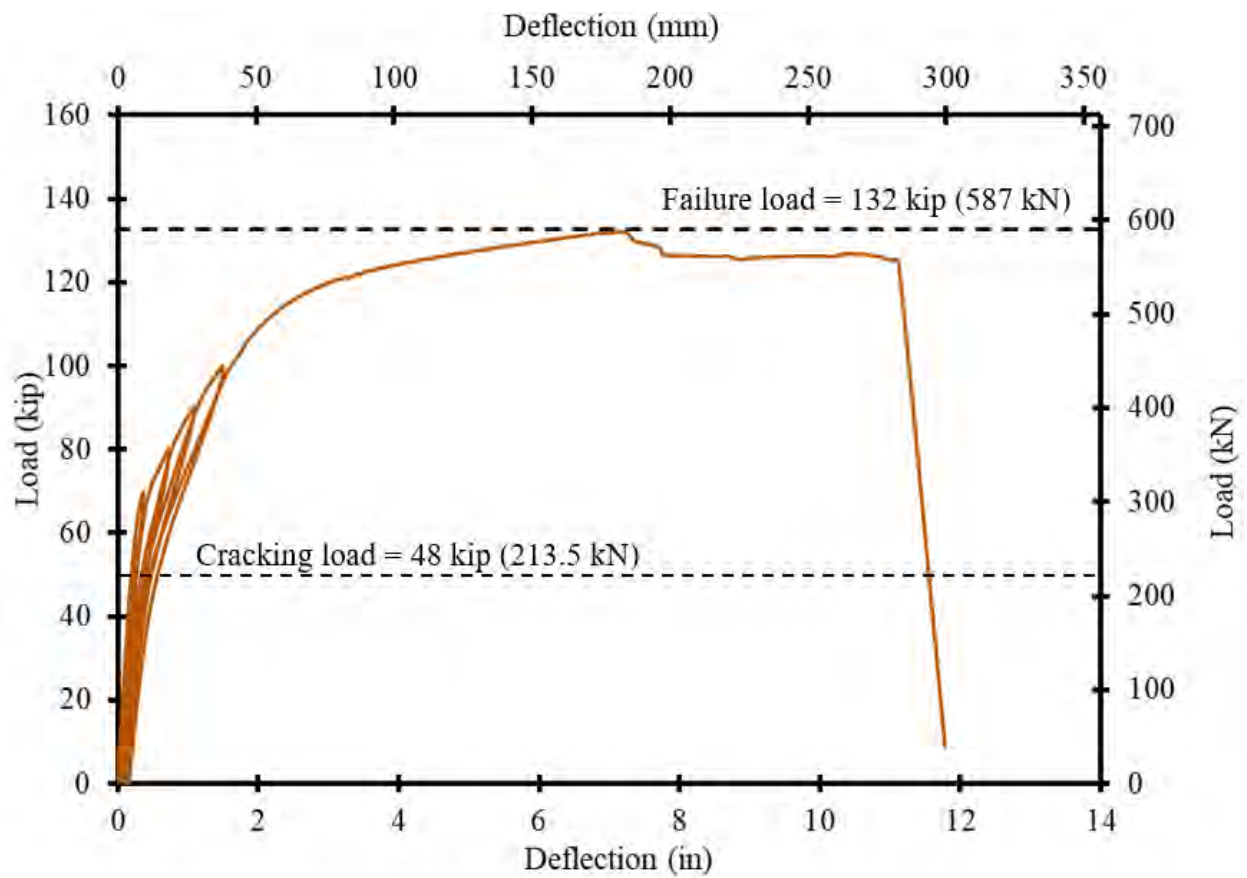
Figure 5.5-16 Load-deflection curves for Beam S0.6

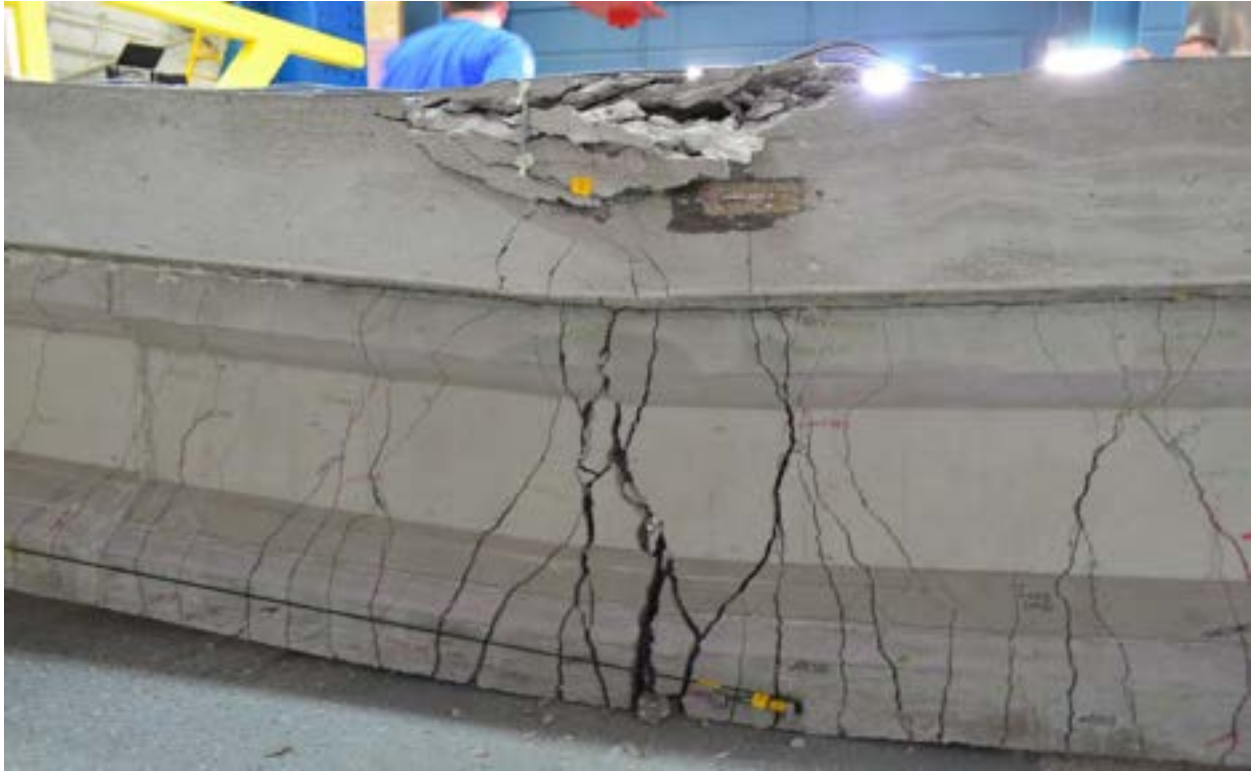
Figure 5.5-17 Failure of Beam S0.6

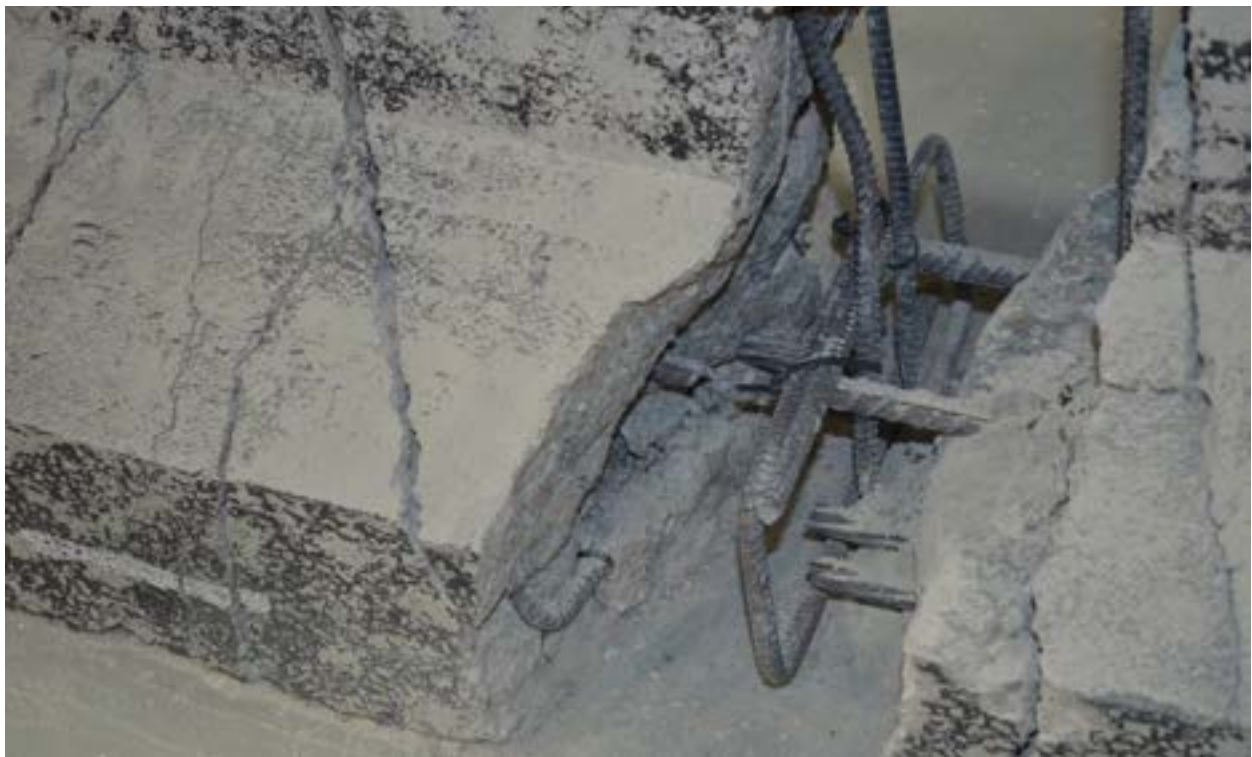
Figure 5.5-18 Rupture of steel prestressing strands during failure of Beam S0.6
