EVALUATION OF 0.7 INCH DIAMETER CARBON FIBER REINFORCED POLYMER PRETENSIONING STRANDS IN PRESTRESSED BEAMS

MICHIGAN DEPARTMENT OF TRANSPORTATION
OHIO DEPARTMENT OF TRANSPORTATION
NORTH CAROLINA DEPARTMENT OF TRANSPORTATION
MAINE DEPARTMENT OF TRANSPORTATION

Nabil F. Grace, PhD, P.E., Project Investigator
Mena Bebawy, PhD, P.E., Co-Project Investigator

Mar. 31st, 2022

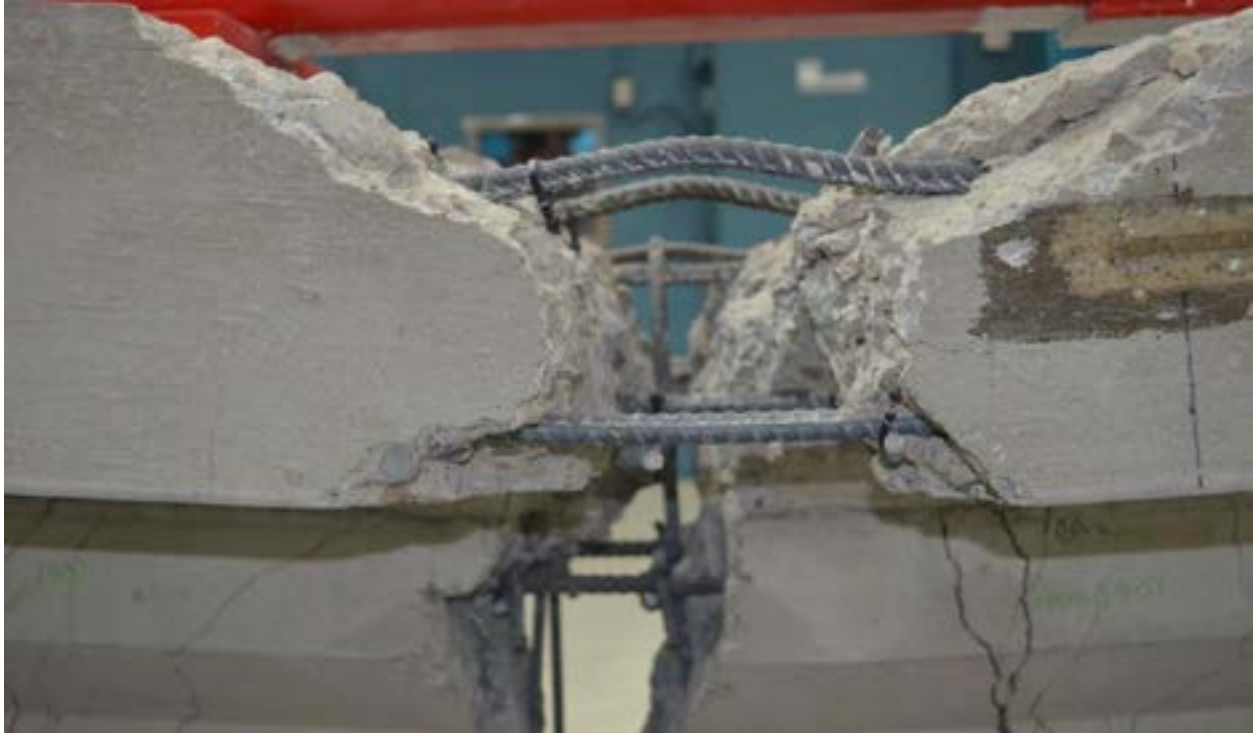
Figure 5.5-19 Buckling of top deck reinforcement at mid-span of Beam S0.6 at failure

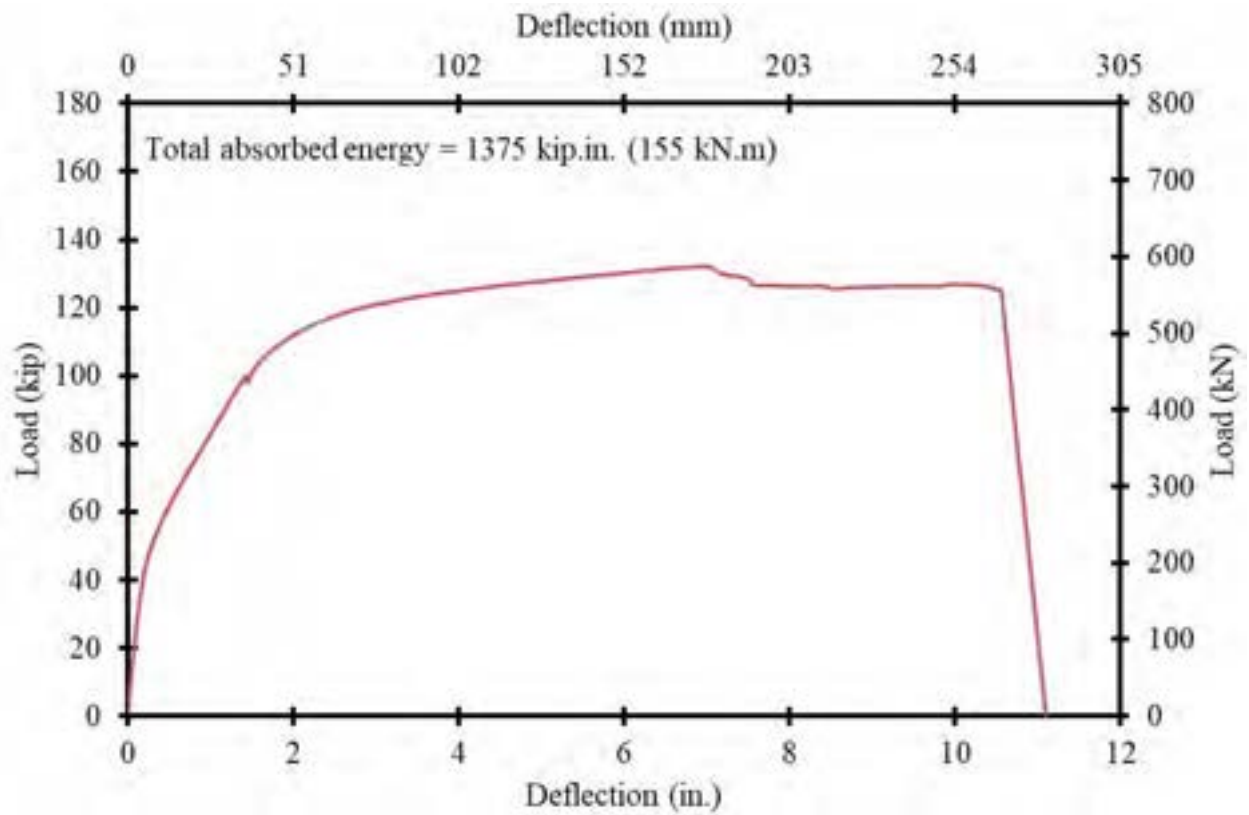
Figure 5.5-20 Energy absorption capacity of Beam S0.6

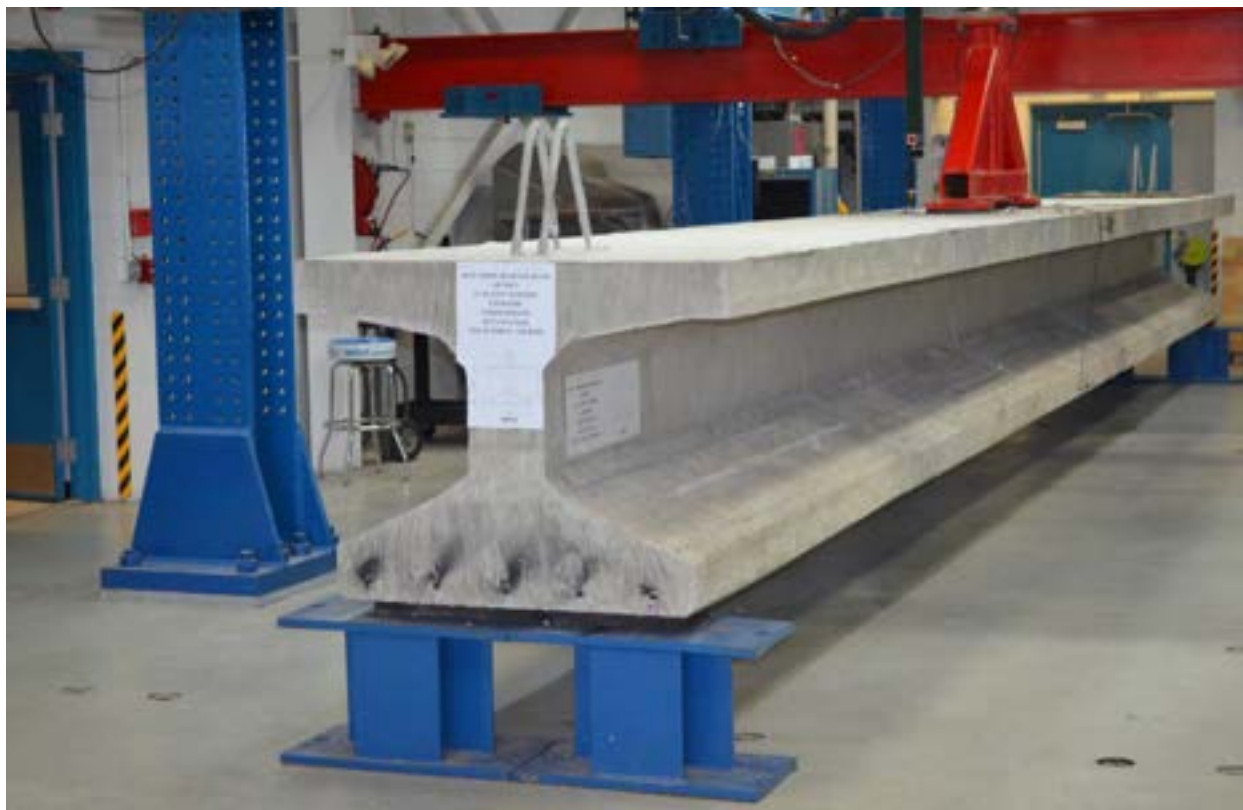
Figure 5.7-3 Flexural testing of full-scale bulb T beam under four-point-loading setup

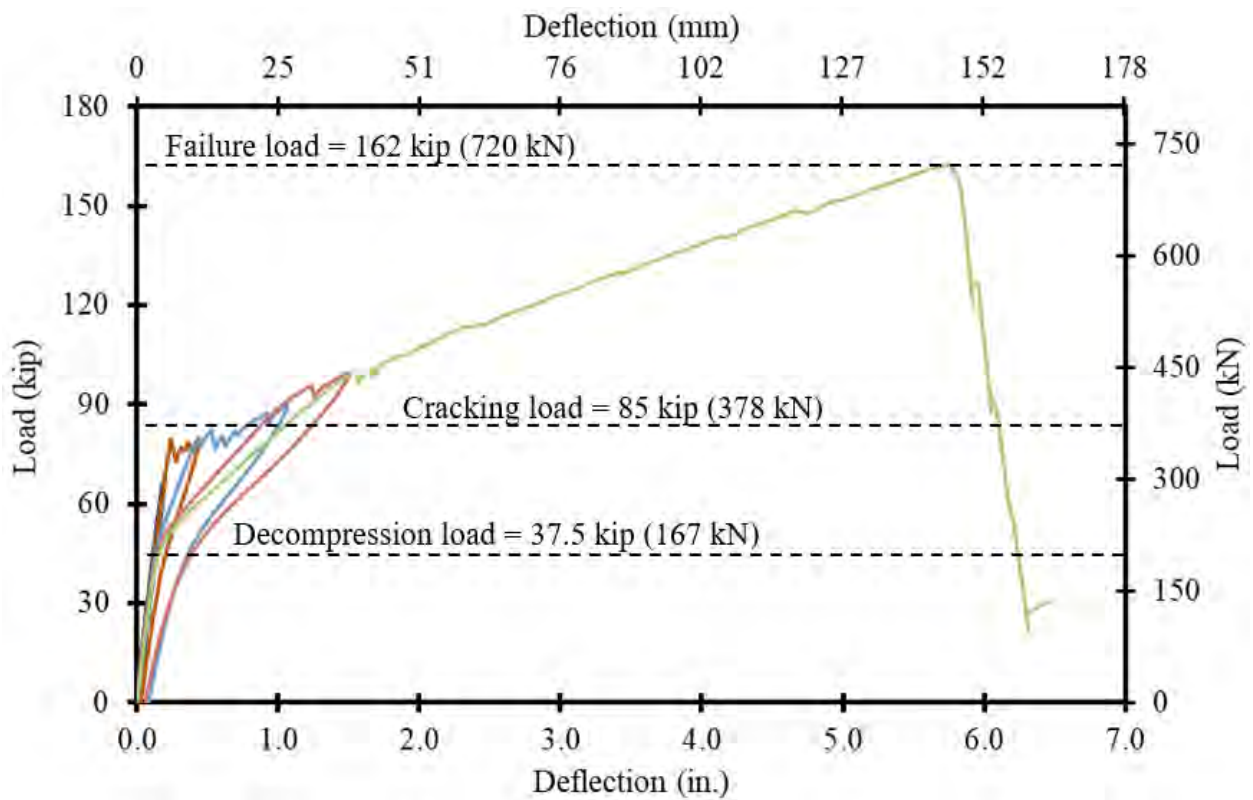
Figure 5.7-4 Load-deflection curves of bulb T beam including all load cycles to failure

the actual failure load was 97 % greater than the design failure load, representing a an experimental-to-design ratio of 1.97.

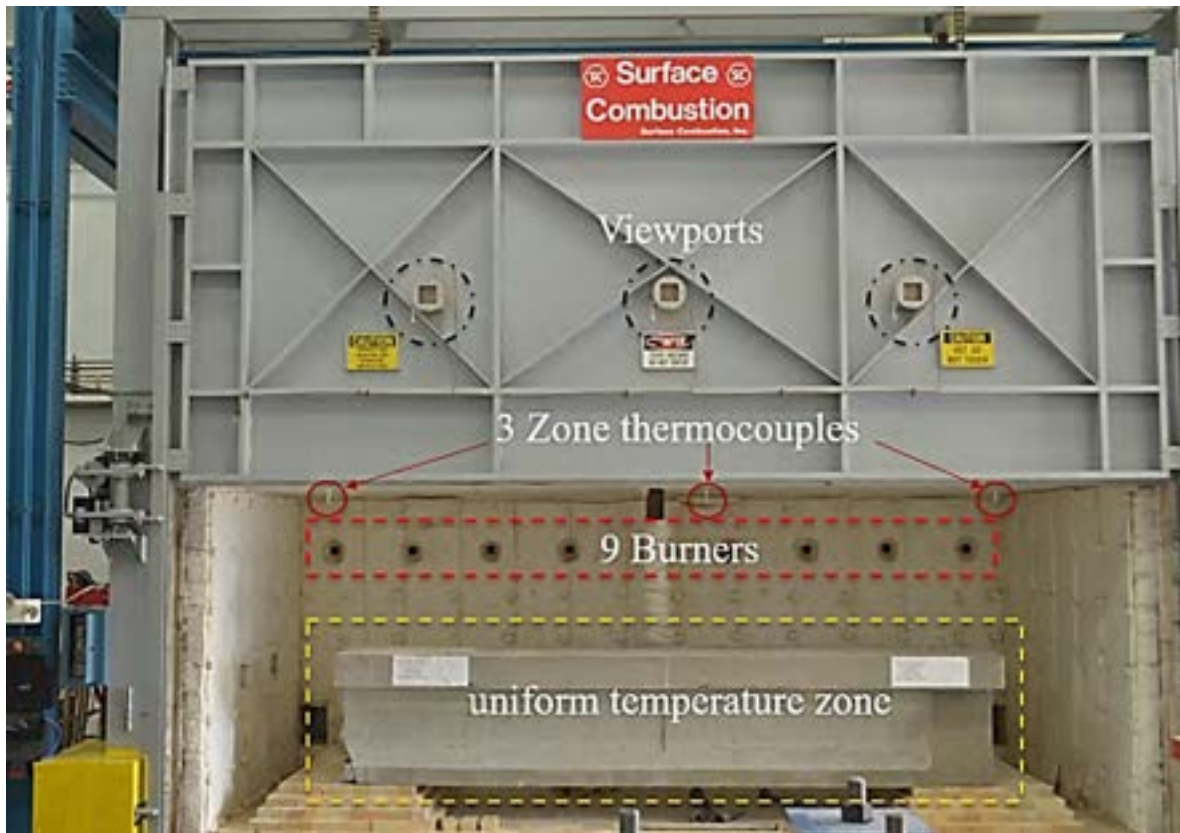
Figure 6.3-22 Furnace for fire testing

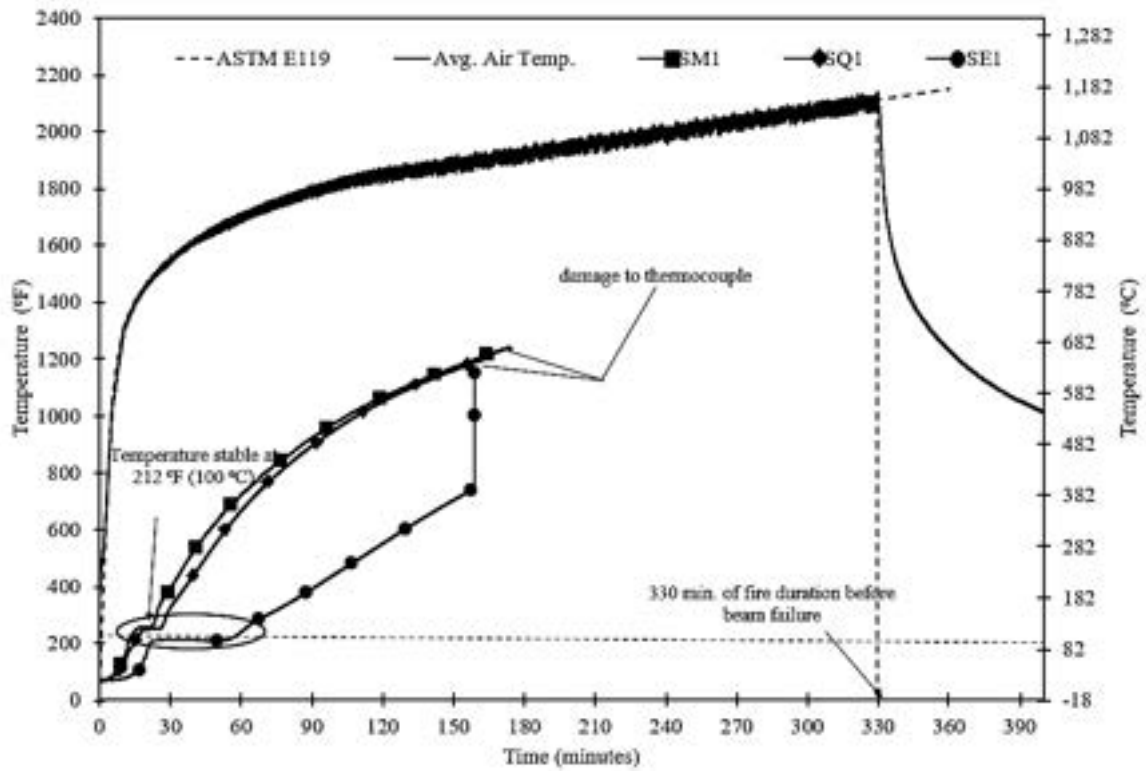
Figure 6.3-56 Time-temperature curves for Beam I-0.6S

The failure temperature at the level of the steel strands in Beam I-0.6S was 1391 °F (755 °C) after 330 minutes. This was significantly higher than the failure temperature at the level of the CFCC strands of 885 °F (474 °C) in Beam I-0.6C after 136 minutes of fire exposure. The time-temperature profiles of the strands in both beams, where were identical in geometry, compared favorably well as shown in Figure 6.3-58.

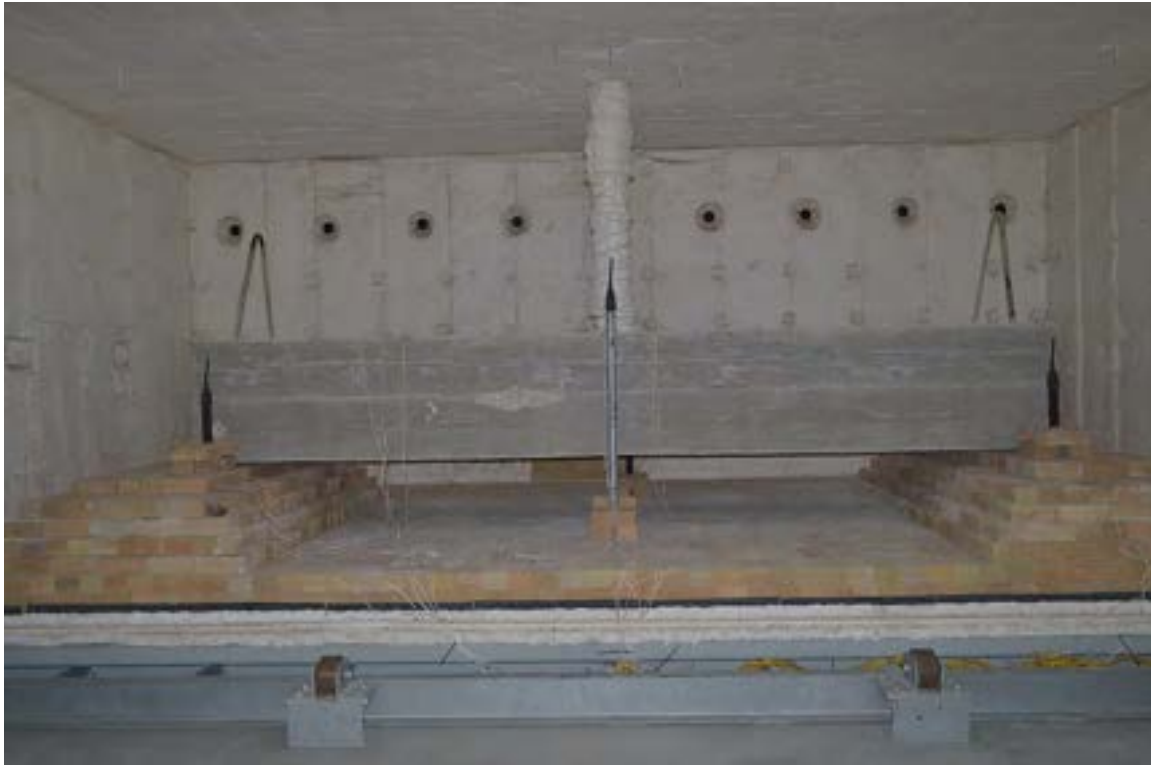
Figure 6.3-73 Beam RB-0.7C after one-hour fire test

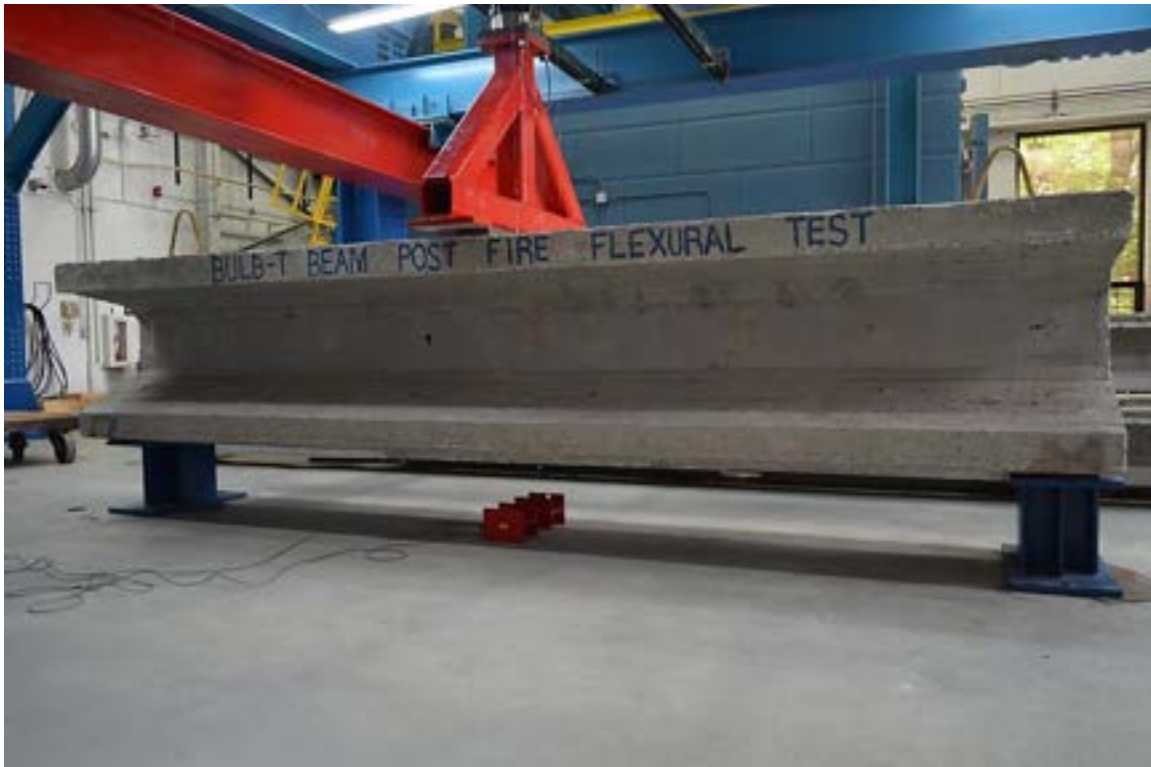
Figure 6.3-88 Test setup for Beam RT-0.7C after fire test

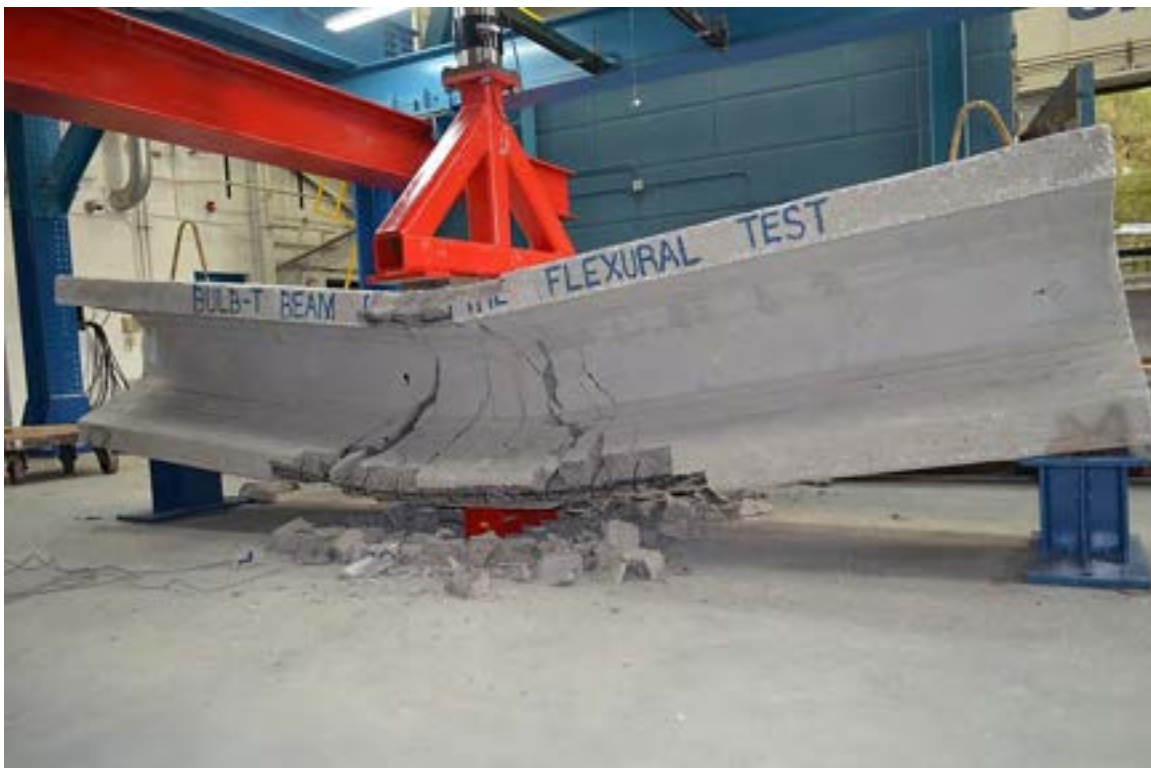
Figure 6.3-89 Failure of Beam RT-0.7C after flexural test

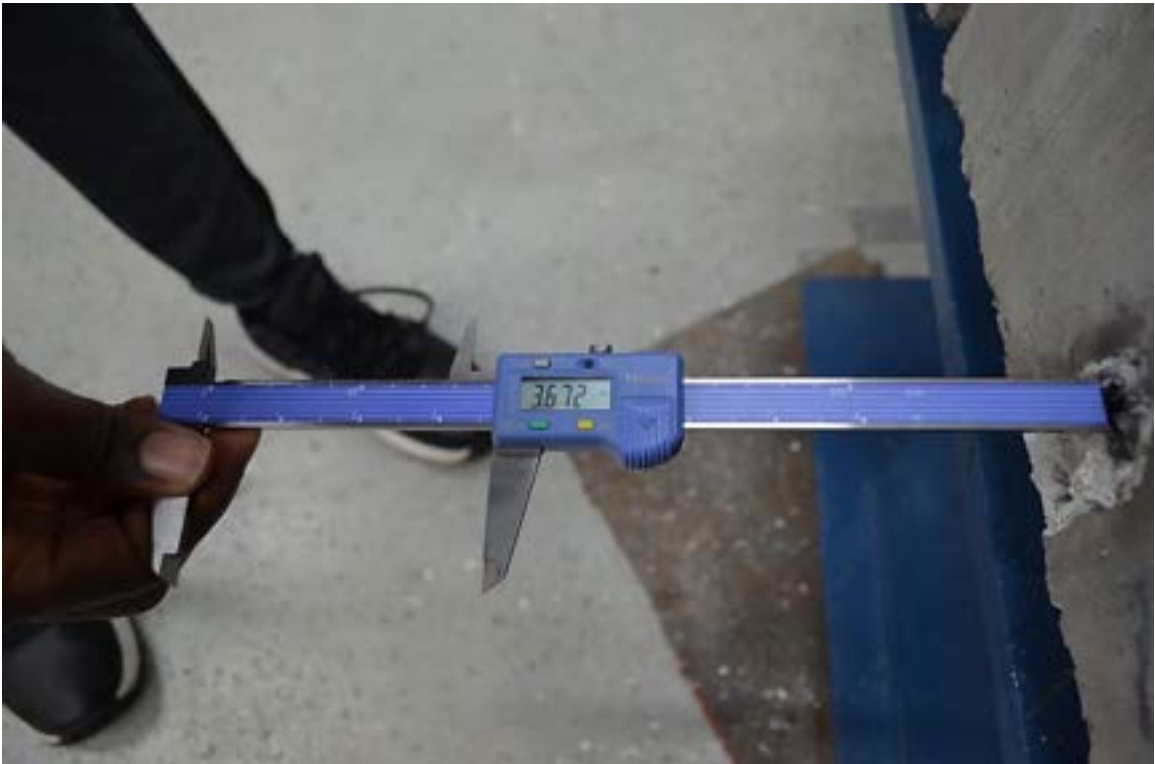
Figure 6.3-91 Measuring strand slip at the end of the beam

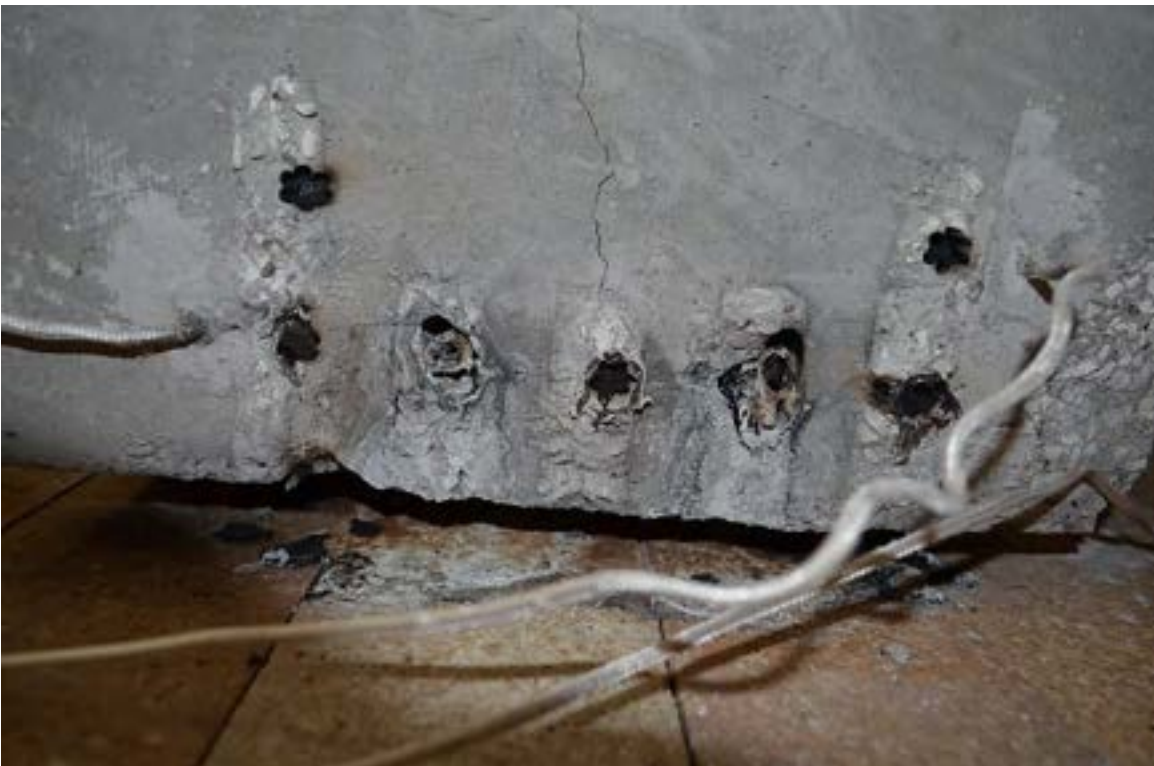
Figure 6.3-98 Close-up look at the end of the beam after fire test

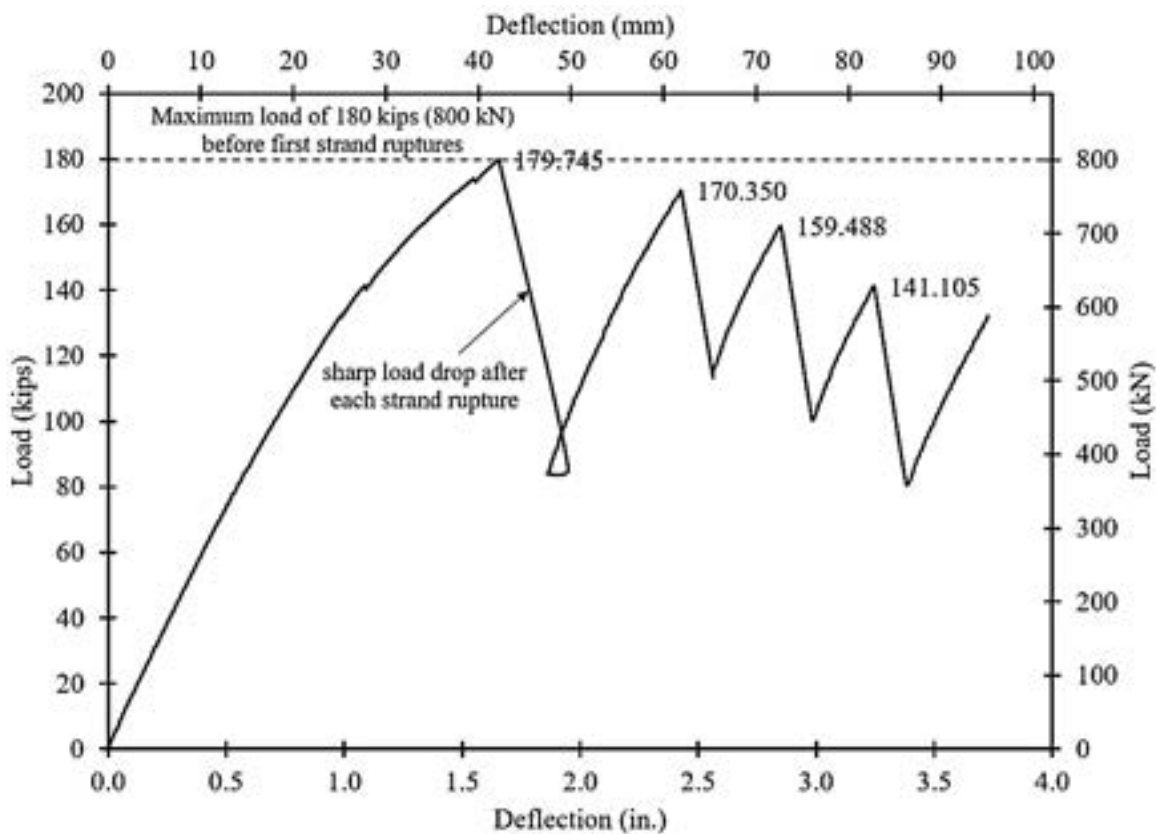
Figure 6.3-99 Load-deflection curve for Beam RI-0.6C

The failure was triggered by strand slippage. The failure load represented 54 % of the anticipated capacity of the beam but nearly 94 % of the theoretical design capacity of the beam after considering strength reduction factors as shown in Table 6.3-6. Figure 6.3-100 through Figure 6.3-103 show the condition of the beam before and after the flexural test.

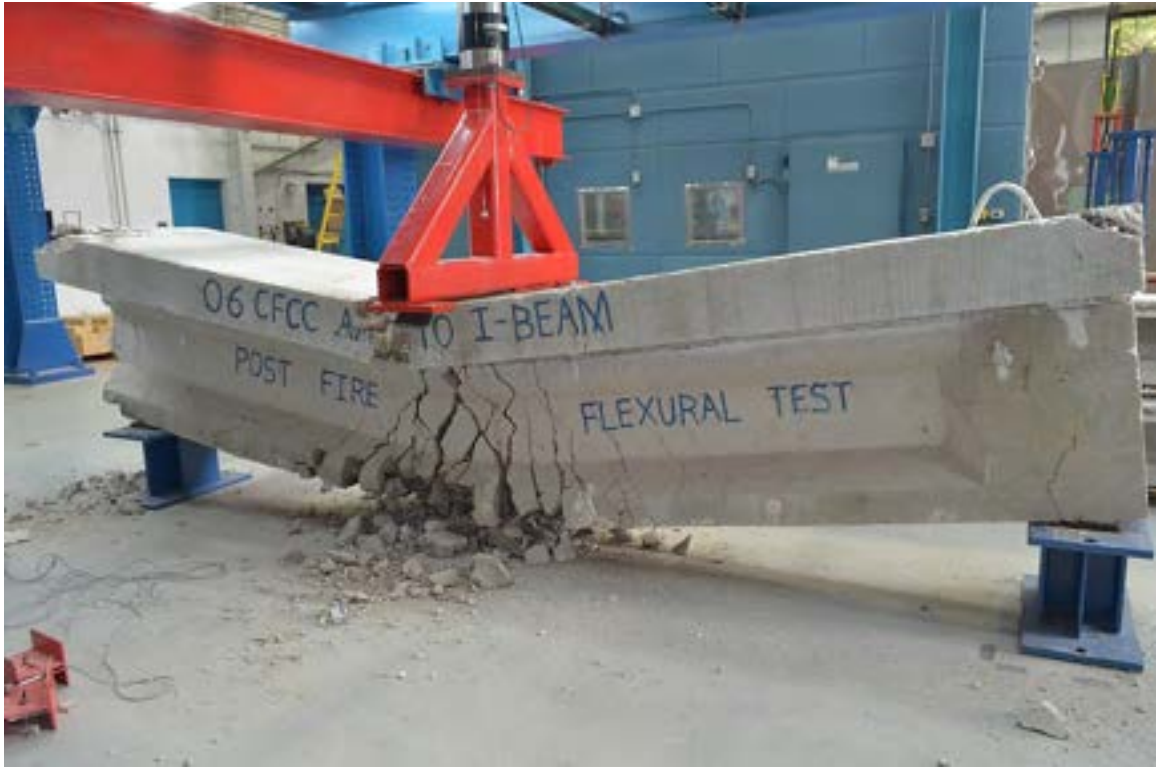
Figure 6.3-101 Failure of Beam RI-0.6C after flexural test

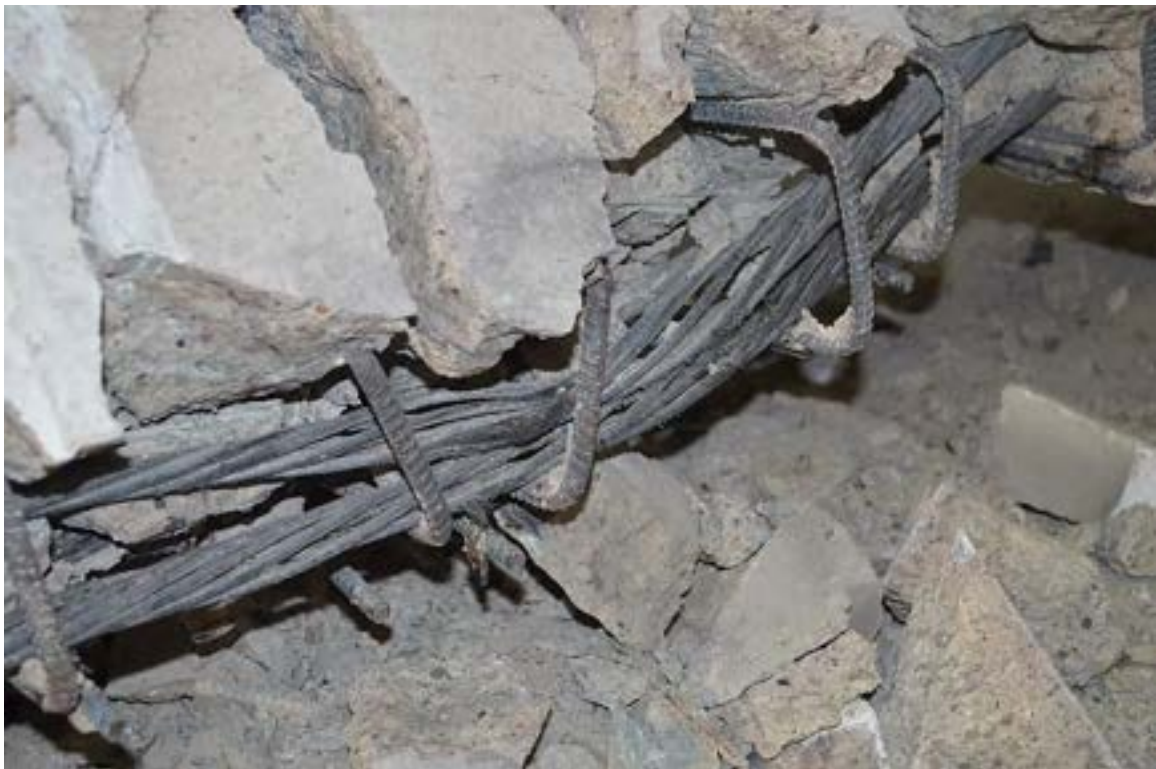
Figure 6.3-102 Rupture and slippage of CFCC strand at failure

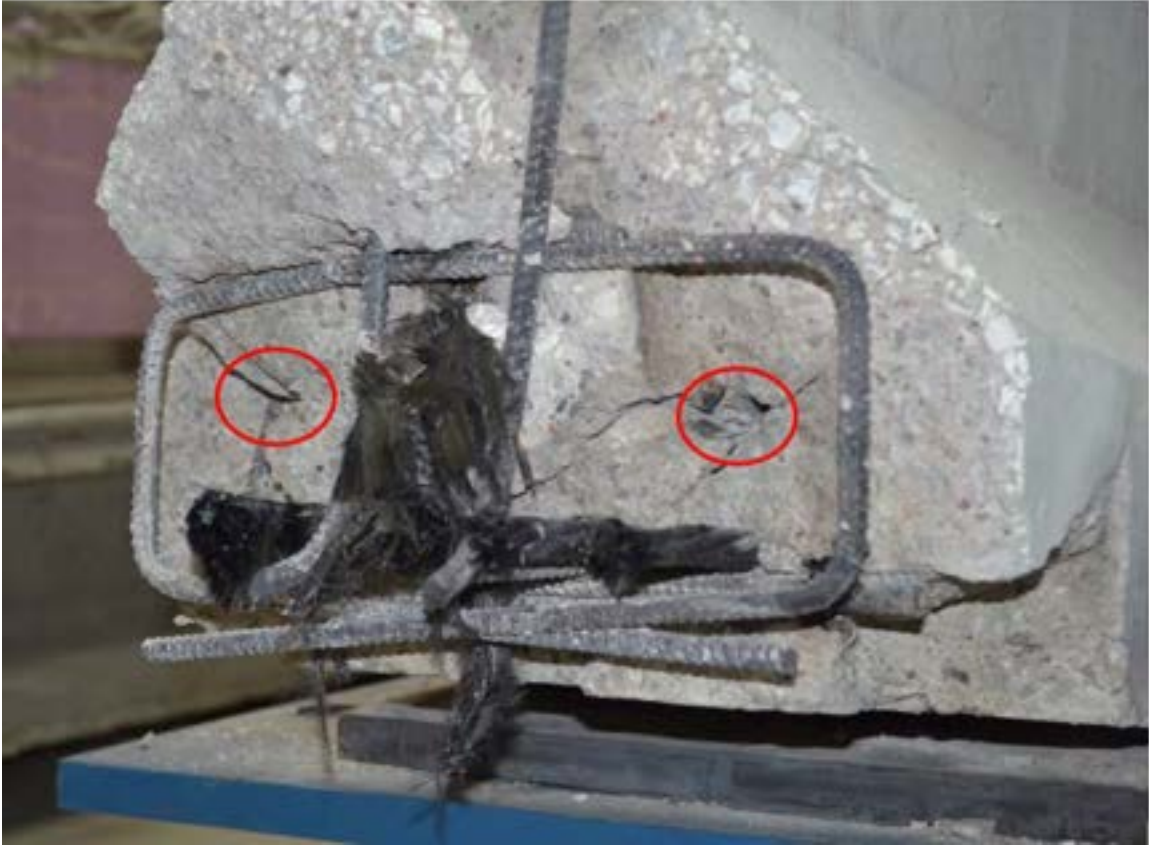
Figure 6.3-103 Rupture and slippage of CFCC strand at failure

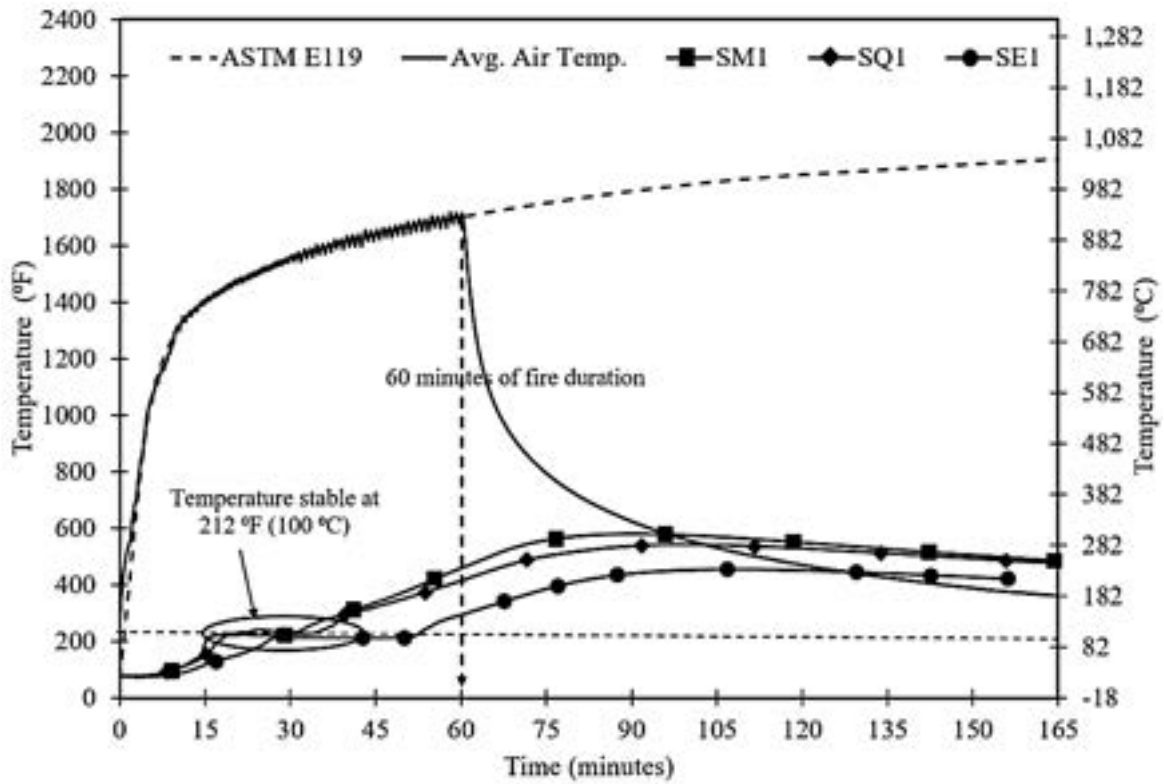
Figure 6.3-104 Time-temperature curve of Beam RI-0.6S (Section-1)

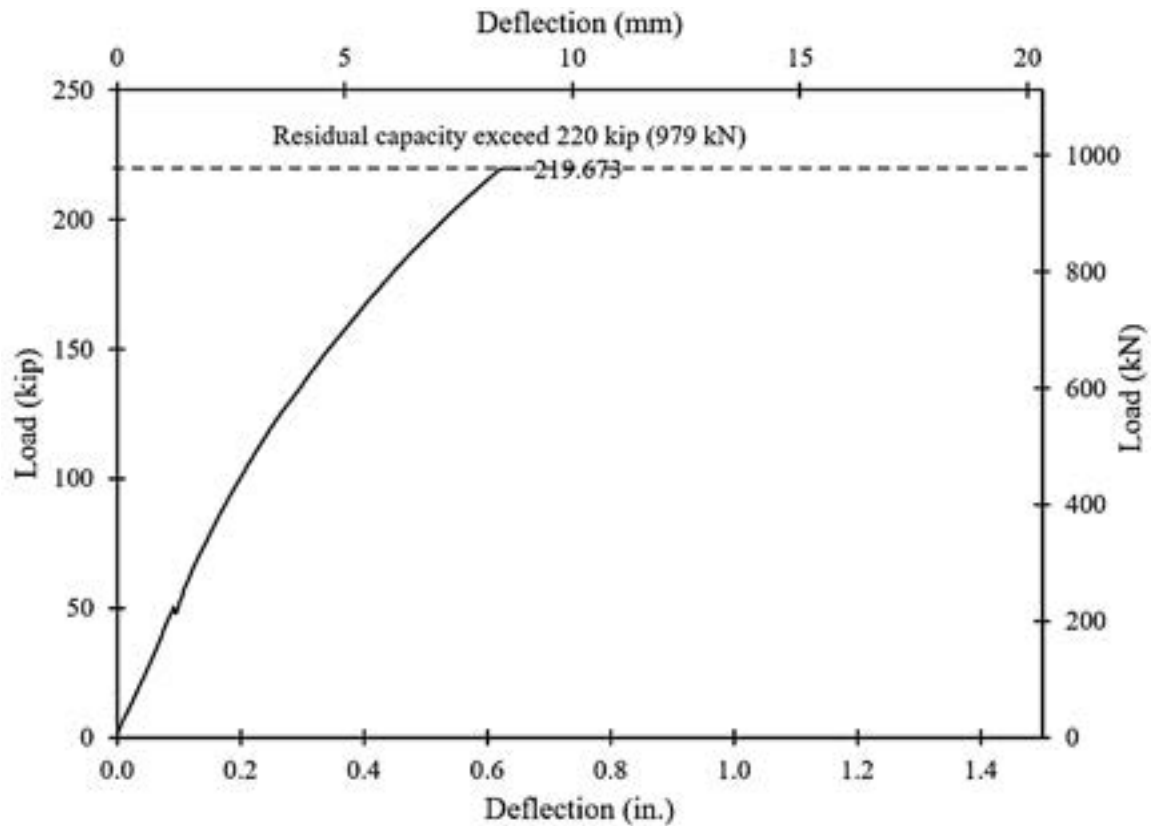
Figure 6.3-111 Load-deflection curve of Beam RI-0.6S under flexural test

Using the results of the full-scale flexural tests discussed in Chapter 5, the anticipated capacity of Beam RI-0.6S was 285 kip (1267 kN). During loading, the beam reached the maximum capacity of the actuator 220 kip (979 kN) without failure. The load-deflection curve is shown in Figure 6.3-111 and indicates that the beam had a linear response from start of loading until reaching the capacity of the actuator. Similar to other beams, the curve showed no decompression load suggesting a loss of the effective prestressing force in the beam. A summary of the test results is presented in Table 6.3-7.

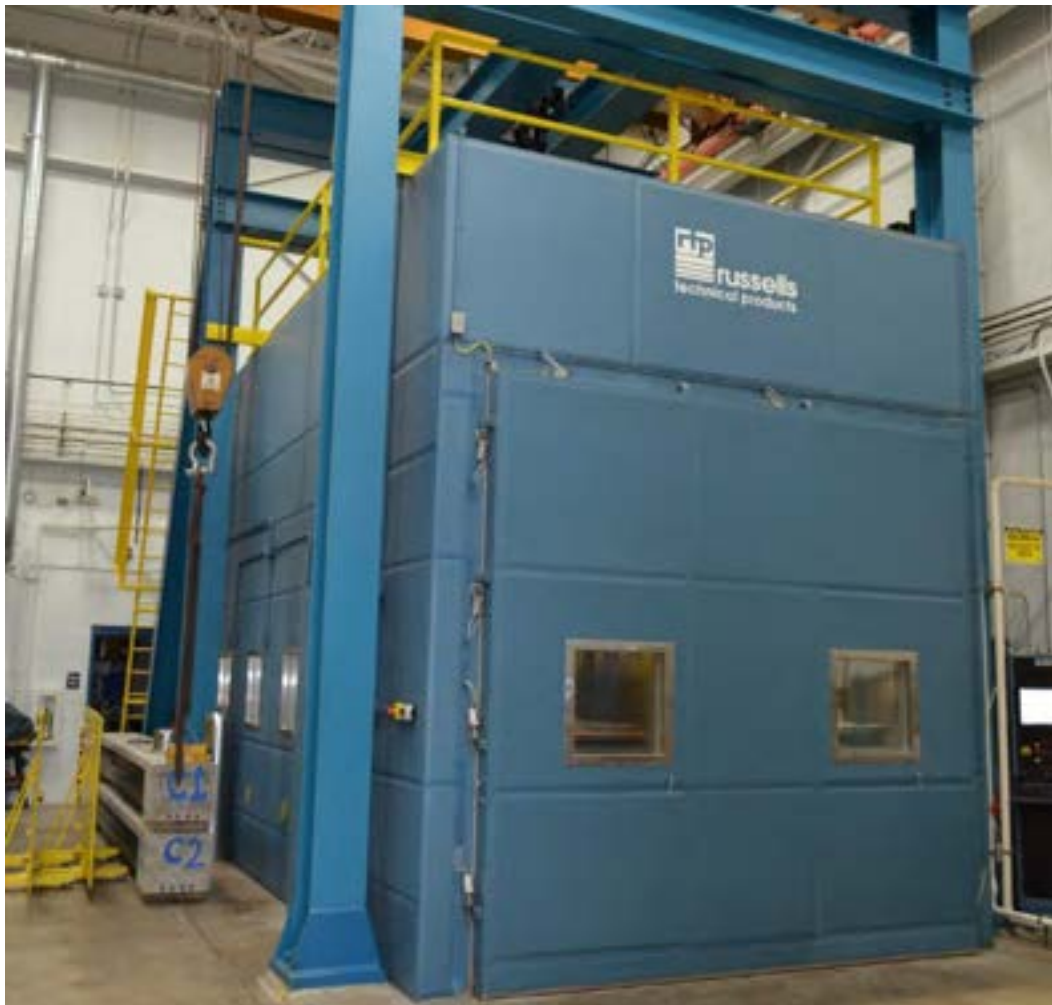
Figure 7.2-1 Environmental Chamber in CIMR

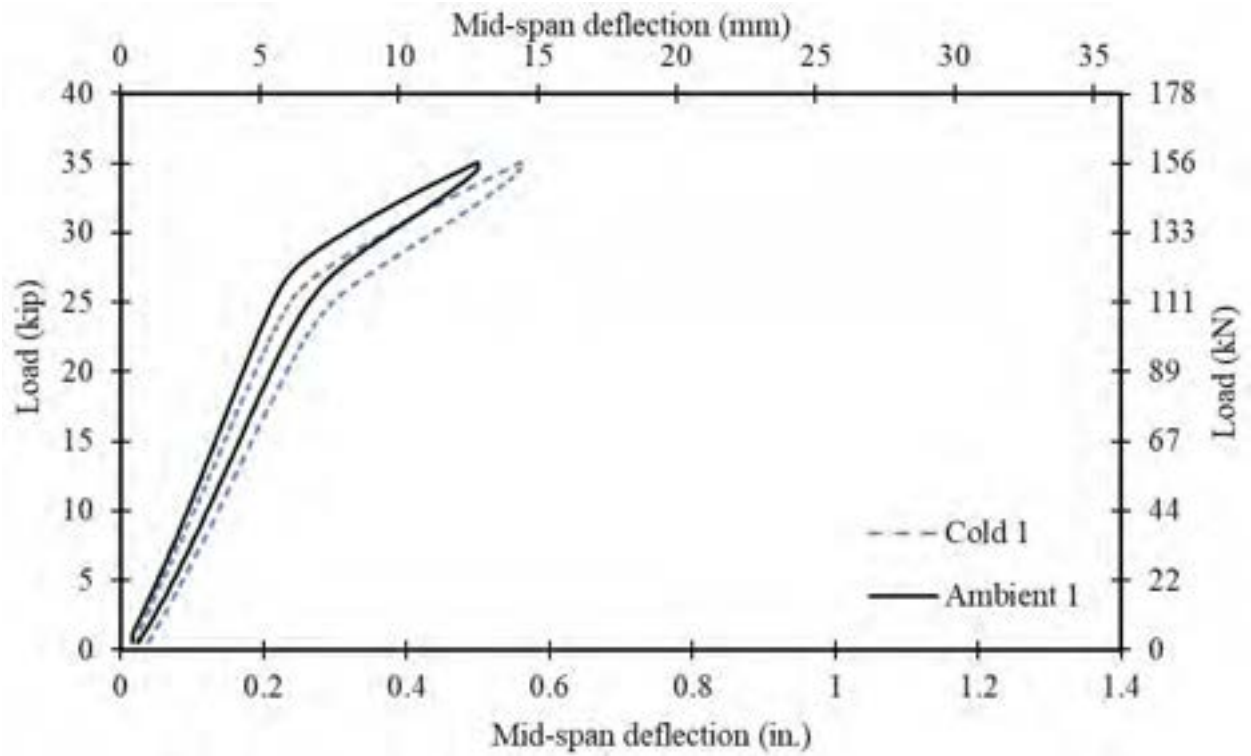
Figure 7.3-21 Change in decompression load with the change in testing temperature in Beam F1

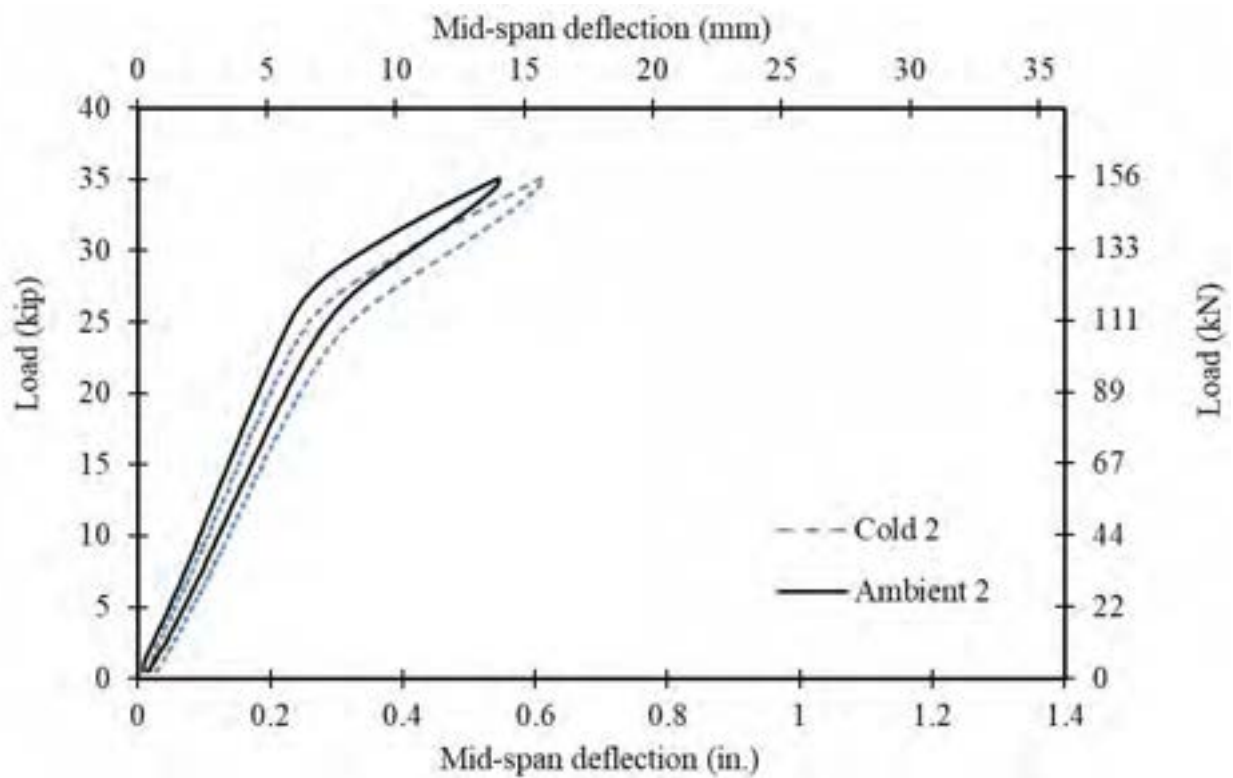
Figure 7.3-24 Change in decompression load with the change in testing temperature in Beam F2

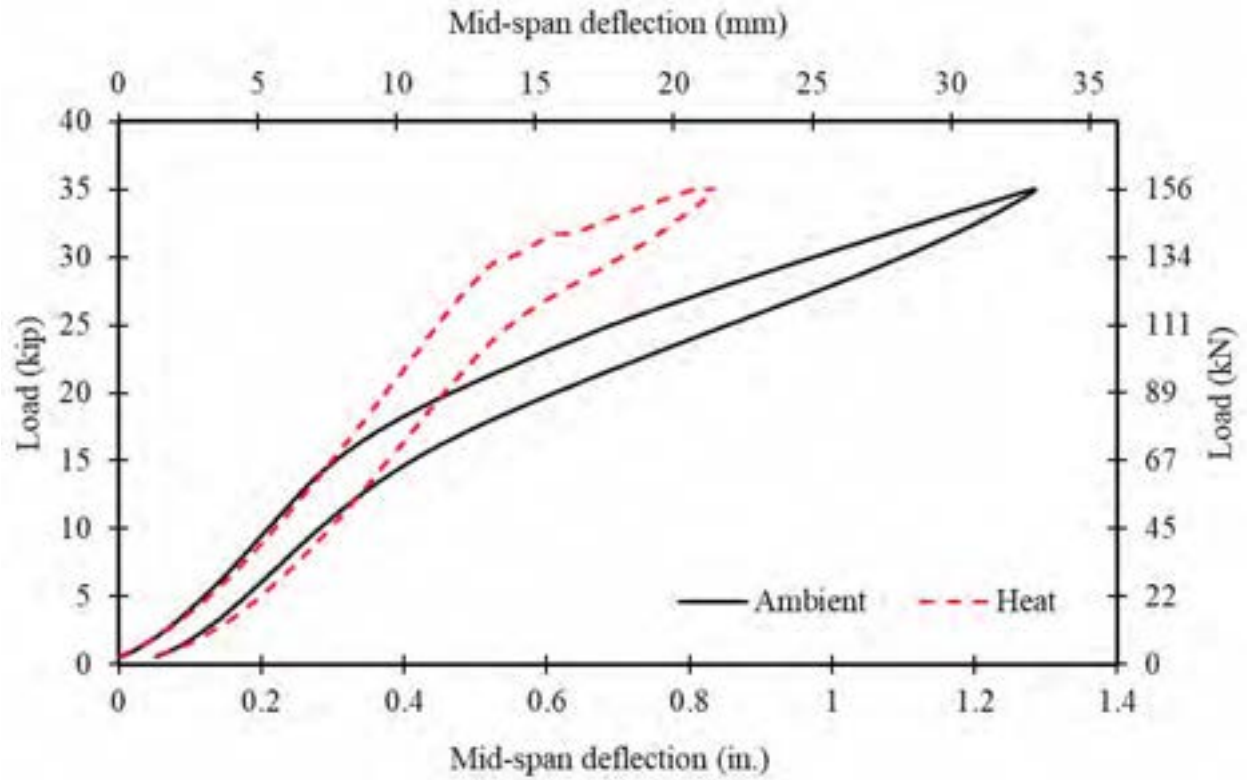
Figure 7.3-27 Change in decompression load with the change in testing temperature in Beam H1

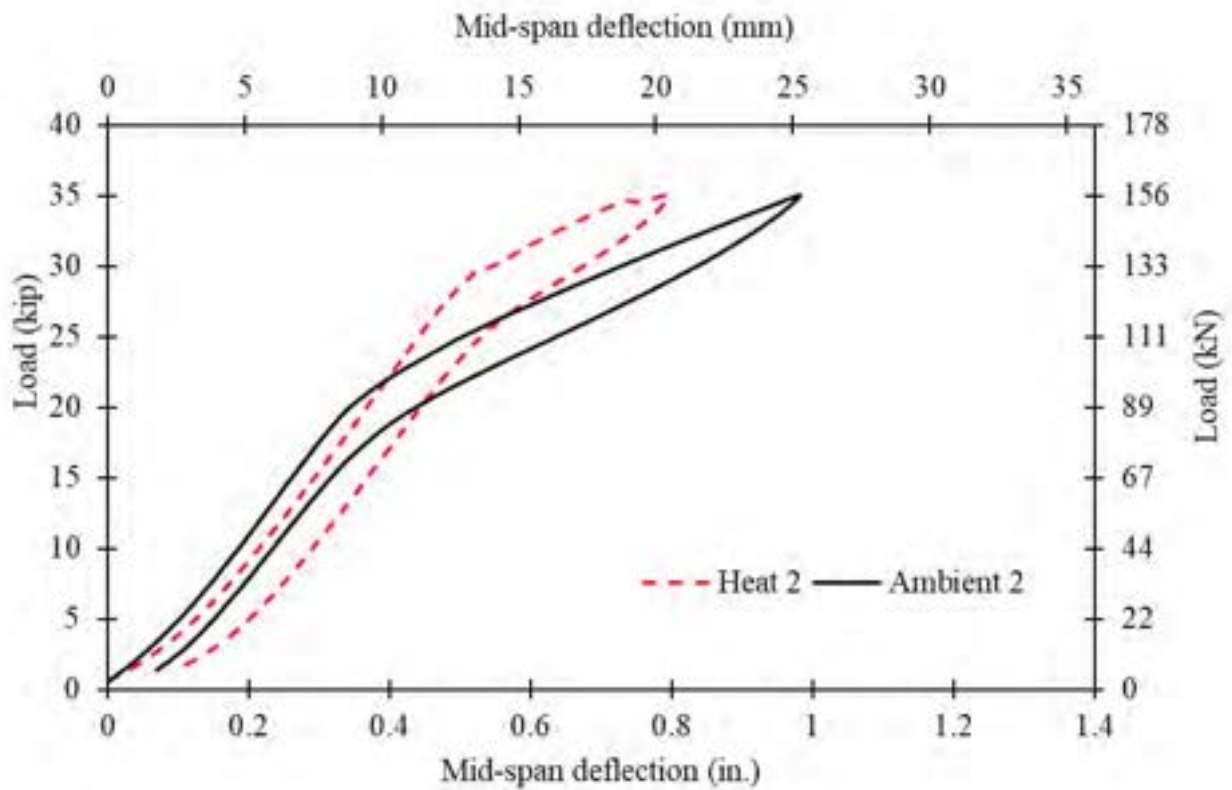
Figure 7.3-30 Change in decompression load with the change in testing temperature in Beam H2

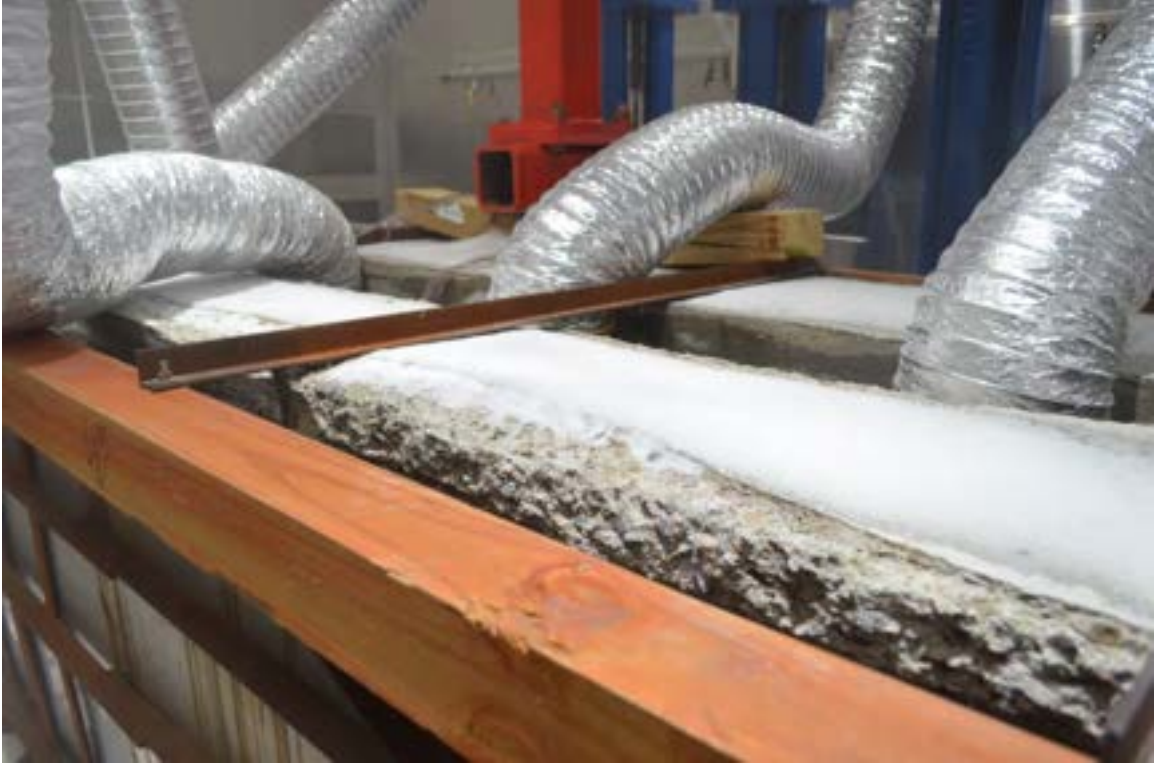
Figure 7.3-45 Deterioration of decked bulb T beams after exposure to 300 freeze-thaw cycles
