EVALUATION OF 0.7 INCH DIAMETER CARBON FIBER REINFORCED POLYMER PRETENSIONING STRANDS IN PRESTRESSED BEAMS

MICHIGAN DEPARTMENT OF TRANSPORTATION
OHIO DEPARTMENT OF TRANSPORTATION
NORTH CAROLINA DEPARTMENT OF TRANSPORTATION
MAINE DEPARTMENT OF TRANSPORTATION

Nabil F. Grace, PhD, P.E., Project Investigator
Mena Bebawy, PhD, P.E., Co-Project Investigator

Mar. 31st, 2022

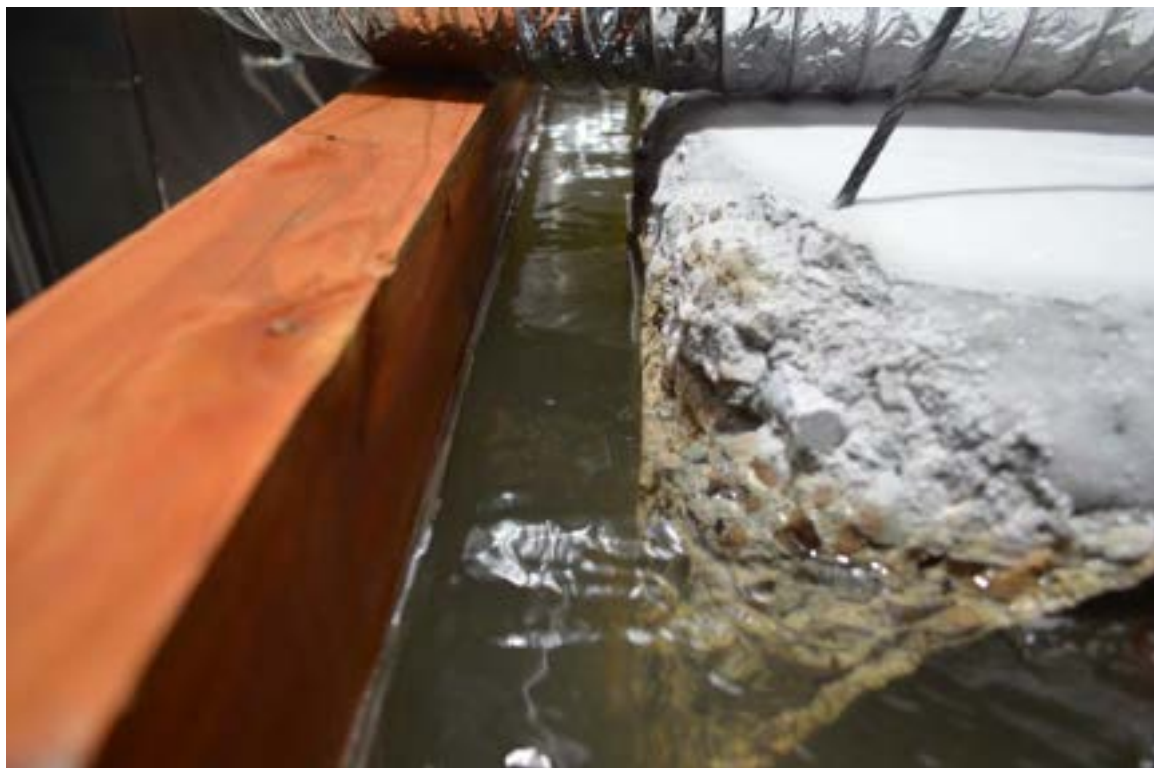
Figure 7.3-46 Concrete corners after exposure to 300 freeze-thaw cycles

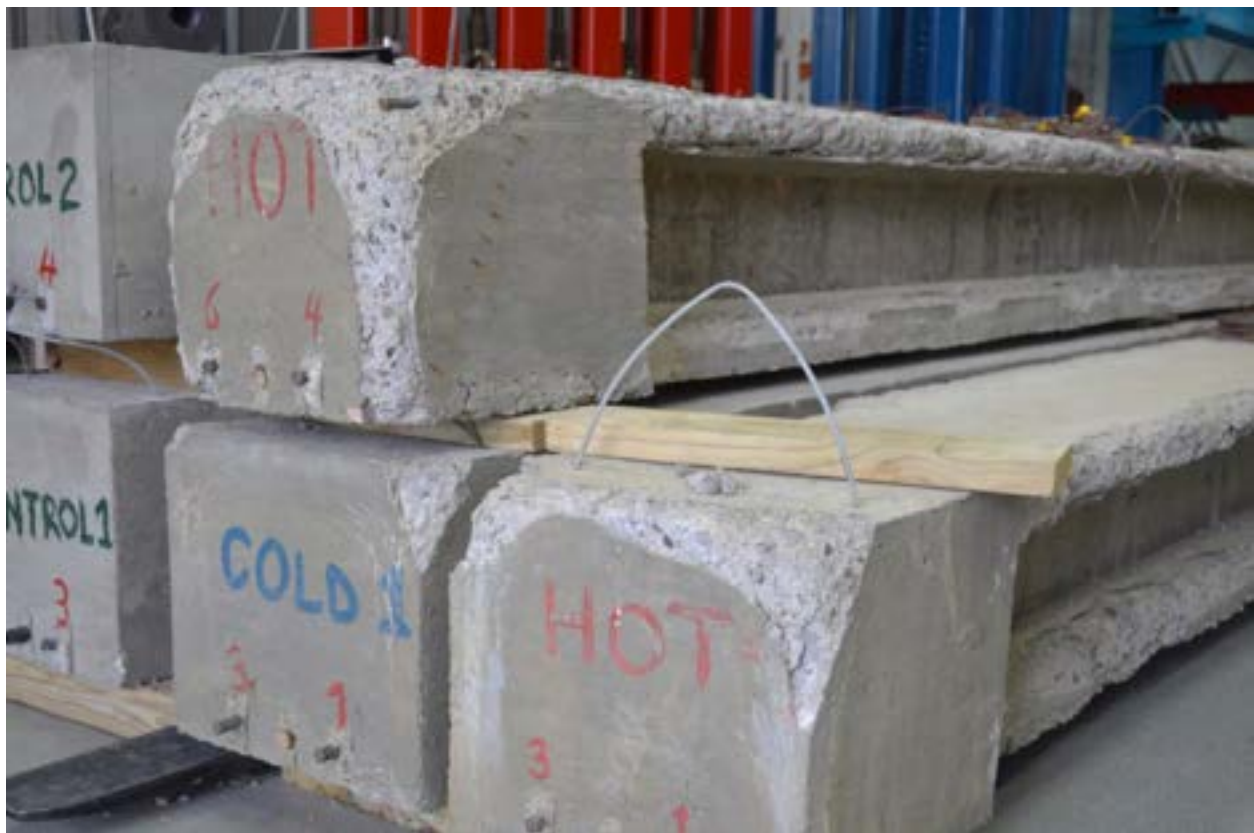
Figure 7.3-48 Decked bulb T beams after exposure to 300 freeze-thaw cycles

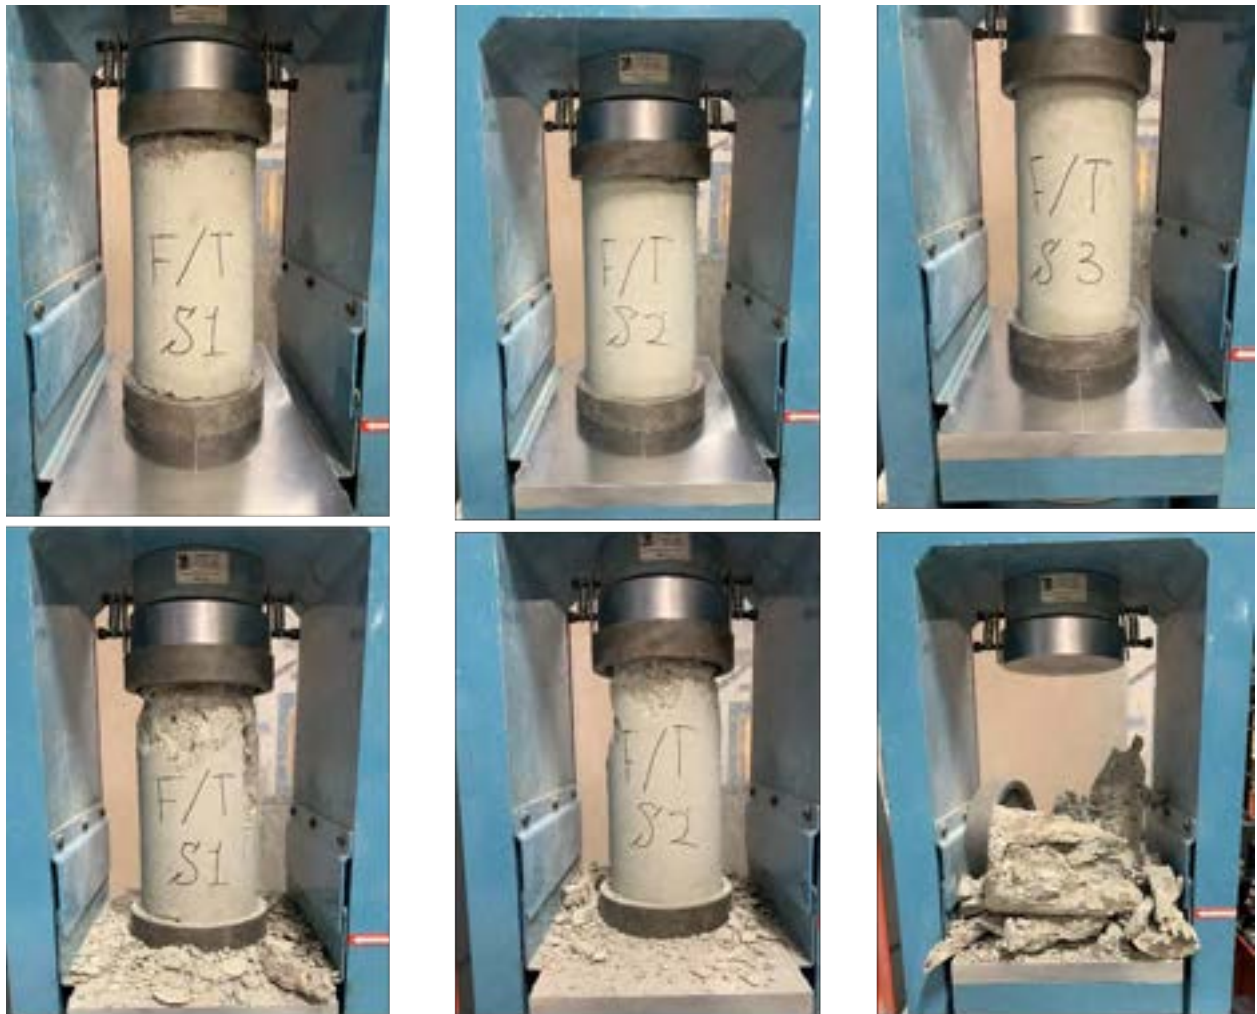
Figure 7.3-50 Testing and failure of concrete cylinders after exposure to 150 freeze-thaw cycles

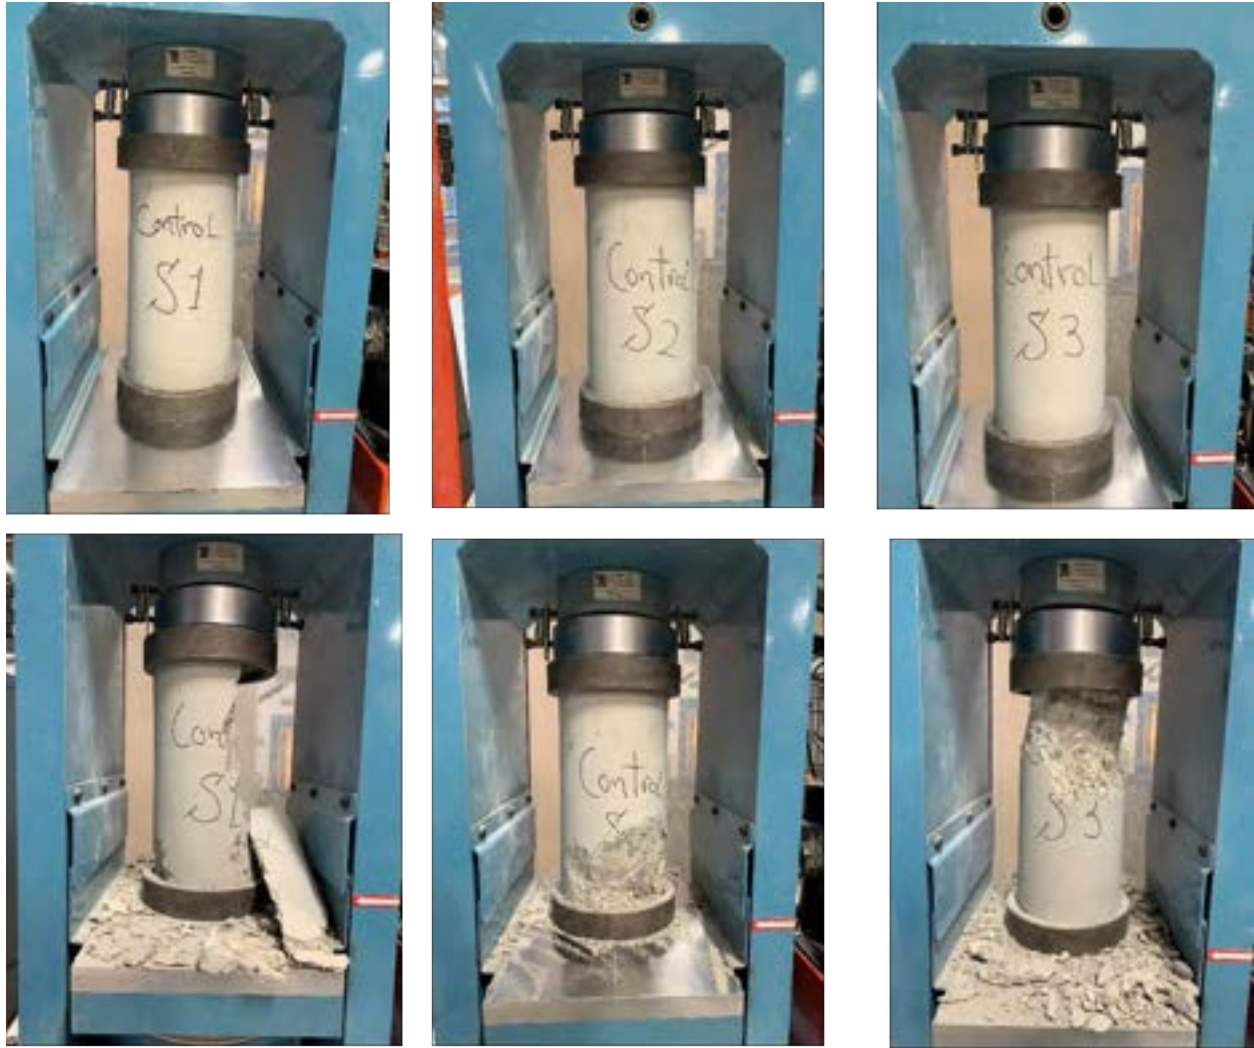
Figure 7.3-51 Testing and failure of control cylinders

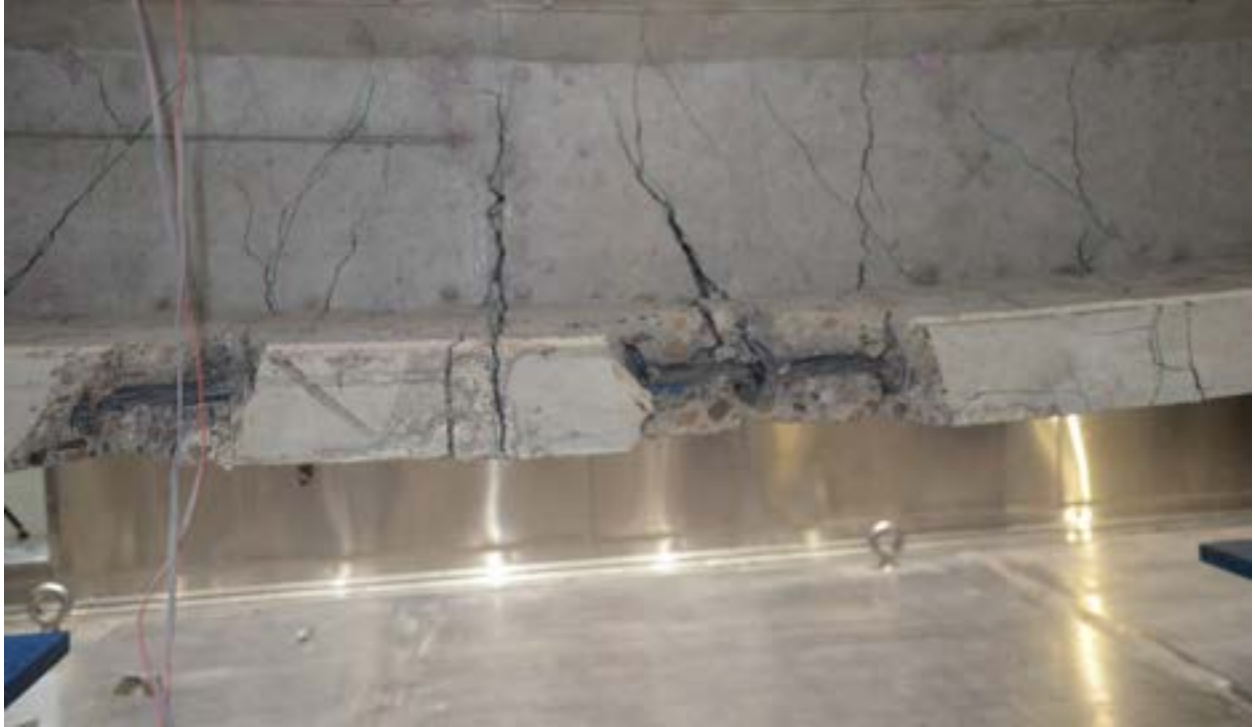
Figure 7.3-54 Debonding of CFCC strands in Beam C1

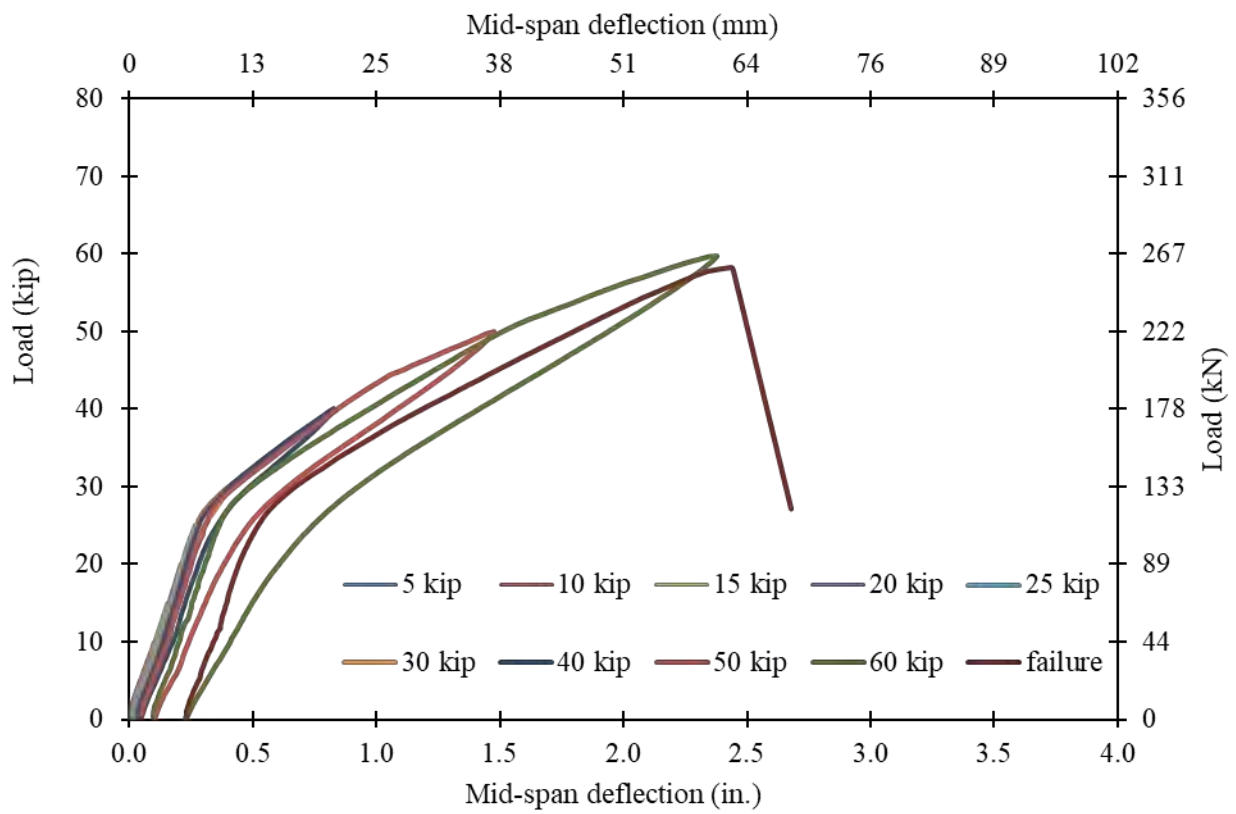
Figure 7.3-60 Load-deflection curves of Beam C2

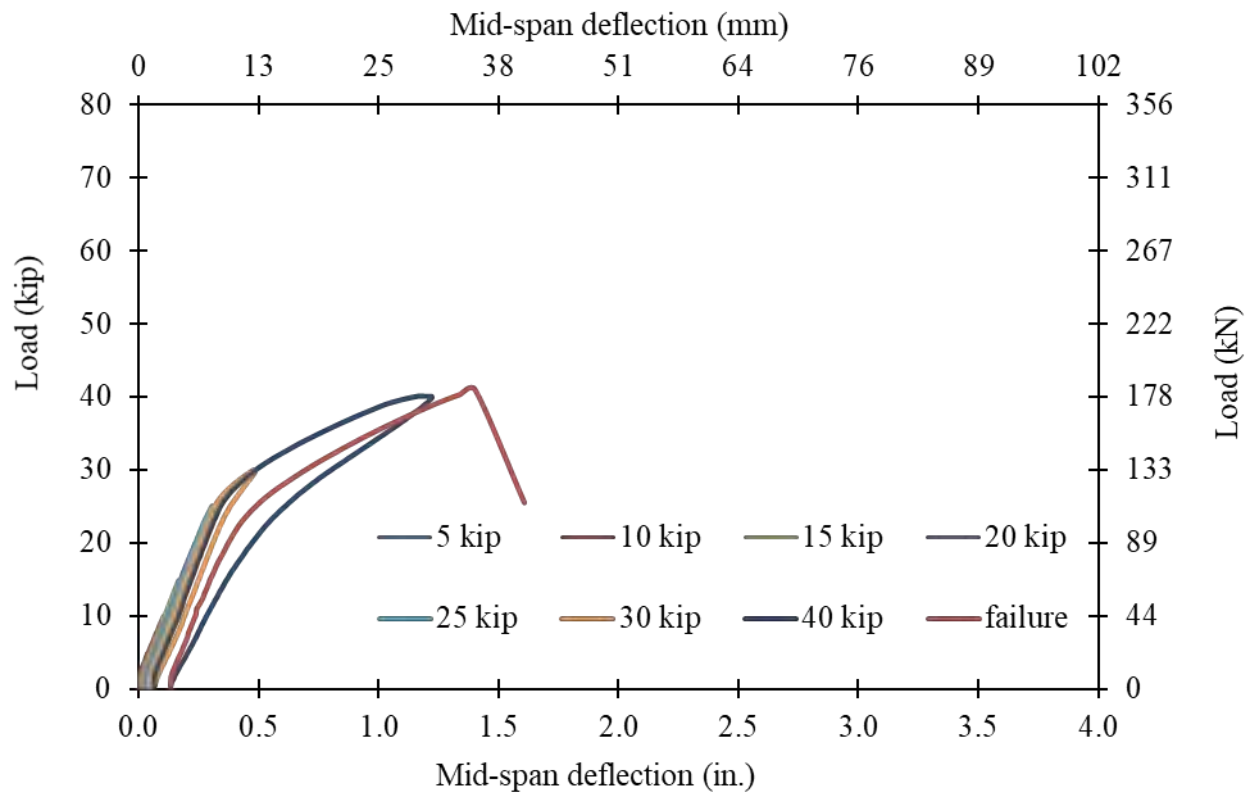
Figure 7.3-71 Load-deflection curves of Beam F2

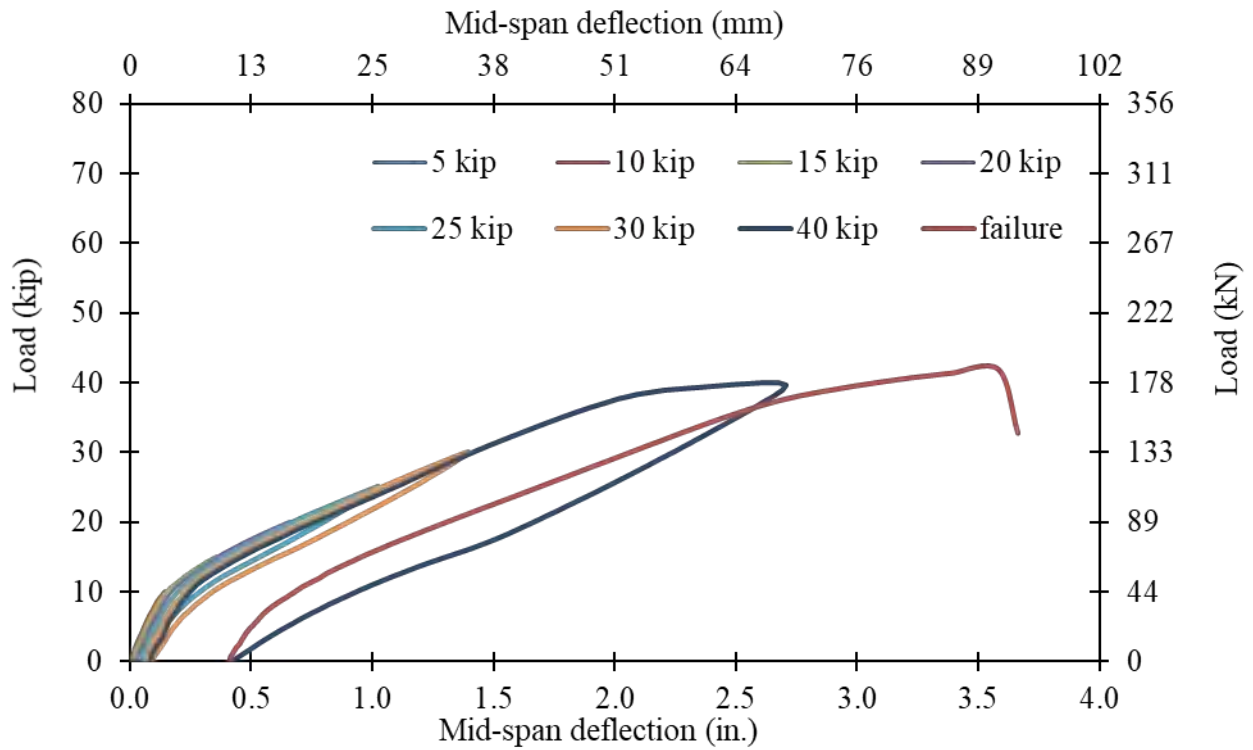
Figure 7.3-77 Load-deflection curves of Beam H1

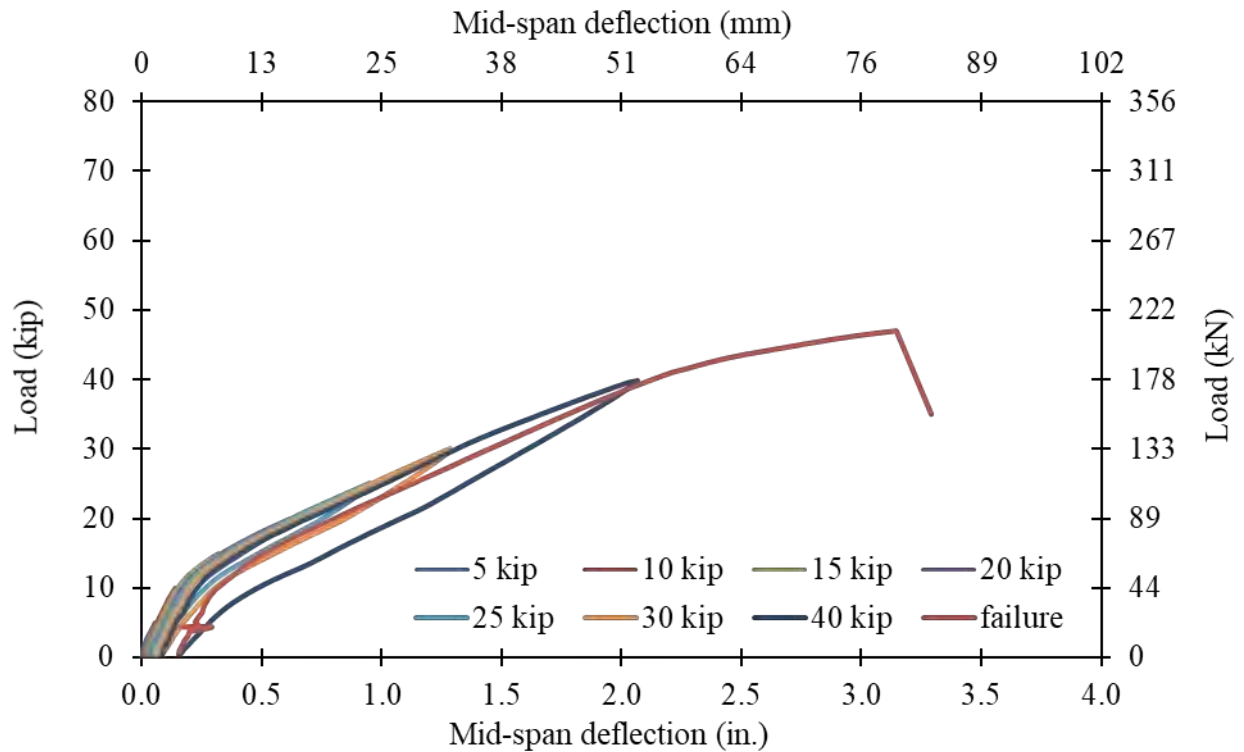
Figure 7.3-83 Load-deflection curves of Beam H2

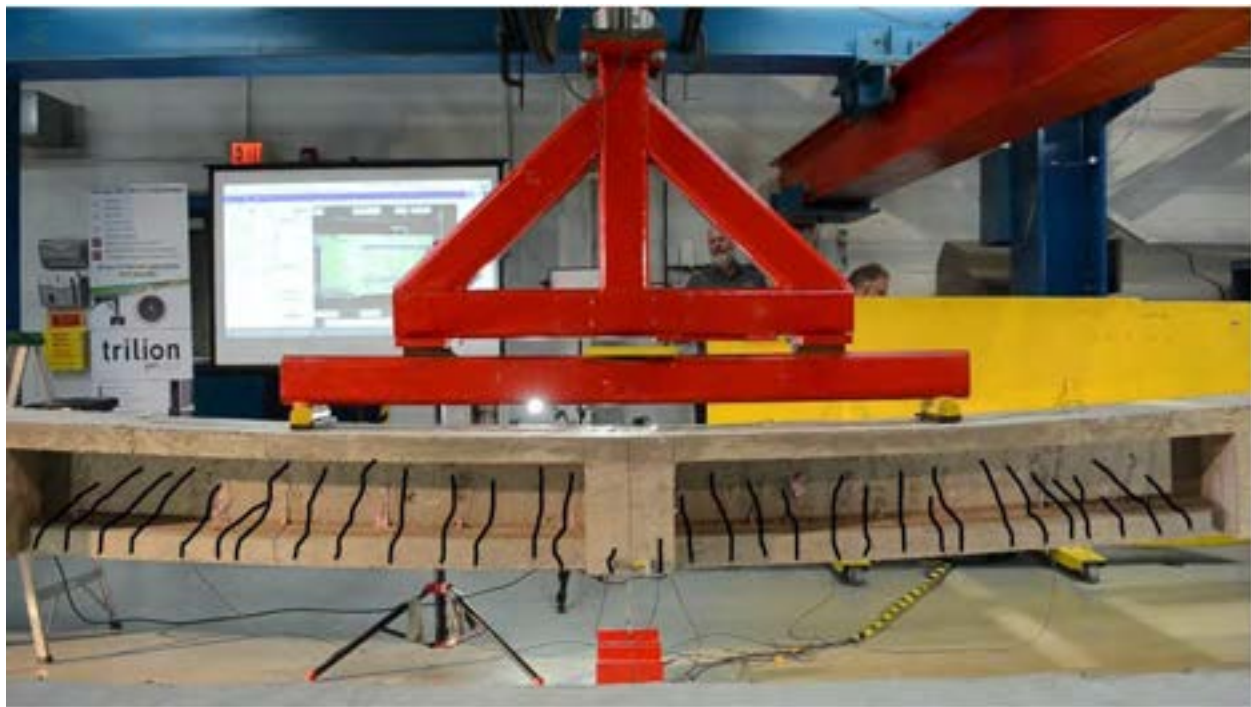
Figure 8.7-3 Crack pattern of control beam at 24-kip (107-kN) load cycle

in the beam with increasing the load beyond the cracking load. Consequently, the beam experienced further reduction in its flexural stiffness with each loading/unloading cycle. The cracks were uniformly distributed under the loading spreader and propagated vertically to the top flange. By increasing the applied load, the beam showed gradual increase in the crack pattern and width. In addition, inclined cracks were developed far from the loading points in the form of flexural-shear cracks, as shown in Figure 8.7-3. The post-cracking stage ended by loading the beam to a load level of 24 kip (107 kN). This corresponded to a midspan deflection of 7.4 in. (188 mm) and residual deflection of 0.5 in. (12.7 mm) from previous load cycles. Figure 8.7-4 shows the deflection of the control beam during the 24-kip (107-kN) load cycle. It should be noted that the beam exhibited significant deflection accompanied by spalling of concrete edges. In practice, those signs serve as a visual warning before failure of bridge beams.

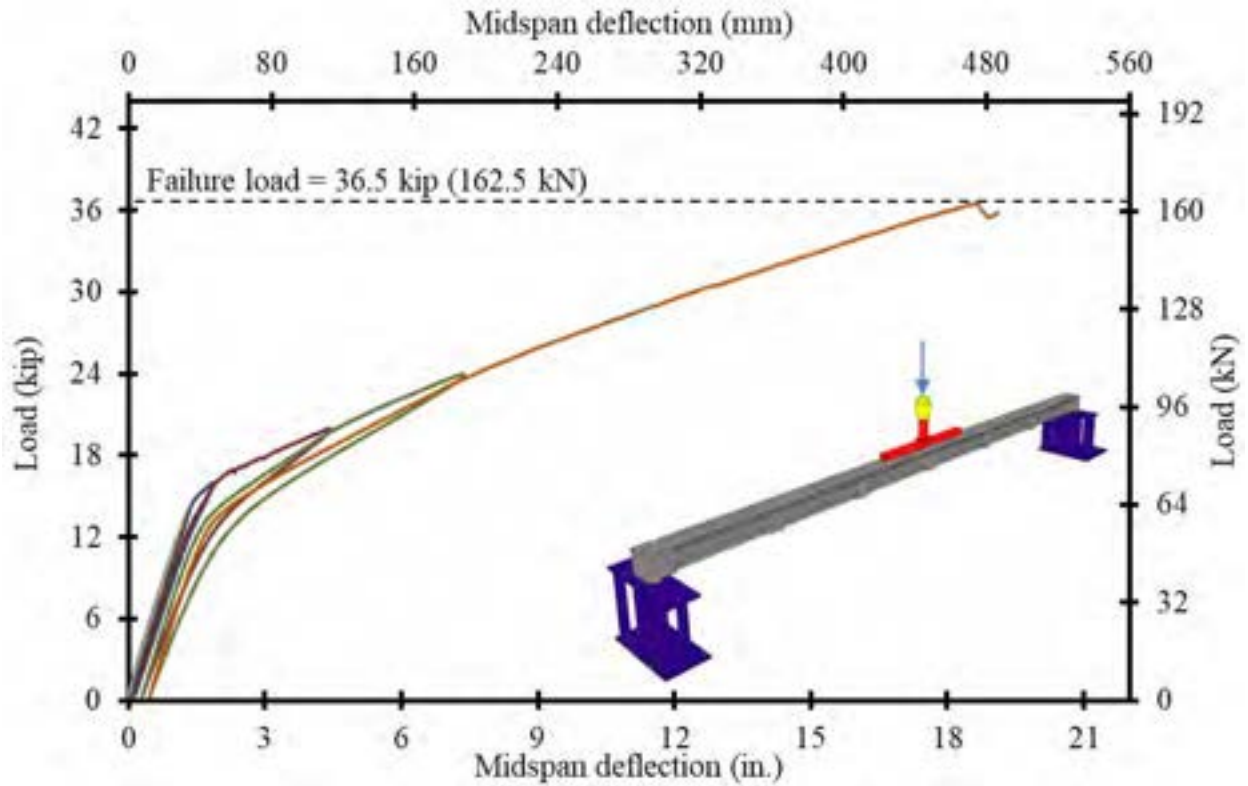
Figure 8.7-5 Load-deflection curves from load cycles performed on control beam until failure

Strength limit state testing was performed after the post-cracking stage by testing the beam monotonically to failure. The failure of the beam took place at a load level of 36.5 kip (162.4 kN) with a corresponding deflection of 18.5 in. (470 mm) not including the residual deflection of 0.5 in. (12.7 mm) from previous load cycles. The maximum recorded strain at the extreme compression zone before failure was approximately $2460 \mu\epsilon$. The load-deflection curves and the load-strain curves of the beam during the loading and unloading cycles until failure is presented in Figure 8.7-5 and Figure 8.7-6, respectively. Failure of the control beam was characterized by rupture of CFCC strands in the tension zone accompanied by spalling of the concrete at multiple locations (Figure 8.7-7). In order to calculate the energy absorbed by the control beam, the area under the load-deflection curves from all load cycles including the ultimate load cycle (Figure 8.7-8) was estimated as 472 kip.in. (53.4 kN.m).

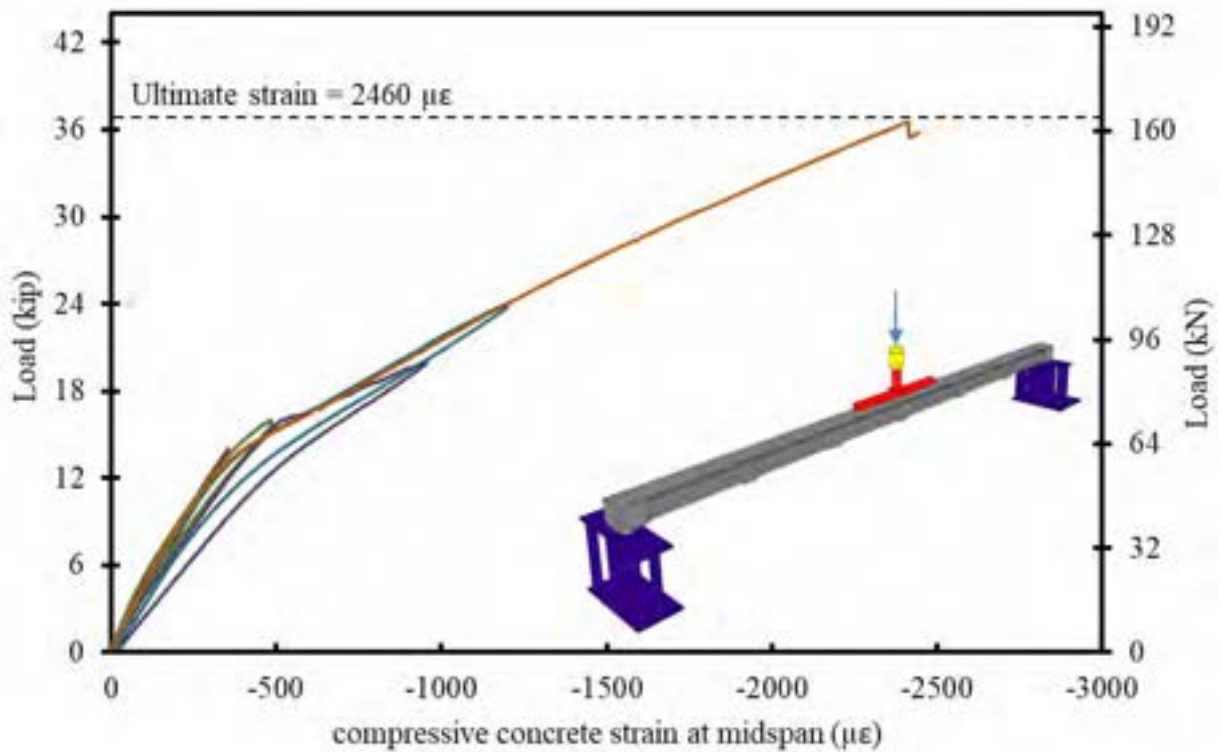
Figure 8.7-6 Load vs. top concrete strain of control beam until failure

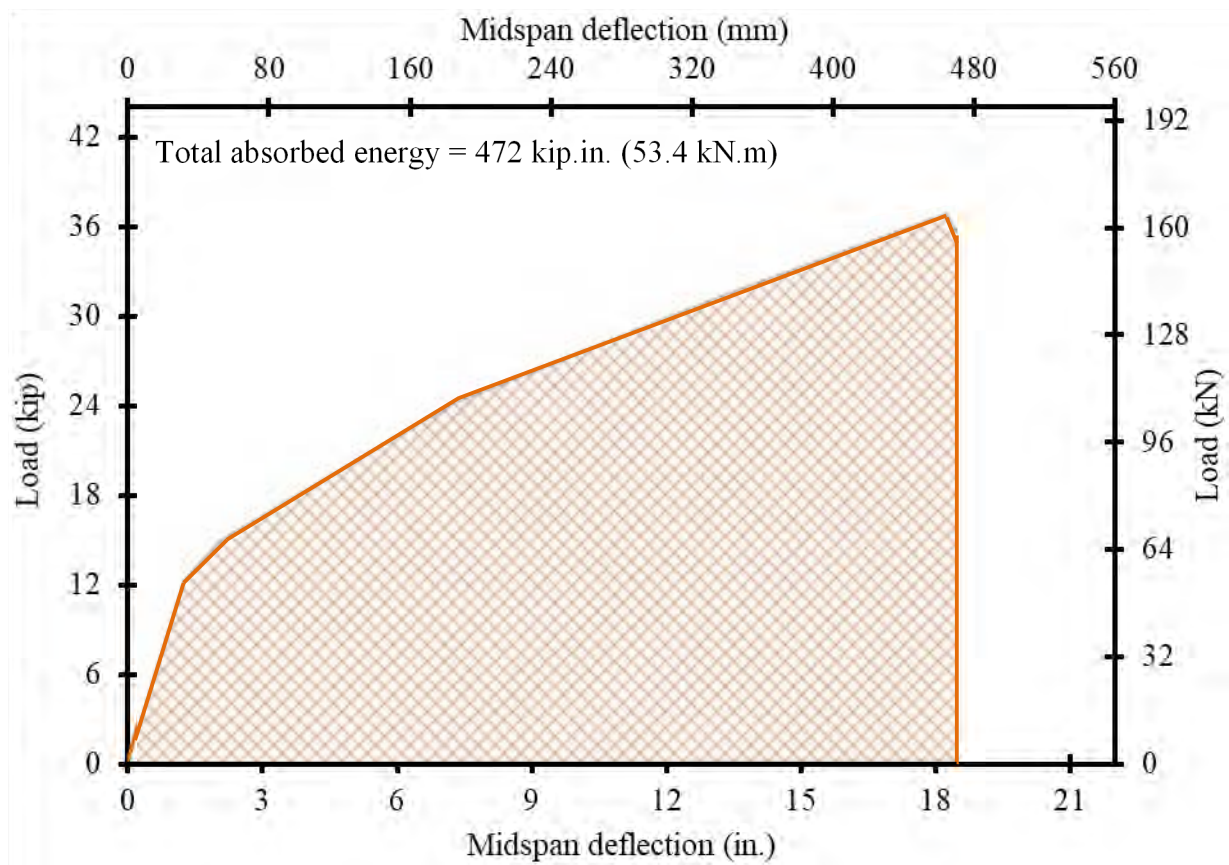
Figure 8.7-8 Estimation of energy absorbed in control beam

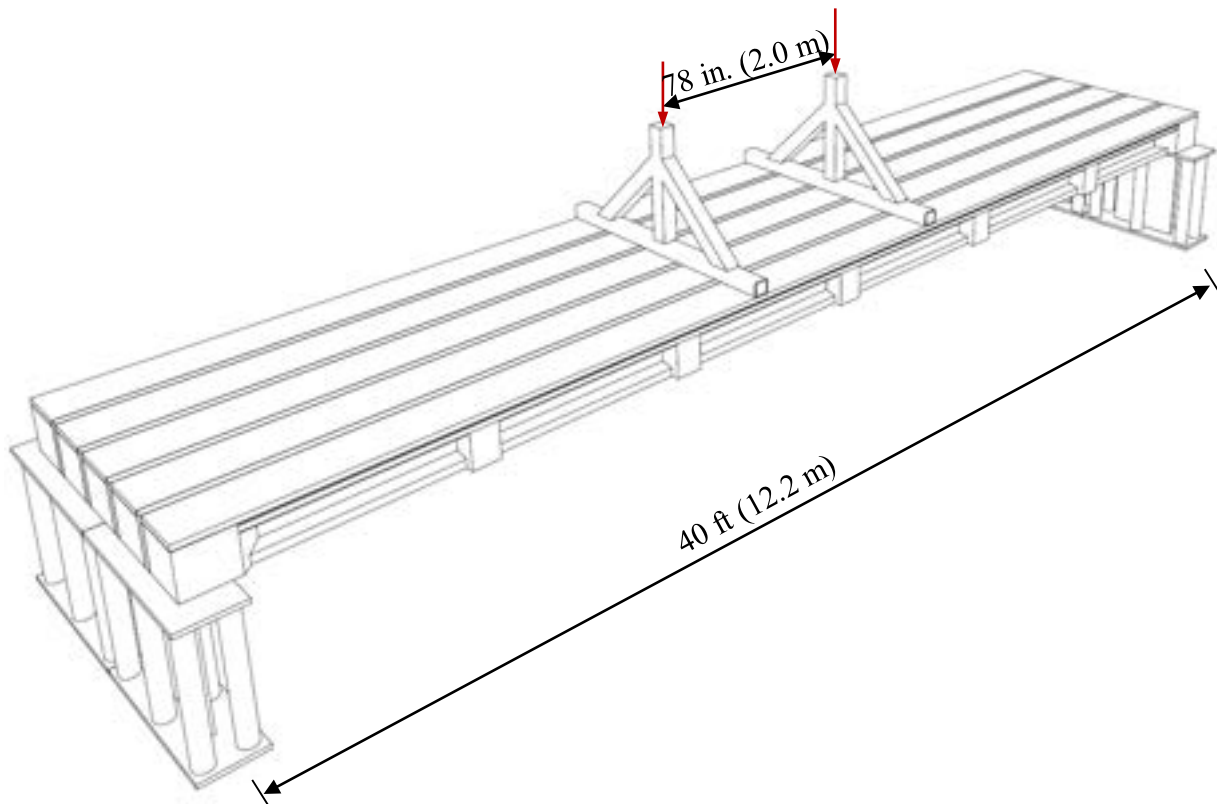
Figure 8.8-6 Schematic diagram showing the four-point load setup for inducing flexural cracks

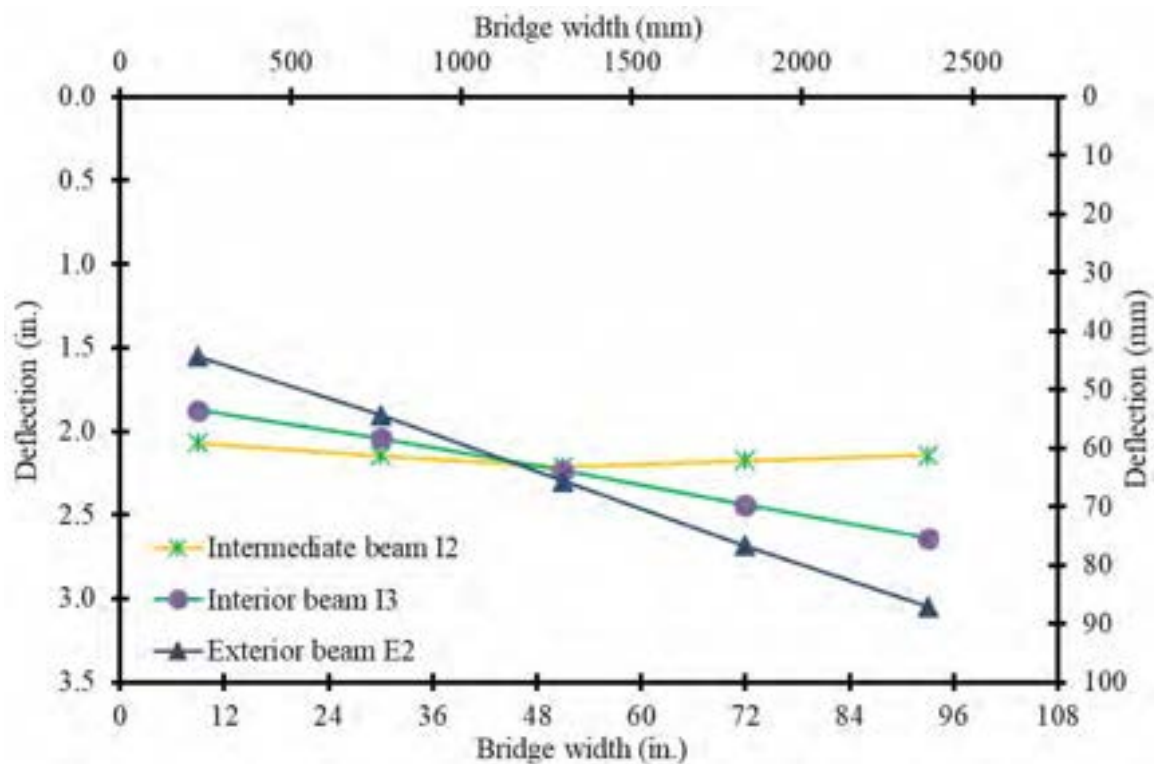
Figure 8.8-9 Deflection curves due to post-cracking loads of 70 kip (312 kN)

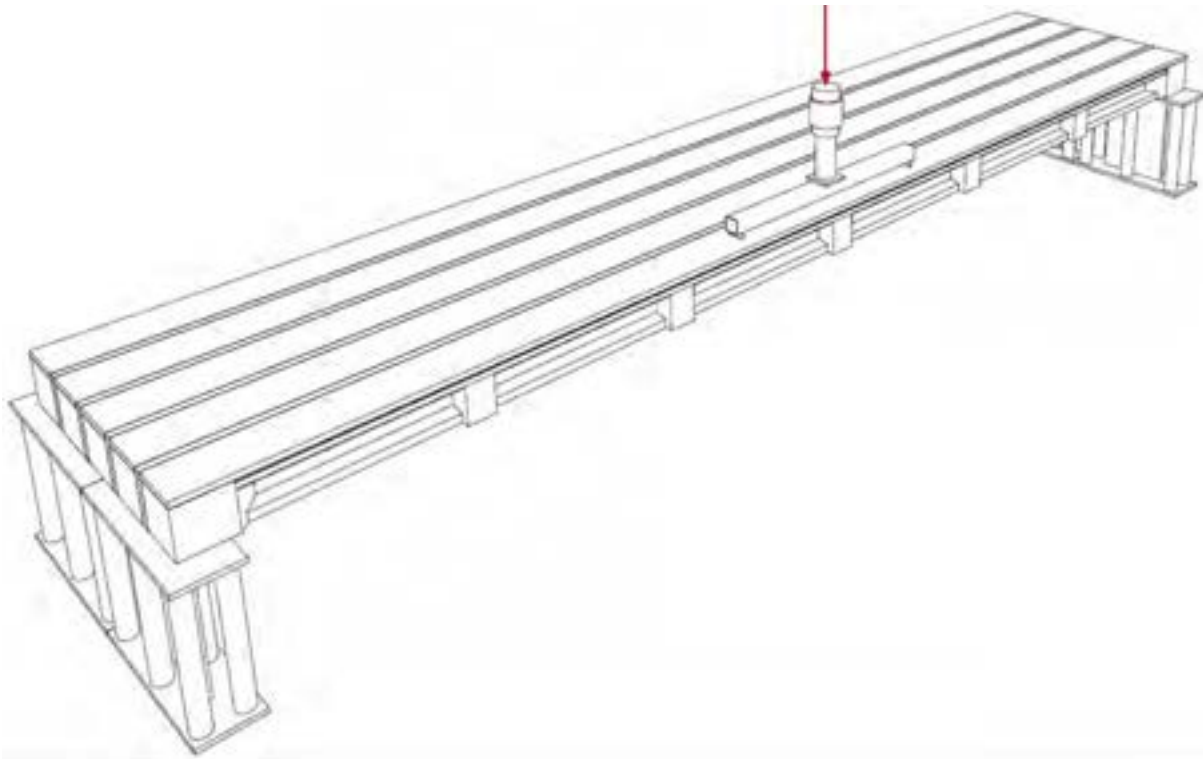
Figure 8.8-10 Schematic diagram of the shear key test

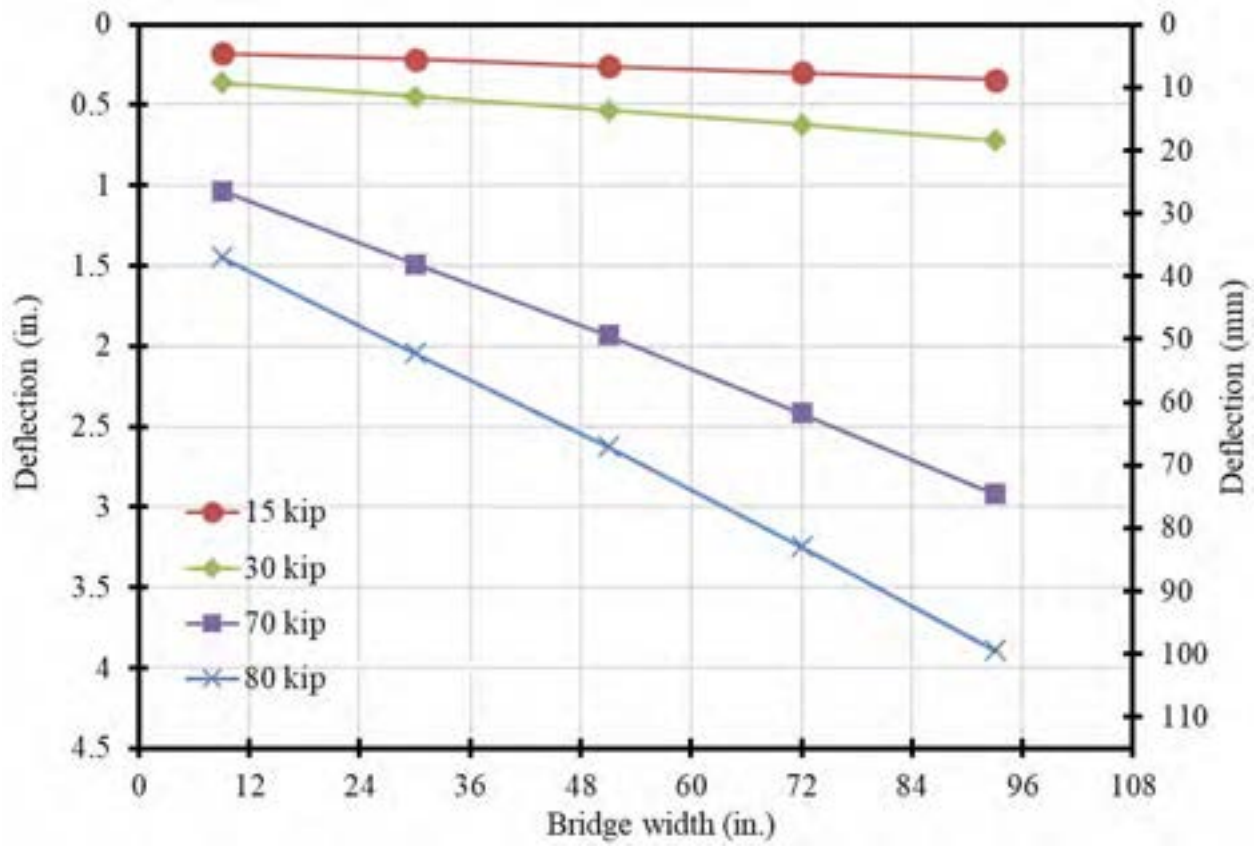
Figure 8.8-13 Deflection curves of bridge model while loading the exterior beam

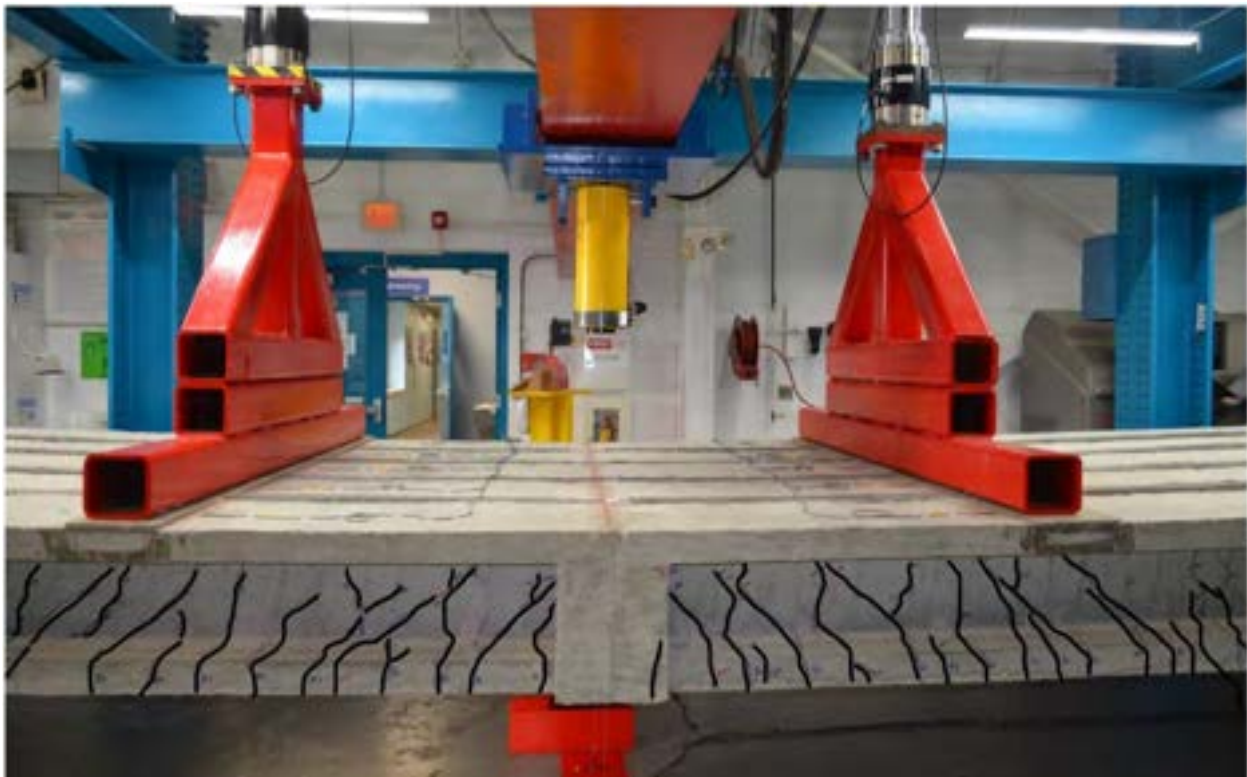
Figure 8.8-14 Crack pattern observed during load cycle test of the bridge model

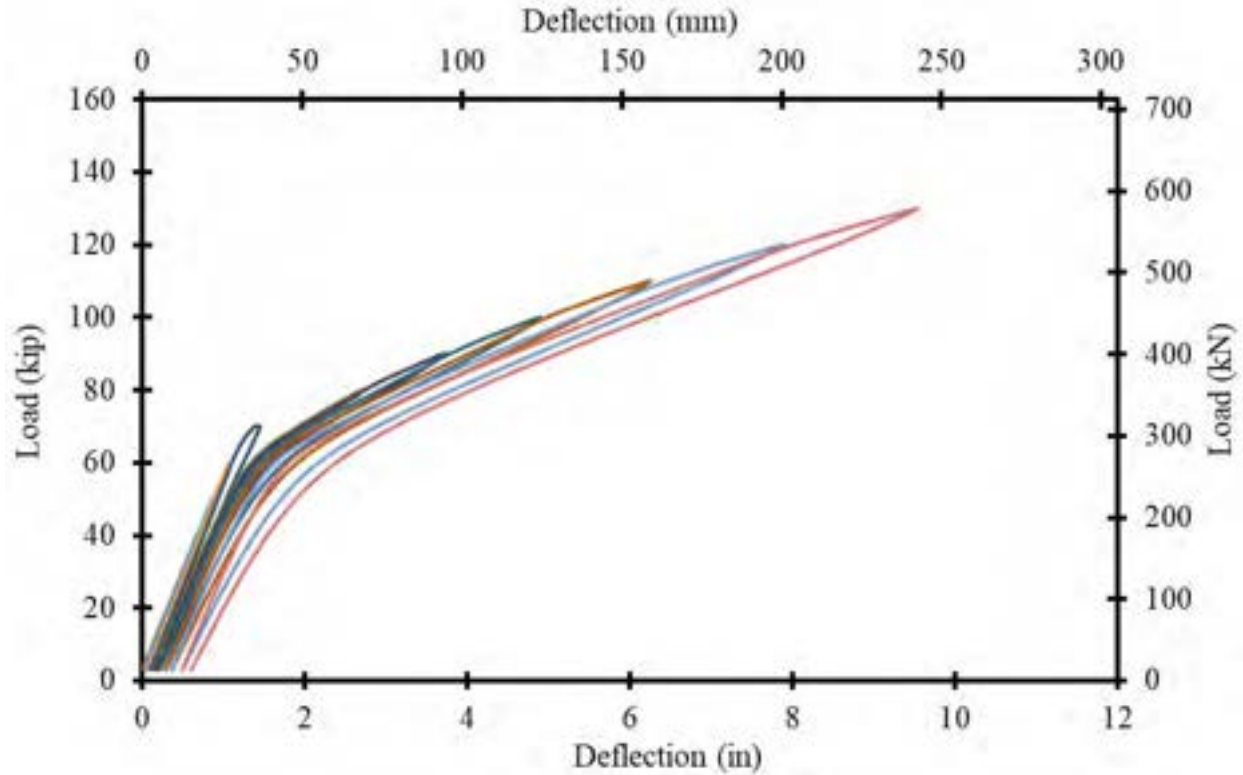
Figure 8.8-15 Load-deflection curves of the bridge model under flexural load cycles

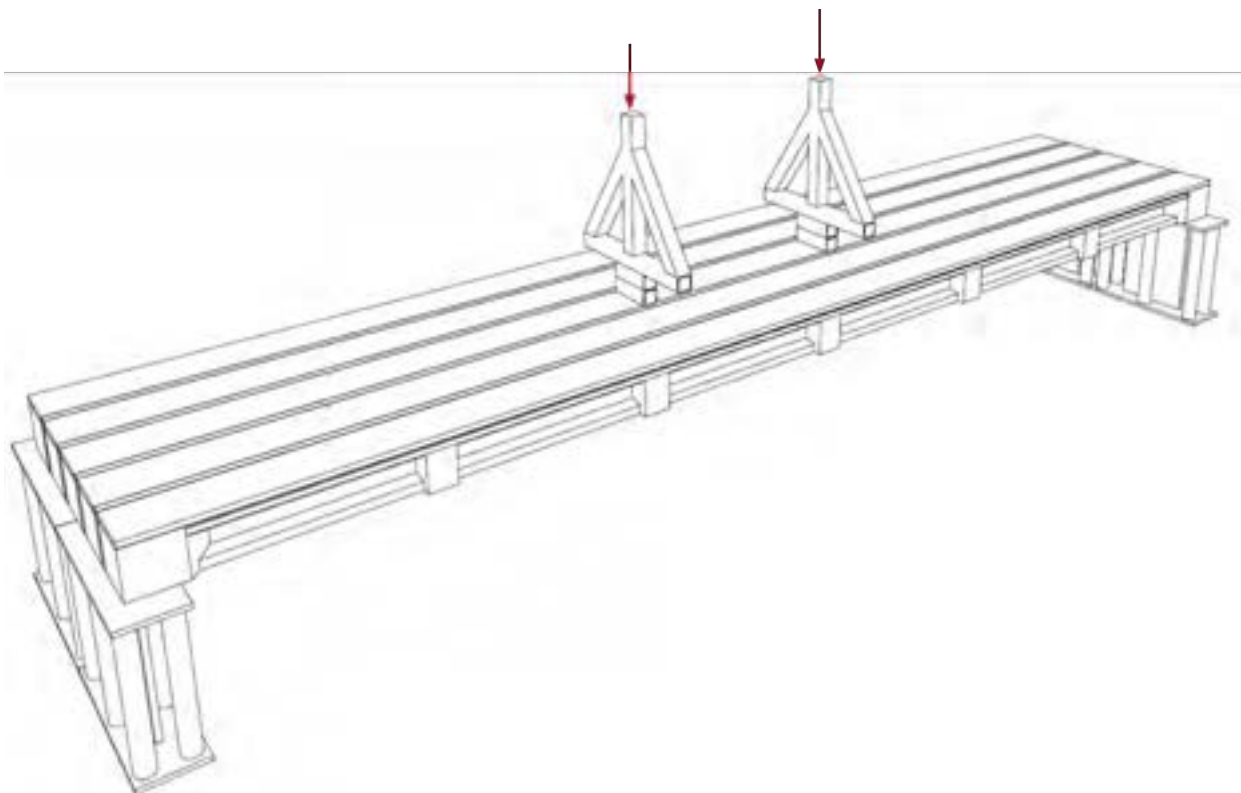
Figure 8.8-16 Schematic diagram showing the strength limit state test

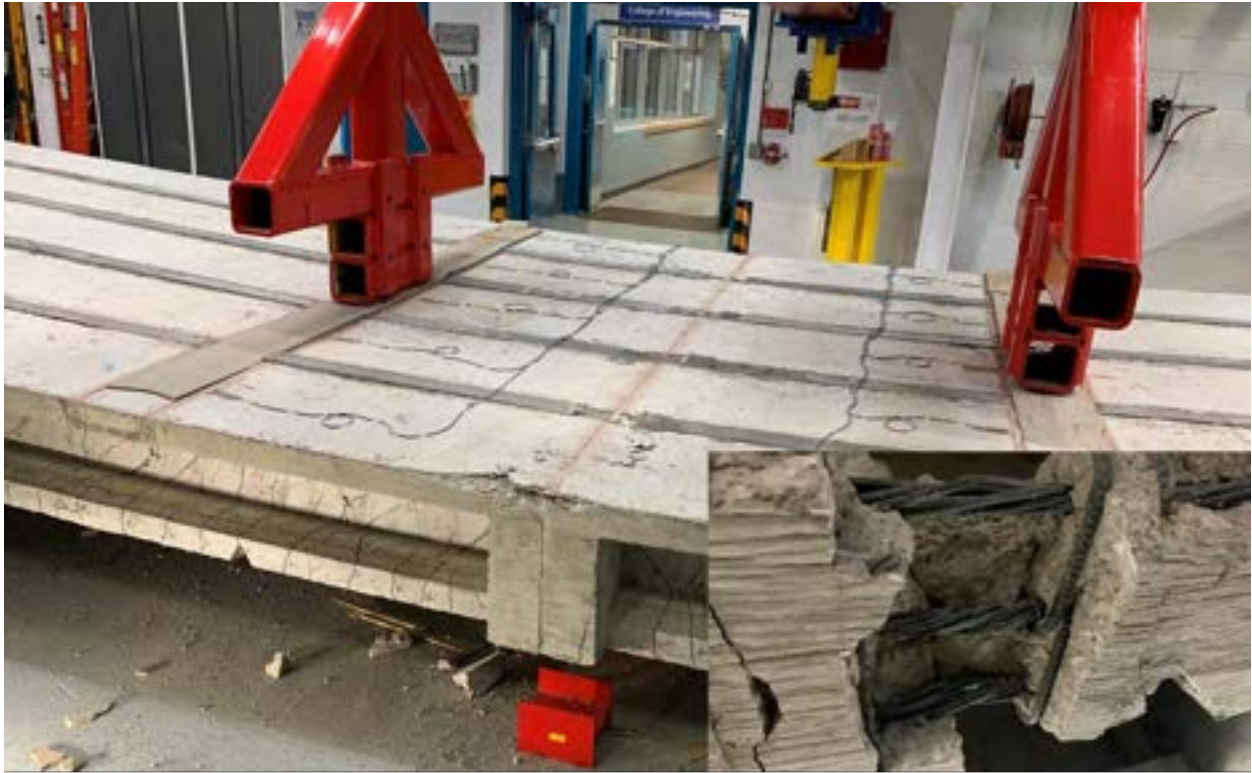
Figure 8.8-20 Rupture of CFCC strands accompanied by partial concrete crushing after failure

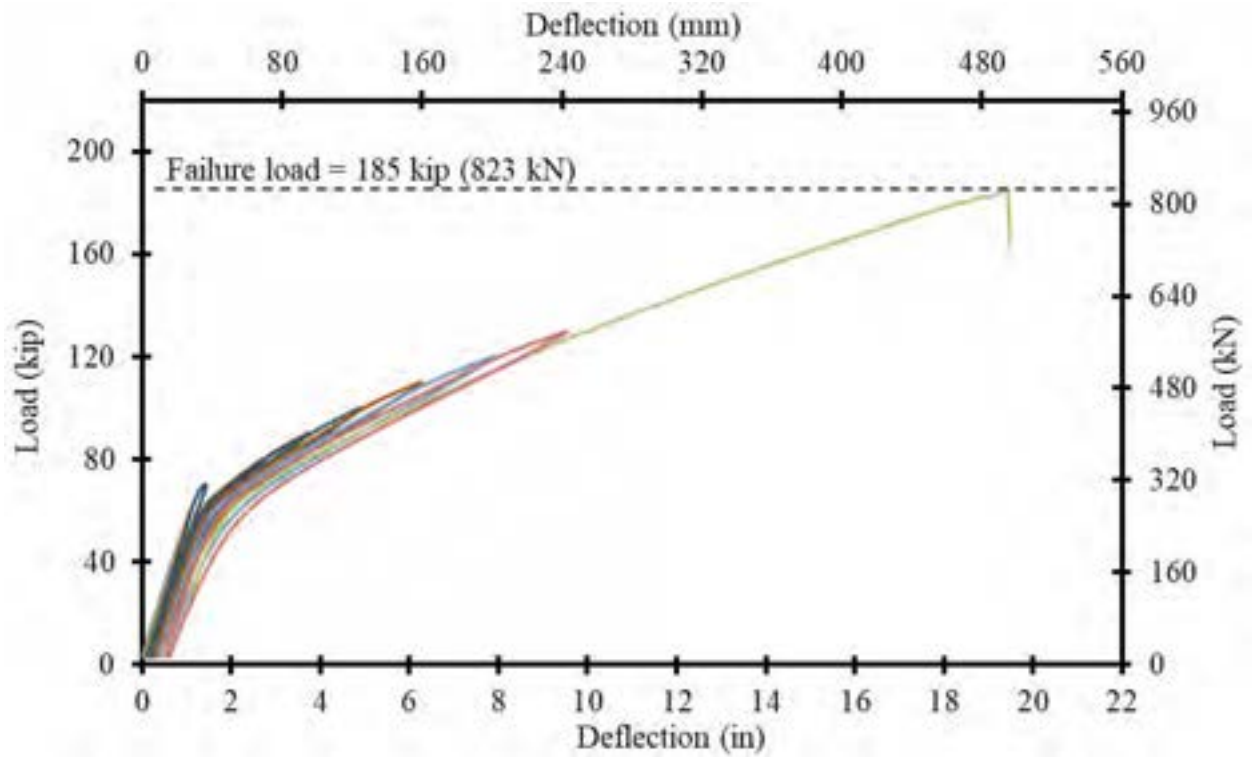
Figure 8.8-21 Combined load-deflection curves including all load cycles until failure
