EVALUATION OF 0.7 INCH DIAMETER CARBON FIBER REINFORCED POLYMER PRETENSIONING STRANDS IN PRESTRESSED BEAMS

MICHIGAN DEPARTMENT OF TRANSPORTATION
OHIO DEPARTMENT OF TRANSPORTATION
NORTH CAROLINA DEPARTMENT OF TRANSPORTATION
MAINE DEPARTMENT OF TRANSPORTATION

Nabil F. Grace, PhD, P.E., Project Investigator
Mena Bebawy, PhD, P.E., Co-Project Investigator

Mar. 31st, 2022

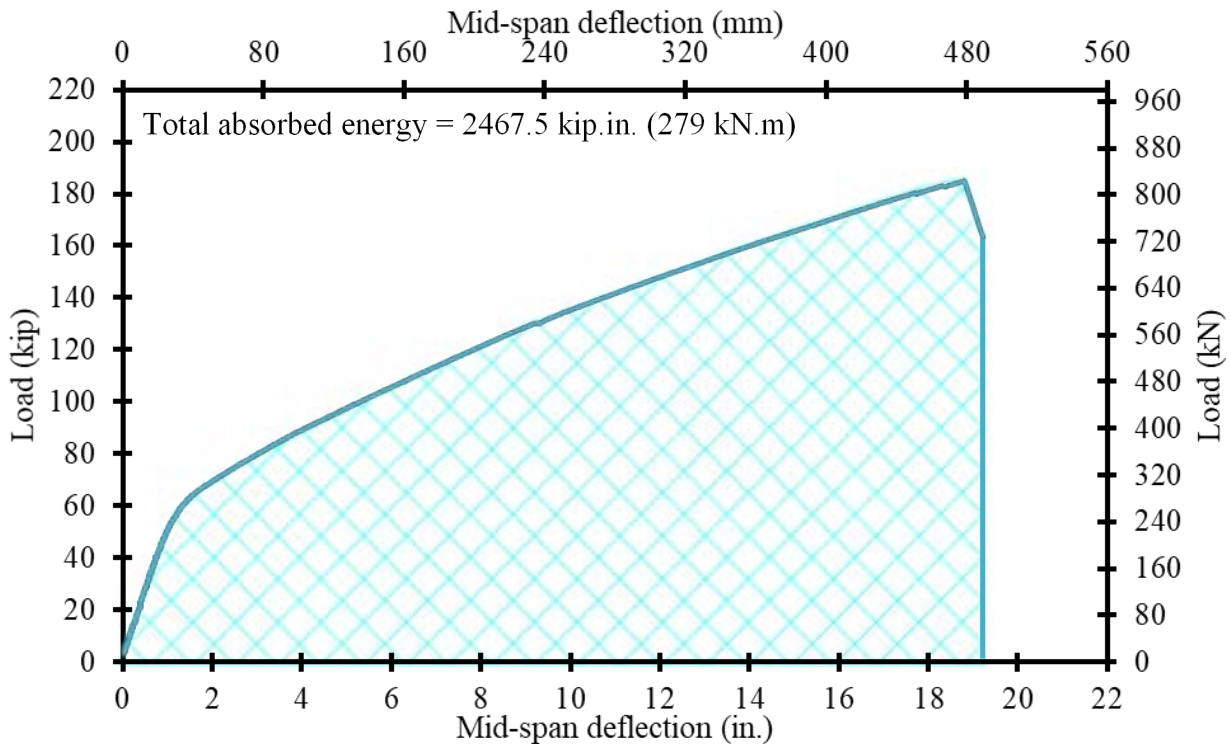
Figure 8.8-22 Total energy absorbed in the bridge model
