SD2002-01-X
TPF-5(042)-X

The Deleterious Chemical Effects of Concentrated Deicing Solutions on Portland Cement Concrete

Study SD2002-01
Executive Summary

Prepared by
Michigan Tech Transportation Institute
1400 Townsend Drive
Houghton, MI

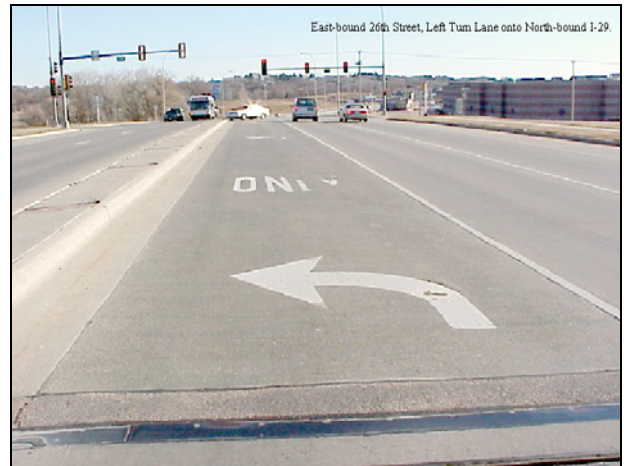
Figure 1. Photograph of core site.

In general, the cores indicated that the concrete was in satisfactory condition. However, the difference in effective w/c between the concrete near the joint and the concrete mid-panel indicates that the concrete near the joint has undergone alteration, most probably dissolution of calcium hydroxide from the hardened cement paste, resulting in a more permeable concrete. There was also significant chloride penetration identified in the chloride profiling that was performed. The depth of chloride penetration is very high for concrete of this age and is most probably due to the concrete being exposed to chlorides only a few weeks after it was placed. Relatively young concrete is more susceptible to chloride ingress because the cement hydration process has not reached completion and the concrete is therefore more permeable.

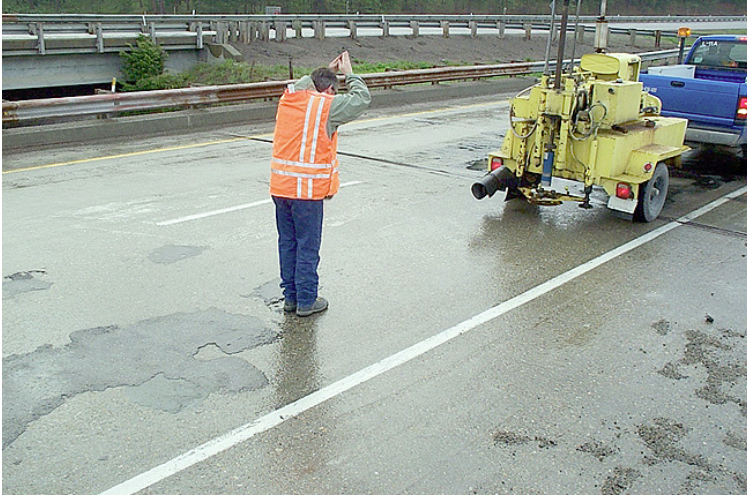
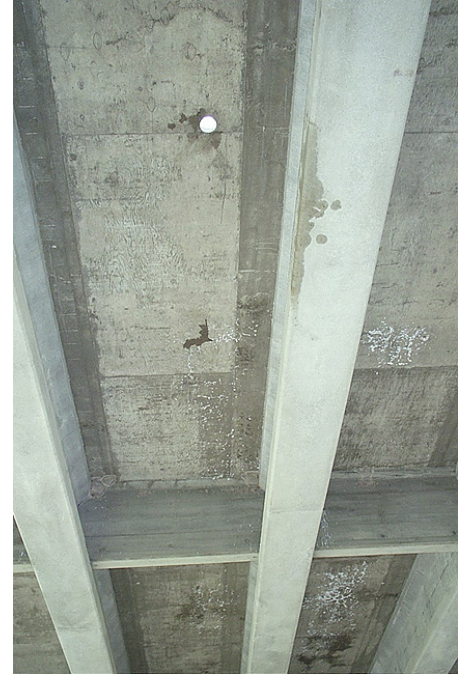
Figure 7. Photographs of core site (left) and from beneath bridge deck (right) after coring operation. Hole from core T-2 is visible. Dampness permeating through cracks visible beneath the area of core T-1. White efflorescence common directly below regions covered with cold patch material.

to its poor condition. The physical observations regarding the presence of the white efflorescence, is important and will be discussed later.

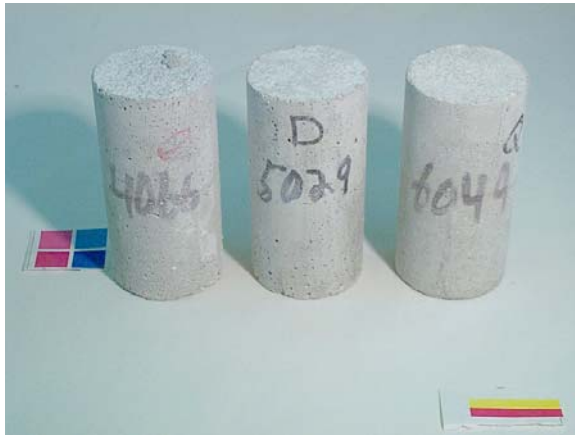
Figure 13. Cylinders exposed to NaCl solution after 84 days of constant low temperature test.
From left to right: 0.40, 0.50, and 0.60 w/c mortar cylinders.

A constant low temperature experiment was designed to monitor chloride ingress at 28, 56, and 84 days at a temperature of 40°F [4 °C]. As shown in Figure 13, the cylinders in the NaCl solution showed no deterioration after 84 days. Figures 14 and 15 show cylinders from the MgCl₂ and CaCl₂ treatments were severely deteriorated by 84 days. The cylinders in the CMA solution showed little to no distress after 84 days as shown in Figure 16, although there was some staining evident in the 0.60 w/c cylinders. The control cylinders in the lime water solution, as shown in Figure 17, showed no signs of distress after 84 days.

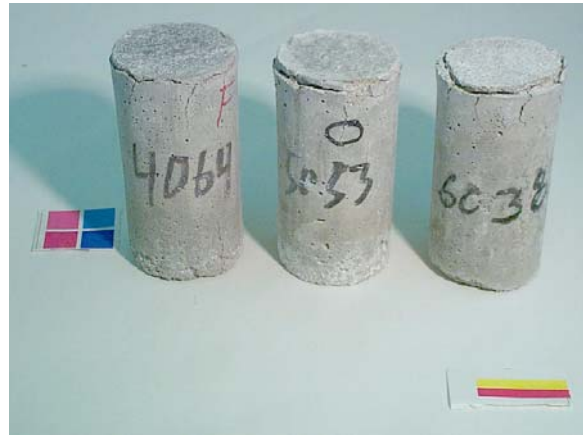
Figure 14. Cylinders exposed to MgCl₂ solution after 84 days of constant low temperature test.
From left to right: 0.40, 0.50, and 0.60 w/c mortar cylinders.

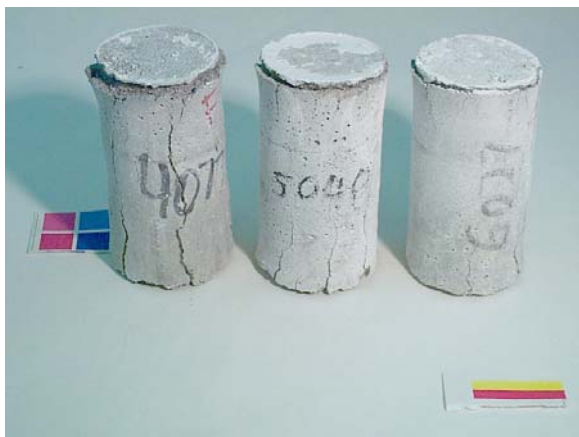
Figure 15. Cylinders exposed to CaCl₂ solution after 84 days of constant low temperature test.
From left to right: 0.40, 0.50, and 0.60 w/c mortar cylinders.

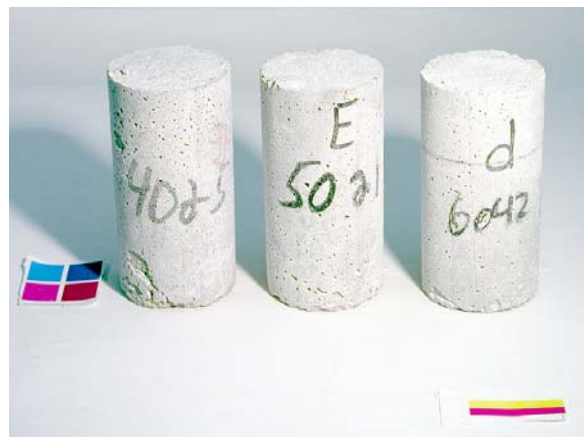
Figure 16. Cylinders exposed to CMA solution after 84 days of constant low temperature test.
From left to right: 0.40, 0.50, and 0.60 w/c mortar cylinders.

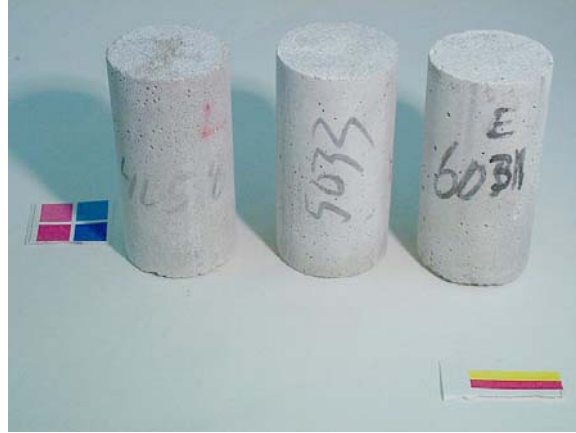
**Figure 17. Control cylinders exposed to lime water solution after 84 days of constant low temperature test.
From left to right: 0.40, 0.50, and 0.60 w/c mortar cylinders.**

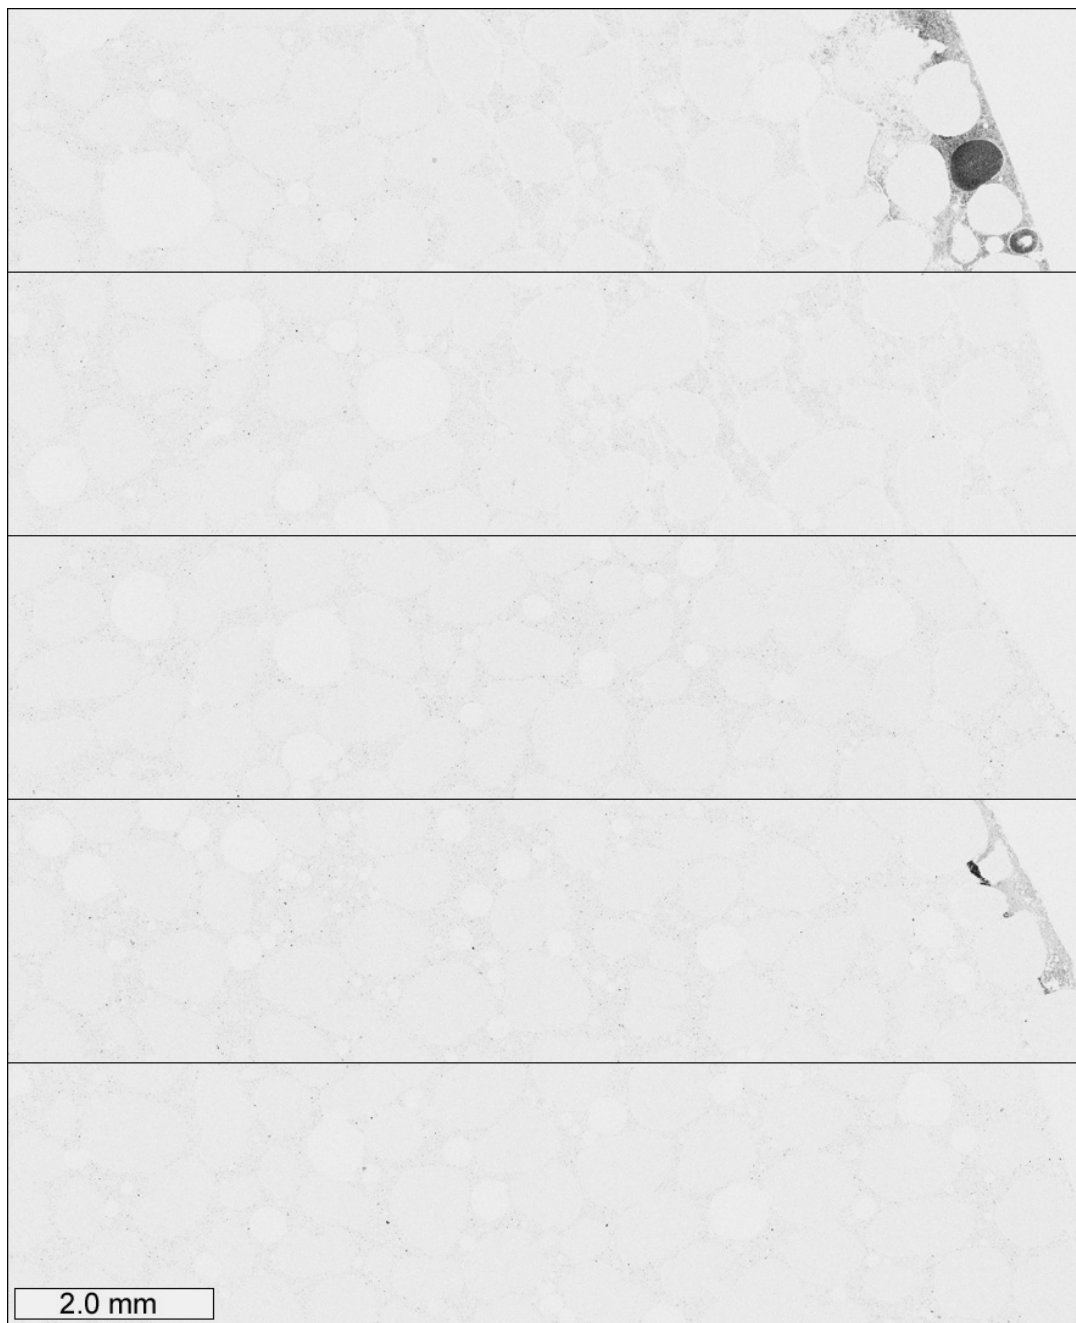
Figure 21. Elemental map for magnesium collected from thin sections prepared from mortar cylinders immersed in chemical solutions. From top to bottom: magnesium chloride, calcium chloride, sodium chloride, calcium magnesium acetate, and lime water. Dark areas indicate higher concentrations.

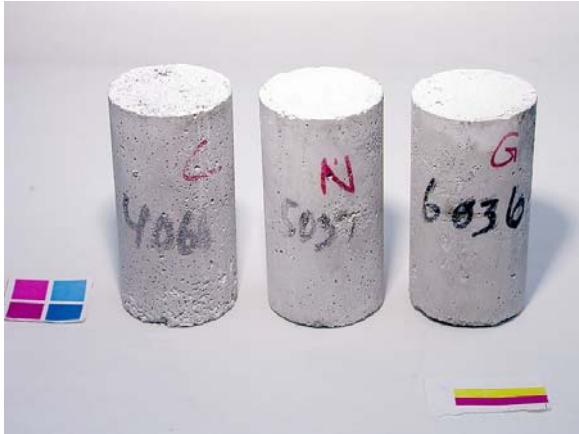
Figure 24. Cylinders exposed to CaCl_2 solution after 56 days of constant low temperature test.
From left to right: 0.40, 0.50, and 0.60 w/c mortar cylinders. Solution strength was 3% CaCl_2 .

Additional tests were performed to determine the effect of solution concentration on the observed distress. New constant low temperature CaCl_2 samples were exposed to the solutions at varying concentrations. For this experiment, solution concentrations were chosen at 3, 7, 10, and 14 weight percent salt for each solution. The specimens were left in solution for 54 days with random samples being pulled every 7 days for inspection and analysis. As can be seen clearly in Figures 24 through 28, concentration clearly has an effect on the observed damage at a given time for mortars exposed to the low temperature test.

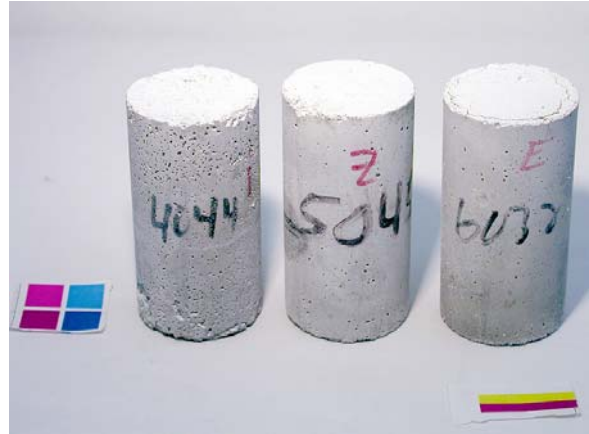
Figure 25. Cylinders exposed to CaCl_2 solution after 56 days of constant low temperature test.
From left to right: 0.40, 0.50, and 0.60 w/c mortar cylinders. Solution strength was 7% CaCl_2 .

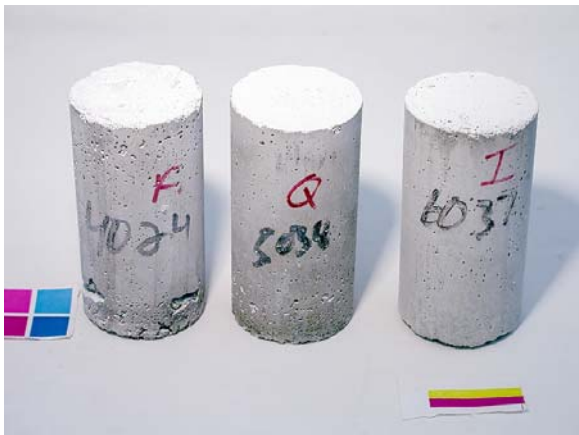
Figure 26. Cylinders exposed to CaCl_2 solution after 56 days of constant low temperature test.
From left to right: 0.40, 0.50, and 0.60 w/c mortar cylinders. Solution strength was 10% CaCl_2 .

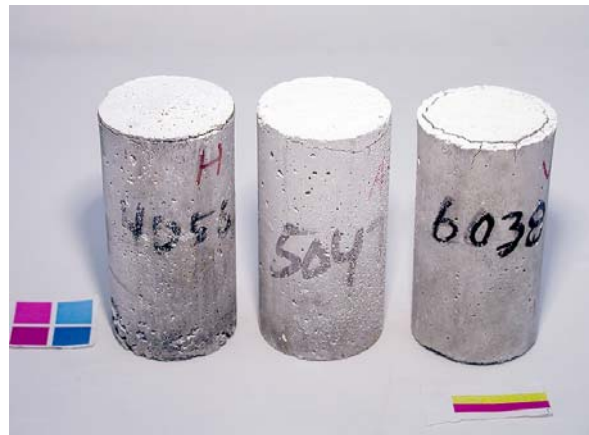
Figure 27. Cylinders exposed to CaCl_2 solution after 56 days of constant low temperature test.
From left to right: 0.40, 0.50, and 0.60 w/c mortar cylinders. Solution strength was 14% CaCl_2 .

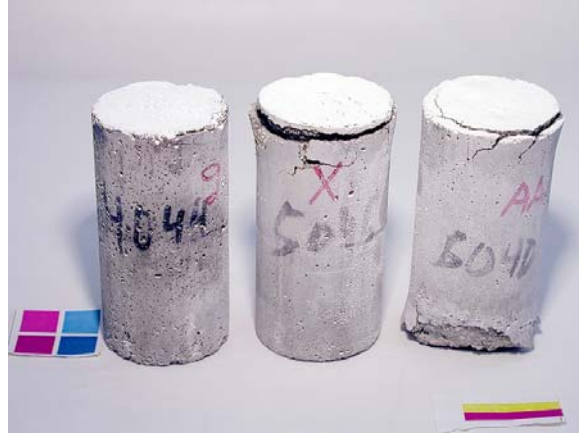
**Figure 28. Cylinders exposed to CaCl_2 solution after 56 days of constant low temperature test.
From left to right: 0.40, 0.50, and 0.60 w/c mortar cylinders.
Solution strength was 17% CaCl_2 .**

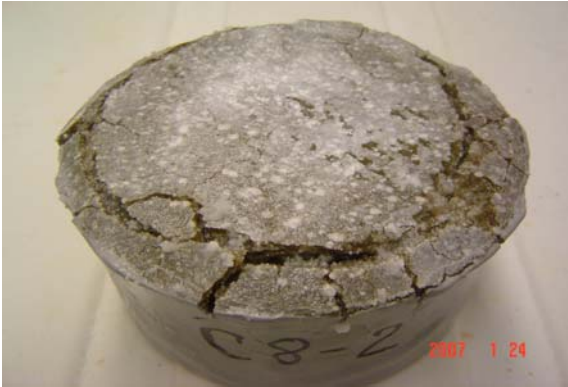
Figure 33. Deteriorated disc sample exposed to 20% MgCl₂ after 150d of exposure.

Mortar cubes were exposed to different concentrations of $MgCl_2$ and $CaCl_2$ to determine the effect of exposure solution concentration on the 30 day compressive strength of the mortar. The effect of concentration on compressive strength is shown in Figure 32. A minimum in compressive strength was seen at solution concentrations of 20% $MgCl_2$ and 22% $CaCl_2$. Examples of the distress observed are shown in Figures 33 and 34.

X-ray diffraction analysis of samples exposed to the pessimum concentration of $MgCl_2$ (i.e. 20%) and $CaCl_2$ (i.e. 22%) showed that the phase formed during the deterioration process of the mortar was magnesium oxychloride for $MgCl_2$ exposure and calcium oxychloride for $CaCl_2$ exposure.

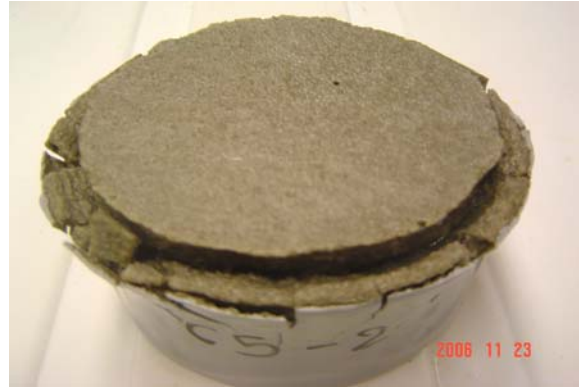
Figure 34. Deteriorated disc sample exposed to 28% CaCl₂ after 150d of exposure.

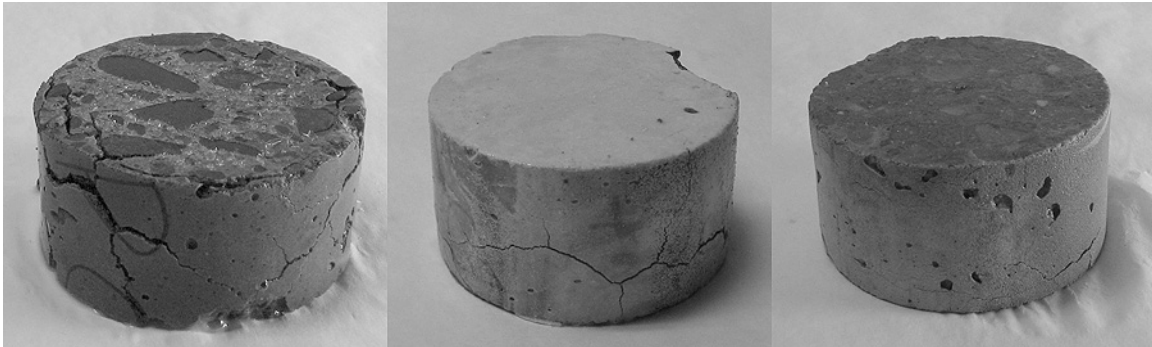
Figure 35. Photographs of 4 inch (100 mm) diameter 0.45 w/c OPC concrete specimens after 500 days in high concentration brines. From left to right: CaCl₂, MgCl₂, and MBAP brines.

Concrete and mortar specimens were removed from the brine solutions at 60 and 500 days. None of the specimens showed any obvious external signs of deterioration at 60 days. At 500 days, many of the specimens from the high-concentration CaCl₂, MgCl₂, and MBAP brines exhibited external cracking, examples of which are shown in Figure 35.

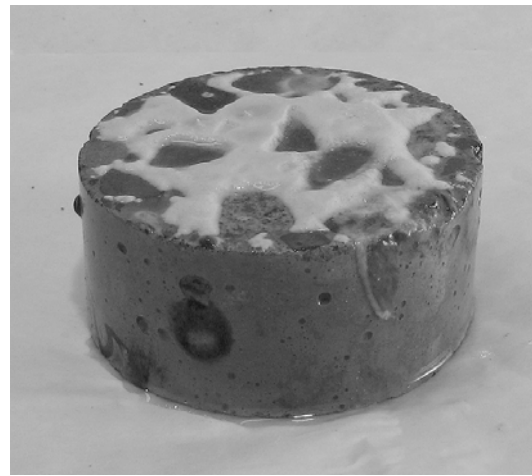
Figure 37. White precipitate on exterior of 4 inch (100 mm) diameter concrete specimen after 500 days immersion in low-concentration CMA solution.

Coatings of oxychloride crystals were typically observed on specimens from the CaCl₂, MgCl₂, and MBAP brines. External precipitates were not observed on specimens from the other brines, with the exception of specimens immersed in the low-concentration CMA brine. Figures 36 and 37 illustrate the precipitates present on the surface of a specimen from the high-concentration CaCl₂ solution and the low-concentration CMA brine, respectively.

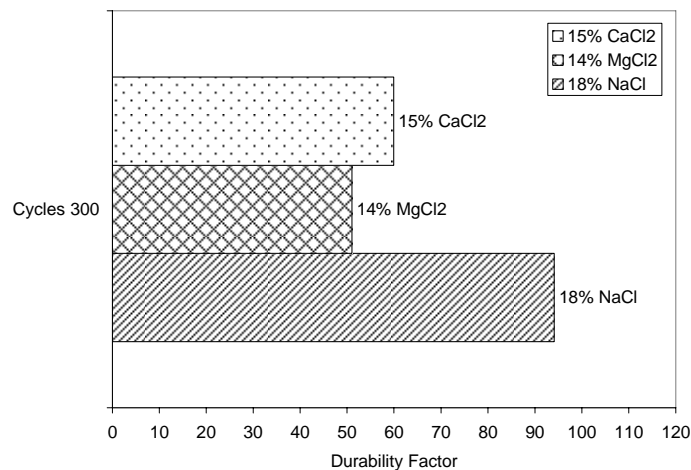
Figure 48. Durability factor of concrete prisms exposed to deicers under freezing and thawing cycles.

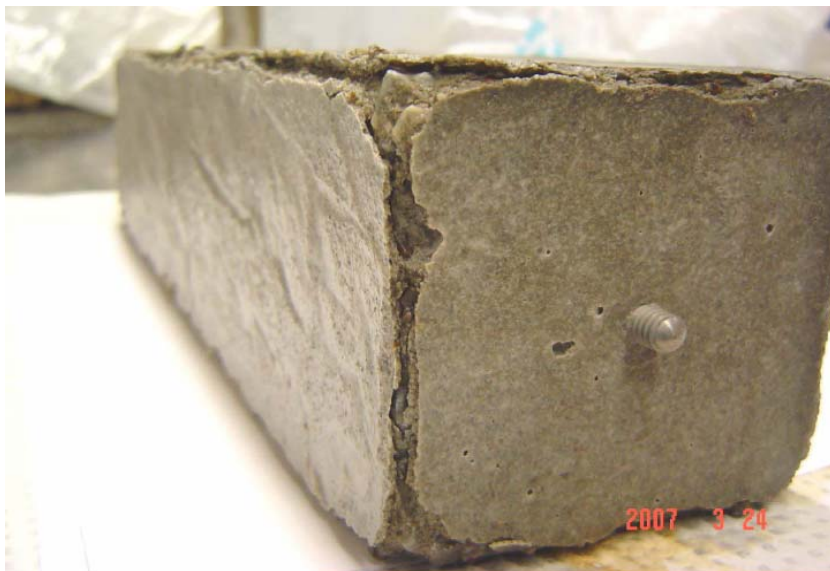
Figure 49. Photographs of concrete prisms subjected to 133 freezing and thawing cycles in 15% CaCl₂ solution.

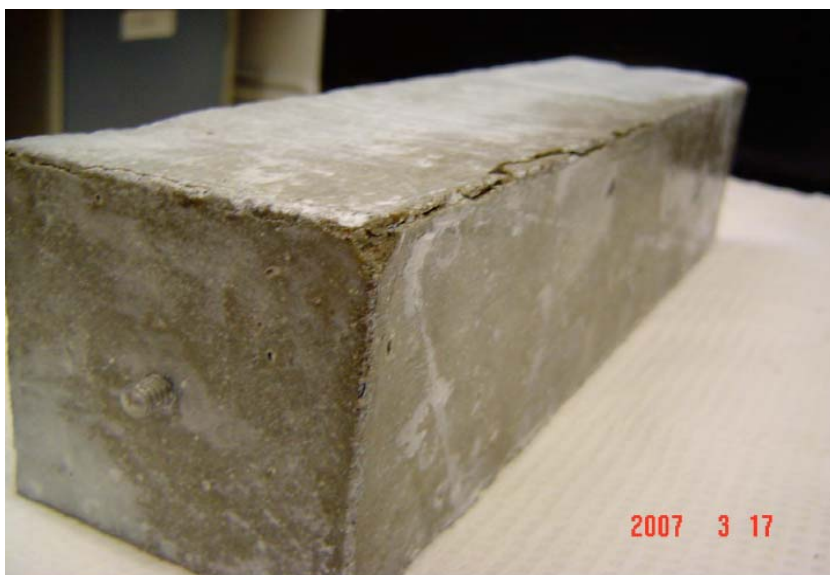
Figure 50. Photographs of concrete prisms subjected to 133 freezing and thawing cycles in 14% MgCl₂ solution.
