Date of Report:	February 27, 2009	Project Number:	9-4	973	<b>RMC:</b> 5
Period Covered:	X September 1, 2008 – 28,2009	February		March 1 – August 3	31
Project Title:	Guidelines for Designing	g Bridge Piers and A	Abut	ments for Vehicle C	Collisions

Research Supervisor (name & agency): C. Eugene Buth, TTI

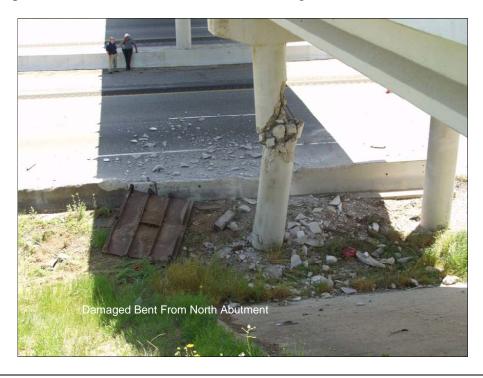
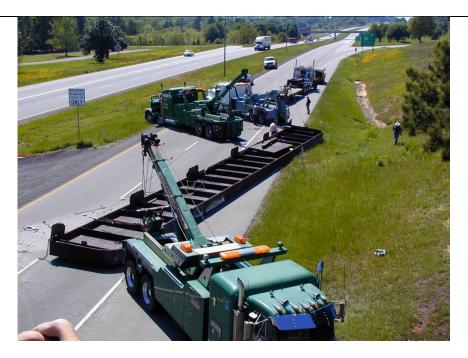
Figure 1 - Truck Accident - FM 2207 Bridge Over IH-10, Tyler, Texas

Several years ago, a truck-tractor trailer loaded with structural steel crashed into a bridge pier on IH-20 near Tyler, Texas. This bridge is located on FM 2207 and carries traffic over IH-20. This vehicle impacted the eastern-most 30-inch diameter pier of the 2-pier bent located on the shoulder of the west bound lanes of IH-20. The collision with the pier caused failure in the 30-inch diameter pier. The bridge did not collapse as a result of impact. Reinforcement in the pier consisted of eight number nine size longitudinal bars equally spaced. Transverse reinforcement in the column consisted of number two spiral stirrup reinforcement with a 6 inch pitch. Photos of the accident are shown in Figure 1.

Typically, the truck collision force is relatively close to the ground surface as shown in Figure 1. Although a large bending force is applied to the pier, the high shear force from the truck collision exceeds the shear capacity of the pier, thus resulting in a shear failure mechanism in the pier. For this project, shear capacity analyses were performed on the piers investigated for this project to determine the shear resistance of the piers.

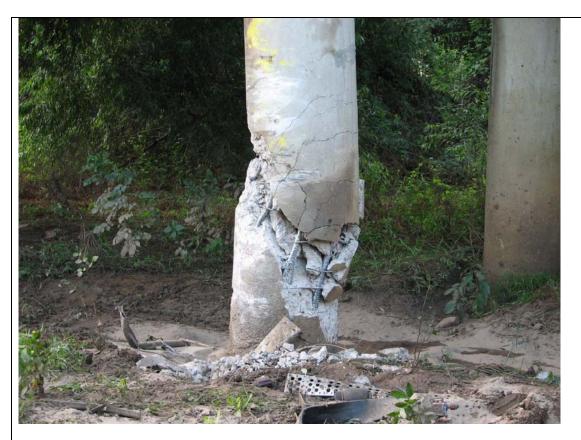
Figure 3 - Truck Accident - IH-20 Bridge Over Rabbit Creek, Longview, Texas

On September 6, 2007, a truck-tractor trailer loaded with an unknown load crashed into a bridge pier on IH-20 near Longview, TX. This bridge is supported by numerous 2 and 3-column bents. This vehicle impacted an exterior 24-inch diameter pier of and interior 3-pier bent located over Rabbit Creek of the east bound lanes of IH-20. The collision with the pier caused failure in the 24-inch diameter pier. A phone interview was conducted with Officer Chris Brock with the Texas Department of Public Safety. Officer Brock indicated that the vehicle weight was estimated to be near 80,000 lbs. The speed of the truck as it left the roadway was estimated to be between 70-75 mph. The bridge did not collapse as a result of the impact. The pier that was impacted was a 24-inch diameter pier with eight number seven size rebars in the longitudinal direction of the pier. Transverse reinforcement in the pier consisted of number two spiral stirrup reinforcement with a 6 inch pitch. A photo of the accident is shown as Figure 3.

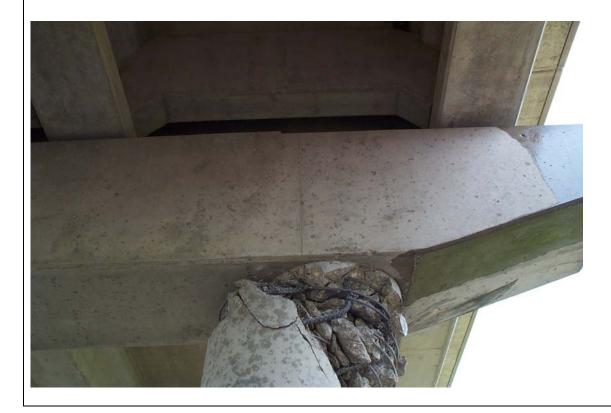
#### Figure 4 - Truck Accident - IH-90 Bridge, #53812, Minnesota

On June 3, 2003, a large single unit truck impacted a bridge pier located along IH-90 in near Worthington, Minnesota. The collision with the pier caused failure in the 32-inch diameter pier. The bridge did not collapse as a result of impact. Reinforcement in the pier consisted of nine number nine size longitudinal bars equally spaced. Transverse reinforcement in the column consisted of number 4 spiral stirrup reinforcement with a 6 inch pitch. A photo of the accident is shown as Figure 4.

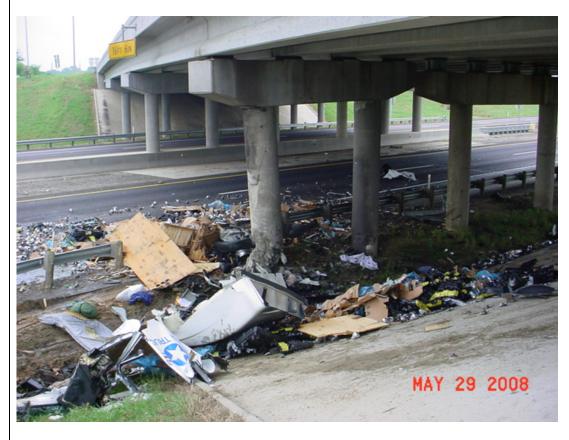
Figure 5 - Truck Accident - FM-1401 Bridge Over IH-30, Mount Pleasant, Texas.

On May 29, 2008, a truck-tractor trailer loaded with car parts crashed into a bridge pier on IH-30 near Mount Pleasant, Texas. This bridge is located on FM 1401 and carries traffic over IH-30. This vehicle impacted the western-most 30-inch diameter pier of the 3-pier bent located on the shoulder of the east bound lanes of IH-30. The collision with the pier caused failure in the 30-inch diameter pier. The bridge did not collapsed as a result of impact. The collision killed the driver. State Trooper Daniel Crooks with the Texas Department of Public Safety was interviewed. Officer Crooks was present on scene immediately after the accident. Officer Crooks indicated that the vehicle was traveling at a high rate of speed. The approximate weight of the vehicle was near 80,000 lbs. when it struck the pier. The column that was impacted was a 30-inch diameter pier with eight number nine size rebars in the longitudinal direction of the pier. Transverse reinforcement in the pier consisted of number 3 spiral stirrup reinforcement with a 6 inch pitch. A photo of the accident is shown as Figure 5.

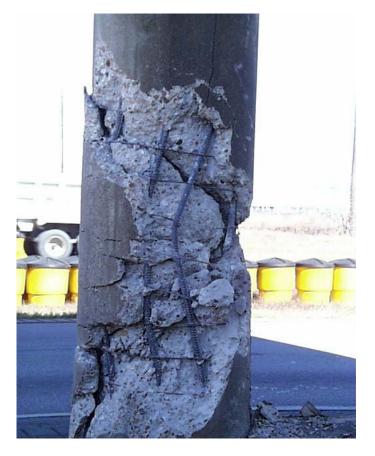
Figure 6 – Typical Failure Mechanism in Bridge Pier From Large Truck Collision.

Bridge piers impacted by large trucks are typically subjected to large shear and bending forces. These forces can cause catastrophic structural failure in the piers. As part of this project, several large truck accidents involving large trucks were investigated. In most of the cases investigated, structural failure in the bridge column occurred as a result of the impact. From the piers investigated for this project, a typical failure

### mechanism from a large truck collision is shown in Figure 6.

To date, data has been obtained for a total of 19 accidents involving large truck collisions. Each accident was numbered from 1 to 19 for the purpose of reporting. Shear capacity calculations were generated for each accident with sufficient information to determine the shear capacity. The failure mechanism shown in Figure 7 was observed in many accidents investigated for this project which were impacted by large trucks. In all cases, the design compressive strength of the concrete as provided by the structural drawings was used. In addition, the nominal shear strength of each pier was calculated using a higher estimated strength which could exist due to years of concrete age. Please refer to Table 1 for a summary of the calculated shear capacities for the piers investigated for this project.
