September 2008 Project Update

PennDOT Project #070202

Project Title: Inspection Methods & Techniques to Determine Non Visible Corrosion of Prestressing Strands in Concrete Bridge Components (LU ID 541671)

Lehigh University / ATLSS Research Center

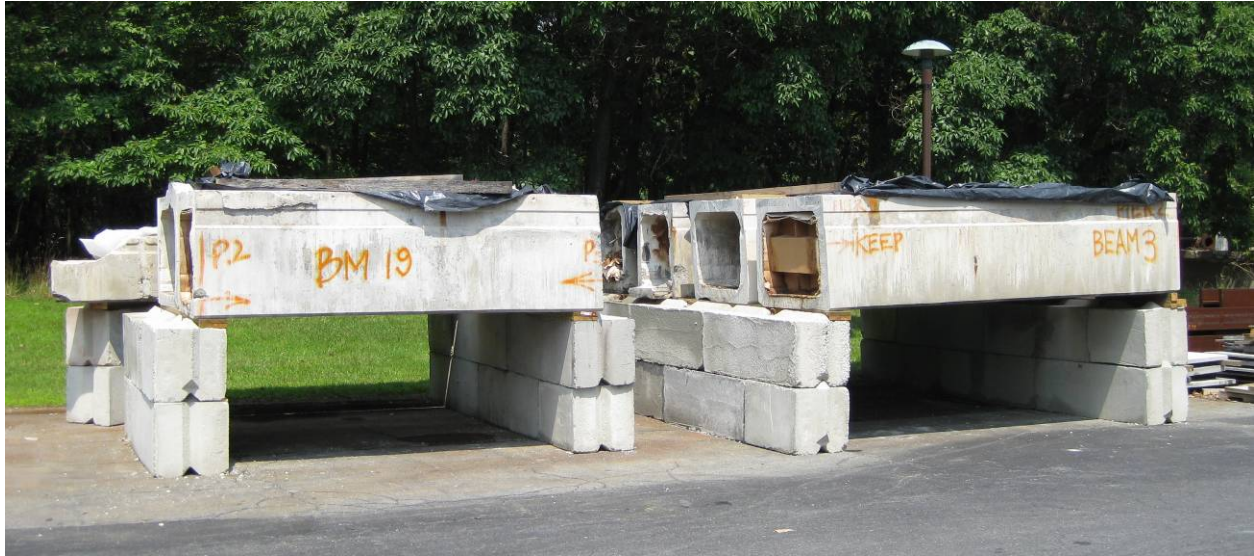
Figure 1: Beam layout at ATLSS Center

All beams have been sectioned and delivered to Lehigh University. The beams are being staged at the rear of the research facility. They are supported on concrete dunnage blocks at approximately 4ft off of the ground as shown in Figure 1. They are supported at their ends in the same orientation that they would be found in service. This will allow for a realistic inspection during the NDE portion of the study. The beams are ready for initiation of the NDE phase of the research.
