Report No. UT-001

**NON-DESTRUCTIVE AND
DESTRUCTIVE INVESTIGATION
OF AGED-IN-THE FIELD CARBON
FRP-WRAPPED COLUMNS**

New York State Department of
Transportation &
Utah Department of Transportation

University of Utah
Department of Civil and Environmental
Engineering

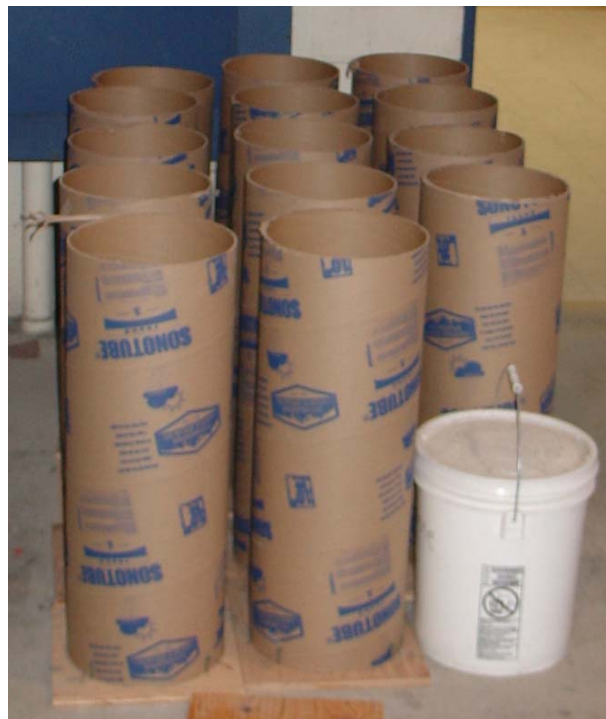
Figure 1. Forms for 14 specimens.

All the small scale specimens are currently being fabricated, as shown in Figures 1-6. A total of 14 specimens will be cast. The specimens are the same as in the proposal with the addition of two specimens where both the internal vertical bars and internal hoops are made with GFRP composites. This was done to compare the three types of internal reinforcement as follows: (a) steel vertical bars with steel hoops, (b) steel vertical bars with internal GFRP hoops, (c) internal GFRP vertical bars with internal GFRP hoops, as shown in Figure 2. For the (a) category with steel vertical bars and steel hoops, two specimens will be wrapped with carbon fiber jackets as described in the proposal.

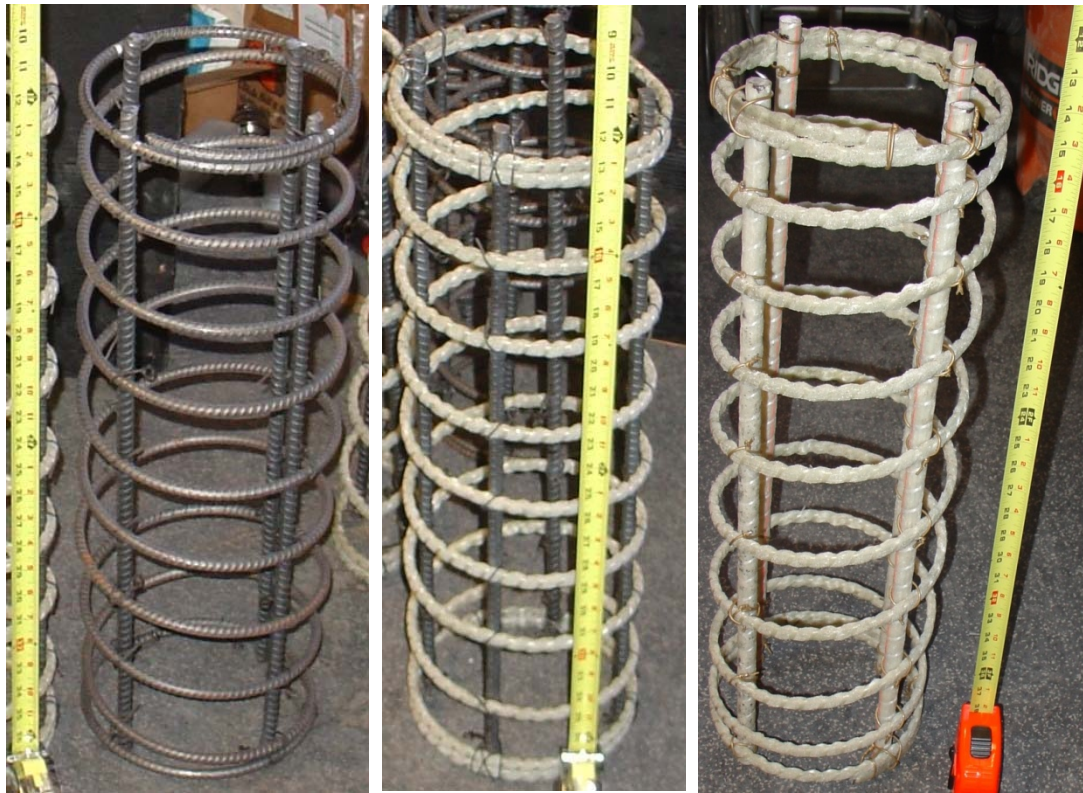
Figure 2. Various configurations of specimens: (a) steel vertical bars with steel hoops, (b) steel vertical bars with internal GFRP hoops, (c) GFRP vertical bars with internal GFRP hoops.

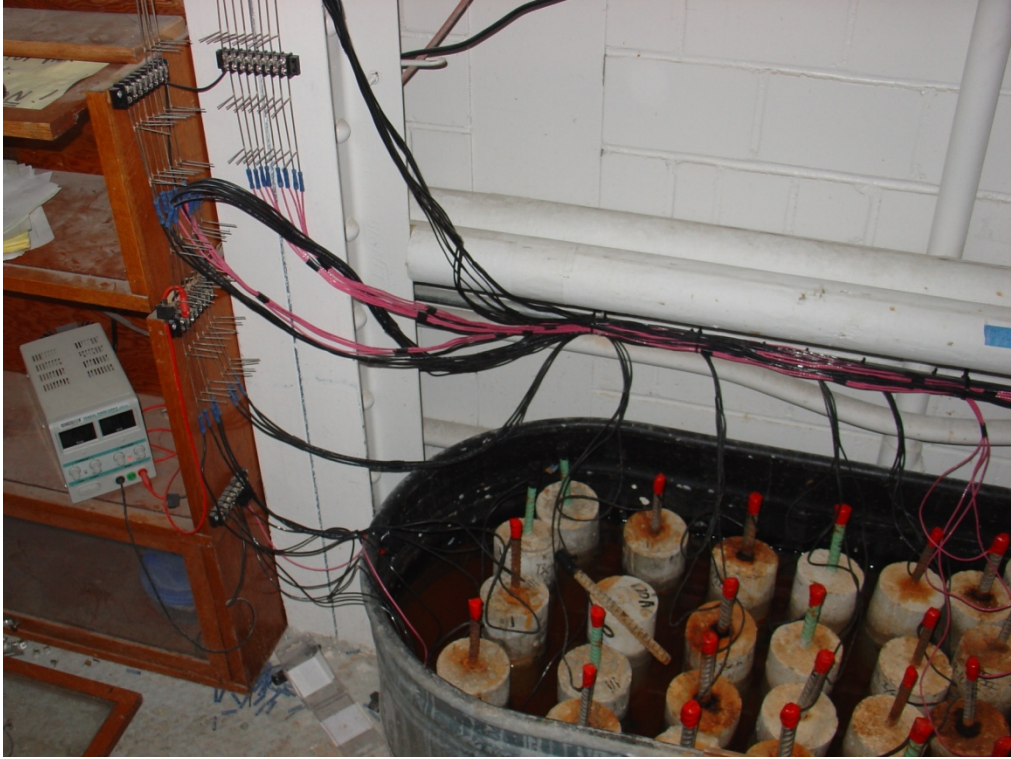
Figure 3. DC-voltage through bars in concrete and salt-water solution tank.

To carry out the corrosion investigation, a tank with a water-salt solution of 5% salt by weight will be used, similar to the one shown in Figure 3 to apply the current through the four vertical bars in the steel reinforcement at the top (shown in Figure 4) and with a steel rod in the water as shown in Figure 5. The corrosion process will be monitored using ASTM Standard C 876 “Standard Test Method for Half-Cell Potentials of Uncoated Reinforcing Steel in Concrete”.

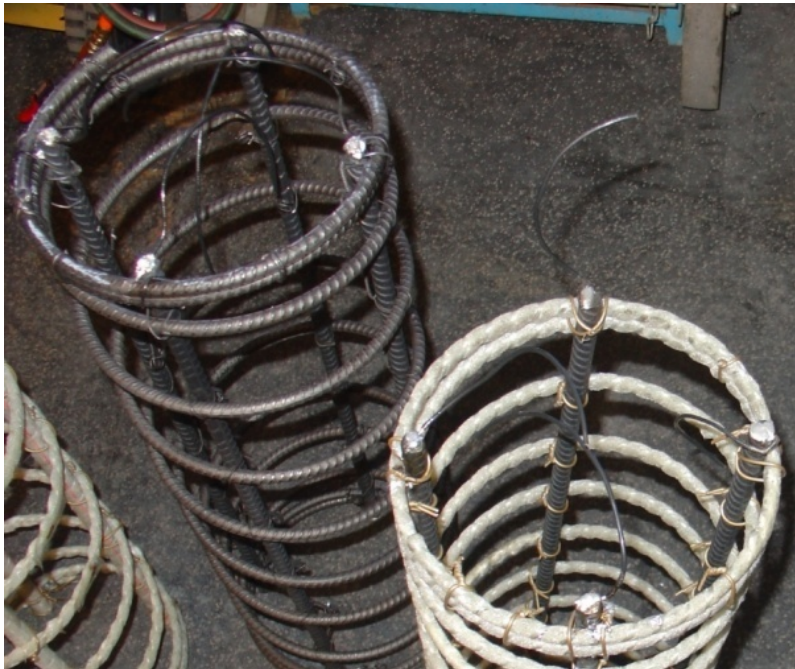
Figure 4. Wires attached to four vertical bars in the steel reinforcement at the top.

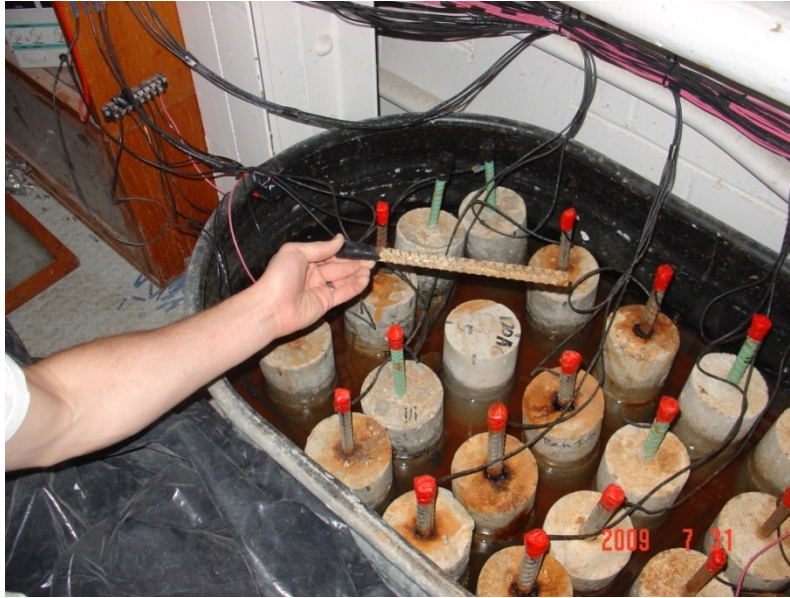
Figure 5. DC voltage through steel rod in the salt-water solution tank.

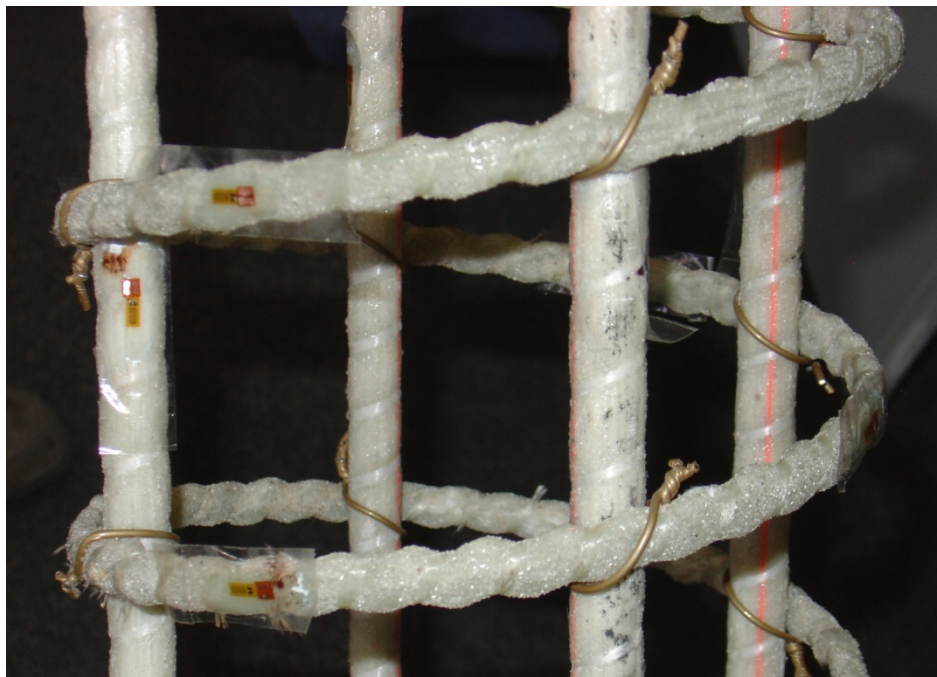
Figure 6. Nine strain gauges each (four on the longitudinal steel or GFRP bars and five on the internal steel or internal GFRP spirals) for control specimens.

All specimens that are being corroded will have strain gauges on the exterior of the specimen as well as Linear Variable Displacement Transformers to measure hoop and axial strains. The specimens that are not being corroded (control specimens) will have nine strain gauges each (four on the longitudinal bars and five on the internal hoop steel or internal hoop GFRP) as shown in Figure 6.

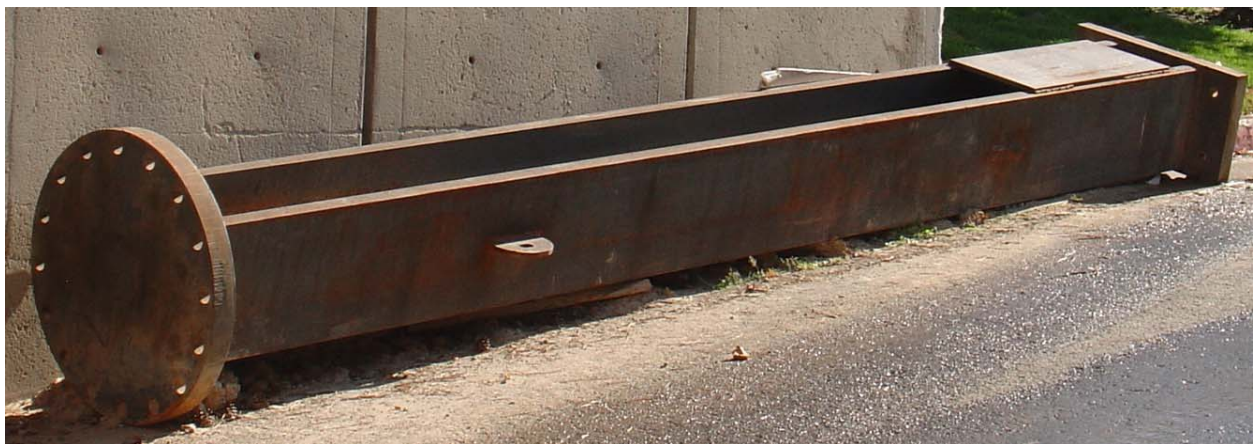
Figure 7. Steel column required to apply 2,000,00 lbs compression load on two RC columns.

In addition to the above activities, the steel column required to apply the 2,000,000 lbs force has been manufactured as shown in Figure 7.
