DESIGN AND CONSTRUCTION GUIDELINES FOR THERMALLY INSULATED CONCRETE PAVEMENTS

TPF-5(149)

MnDOT Contract No. 89261

July 2009

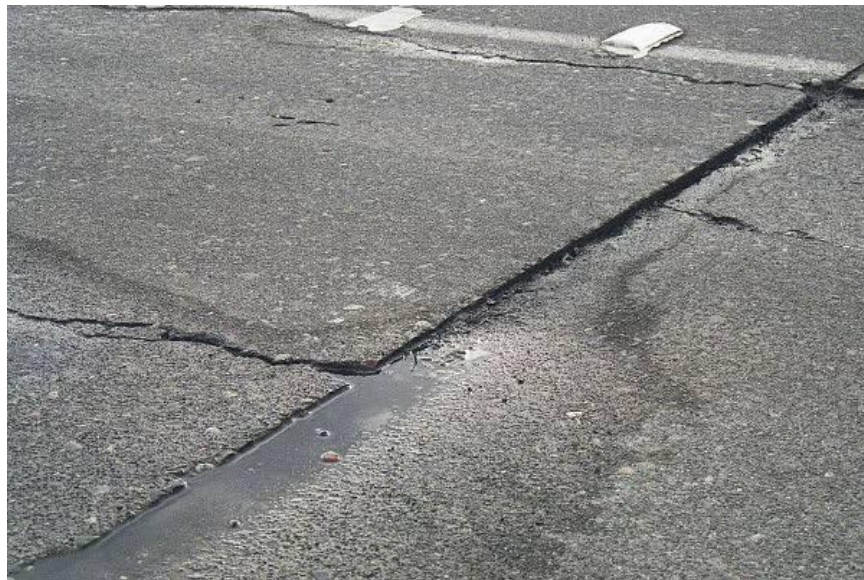
Figure 2.4. Faulting in jointed PCC pavement (WSDOT Pavement Guide).

Repeated heavy axle loads crossing transverse joints creates the potential for joint faulting, as shown in Figure 2.4. Faulting can become severe and cause loss of ride quality and require premature rehabilitation if any of the following conditions occurs:

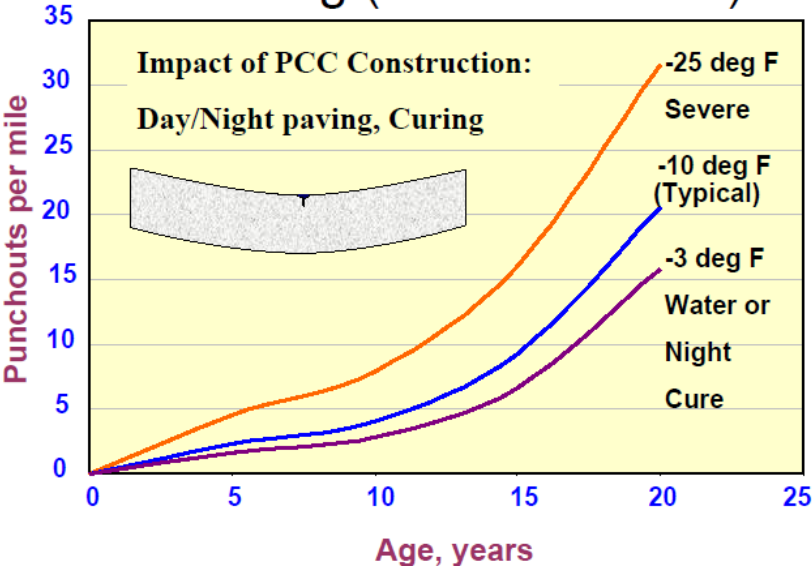
Figure 2.6. Built-in curl and pavement performance.

Although the fact of initial (“built-in”) curling was relatively well-known to researchers, only recently has this effect been acknowledged as a contributing factor to distresses and long-term pavement performance. Figure 2.6 illustrates the importance of considering built-in curl. Built-in curling is influenced by many factors, including material properties (PCC shrinkage, coefficient of thermal expansion, heat of hydration, etc.), placement conditions (ambient temperature, ambient relative humidity, wind, sunshine) and curing techniques. Excessive built-in curling can increase the initial roughness of concrete pavements and may increase top-down cracking and faulting in JPCP and punchouts in CRCP.

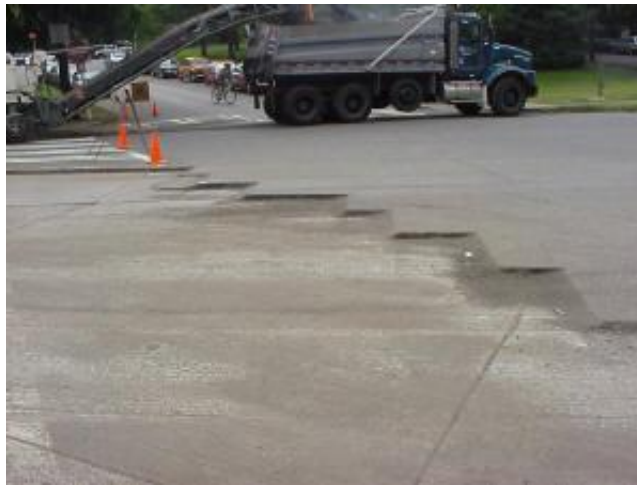
Figure 3.1. Milled road showing complete removal of the HMA overlay to expose the PCC slabs beneath (WSDOT).

- Surface preparation – Before placing the AC overlay on the existing PCC pavement it is important to repair, clean, level, and coat it with a binding agent (Figures 3.1 and 3.2). These techniques help insure the bonding of the overlay to the existing surface and are critical for pavement performance.

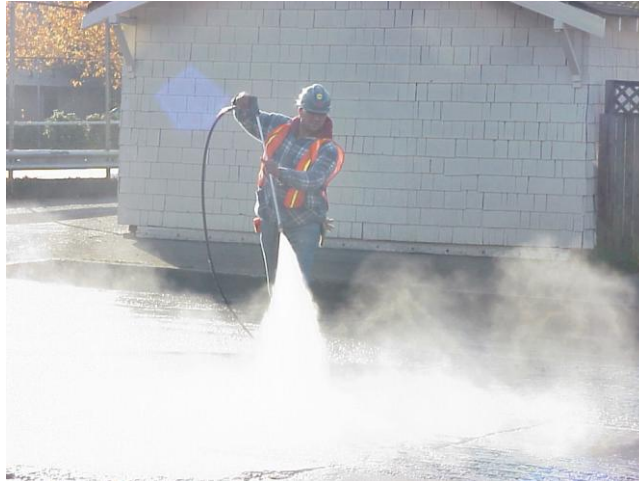
Figure 3.2. Washing the Existing Surface Prior to Overlay (WSDOT).

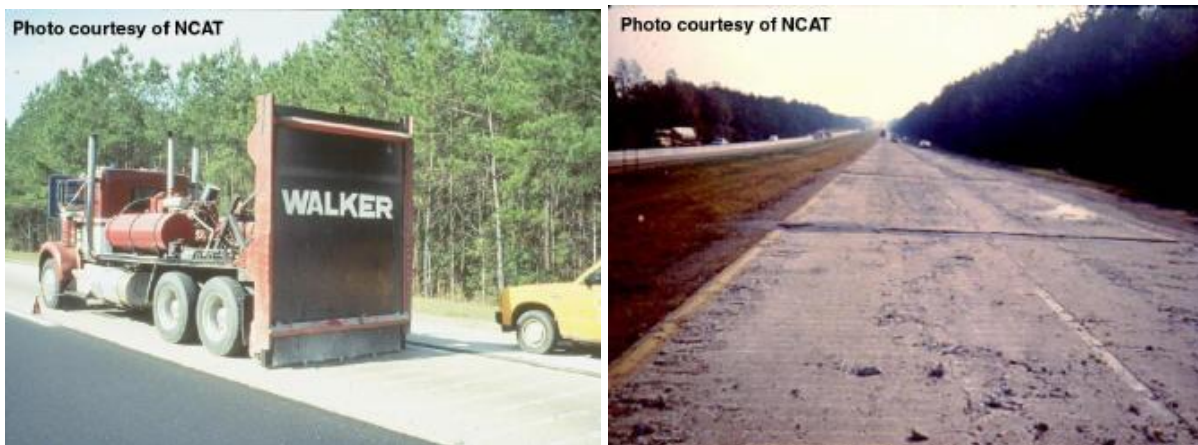
Figure 3.4. At left, guillotine hammer used for cracking and seating PCC; at right, PCC pavement after cracking and seating with guillotine hammer (WSDOT)

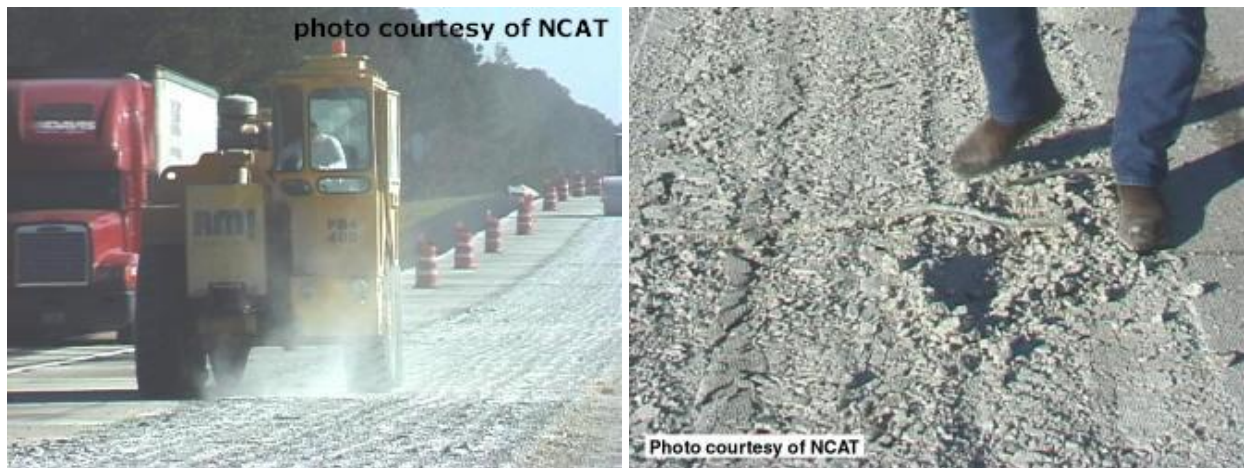
Figure 3.5. At left, resonant pavement breaker used to rubblize PCC pavement; at right, PCC pavement after rubblization with a resonant pavement breaker (WSDOT).

The rubblization process consists of converting a badly distressed PCC pavement into a high quality aggregate base. A National Asphalt Pavement Association (NAPA) study reported that the strength of the rubblized layer can be approximately 1.5 times greater than a conventional dense graded aggregate base (PCS 1991). This method of rehabilitation is usually considered cost effective when the PCC pavement has suffered structural distresses such as D-cracking, alkali-silica reaction, freeze-thaw damage, faulting, and patching of more than 10% of cracked slabs (Thompson 1999). Figure 3.5 presents a rubblized PCC pavement using resonant pavement breaker.

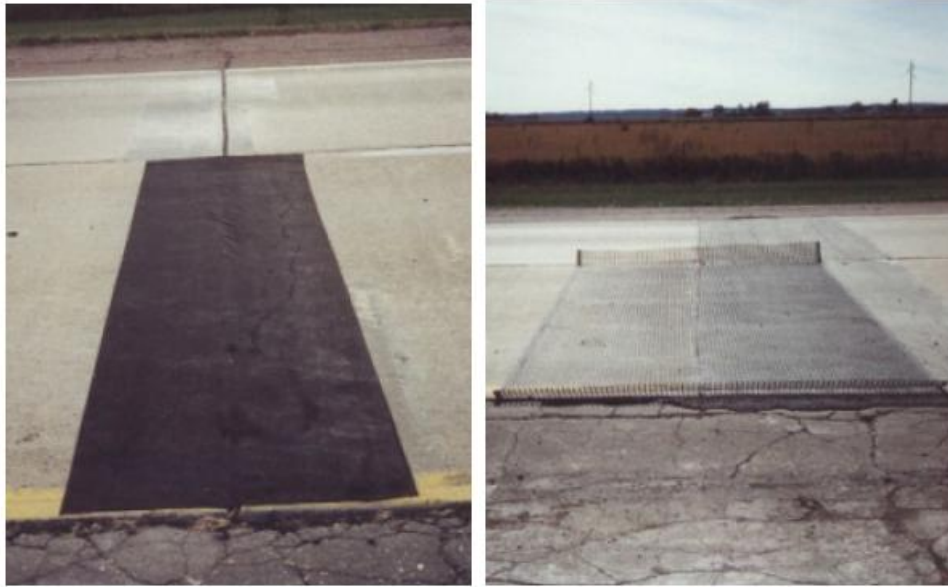
Figure 3.6. Linq-Tac -711N (at left) and Strata Grid-200 geogrid products (Rumpca and Storsten 2000).

The results indicated that most of the joints reflected through to the asphalt overlay regardless of the use of a geogrid treatment. Table 3.5 illustrates the results of the study, obtained through the use of statistical software, with the mean amount of reflective cracks experienced by each treatment. The largest observed difference in performance was between sawed joints and unsawed joints, with 12% of the sawed joints experiencing reflective cracks and 25% of the unsawed joints experiencing reflected cracks. As the results indicate, the most economical and best performing option was the section that did not use a geosynthetic fabric, had minimal joint treatment, and had sawed joints (Rumpca and Storsten 2000). In support of this conclusion is the survey conducted by Bennert and Maher (2007), whose survey of DOTs on the use of interlayers concluded that the worst performance is given by paving fabrics and geotextiles.

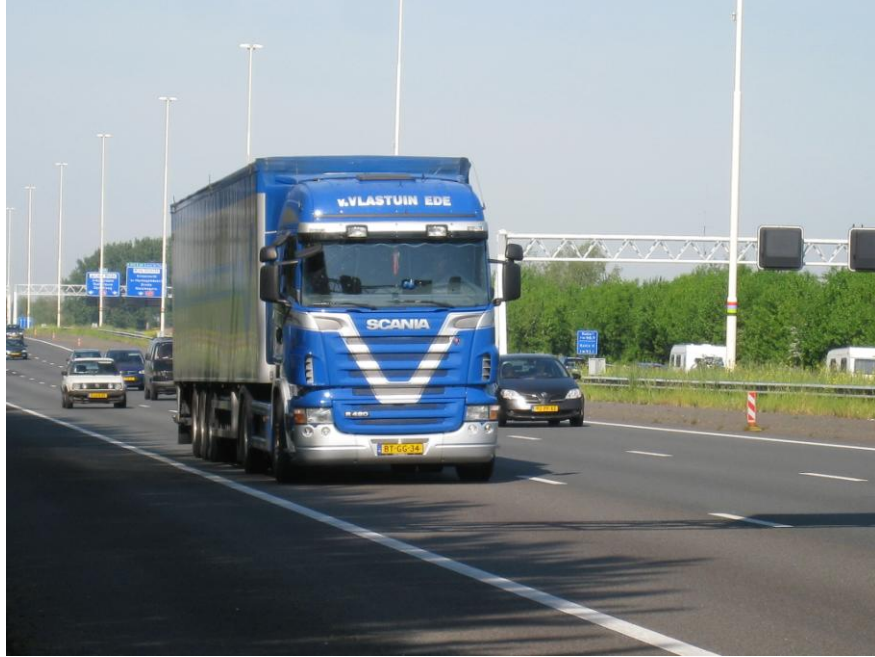
Figure 4.1. A12 between Utrecht and Ede, Netherlands, May 2008 (SHRP2 2009).

Transportation officials in the Netherlands believe that the porous AC reduces noise by about 7dB, and the performance observed by SHRP2 suggested as much. The project were noted to have performed well to date, though projects were noted to begin raveling after approximately 10 years. Hence, based on observations in the Netherlands, replacement of the porous surface layer would need to occur every 10 to 12 years.

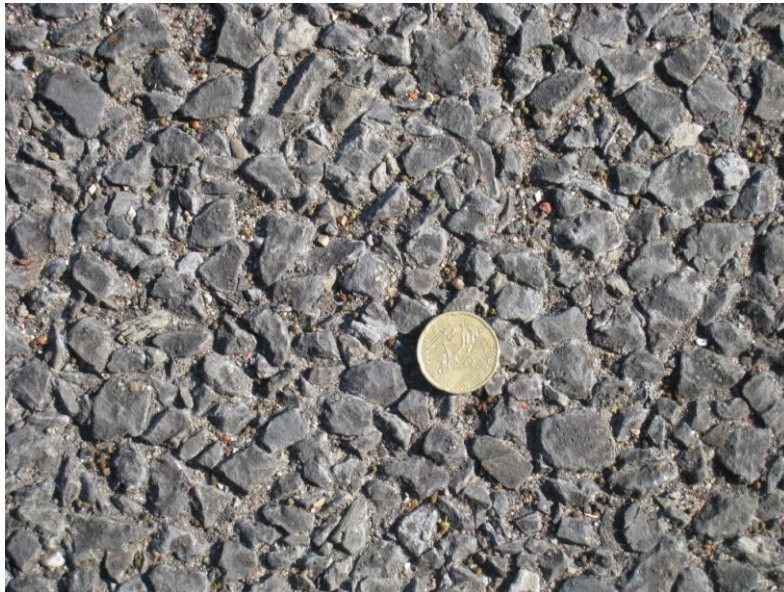
Figure 4.2. Close-up of the porous asphalt surface of the A12 motorway. Note fines infiltrating the porous asphalt surface on the edge of the traffic lane (SHRP2 2009).

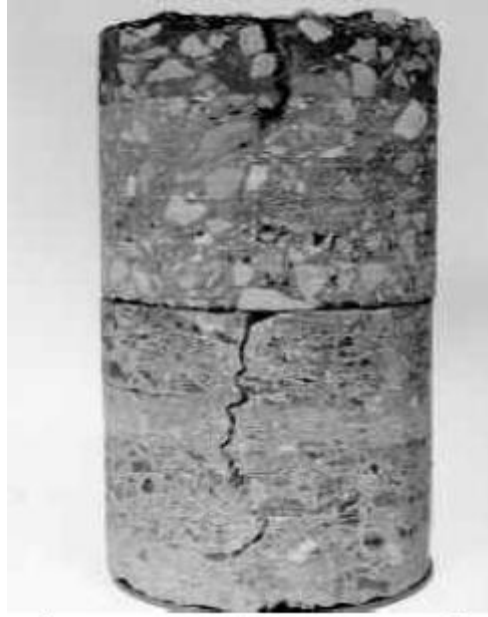
Figure 5.1. Core sample from recently initiated top-down crack in as-built AC/PCC (Nesnas and Nunn 2004).

Nernas and Nunn (2004) recently reported that cracking in the asphalt layer of an as-built AC/PCC composite system generally initiates in the upper layer and travels downward, contrary to asphalt overlays of cracked pavements where reflective cracks initiate at the asphalt-concrete interface and propagate upwards. The researchers cited field evidence in the investigation of over 50 recent cracks in nine as-built composite pavements, such as Figure 5.1, to support their claim, and developed a response model which treats the concrete and asphalt layers as a composite system that acknowledged the following:
