September 2009
OR10.007

Development of Hand-held Thermographic Inspection Technologies

Prepared by University of Missouri -
Columbia and Missouri Department
of Transportation

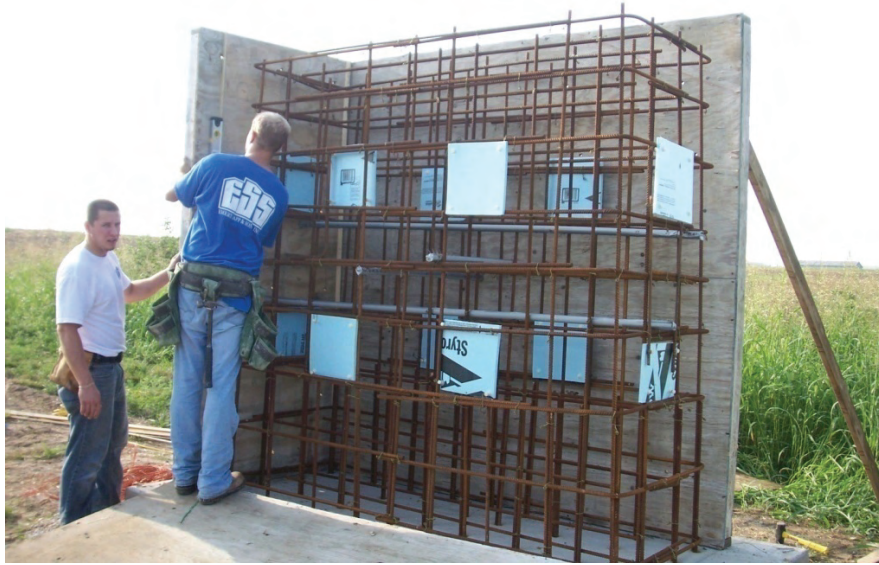
Figure 3.3 : Photograph of the test block during construction showing the targets mounted on the rebar cage.

held in place with steel ties that traversed the block in the north-south and east-west directions. These steel ties held the forms at a fixed separation during the concrete pour. The ties were cast into the block and ground flush once the concrete was cured.

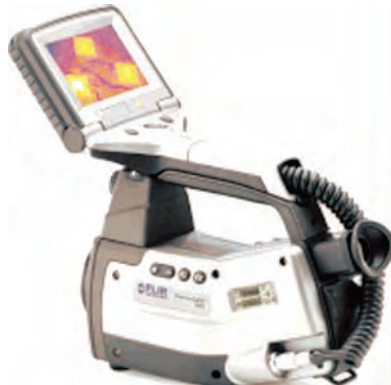
Figure 3.6 : FLIR ThermoCAM S65 infrared research camera.

The images captured by the IR camera are displayed in the viewfinder and on the handheld LCD display, and stored on computer. Images were captured according to a pre-defined schedule of 1 image captured every 10 min, 24 hrs a day. The camera required a distance of approximately 6 m (20 ft.) to capture the entire 2.4 m x 2.4 m (8 ft. x 8 ft.) face of the test block with its regular lens. Figure 3.6 shows the FLIR S65 ThermoCAM.

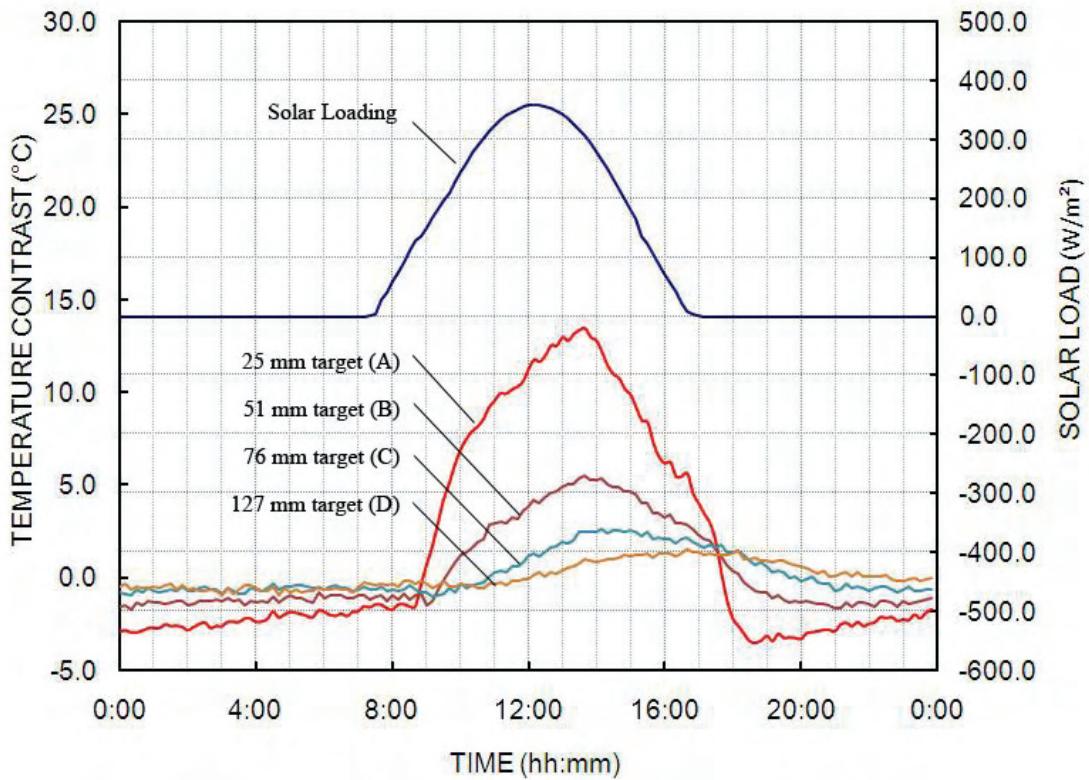
Figure 3.10 : Thermal contrast developed in the test block for each of the targets, and the solar loading.

The results of this data processing are shown in Figure 3.10, which shows the thermal contrast for each of the four targets on the south side of the test block. The figure also shows the solar loading (radiant heating of the sun) for that day. The thermal contrast values correspond to the left vertical axis and the solar loading is on the right vertical axis. The horizontal axis is Time over a 24-hour period. As can be observed in this figure, the thermal contrast for each of the targets develops at different times of the day, with deeper targets developing thermal contrast later in the day. Additionally, the magnitude of the thermal contrast, that is the peak contrast value, is reduced as the target depth increases. This is the behavior anticipated based on fundamental heat transfer theories.

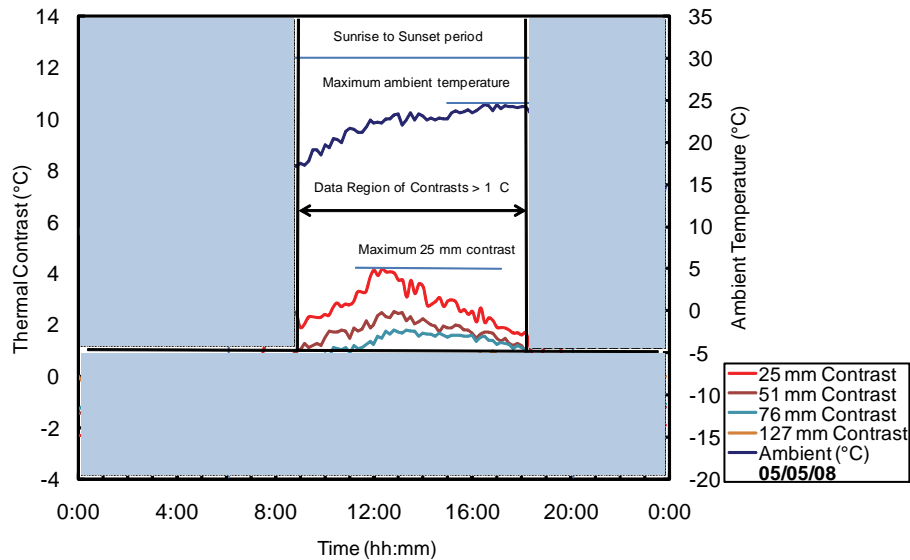
Figure 4.5 : The selection of 51 mm target positive thermal contrasts greater than 1 °C for May 5th, 2008 as compared to thresholds of sunrise and sunset, north side.

was normalized to the sunrise and sunset of each day to account for variations in day length over the course of time. Figure 4.5 shows the inspection period based on the 1°C (1.8°F) threshold. As can be seen in the figure, the threshold is achieved at different times for each target, depending on the target depth. The time period over which a particular target's contrast value exceeds the threshold also varies depending on target depth. The time at which the contrast exceeds the selected threshold was defined as the "inspection period" during which thermography is most likely to be useful for bridge inspection. The results of this analysis are included in section 5.4.

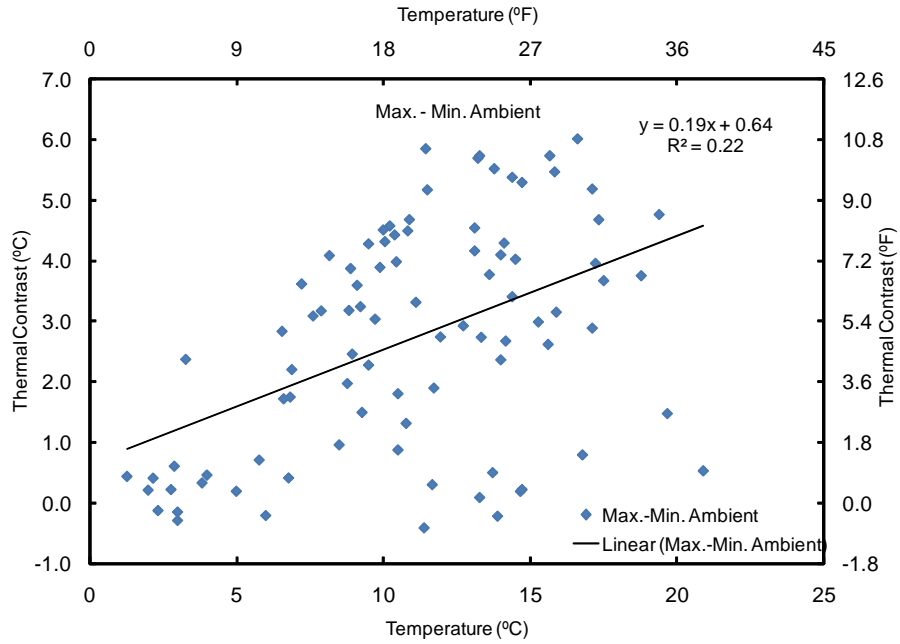
Figure 5.1 : Scatter plot with trend line for ambient temperature change versus thermal contrast.

Figure 5.1 shows the scatter plot of ambient temperature change versus the thermal contrast for the 51 mm (2 in.) deep target. The vertical axis indicates the thermal contrast in units of °C. A best-fit line was calculated for the data points and the equation of the trend line is in the graph along with coefficient of determination (R^2 value), which shows the degree of correlation of the data, on a range of 0 to 1. The data in this figure was derived by taking the range of ambient temperature changes for a given day, and plotting that against the maximum thermal contrast for that day. As shown in the figure and by the relatively low R^2 value (0.22), there was relatively poor correlation between the ambient temperature change and the resulting thermal contrast in the test block. However, the trend line does have a positive slope, which indicates that higher ambient temperature changes correlate somewhat with increased thermal contrast that developed for the 51 mm (2 in.) deep target. However, it can be observed that on certain days, even though there was a high ambient temperature change, significant thermal contrasts were not developed.

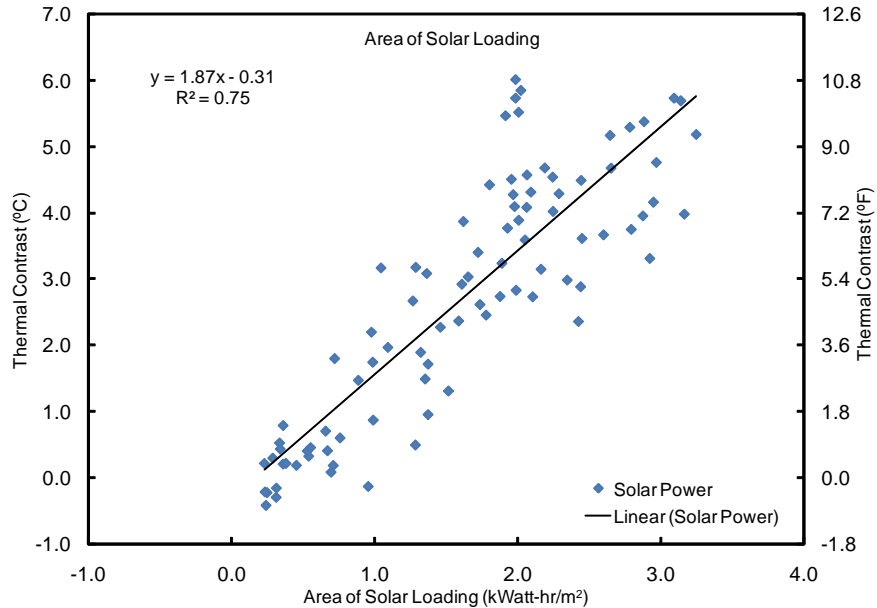
Figure 5.3 : Scatter plot with trend line for area of solar loading versus thermal contrast.

thermal contrast was found to be linear, longer periods of intense sunlight are proportionally better than shorter time periods. In other words, inspection conducted during longer days (summer) will provide improved results over inspections conducted on shorter days (winter).

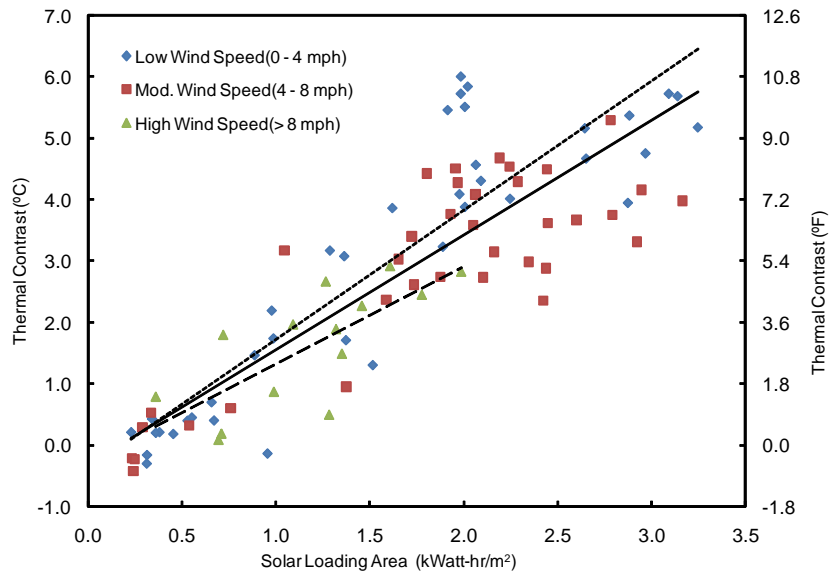
Figure 5.6 : Scatter plot of solar loading vs thermal contrast, with low, moderate and high wind speeds, 2nd quarter.

This data was further analyzed by examining the characteristic thermal contrasts for three groupings of wind speed, 0 to 4 mph (low wind speed), 4 to 8 mph (moderate wind) and >8 mph (high wind speeds). Analysis of this data using a scatter plot of the solar loading and the maximum thermal contrast showed that the trend for thermal contrast was lower for days with high winds (>8 mph) relative to the trend for all days combined, and much lower than the trend when winds were low. Figure 5.6 shows the scatter plot for maximum thermal contrast vs. the solar loading area ($\text{kW}\cdot\text{hr}/\text{m}^2$), with the three wind categories, low, moderate and high shown as different markers. Also shown on the plot is the trend line for high winds (long dash lines), low winds (short dashed lines), and all of the data as one group (solid line). As can be seen, the trend of the correlation for days with low wind speeds is much higher than days with high winds. Figure 5.7 shows the same relationships for the 3rd quarter wind speeds. The third quarter is from the hours of 12:00 noon to 6:00 pm., which is envisioned as the primary time for inspections, due to the time delay for the concrete to warm over the course of the day.

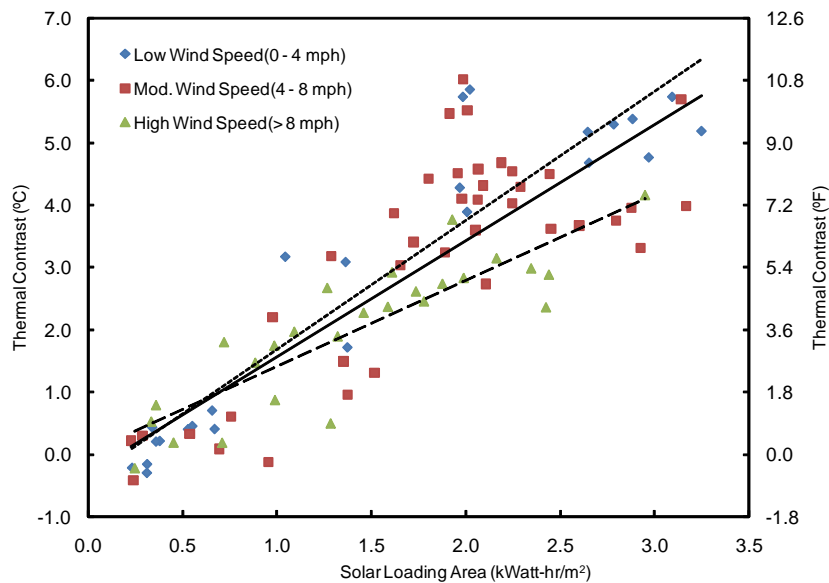
Figure 5.7 : Scatter plot of solar loading vs thermal contrast, with low, moderate and high wind speeds, 3rd quarter.

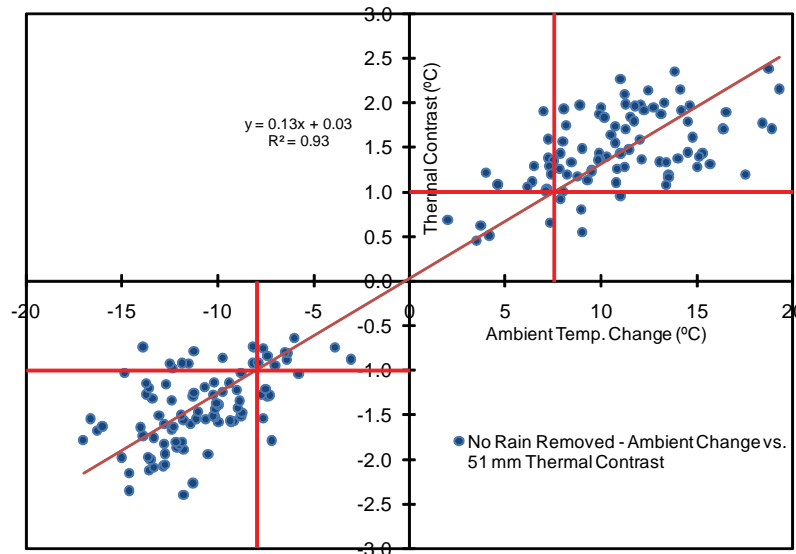
Figure 5.8 : Thermal contrast in north side of test block compared with ambient temperature changes.

To evaluate the effect of ambient temperature, the maximum thermal contrast for the 51 mm (2 in.) deep target was correlated with the changes in ambient temperature. As noted previously, this maximum value is based on a 1-hr, running average value. Figure 5.8 shows the results of this analysis for both positive (daytime) and negative (nighttime) contrast on a single plot. The figure shows the thermal contrast for all 92 days of data collected on the north side of the test block. The vertical axis is the change in ambient temperature and the horizontal axis is the thermal contrast observed for the 51 mm (2 in.) deep target.

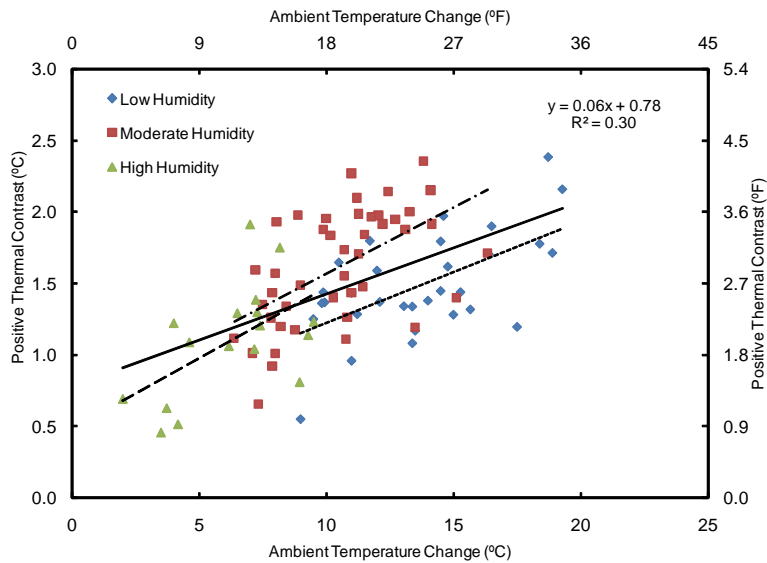
Figure 5.12 : Thermal contrast vs. ambient temperature changes with markers indicating high, moderate and low humidity.

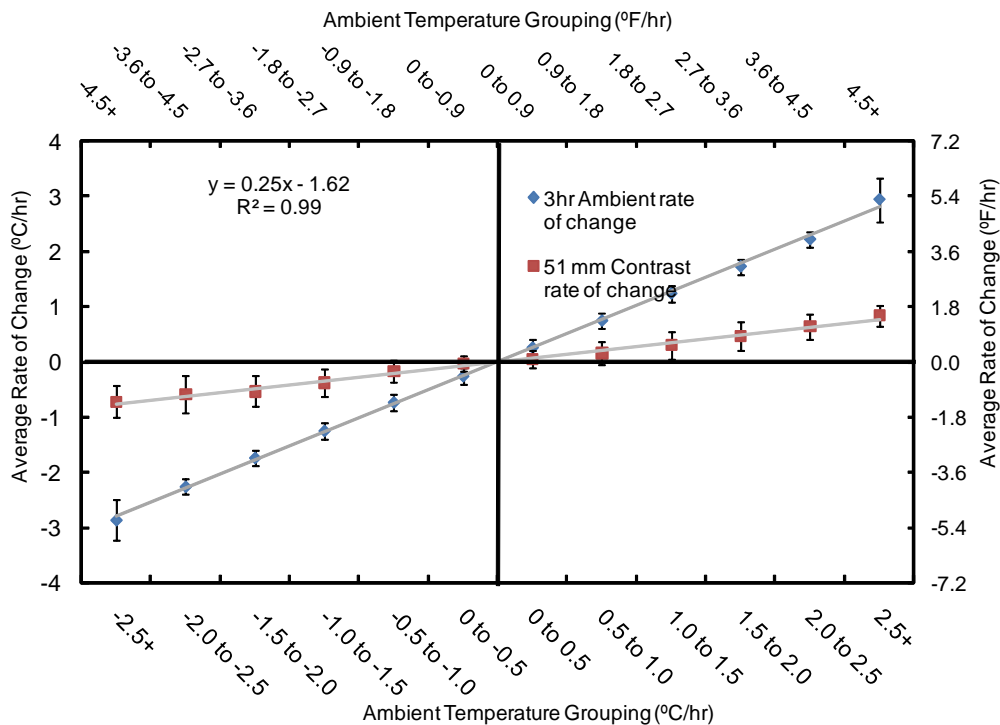
Figure 5.18 : Relationship between ambient temperature rate of change (x-axis) and thermal contrast rate of change (y-axis).

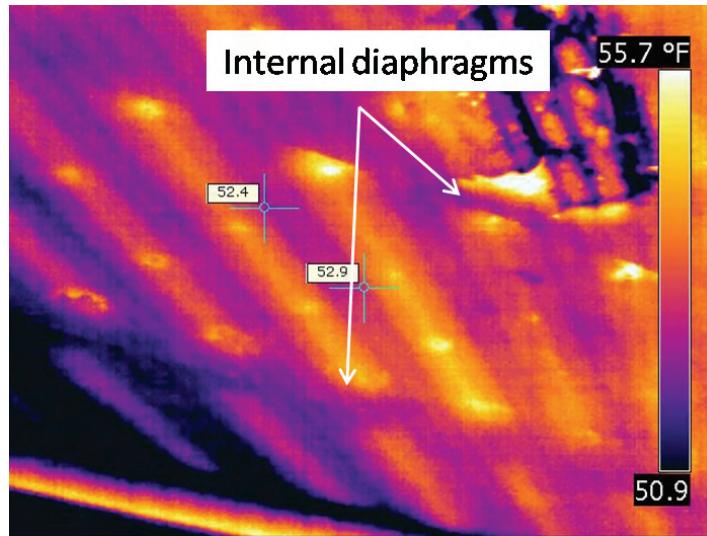
Figure 6.7 : Thermal image of the soffit of a bridge deck showing thermal signature of internal sonatubes and diaphragms.
