Review of California's Rural Intersection Crashes: Application of Methodology for Identifying Intersections for Intersection Decision Support (IDS)

Report #8 in the Series: Toward a Multi-State Consensus on
Rural Intersection Decision Support

Technical Report Documentation Page

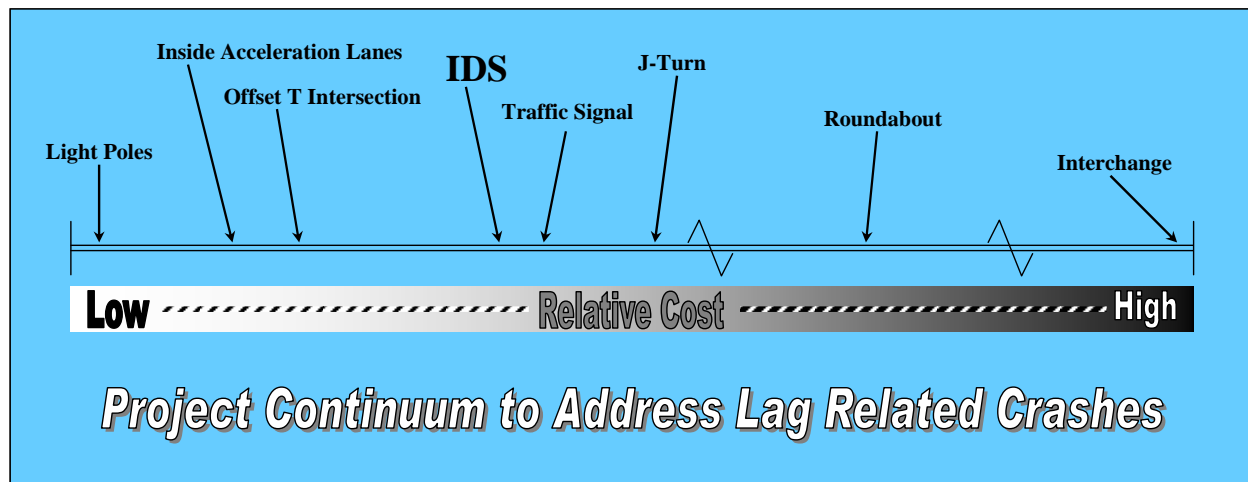
FIGURE 1-1
Lag Selection Related Safety Strategies

The concept of lag recognition being a key factor contributing to rural intersection safety appears to be a recent idea. As a result, there are relatively few devices in the traffic engineer's safety toolbox to assist drivers with lag recognition and they mainly consist of a few high cost geometric improvements and a variety of lower cost strategies that are considered to be experimental because they have not been widely used in rural applications. **Figure 1-1** illustrates the range of strategies currently available to address safety deficiencies associated with lag recognition problems, organized in order of the estimated cost to deploy (based on Minnesota conditions and typical implementation costs). The strategies include:

- The use of supplemental devices such as street light poles to mark the threshold between safe and unsafe lags
- Minor geometric improvements to reduce conflicts at intersection such as inside acceleration lanes, channelized median openings to eliminate certain maneuvers (sometimes referred to as a J-Turn), or revising a 4-legged intersection to create off-set T's
- Installing a traffic signal to assign right-of-way to the minor street

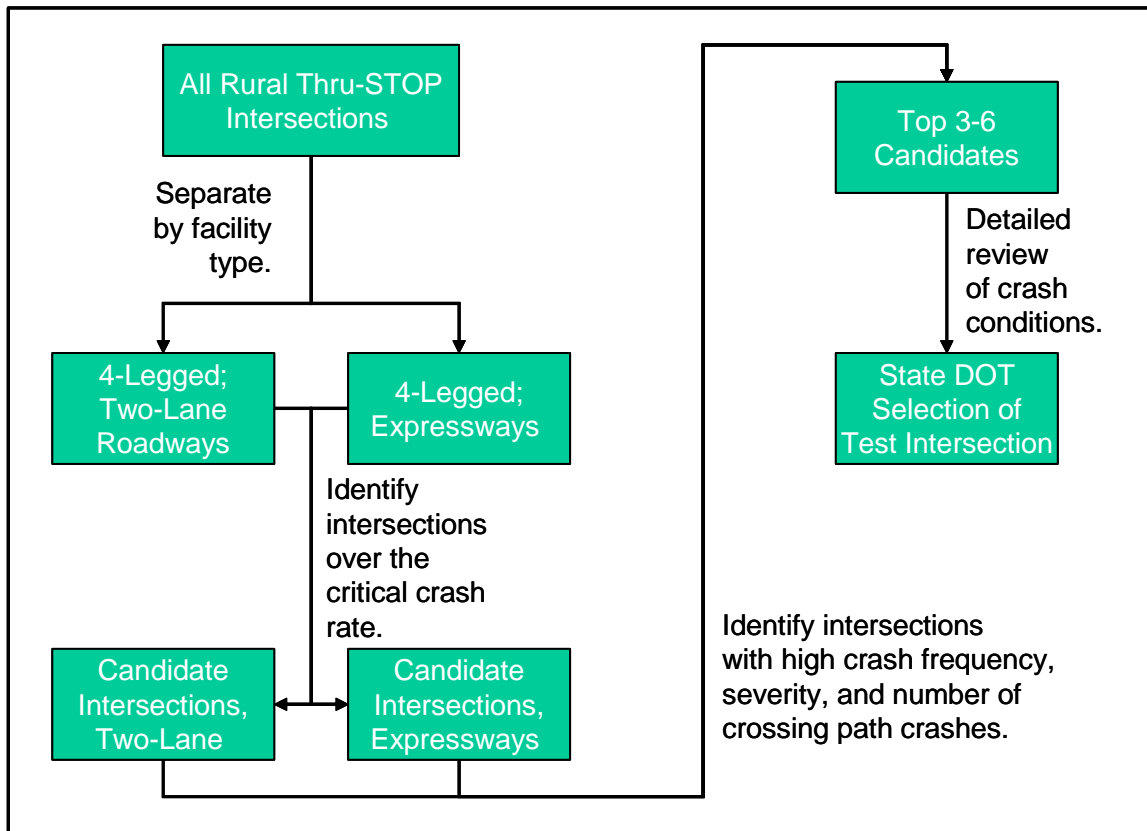
FIGURE 2-1
Preferred Crash Analysis Process

A comprehensive method for intersection identification was developed using Minnesota's crash record system (see **Figure 2-1**).

The method was applied to all rural, thru-STOP intersections in Minnesota, as this is the most frequent intersection situation in Minnesota. This intersection type is also the most likely where a driver will have to judge and select a lag at a rural intersection (i.e., stopped vehicle on the minor approach). The approach to identify the intersection selected for a potential field test of the technology used the three screens described in the following:

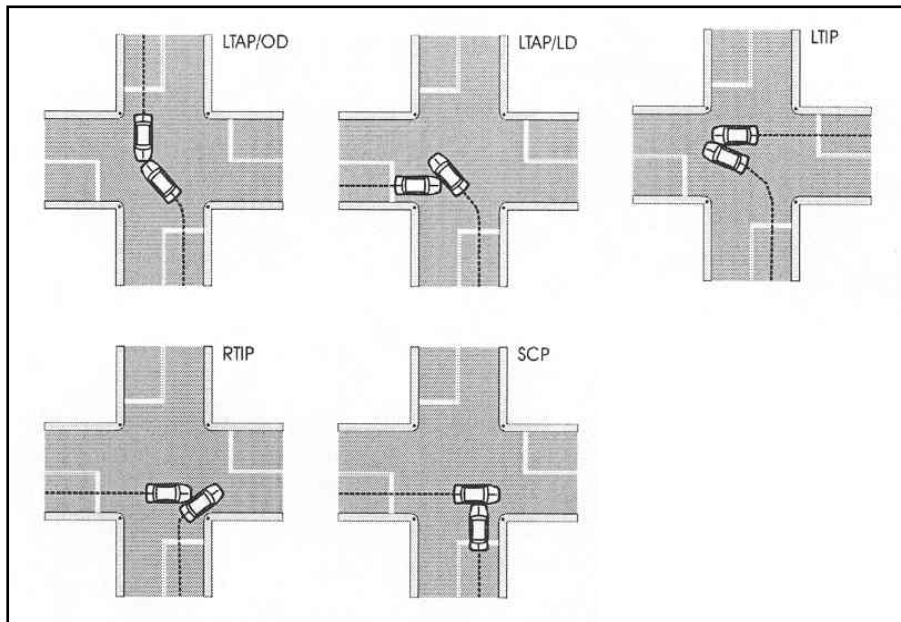
- Left Turn Across Path – Opposite Direction (LTAP/OD),
- Left Turn Across Path – Lateral Direction (LTAP/LD),
- Left Turn Into Path – Merge (LTIP),
- Right Turn Into Path – Merge (RTIP), and
- Straight Crossing Path (SCP).

FIGURE 3-1
GES Crossing Path Crash Types

The General Estimates System (GES) crash database is a national sample of police-reported crashes used in many safety studies. In the GES, five crossing path crash types have been identified (see **Figure 3-1**), they are:

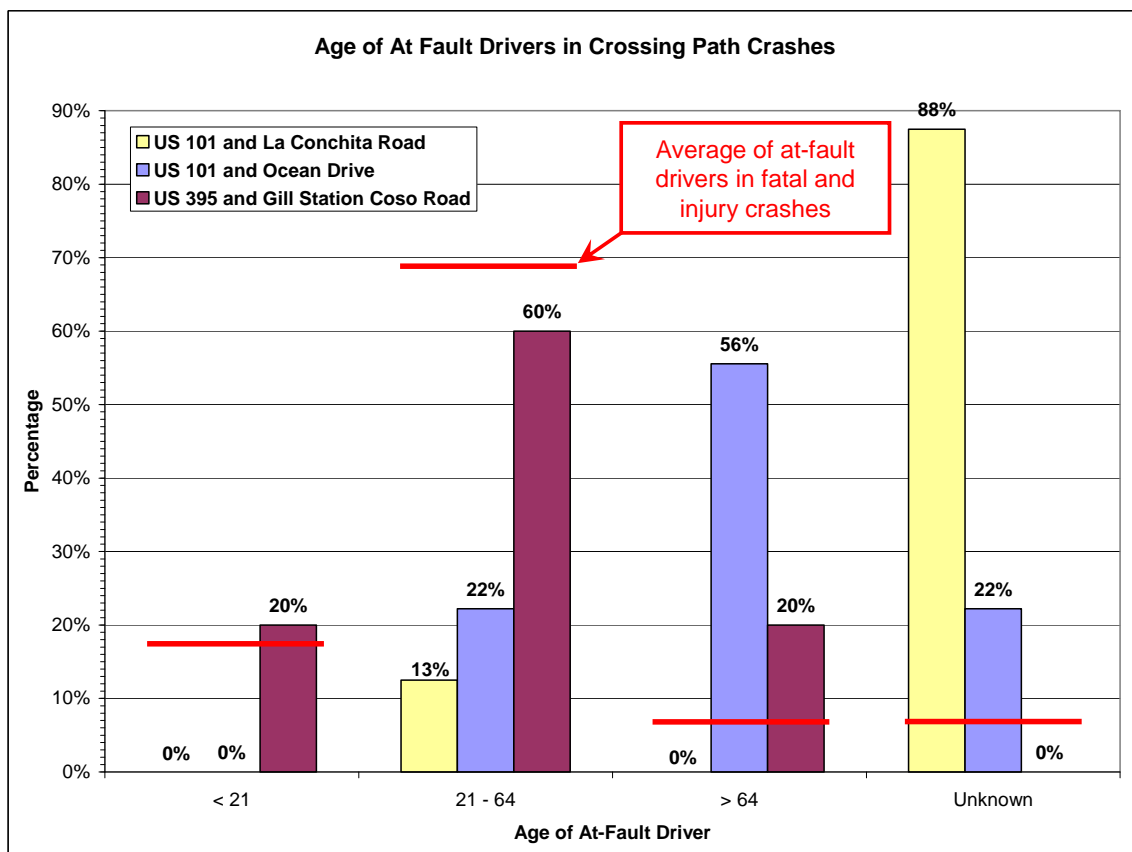
FIGURE 3-2

Age of At-Fault Drivers in Correctable Crash Types at the Candidate Intersections

For the candidate intersections, officer reports were reviewed to identify the driver whose action most likely caused the accident, also known as the at-fault driver (see **Figure 3-2**). Which driver was determined to be the at-fault driver was made using the narrative recorded by the investigating officer. For the at-fault drivers, the age was determined to be an important piece of information and was recorded because the IDS system may have its greatest benefit in assisting

At the intersection of US 101 and Ocean Drive, older drivers (age > 64-years) were determined to account for 56% of the at-fault drivers involved in the crossing path crashes. This is more than eight times greater than the statewide average of at-fault older drivers in fatal and injury crashes. At US 395 and Gill Station Coso Road, while the percentage of older drivers was above the statewide experience, it is considerably less than US 101 and Ocean Drive. As stated earlier, the driver information was removed from most of the officer reports at US 101 and La Conchita Road and prevented a similar analysis.

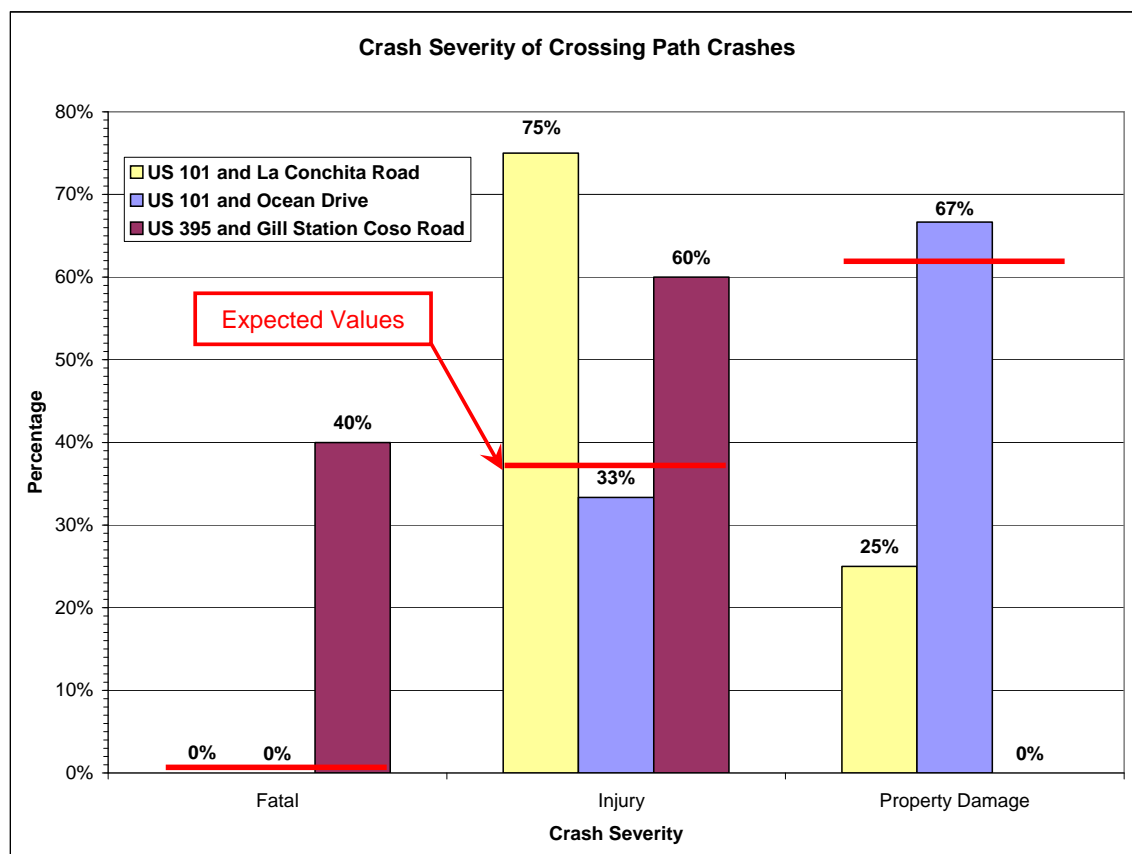
FIGURE 3-3

Crash Severity of Correctable Crash Types at the Candidate Intersections

Another goal of the IDS system is to address the most serious intersections crashes, especially fatal crashes. Therefore, the most appropriate candidate intersection would have a high percentage of fatal and injury crashes. Of California's 2005 crashes, fatal crashes represented approximately 0.7% of all of crashes, with injury crashes at 37.3% and property damage (PD) crashes accounting for 62.0% of all crashes (Source: *2005 Annual Report of Fatal and Injury Motor Vehicle Traffic Collisions*). **Figure 3-3** shows that neither intersection on US 101 had a fatal crash during the study period; however, this is not unusual given that fatal crashes are a rare event in comparison to injury and PD crashes. Of the two US 101 intersections, the percentage of crossing path crashes that resulted in an injury at US 101 and La Conchita Road was approximately twice the rate for all crashes in the state. The crash severity at US 395 was unusually high, with 40% of crashes resulting in a fatality and the remaining involving an injury.

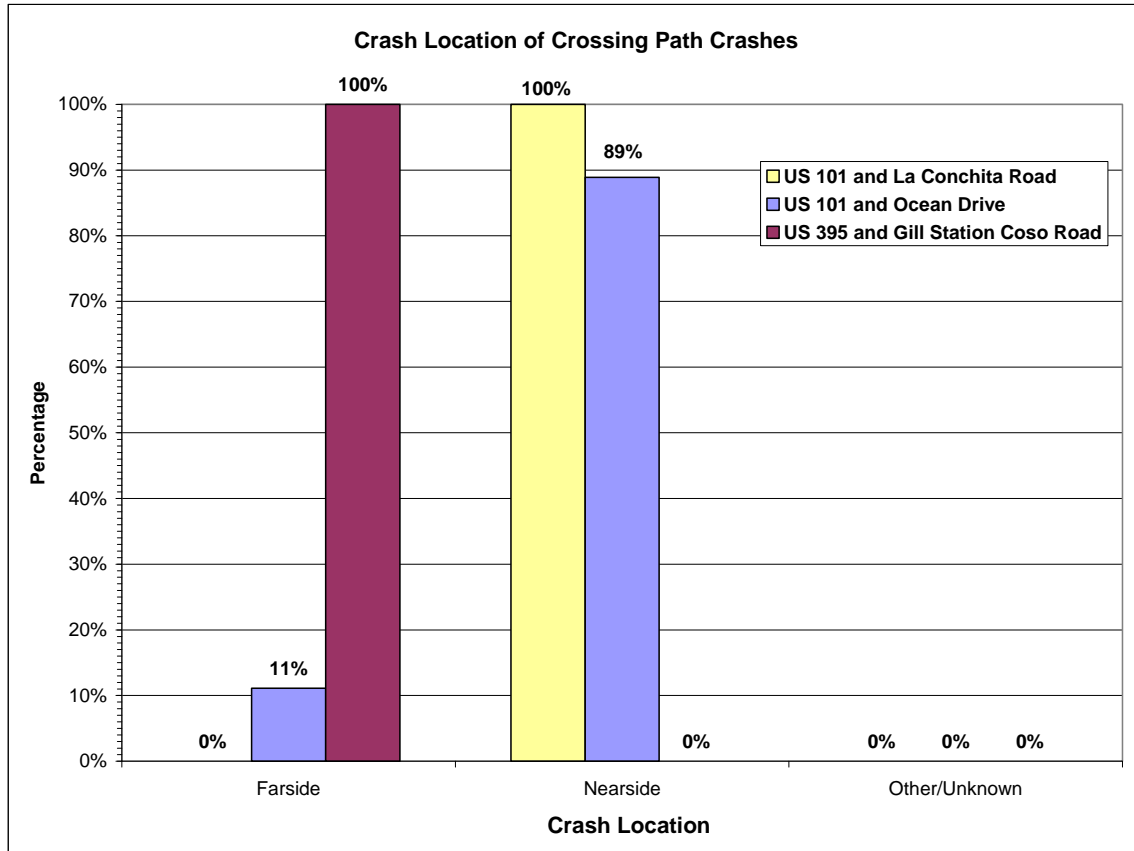
FIGURE 3-4

Crash Location of Correctable Crash Types at the Candidate Intersections

At the US 101 locations (see **Figure 3-4**), nearly all correctable crossing path crashes were near-side crashes. This pattern is generally opposite of what was found in the other states that selected to study rural expressways. This may be a result of the T-intersection design or the left-turn median acceleration lanes which help prevent far side crashes. In contrast, all crossing path crashes at US 395 and Gill Station Coso Road were farside crashes.

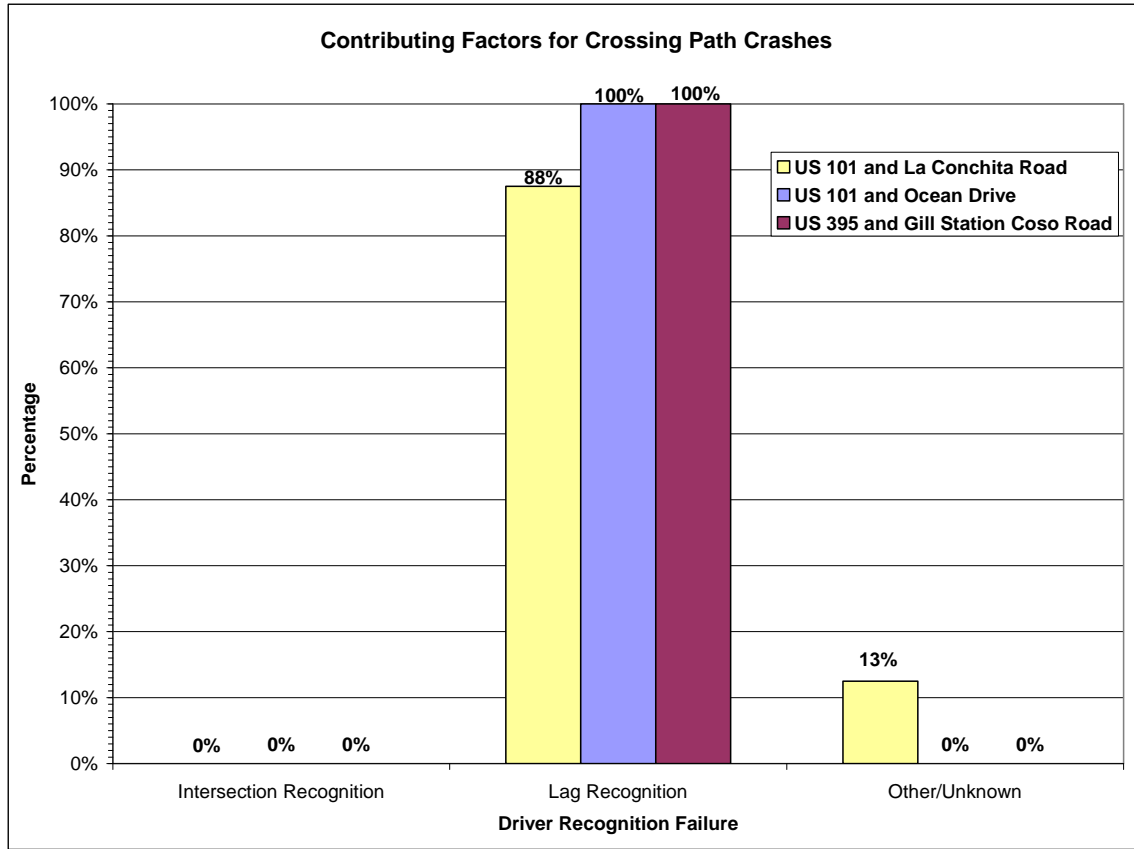
FIGURE 3-5
Contributing Factors of Correctable Crash Types at the Candidate Intersections

As shown in **Figure 3-5**, 88% of the crossing path crashes at US 101 and La Conchita Road were lag recognition and all crossing path crashes at US 101 and Ocean Driver as well as US 395 and Gill Station Coso Road were lag recognition crashes. This strongly suggests that a high percentage of these crossing path crashes could have been prevented if the at-fault drivers had assistance in identifying, judging and selecting a safe lag.

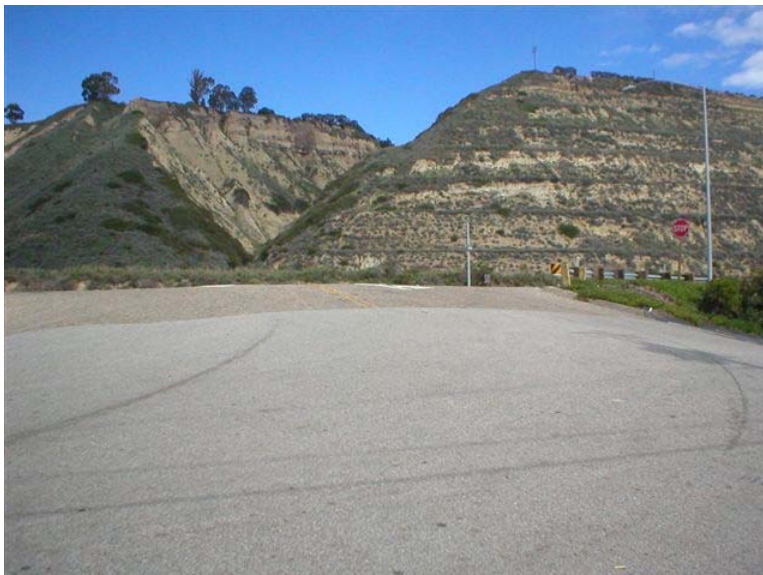
FIGURE 4-1
Ocean Drive Approach

The collision diagram in **Appendix A** reveals that eight of the nine correctable crossing path collisions involved a driver on the Ocean Drive approach turning left. Furthermore, all eight crashes involved a vehicle on US 101 approaching from the west (left).

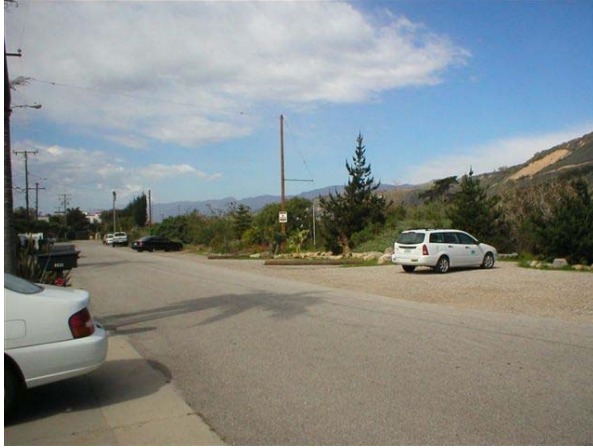
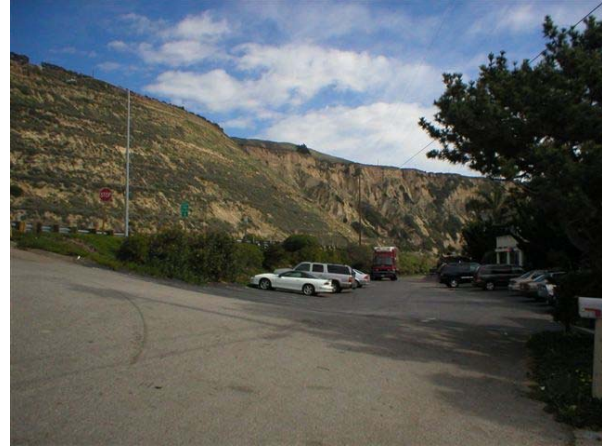
FIGURE 4-2

Parking to the West (left photo) and East (right photo) of the Intersection

Ocean Drive is a low-speed roadway, serving local traffic and providing parking for local business (see **Figure 4-2**). In fact, immediately east of the intersection is a parking lot for the Cliff House Inn.

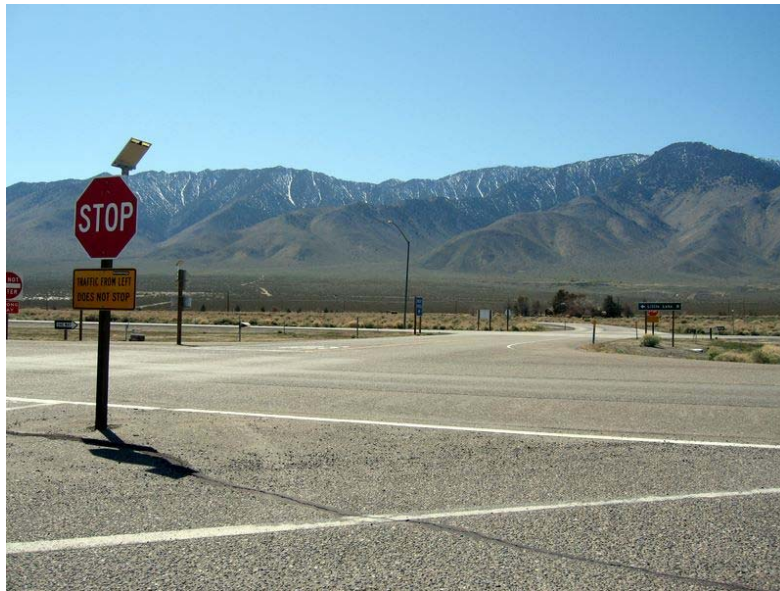
FIGURE 4-4

View of Median from East
Approach of Gill Station Coso Road

One unique aspect of this intersection is the wide median, which provides approximately 150 feet of storage in the median. Because of the extra storage space, STOP signs (instead of YIELD signs) have been placed at the each end of the median. Other safety countermeasures visible in Figure 4-4 include intersection lighting, warning signs mounted under STOP sign to remind drivers that traffic from left/right does not stop, and LED flashers around the face of STOP signs (powered by solar panels). Also visible in the aerial image (Appendix B) is an inside acceleration lane for vehicles turning left onto southbound US 395 and a free right for vehicles turning right onto northbound US 395.

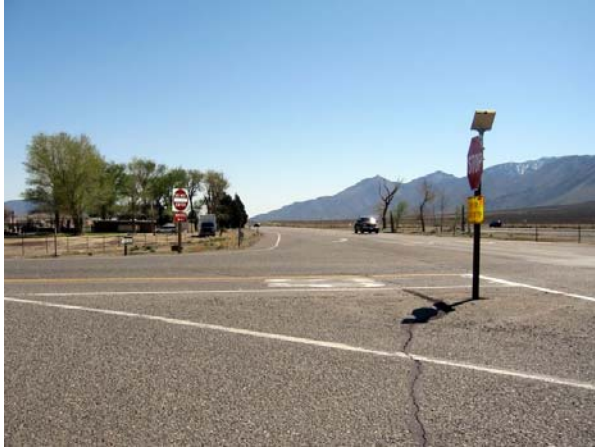
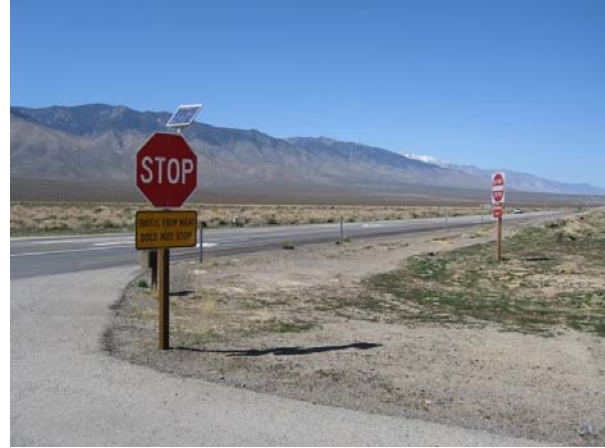
FIGURE 4-5
View of US 395 Approach Alignment for Northbound (left photo) and Southbound (right photo) Traffic

The US 395 alignment in the vicinity of the intersection is straight and nearly flat (see **Figure 4-5**), which means drivers on Gill Station Coso Road or in the median have no alignment related obstacles to identifying approaching vehicles and judging lags. While the US 395 alignment doesn't create any barriers for entering traffic, it was observed that the placement of a DO NOT ENTER and WRONG WAY sign does create a large blind spot. The specific sign combination is in the driver's sight triangle when looking south from the median (see **Figure 4.6**). Interestingly, all five crashes at the intersection included vehicles making this crossing movement. However, the location of the sign was not specifically listed as a cause in any officer report.

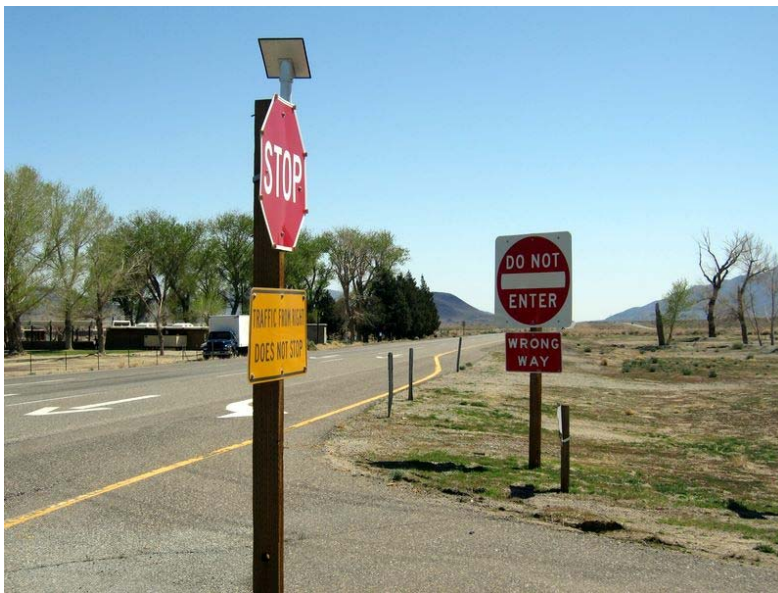
FIGURE 4-6
Sight Obstruction While Looking South from the Median

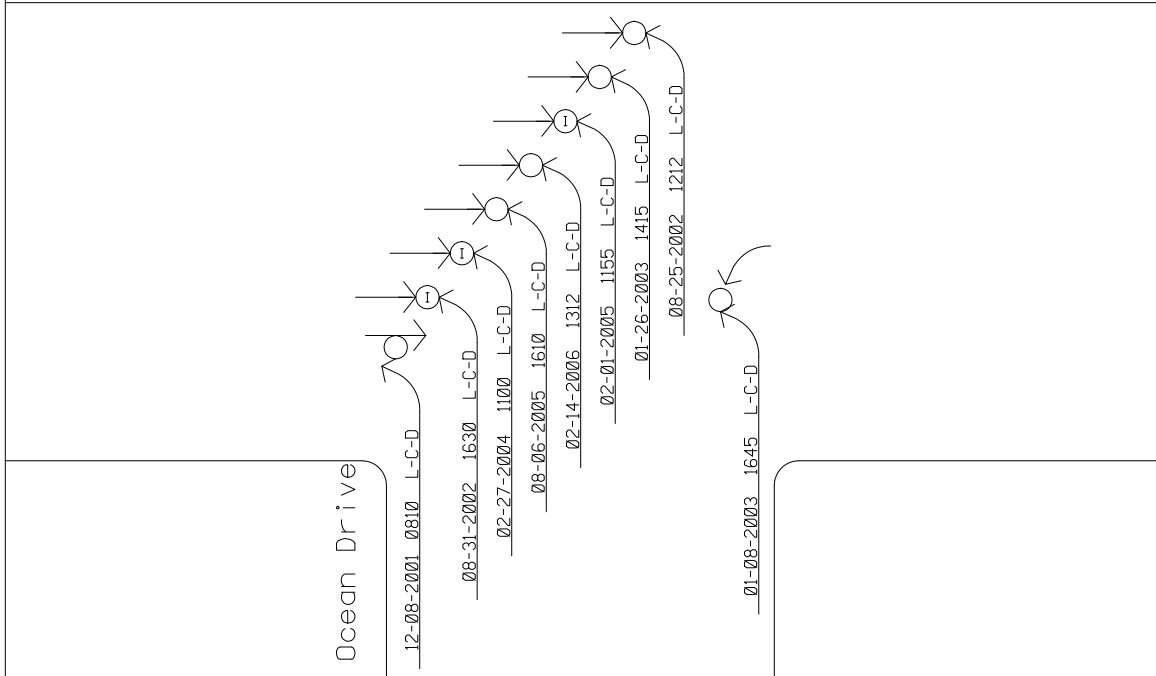
Collision Diagram

Fatal=	0
Injury Total=	10
Property Damage=	14
Total Accidents=	24

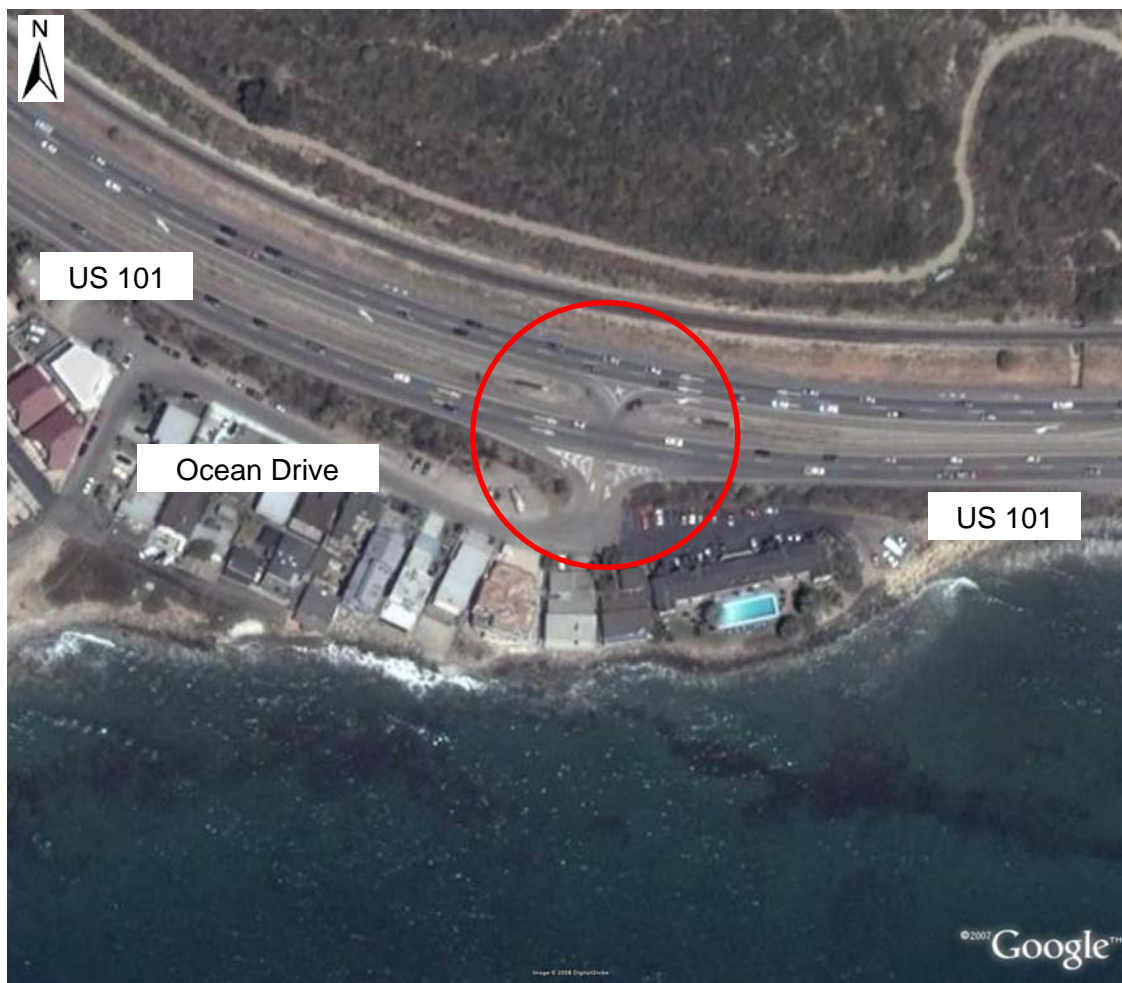
FIGURE B-1
Aerial Photo of US 101 & Ocean Drive (Ventura County)

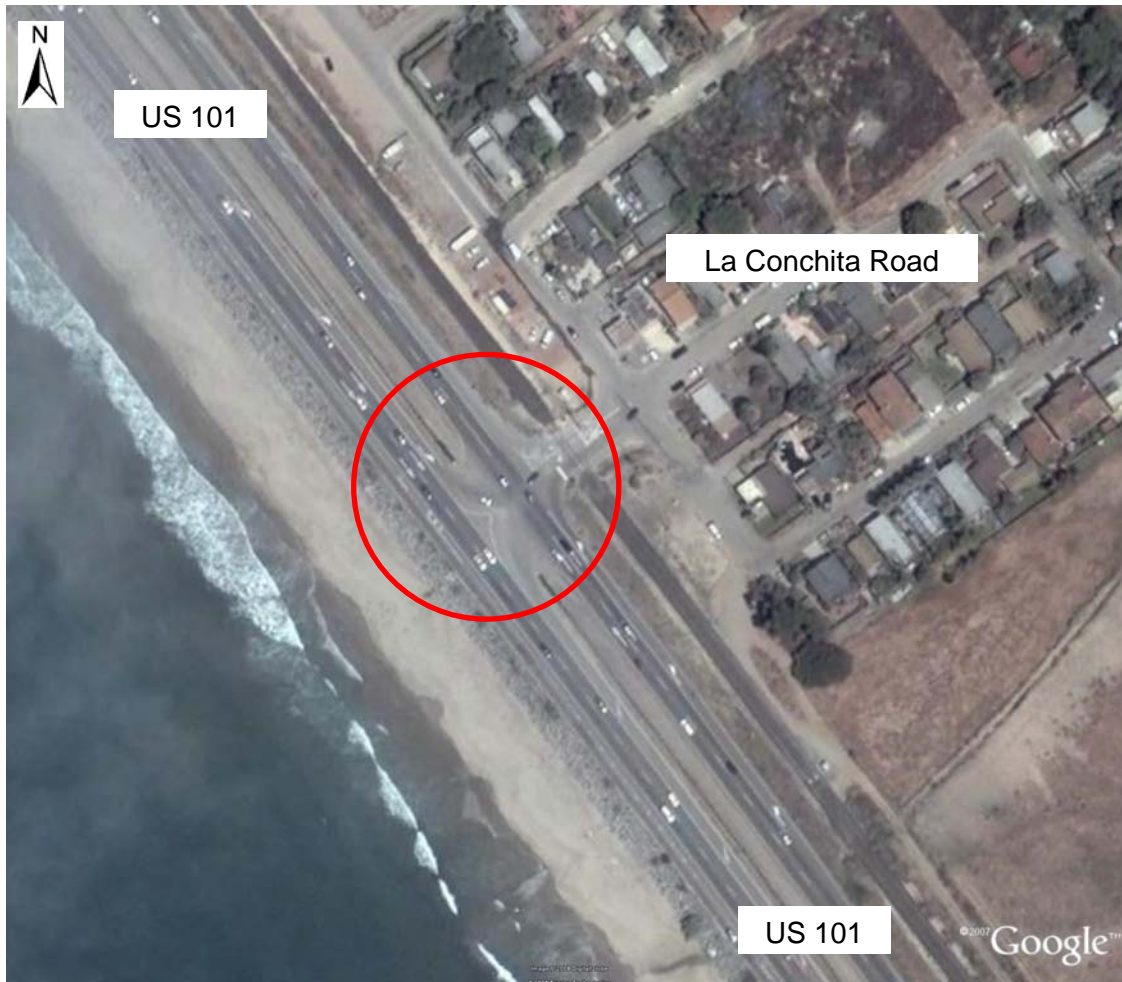
FIGURE B-2

Aerial Photo of US 101 & La Conchita Road (Ventura County)

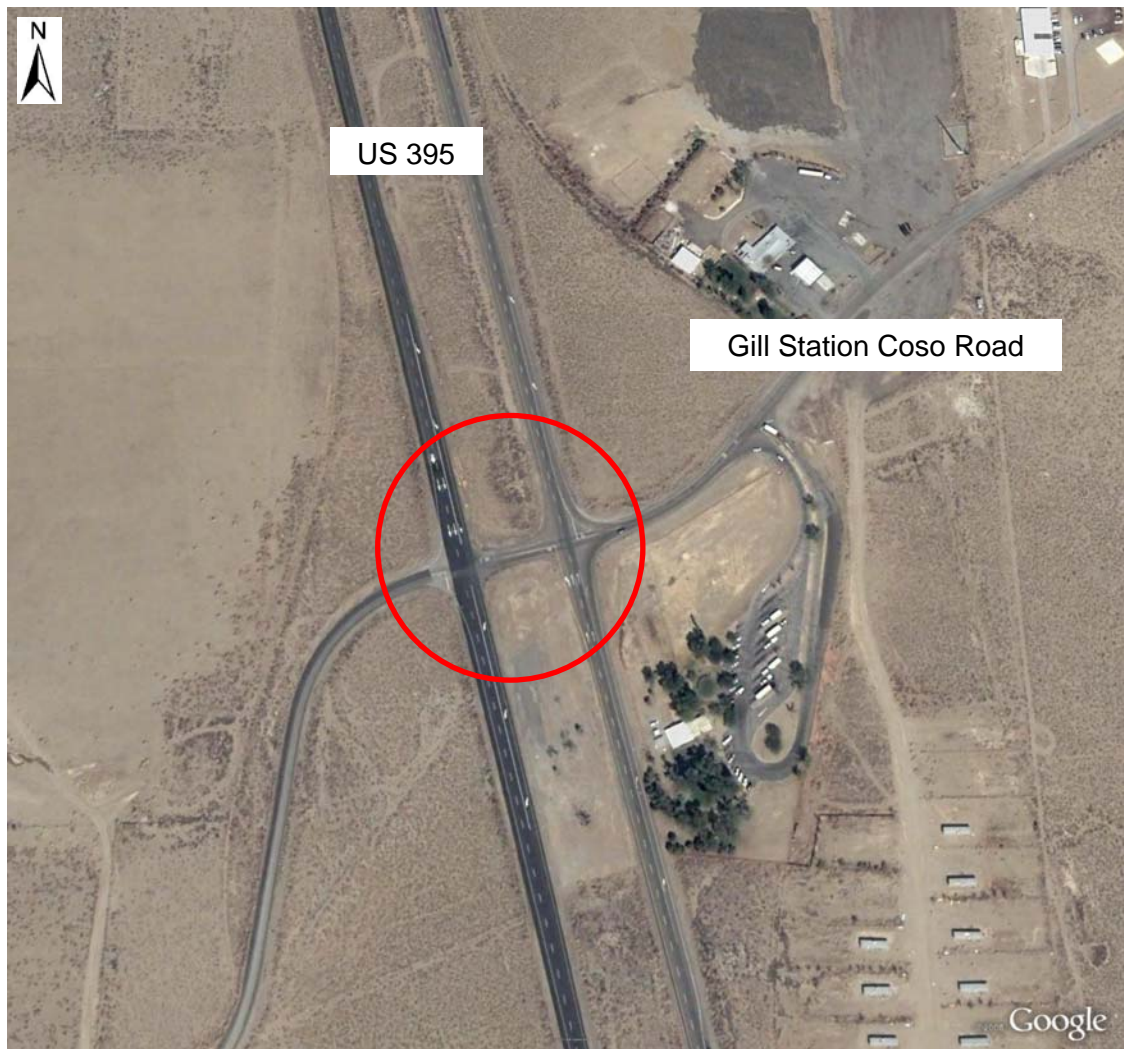
FIGURE B-3

Aerial Photo of US 395 & Gill Station Coso Road (Inyo County)
