## **MIDWEST POOLED FUND PROGRAM**

### **Progress Report - Third Quarter 2009 July 1<sup>st</sup> to September 30<sup>th</sup>**

Midwest Roadside Safety Facility  
Nebraska Transportation Center  
University of Nebraska-Lincoln

September 30, 2009

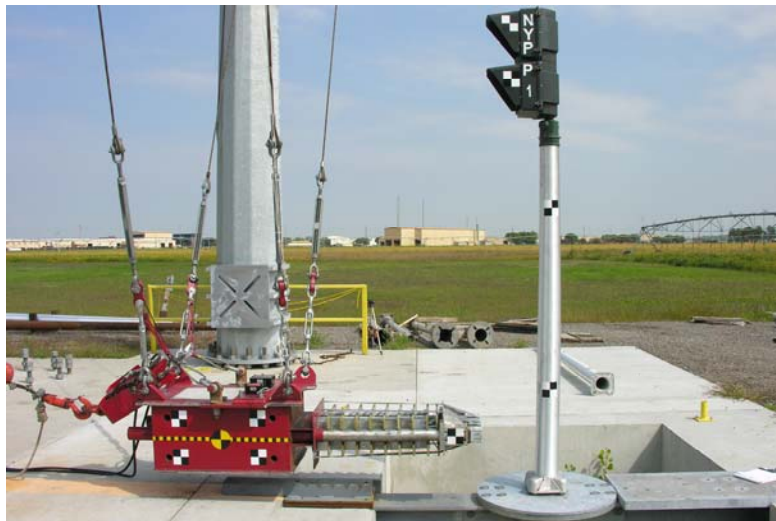
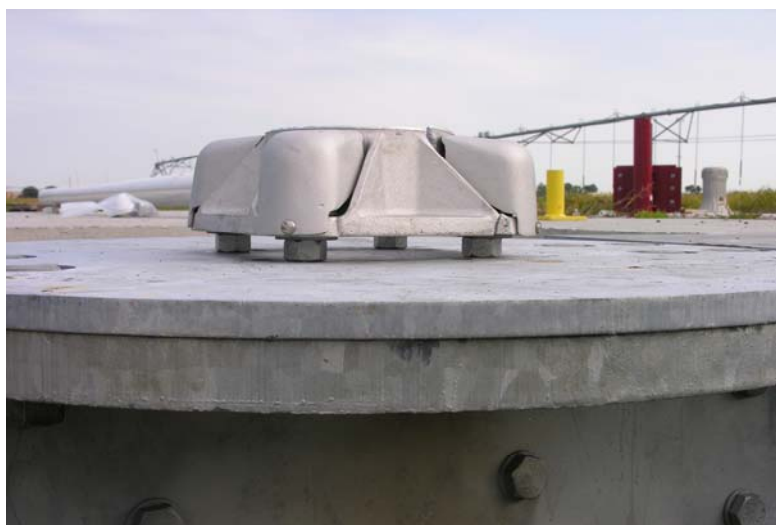
In the Third Quarter of 2009, all of the construction materials for the aluminum pole and signal system were acquired. On September 2, 2009, one low-speed, crushable-nose, pendulum test was conducted according to test designation no. 3-60 of NCHRP Report No. 350. An aluminum pole and base was evaluated without the use of a traditional breakaway assembly. During the test, the welds which attach the pole to the base plate assembly fractured, and the pole was dislodged away from the base. The accelerometer data was analyzed and indicated that the impact event resulted in acceptable levels of occupant risk, deceleration, and change in velocity. However, the remaining stub height of the base plate measured 4.5 in., thus violating the 4-in. threshold value established by FHWA and AASHTO. Approximately 0.5 in. of the 4.5 in. stub height pertained to the thickness of the leveling nuts.

At this time, MwRSF is working with the sponsor to determine how to proceed with the project. In the Fourth Quarter, the test results will be documented with the preparation of a letter-type report.

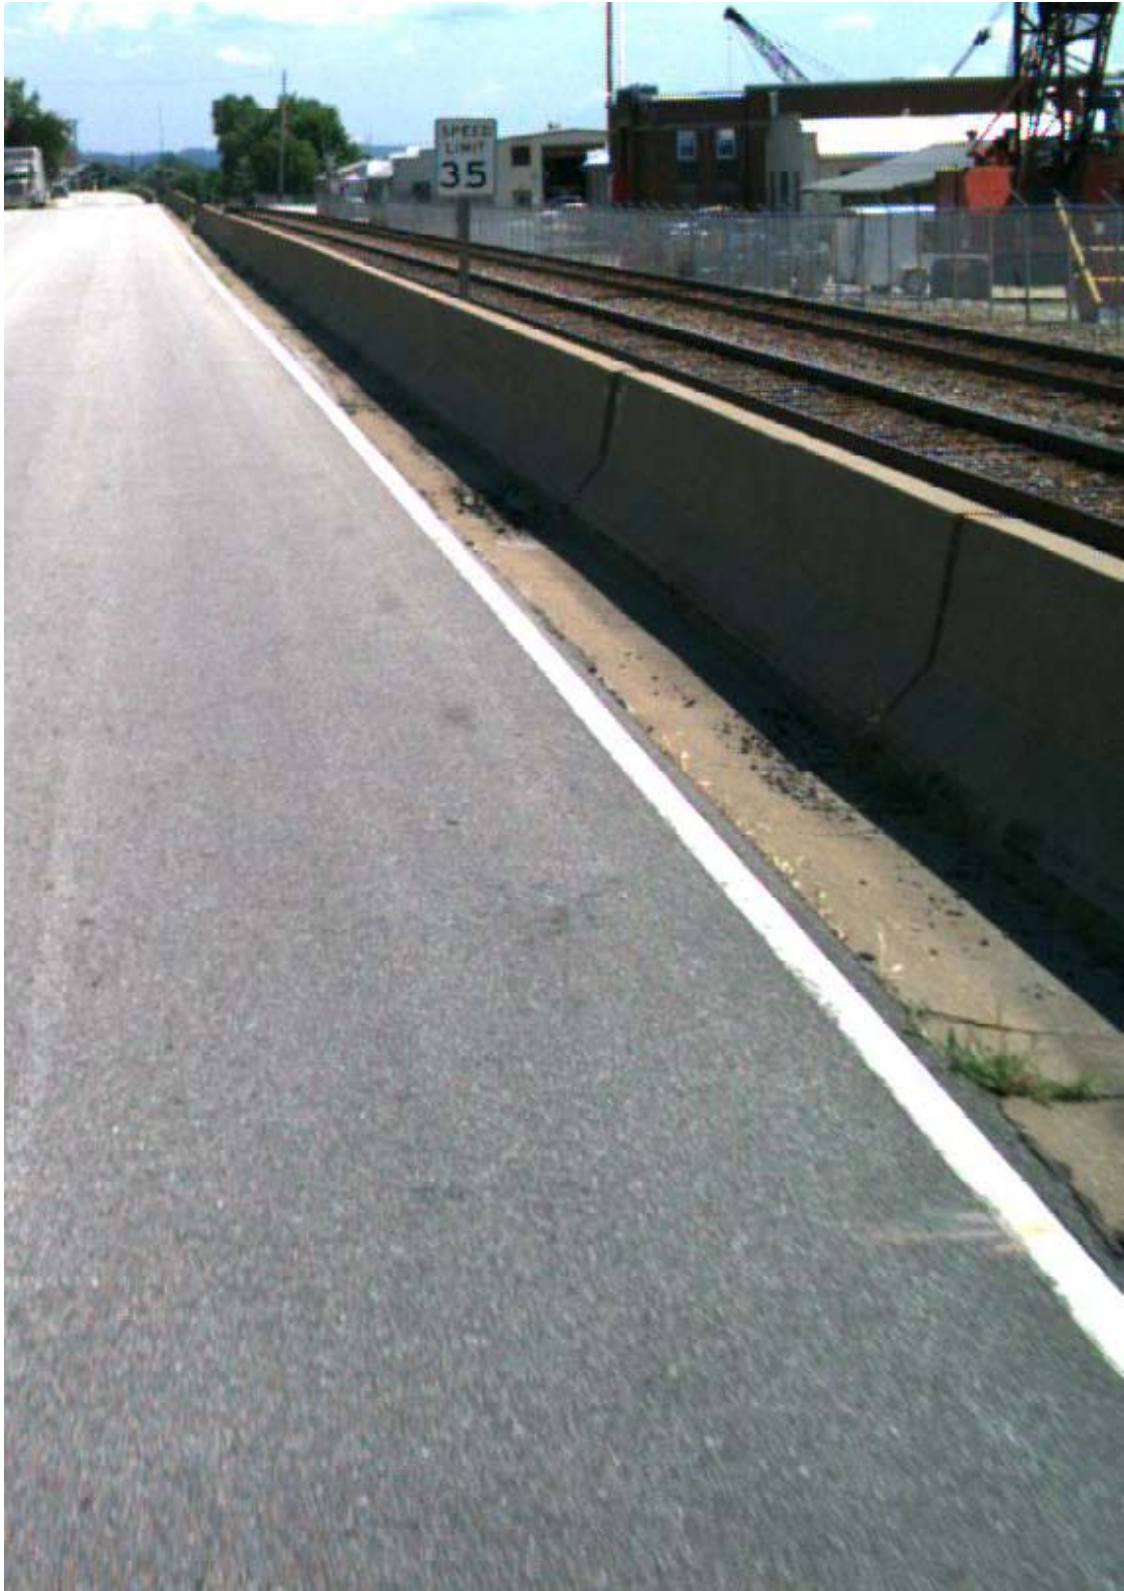
Figure 1. Barrier Alignment

With regards to permanent concrete barrier, we would recommend keeping the lateral offset or alignment offset minimized to eliminate snag. Variations of 1" or less would be preferred.

For the temporary barrier installation shown in your photo, we would prefer that the alignment gap be 1" or less, but we believe that gaps as large as 2" are likely permissible. The rationale behind the larger alignment gap allowance is that temporary barrier segments will move when impacted and cause changes in the alignment gap as the impacting vehicle reaches the barrier joint. Thus, a joint that has a given initial alignment will move change alignment as the barrier is impacted. This allows for more tolerance for the temporary barrier gap. Alignments gaps larger than 2" would indicate problems with the temporary barrier joint and would require investigation.

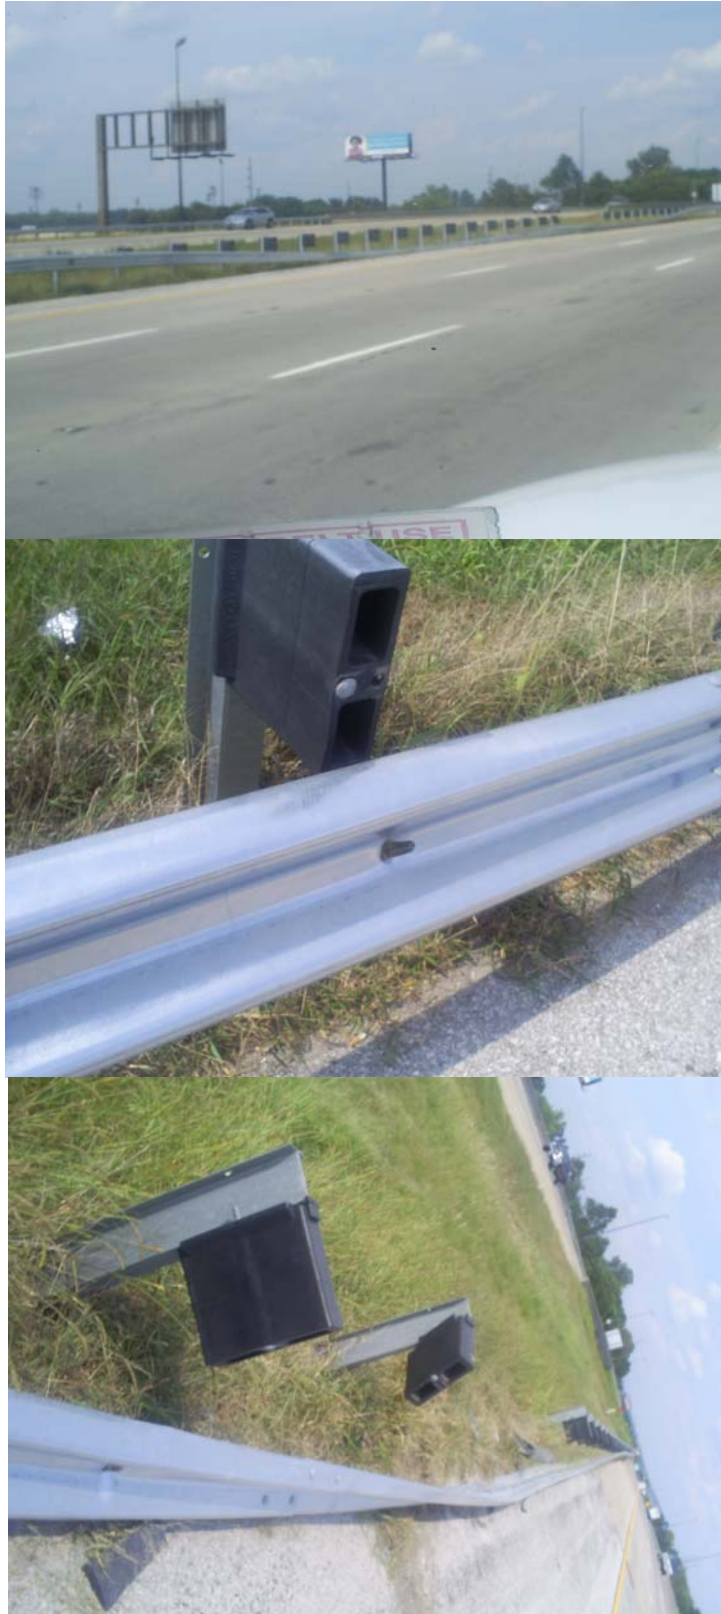
Figure 2. MGS Guardrail Damage

Here's some feedback from the field on the MGS. In this case the rail was hit from the back and popped off a longer run. I don't think this is surprising, but would appreciate any comments. One question this raises, is about re-using the rail element. The only damage appears to be a little deformation around the bolt hole where the button head pulled through. This could probably be straightened in the field.

Thanks for the guardrail damage photographs. From the photographs, I only can see some minor deformation around the guardrail bolt slots. As long as there are not any fractures or cracks around the slotted holes, I am not too concerned about reusing the rail by re-mounting it to the posts/blocks. However, you may consider using the downstream side of the slot if the downstream hole can be used on each blockout/post.

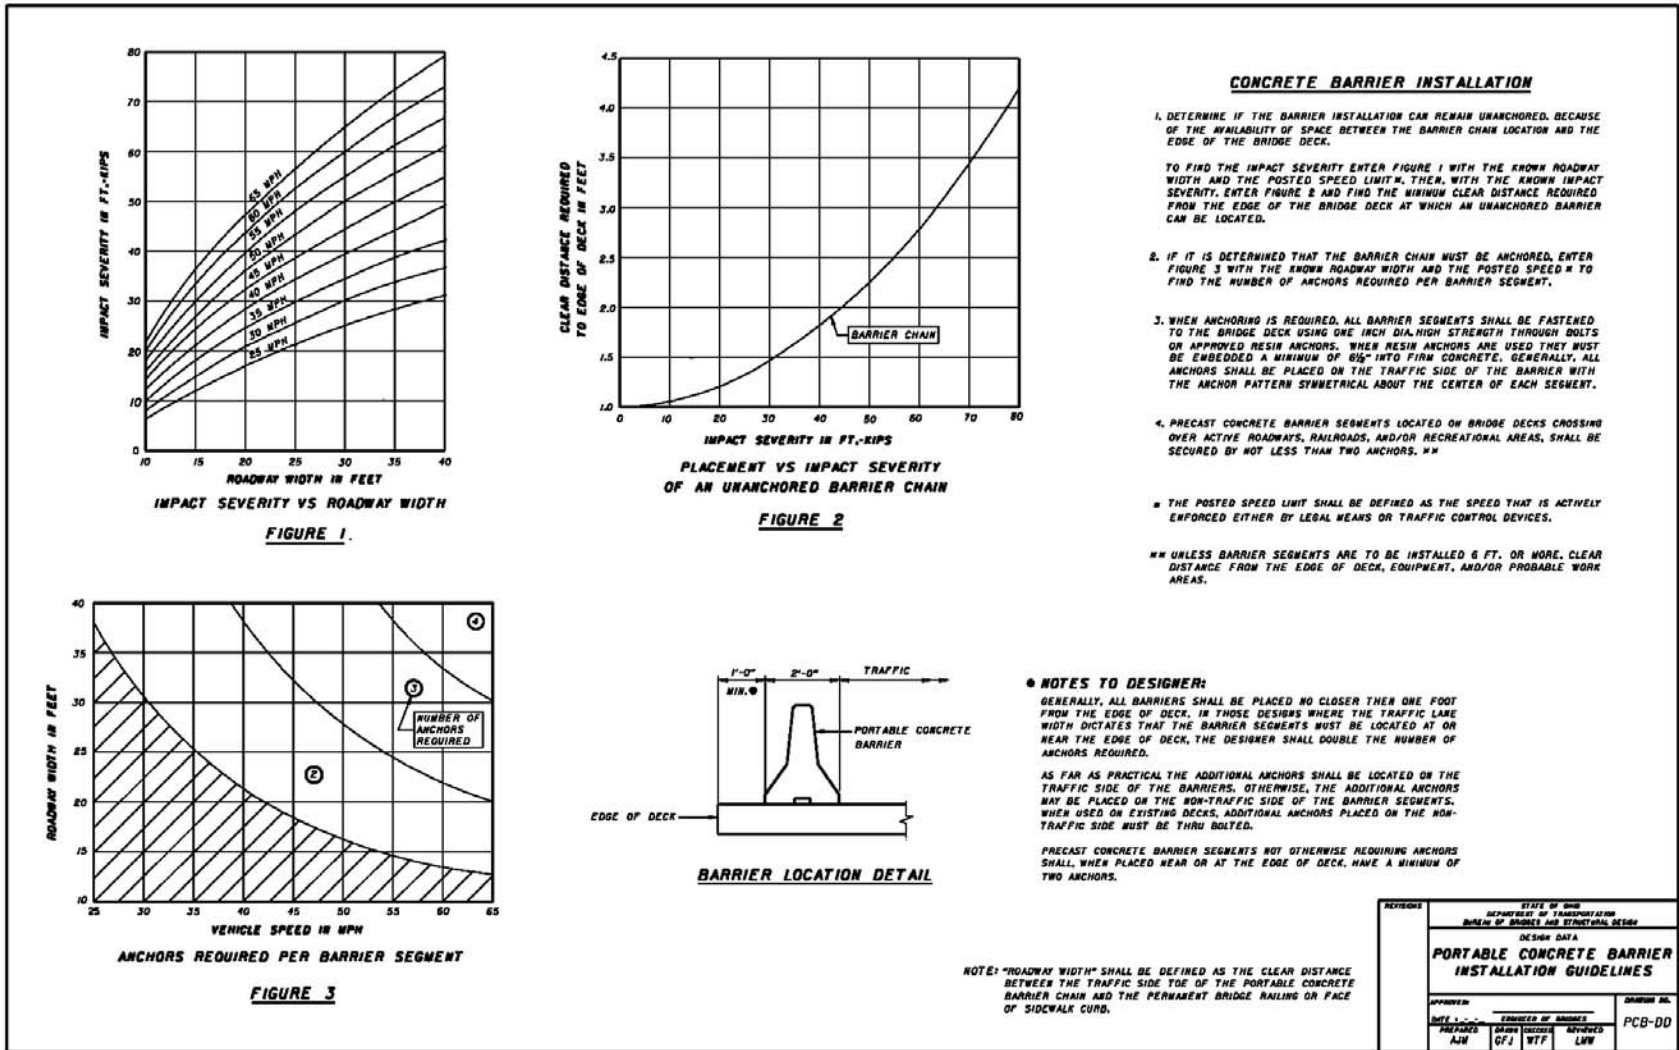
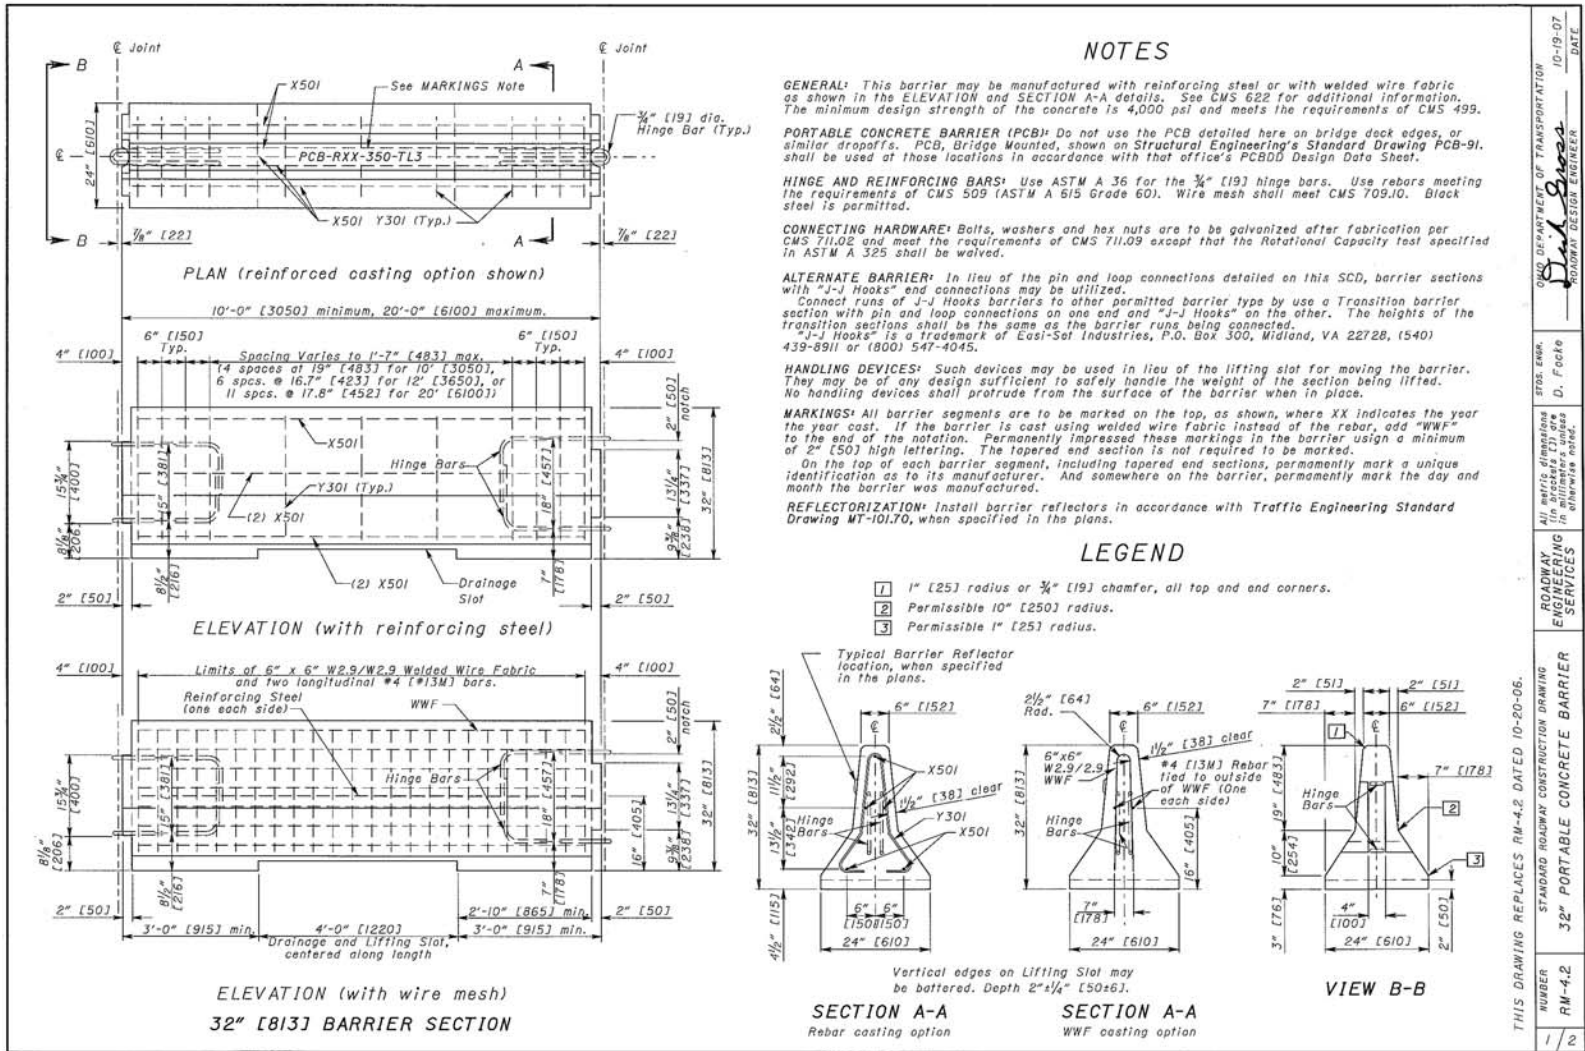
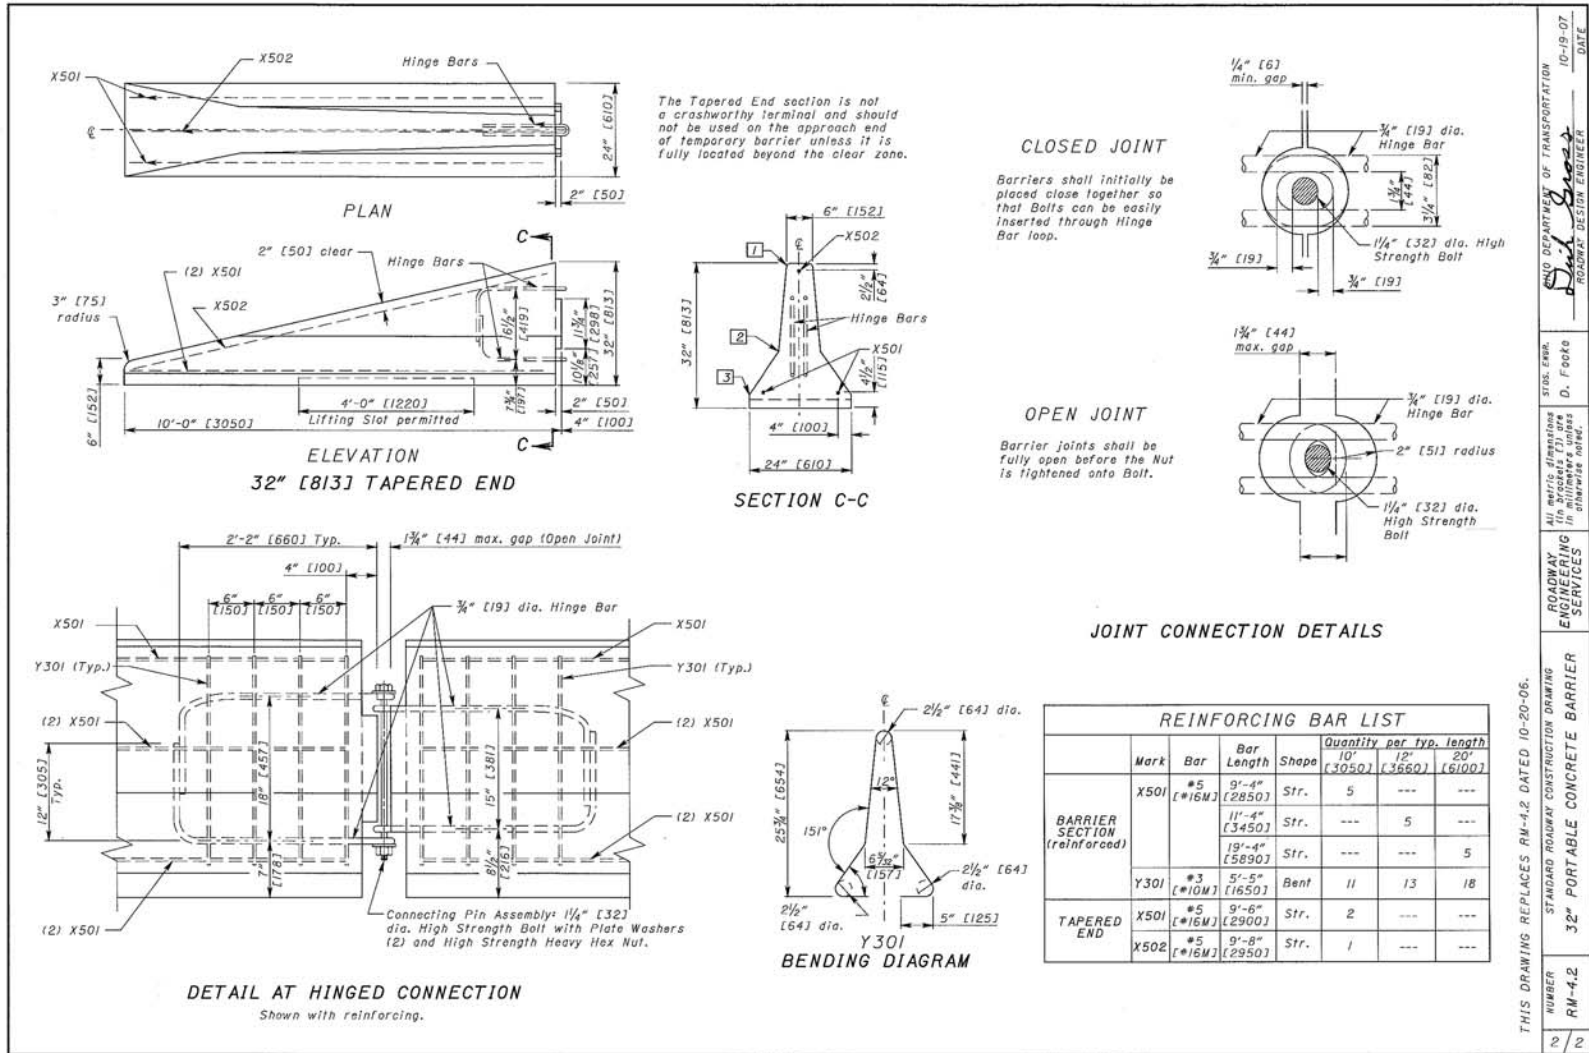
2. We did recognize that you have more anchors than use used in our anchored barriers, but that is another cause for concern. We do not recommend placing anchors on the backside of barriers. There are concerns that placing anchorage on back side of the barrier can induce increased vertical rotation of the barrier segments which could increase the potential for vehicles to climb the sloped barrier face and become unstable. Thus, we would recommend no anchorage on the backside of your barrier.

3. Barrier reinforcement in your barrier is not sufficient to derive the full strength of the 1” dia. high-strength steel rod used. In our anchored barriers, the anchor pockets have reinforcement loops that go around the packet to contain the anchors. Without this type of reinforcement, we do believe your anchors will fracture through the anchor pocket and become ineffective.

4. I also noted that you allow the use of JJ-Hooks barrier segment connections with your PCB. We would not recommend this connection for use in an anchored barrier system. The JJ-Hooks connection is fine for free-standing systems. However, to be safely used in an anchored barrier or approach transition, the barrier joints must have comparable or greater torsional rigidity about the longitudinal barrier axis when compared to that of the as-tested configuration. JJ Hooks connection is not similar in torsion to the Kansas barrier joint, and the JJ Hooks connection is also non-symmetric in that it has different capacities depending on the direction it is loaded.

Figure 4. Ohio Anchored New Jersey Shape PCB

In order to adapt your barrier to safely use the approach transition, we would recommend that you change your current barrier and anchorage system to:

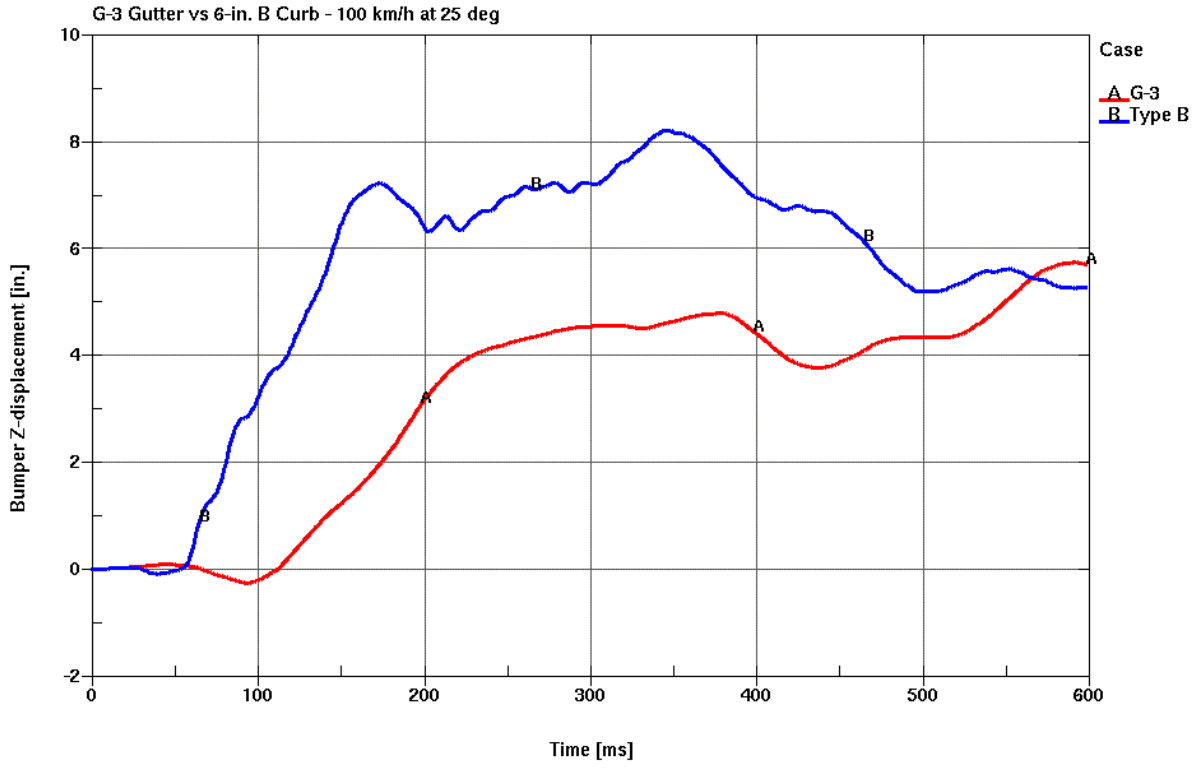
Dr. John Reid has made a very brief comparison between the two noted curb geometries – the 6-in. tall AASHTO Type B curb and the Illinois Tollway's wedge-shaped curb. This initial investigation included both an examination of vehicle trajectories and motions with and without the guardrail in place behind the curb. From this study, the use of the wedge-shaped curb in combination with the MGS (located per your prior CAD details) does not appear to degrade barrier performance over that observed for the MGS with the 6" Type B curb. As such, MwRSF is not concerned with placing the MGS behind the wedge-shaped curb using the previously noted details.

Figure 9. Vertical Bumper Displacement for 6" Type B Curb and 3" G-3 Gutter

Although there are slight differences between the successfully crash-tested system and the IL Tollway detail, we believe that the noted system with MGS in combination with the G-3 curb would provide a crashworthy system. However, we do not have physical or scientific evidence to support this opinion and would like to conduct a brief analysis to investigate the alternative scenario. As such, we used LS-DYNA to evaluate and compare the two scenarios since we have experimental data to validate the 6" Type B curb cases.

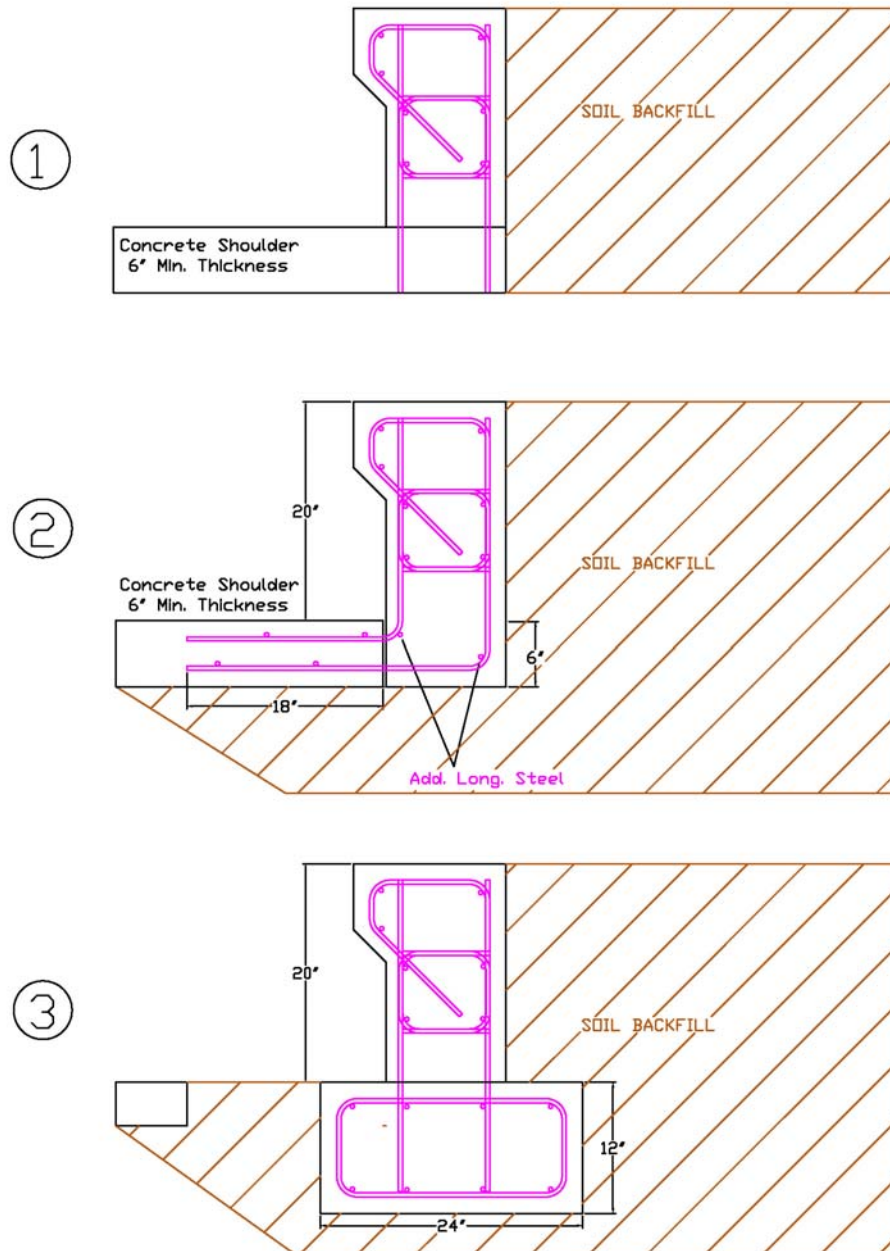
To adapt the low profile, TL-2, concrete bridge rail to roadside applications, I see three options. These options are shown in the PDF file in the folder noted below. Also, 2 digital videos of the full-scale crash test are in the folder.

Figure 10. TL-2 Barrier

Wisconsin was interested in installing a TL-2, low profile bridge rail that will be backfilled with soil and were looking for guidance pertaining to the foundation/anchorage requirements. The barrier in question was the TL-2 concrete barrier designed by MwRSF in report TRP-03-109. It was planned for use in both median or roadside applications. The backfill was expected to be 21 feet in median applications, and the roadside application may place a 6:1 on the backside. The roadway in question was being reconstructed. In the median, the expected barrier placement was at least 2' from edge of lane, and on the roadside the region is pushing for 10' shoulder on the outside, but may not get it.

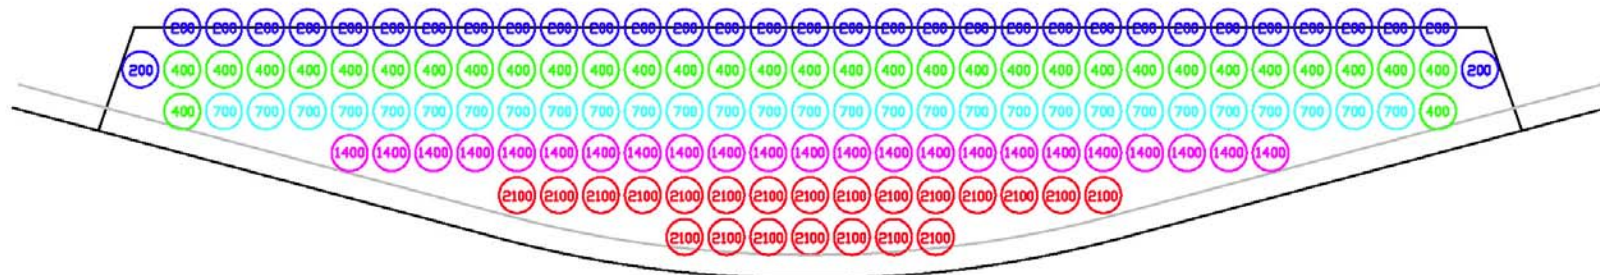
- (1) Barrels are 3 ft in diameter and should be spaced 6 in. apart.
- (2) The gray line in the drawing represents the 24 in. clear space recommended between sand barrels and the hazard.

3 ft Diameter Barrels  
 6 in. clear space between all barrels  
 Black line is hatched area  
 Grey line is recommended offset for barrels = 24 in.

Blue = 200 lb. barrel  
 Green = 400 lb. barrel  
 Cyan = 700 lb. barrel  
 Magenta = 1400 lb. barrel  
 Red = 2100 lb. barrel

Figure 12. Kearney Bypass Sand Barrel Layout

I've attached my recommended configuration for the sand barrel crash cushion. It takes a lot of barrels to protect such a wide area!
