**March 31, 2011 Progress Report on Pooled Fund Study TPF-5(189):**  
***"Enhancement of Welded Steel Bridge Girders Susceptible to Distortion-Induced Fatigue"***

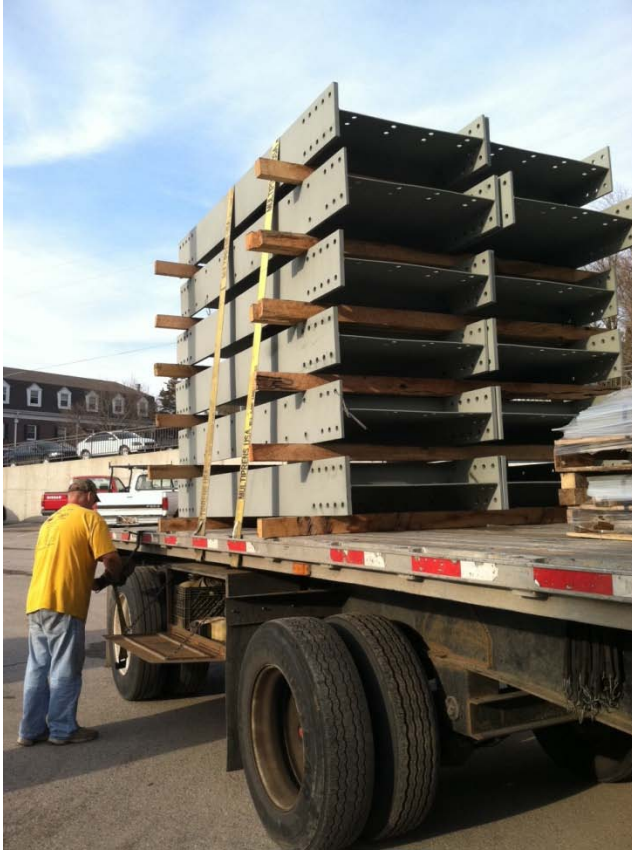
Fig. 1. Shipment of girders from CTIW received at the KU Structures Lab for use in 30 ft. girder test set-up

Test specimens, fabricated by Central Texas Iron Works, arrived March 16, 2011. This shipment included steel for six test setups, and all fabricated steel was received in excellent condition. Construction for first test setup is well-underway. Steel support fabrication at Rice Precision was completed March 28, 2011, and the concrete "pier" supports for bridge girders have been set. Strain gaging of the steel girders to measure web gap stress and flexural stresses is underway.

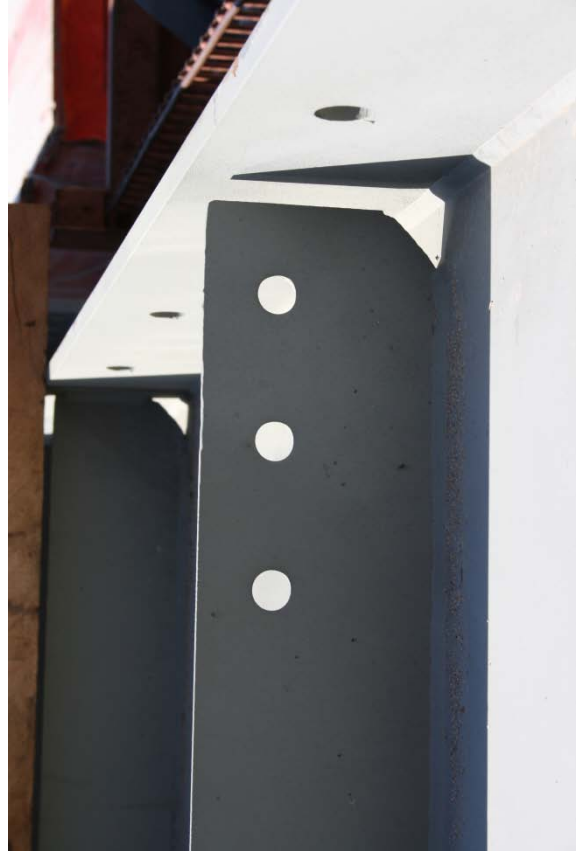
Fig. 2. View of web gap region in segment of test girder intended to develop fatigue failure

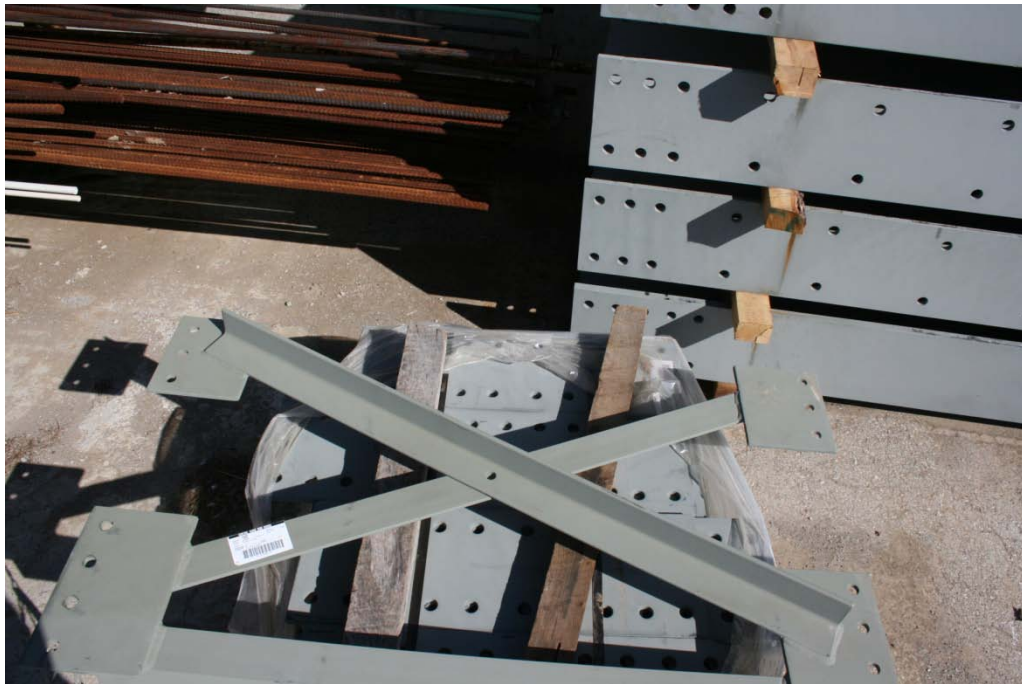
Fig. 3. View of one of the typical cross-frames to be used in the bridge test set-up

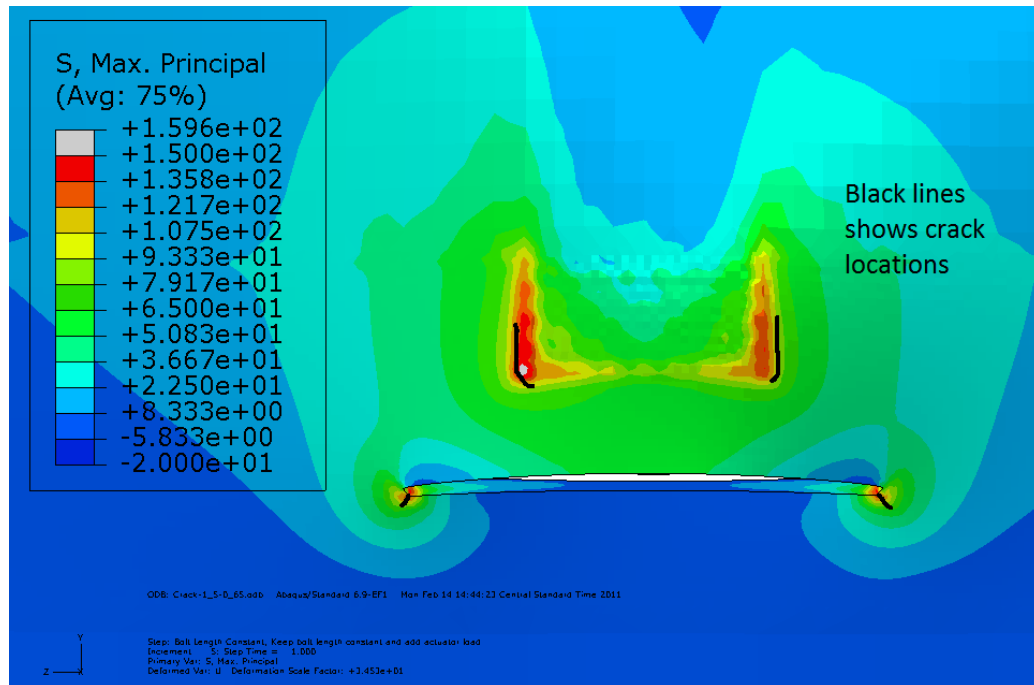
Fig. 5. Finite element model predictions of maximum principal stress in the web gap region of the 9 ft. specimen test set-up. Crack diagrams from the physical test have been superimposed in black on the model screenshot.

Fig. 5 shows a view of the finite element model for the 9 ft. specimens zoomed into the web gap region (the connection stiffener and flange have been removed from view). The prefabricated "starter" crack can be seen towards the bottom of the figure. Crack locations have been superimposed on the screenshot, and correlate to the state of cracking after 200,000 fatigue cycles. There are two items in particular to note: (1) the FE results hot spot stress locations correlated extremely well with the locations of physical crack initiation and growth observed in the experimental tests; and (2) even with a "starter" crack in the web gap region, cracking still initiated in the connection stiffener welds. The stiffener-to-web weld cracks propagated quite quickly, and therefore, subsequent tests were performed without an initial, pre-fabricated crack.
