**EVALUATION OF NON-INTRUSIVE TECHNOLOGIES
FOR TRAFFIC DETECTION
TPF-5[171]**

FINAL REPORT

United States Department of Transportation
Federal Highway Administration

Minnesota Department of Transportation
Office of Traffic, Safety and Technology
1500 W Co Rd B2
Mailstop 725
Roseville, MN 55113
(651) 234-7054

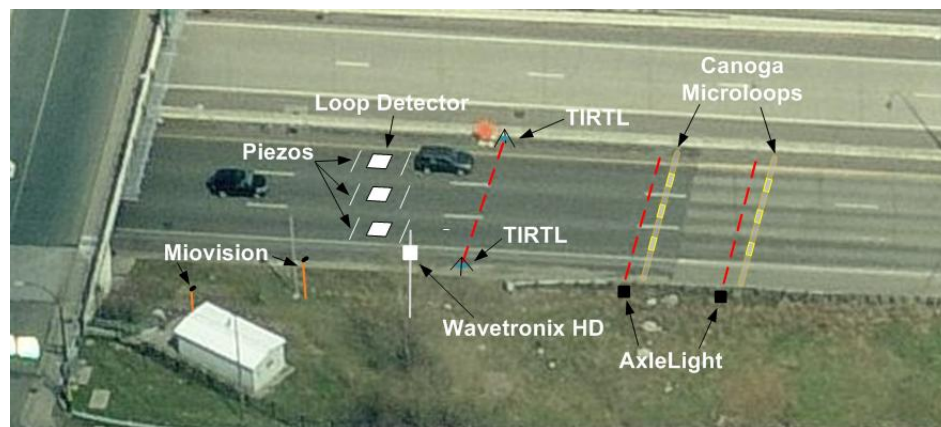
Figure 2. NIT Test Site Showing Approximate Sensor Locations

The freeway test site features a variety of side mounting locations. The active infrared devices were mounted on a guard rail on a base as recommended by the manufacturer. All other devices were mounted on sidefire poles or railings. Mounting heights ranged from 10 to 40 feet. One pole is approximately 19 feet from the edge of the closest travelled lane. Another pole was installed 30 feet from the nearest travelled lane.

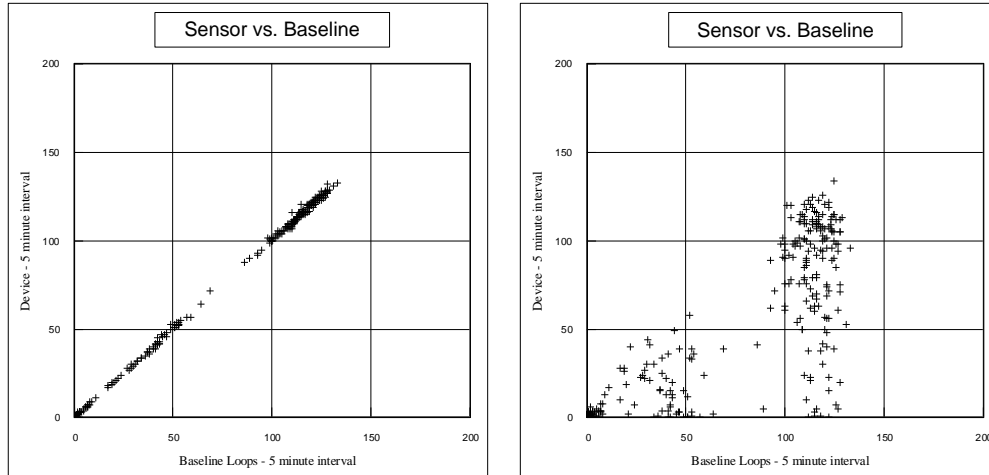
Figure 6. Examples of Volume Scatter Plots

Scatter plots show the relationship between two sets of numbers as one series of x-y coordinates. Each point on a scatter plot represents traffic data for a given sampling interval (i.e., 15 minutes) as measured by the baseline on the horizontal axis and the sensor on the vertical axis. Data points falling on a linear 45-degree line represent perfect agreement between the two compared data sets. This approach provides a straightforward visual representation of variation between each sensor and the baseline data. Figure 6 provides examples of volume scatter plots. The one on the left shows that the sensor correlates closely with the baseline data. The one on the right has some problems with undercounting vehicles.

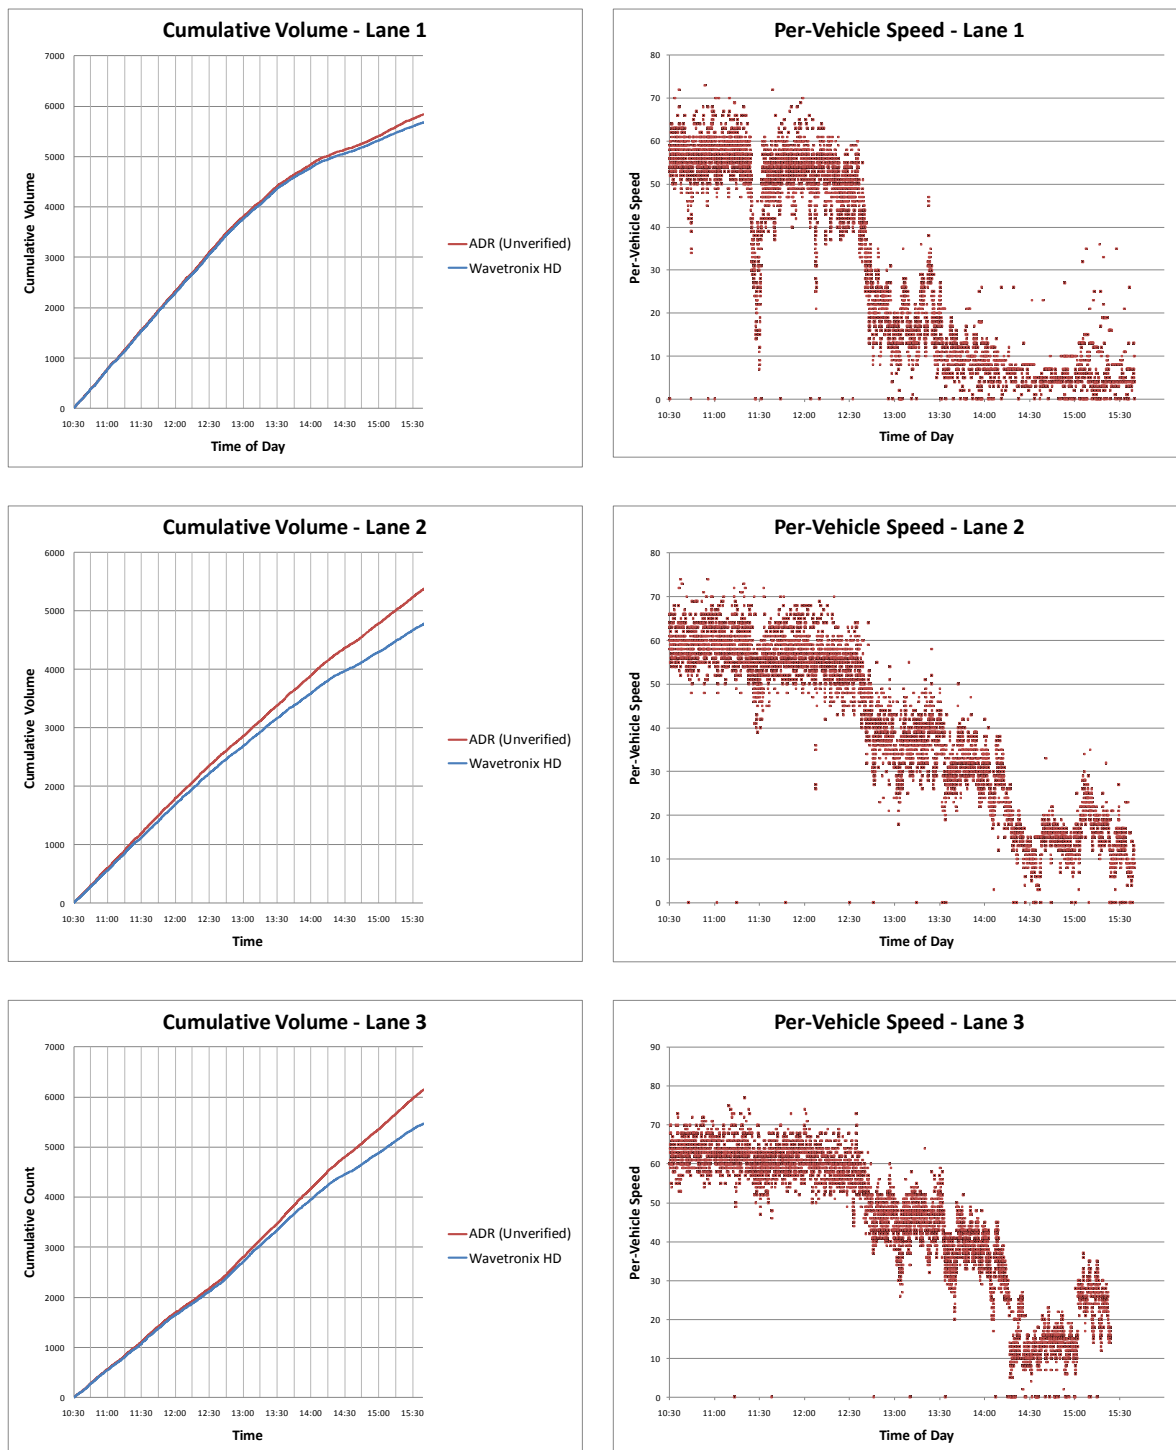
Figure 7 illustrates the effect slow traffic in the first lane has on adjacent lane volume accuracy. While Lane 1 volumes are consistently accurate, even when speeds drop, Lane 2 and Lane 3 volumes drop off due to occlusion from Lane 1. From 14:30 to 15:30, the sensor missed 20.0 percent of the vehicles in Lane 2 and 22.6 percent of vehicles in Lane 3. During the same period of slow moving traffic, it only undercounted 12.2 percent of vehicles in Lane 1. During this period, vehicles in Lane 1 were travelling 0-10 miles per hour.

Figure 7. Wavetronix SmartSensor HD data captured on December 8, 2009
Traffic was unusually slow due to light snow conditions. Traffic undercounting in Lanes 2-3 (far two lanes) is attributed to occlusion from Lane 1 (lane nearest sensor).

After reviewing these findings with the vendor, it was learned that the Wavetronix SmartSensor HD has a built-in method to mitigate the negative effects of occlusion by scaling up volume when certain traffic flow characteristics are met. Thus, for example, when vehicles in the lane closest to the sensor have low speeds, traffic volumes in the occluded lanes are scaled up to adjust for vehicles the sensor does not detect. This feature has not yet been evaluated, but may be examined in future test activities.

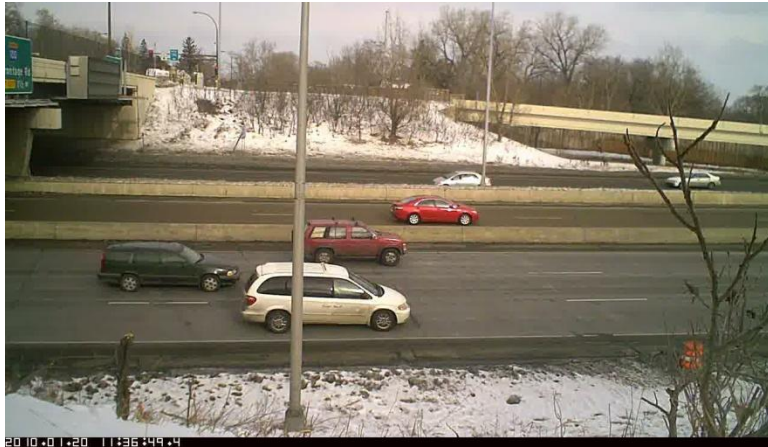
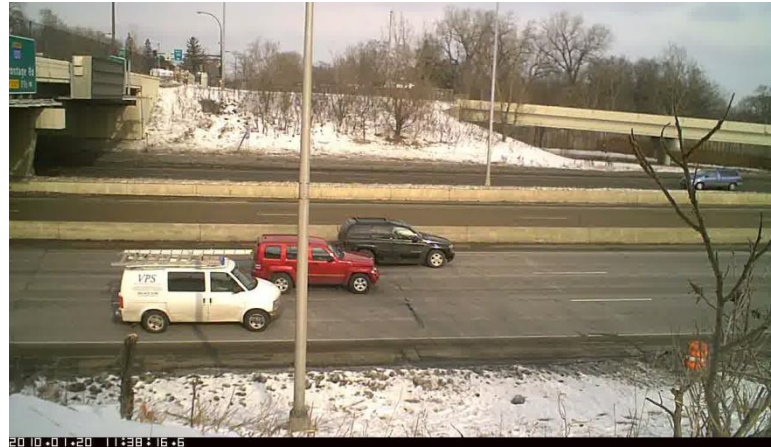
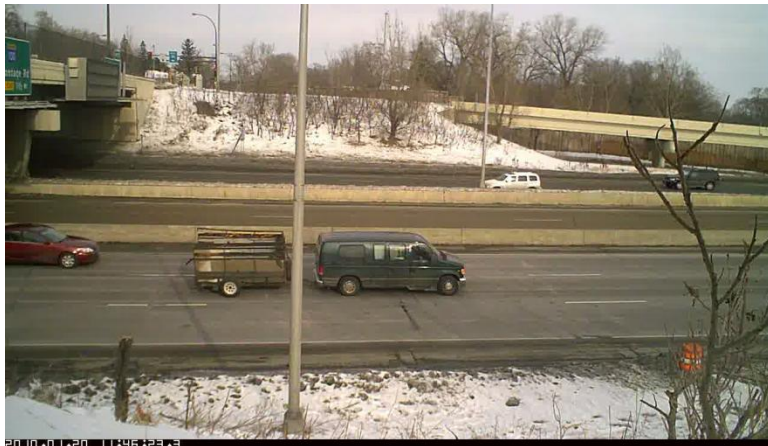
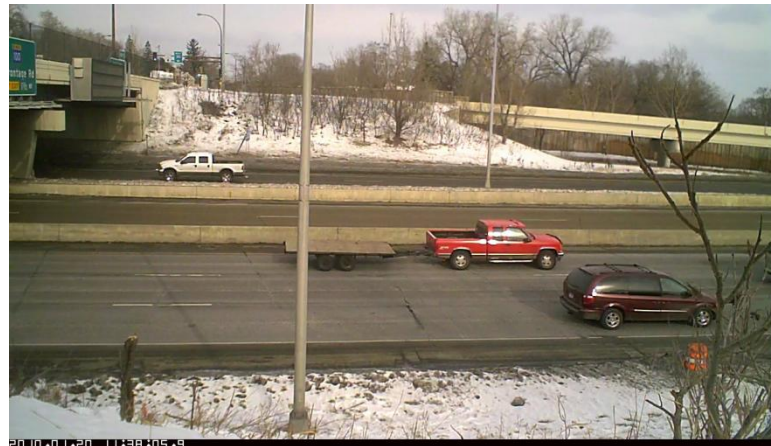
Figure 8. Sample Wavetronix SmartSensor HD misclassifications.

Another source of error was when trucks were hauling a trailer. The Wavetronix SmartSensor HD generally does not detect a trailer as being separate from the primary vehicle. In this case, the sensor is accurately reporting the entire length of the vehicle/trailer combination. However, depending on how the data is used, it is often important to differentiate trucks from passenger vehicles. Even when hauling a trailer, the passenger vehicle does not load the pavement as significantly as a truck and some agencies would want to separate these vehicles from trucks. Figure 8 shows examples of passenger vehicles that were detected as long trucks. A summary of

SUV in Lane 3 (far lane) detected as a 25 foot vehicle.

SUV in Lane 3 (far lane) detected as a 24-foot vehicle.

Van in Lane 2 pulling a trailer that was classified as a truck.

Pickup truck in Lane 3 hauling a trailer that was detected as a large truck.

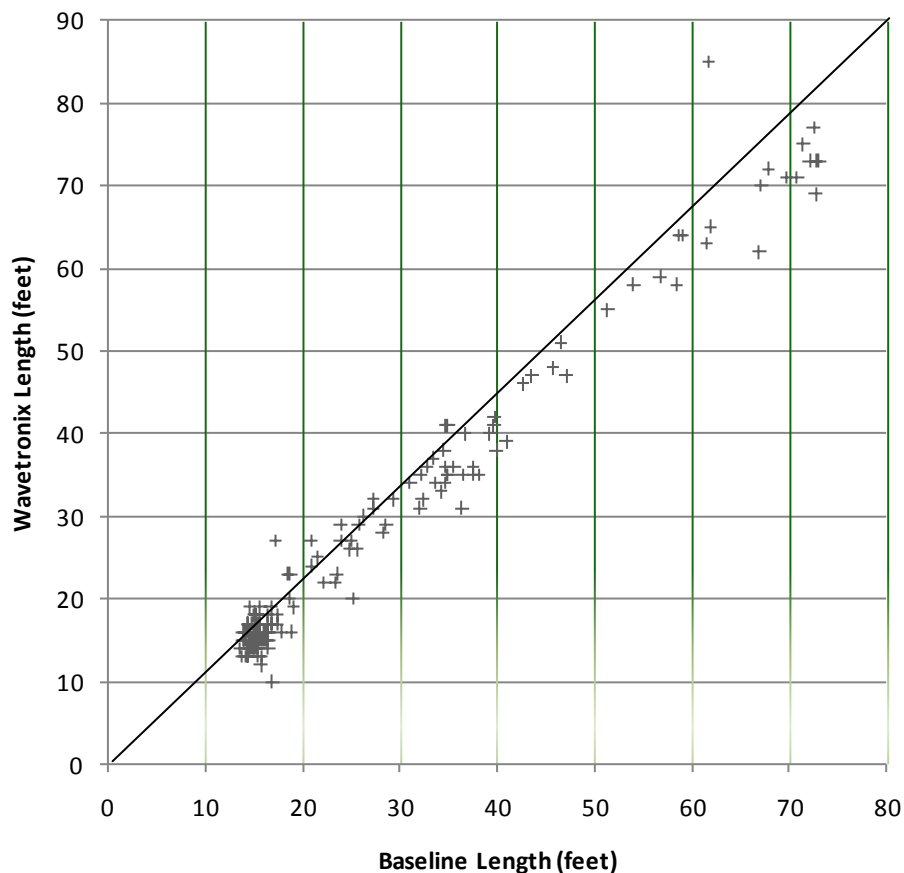
Figure 9. Baseline Length Compared to Wavetronix SmartSensor HD Length

In contrast to the axle-based classification, a test was run to compare Wavetronix SmartSensor HD length data to manually-measured vehicle lengths. This test was only conducted during free-flow traffic. This analysis disregards the type of vehicle and instead simply compares the length of the vehicle. It was found that for most vehicles, the Wavetronix SmartSensor HD reported a very accurate length. One outlier was a large Class 9 truck that the Wavetronix SmartSensor HD reported was 85 feet long due to grouping the truck (in the middle lane) with a passenger vehicle in the near lane, see Figure 9 with a following car in Lane 1. The Wavetronix records show that this vehicle did not appear on the Wavetronix PVR. As shown in the data, these cases were few. Because passenger vehicles tend to be similar sizes, emphasis was placed on manually observing additional trucks to develop a more even distribution of vehicle lengths.

The average error among passenger vehicles was 0.6 feet with an absolute average error of 1.6 feet. The average error for trucks was 1.7 feet with an absolute average error of 2.8 feet. These findings demonstrate that the Wavetronix can accurately determine vehicle length in free-flow traffic. The most significant error with length measurement is shown in Figure 10. The “outlier” point in Figure 9 (Wavetronix SmartSensor HD recorded it as an 85-foot long truck).

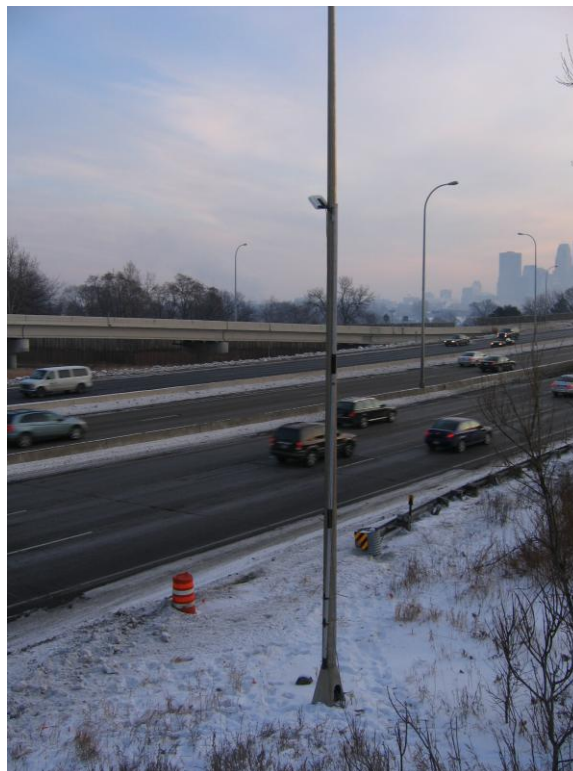
Figure 11. Wavetronix SmartSensor HD Mounted on Lighting Pole at NIT Test Site

The Wavetronix SmartSensor HD has a relatively simple setup procedure. For the testing, the sensor was mounted at the recommended height of 28 feet at a 30-foot offset. This height was too high for an installer to install with a ladder, so the PNITDS (Portable Non-Intrusive Traffic Detection System) system was used. This system is a series of aluminum poles that can be attached at the bottom of an in-place pole and tipped up against the pole. To reach a height of 28 feet, three 8-foot poles were used in addition to the pole being mounted on a gradual slope. The PNITDS pole was secured with hose clamps. The installation is shown in Figure 11.

Because the sensor was mounted for a semi-permanent installation so that it could record continuous data, power and communications were connected from the sensor to the shelter at the NIT Test Site. From the sensor, a multiconductor cable was run to the base of the pole. At the base, the cable was terminated on a lightning protection module within a polycarbonate base. Both serial and power were run from the base of the pole into the shelter with a 4-conductor cable. The other end of the cable was terminated on a lightning protection module in the shelter. A 9-pin RS-232 cable connected the computer to the module and 120V AC power was connected to the power supply. The entire run was about 150 feet.

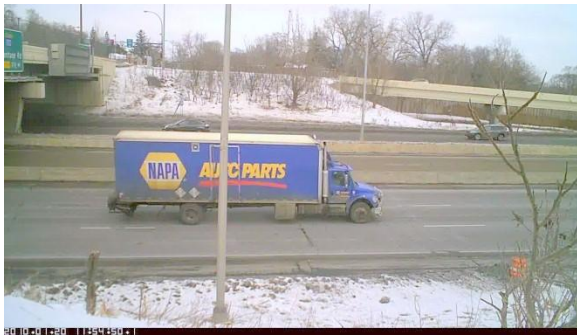
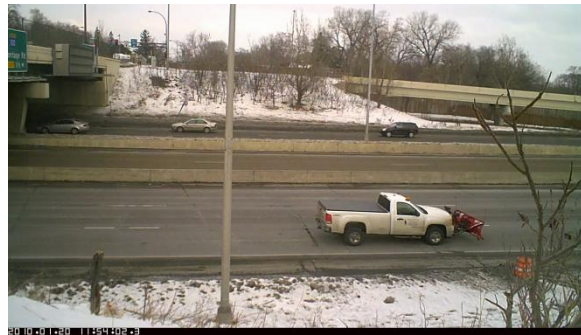
Figure 12. Sample GTT Microloop Misclassifications

Small Class 5 truck classified as PV by the GTT Canoga Microloops.

Class 6 truck classified as PV by the GTT Canoga Microloops.

Long Class 5 truck classified as a MU Truck by the GTT Canoga Microloops.

Class 3 pickup truck classified as a SU Truck by the GTT Canoga Microloops because of the plow mounted on the front of the truck.

Tailgating passenger cars classified as a MU truck.

Tailgating passenger cars classified as a MU truck (Lane 1).

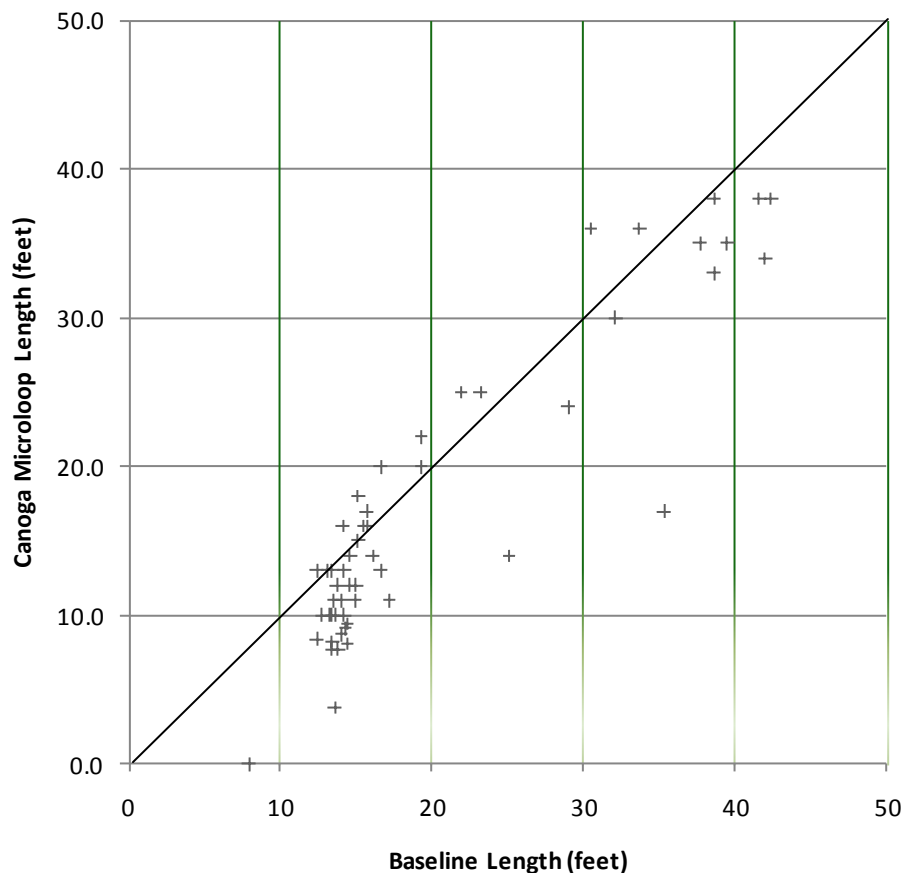
Figure 13. Comparison of Baseline Length to Canoga Microloops

In contrast to the axle-based classification, a test was run to determine how close the Canoga Microloops would report to manually measured vehicle lengths. This test was only conducted during free-flow traffic. This analysis disregards the type of vehicle and instead simply compares the length of the vehicle. Because passenger vehicles tend to be similar sizes, additional trucks were examined to develop a more even distribution of vehicle lengths. Figure 13 shows a graphical representation of the baseline and sensor length comparison.

The average error among passenger vehicles was -3.1 feet with an absolute average error of 3.7 feet. The average error for trucks was -2.0 feet with an absolute average error of 4.0 feet. The Canoga Microloops were reasonably accurate among a wide varied of different vehicle sizes, but there was significantly more variation when compared to the Wavetronix SmartSensor HD sensor. It is interesting to note that although there is a relatively tight distribution of passenger vehicles, the Canoga Microloops reported a rather large distribution of these vehicles. There were also some obvious outliers where the sensor vastly underreported vehicle length. A few examples are shown in Figure 14.

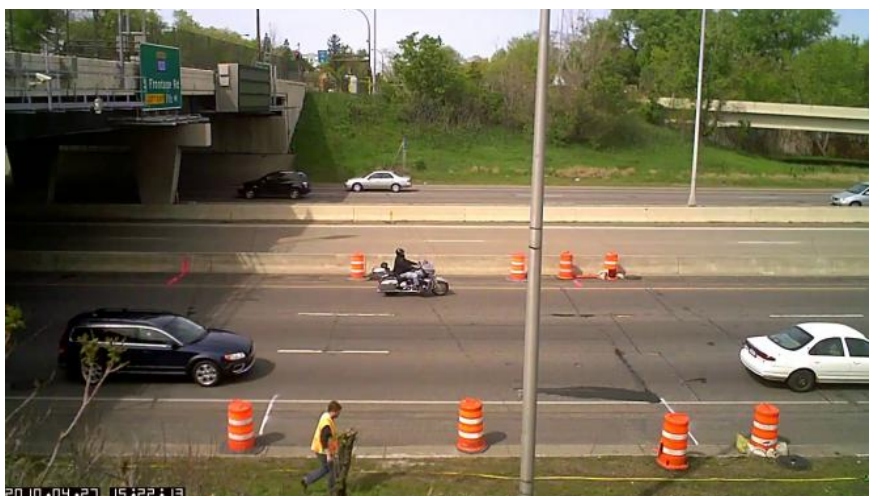
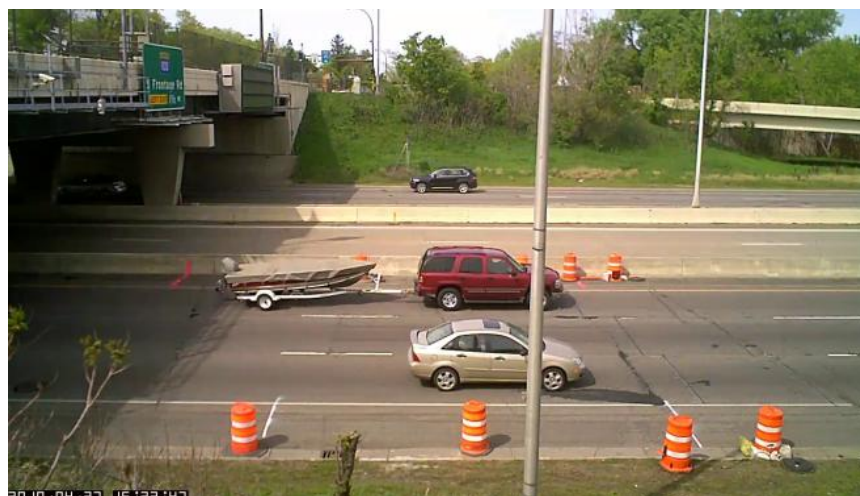
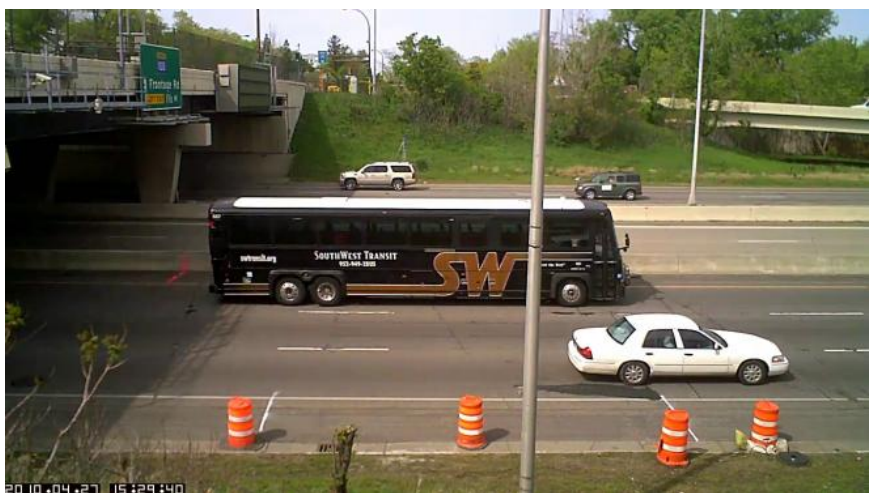
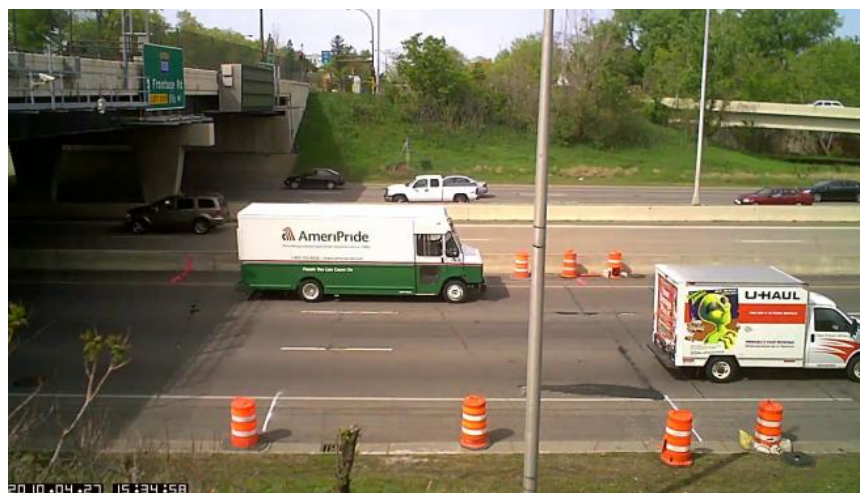
Figure 14. Selected Vehicles That Canoga Microloops Measured Length Less Than Actual Length

7.9-foot motorcycle measured at 0 feet long by Canoga Microloops.

35.3-foot SUV pulling trailer measured at 17 feet long by Canoga Microloops.

42-foot bus measured at 34 feet long by Canoga Microloops.

25.1 foot truck measured at 14 feet long by Canoga Microloops

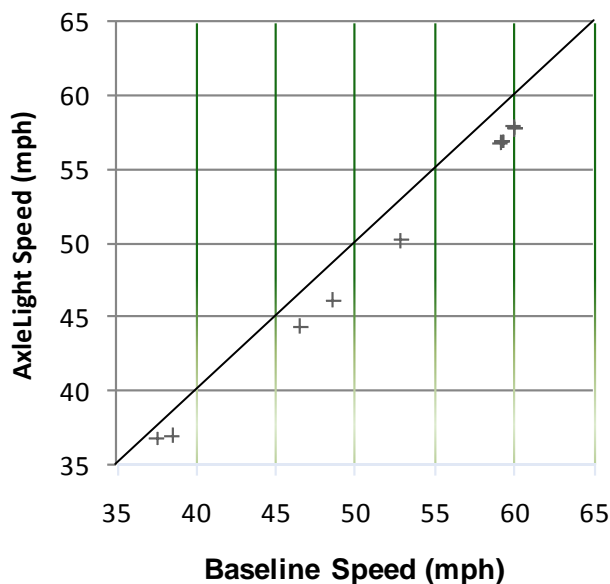
Figure 15. Baseline Speed vs. AxleLight Speed, Average Speed for 15 Minute Intervals

The PEEK AxleLight demonstrated very consistent speed data at a wide range of average speeds in 15 minute intervals. The graph in Figure 15 shows that the AxleLight consistently underreported speeds for the test examined. Note that the axes start at 35 mph and go to 65 mph. One caveat to this data is that the sensor was placed downstream of the baseline and it is possible that vehicles slow as they begin to climb the hill. The speed trap method that the sensor uses to determine vehicle speed should produce accurate results, but some unknown parameter caused it to underreport the data. The sensor spacing (distance from sensor to sensor) was set at 12.5 feet. This value was entered into the ADR 1000 during configuration. This error indicates that the sensors were about 4 percent farther apart than configured or about 1/2 foot.

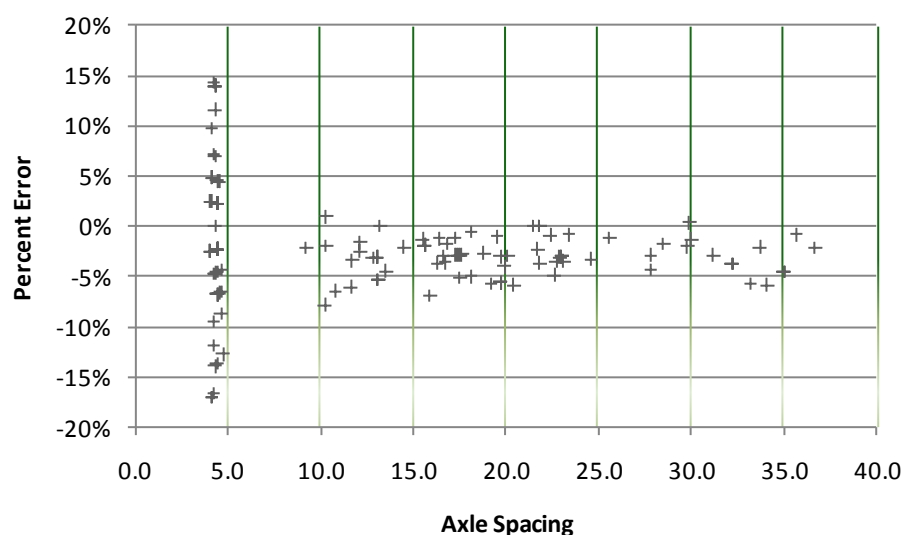
Figure 16. Percent Error of AxleLight at Various Axle Spacings

Axle-based sensor performance is based on detecting axle spacings. The axle spacings from individual PVR for several trucks were compared to the PLP baseline. This showed that the trend was toward the axle spacings being within 0 to 5 percent error for a wide range of axle spacings. However, there was significantly more variability with the detected axle spacings of a truck's tandem axles. This is due in large part to the smaller spacings leading to small errors being reflected as larger percent errors. Also, the resolution of the reported data was to the nearest tenth of a foot which explains the clusters of data points lower than 5.0 feet. Figure 16 shows the percent error for various axle spacings of selected trucks. Note that there is a wide distribution in percent error of axle spacings lower than 5 feet (tandem axles).

The key finding is that the sensor is capable of determining accurate axle spacings and making accurate classifications. For trucks that fit the classification scheme, the sensor generally classifies them correctly. However, a few complicating factors make the classification performance suboptimal. As explained in the description of AxleLight volume performance, tailgating vehicles with under 45-foot spacing are grouped. This causes trucks to be overrepresented and passenger vehicles to be underrepresented in the classification count. The impact on the passenger vehicle count is less significant than the truck counts because the number of these errors is small in comparison to the total correct classifications. However, the AxleLight recorded 152 6+ axle vehicles within the span of three hours where the baseline recorded only eight. These were misclassifications due to grouping.

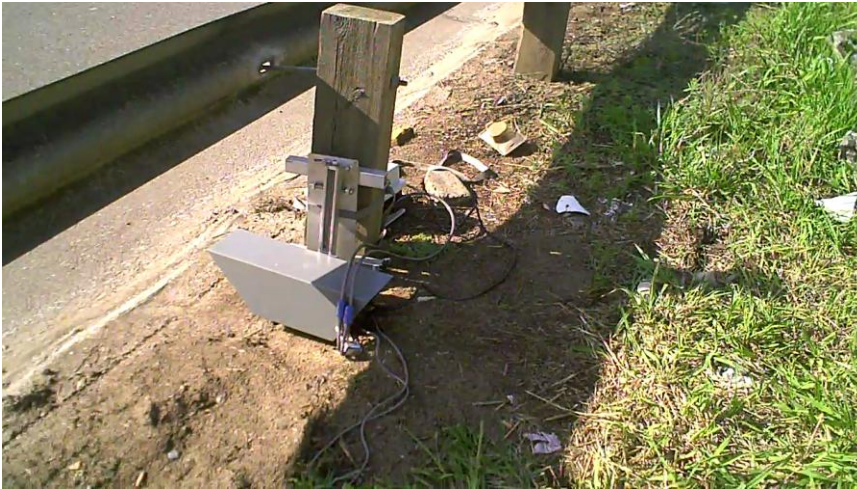
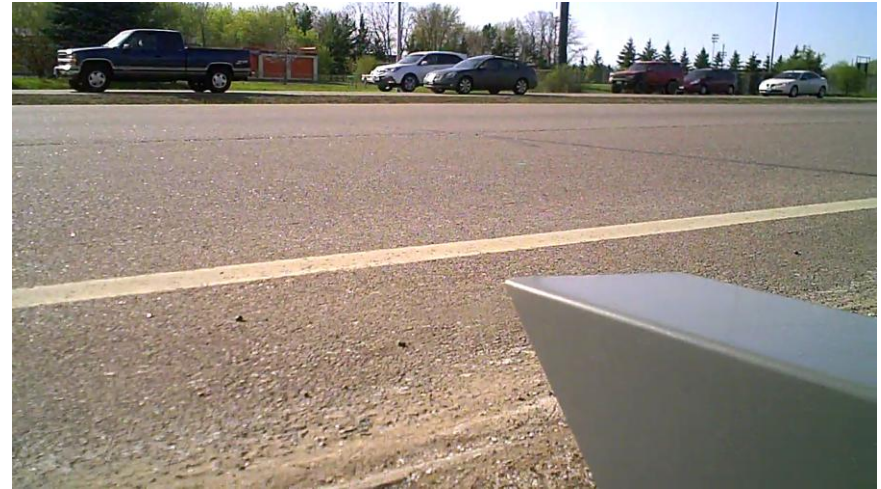
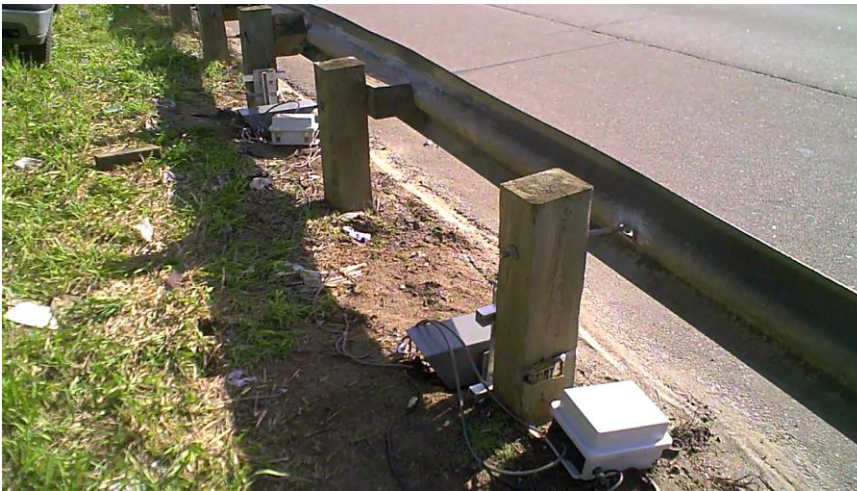
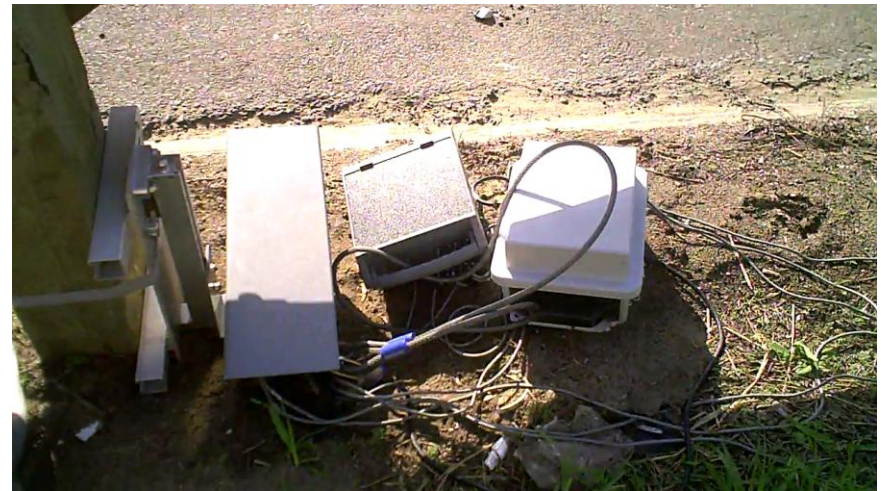
AxleLight mounted to guard rail at TH 52 Test Site.

View from AxleLight sensor.

Two AxleLight sensors set up in a speed trap configuration.

AxleLight, PEEK ADR 1000 and battery module.

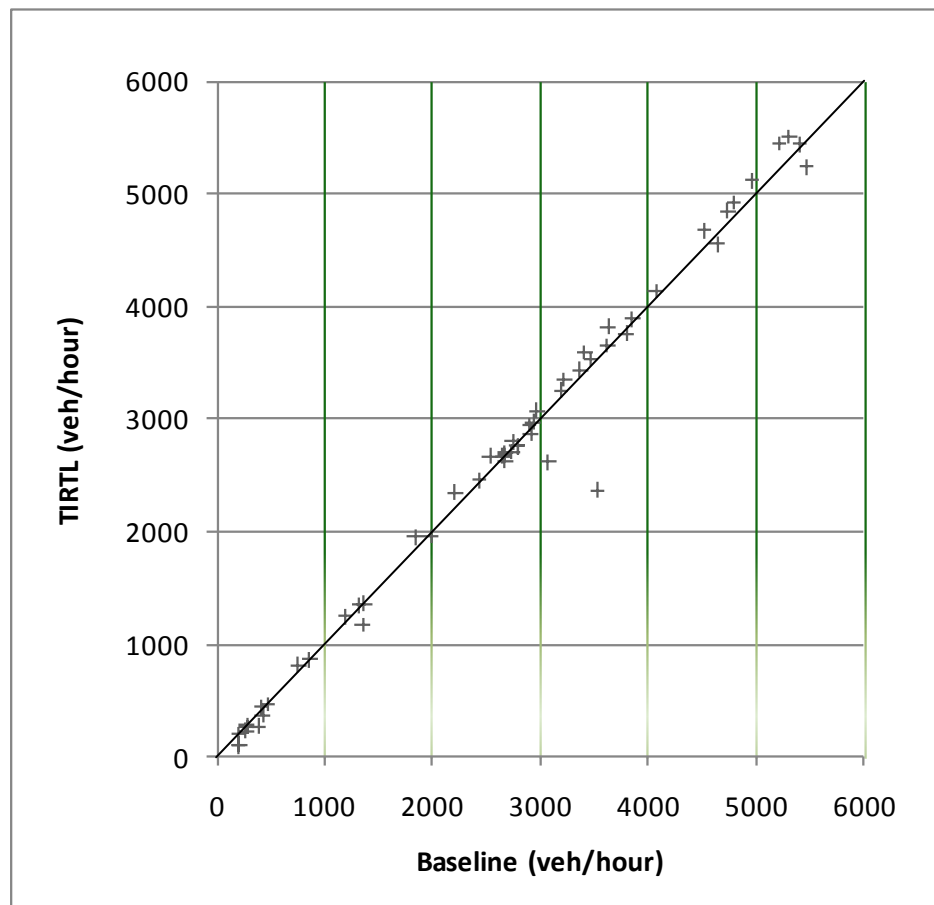
The TIRTL performed consistently in volume data collection, but at slow speeds, and especially if the sensor is covering several lanes, there is a possibility that vehicles with large wheels will occlude other lanes. The scatter plot in Figure 18 shows that across many volume levels, the sensor generally accurately reports volume. Among the entire test duration, sensor undercounting and overcounting balanced to give a final percent error of 0.4 percent. There was a general trend of overcounting with a median overcount of 2 percent per hour period. A few periods of undercounting balanced this overcounting, but no specific cause of this undercounting could be identified. The periods were from 1:00 pm to 3:00 pm and 12:00 am to 6:00 am. No environmental cause could be linked to these times. All percent error for other time periods were within one standard deviation. The system has an alarm system that could be used to diagnose volume issues in future deployments. The finding from this test was that the TIRTL generally reports volume within 2 percent of the baseline, but a few outliers of unknown cause produced errors.

**Figure 18. Baseline Compared to TIRTL Volume
All Lanes, LOS A-B, TH 52 Test Site**

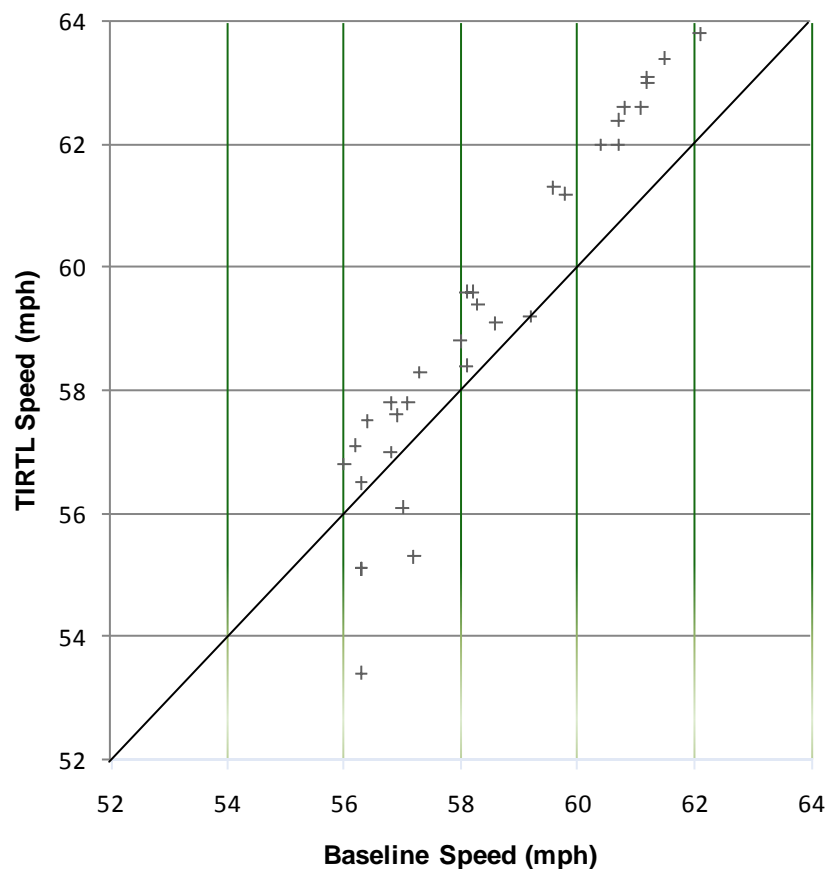
Figure 19. Baseline Speed vs. TIRTL Speed, Average Speed for 15 Minute Intervals

At both free-flow and speeds, the TIRTL is capable of measuring accurate speeds. Average speeds for 15 minute intervals were compared to baseline speeds measured by the TH 52 WIM site. The comparison of these aggregate speeds are shown in Figure 19. Note that the axes in this graph are centered around the average free flow speeds. The average error throughout the entire tested period was 0.7 mph higher than the baseline speed. The absolute average error was found to be 1.2 mph. This shows that the TIRTL can consistently report accurate speed in free flow traffic. The manufacturer claims that TIRTL can provide accurate data at speeds as low as 5 mph.

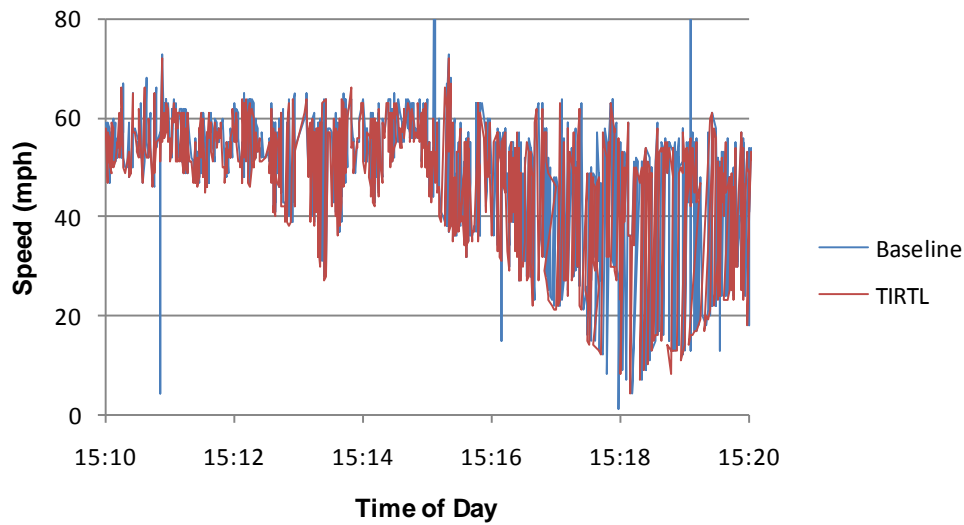
Figure 20. Comparison of Baseline Speed to TIRTL Speed, Congested Traffic All Lanes at the NIT Test Site

A separate test was done to determine how well the TIRTL matched the baseline speeds at the NIT Test Site in congested traffic. The graph in Figure 20 shows that the TIRTL speed matched the baseline speed well in both free flow and congested traffic conditions. Note that the baseline data (shown in blue) has some outlier points that are shown in the graph (spikes with high or low values). These points are where the baseline inaccurately measured a vehicle due to multiple vehicles being over the sensors. The TIRTL sensor had fewer of these types of errors than the baseline presumably because it does not use a traditional speed trap method to determine vehicle speeds.

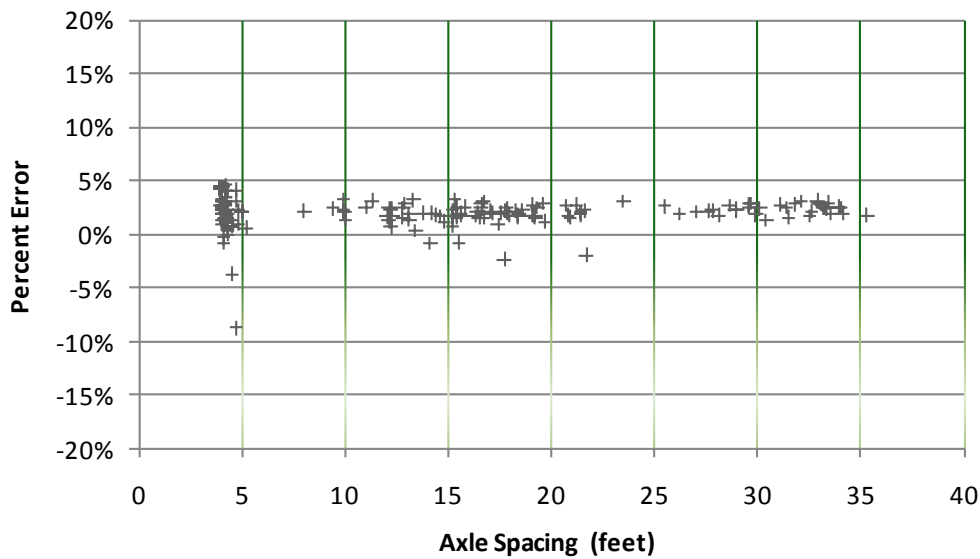
Figure 21. TIRTL Axle Spacing Percent Error

The sensor reported axle spacings within about 2 percent of the actual axle spacing measured by the baseline. This performance did not vary significantly across various axle spacing lengths. The measurements were taken on large trucks passing at free flow speeds. Figure 21 shows the distribution of axle spacing percent error. Table 19 shows a summary of the percent error.

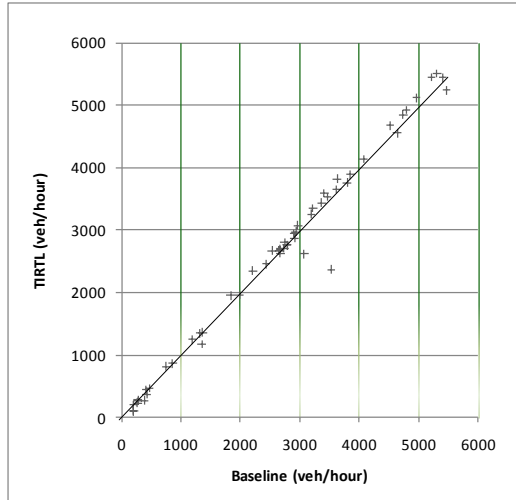
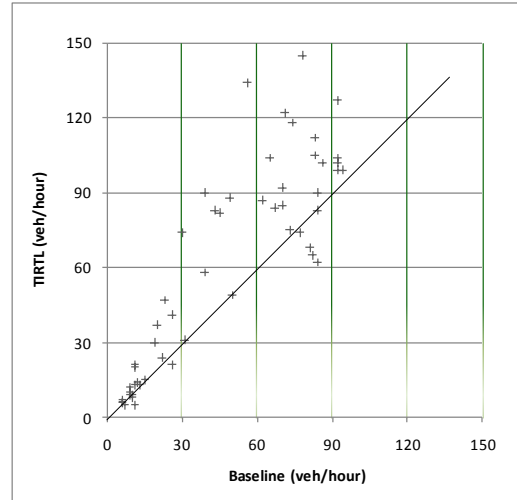
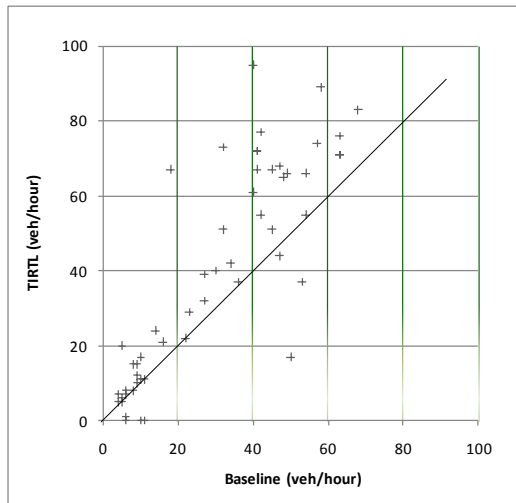
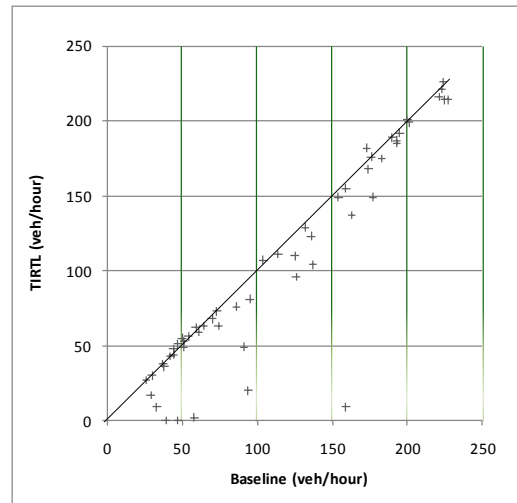
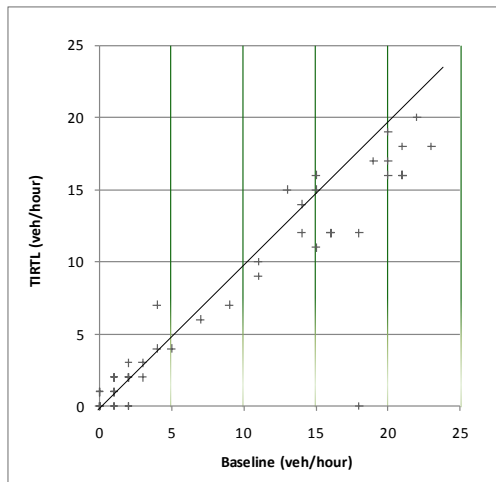
2-axle vehicles. $r^2=0.985$.

3-axle vehicles. $r^2=0.767$.

4-axle vehicles. $r^2=0.734$.

5-axle vehicles. $r^2=0.871$.

6+ axle vehicles. $r^2=0.872$.

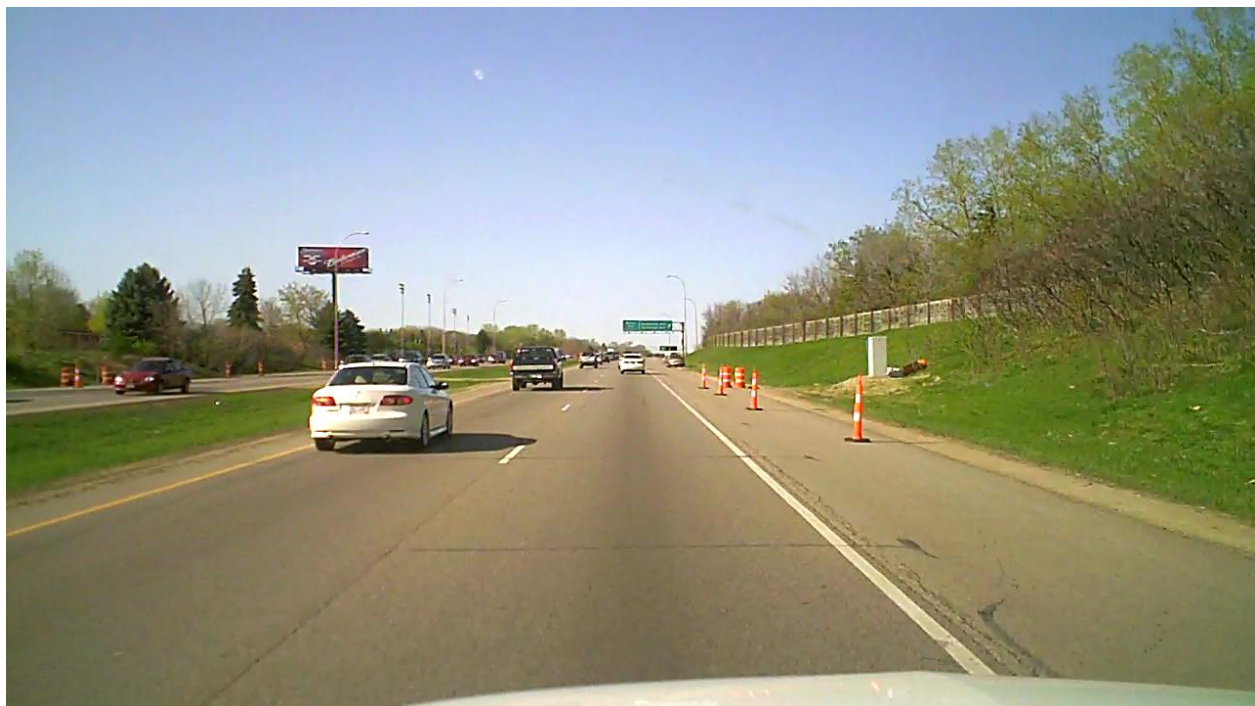
Figure 23. Traffic Control for TIRTL Mounted on the Roadway Shoulder

Because the TIRTL system was used in temporary deployments, traffic delineators and barrels were used to house the system, provide some traffic control and protect the sensors from traffic. At the TH 52 Test Site, a series of five delineator cones were set on each side to taper the

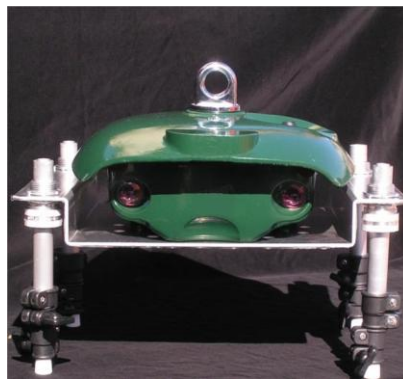
Figure 25. TIRTL Base

Setup of the traffic control equipment took approximately 30 minutes with another 20 to 30 minutes to take the traffic control equipment and sensor down after testing. Figures 24 and 25 show the traffic barrel and TIRTL base.

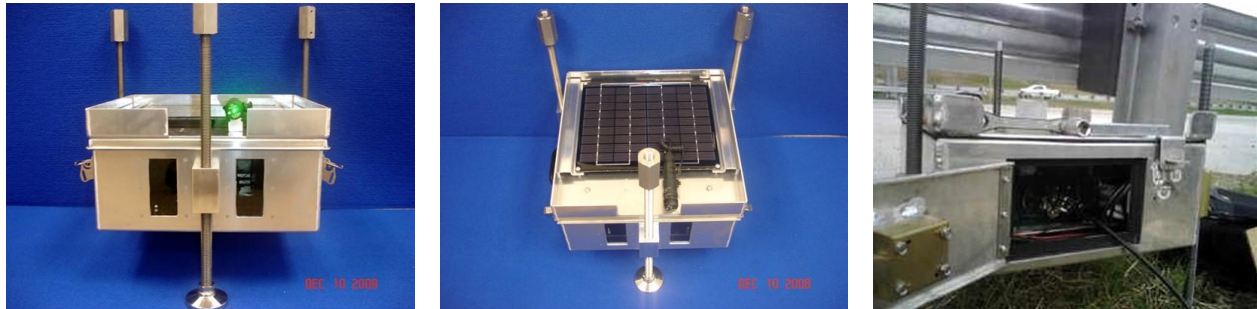
Figure 27. TIRTL with Portable Enclosure

Figure 27. This system uses two 12-volt rechargeable batteries which are charged with a 12-watt solar panel integrated with the cabinet. The threaded legs can be cut to specified length. The threads allow for fine adjustments to the height and tilt. The visible green laser recommended for sensor aiming is shown in the leftmost image.

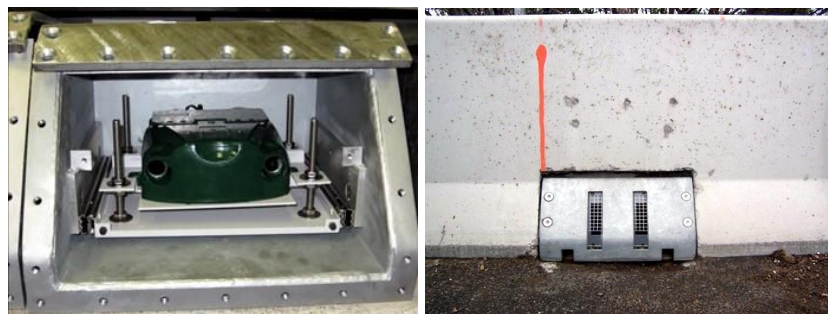
Figure 28. Barrier-Mounted TIRTL Sensors (Permanent Installation)

During the course of the project, two solutions for permanent or semi-permanent were suggested. The first was to mount the TIRTL in a small cabinet placed on the side of the road. This cabinet protects the TIRTL and could provide additional capacity for batteries. These cabinets should be installed outside the clear zone or otherwise be protected. The TIRTL vendor supplied photos of other permanent installations of both barrier-mounted units (Figure 28) and roadside mount units (Figure 29).

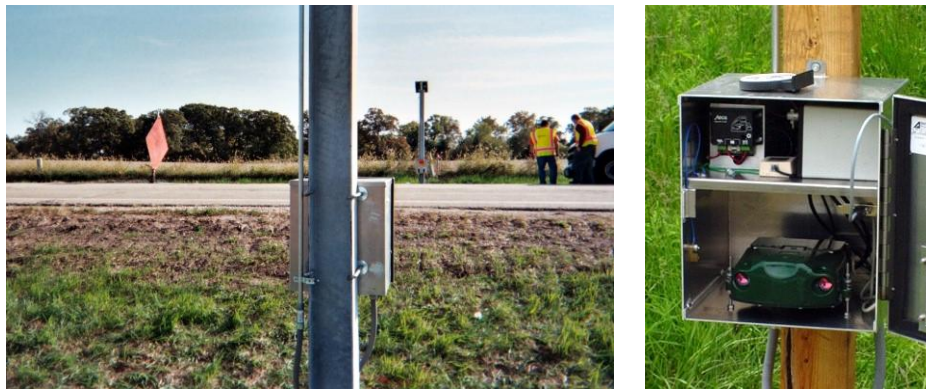
Figure 30. TIRTL Pole Mount Examples (Permanent Installation)

Another suggested method is to mount the sensors to poles located outside the roadway as shown in Figure 30. It is reported that a pole-mount configuration has worked for Illinois DOT, although it was not tested for this project.

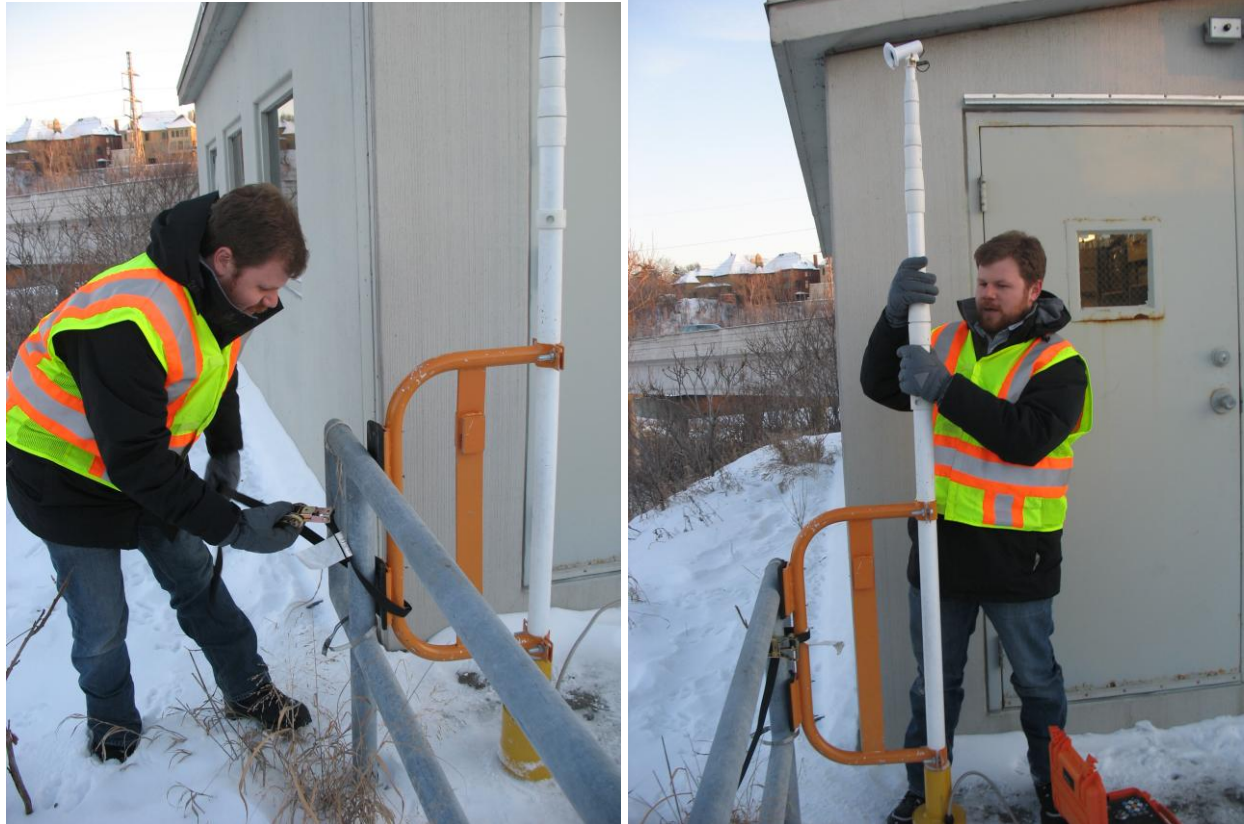
Figure 34. Miovision Setup at NIT Test Site (Railing Mount)

The telescoping mast is attached to the pole mount. The pole mount and mast assembly can be mounted on various types of poles or similar structures with tie straps. Rubber pads on the two places the pole mount contacts the pole protect the pole from scratching the pole. However, care must be taken to not scratch a painted pole with the tie strap clasp. Images of the pole mount system being installed are shown in Figure 34.
