**EVALUATION OF NON-INTRUSIVE TECHNOLOGIES
FOR TRAFFIC DETECTION
TPF-5[171]**

FINAL REPORT

United States Department of Transportation
Federal Highway Administration

Minnesota Department of Transportation
Office of Traffic, Safety and Technology
1500 W Co Rd B2
Mailstop 725
Roseville, MN 55113
(651) 234-7054

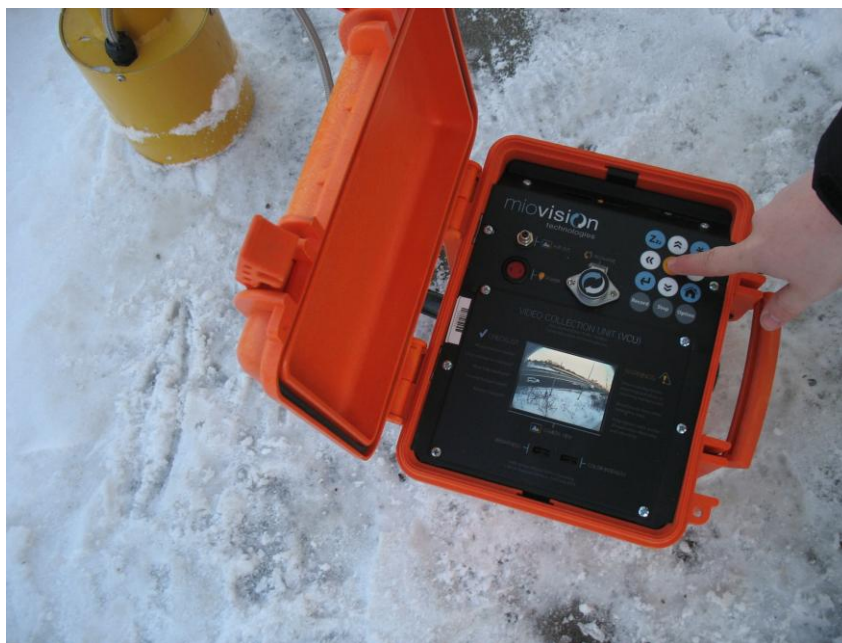
Figure 35. Miovision VCU with Video Display

The physical setup of the sensor is relatively easy with some practice. It is easy to elevate the camera into position once the pole mount is securely mounted to the pole. Rotating the camera into place is easy to do and the camera view can be seen on the VCU. It is important to adjust the camera so that it can see all relevant lanes. On a large intersection, this can be difficult. For example, on the turning movement count at TH 7 and Louisiana Ave, Miovision recommended that two units be used to cover all movements. Because only one unit was available for this test, the sensor was set up to collect as many movements as possible and was able to observe ten of twelve movements.

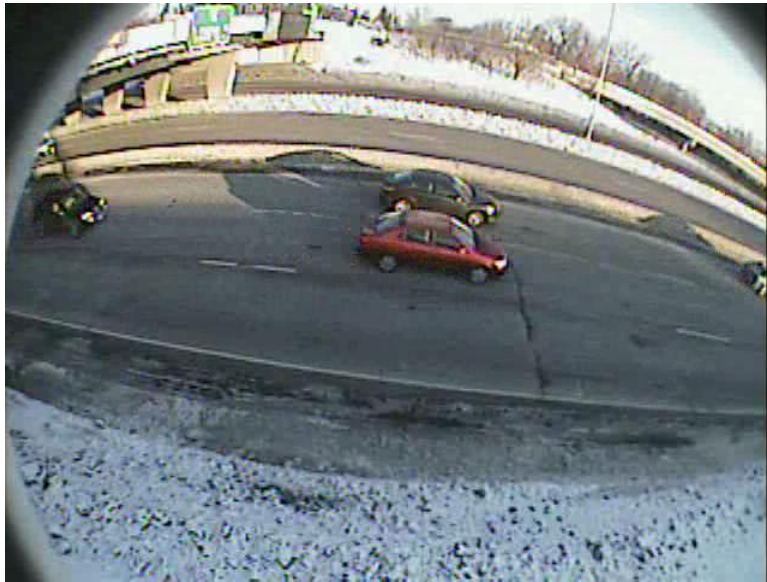
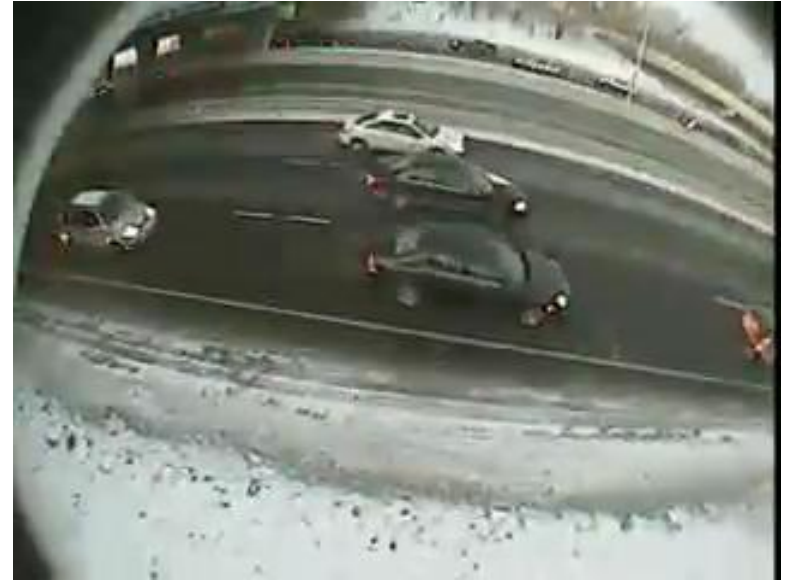
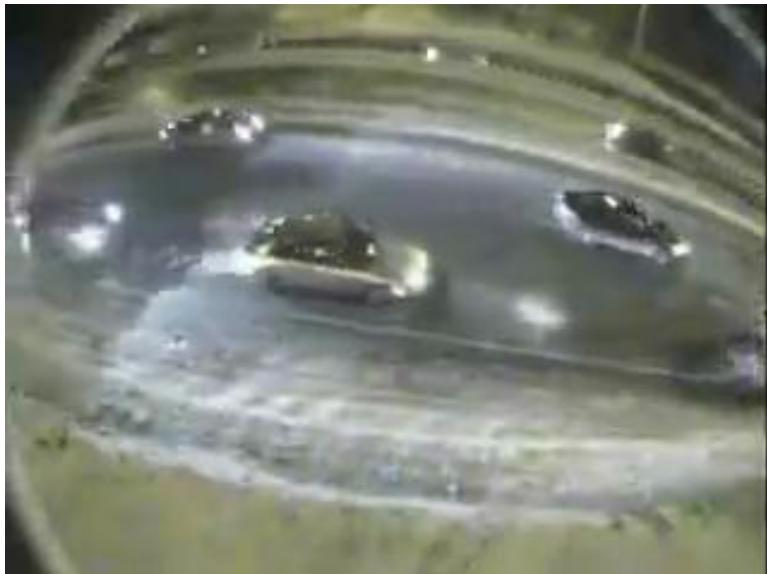
Also, the website organizes and stores the traffic data and supports downloading in a variety of standard formats. Miovision gives a rating to each installation. In Figure 37 (top), the sensor was mounted far from the roadway and Miovision gave the feedback that the sensor should be mounted within 20 feet of the roadway. As shown the bottom images of Figure 37, the setup on the lighting pole near the roadway was given a perfect score.

Daytime, High Resolution

Daytime, Downloadable Resolution

Nighttime, Downloadable Resolution
