**Midwest States Pooled Fund Program
Quarterly Progress Report – First Quarter 2011
June 15, 2011**

Project No.: RPPF-07-01 – SPR-3(017) Supplement #38
Project Title: Cost-Effective Upgrading of Existing Guardrail Systems
Starting Date: February 26, 2007
Completion Date: December 31, 2012
Principal Investigator: Reid, Rohde, Sicking, Faller
Co-PIs & Team Members: Lechtenberg, Rosenbaugh
Author: K. Lechtenberg

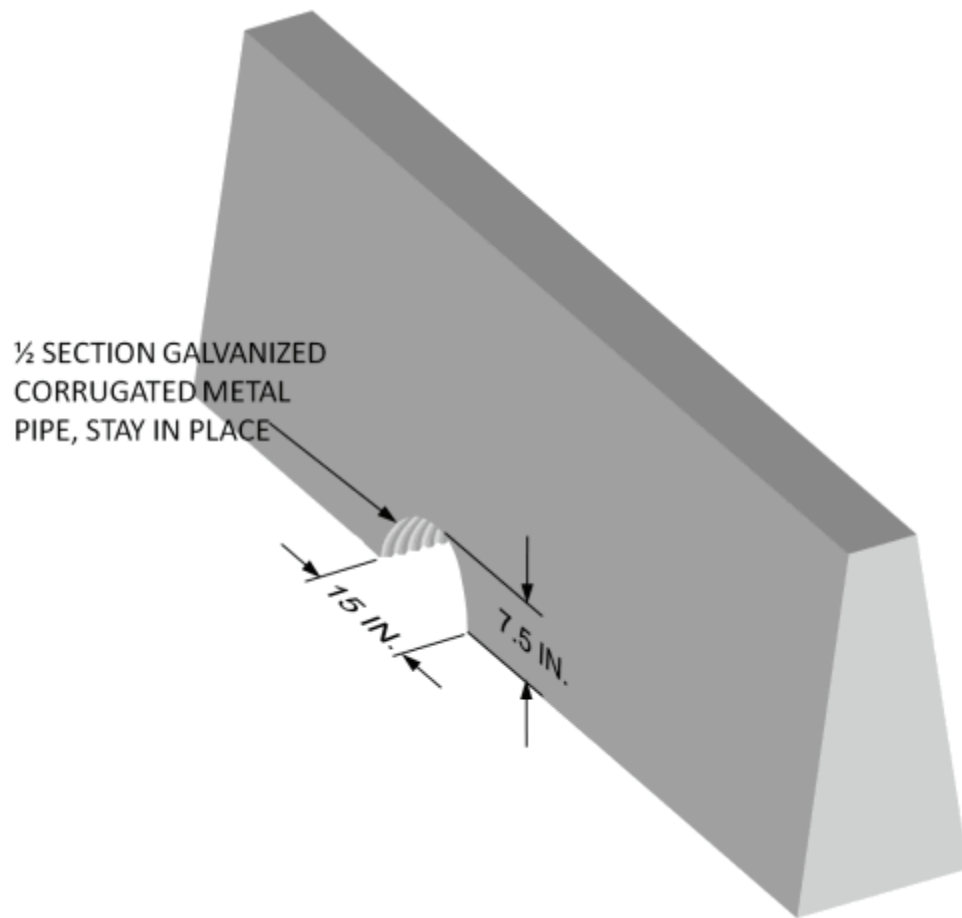
Figure 1. Wildlife Crossing Holes in Barrier

In general, it would be my first impression that the size of the half hole (i.e., 15 in. diameter by 7.5 in. tall) through the barrier would not significantly degrade barrier performance as long as the vertical steel anchorage could be placed at its normal locations adjacent to the opening, adequate longitudinal steel is provided, and as long as the small car's front wheel does not negatively

interact with the downstream side of the opening. Small cars have wheel center heights ranging from 10 to 12 in. As such, it would be necessary to ensure that the wheel/steel rim does not snag on the downstream side of the hole, cause increased vehicle climb up the barrier, or result in barrier override or vehicle instability.

For rigid, vertical shapes, it would seem reasonable to assume that a hole height less than or equal to 50% of small car wheel center height, or 5 to 6 in., would not post too much concern for small car instability, climb, or snag. For rigid, safety shape parapets, the safety risks would be accentuated due to increased lateral snag distance at the downstream side of hole caused by a sloped, front face on a barrier system. As such, the maximum allowable hole height would likely be lower for safety-shape parapets as compared to vertical parapets. Previously, MwRSF provided guidance as to a 3-in. maximum allowable hole height for safety-shape parapets. Single-slope parapets would likely fall somewhere between the two noted above, or between 3 and 6 in. However, it should be noted that no official safety guidance or criteria exists for configuring the size and height a drainage holes in rigid, concrete barriers.

Safe half-hole heights for single-slope parapets are believed to fall somewhere between 3 to 6 in. using my best engineering judgment. It would seem possible for them to work 7.5 in. as well. However, my concerns for small car rim snag on hole edge, wheel climb on hole, instability go up as we increase hole size. If I were picking a recommended upper limit for the single slope barrier, I would say 5-6 in. for half-hole height.

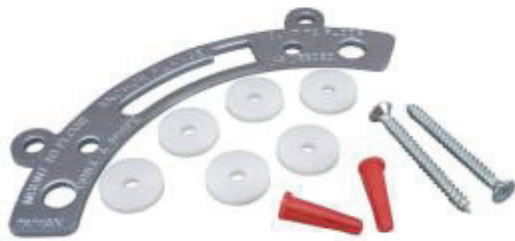
If we slide the bolt against something that keeps the bolt from rotating we can repair it from the top side without digging under it. I'm thinking of something similar to the slot on the flange under my toilet. The keyway does not need to be this long.

For a hex head the bottom would need ribs on each side or a channel from the larger opening back to the left under the small opening to hold the head from turning.

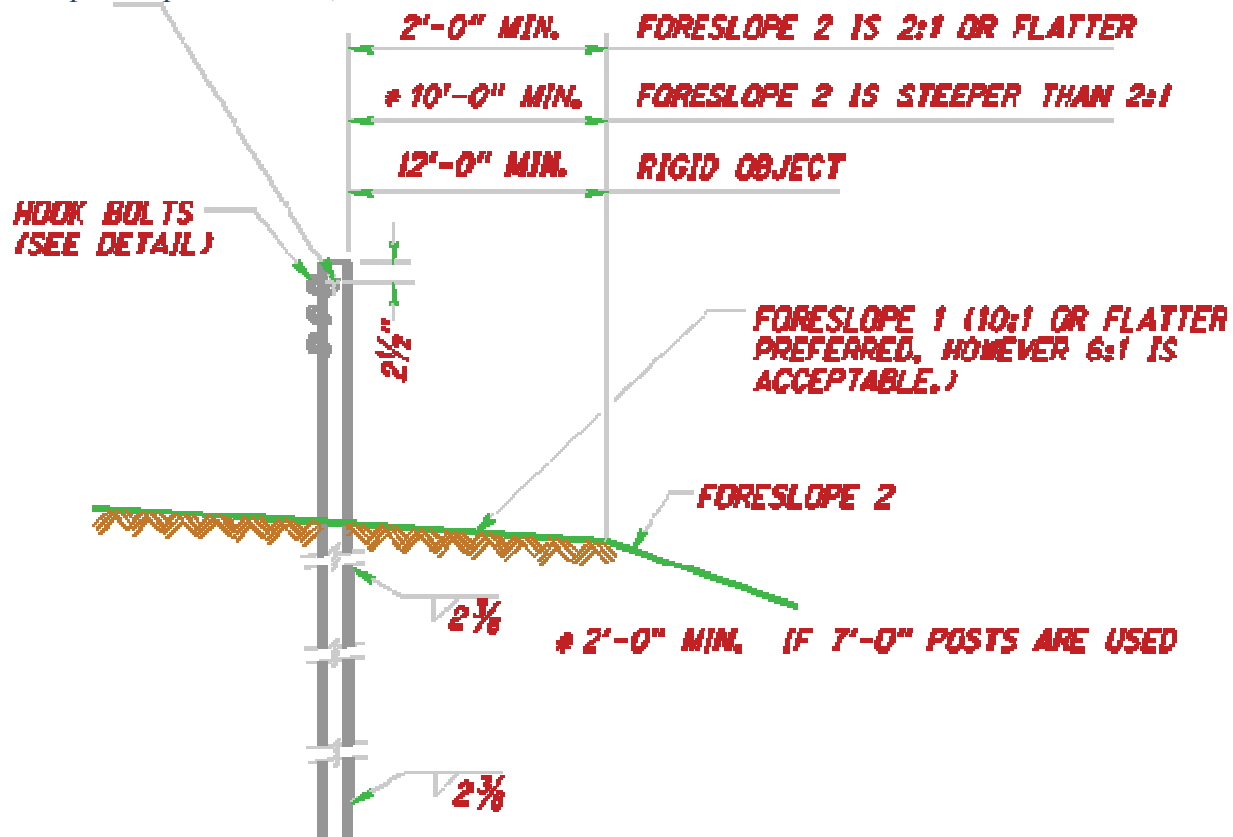
This sketch with 16' post spacing has seemed to work very well.

I am aware that MwRSF tested a system in front of the 1.5:1 slope with ¼ post spacing. However, I know there are states that would install with 16' spacing if the cable was 2' from a 2:1 slope as you show below and I don't believe that is a major concern.

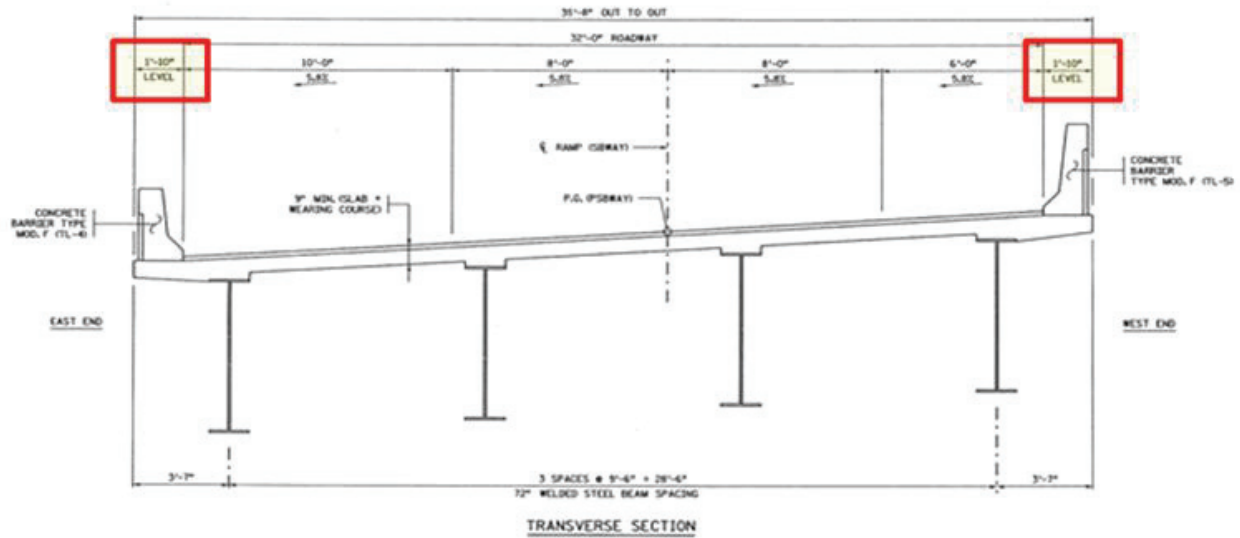
Typical Mn/DOT Bridge Barrier Placement

#1). Mn/DOT's current policy regarding placement of traffic barriers on bridges is to place them "plumb" or "level" as indicated in the drawing below.

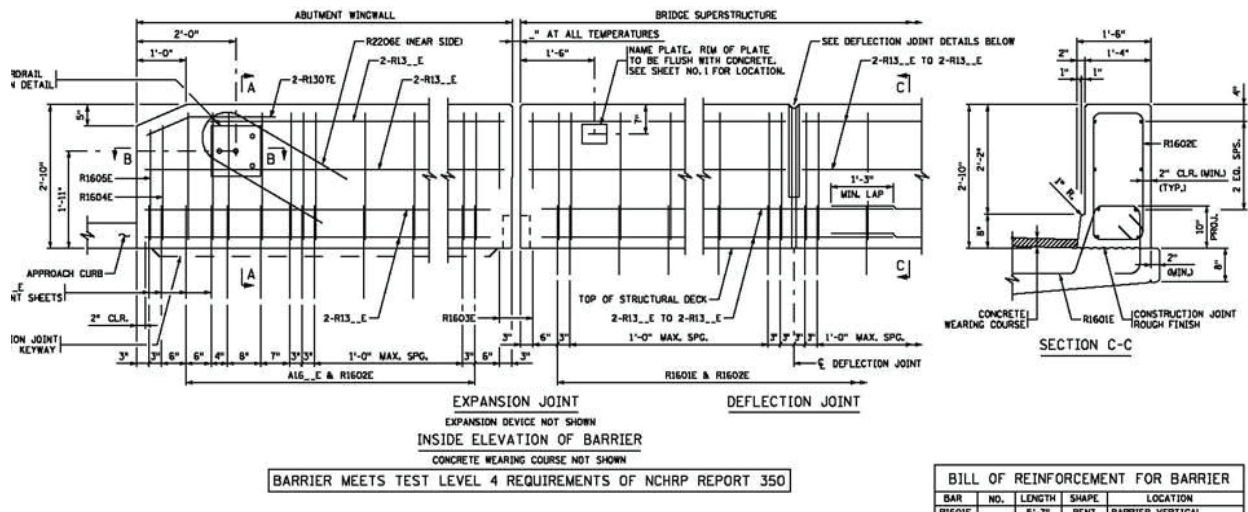
TL-4 (Vertical Face) Barrier

Texas has developed a single slope shape with a 10.3 degree slope. California has developed a shape with a 9.1 degree single slope. Some observations based on studies of bridge rails in Iowa and elsewhere;

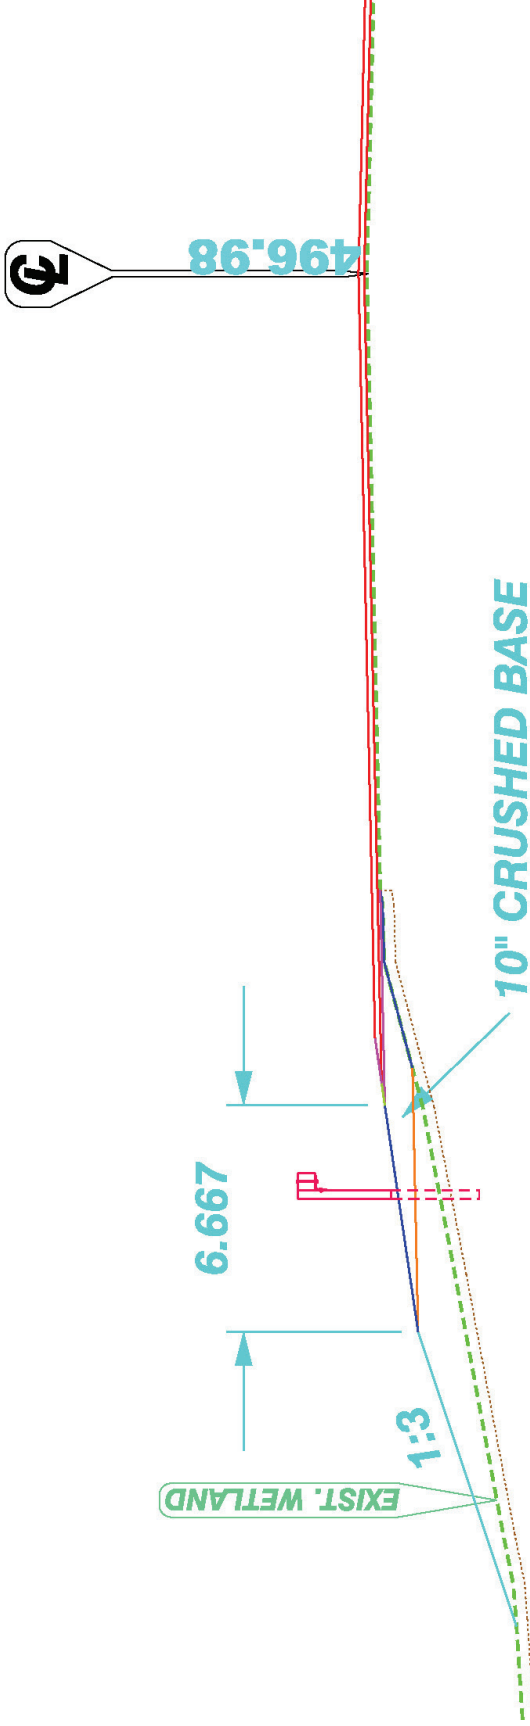
Figure 6. High Tension Cable Guardrail with a 1V:3H Slope Behind

We looked over your installation and compared it with the testing we conducted with the MGS on 8:1 slope and our current cable testing. In that testing, we found that with a 5 ft offset, the MGS (with a 31 in. top rail height) just captured and contained the 2270P vehicle. We don't have similar cable testing on 8:1 slopes to compare with, but we know that the cable can redirect vehicles on the 4:1 slope as long as the vehicle is effectively captured. Based on this comparison we would recommend that the Trinity system be installed with the 2 ft offset rather than the larger 5 ft offset. The decreased offset should compensate for the cable heights of the Trinity system. In addition, offset should allow for capture of the vehicle and redirection even with the 1:3 slope behind the system. We believe that if the Trinity system captures the vehicle then the system will redirect the vehicle even if it intrudes on the 1:3 slope to some extent.

This short offset recommendation is based on the fact that the Trinity system has not been tested on approach slopes, and thus it is difficult to make recommendations regarding its performance in those situations. In our experience, it is necessary to capture the front corner and rear corner of the vehicle with a cable system on slope to capture and redirect the vehicle. Therefore, the shorter 2 ft offset will give more confidence that the system will perform safely.

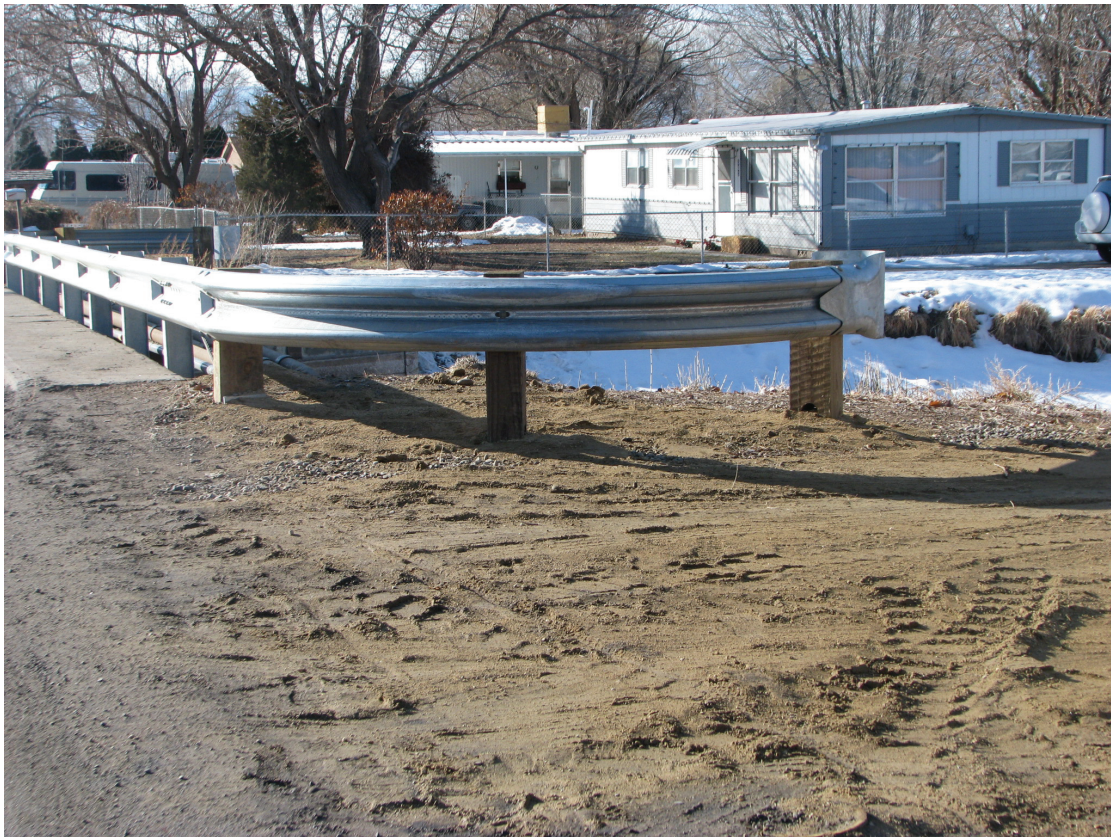
My first guess is to remove the beam guard and delineate, but this is just base on the fact that the installed system is not crashworthy and it may not be possible to install any crashworthy alternative without significant modification to the drainage canal or service road.

This would appear to be a low- to moderate-speed, low- volume crossing situation. From a roadside safety perspective, one would possibly argue for complete removal of the system if adequate end treatment and shielding of the hazard via the ends cannot be achieved. I realize the public wants the feeling of security with a rail for pedestrians and bicyclists, but rail height for those purposes is inadequate anyway. Without seeing the width and available space along service roads at ends, it is difficult to determine what other options may be available.

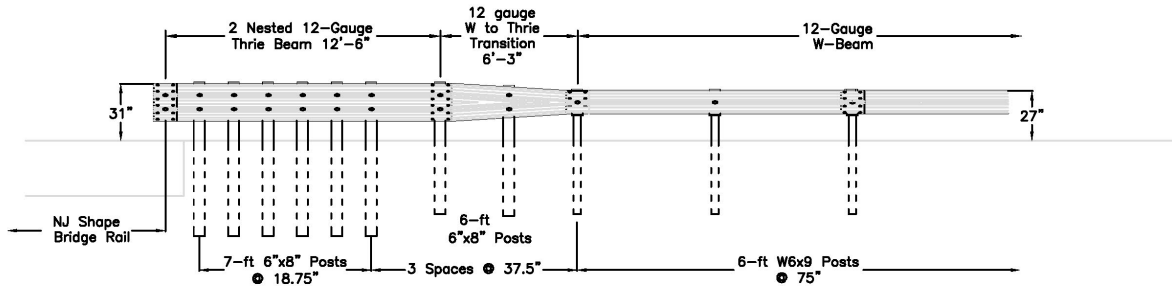
Iowa Transition to NJ Shape Concrete Bridge Rail

ITNJ Testing Series

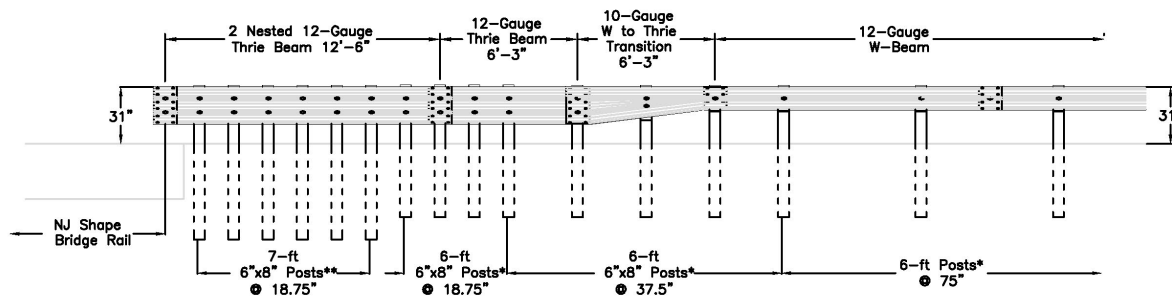
Adapted Iowa Transition

* Embedment of 6-ft Posts = 40" (MGS)
 ** Embedment of 7-ft Posts = 52" (as per Test No. ITNJ-4)

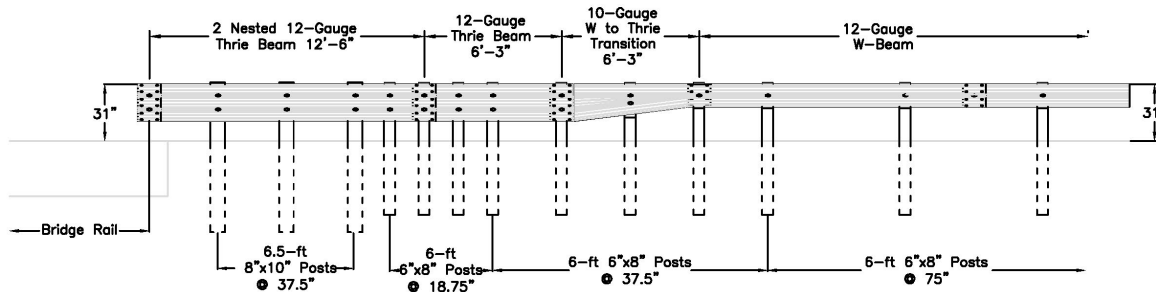
Recommended Wood Post Design for Tested MWTSP Approach Transition

I have attached the recommended wood post alternative to the transition you noted from page 167 of the steel post transition report. The attached figure comes from the wood post transition report that is currently under in-house review at MwRSF and should be sent to the Midwest Pooled Fund States in the near future.

Figure 7. Alternative Wood Post Transition
