INVESTIGATION OF THE EFFECT OF THE INTERFACIAL ZONE ON JOINT DETERIORATION OF CONCRETE PAVEMENTS

**Submitted: April 2012 to the International Conference on Long-Life Concrete Pavements –
Seattle, September 2012 Preliminary Technical Program**

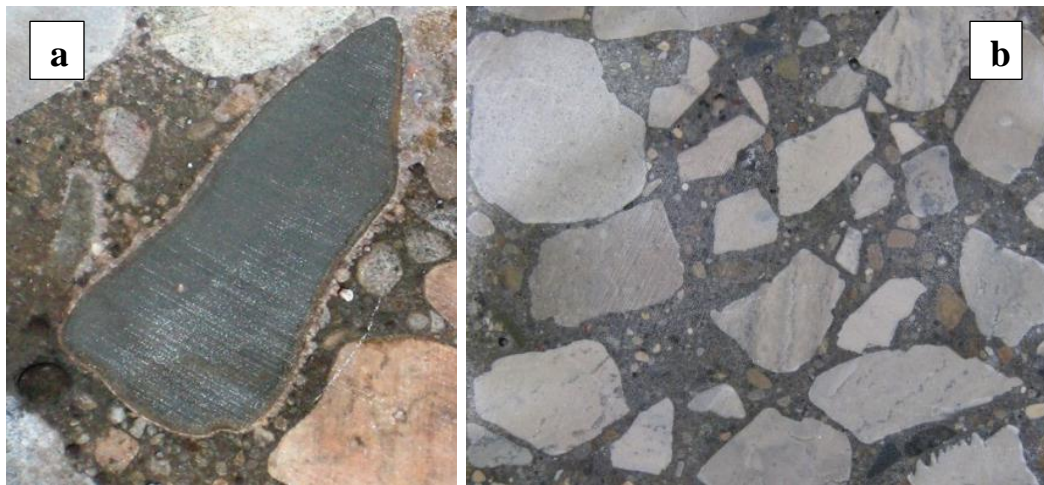
Figure 6. Silver nitrate sprayed samples for mapping chloride (a: concrete mixture using gravel; b: concrete mixture using limestone)

Concrete beams tested under salt solution were further investigated using silver nitrate to map the distribution of chloride on a face perpendicular to the length of the beam. Two slices were cut from each beam. One slice was sprayed with silver nitrate after the surface dry out after cyclic testing was completed, and the other was vacuum saturated under salt solution prior spraying silver nitrate.

Some locations show a narrow “white ring” around the aggregate as shown in Figure 6, which indicated the salt solution preferentially penetrated into the ITZ. The sample limestone aggregate show fewer “white rings” than the sample mixed with gravel. The sample mixed with gravel had a higher w/cm without any silica fume, all factors likely leading to a more dominant ITZ.

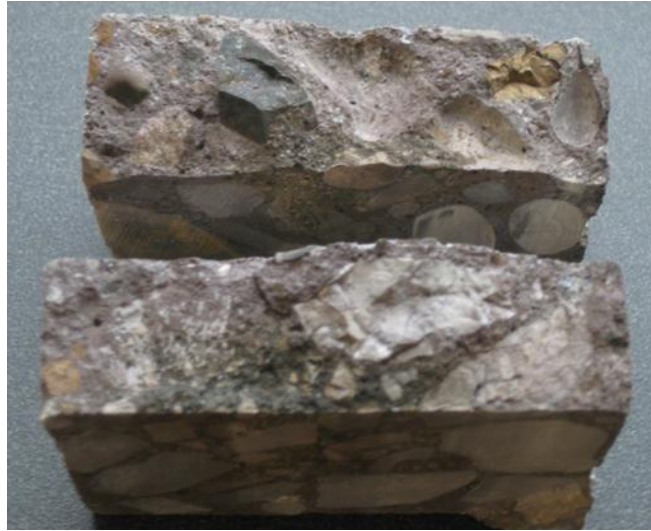
Figure 7. Fracture surface of silver nitrate sprayed samples

If such porous ITZ zones were more saturated with water and/or salt solution than the bulk paste when the concrete was frozen, it is likely that the paste would separate from the aggregate, as is seen in the field. This is supported by examination of the fracture surfaces of slices broken in half. In the gravel, high w/cm case, the aggregate has debonded from the bulk paste, and the silver nitrate is showing some chloride presence in the cavity left behind (top slice in Figure 7). In the other low w/cm sample with silica fume, a similar fracture has propagated through the aggregate rather than around it.
