# Guide for Optimum **JOINT PERFORMANCE** of Concrete Pavements

**JULY 2012**

This guide will help practitioners optimize concrete pavement joint performance by preventing, identifying, and mitigating premature joint deterioration.

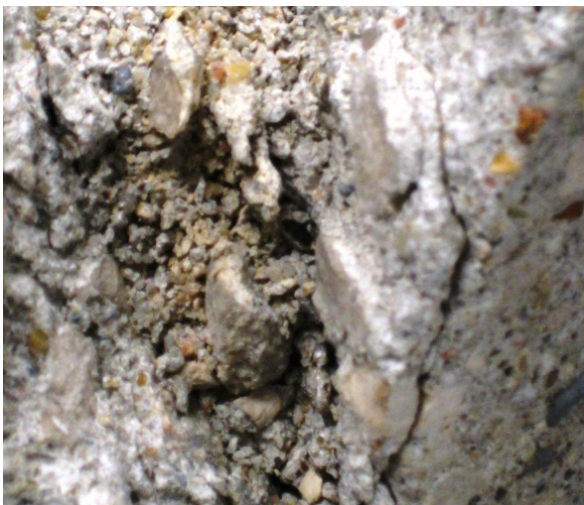
Figure 1. Typical slivers from freezing and thawing cycles

- Pavement saturated for long periods, regardless of the source of water.
- Pavement with marginal air-void systems (total air content, spacing factors, and specific surface).
- The use of significant quantities and/or potentially aggressive deicing salts.
- Secondary ettringite deposits that fill the air-void system under saturated conditions.
- The damage appears as thin flakes of mortar that form parallel to the exposed surface (Figure 1)

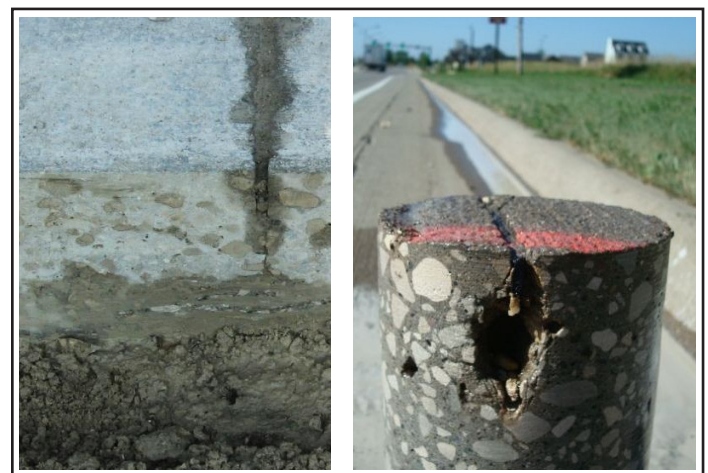
Figure 3. Saturated soils due to inadequate drainage and roadside irrigation (left) leading to joints showing frost damage (right) (Source: Snyder and Associates)

non-draining joint. Weiss and Nantung have modeled how a joint face can be saturated when a seal fails to prevent water ingress (1) (Figure 2). Figure 3 illustrates how inadequate subsurface drainage can be a contributor, especially when coupled with excessive roadside irrigation.

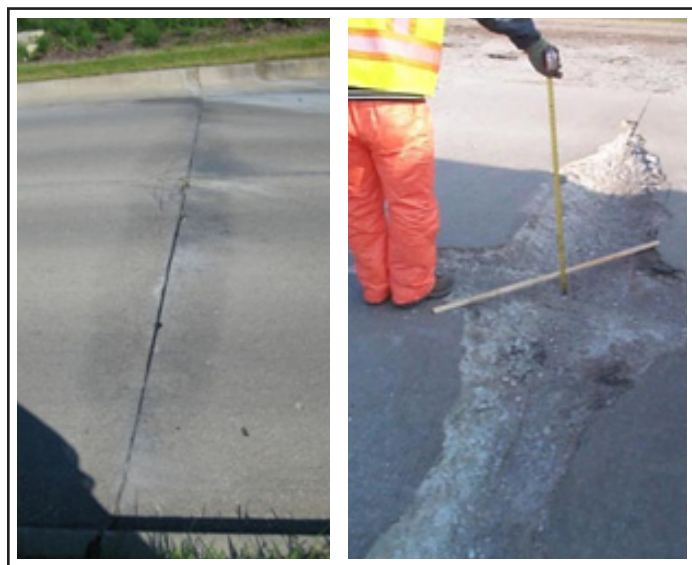
Figure 4. Evolution of joint deterioration from shadowing (left) to high severity (right)

Deterioration is sometimes first observed as shadowing or darkening of a zone a few inches on either side of a joint. This effect is the result of a fine network of microcracks that develop near and parallel to the joint. The cracks trap water, which lead to the darker color. Over time significant loss of material may occur (Figure 4). In most cases where shadowing is observed the system is not well drained (Figure 5), and the air-void system is often marginal or poor. It is also common to observe evidence of secondary ettringite deposits in the air voids (Figure 6). This indicates abundant water within the concrete, although the exact mechanisms and effects of this ettringite are still not resolved.

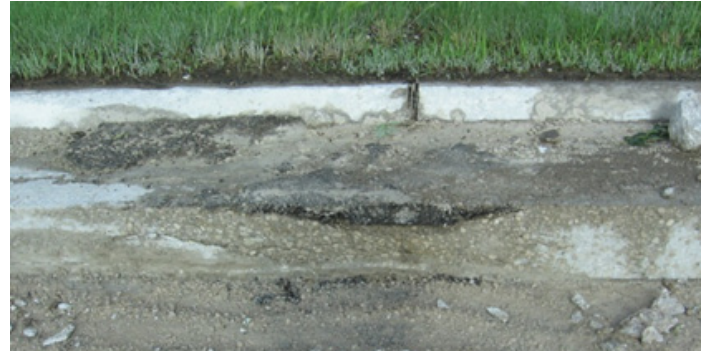
Figure 5. Typical saturated foundations under a shadowed section (Source: Snyder and Associates)

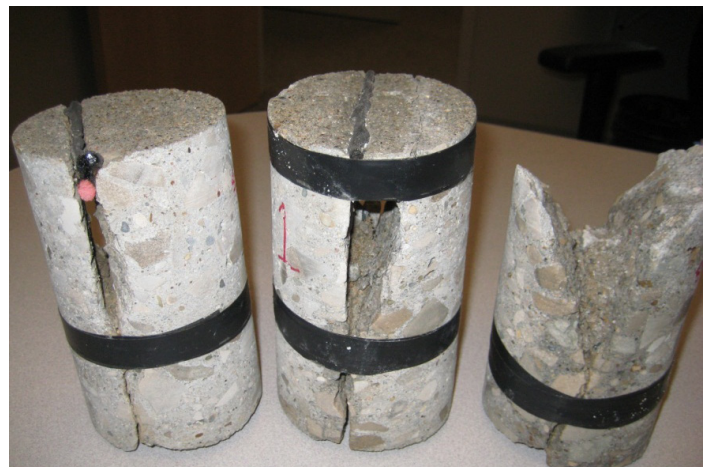
Figure 7. Three cores illustrating progression of distress from bottom-up moisture

When the pavement is placed on a non-draining base and/or when the water table is above the bottom of the slab, the top of the pavement may appear to be in reasonable condition, but coring reveals concrete that has been seriously damaged in the joint (Figure 7). Interestingly, the damage is more pronounced in the saw-cut than in

the crack, presumably because a significant amount of water can collect in the saw-cut while cracks tend to be tight. Figure 8 illustrates the site where these cores were extracted, showing the clear signs of abundant water flow.

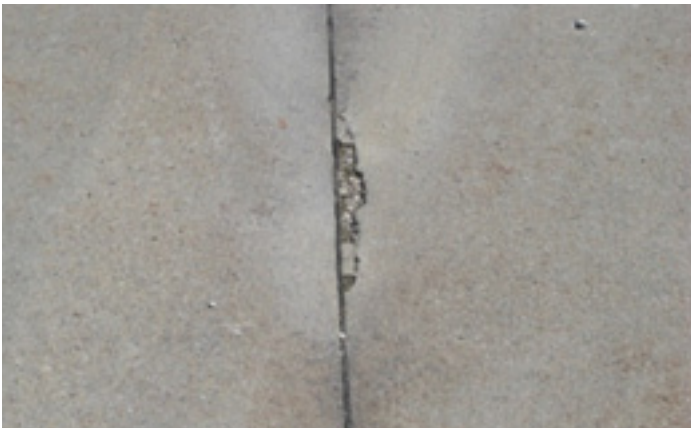
Figure 8. Water flow through joints from a high water table (bottom-up moisture); note staining on surface

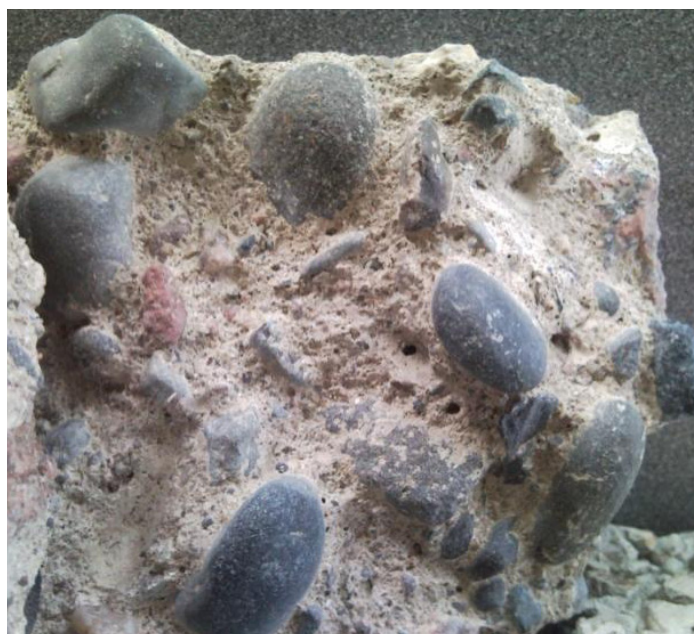
Figure 10. Coarse aggregate exposed by damage to the paste

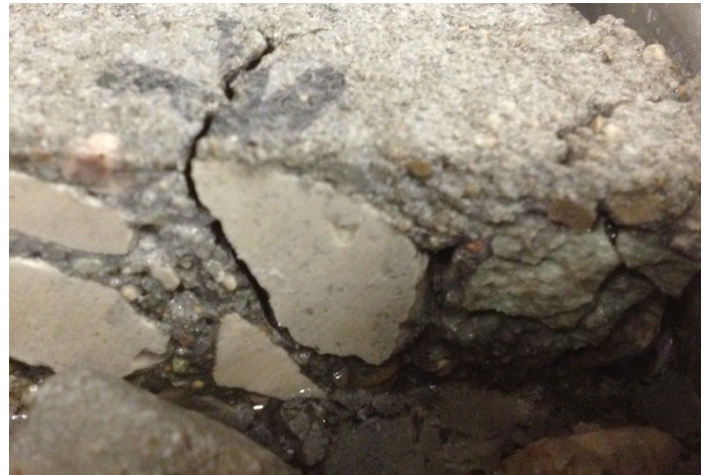
Figure 12. Photograph of a crack around an aggregate particle

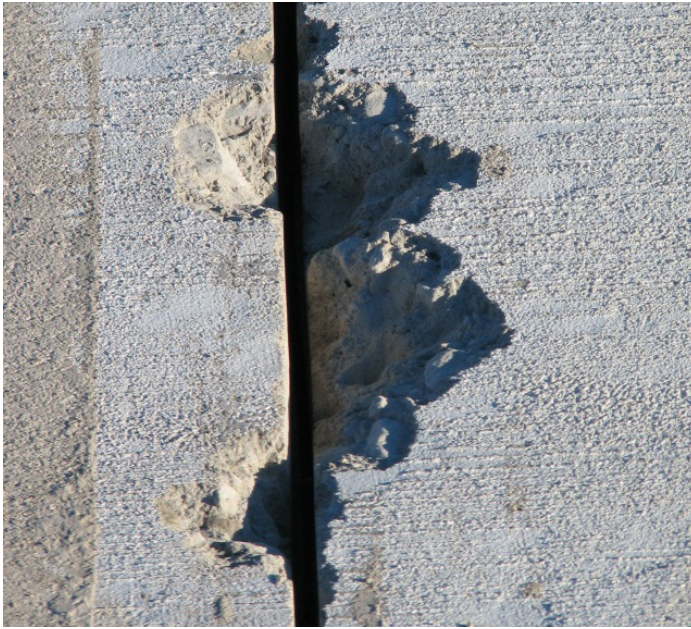
Figure 14. Raveling due to poor sawing practice (Source: Iowa Department of Transportation)

Raveling of a saw cut can also be caused by aggregate particles being dislodged during sawing, typically because the concrete strength is too low when conventional sawing is conducted. Alternatively, raveling is observed when the

shoe on an early-entry saw is not functioning properly (Figure 14). Such spalling is typically found at the surface and will rarely extend through the depth of the slab.

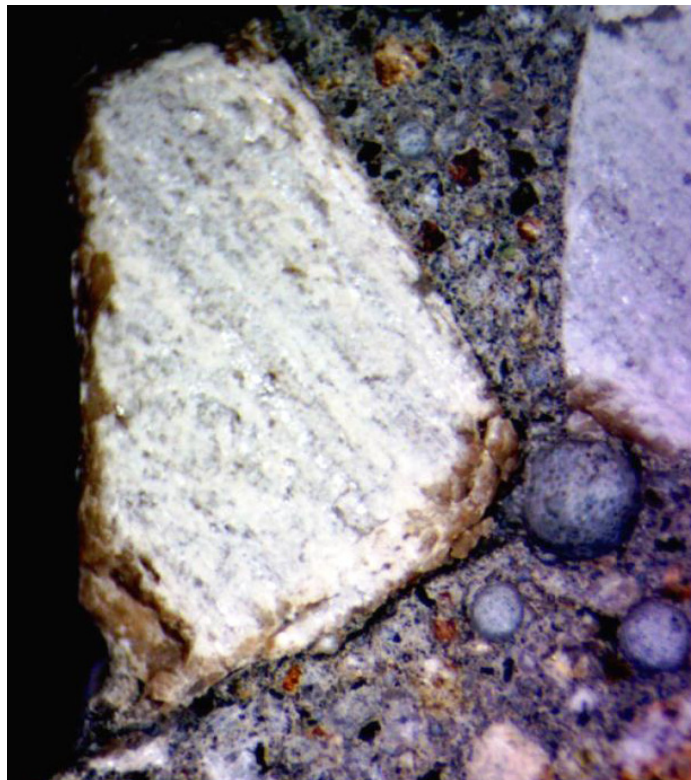
Figure 15. Photograph of an aggregate particle dislodged by inappropriate sawing (Field of view 5mm)

Concrete at the bottom of a saw cut may become damaged during sawing using machines with worn bearings or an inappropriate blade, or when cutting on a curve (Figure 15). Erosion and/or a zone of microcracking is possible, which can lead to water being trapped, thus increasing the risk of damage from frost action.

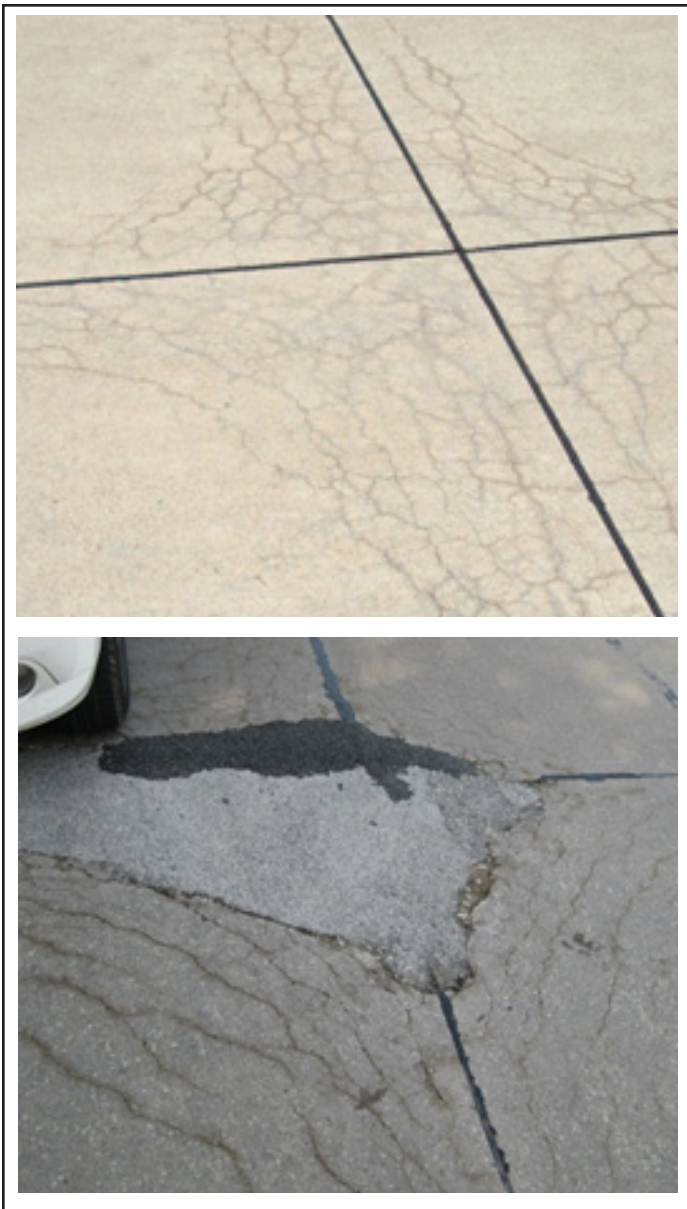
Figure 16. D cracking of low severity (top) and high severity (bottom) (Source: The Transtec Group)

D-cracking is a type of deterioration caused by expansive freezing of water trapped inside some types of aggregate particles. The damage normally starts near joints and forms a characteristic crack pattern (Figure 16). The damage is generally worse at the bottom of a slab than at the top. As long as freeze-thaw cycles continue, the distress cannot be stopped.

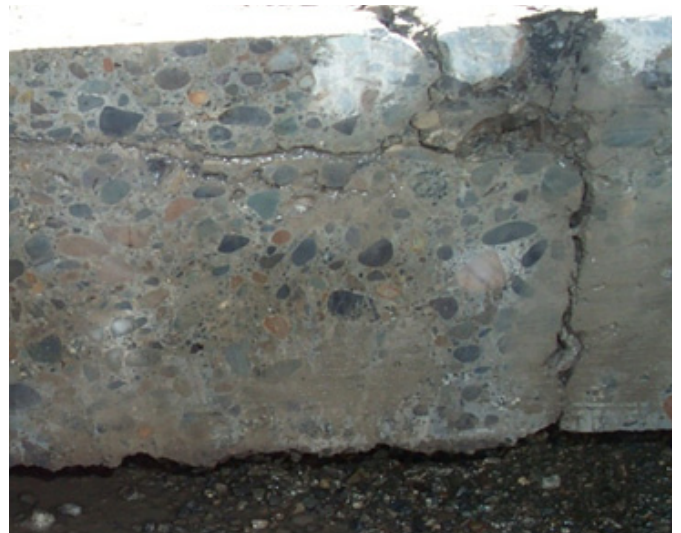
Figure 18. Example of delaminations spalling (Source: Washington State)

process is illustrated in Figure 17 and the result is shown in Figure 18.

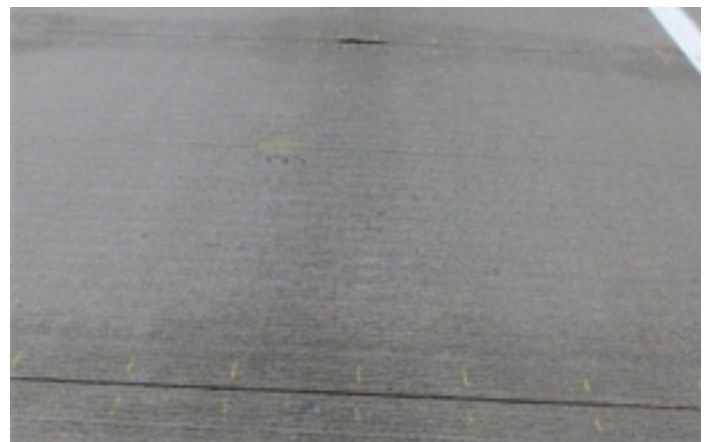
Figure 19. Shadowing at the joints, which is commonly followed by loss of material

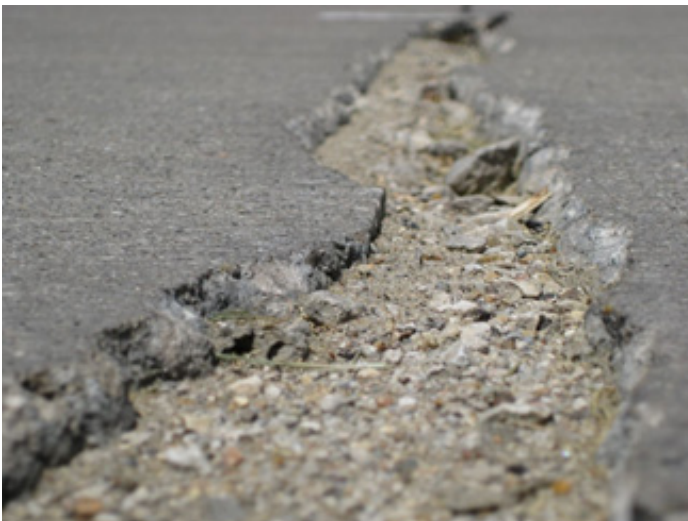
Figure 20. Top-down joint distress, with vertical edges and shallow depth

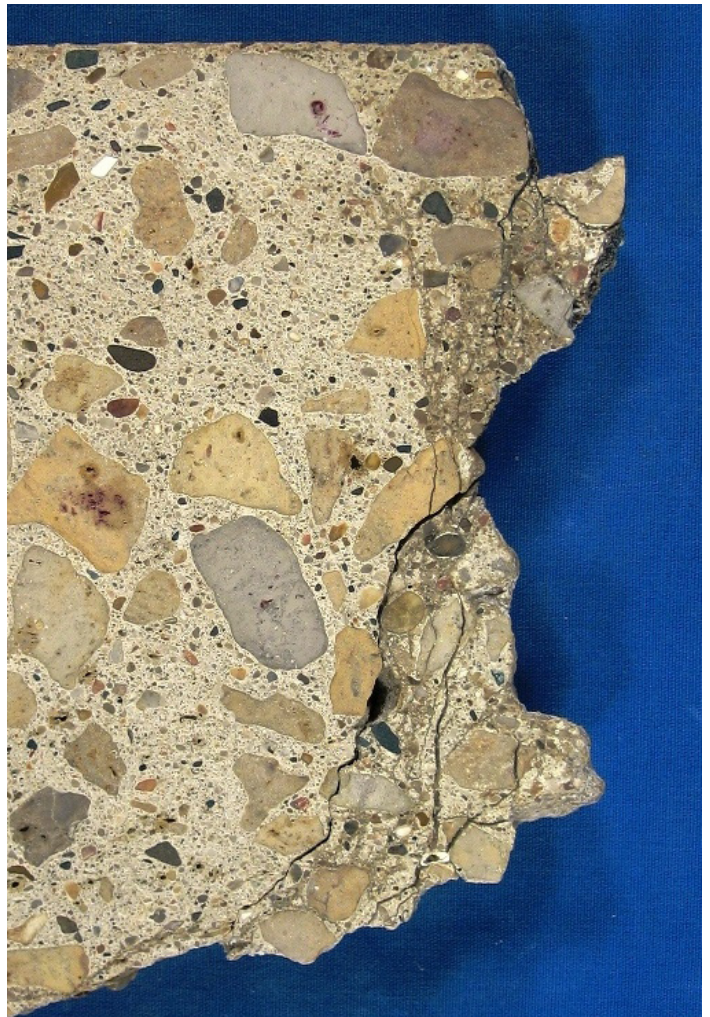
Figure 23. Deterioration due to bottom-up moisture

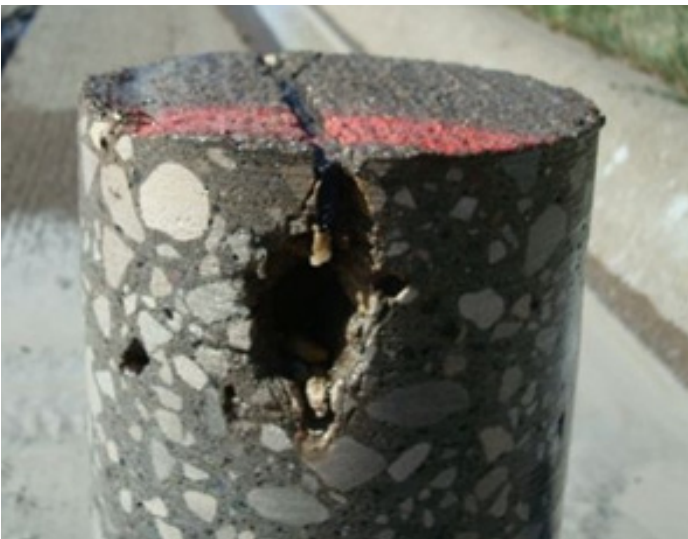
Figure 21. Joint deterioration evident below the joint sealant

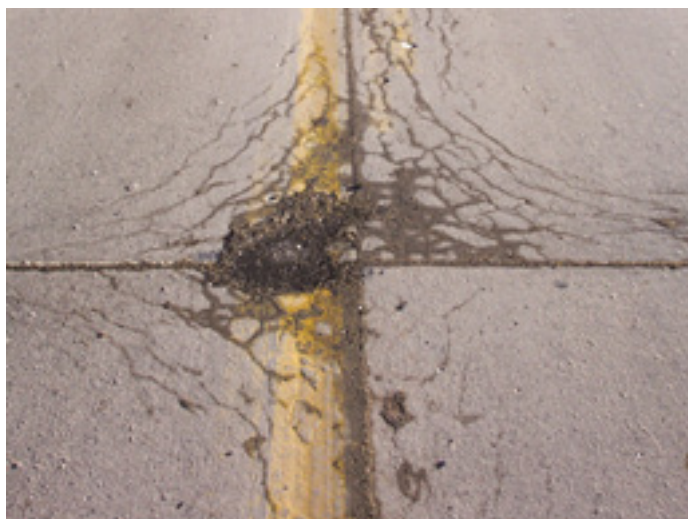
Figure 22. Deterioration due to D cracking

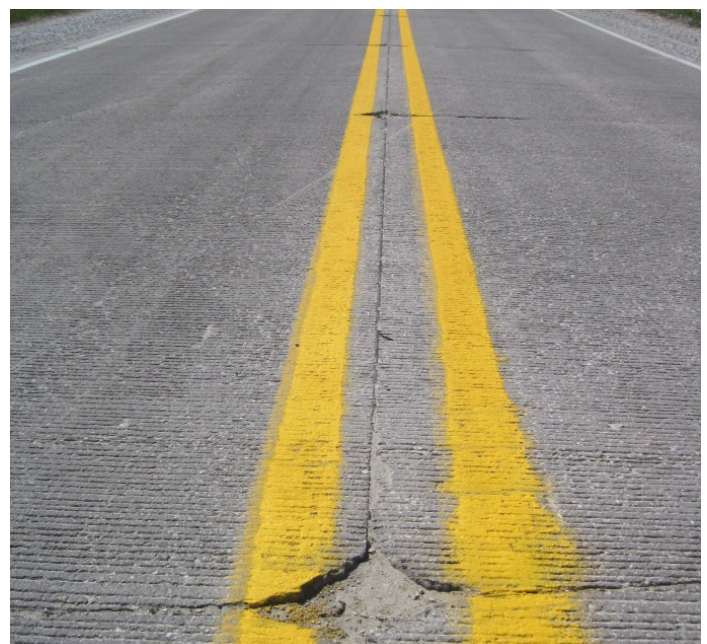
Figure 25. Damage starting at joint intersections

Both of these distresses occur early in the life of a pavement, so the root causes can no longer be mitigated. Often, however, damage caused by these early-age mechanisms provides places for water to collect and thus becomes a starting point for frost damage. For example, it is common to see distress starting at intersections of longitudinal and transverse saw cuts (Figure 25). It is likely that some “bruising” due to sawing of the concrete at the joints can become a zone where water is trapped, thus accelerating subsequent frost damage.

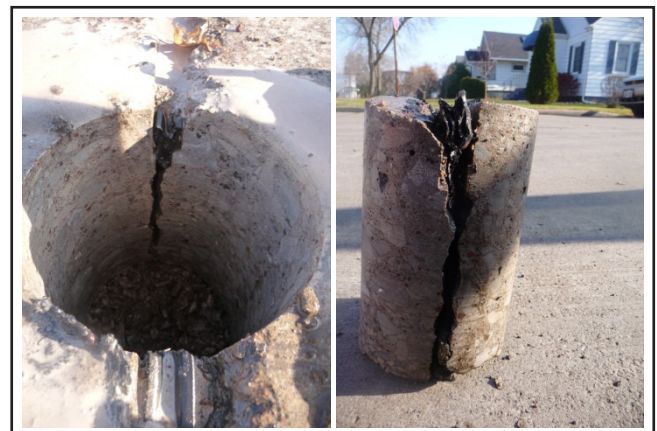
Figure 26. Coring at deteriorated joints to help identify causes of failure

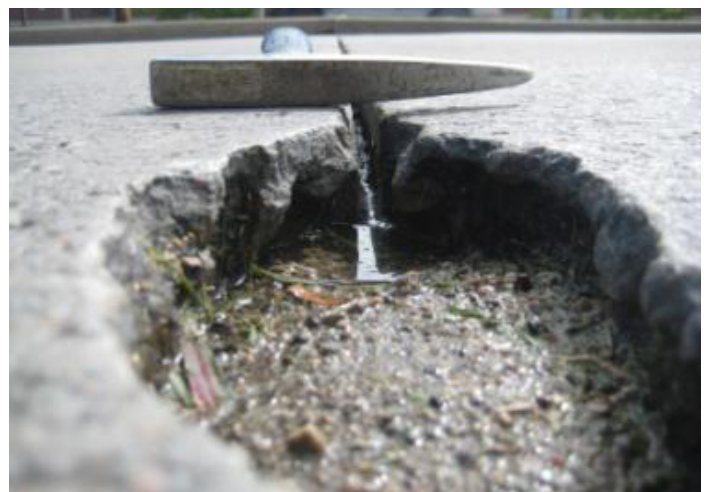
Figure 27. Example of a poorly draining pavement

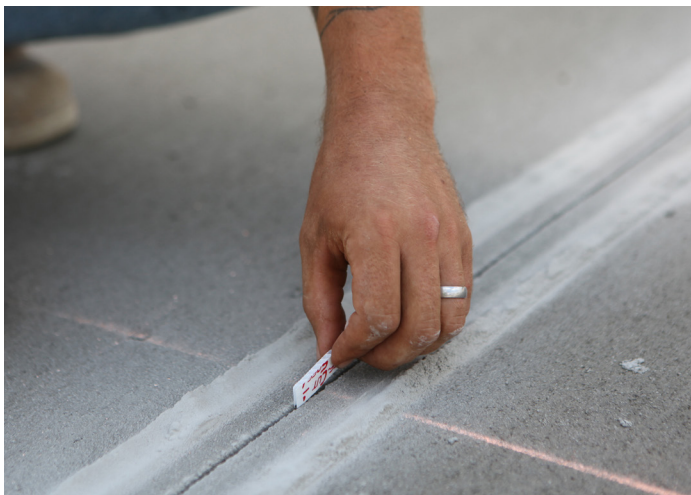
Figure 30. Using temporary joint spacers to protect and minimize damage due to early entry sawing (Source: Husqvarna)

When using early-entry saws, it is recommended that temporary spacers be inserted where cuts intersect existing cuts, in order to prevent corner damage and the subsequent risk of other joint deterioration mechanisms (Figure 30).

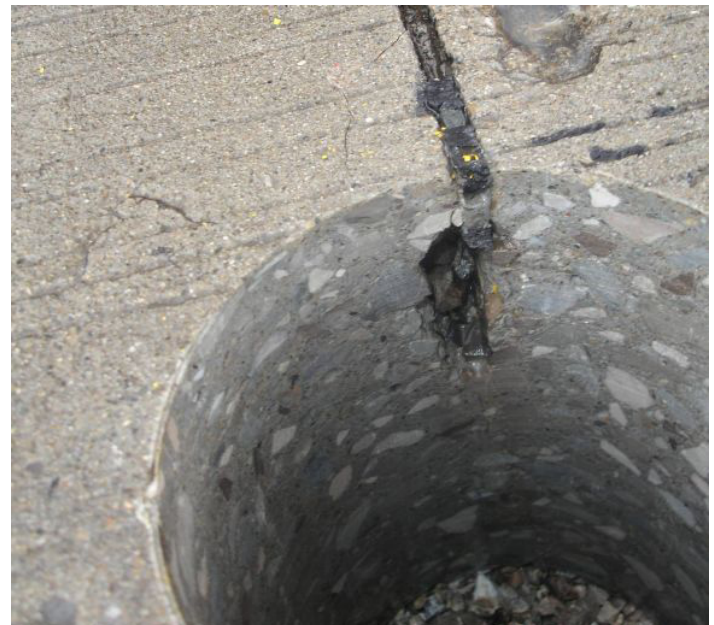
Figure 31. Evidence of saturation within joint beneath seal (Source: Purdue)

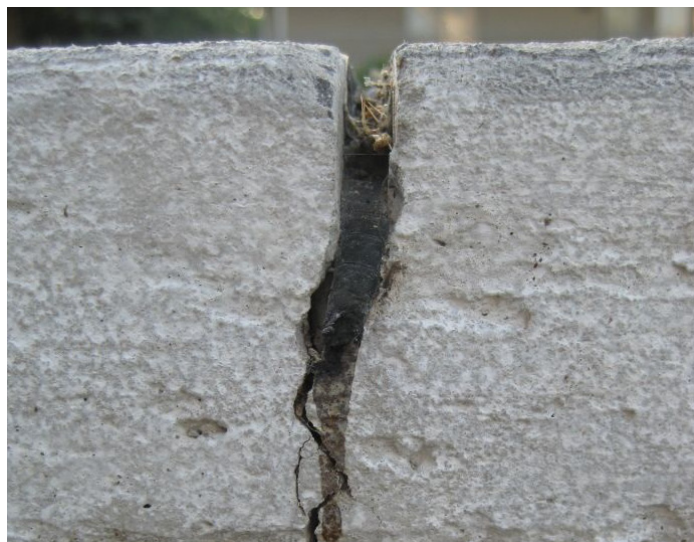
Figure 32. Joint filled with hot-pour sealant (Source: The Transtec Group)

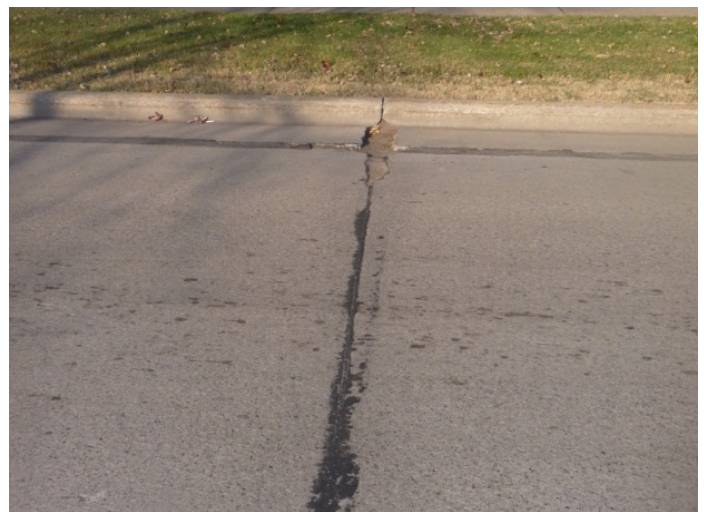
Figure 33. Failing transverse joint associated with poor drainage at gutter

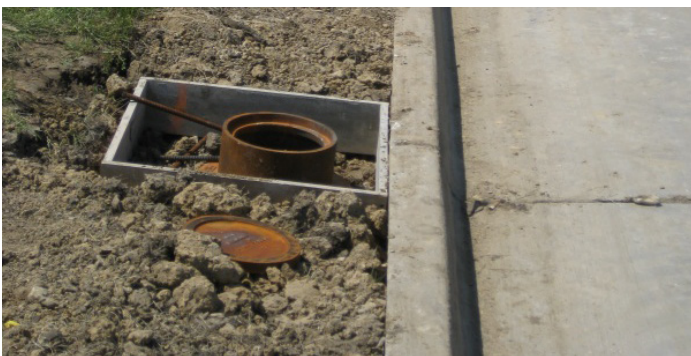
Figure 35. Subdrain retrofit operation including cleanout (The Transtec Group)

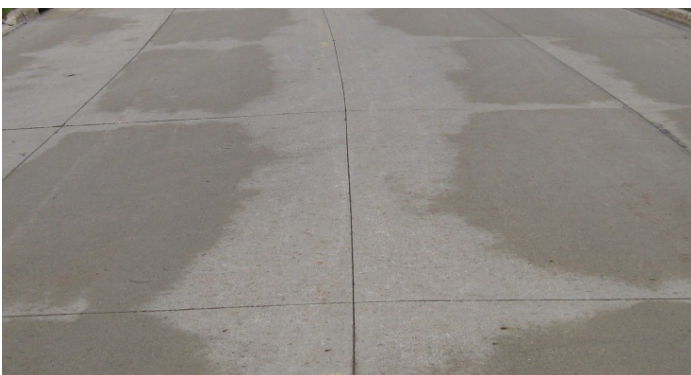
Figure 36. Example of effective drainage of unsealed joints

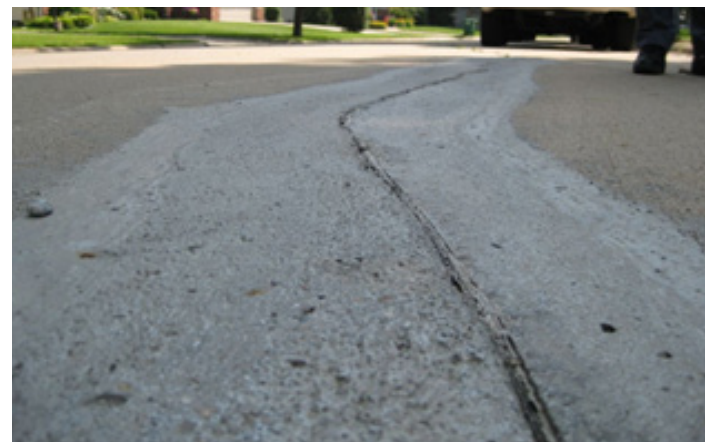
Figure 39. Completed patch (Source: The Transtec Group)

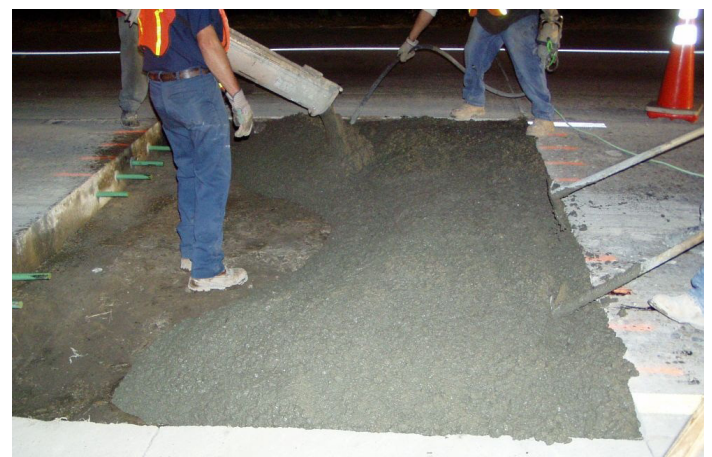
Figure 40. Full-depth patching

In cases where deterioration has occurred through more than one-half the depth of the pavement, a full-depth repair is required. As shown in Figure 40, a full-depth repair is a cast-in-place concrete repair that extends through the full thickness of the existing concrete slab.
