## INTERIM REPORT

Investigation of the Long Term Effects of Magnesium Chloride and  
Other Concentrated Salt Solutions on Pavement and Structural  
Portland Cement Concrete

SD2002-01  
Submitted by:

January 2005

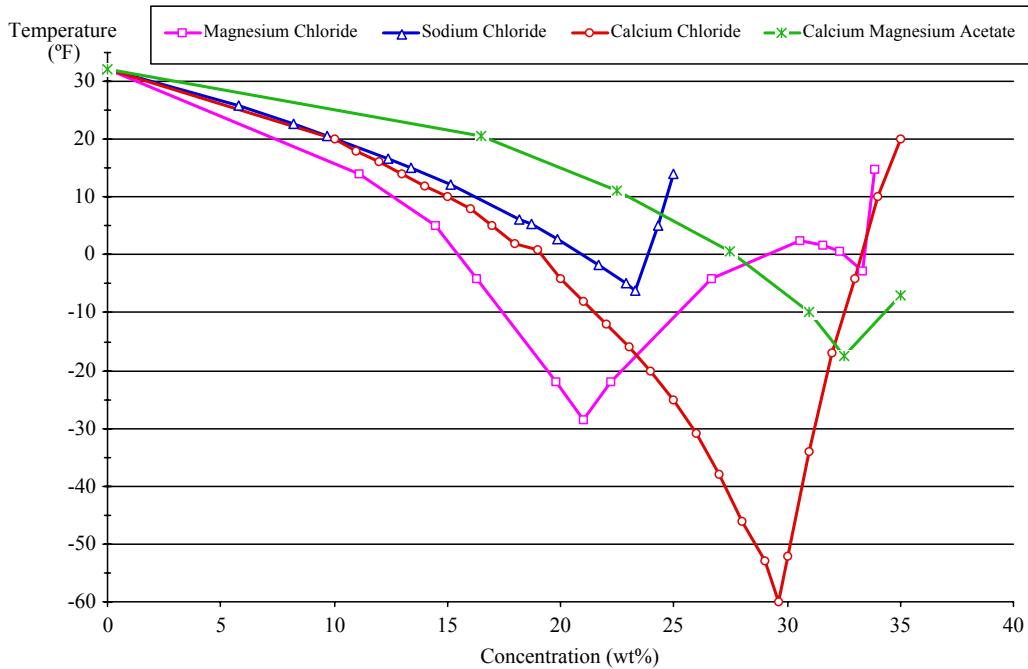
Figure 2.1 The partial phase diagrams for the common deicer solutions

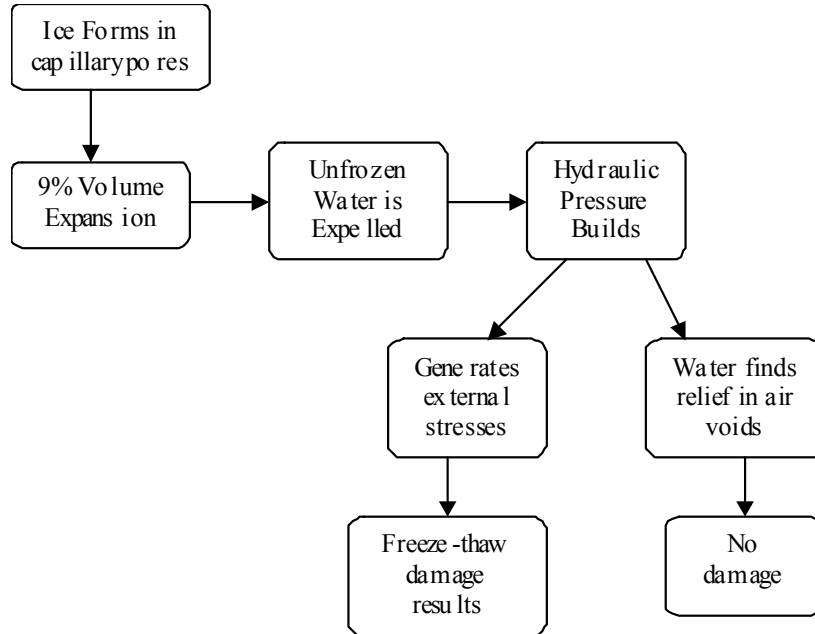
Figure 2.3. Schematic representation of the hydraulic pressure theory.

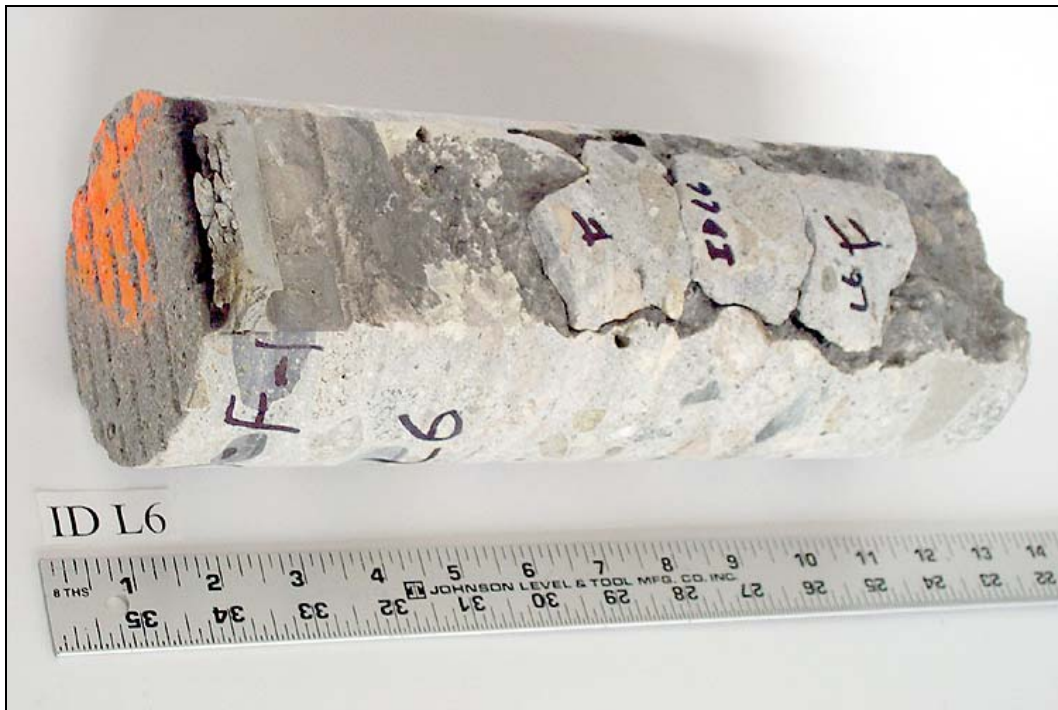
Figure 3.1. Core as received from Idaho site, left-most lane, at joint, (ID\_L06).

A total of 18 cores were received from the Idaho site, nine from the left-most lane, and nine from the right-most lane. Four cores were selected for study, two from each lane. From each lane, one core was selected from the joint, and another core was selected away from the joint. Figures 3.1 through 3.4 show the cores as received. None of the cores exhibited any obvious signs of distress. No photos of the core site were available. Table 3.1 summarizes the results of a modified point-count performed according to ASTM C 457 performed on a polished slab from each of the cores. Figures 3.5 and 3.6 show successively zoomed in images of the core ID\_R07 to illustrate the air void structure.

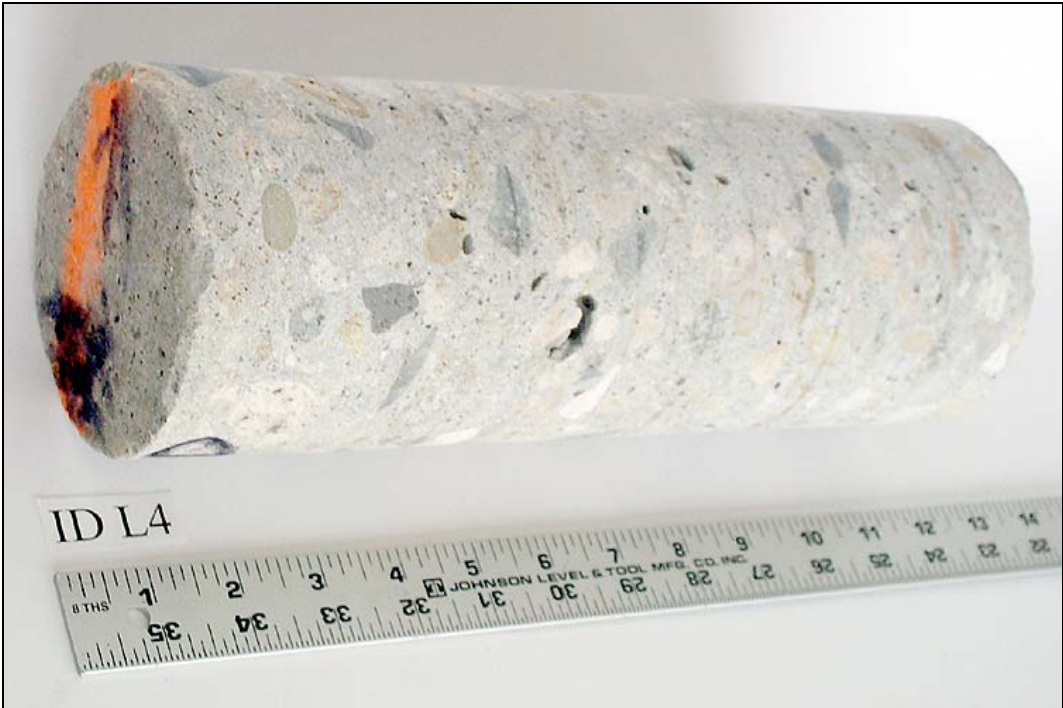
Figure 3.2. Core as received from Idaho site, left-most lane, away from joint, (ID\_L04).

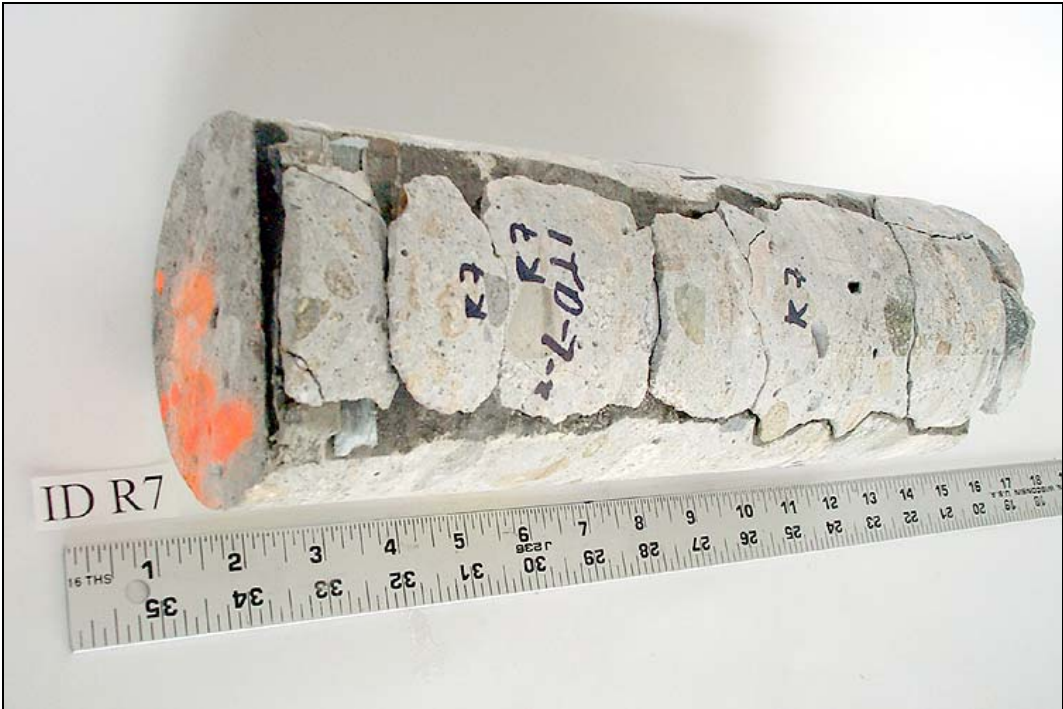
Figure 3.3. Core as received from Idaho site, right-most lane, at joint, (ID\_R07).

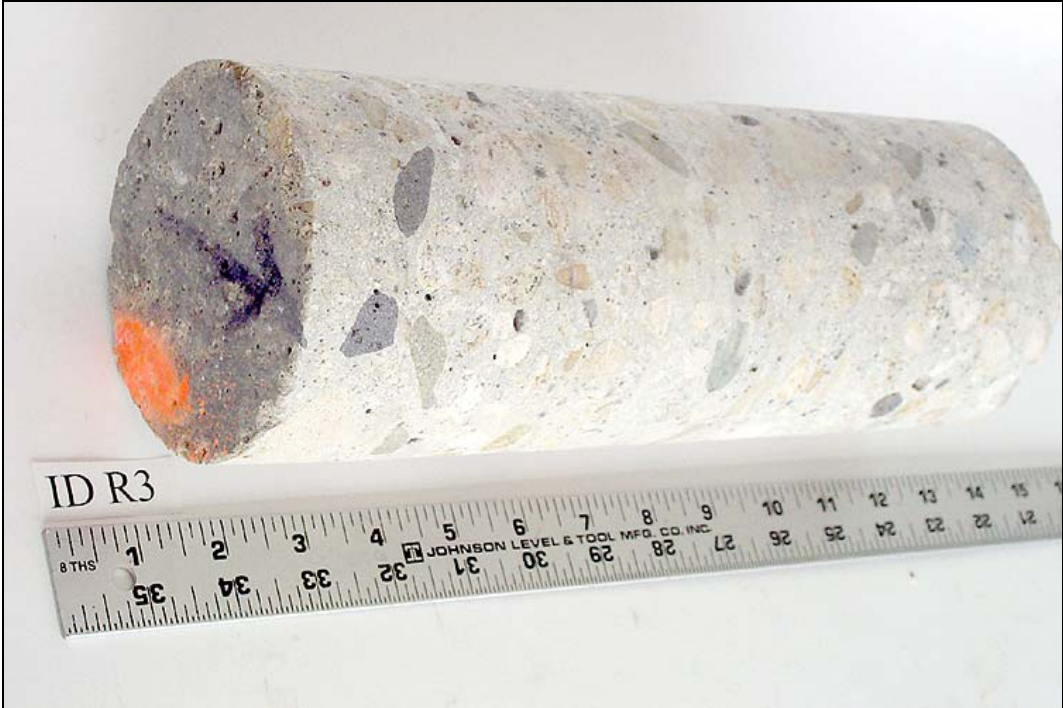
Figure 3.4. Core as received from Idaho site, left-most lane, at joint, (ID\_R03).

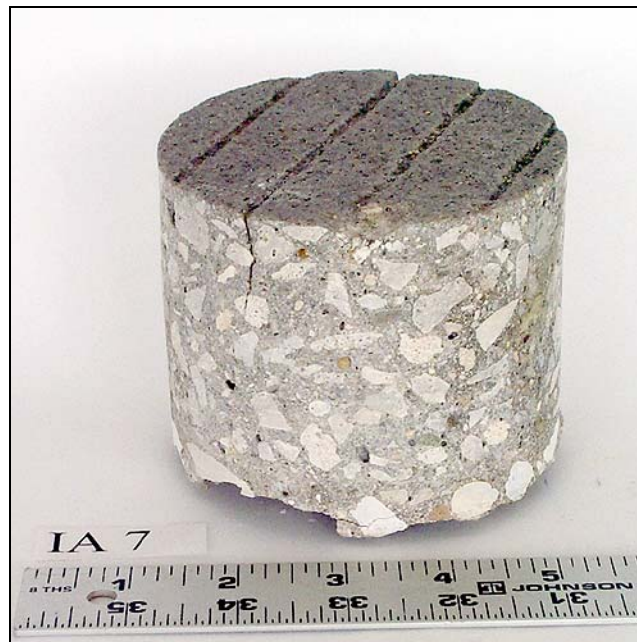
Figure 3.7. Core as received from Iowa site, with surface crack, (IA\_07).

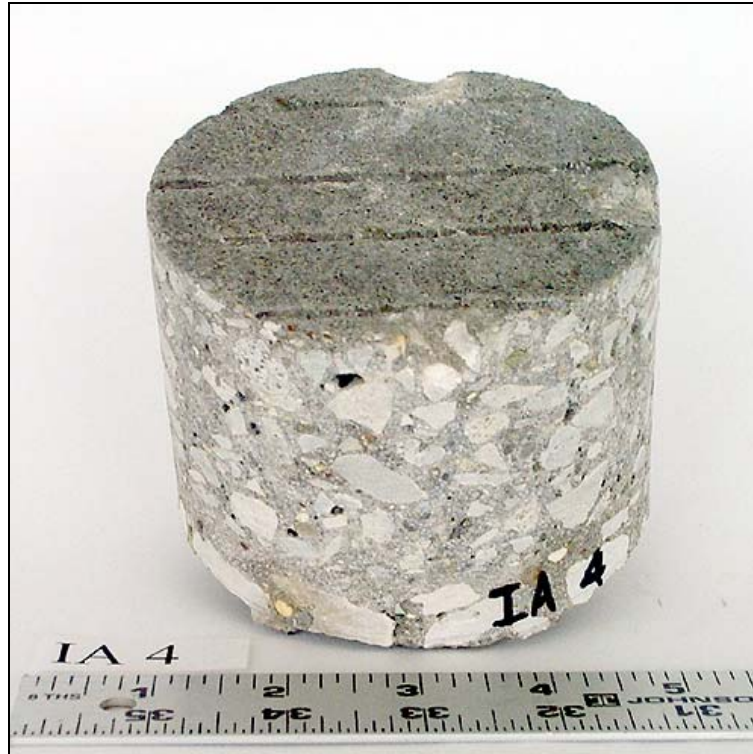
Figure 3.8. Core as received from Iowa site, without surface crack, (IA\_04).

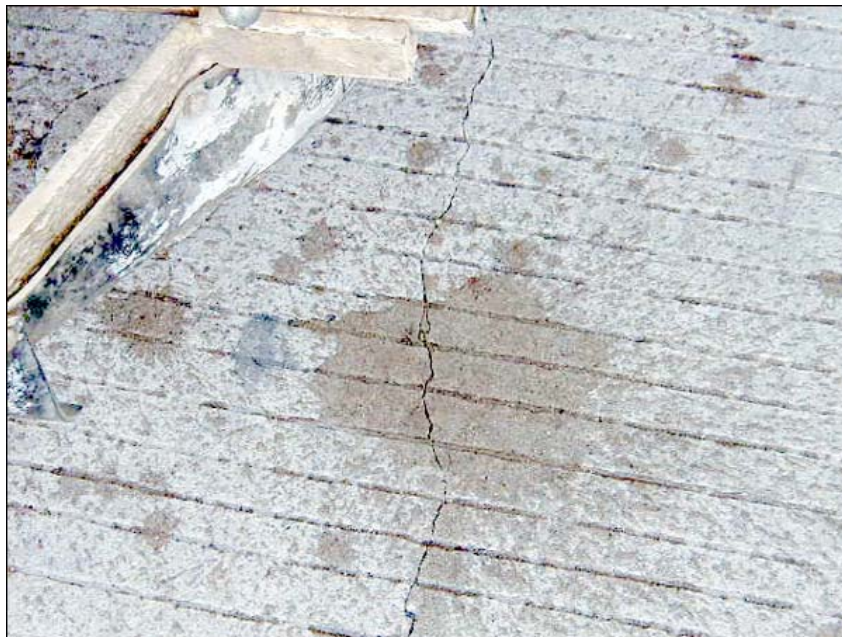
Figure 3.9. Photograph of crack at Iowa site.

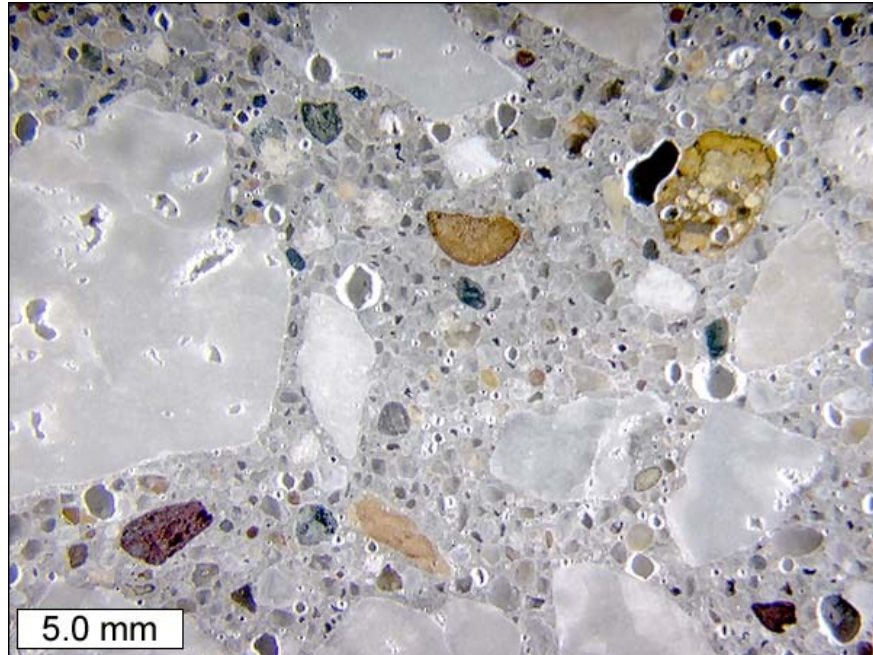
Figure 3.10. Stereomicroscope image of polished surface from core IA\_04, magnified here approximately 4x.

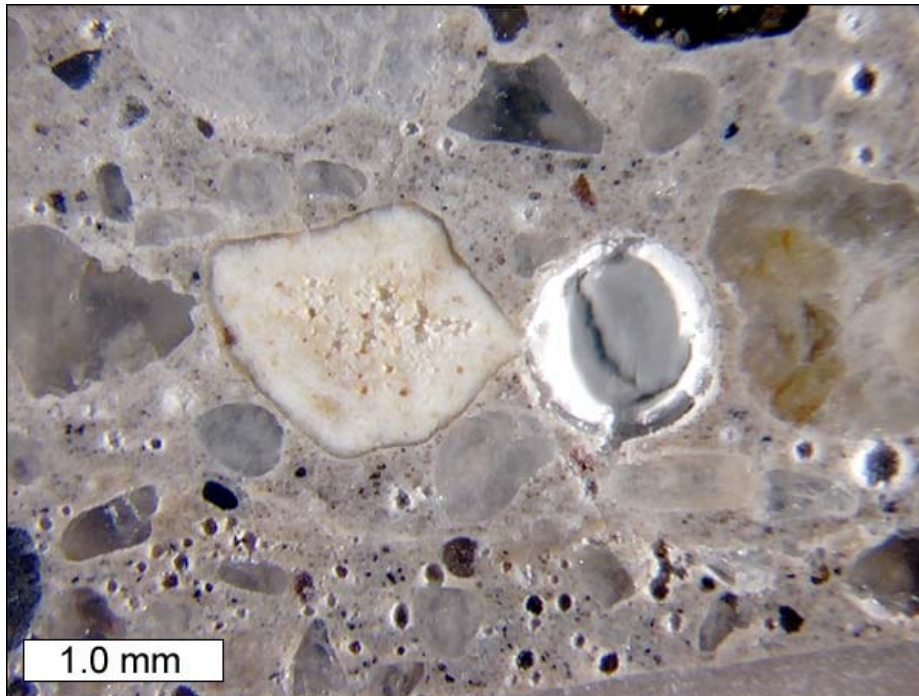
Figure 3.12. Stereomicroscope image of polished surface from core IA\_07 showing alkali-silica reactive sand particle before staining procedure.

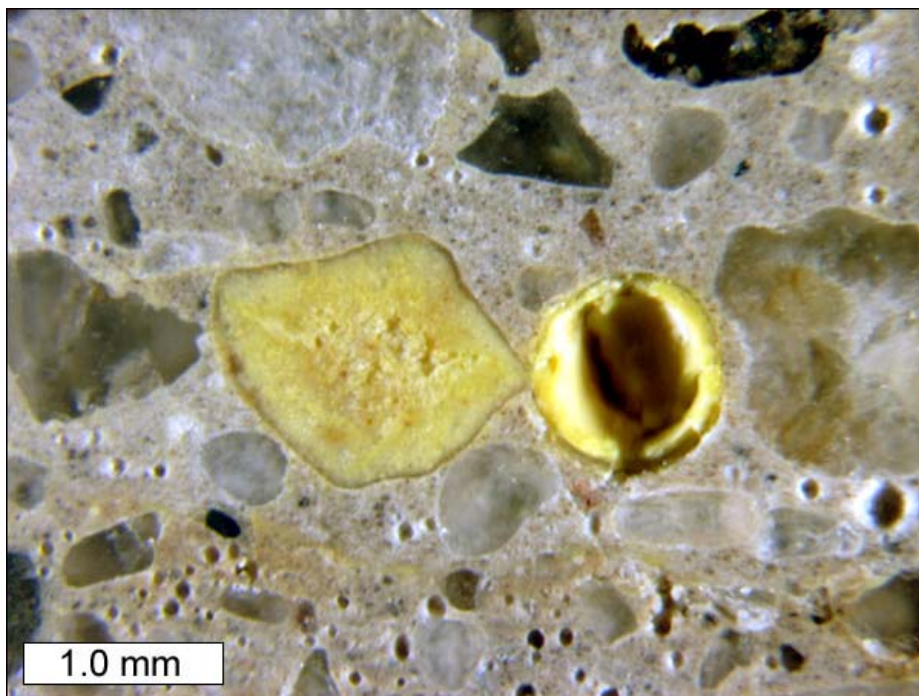
Figure 3.13. Stereomicroscope image of polished surface from core IA\_07 showing alkali-silica reactive sand particle after staining procedure.

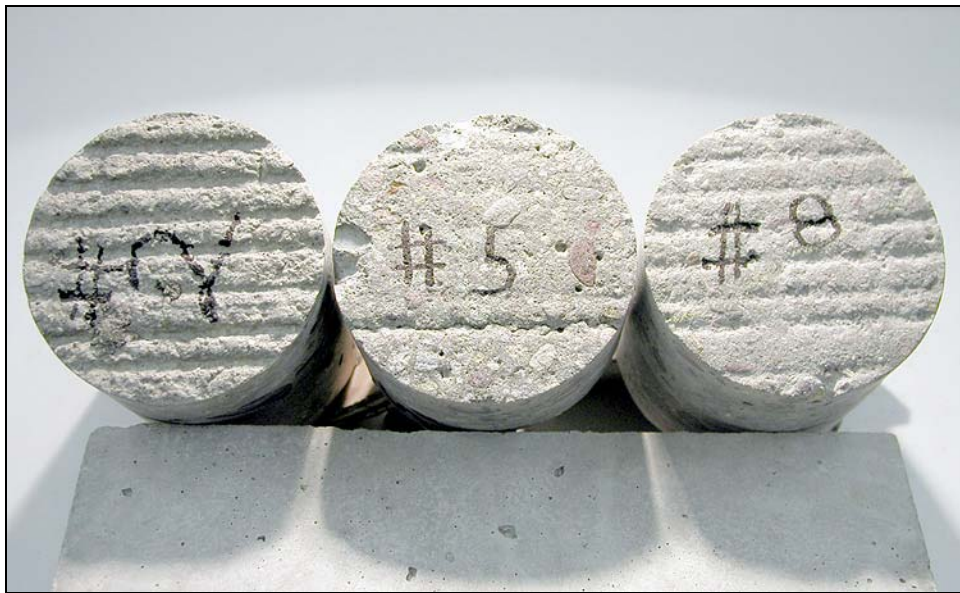
Figure 3.14. Variable wear of pavement surface at Montana site.

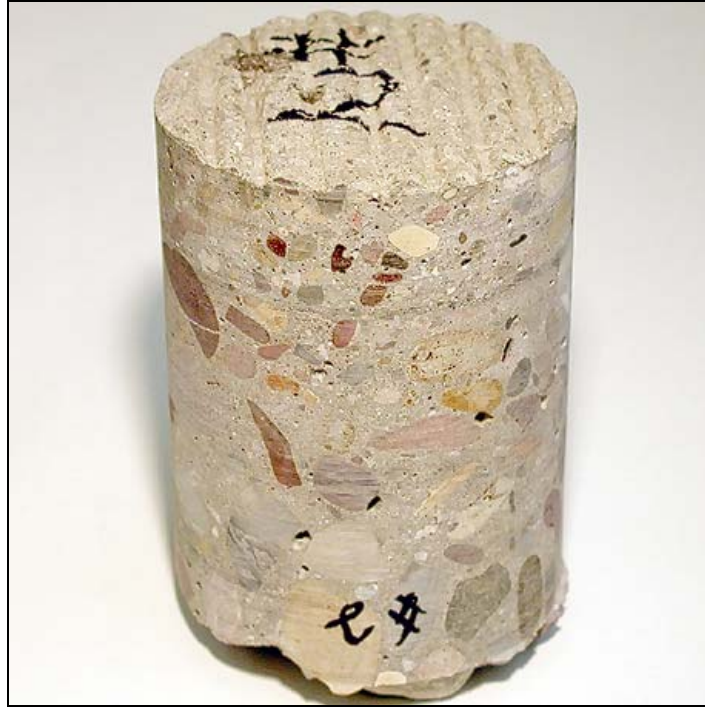
Figure 3.15. Core as received from Montana site, with little surface wear (MT\_02).

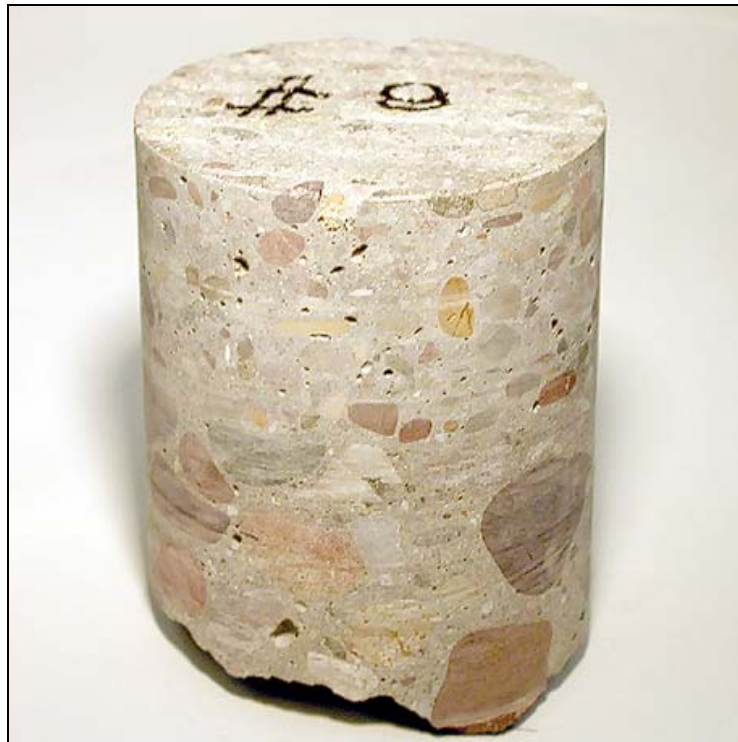
Figure 3.16. Core as received from Montana site, with some surface wear (MT\_08).

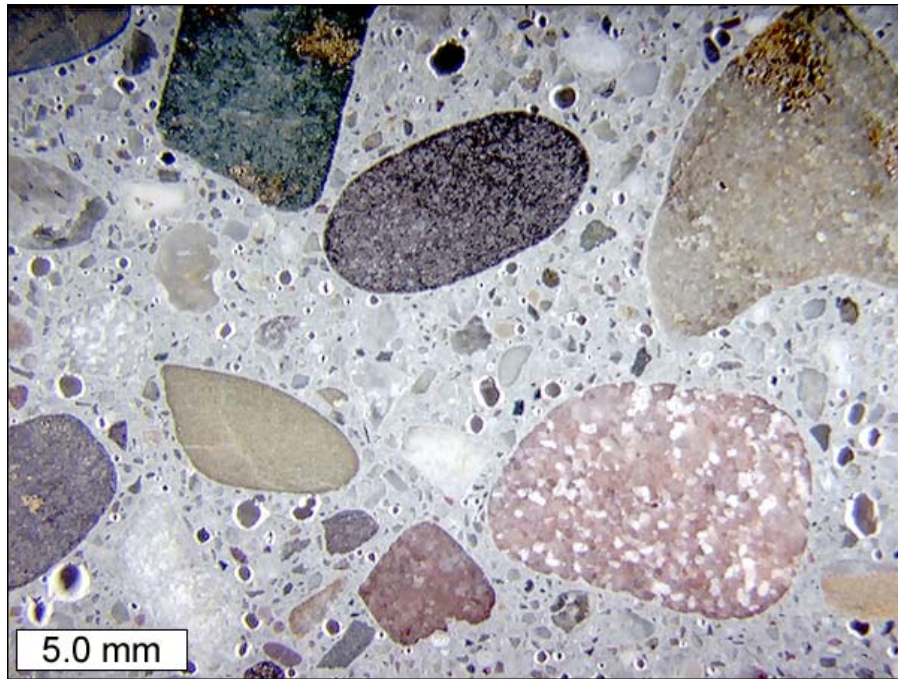
Figure 3.17. Stereomicroscope image of polished surface from core MT\_02, magnified here approximately 4x.

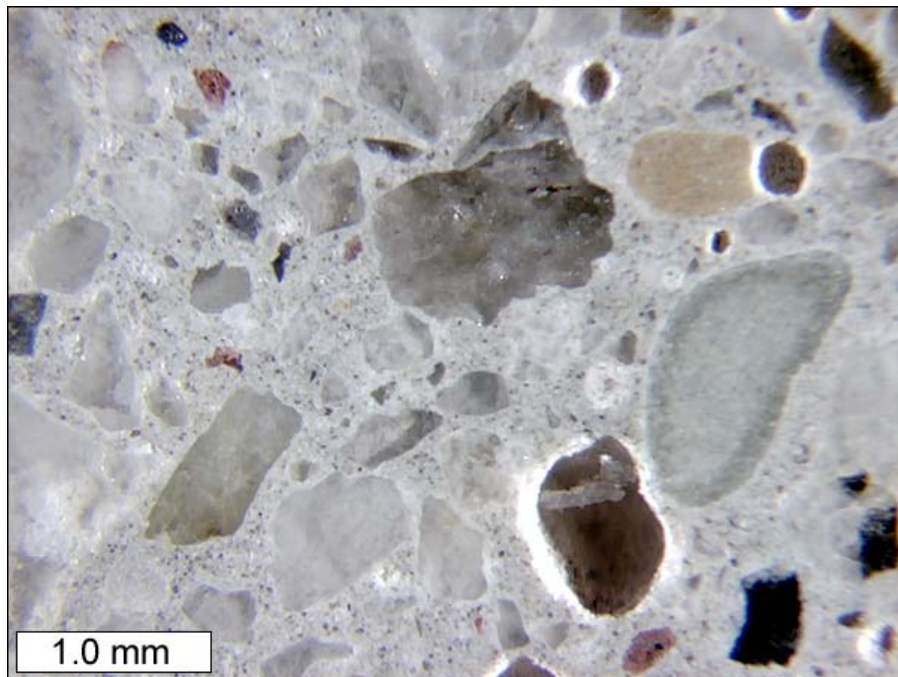
Figure 3.18. Stereomicroscope image of polished surface from core MT\_02, magnified here approximately 22x.

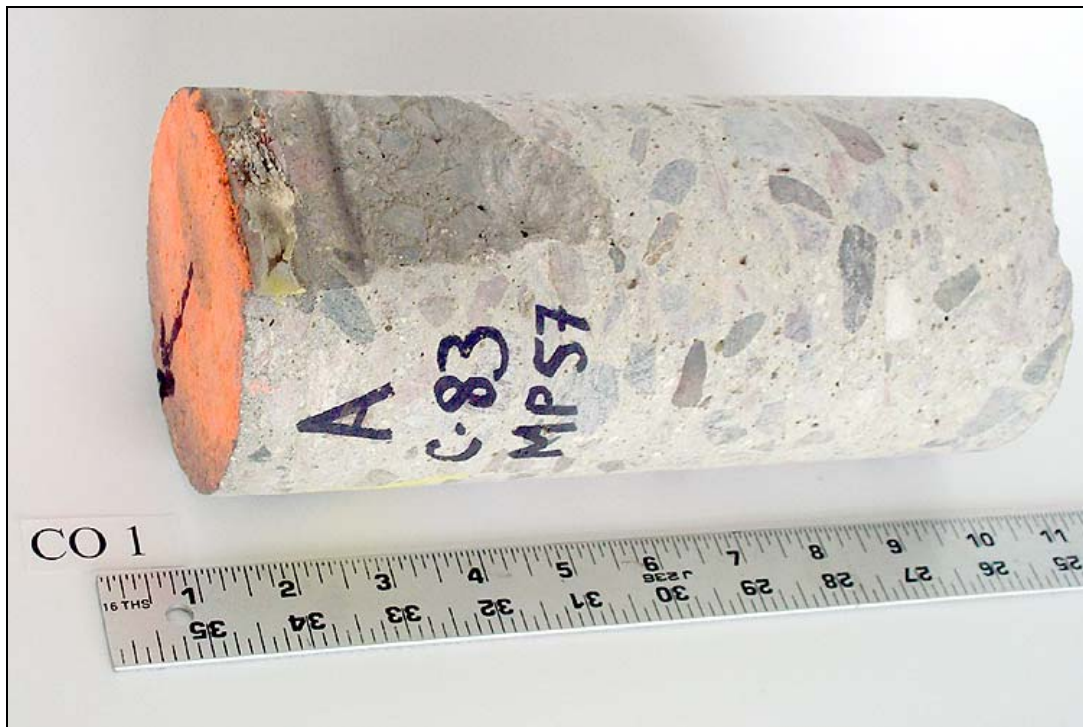
Figure 3.19. Core as received from Colorado site, at joint (CO\_01).

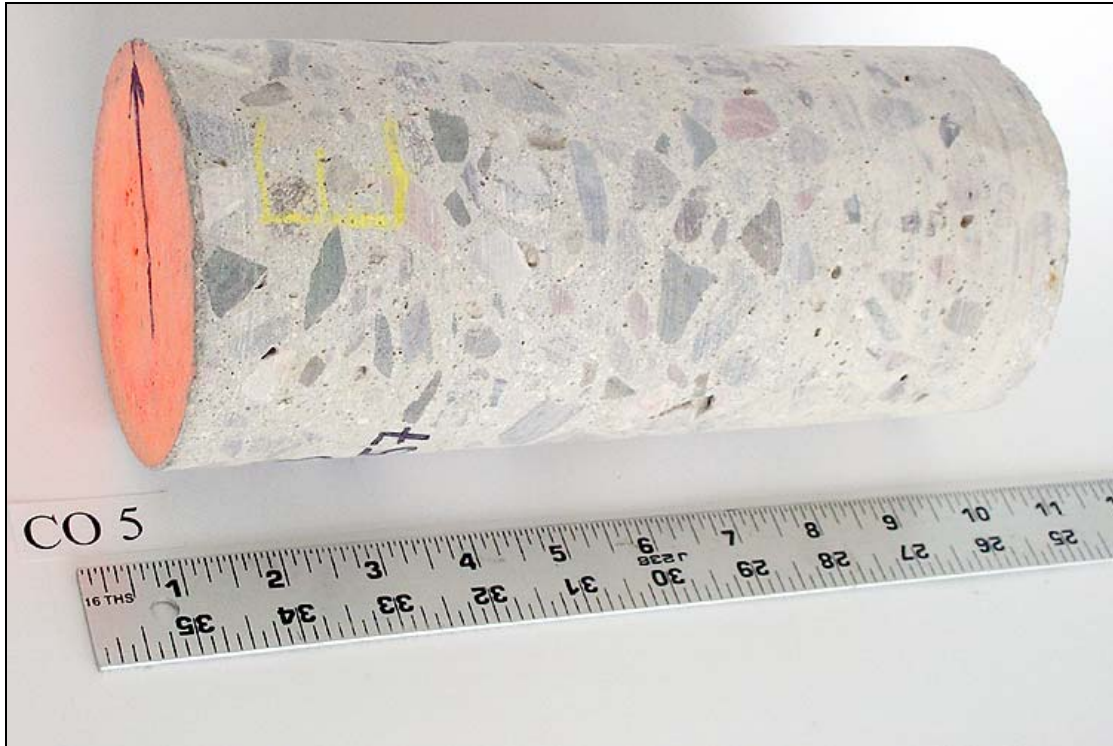
Figure 3.20. Core as received from Colorado site, away from joint (CO\_05).

Ten cores were received from the Colorado site. Four cores were taken at the joint, and six cores were taken away from the joint. Two cores were selected for study, one core from the joint, and one core away from the joint. Figures 3.19 and 3.20 show the cores as received. Figure 3.21 shows a photograph of cracks in the pavement at the site. Table 3.4 summarizes the results of a modified point-count performed according to ASTM C 457 performed on a polished slab from each of the cores. Figures 3.22 and 3.23 show successively zoomed in images of the core ID\_R07 to illustrate the air void structure. Some alkali-silica reactive sand particles were observed on the polished slabs. Figures 3.24 and 3.25 show a reactive sand particle and an adjoining mass of alkali-silica reaction product both before and after staining with sodium cobaltinitrite solution.

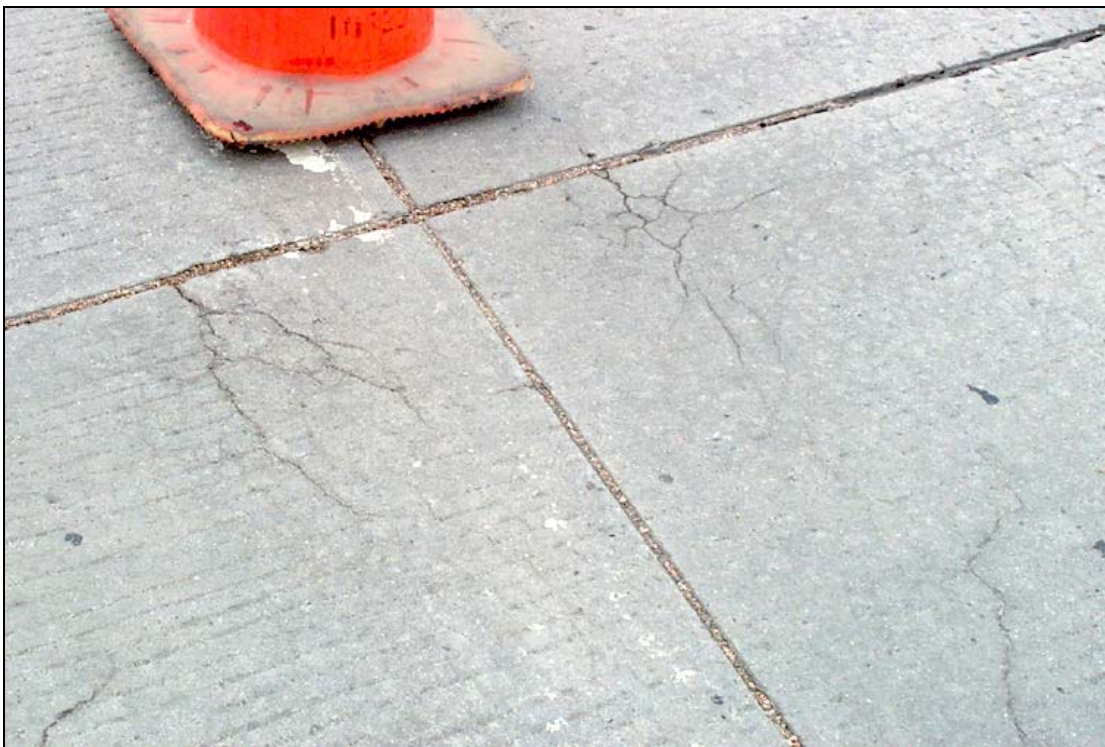
Figure 3.21. Photograph of cracks in pavement at Colorado site.

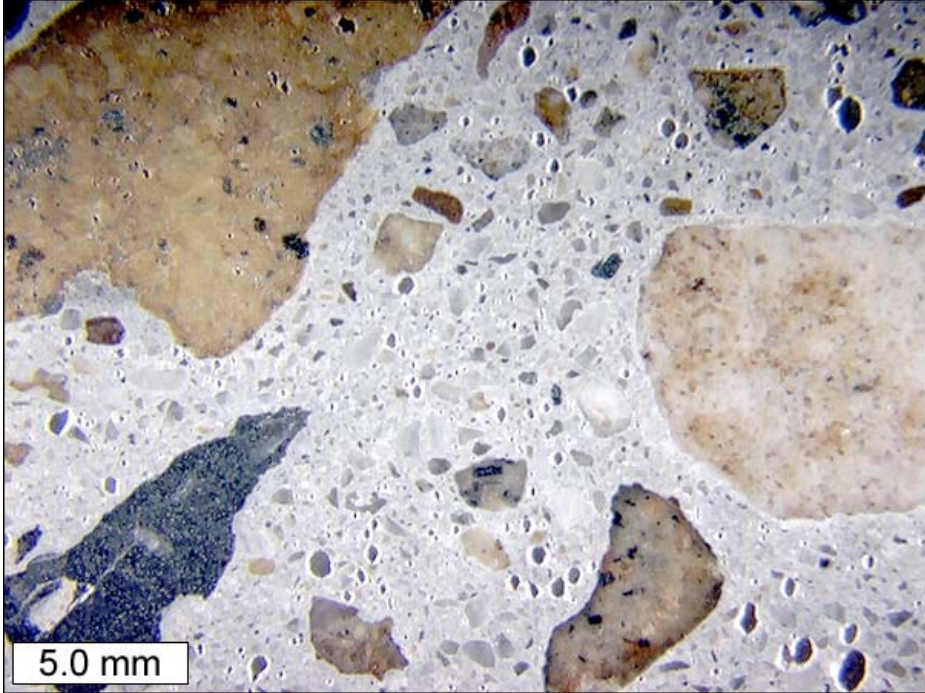
Figure 3.22. Stereomicroscope image of polished surface from core CO\_01, magnified here approximately 4x.

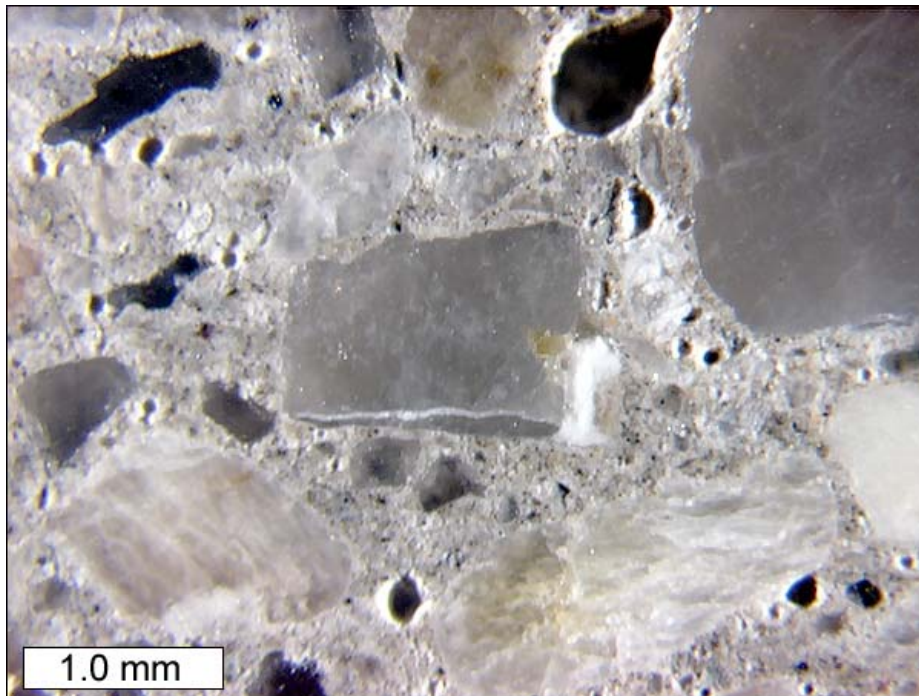
Figure 3.24. Stereomicroscope image of polished surface from core CO\_05 showing alkali-silica reactive sand particle before staining procedure.

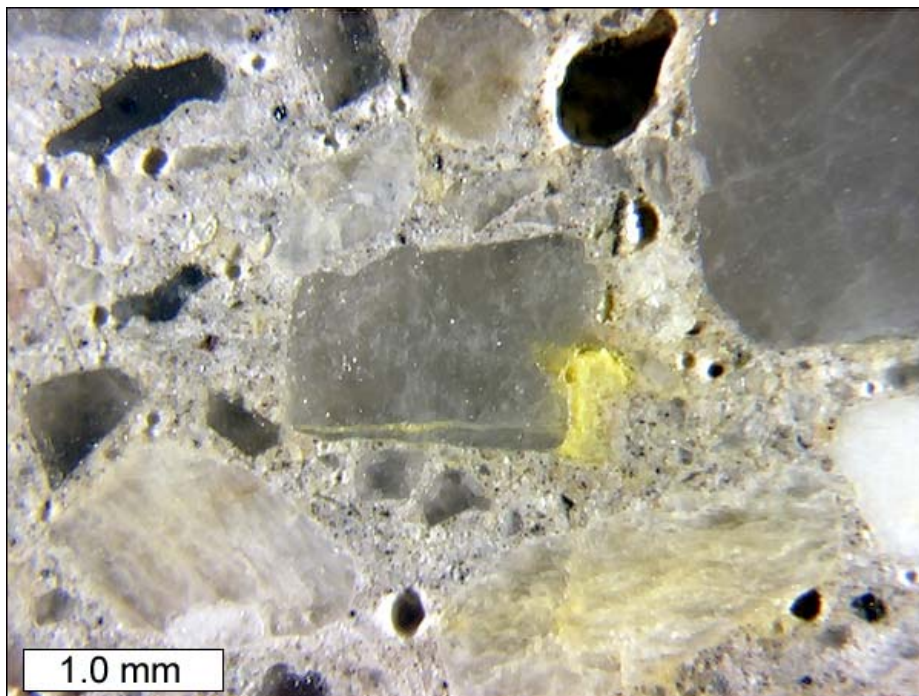
Figure 3.25. Stereomicroscope image of polished surface from core CO\_05 showing alkali-silica reactive sand particle after staining procedure.

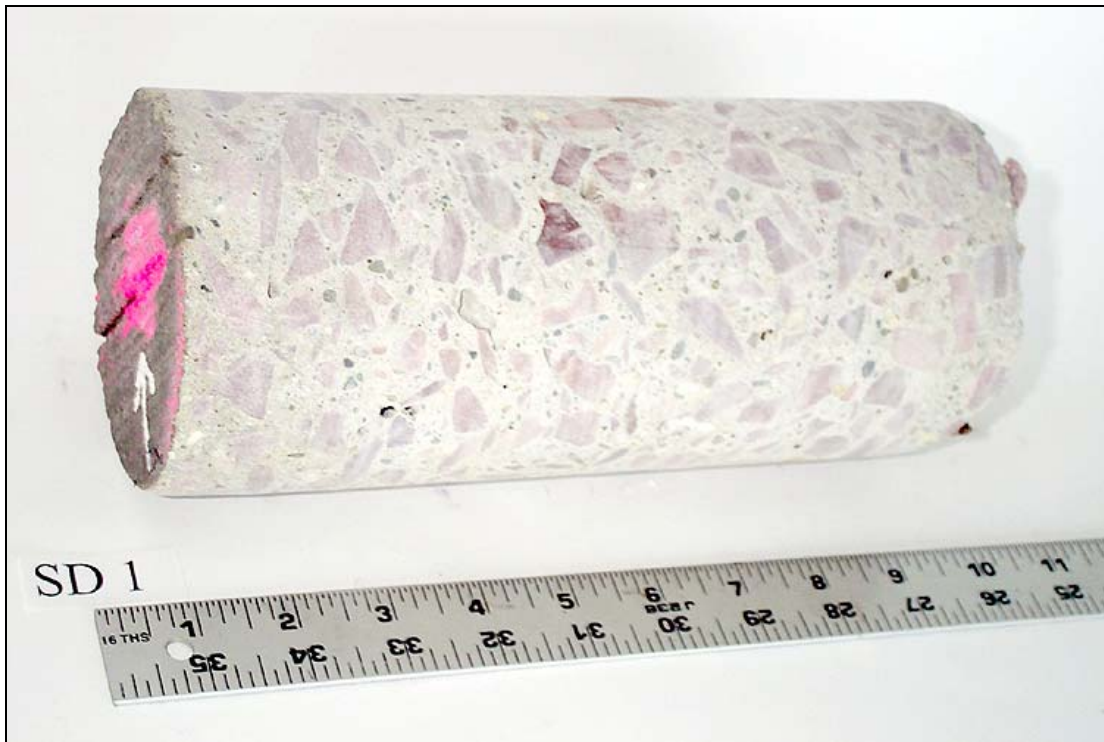
Figure 3.26. Core as received from South Dakota site, at joint (SD\_01).

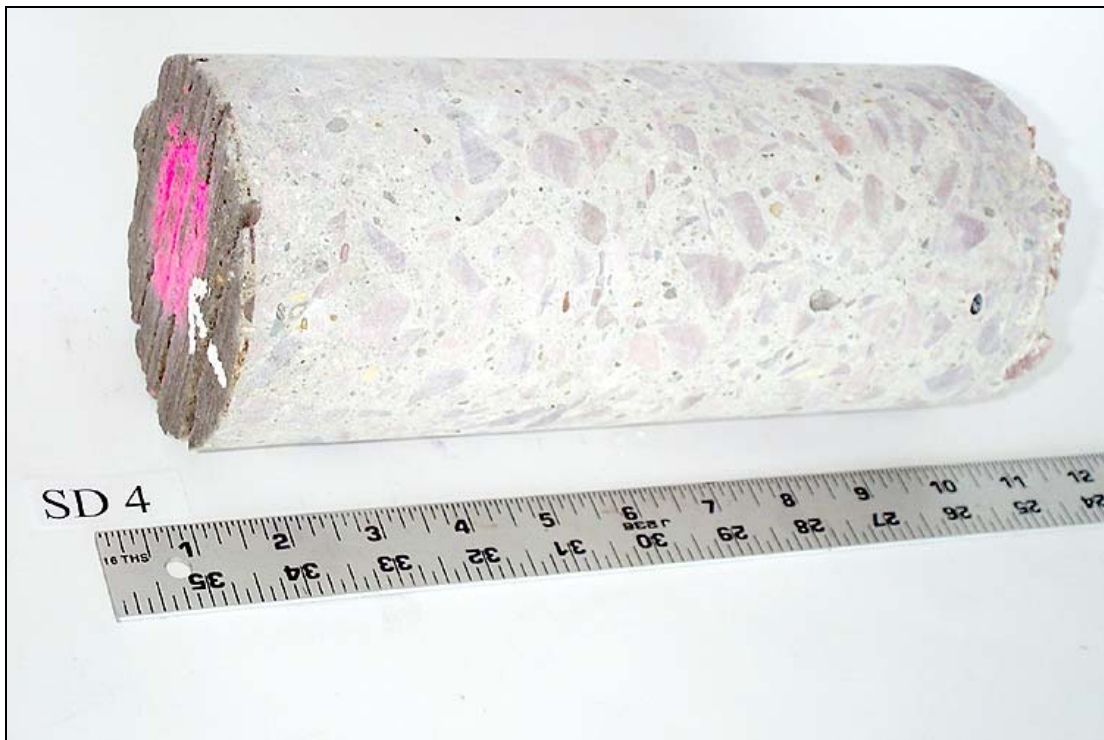
Figure 3.27. Core as received from South Dakota site, away from joint (SD\_04).

Ten cores were received from the South Dakota site. Four cores were taken at the joint, and six cores were taken away from the joint. Two cores were selected for study, one core from the joint, and one core away from the joint. Figures 3.26 and 3.27 show the cores as received. Figures 3.28 and 3.29 show photographs of the coring site. Table 3.5 summarizes the results of a modified point-count performed according to ASTM C 457 performed on a polished slab from each of the cores. Figures 3.30 and 3.31 show successively zoomed in images of the core SD\_04 to illustrate the air void structure.

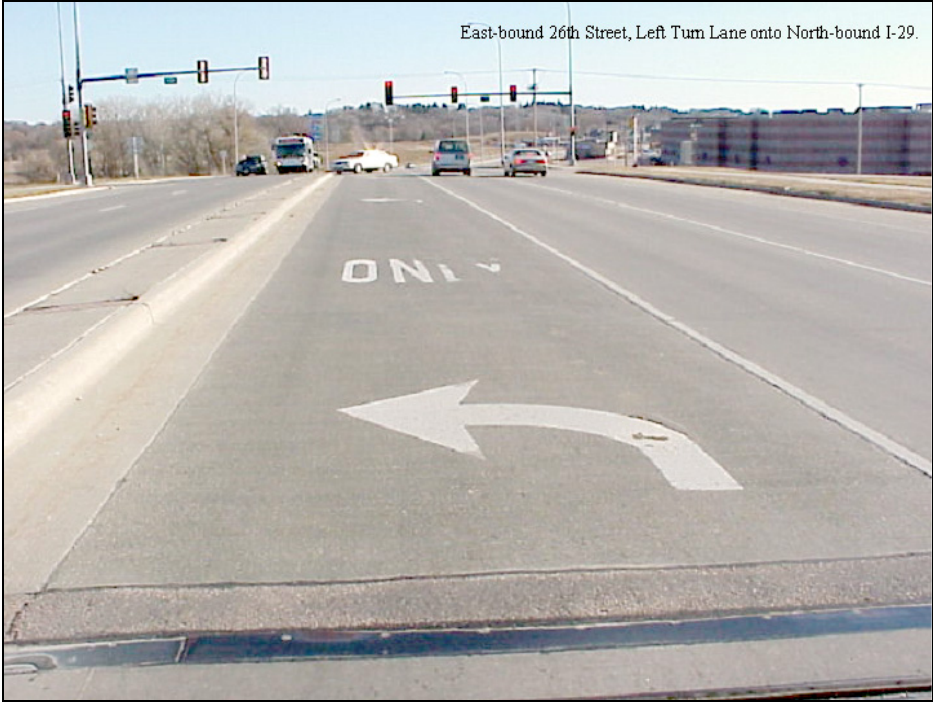
Figure 3.28. Photograph of South Dakota coring site.

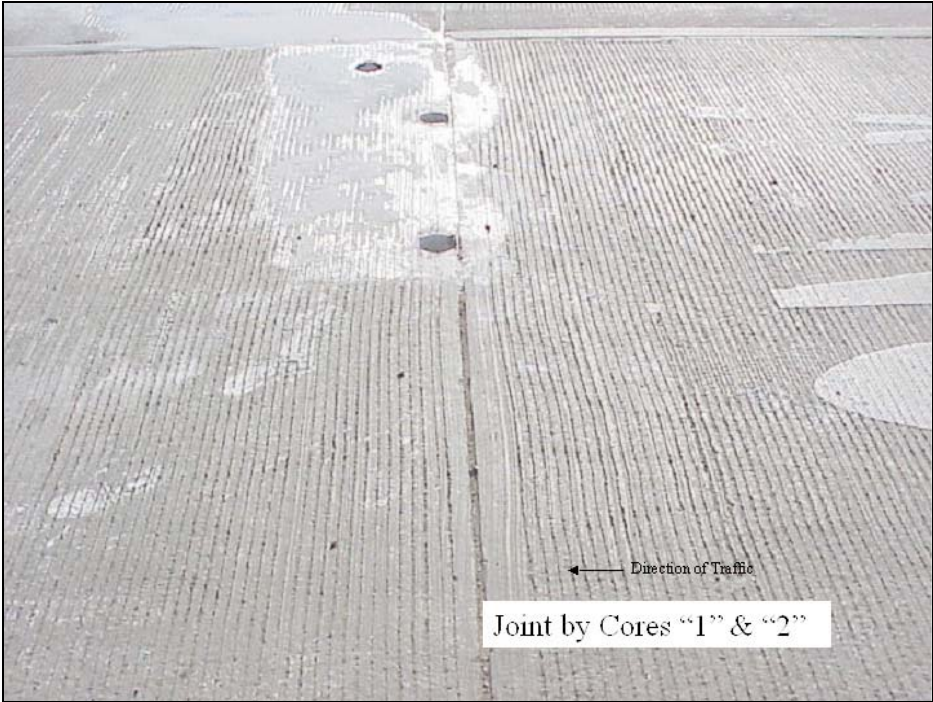
Figure 3.29. Photograph of South Dakota coring site.

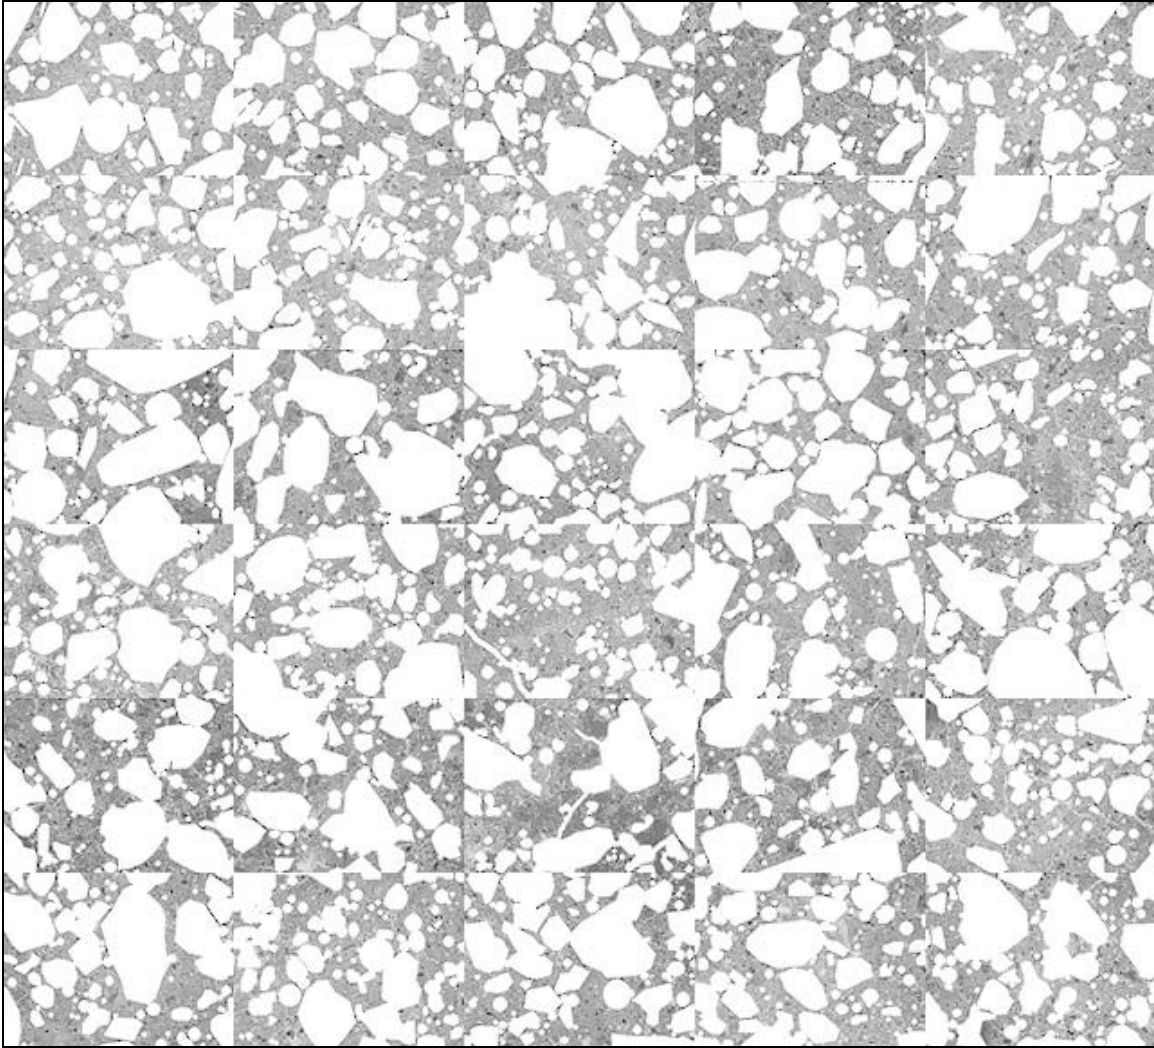
Figure 3.33. A 5 x 6 mosaic of 30 epifluorescent mode images from thin sections prepared from core SD\_01 after masking out sand and air voids, magnified 17x.

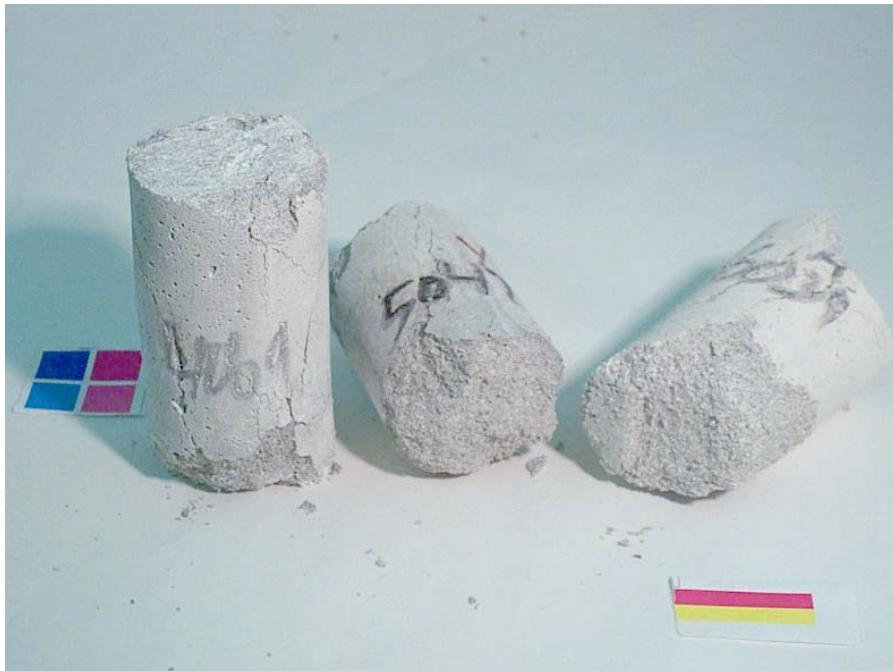
Figure 3.40. Cylinders exposed to rock salt NaCl solution after 8 days of cyclic temperature test. From left to right: 0.40, 0.50, and 0.60 w/c mortar cylinders.

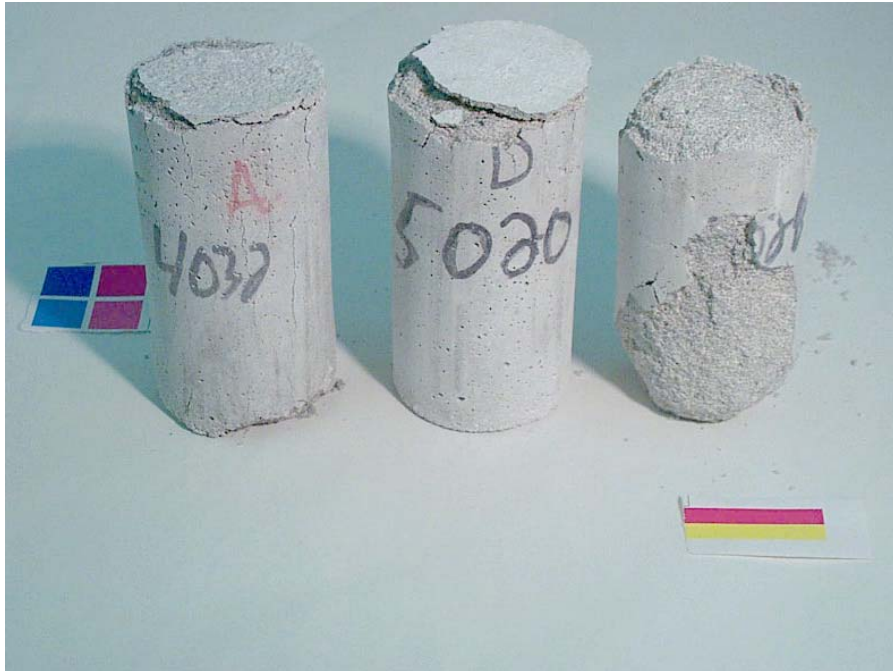
Figure 3.41. Cylinders exposed to food grade NaCl solution after 8 days of cyclic temperature test. From left to right: 0.40, 0.50, and 0.60 w/c mortar cylinders.

completely disintegrated. The experiment was repeated a second time, replacing the rock salt NaCl with food grade NaCl to ensure sulfate impurities were not to blame. The results were the same. Figure 3.40 shows three of the cylinders exposed to rock salt NaCl solution after 8 days, and Figure 3.41 shows three of the cylinders exposed to food grade NaCl solution after 8 days. Figures 3.42 and 3.43 show the cylinders in the drained test bins for both the rock salt NaCl and food grade NaCl solutions after 28 days. After 28 days, the NaCl deicer experiments were aborted.

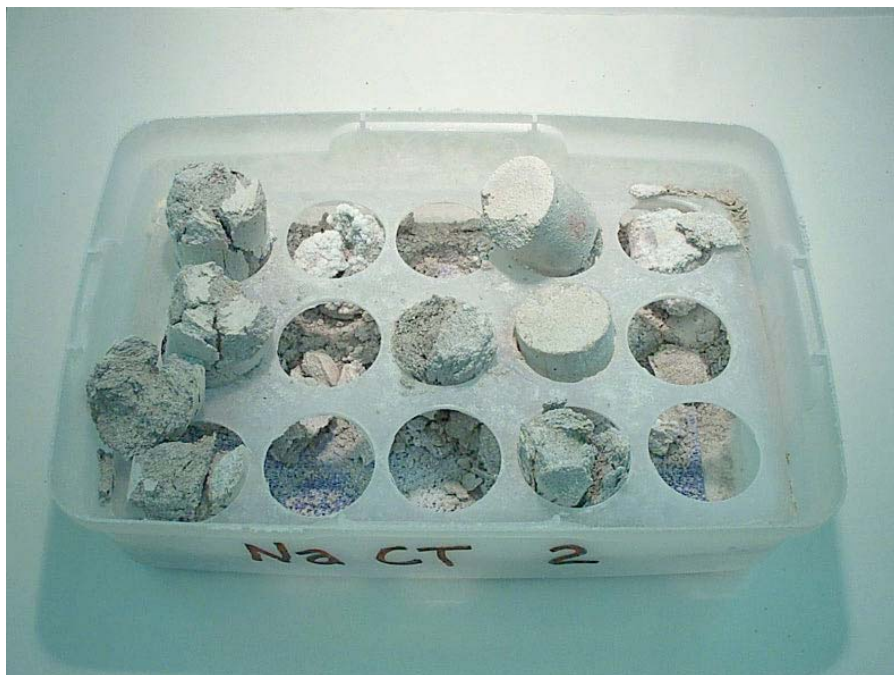
Figure 3.42 Cylinders exposed to rock salt NaCl solution in drained tray after 28 days of cyclic temperature test.

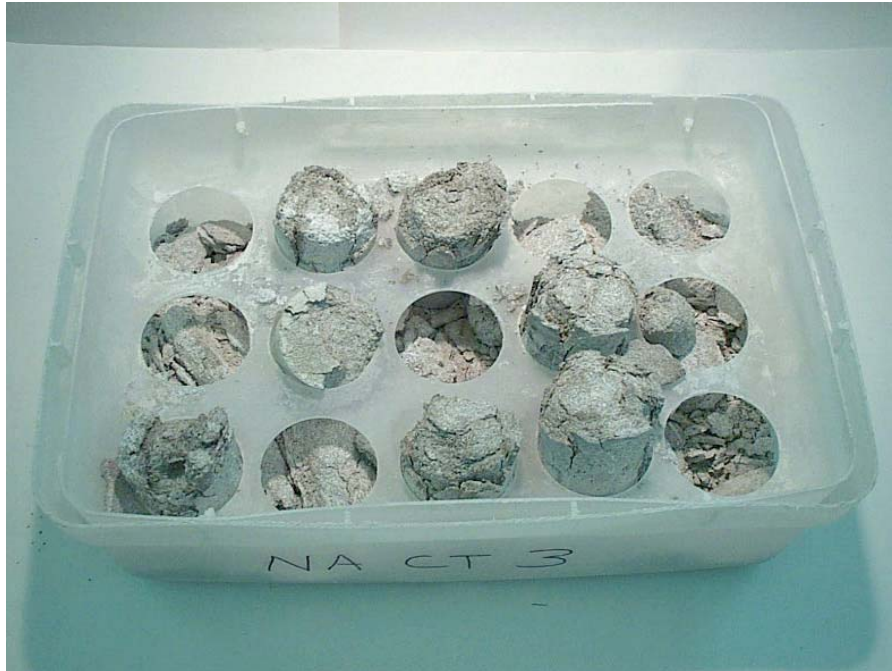
Figure 3.43 Cylinders exposed to food grade NaCl solution in drained tray after 28 days of cyclic temperature test.
