## INTERIM REPORT

Investigation of the Long Term Effects of Magnesium Chloride and  
Other Concentrated Salt Solutions on Pavement and Structural  
Portland Cement Concrete

SD2002-01  
Submitted by:

January 2005

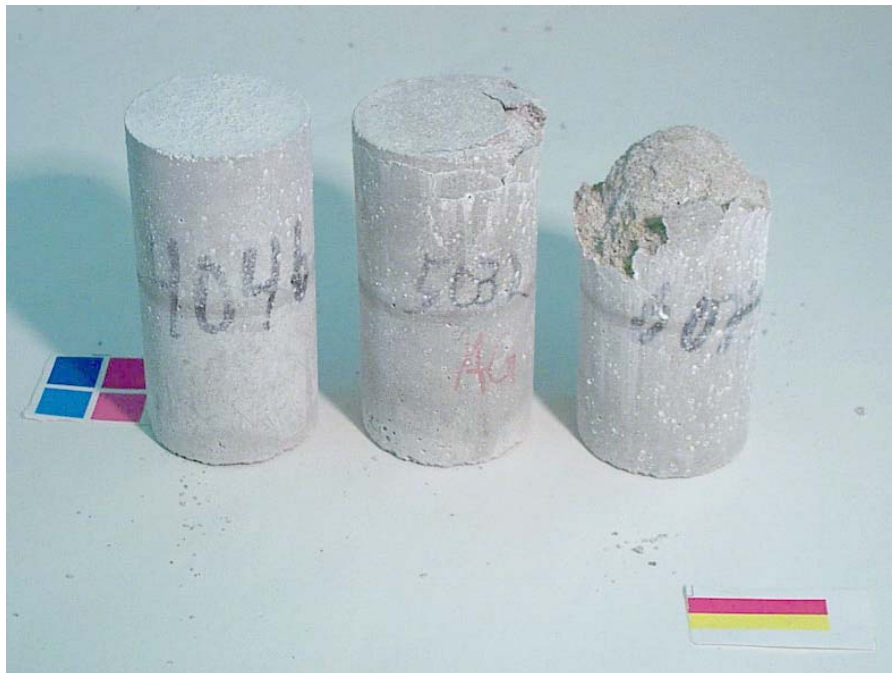
Figure 3.44 Cylinders exposed to  $MgCl_2$  solution after 56 days of cyclic temperature test. From left to right: 0.40, 0.50, and 0.60 w/c mortar cylinders

At 28 days the cylinders in the  $MgCl_2$  and  $CaCl_2$  solutions began to show some signs of cracking and expansion. By 56 days, the cylinders in the  $MgCl_2$  and  $CaCl_2$  solutions exhibited advanced deterioration. Figure 3.44 shows three of the cylinders exposed to  $MgCl_2$  solution after 56 days. Figure 3.45 shows three of the cylinders exposed to  $CaCl_2$  solution after 56 days. By 84 days the cylinders exposed to  $MgCl_2$  and  $CaCl_2$  solutions were severely deteriorated, as shown in Figures 3.46 and 3.47. It was decided that instead of running the testing out to the original 112 days, to end the test for all the cylinders at 84 days. The control cylinders exposed to lime water were in good condition at 84 days, as shown in Figure 3.48. The cylinders exposed to the CMA solution were cycled to 84 days. Figure 3.49 shows the cylinders exposed to CMA at 84 days, with limited cracking and crumbling evident near the bases of the 0.60 w/c cylinders. Table 3.9 summarizes the visual ratings for all cylinders exposed to the cyclic temperature experiment over time for both the control (lime water) and deicer solutions.

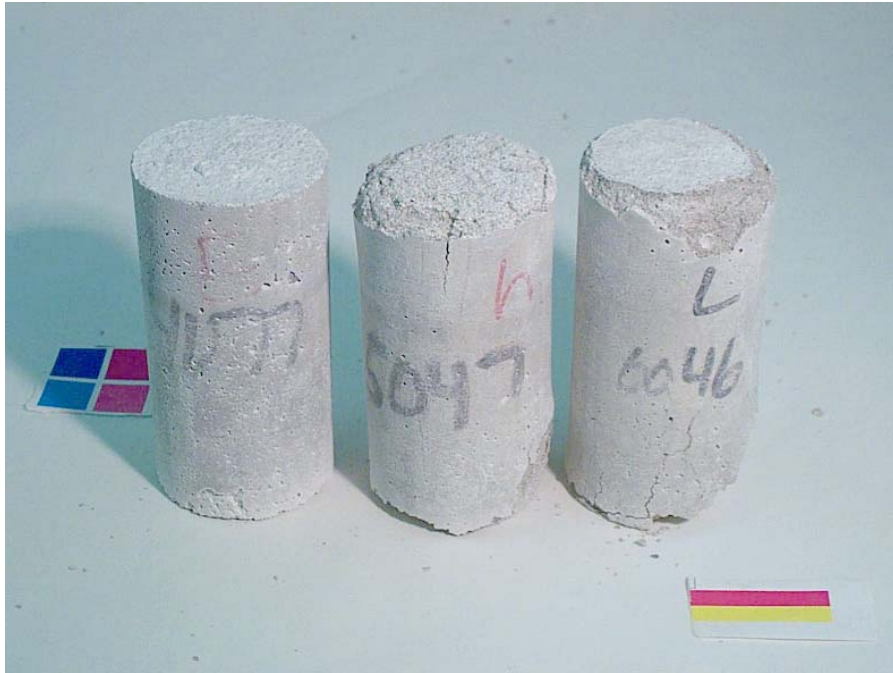
Figure 3.45 Cylinders exposed to  $\text{CaCl}_2$  solution after 56 days of cyclic temperature test. From left to right: 0.40, 0.50, and 0.60 w/c mortar cylinders.

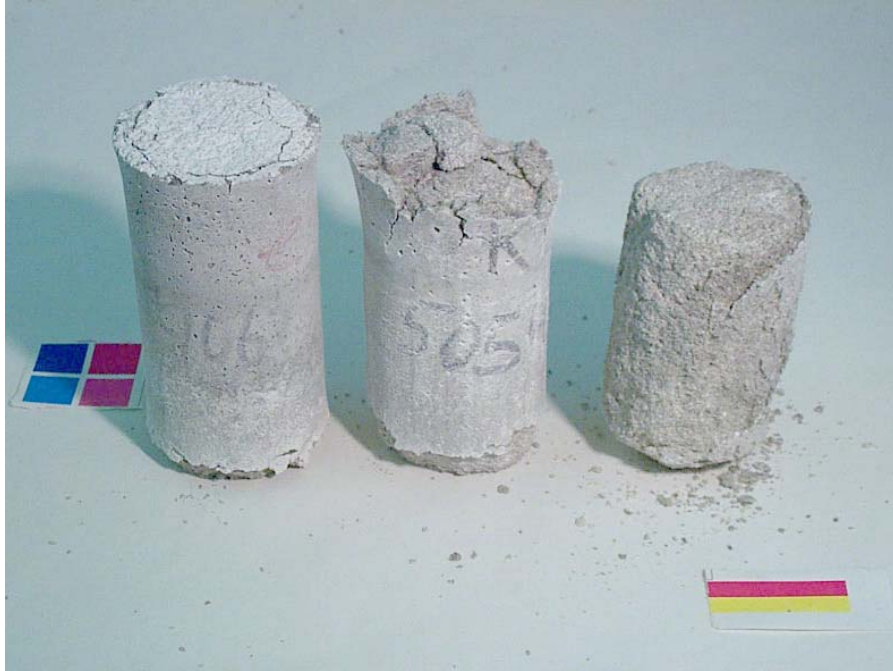
Figure 3.47. Cylinders exposed to  $\text{CaCl}_2$  solution after 84 days of cyclic temperature test. From left to right: 0.40, 0.50, and 0.60 w/c mortar cylinders.

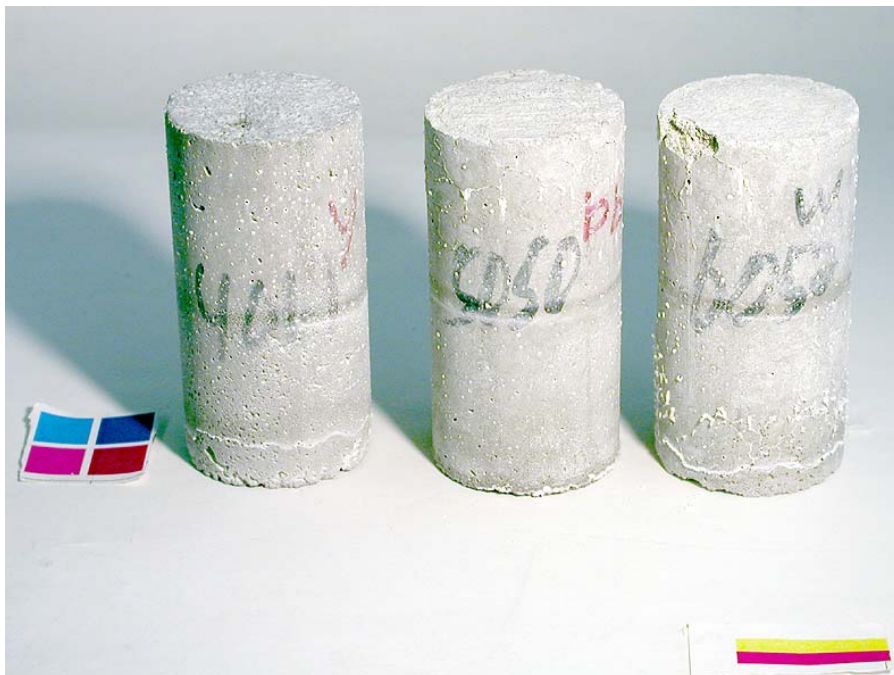
Figure 3.48. Cylinders exposed to CMA solution after 84 days of cyclic temperature test. From left to right: 0.40, 0.50, and 0.60 w/c mortar cylinders.

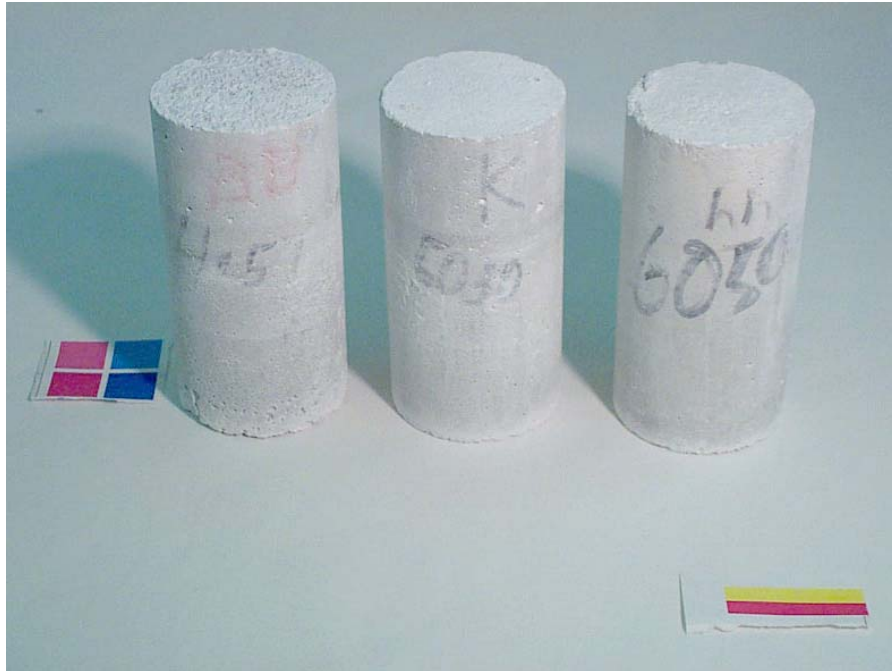
Figure 3.49. Control cylinders exposed to lime water solution after 84 days of cyclic temperature test. From left to right 0.40, 0.50, and 0.60 w/c mortar cylinders.

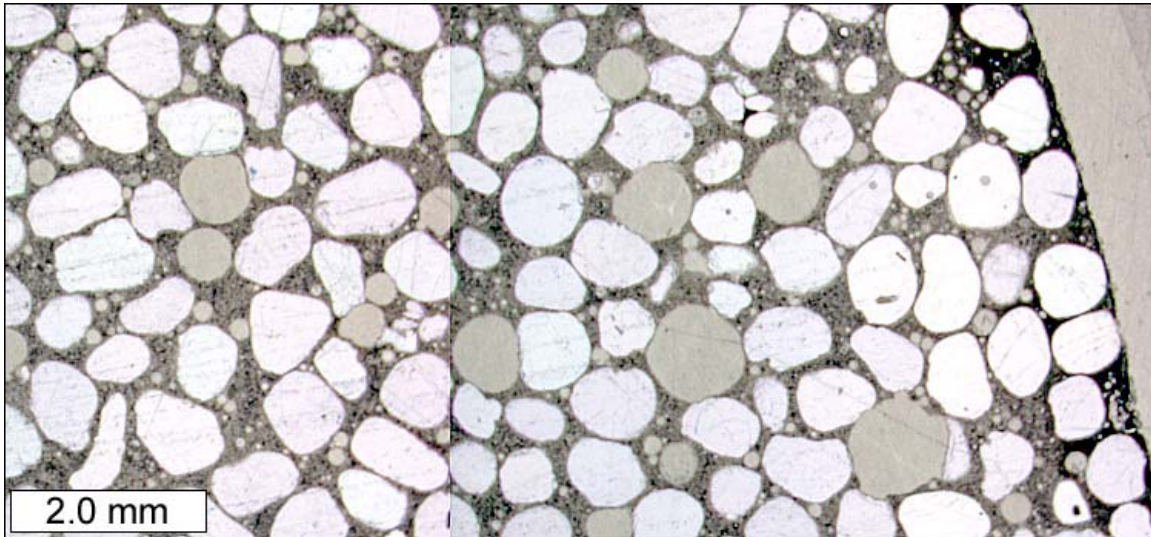
Figure 3.50a: Plane polarized light image from control cylinder.

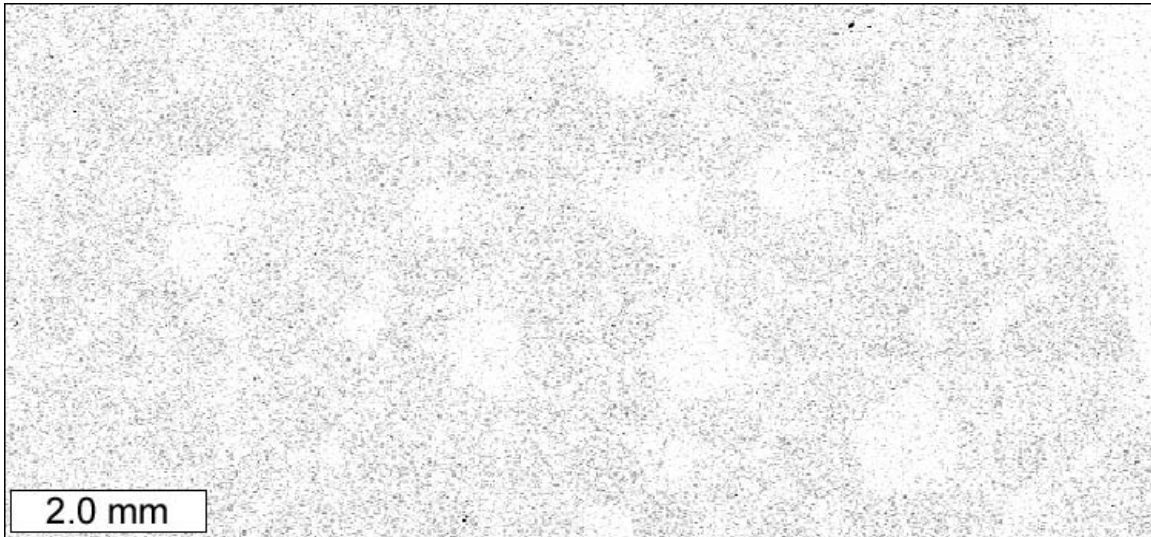
Figure 3.55a: Sodium  $K\alpha$  x-ray map from control cylinder. Darker areas correspond to higher  $K\alpha$  x-ray counts.

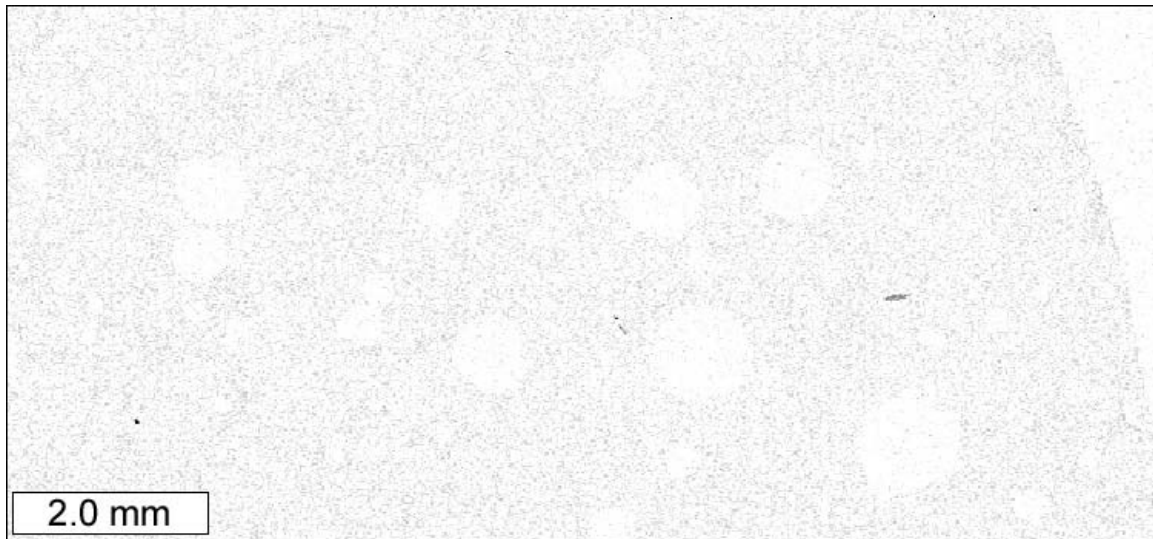
Figure 3.61a: Potassium  $K\alpha$  x-ray map from control cylinder. Darker areas correspond to higher  $K\alpha$  x-ray counts.

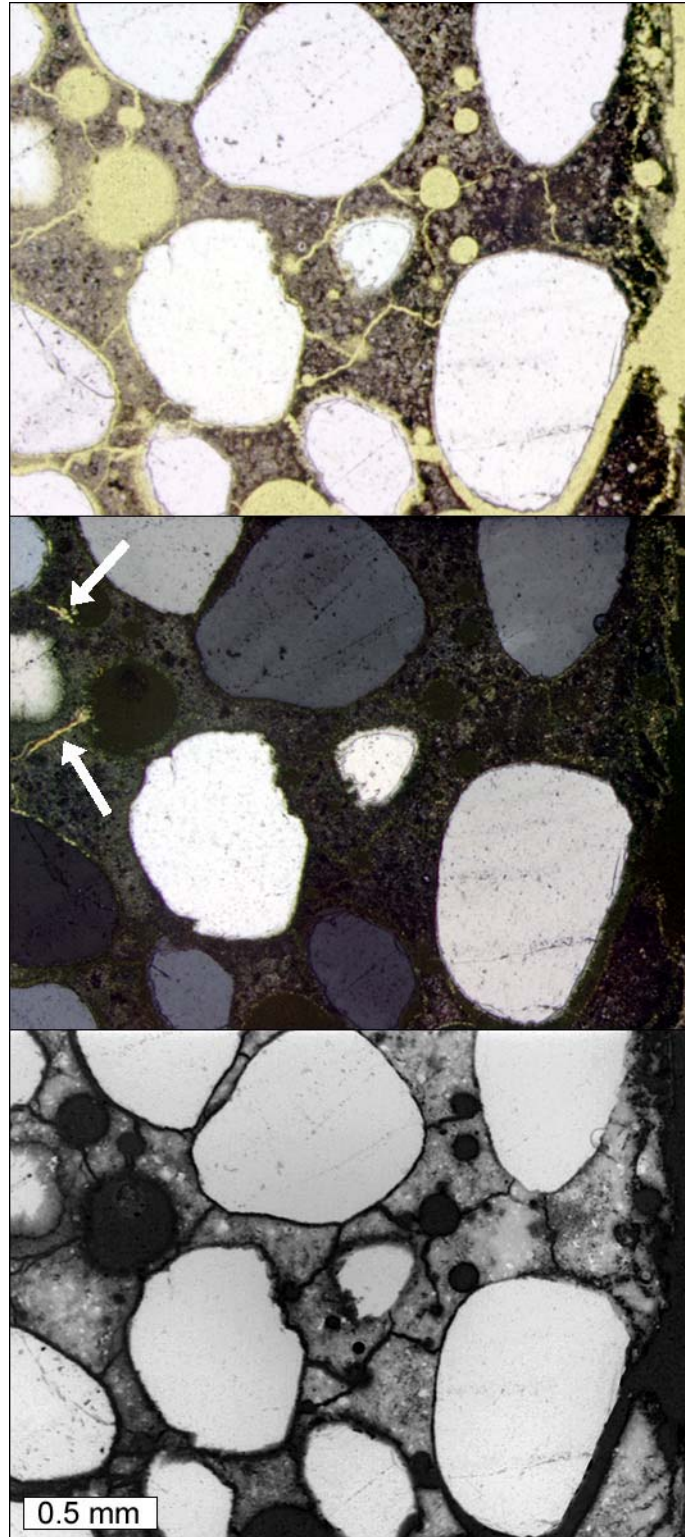
Figure 3.64: Petrographic microscope images of early onset of cracking in  $MgCl_2$  exposed sample from cyclic experiment. White arrows indicate crystalline material filling cracks. From top to bottom: plane polarized light, cross polarized light, and epifluorescent mode.

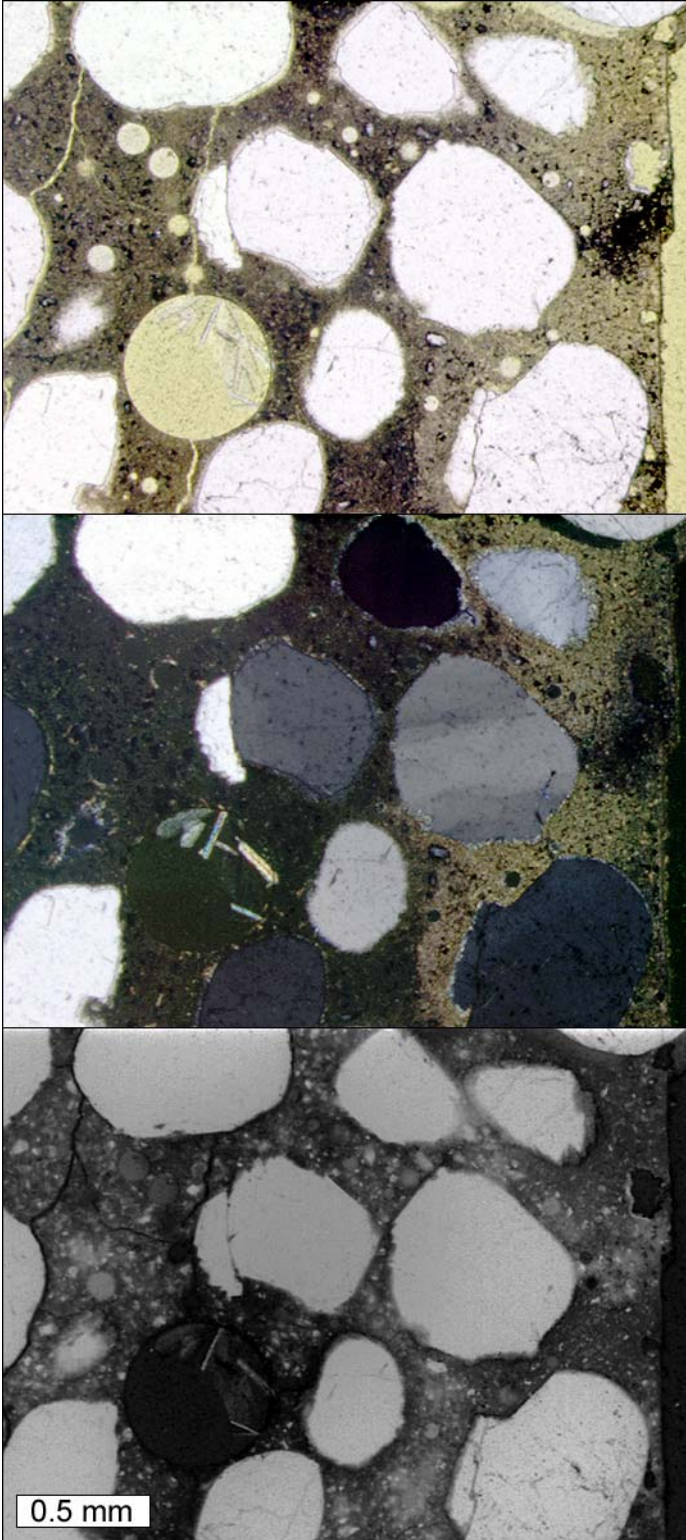
Figure 3.65: Petrographic microscope images of early onset of cracking in NaCl exposed sample from cyclic experiment. From top to bottom: plane polarized light, cross polarized light, and epifluorescent mode.

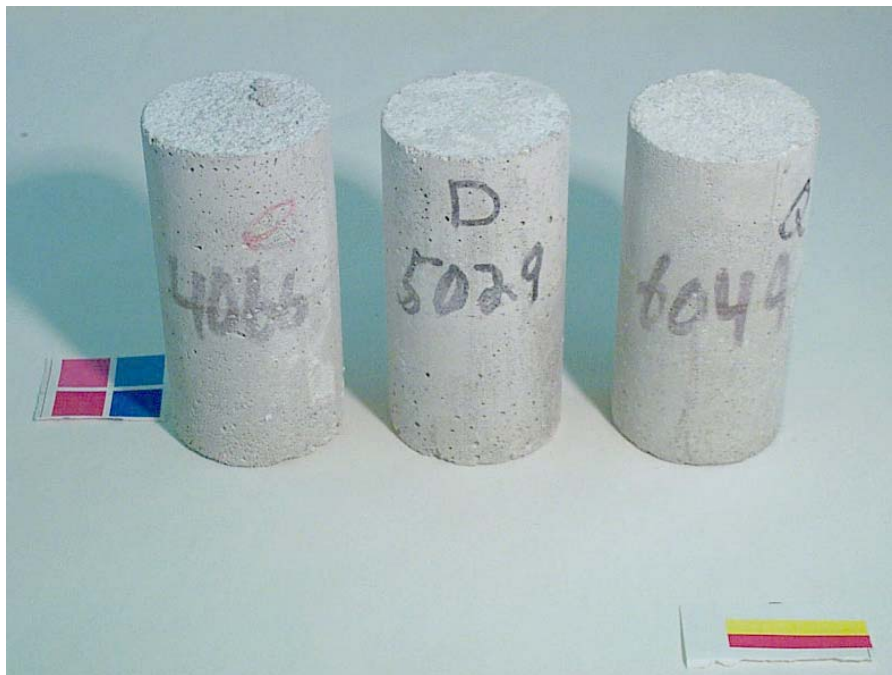
Figure 3.66 Cylinders exposed to NaCl solution after 84 days of constant low temperature test. From left to right: 0.40, 0.50, and 0.60 w/c mortar cylinders.

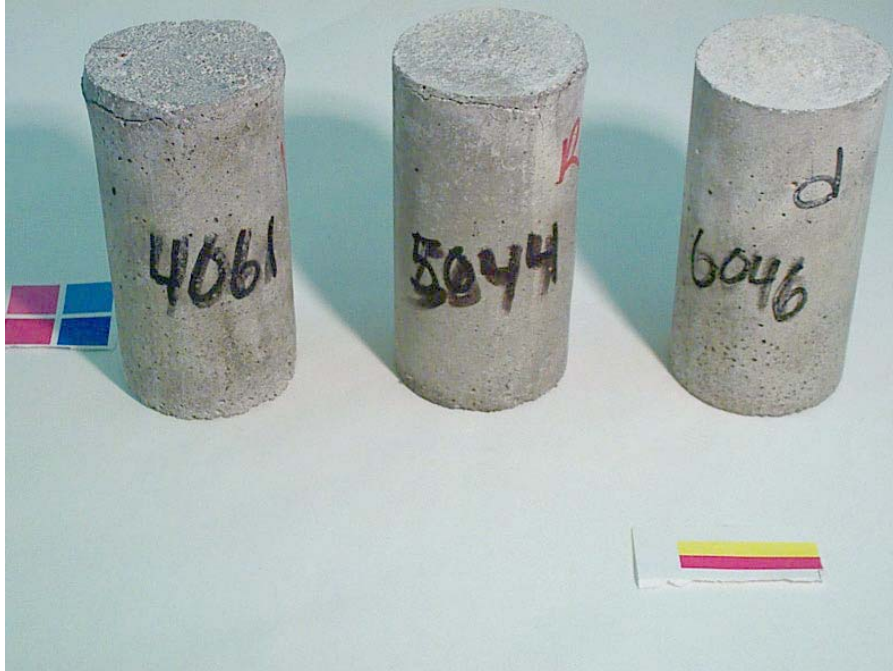
Figure 3.67. Cylinders exposed to  $MgCl_2$  solution after 56 days of constant low temperature test. From left to right: 0.40, 0.50, and 0.60 w/c mortar cylinders.

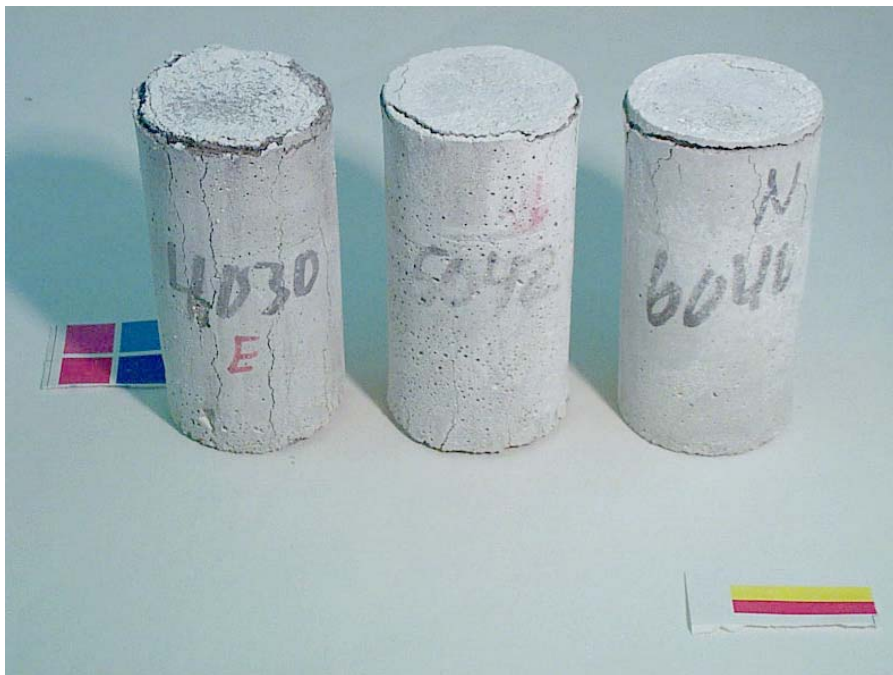
Figure 3.68 Cylinders exposed to  $CaCl_2$  solution after 56 days of constant low temperature test. From left to right: 0.40, 0.50, and 0.60 w/c mortar cylinders.

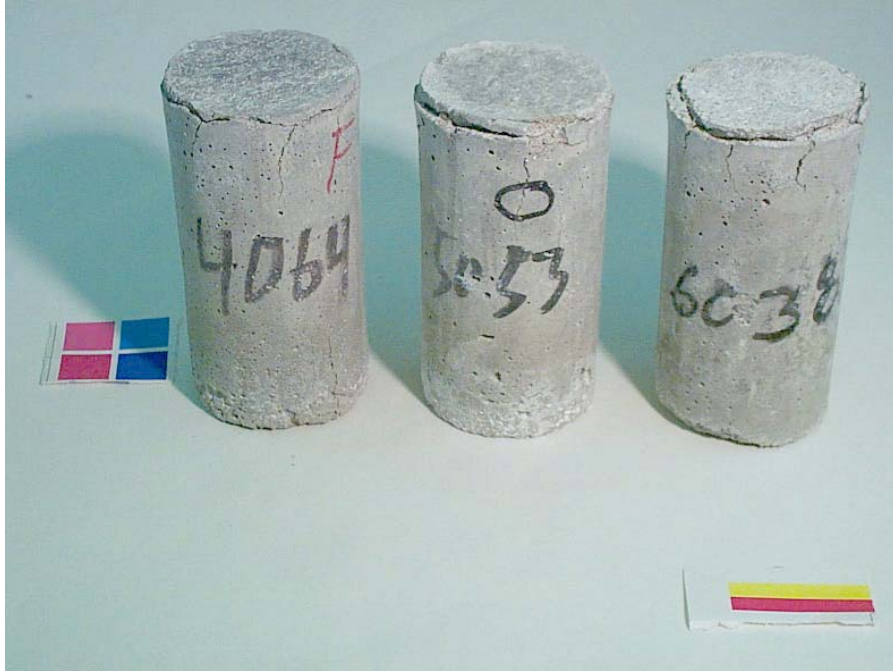
Figure 3.69 Cylinders exposed to  $MgCl_2$  solution after 84 days of constant low temperature test. From left to right: 0.40, 0.50, and 0.60 w/c mortar cylinders.

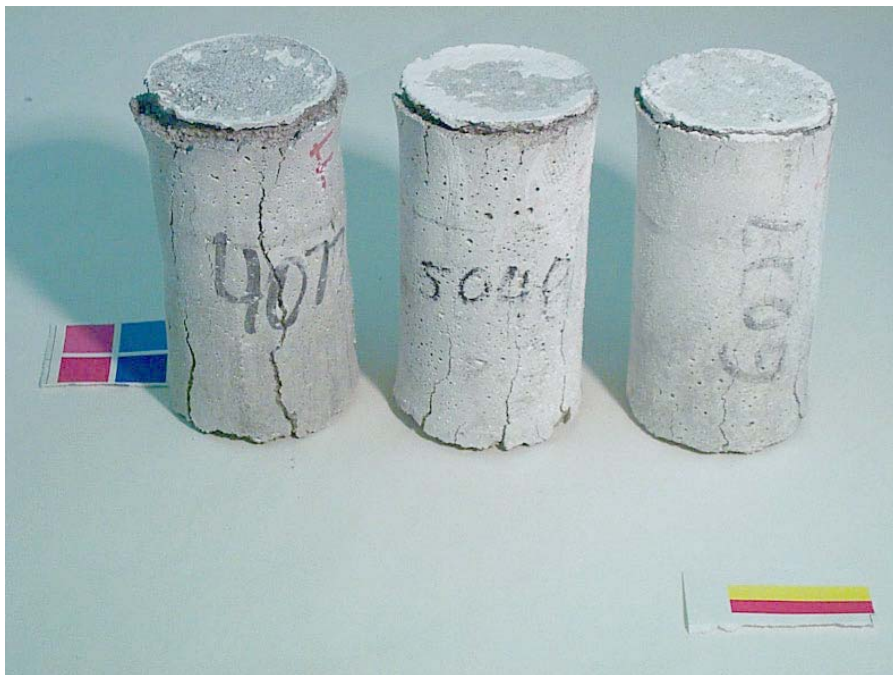
Figure 3.70. Cylinders exposed to  $CaCl_2$  solution after 84 days of constant low temperature test. From left to right: 0.40, 0.50, and 0.60 w/c mortar cylinders.

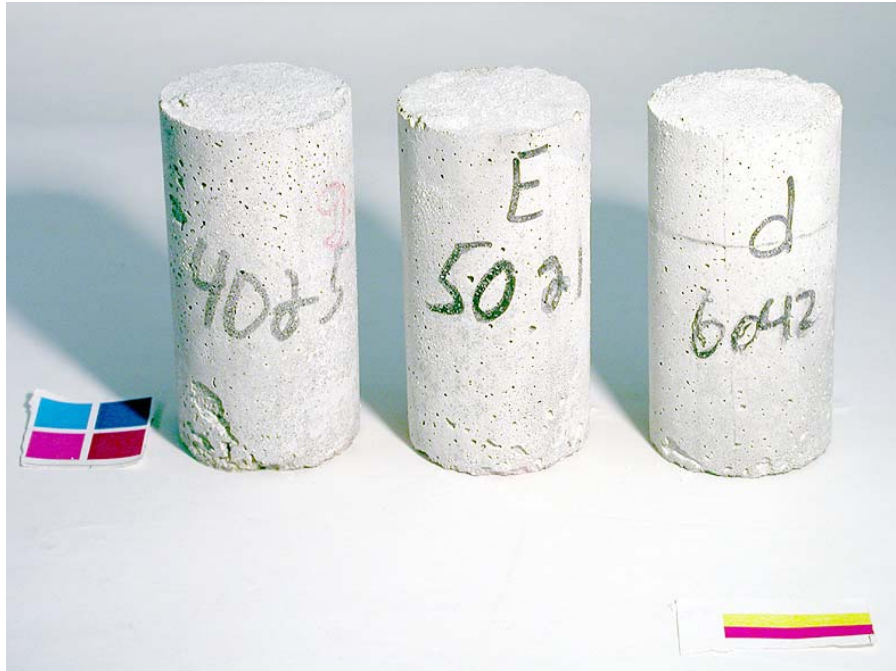
Figure 3.71. Cylinders exposed to CMA solution after 84 days of constant low temperature test. From left to right: 0.40, 0.50, and 0.60 w/c mortar cylinders.

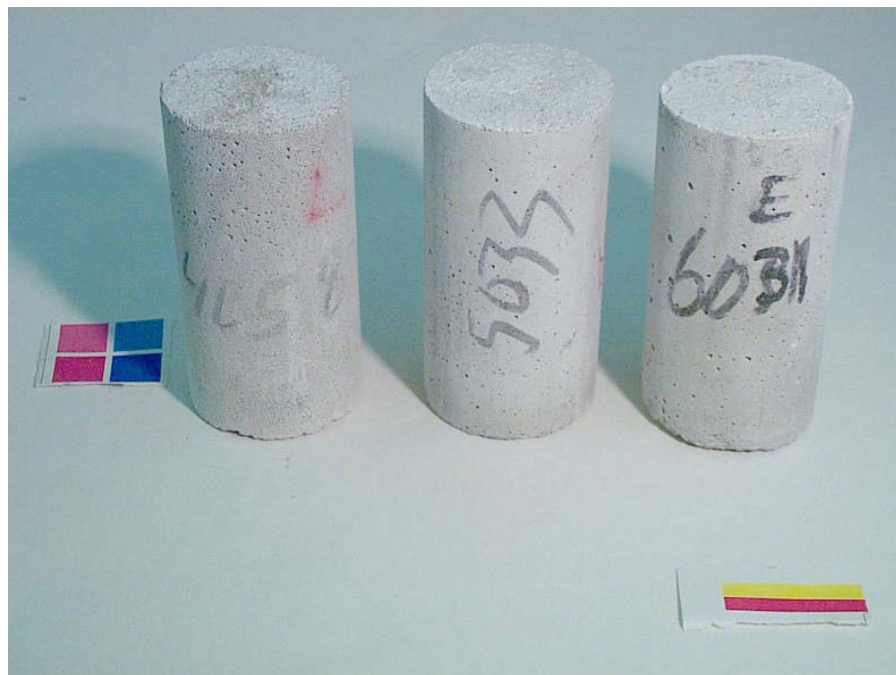
Figure 3.72 Control cylinders exposed to lime water solution after 84 days of constant low temperature test. From left to right: 0.40, 0.50, and 0.60 w/c mortar cylinders.

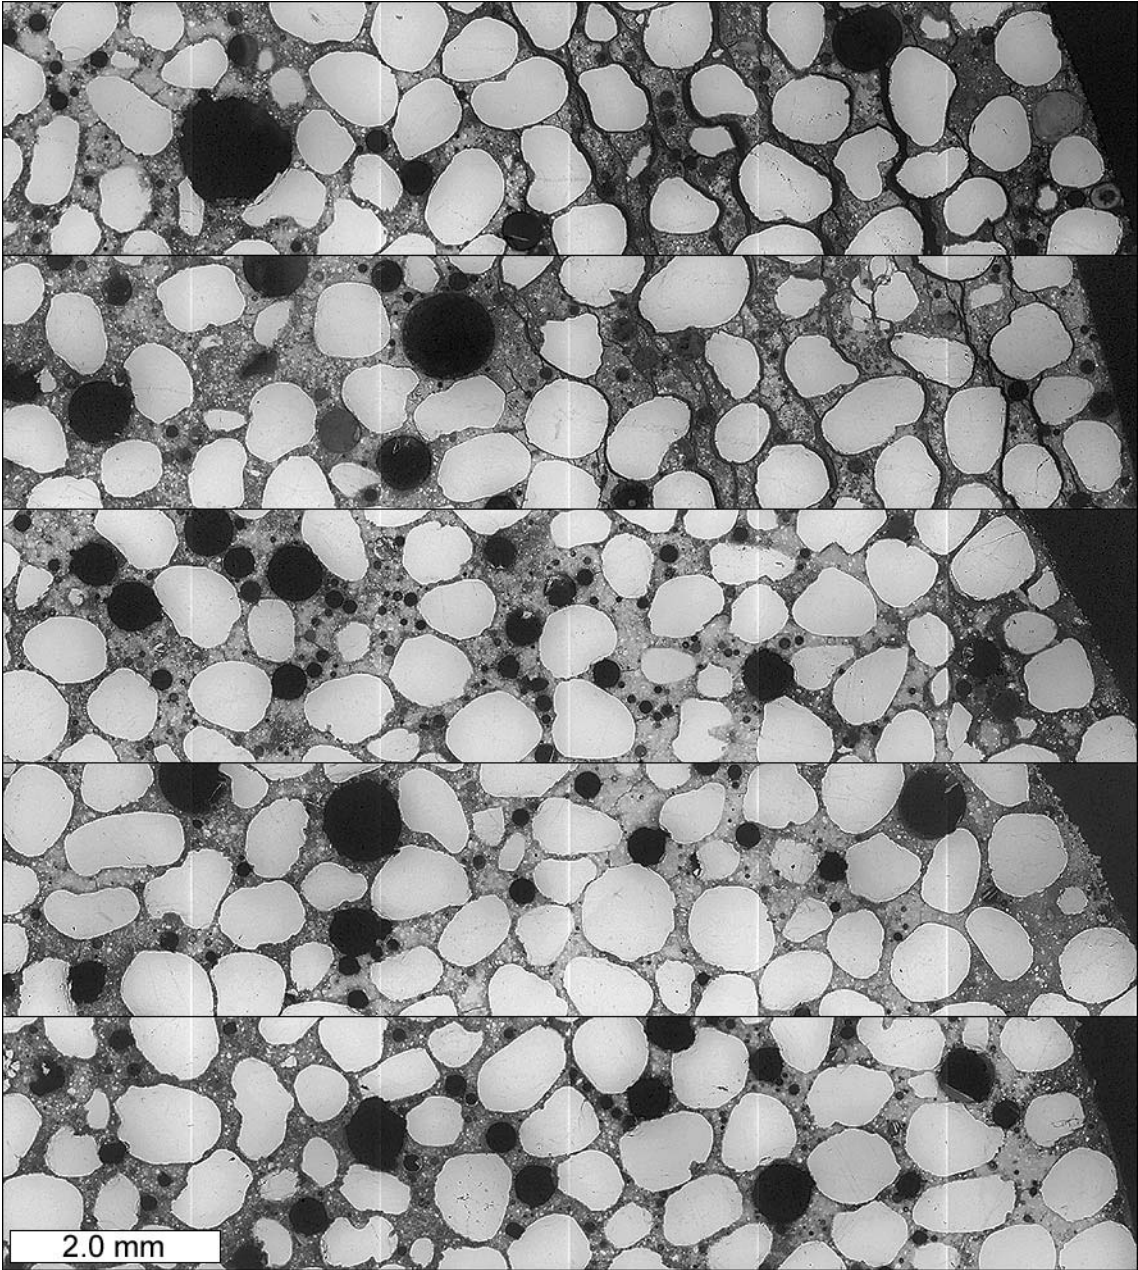
Figure 3.73: Epifluorescent mode images of thin sections prepared from mortar cylinders immersed in the following solutions, from top to bottom: magnesium chloride, calcium chloride, sodium chloride, calcium magnesium acetate, and lime water.

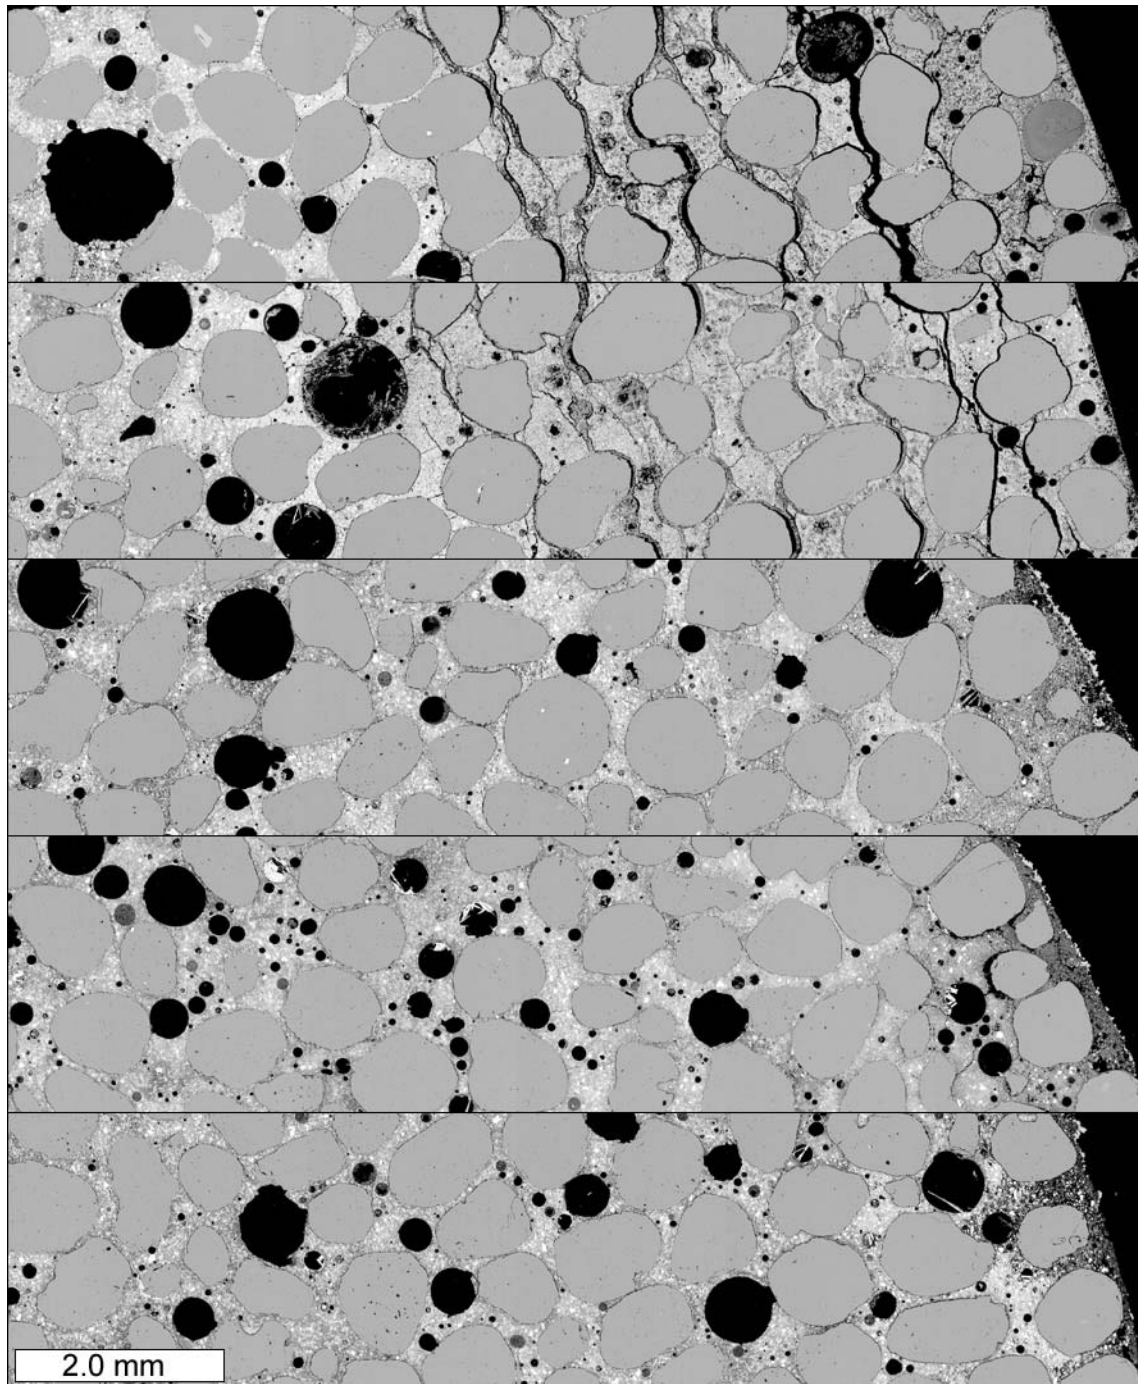
Figure 3.74: Back-scattered electron images of thin sections prepared from mortar cylinders immersed in the following solutions, from top to bottom: magnesium chloride, calcium chloride, sodium chloride, calcium magnesium acetate, and lime water.

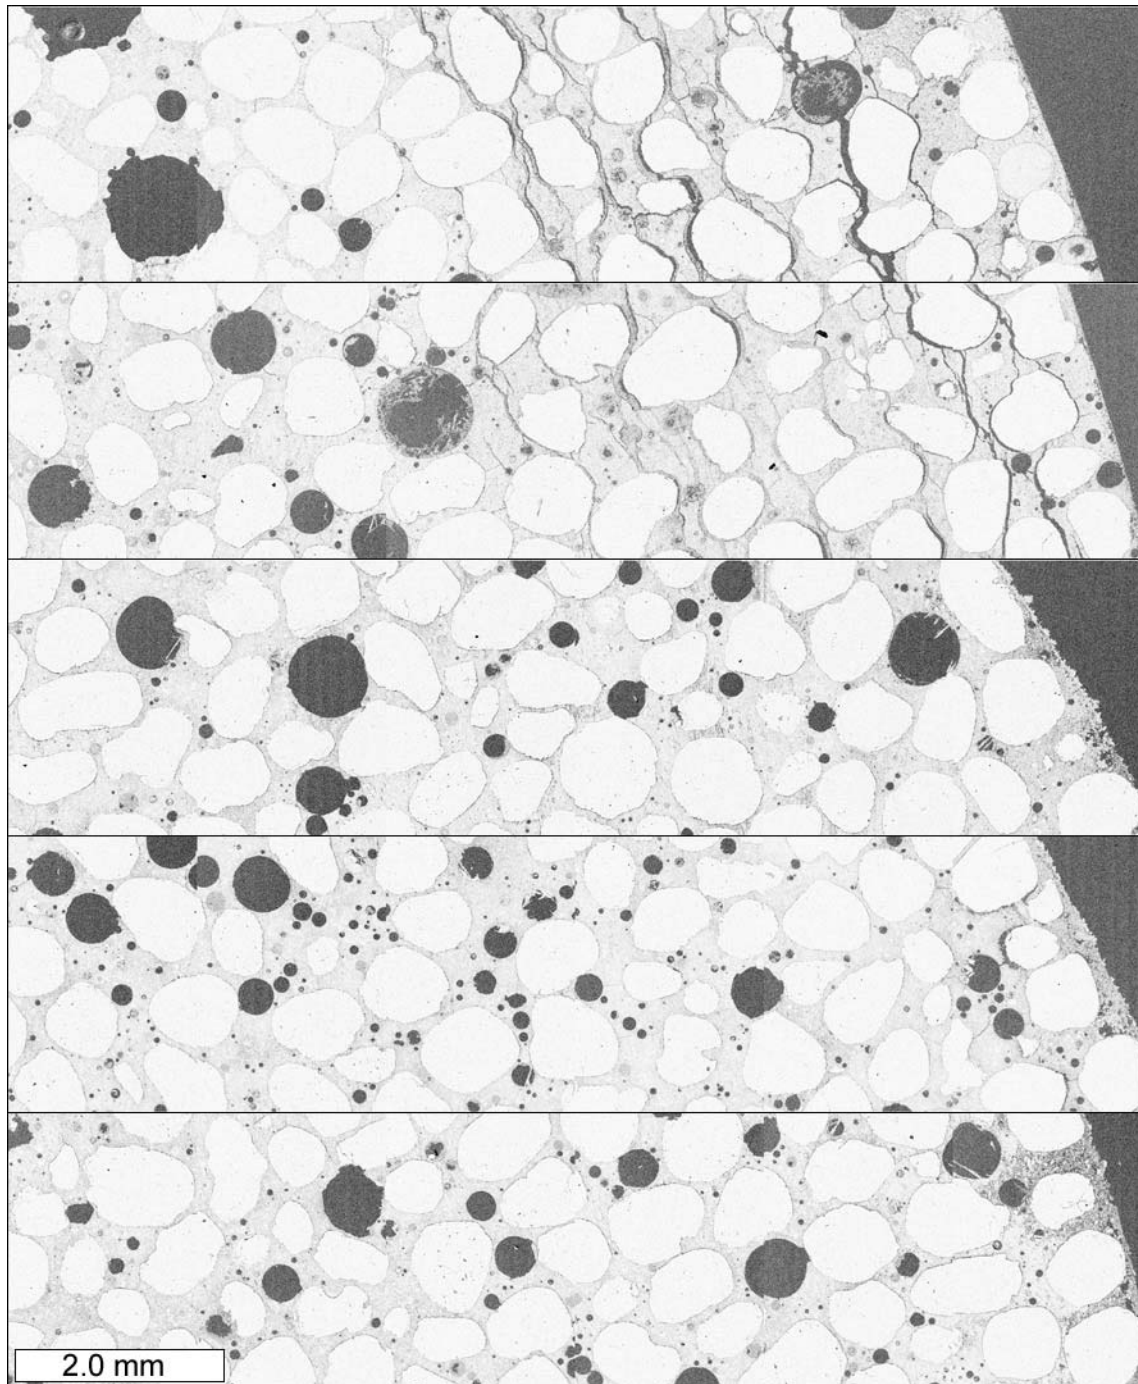
Figure 3.75: Elemental map for carbon collected from thin sections prepared from mortar cylinders immersed in the following solutions, from top to bottom: magnesium chloride, calcium chloride, sodium chloride, calcium magnesium acetate, and lime water.

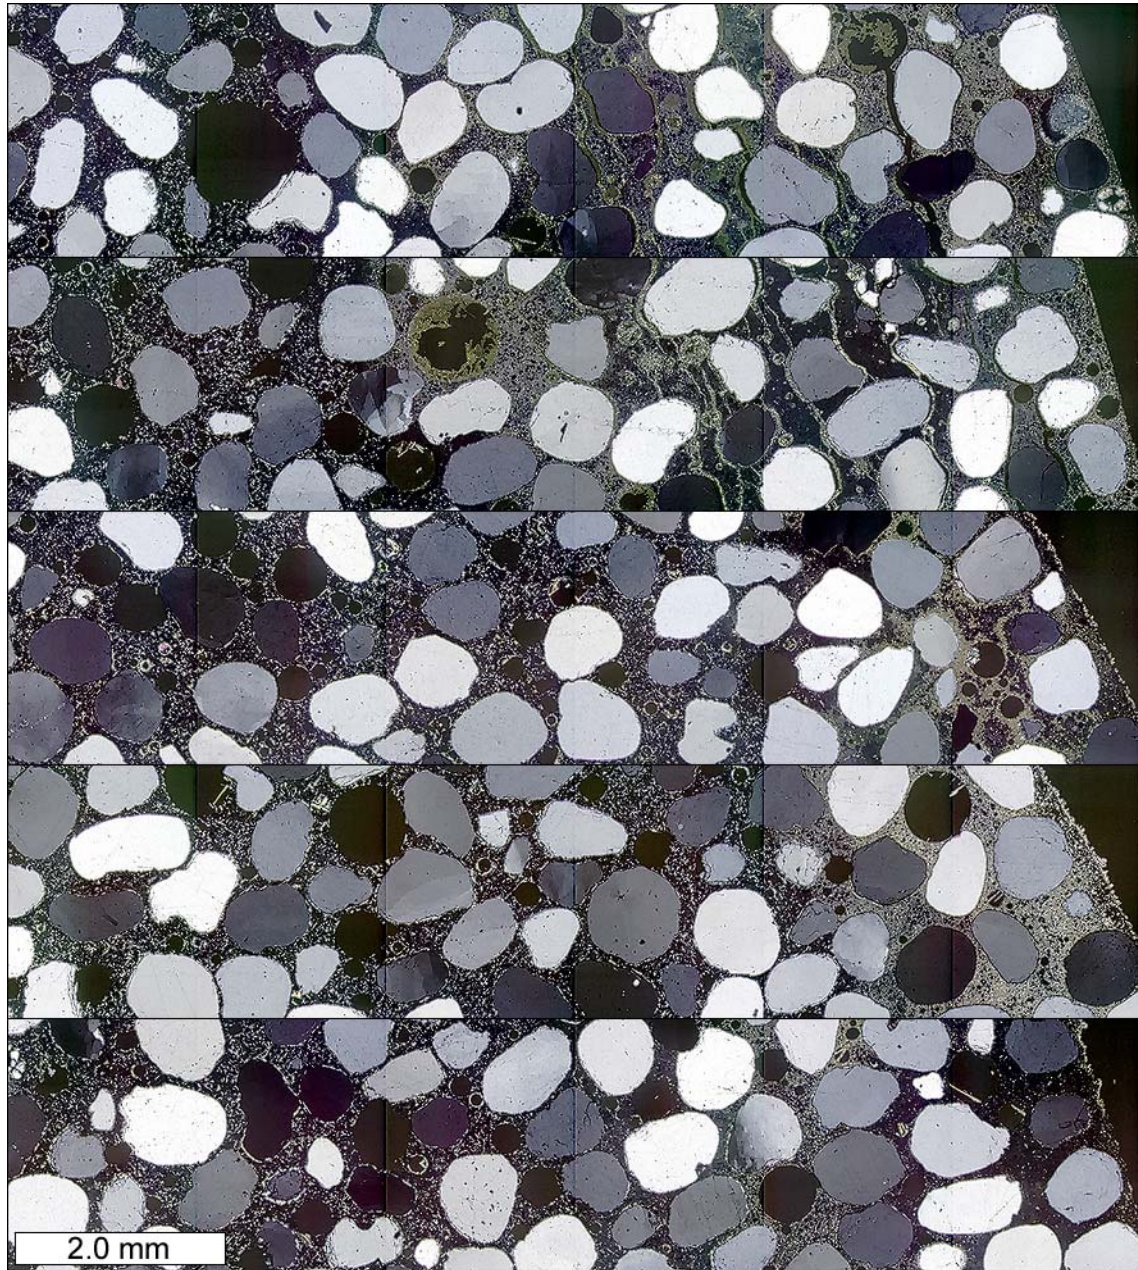
Figure 3.76: Cross-polarized light images of thin sections prepared from mortar cylinders immersed in the following solutions, from top to bottom: magnesium chloride, calcium chloride, sodium chloride, calcium magnesium acetate, and lime water.

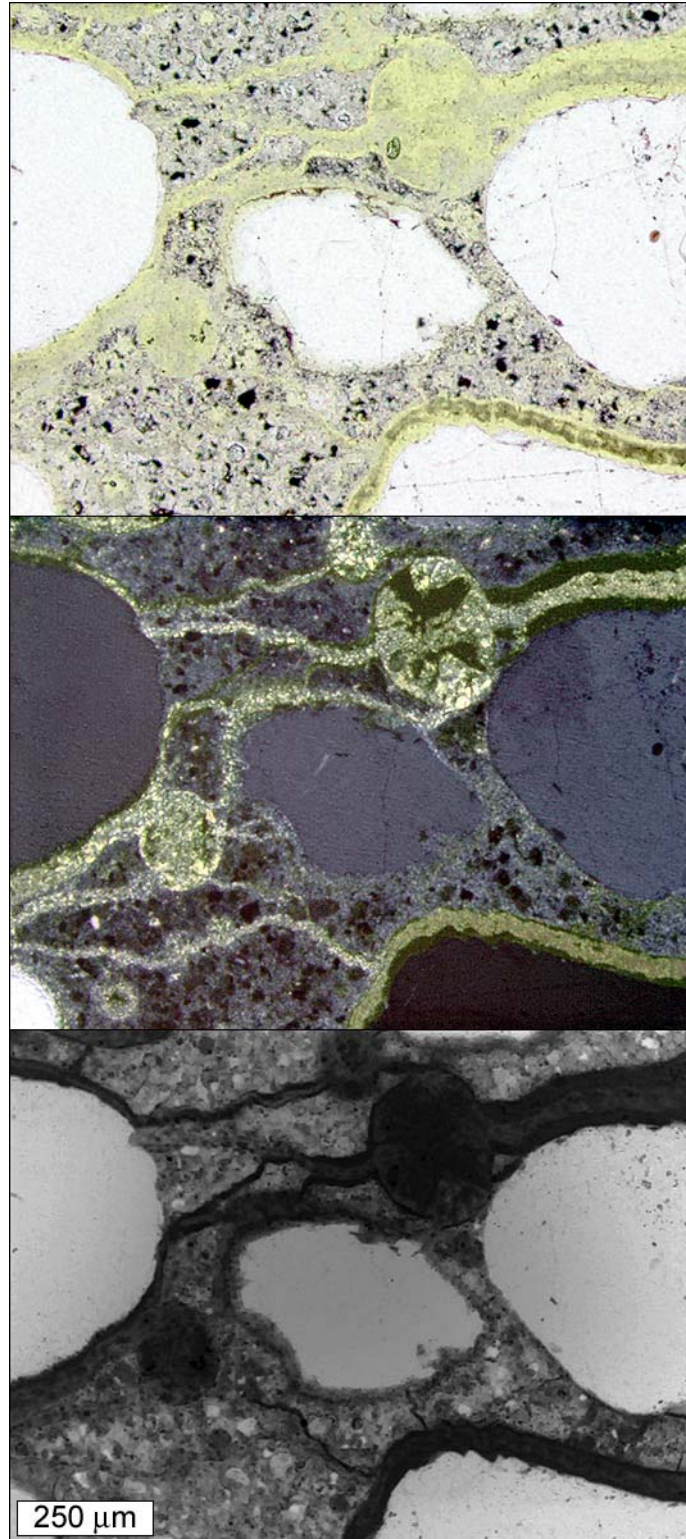
Figure 3.77: Cracks and air voids filled with remnant calcium oxychloride crystals in thin section prepared from magnesium chloride solution immersed sample. From top to bottom: plane polarized light, cross polarized light, and epifluorescent mode.

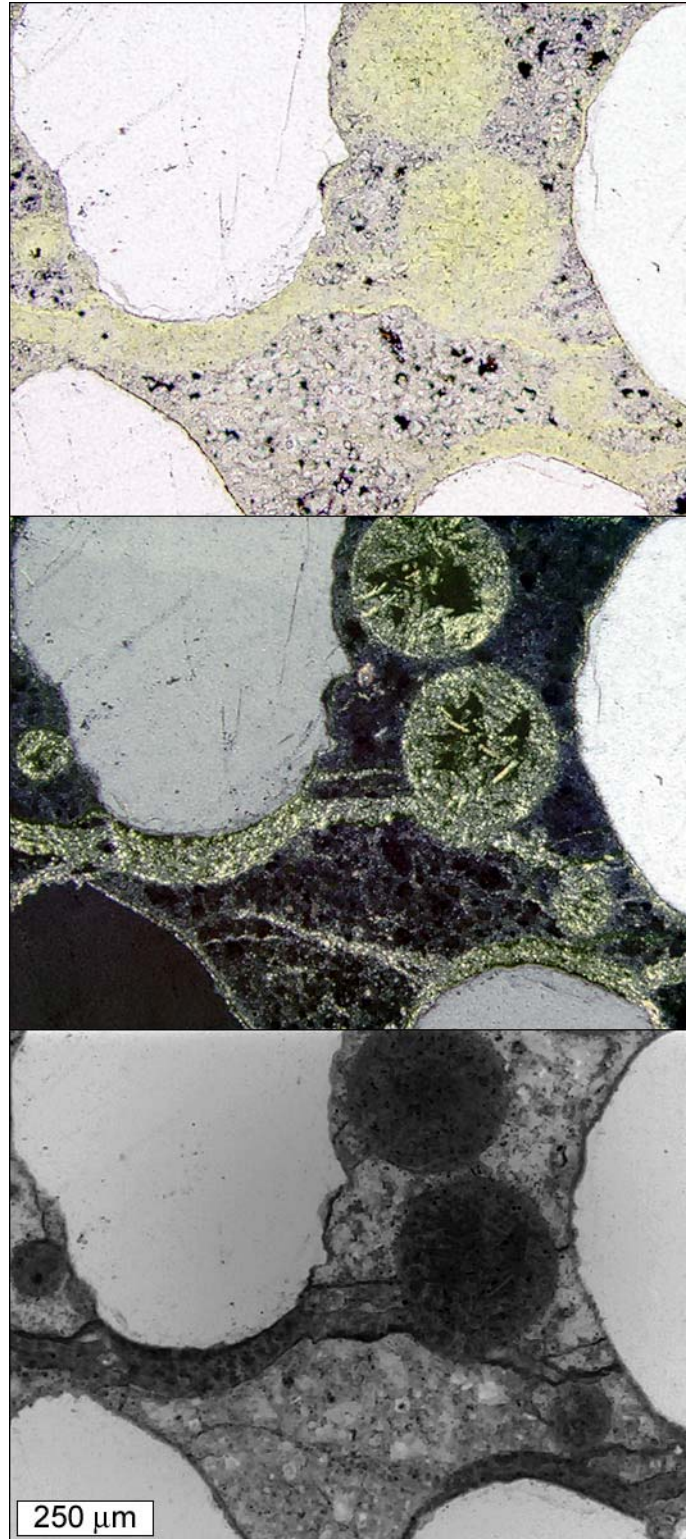
Figure 3.78 Cracks and air voids filled with remnant calcium oxychloride crystals in thin section prepared from calcium chloride solution immersed sample. From top to bottom: plane polarized light, cross polarized light, and epifluorescent mode.

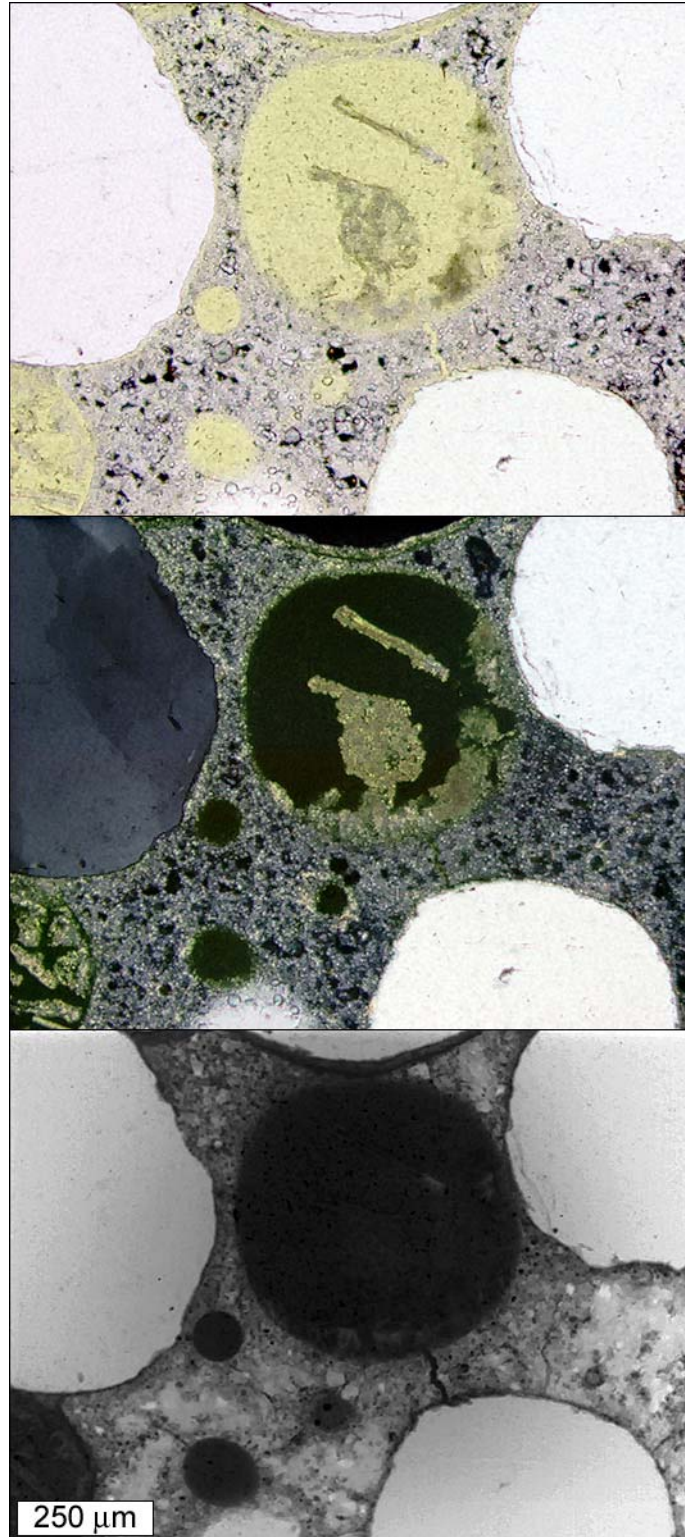
Figure 3.79 Remnant calcium oxychloride crystals that are pseudomorphs of secondary calcium hydroxide crystals initially formed in an air void from thin section prepared from magnesium chloride solution immersed sample. From top to bottom: plane polarized light, cross polarized light, and epifluorescent mode.
