## INTERIM REPORT

Investigation of the Long Term Effects of Magnesium Chloride and  
Other Concentrated Salt Solutions on Pavement and Structural  
Portland Cement Concrete

SD2002-01  
Submitted by:

January 2005

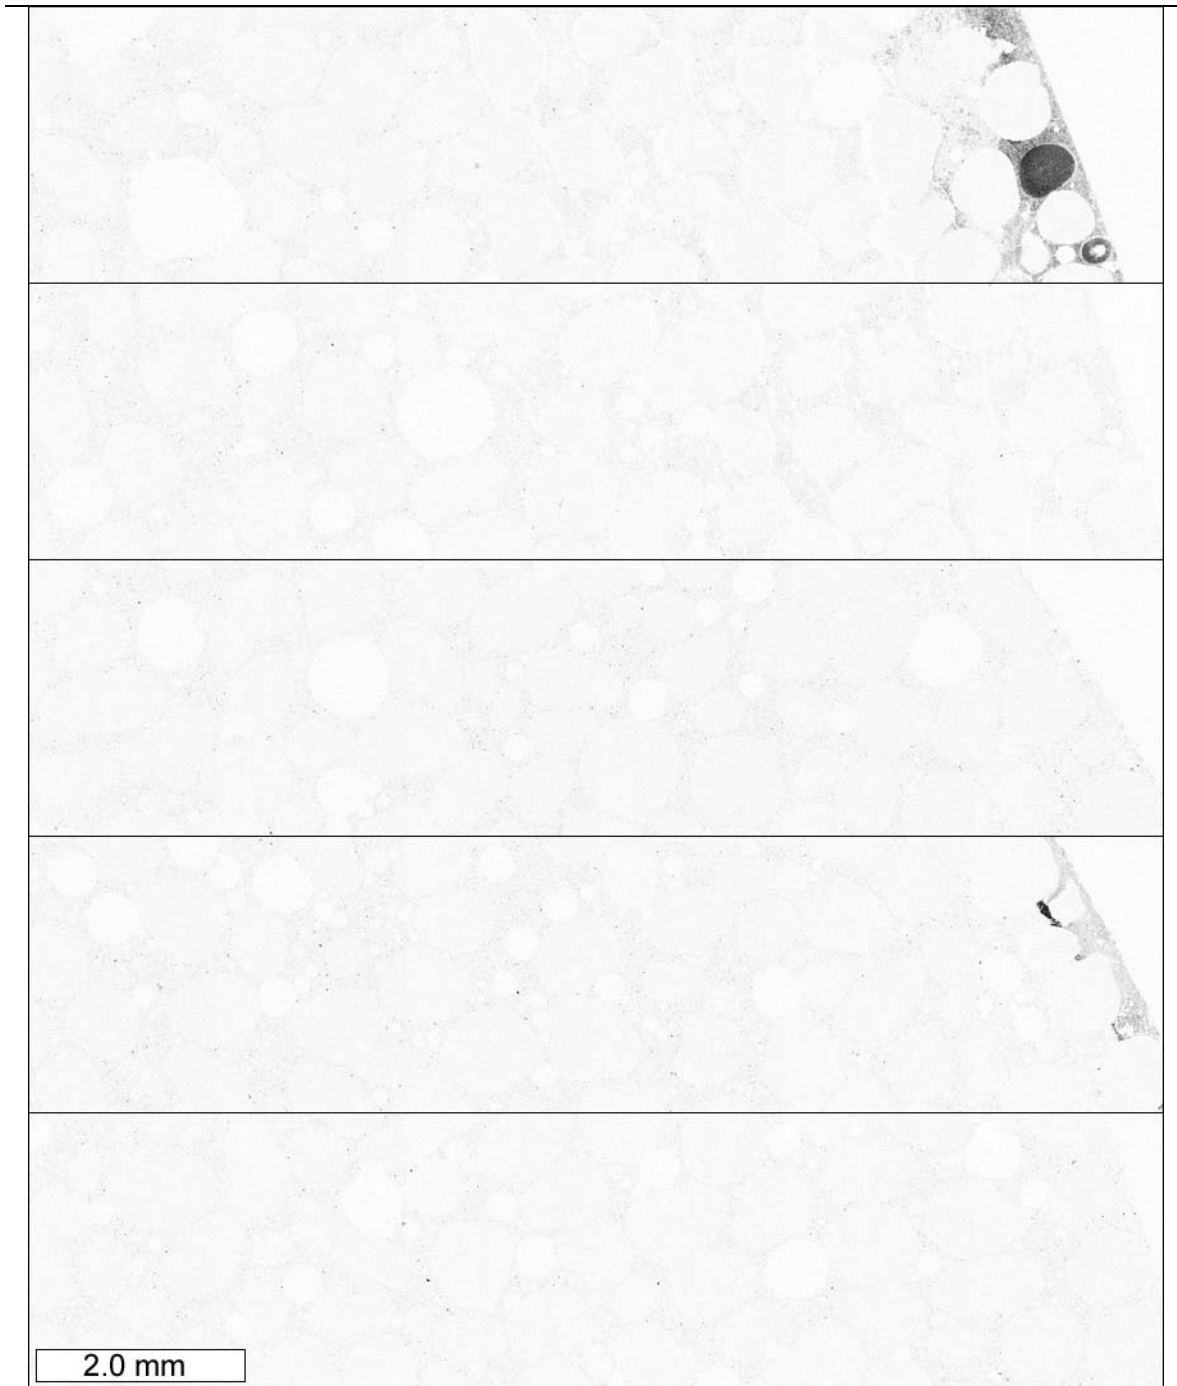
Figure 3.80 Elemental map for magnesium collected from thin sections prepared from mortar cylinders immersed in the following solutions, from top to bottom: magnesium chloride, calcium chloride, sodium chloride, calcium magnesium acetate, and lime water.

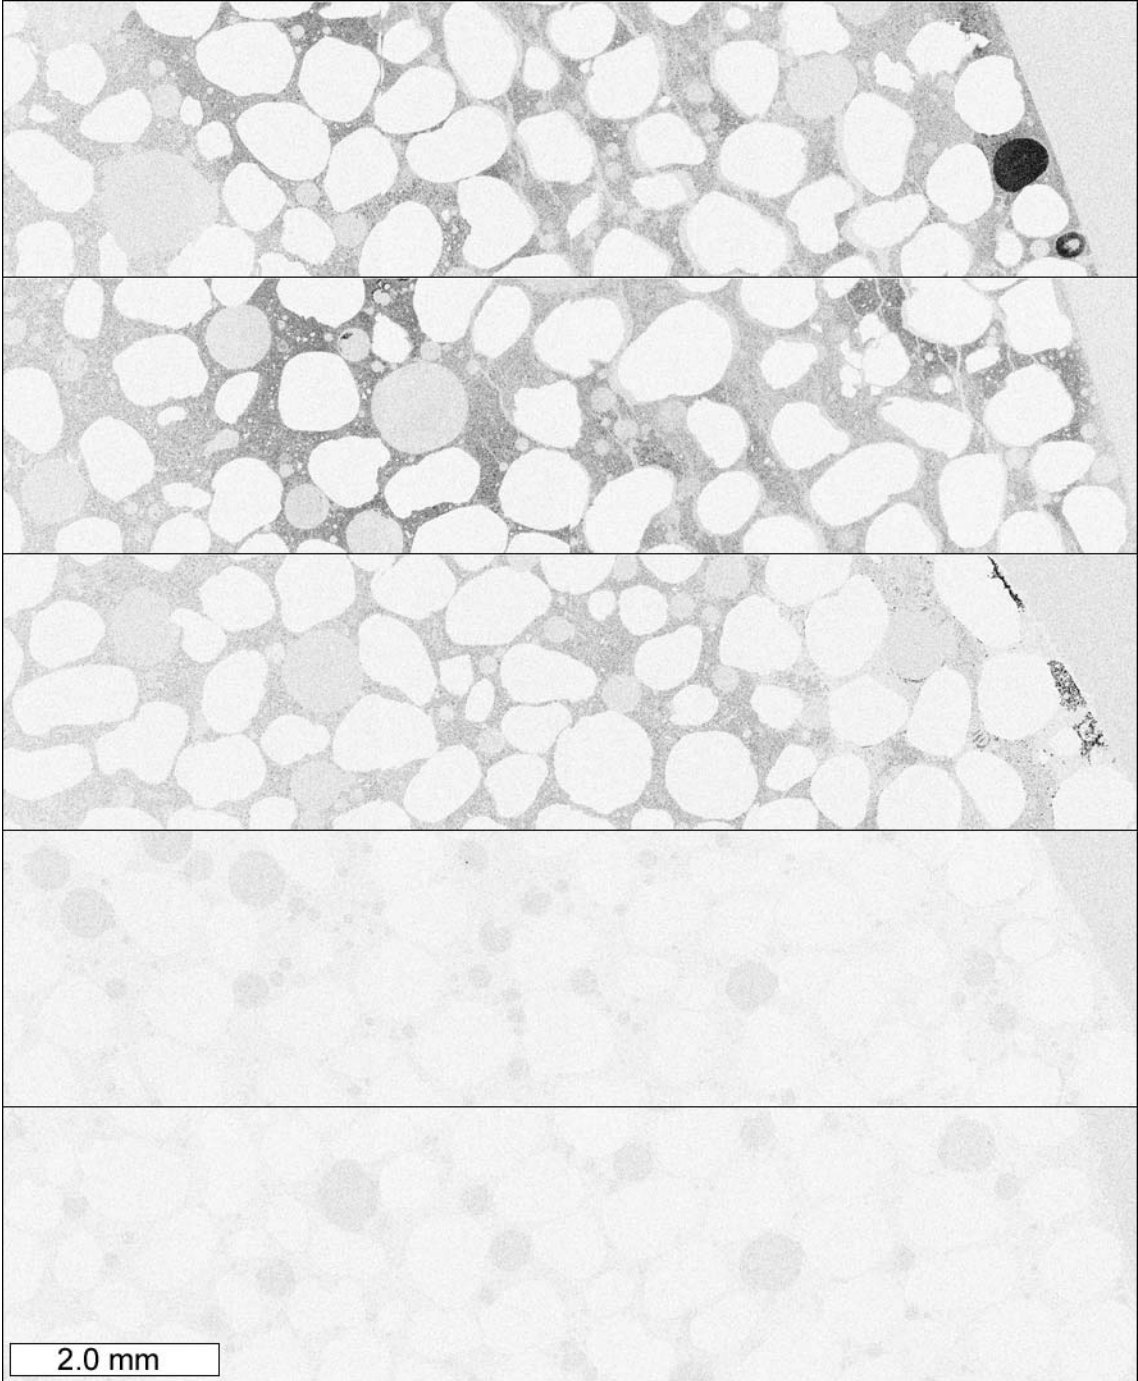
Figure 3.83: Elemental map for chlorine collected from thin sections prepared from mortar cylinders immersed in the following solutions, from top to bottom: magnesium chloride, calcium chloride, sodium chloride, calcium magnesium acetate, and lime water.

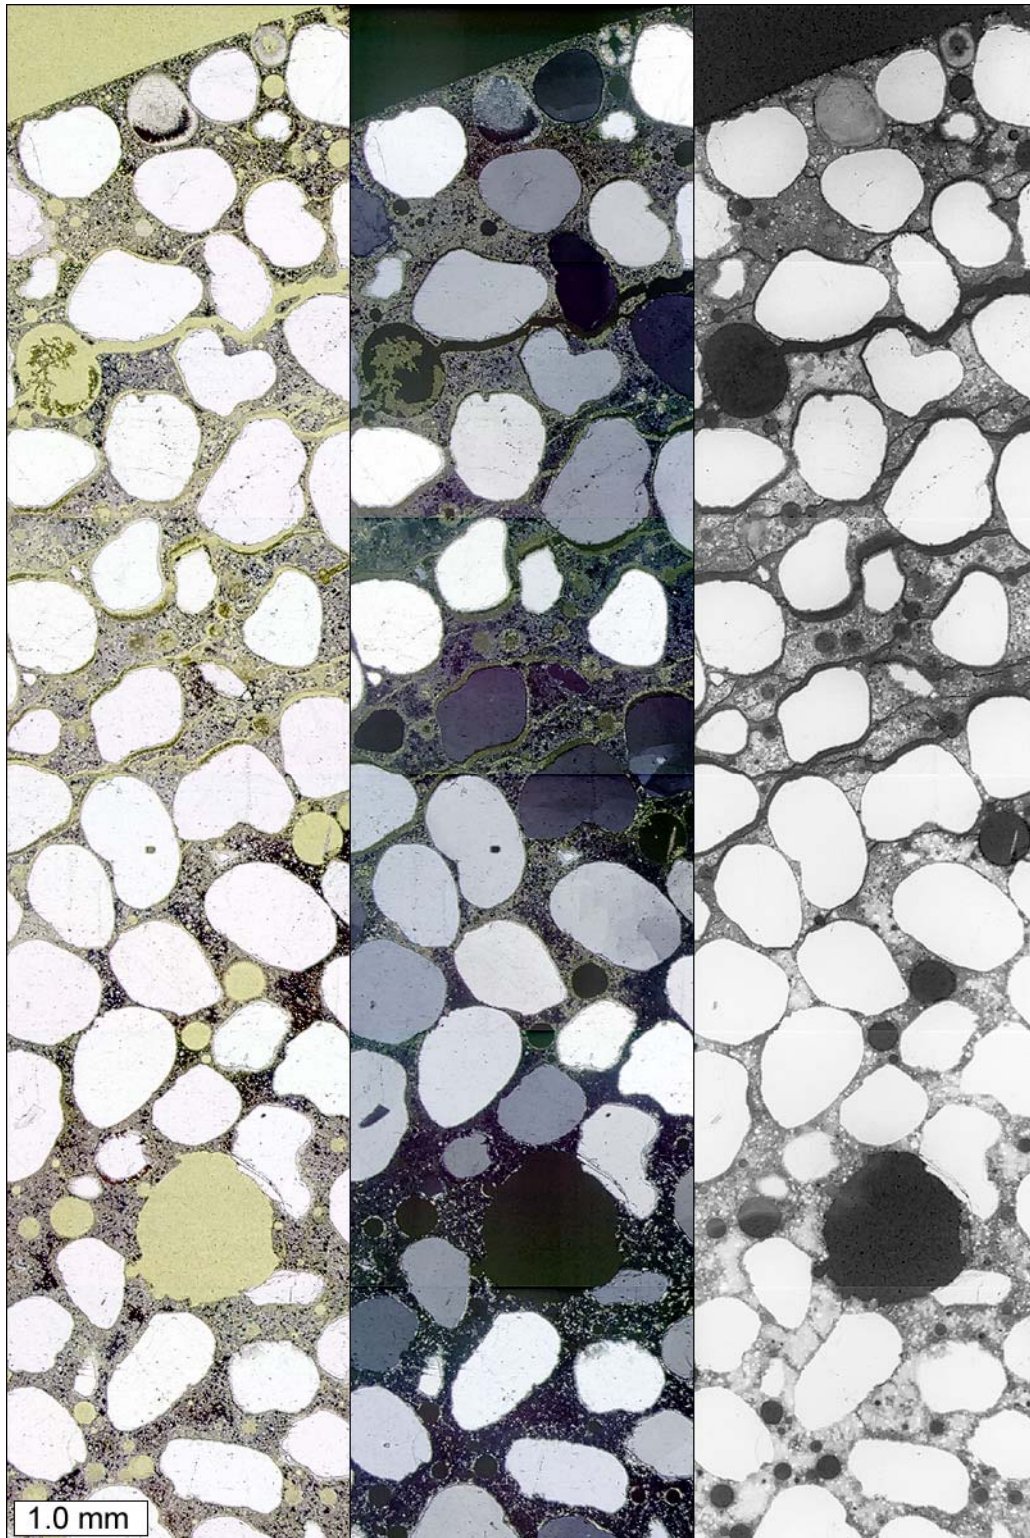
Figure 3.84: From left to right: plane polarized light, cross polarized light, and epifluorescent mode images of a thin section prepared from a cylinder immersed in magnesium chloride solution.

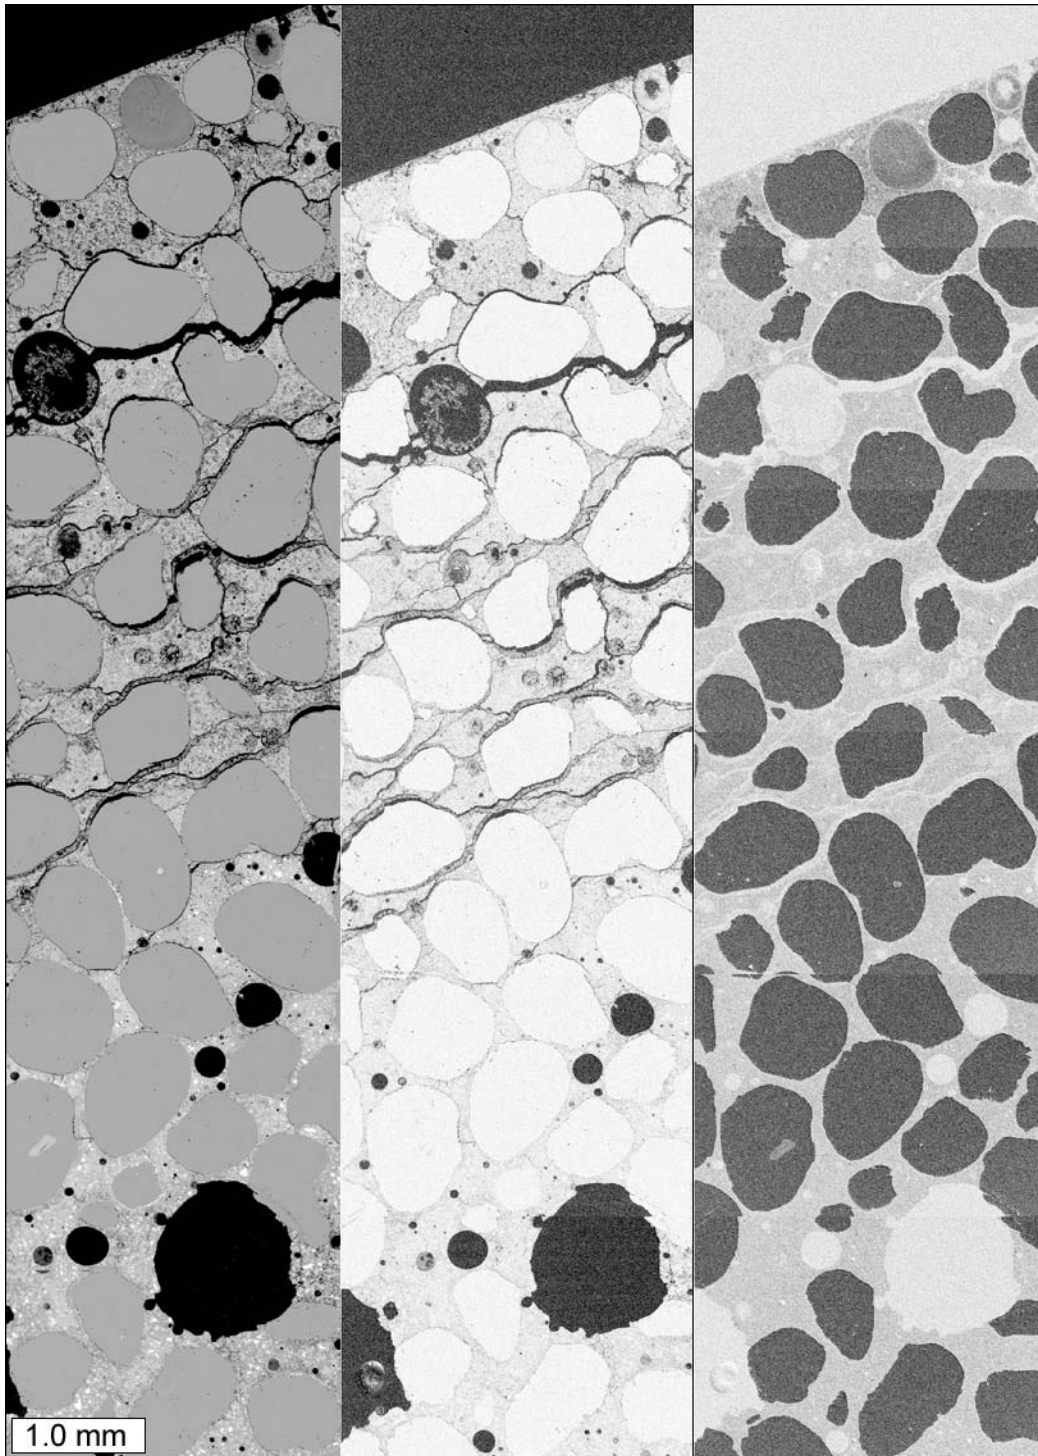
Figure 3.85: From left to right: back scattered electron image, elemental map for carbon, and elemental map for oxygen. Images were collected from a thin section prepared from a cylinder immersed in magnesium chloride solution.

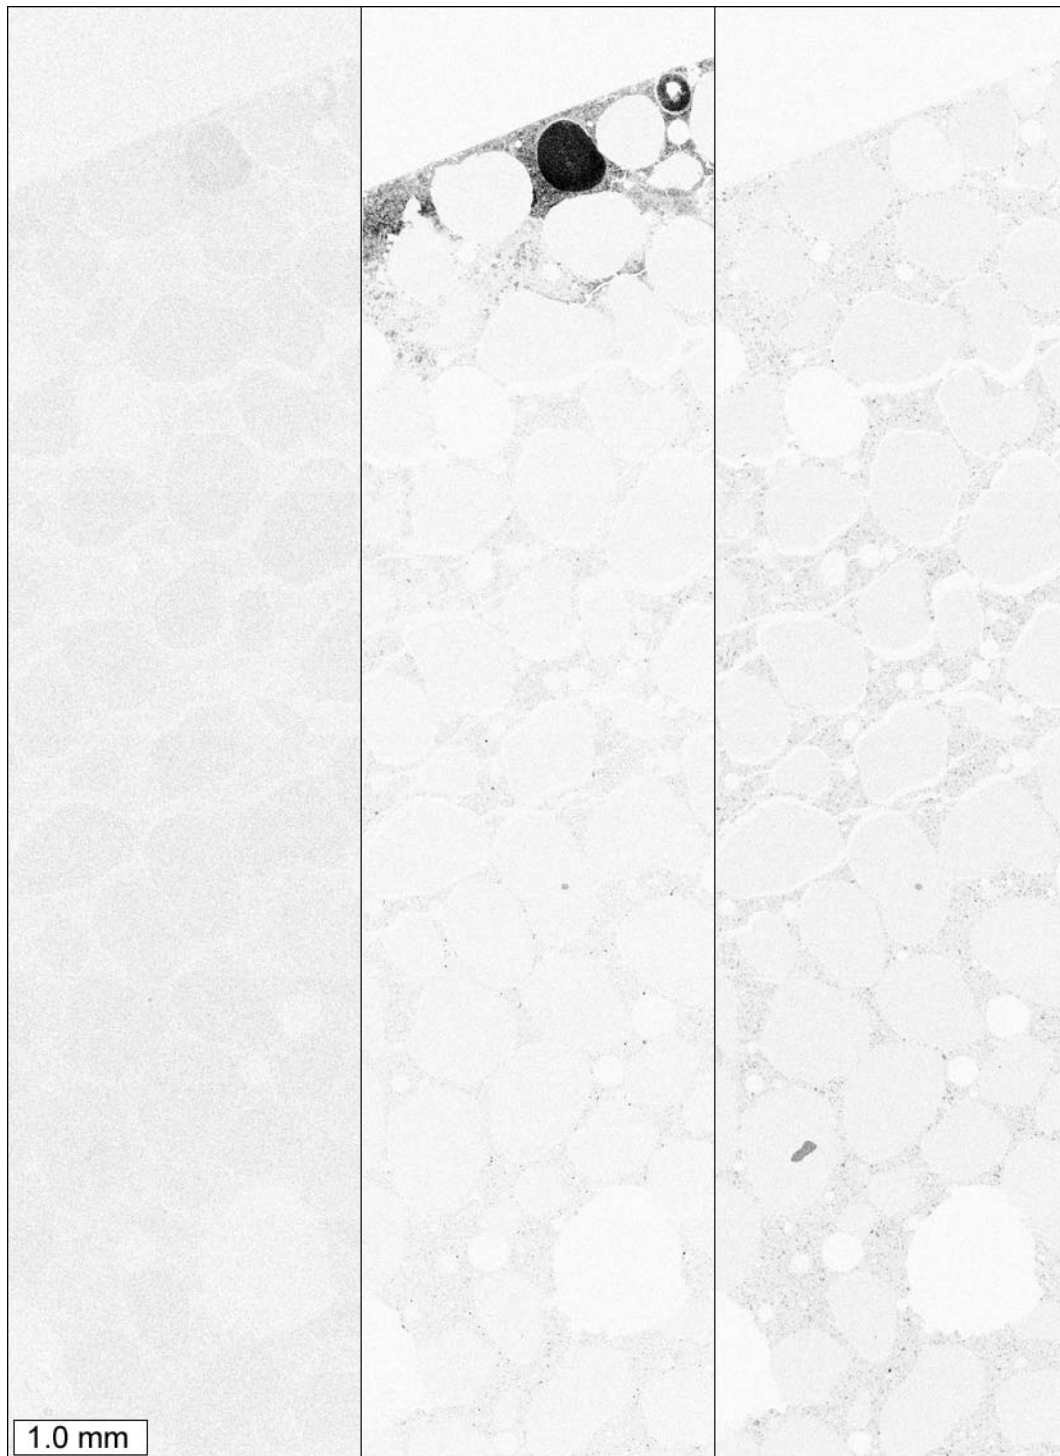
Figure 3.86: Elemental maps, from left to right: sodium, magnesium, and aluminum. The elemental maps were collected from a thin section prepared from a cylinder immersed in magnesium chloride solution.

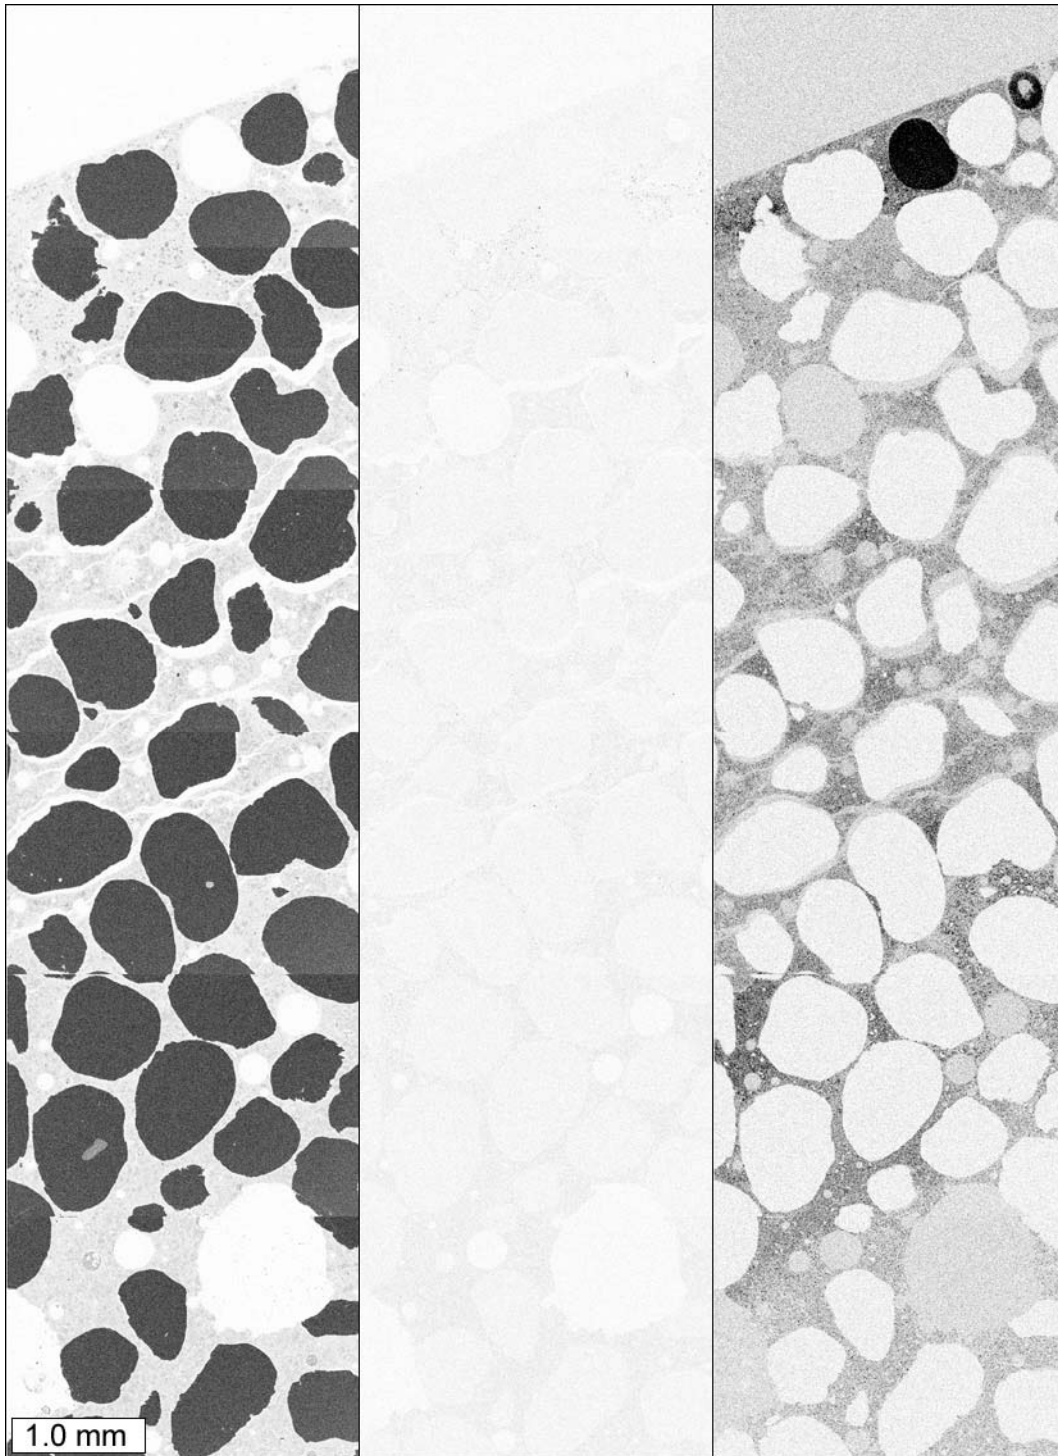
Figure 3.87: Elemental maps, from left to right: silicon, sulfur, and chlorine. The elemental maps were collected from a thin section prepared from a cylinder immersed in magnesium chloride solution.

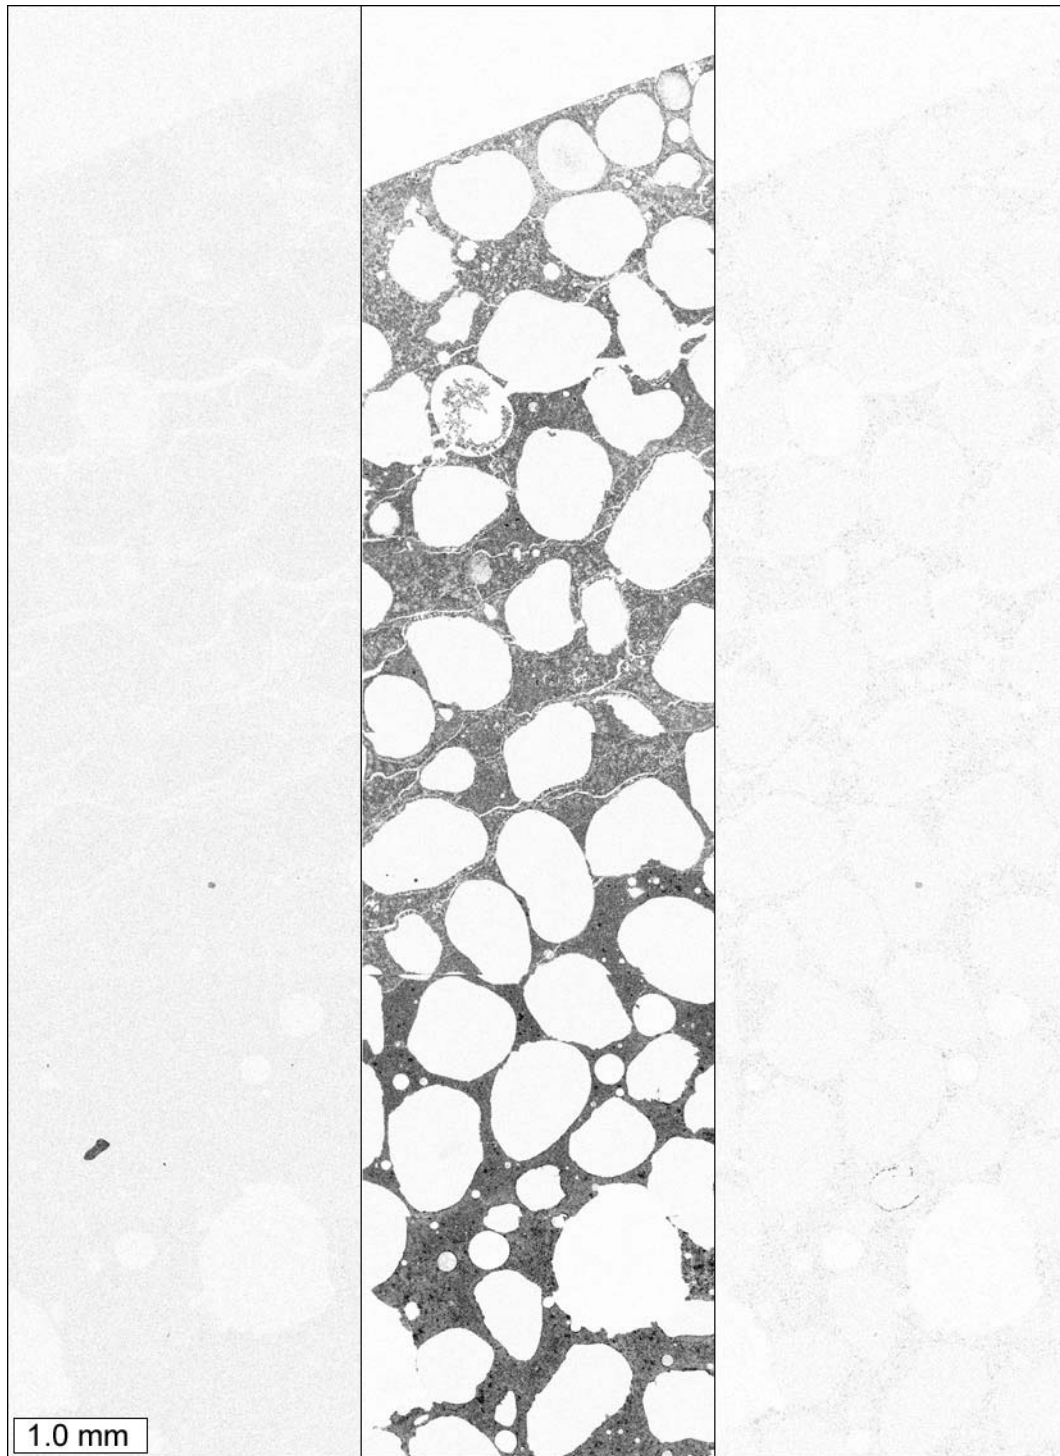
Figure 3.88: Elemental maps, from left to right: potassium, calcium, and iron. The elemental maps were collected from a thin section prepared from a cylinder immersed in magnesium chloride solution.

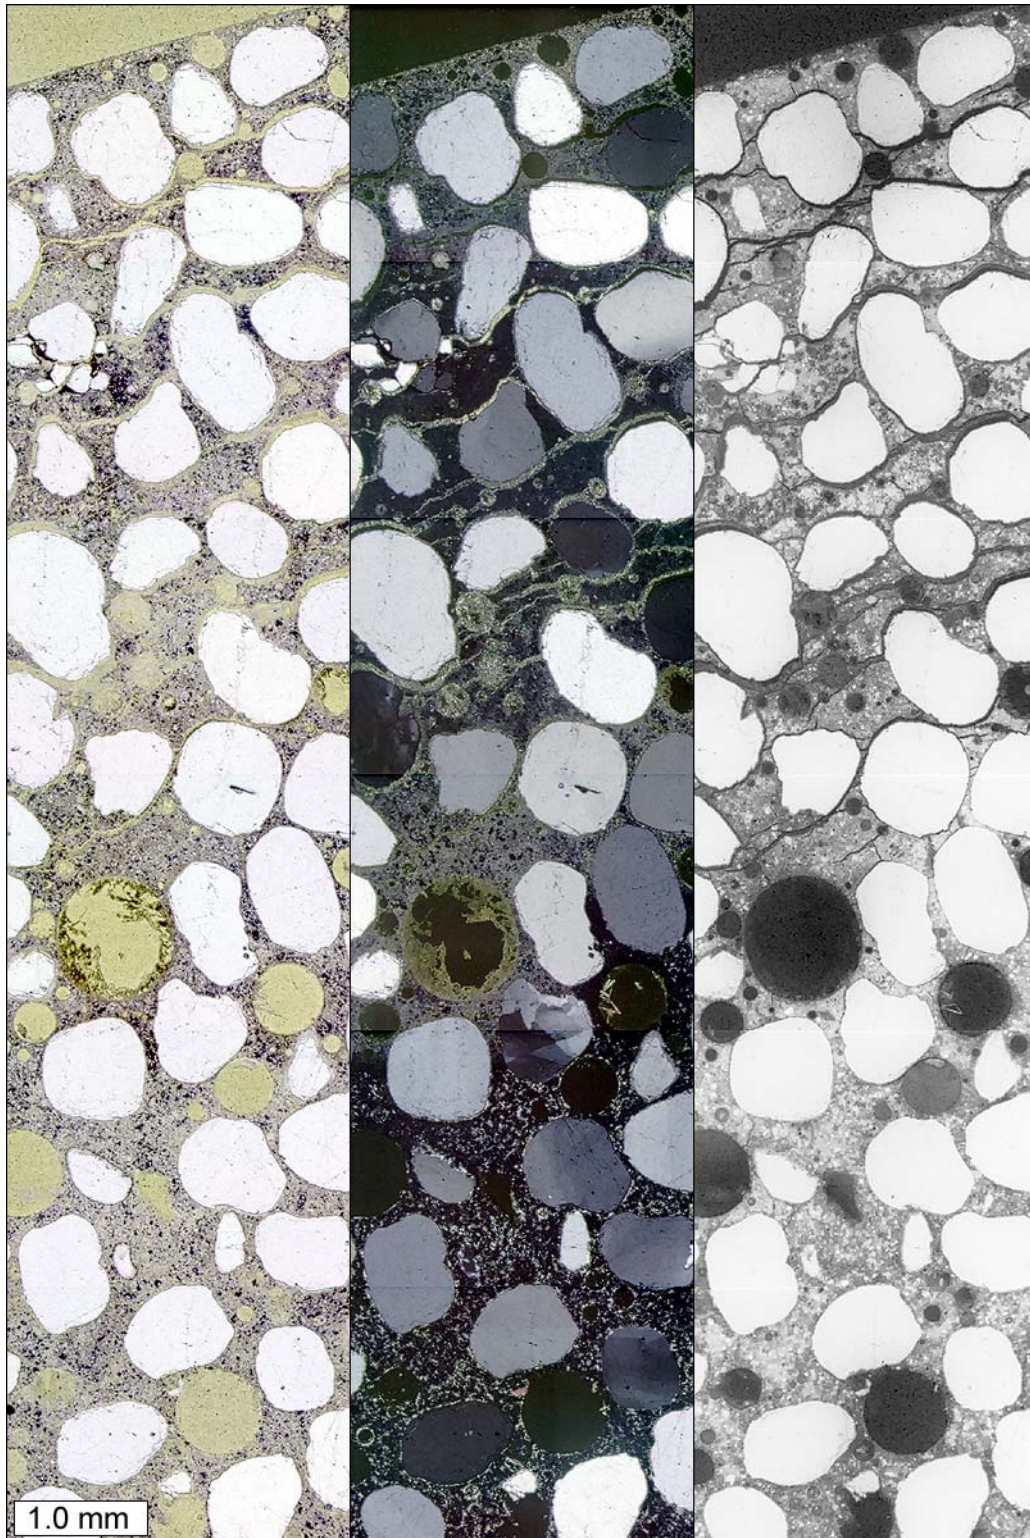
Figure 3.89: From left to right: plane polarized light, cross polarized light, and epifluorescent mode images of a thin section prepared from a cylinder immersed in calcium chloride solution.

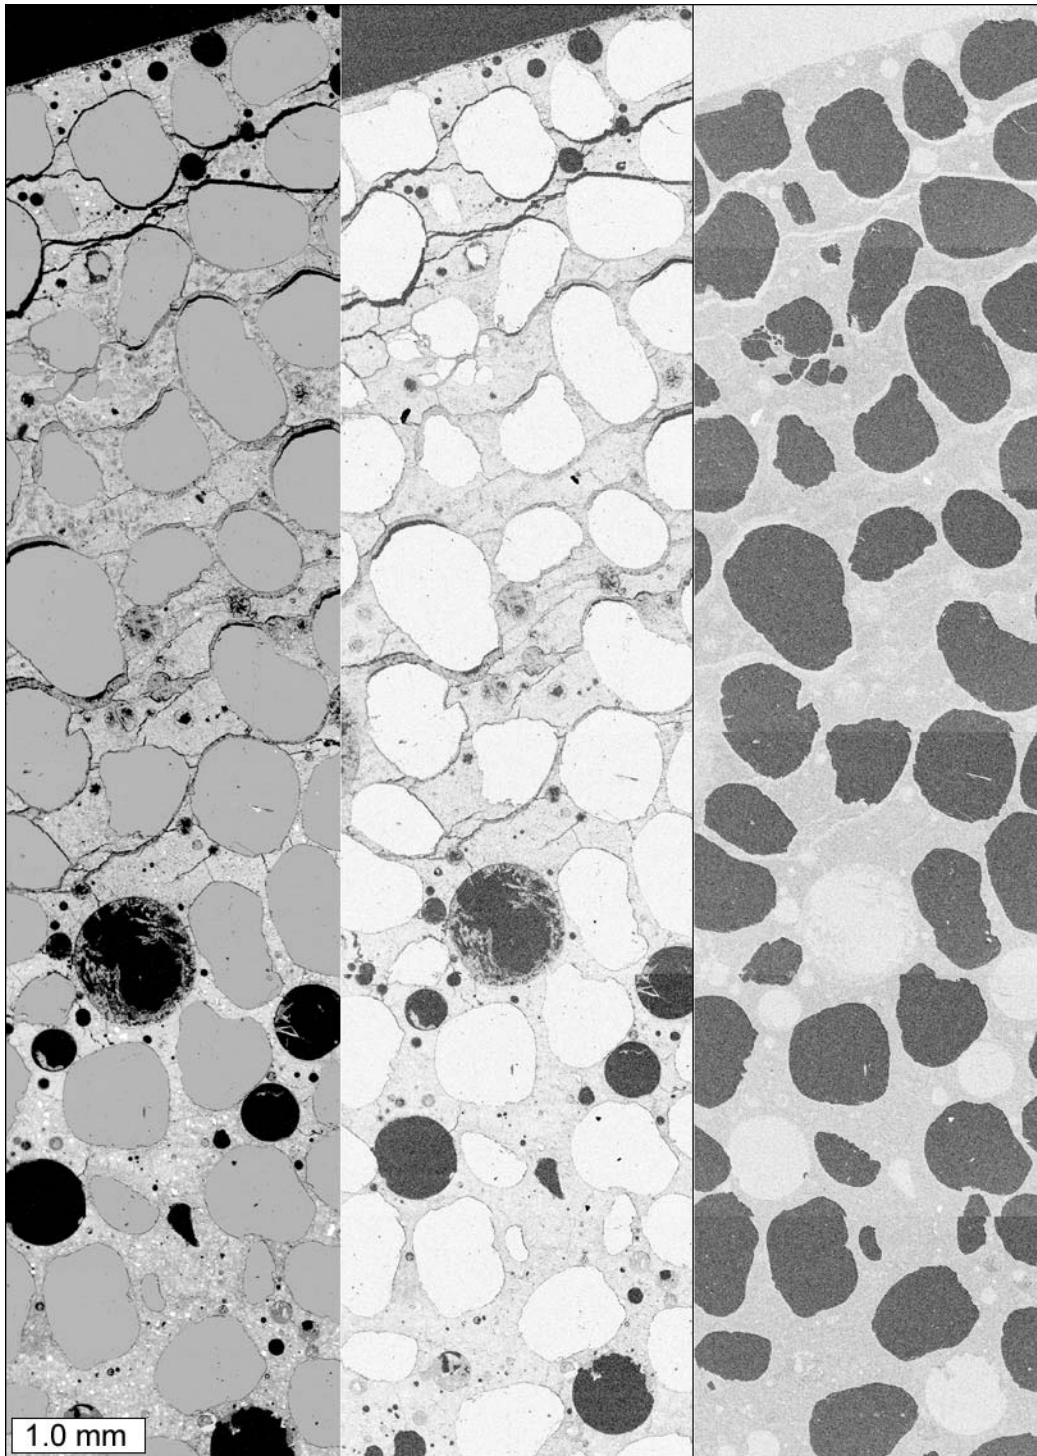
Figure 3.90: From left to right: back scattered electron image, elemental map for carbon, and elemental map for oxygen. Images were collected from a thin section prepared from a cylinder immersed in calcium chloride solution.

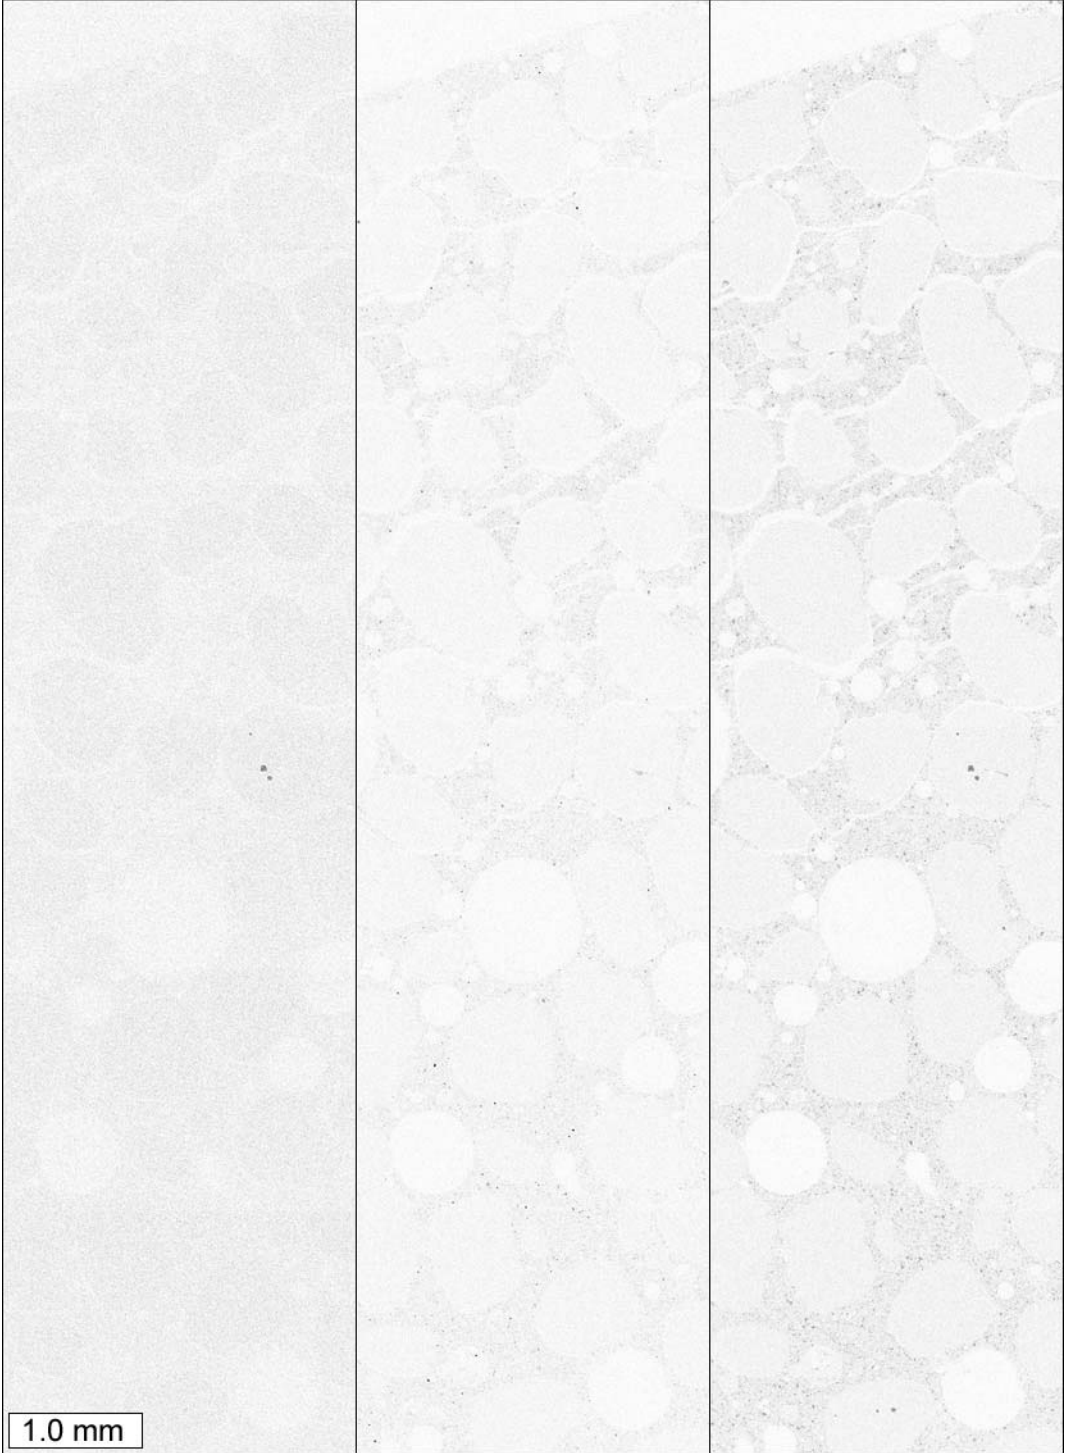
Figure 3.91: Elemental maps, from left to right: sodium, magnesium, and aluminum. The elemental maps were collected from a thin section prepared from a cylinder immersed in calcium chloride solution.

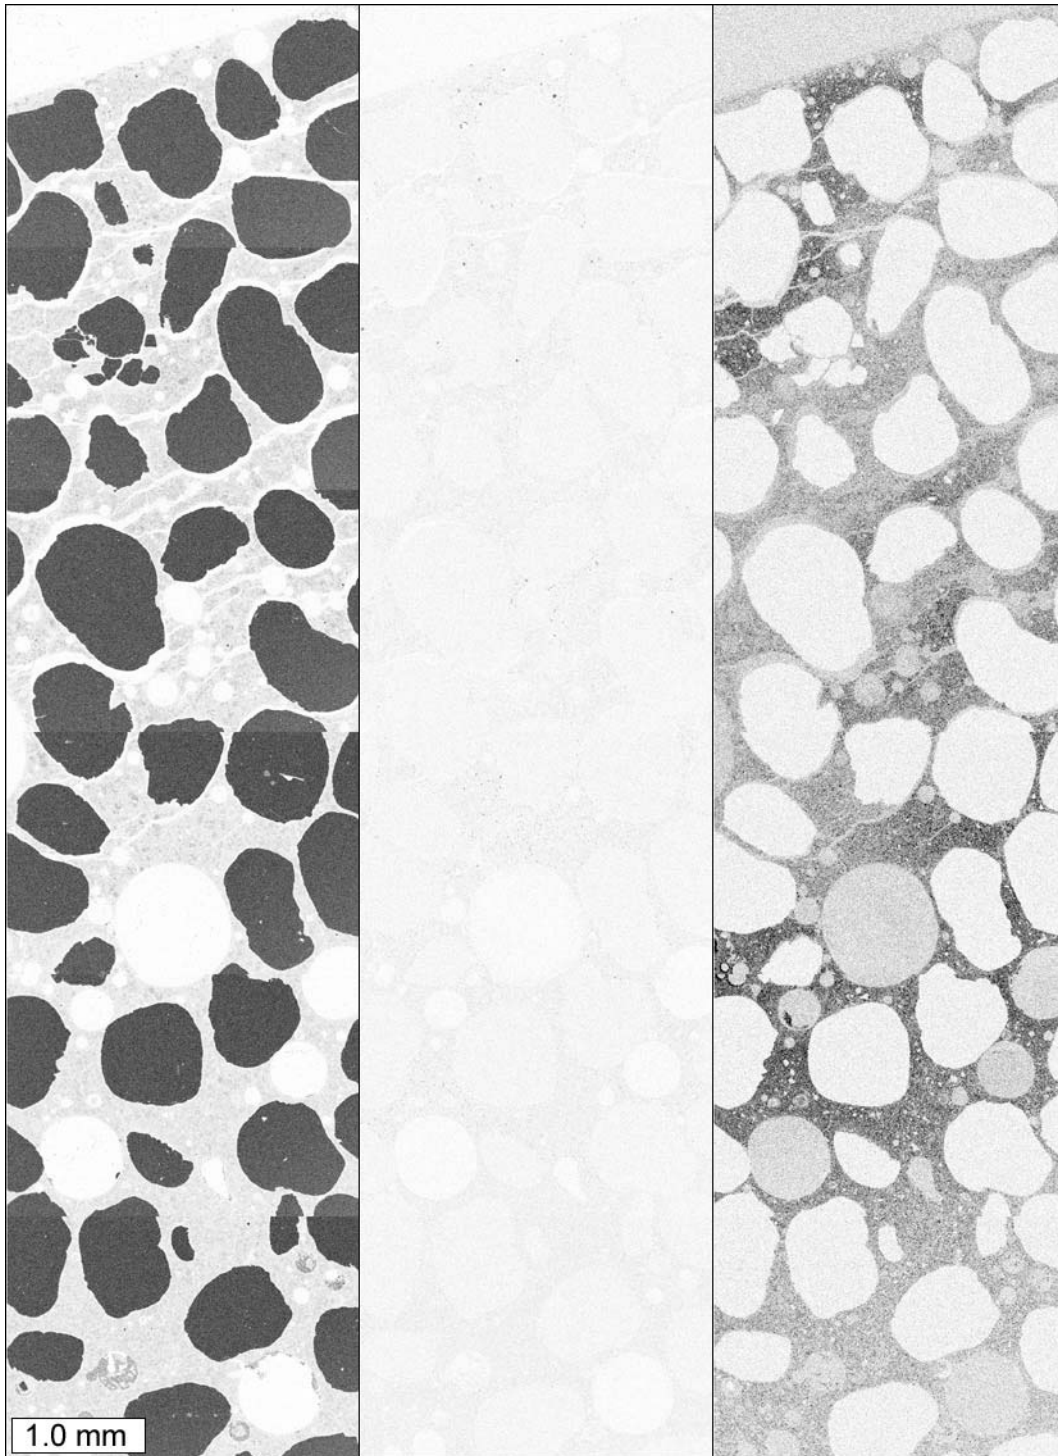
Figure 3.92: Elemental maps, from left to right: silicon, sulfur, and chlorine. The elemental maps were collected from a thin section prepared from a cylinder immersed in calcium chloride solution.

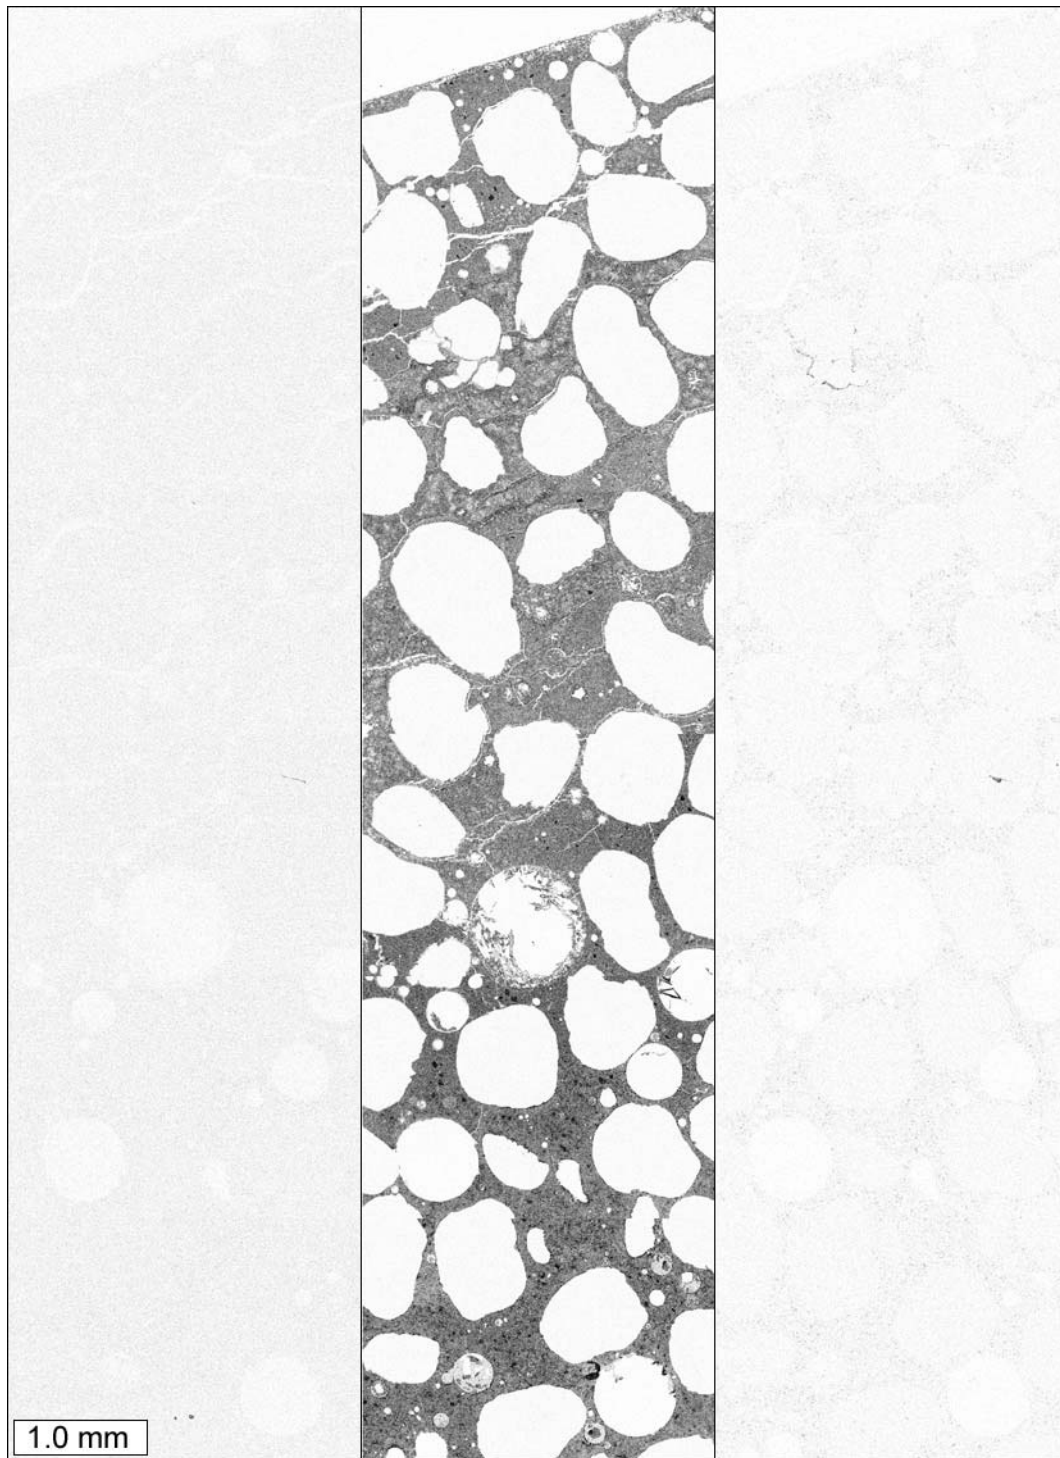
Figure 3.93: Elemental maps, from left to right: potassium, calcium, and iron. The elemental maps were collected from a thin section prepared from a cylinder immersed in calcium chloride solution.

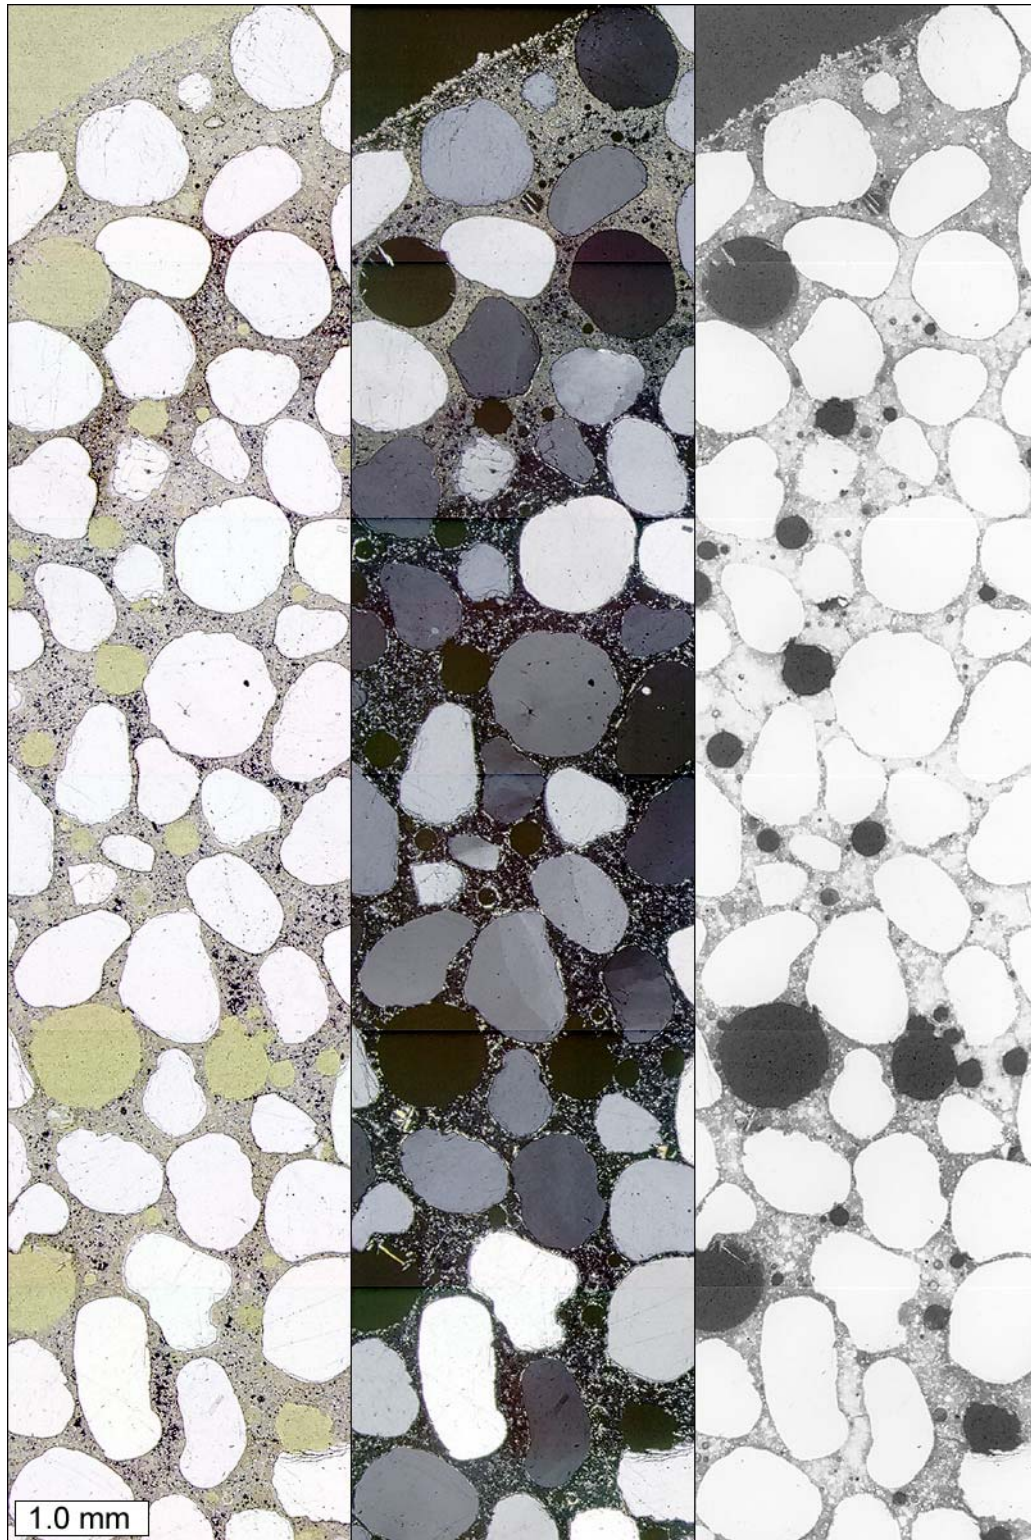
Figure 3.94: From left to right: plane polarized light, cross polarized light, and epifluorescent mode images of a thin section prepared from a cylinder immersed in sodium chloride solution.

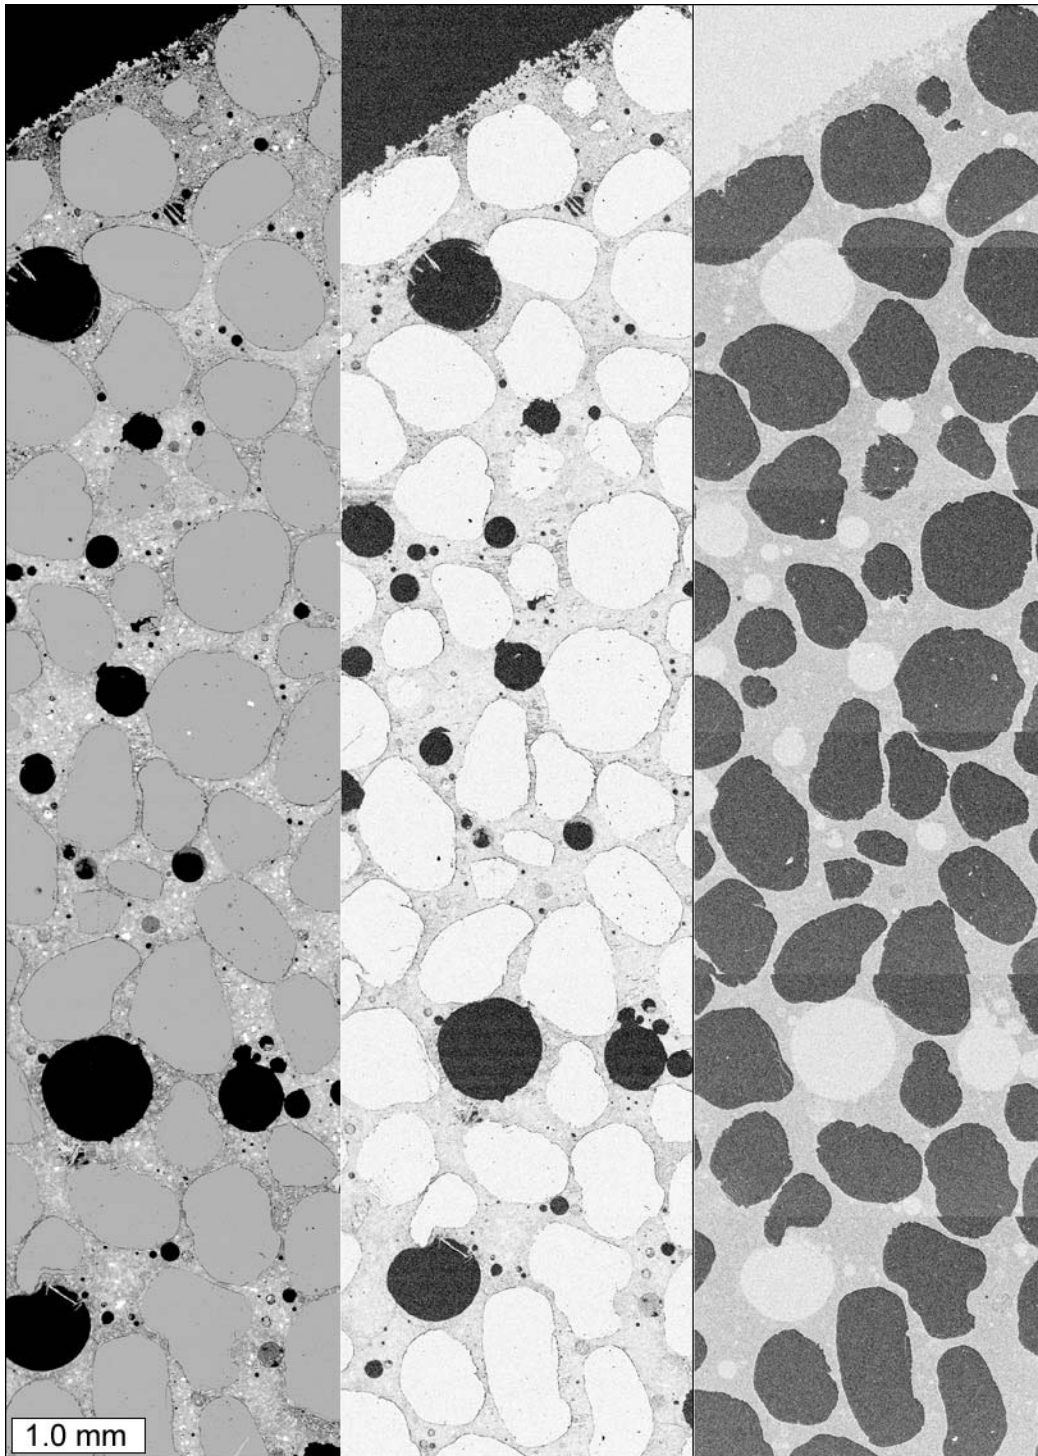
Figure 3.95: From left to right: back scattered electron image, elemental map for carbon, and elemental map for oxygen. Images were collected from a thin section prepared from a cylinder immersed in sodium chloride solution.
