## INTERIM REPORT

Investigation of the Long Term Effects of Magnesium Chloride and  
Other Concentrated Salt Solutions on Pavement and Structural  
Portland Cement Concrete

SD2002-01  
Submitted by:

January 2005

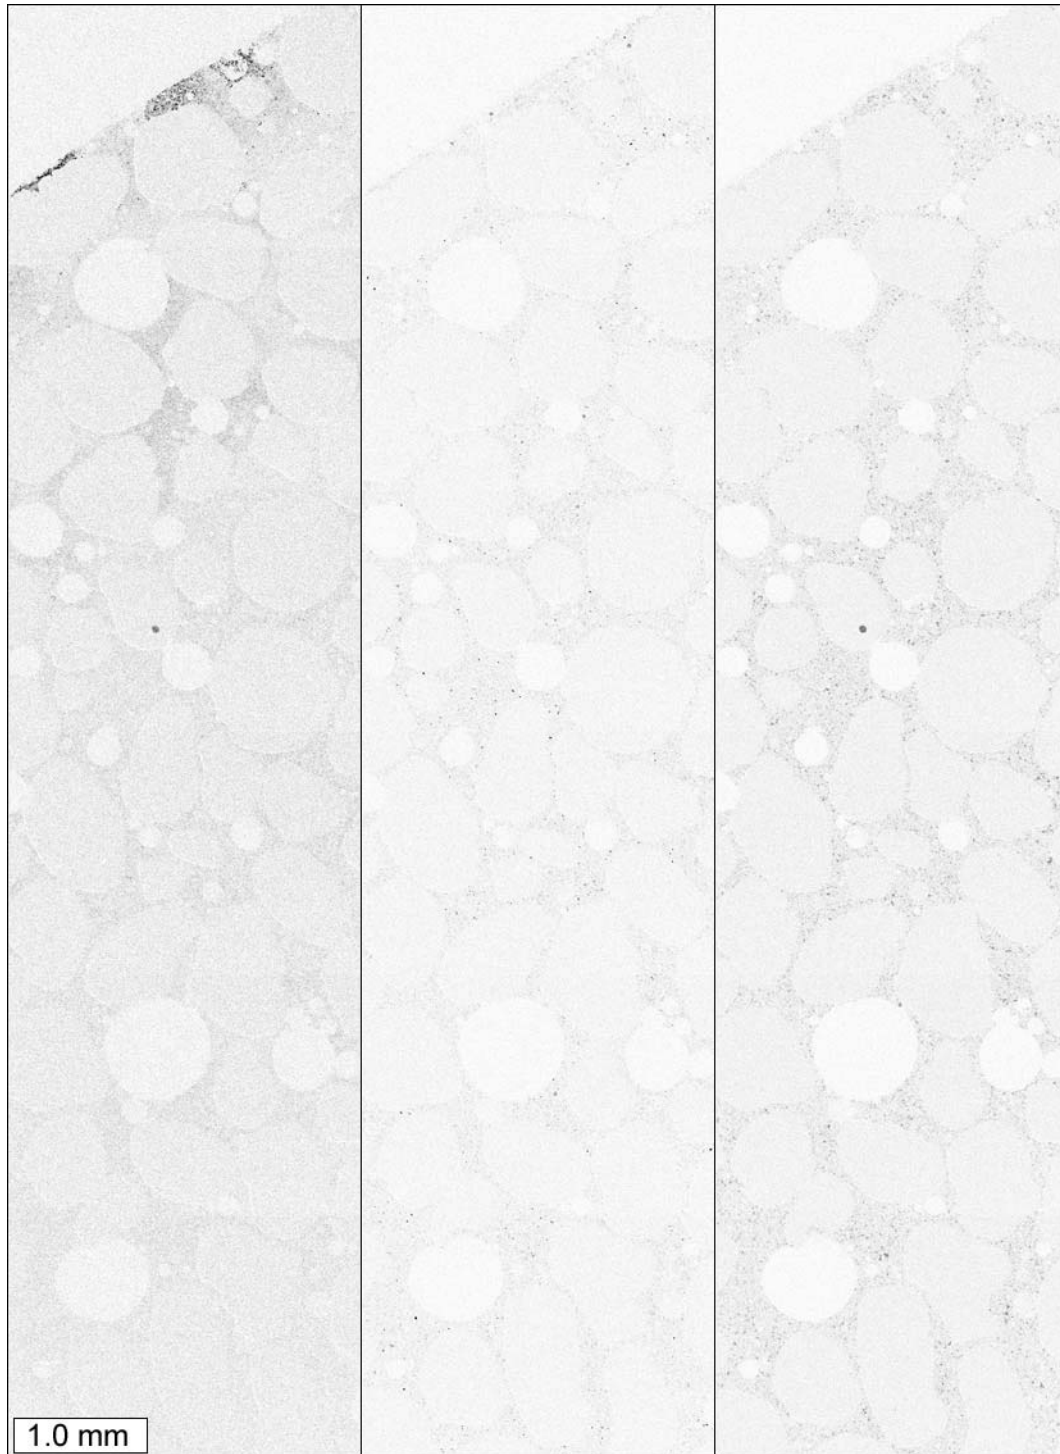
Figure 3.96: Elemental maps, from left to right: sodium, magnesium, and aluminum. The elemental maps were collected from a thin section prepared from a cylinder immersed in sodium chloride solution.

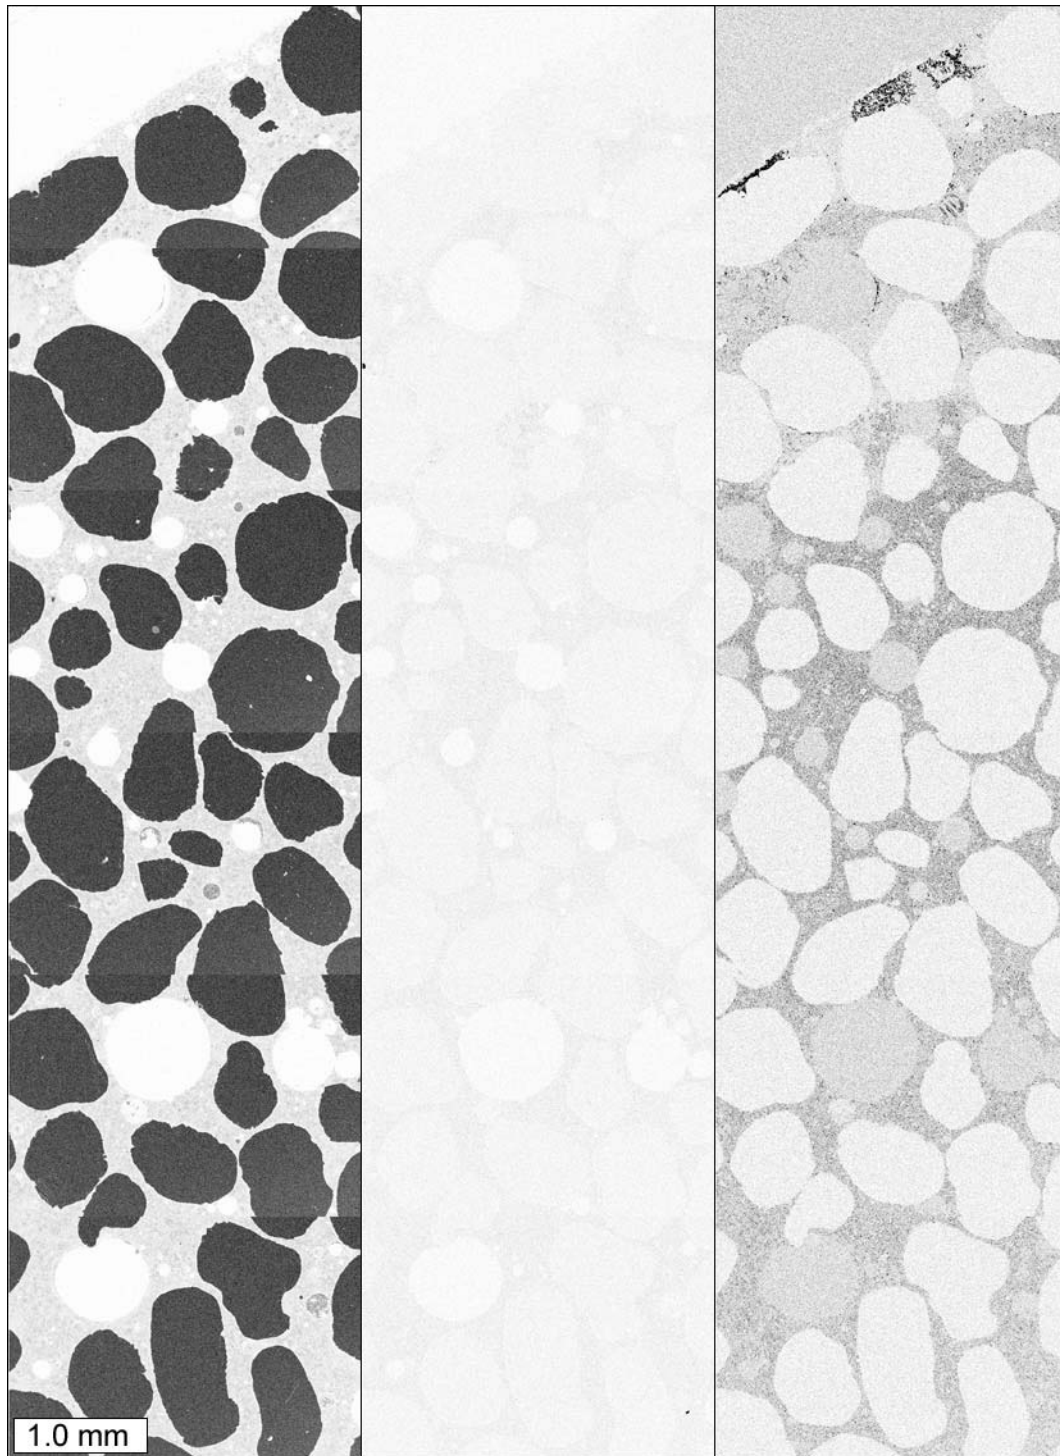
Figure 3.97: Elemental maps, from left to right: silicon, sulfur, and chlorine. The elemental maps were collected from a thin section prepared from a cylinder immersed in sodium chloride solution.

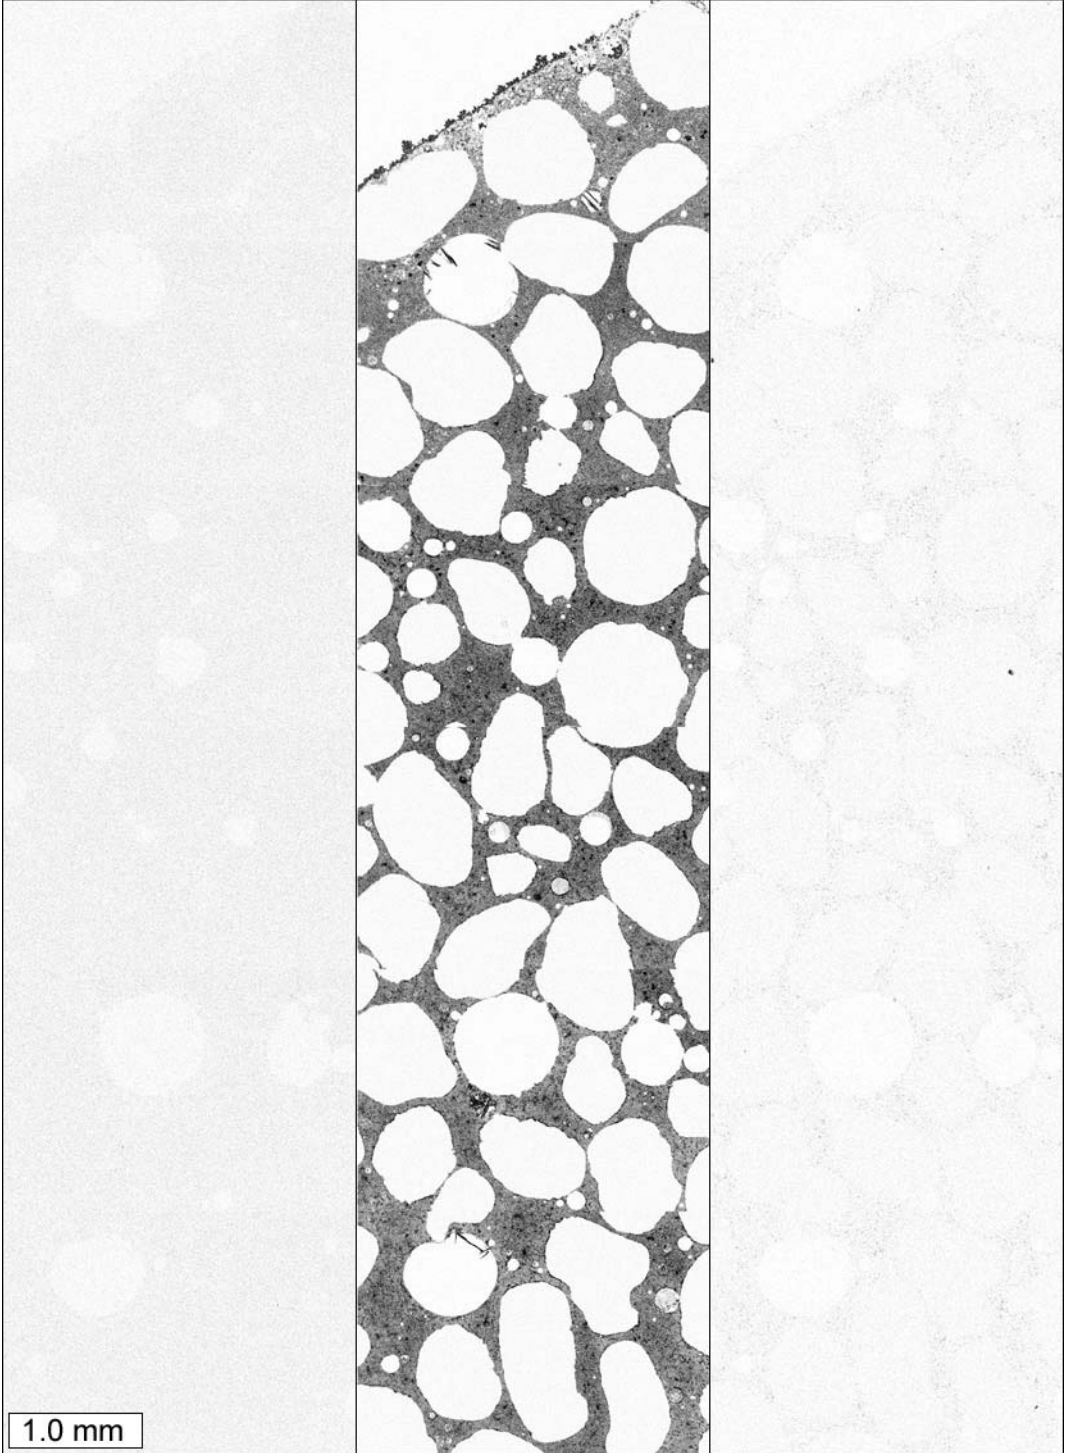
Figure 3.98: Elemental maps, from left to right: potassium, calcium, and iron. The elemental maps were collected from a thin section prepared from a cylinder immersed in sodium chloride solution.

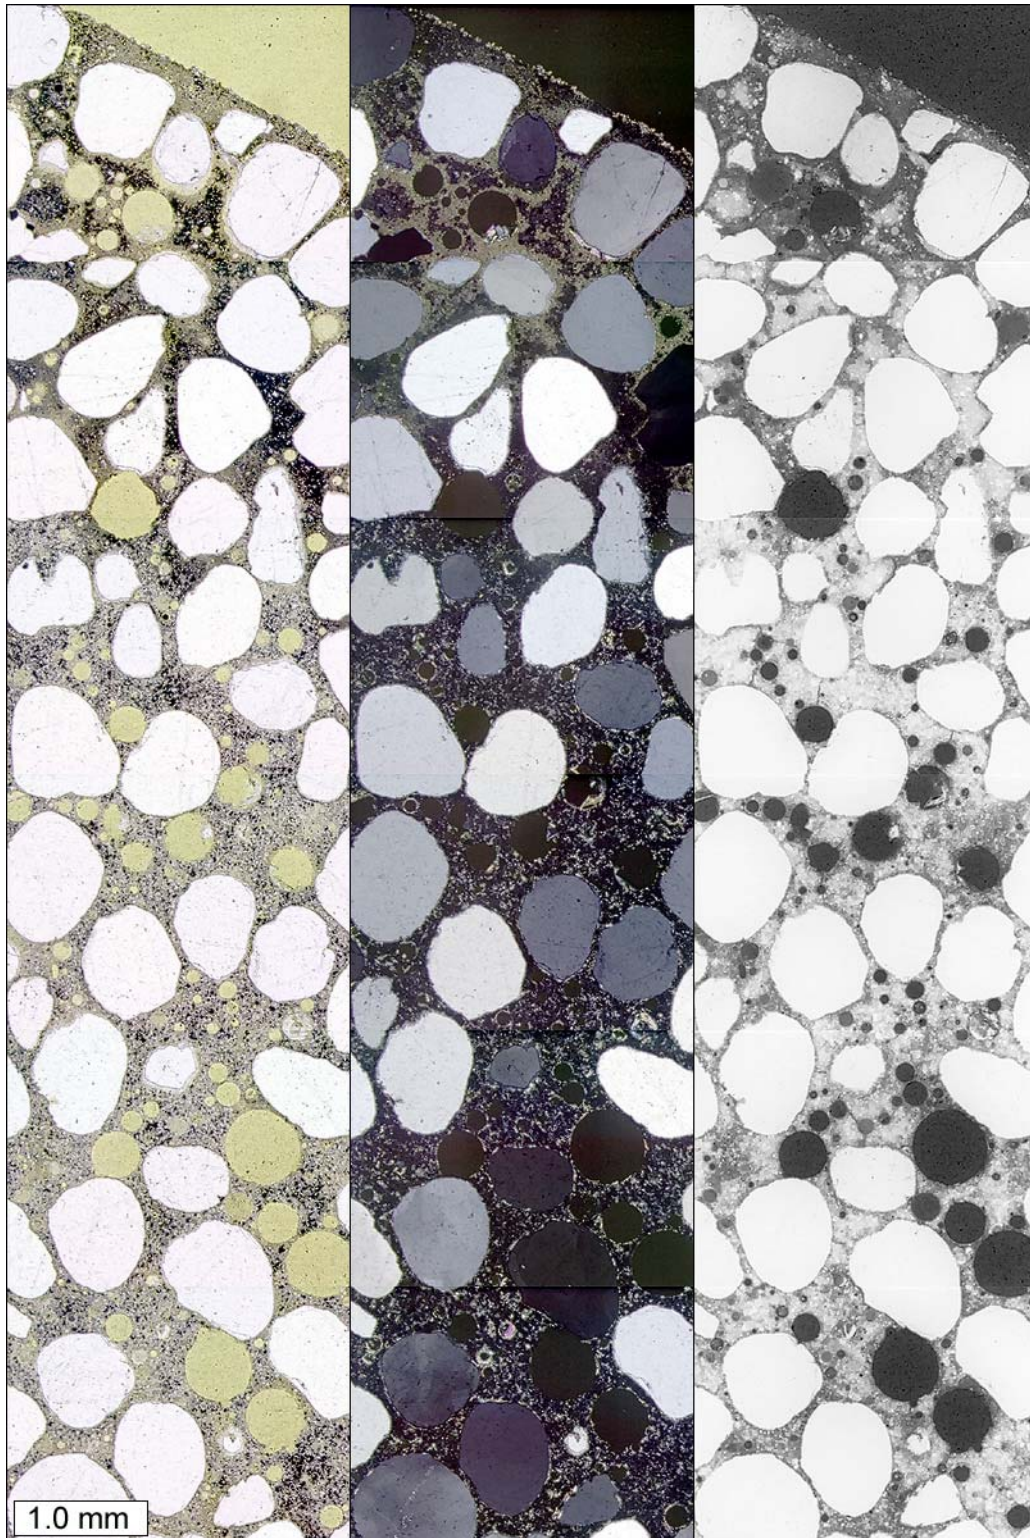
Figure 3.99: From left to right: plane polarized light, cross polarized light, and epifluorescent mode images of a thin section prepared from a cylinder immersed in calcium magnesium acetate solution.

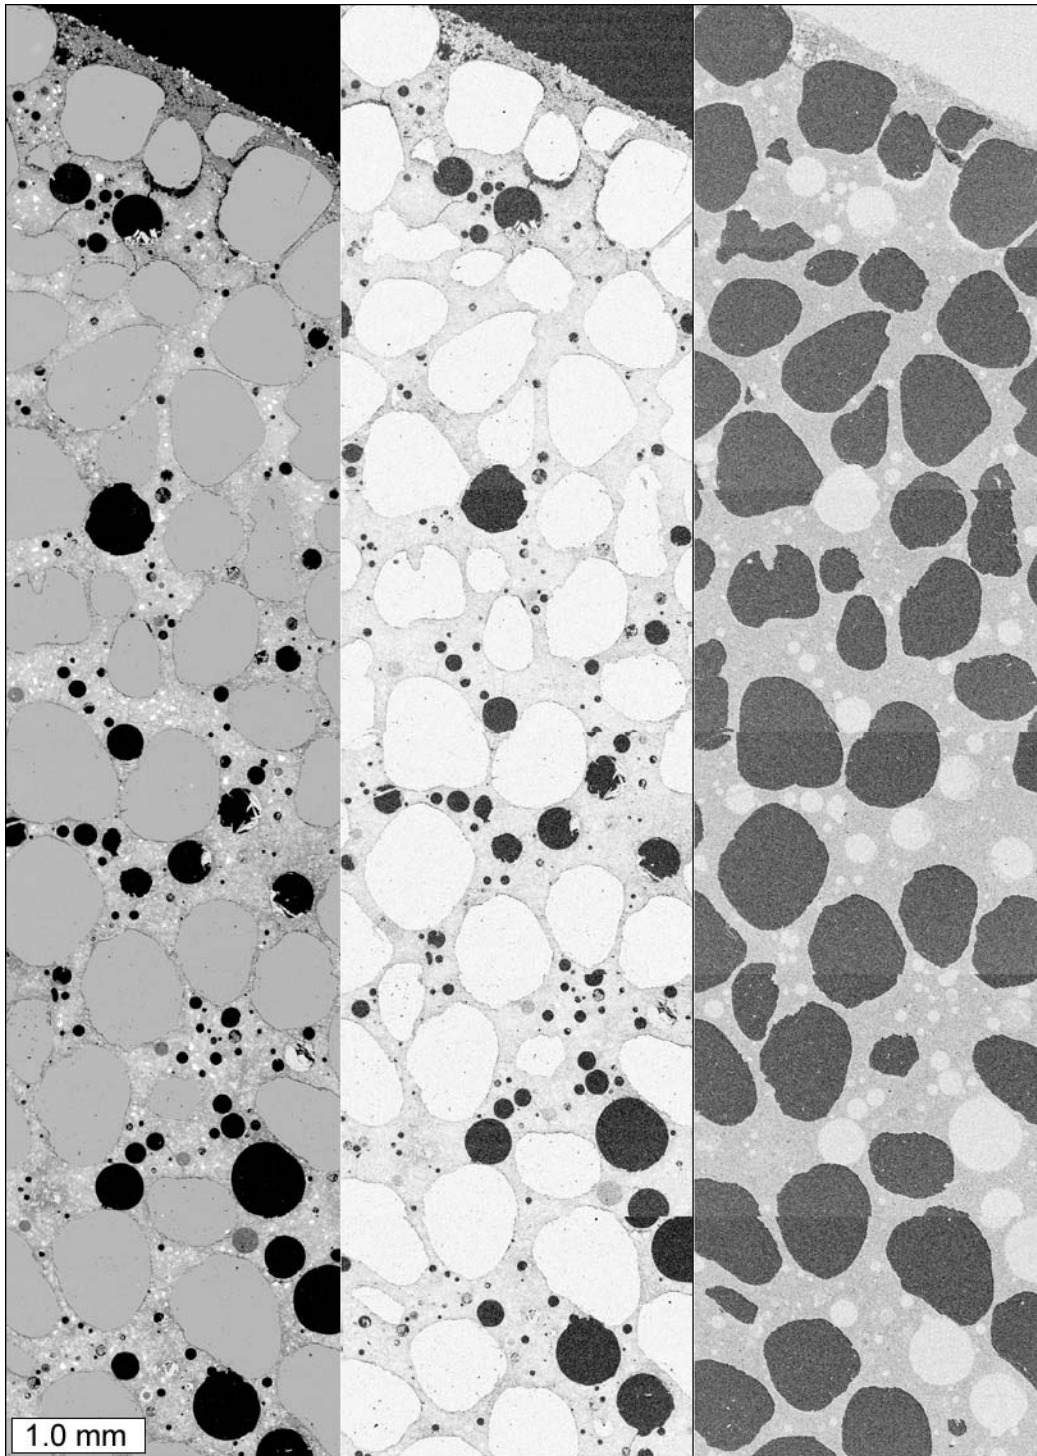
Figure 3.100: From left to right: back scattered electron image, elemental map for carbon, and elemental map for oxygen. Images were collected from a thin section prepared from a cylinder immersed in calcium magnesium acetate solution.

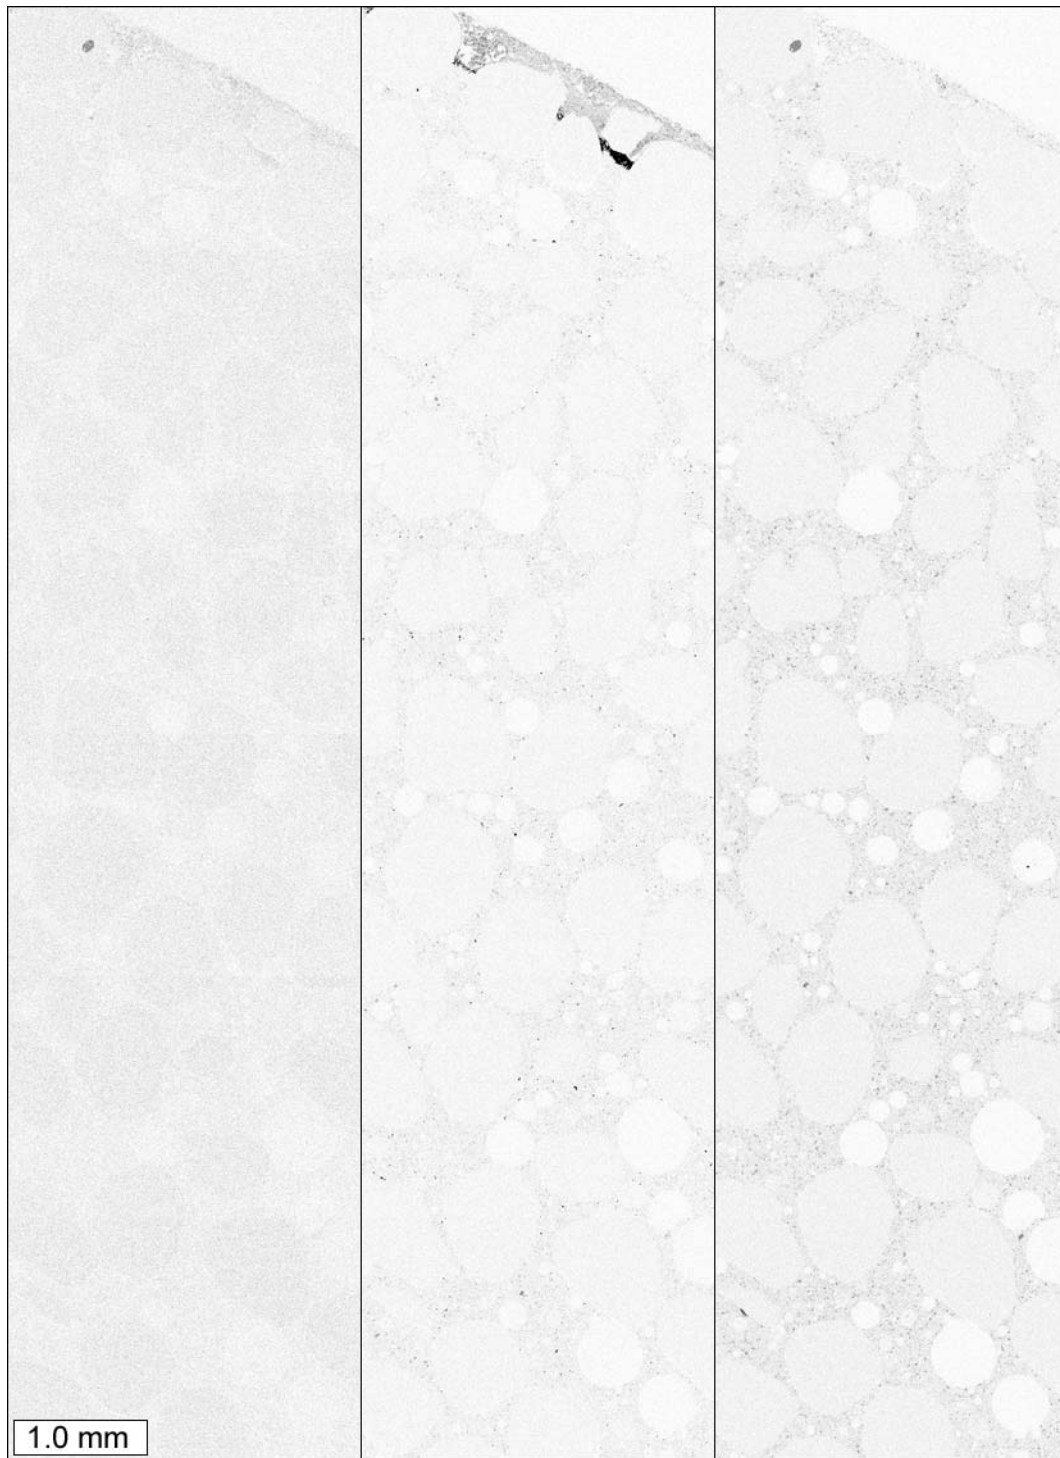
Figure 3.101: Elemental maps, from left to right: sodium, magnesium, and aluminum. The elemental maps were collected from a thin section prepared from a cylinder immersed in calcium magnesium acetate solution.

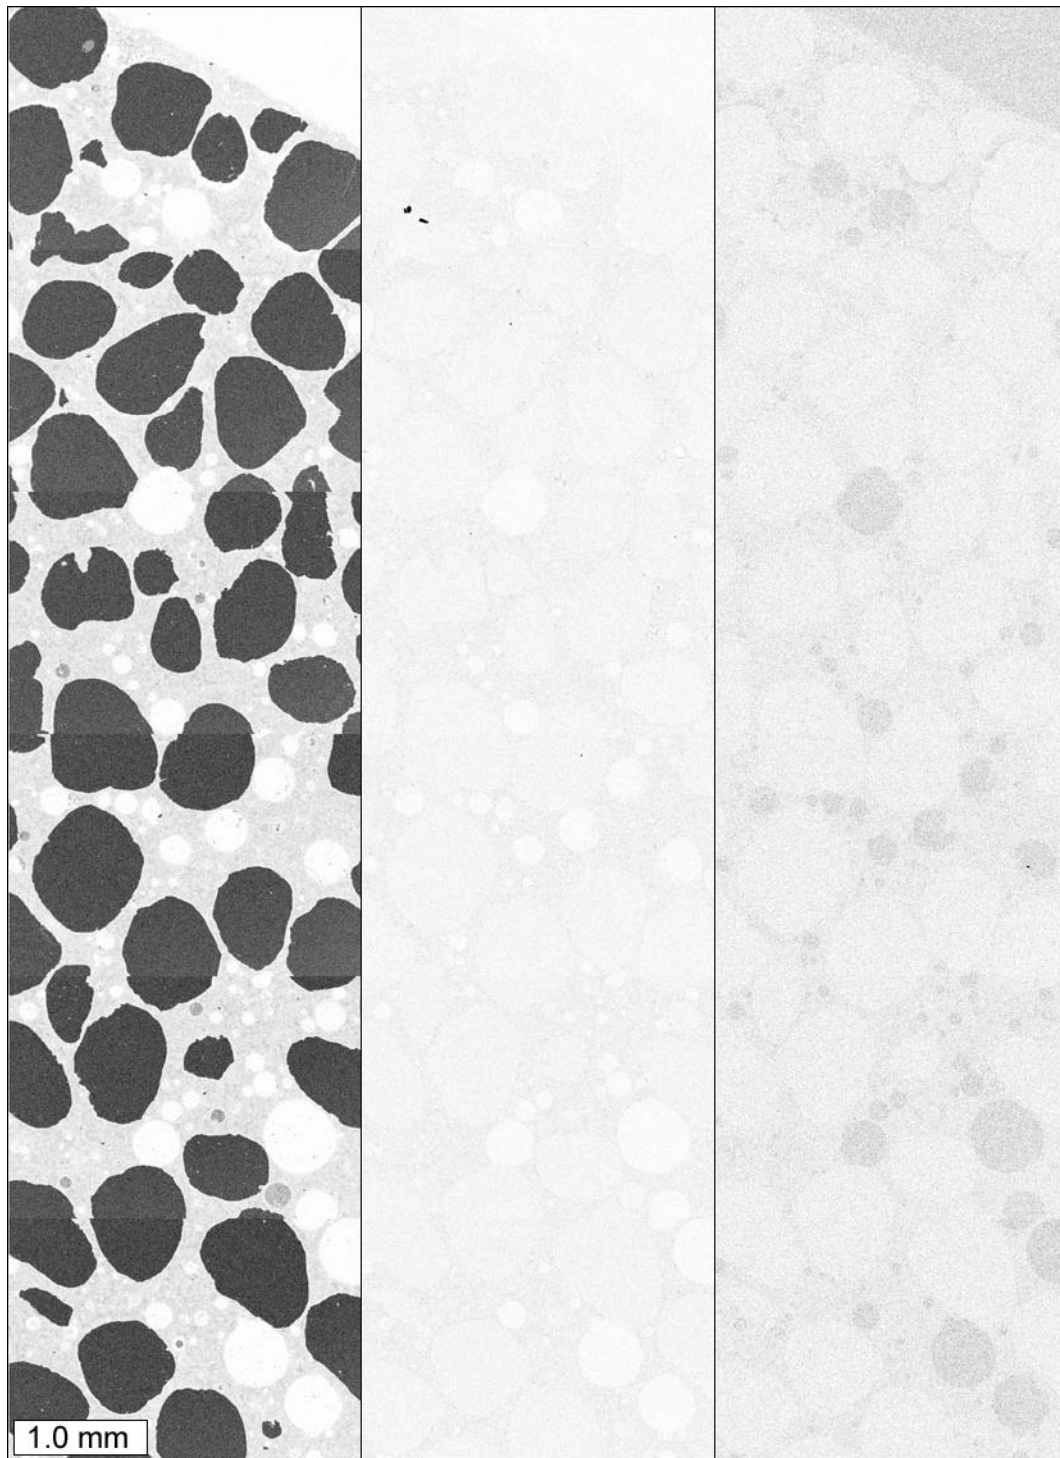
Figure 3.102: Elemental maps, from left to right: silicon, sulfur, and chlorine. The elemental maps were collected from a thin section prepared from a cylinder immersed in calcium magnesium acetate solution.

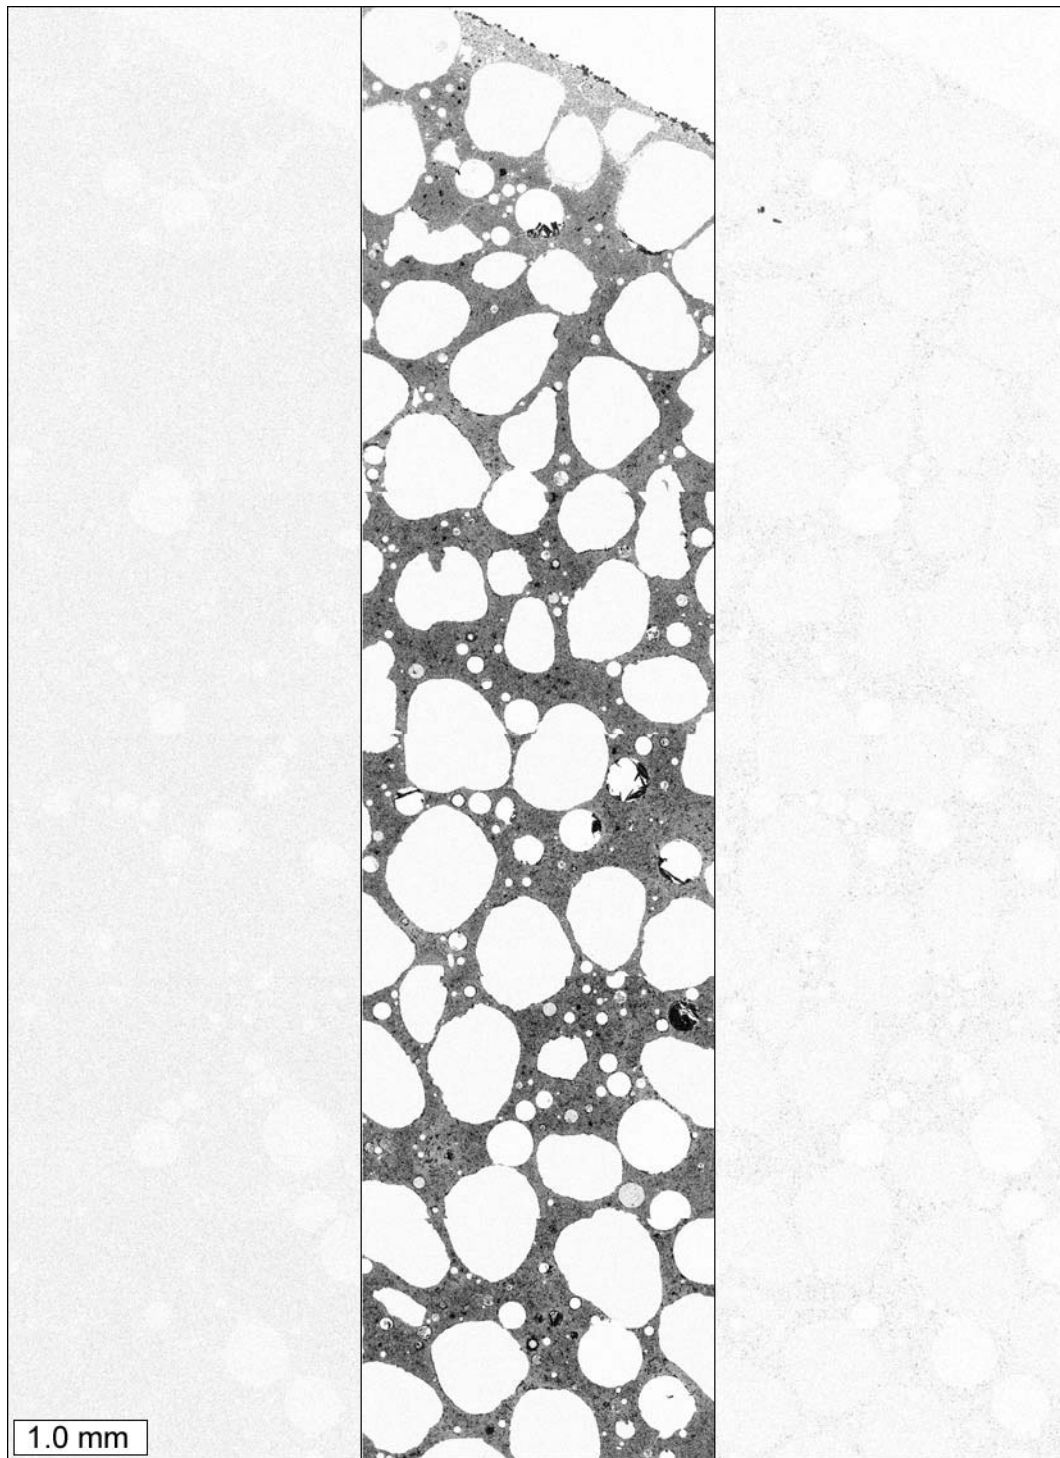
Figure 3.103: Elemental maps, from left to right: potassium, calcium, and iron. The elemental maps were collected from a thin section prepared from a cylinder immersed in calcium magnesium acetate solution.

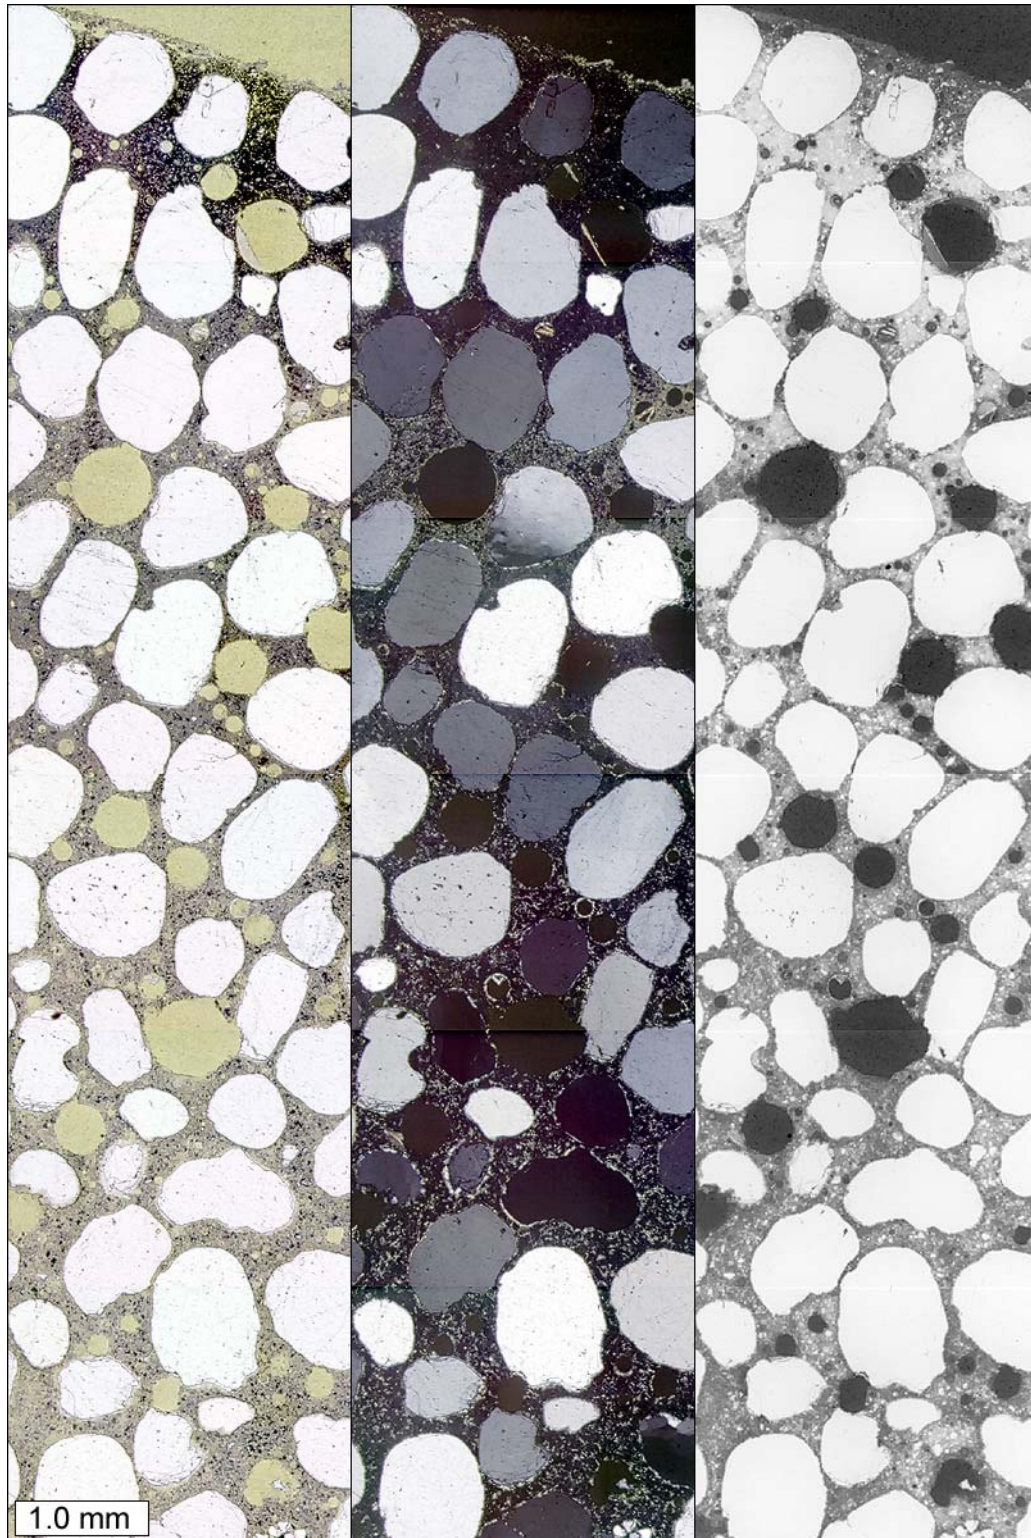
Figure 3.104: From left to right: plane polarized light, cross polarized light, and epifluorescent mode images of a thin section prepared from a cylinder immersed in lime water .

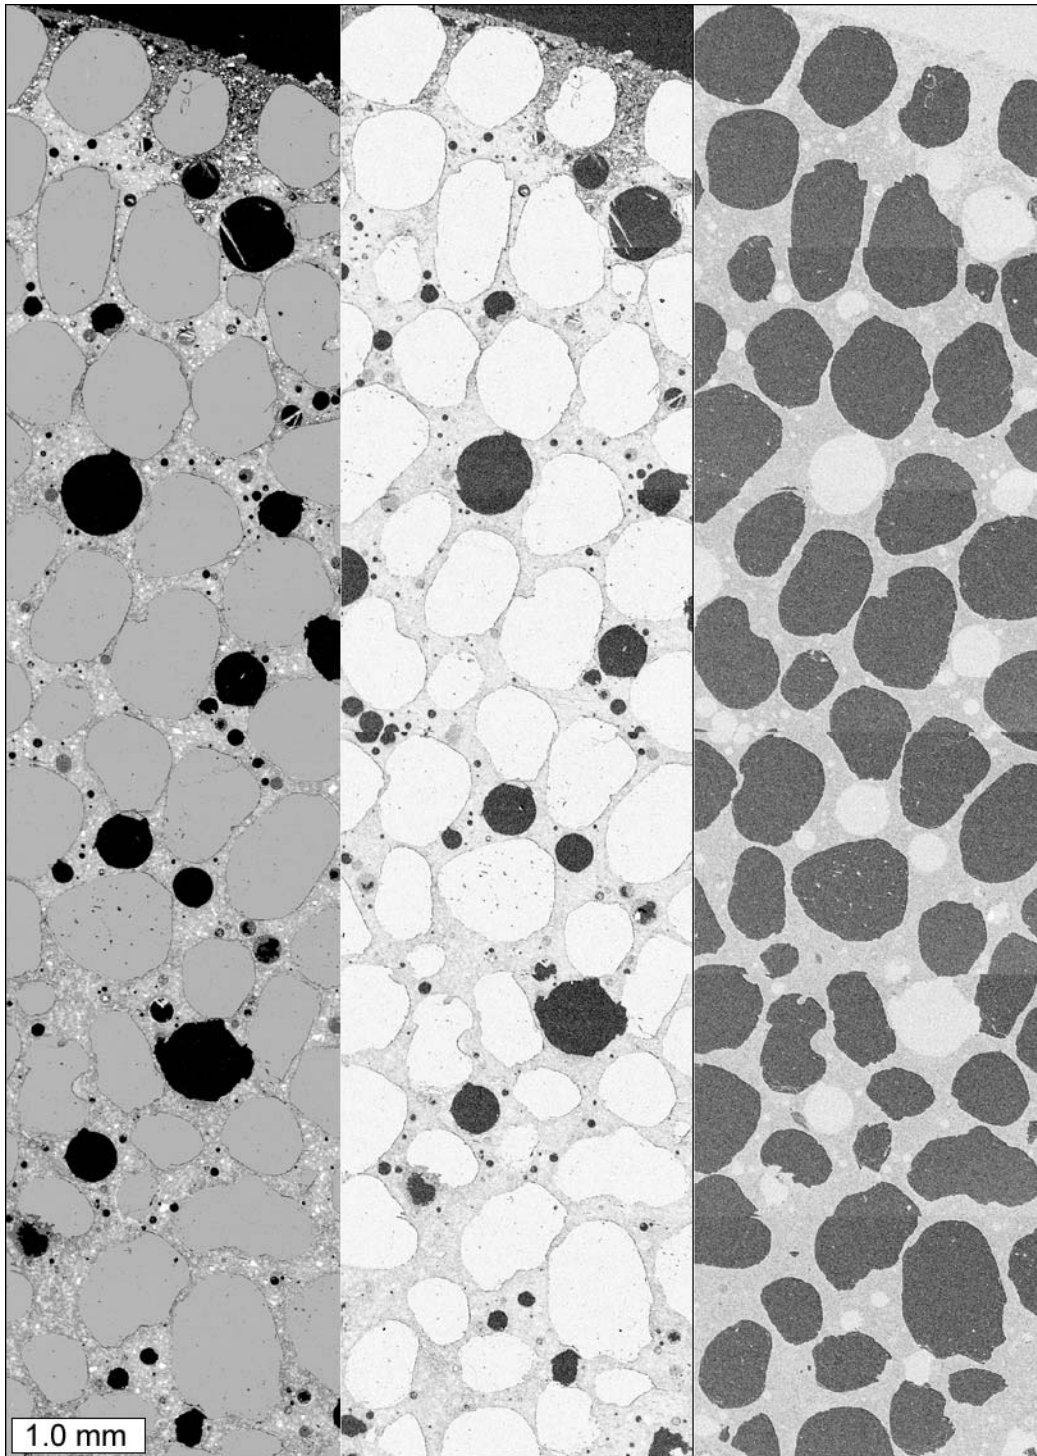
Figure 3.105: From left to right: back scattered electron image, elemental map for carbon, and elemental map for oxygen. Images were collected from a thin section prepared from a cylinder immersed in lime water .

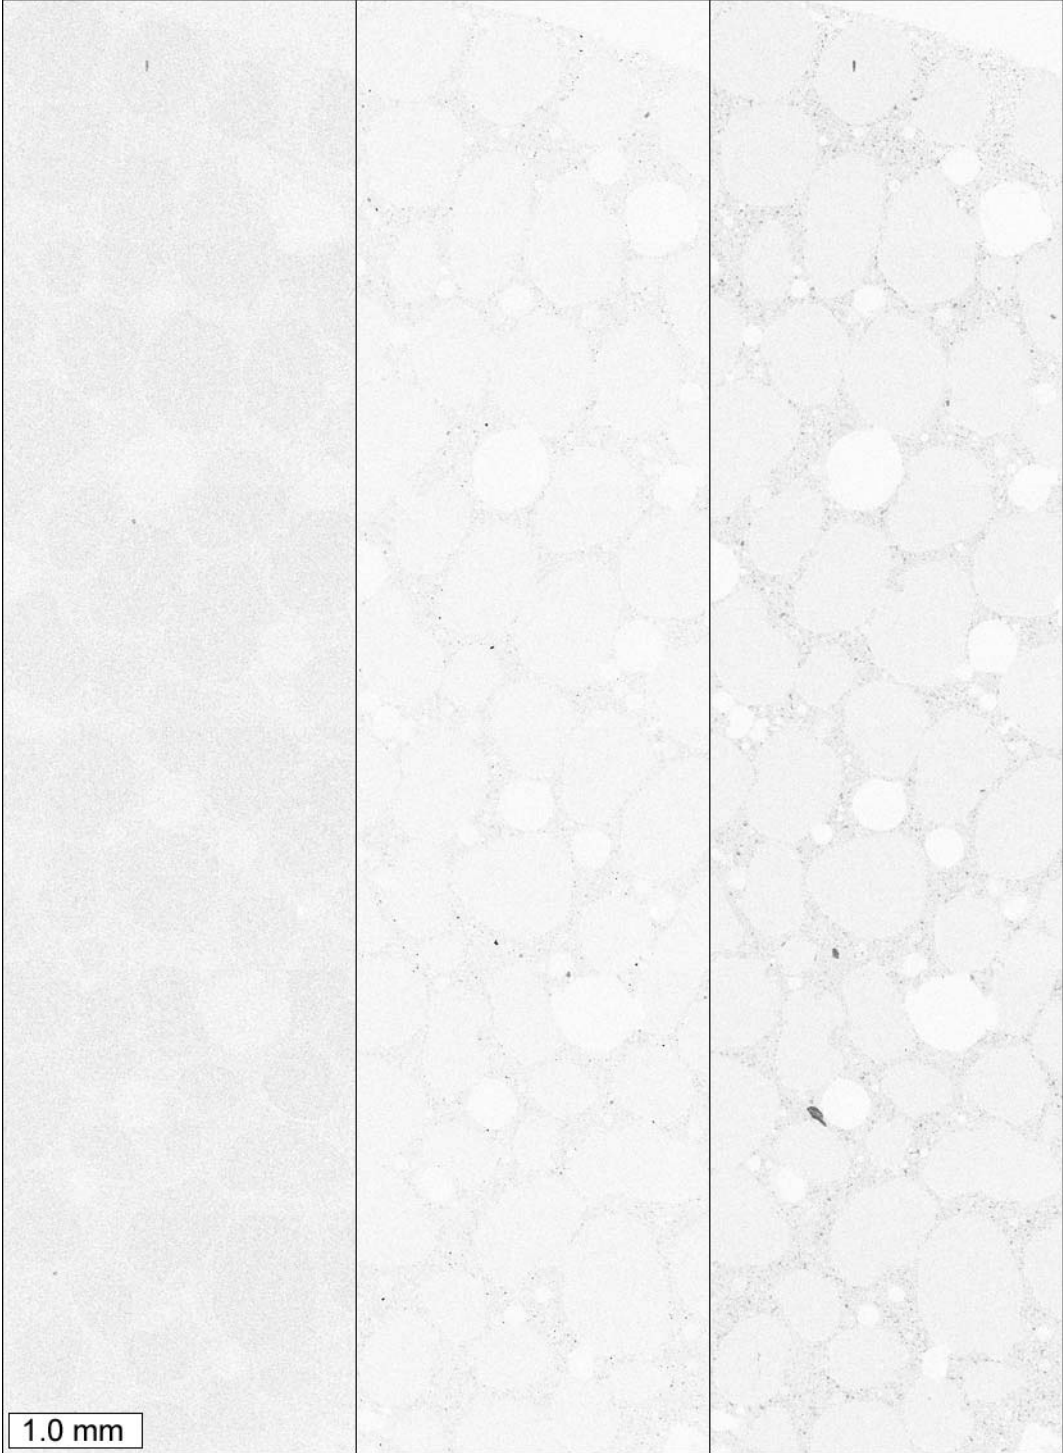
Figure 3.106: Elemental maps, from left to right: sodium, magnesium, and aluminum. The elemental maps were collected from a thin section prepared from a cylinder immersed in lime water .

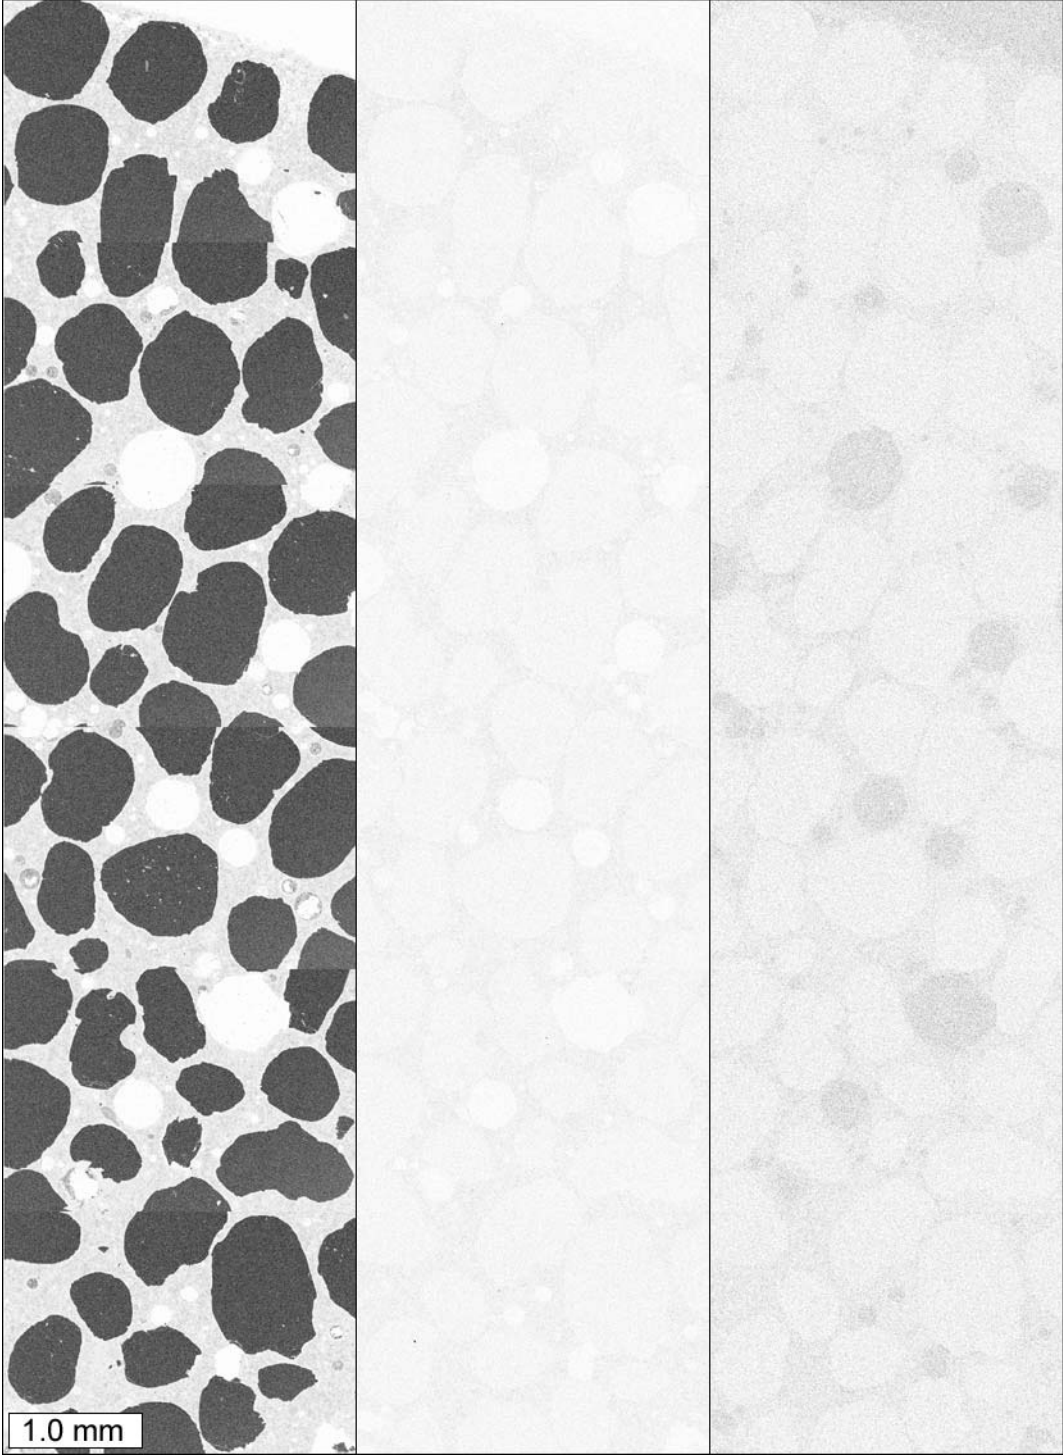
Figure 3.107: Elemental maps, from left to right: silicon, sulfur, and chlorine. The elemental maps were collected from a thin section prepared from a cylinder immersed in lime water .

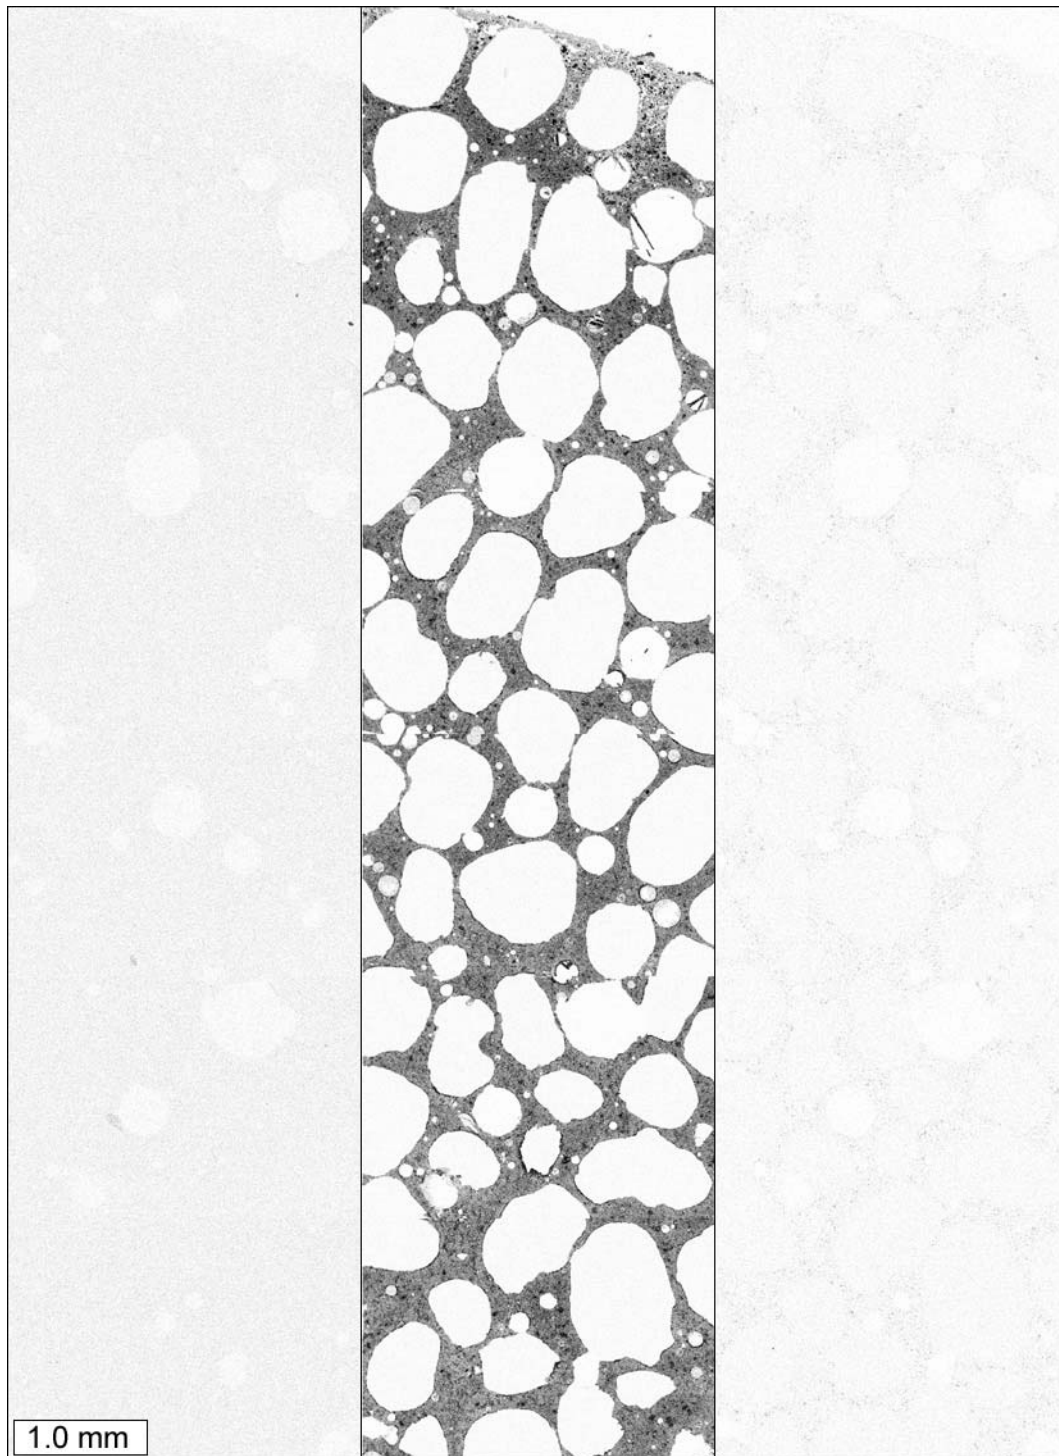
Figure 3.108: Elemental maps, from left to right: potassium, calcium, and iron. The elemental maps were collected from a thin section prepared from a cylinder immersed in lime water .

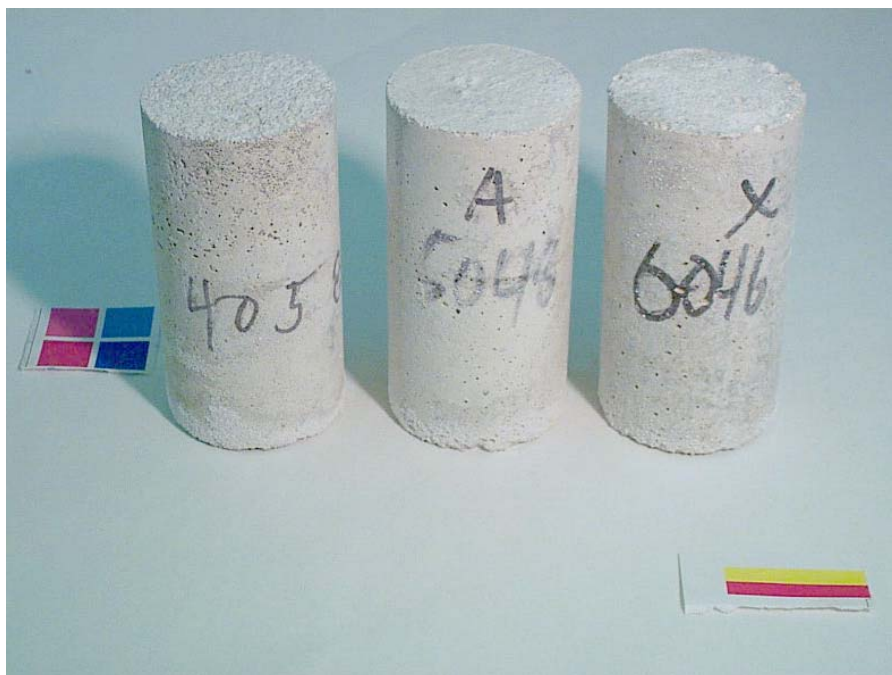
Figure 3.109. Cylinders exposed to NaCl solution after 84 days of constant high temperature test. From left to right: 0.40, 0.50, and 0.60 w/c mortar cylinders.

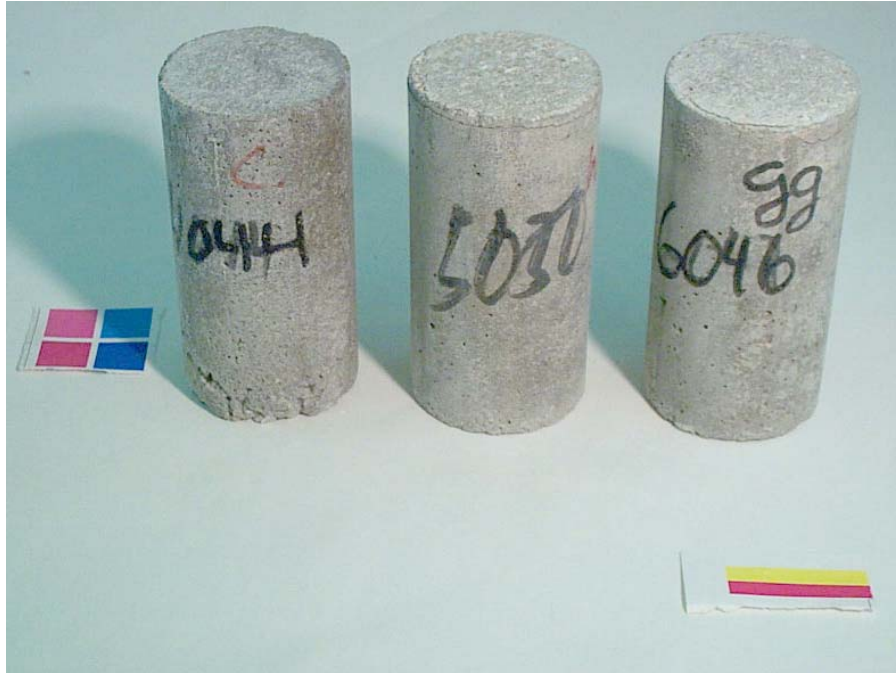
Figure 3.110. Cylinders exposed to  $MgCl_2$  solution after 84 days of constant high temperature test. From left to right: 0.40, 0.50, and 0.60 w/c mortar cylinders.

The constant high temperature experiment was run in the same manner as the constant low temperature experiment, but at an elevated temperature of 135 °F. At 84 days the cylinders in the NaCl solutions showed no distress, as shown in Figures 3.109. The cylinders in the MgCl<sub>2</sub> solution began to show some cracking at 84 days, as shown in Figure 3.110. Figure 3.111 shows the CaCl<sub>2</sub> specimens after 84 days and no visible signs of distress are present. As shown in Figure 3.112, the cylinders in the CMA solution began to disintegrate after 28 days. It was decided to abort the CMA test at 28 days. At 84 days, the control samples in lime water were still unaffected as shown in Figure 3.113. Table 3.16 summarizes the visual ratings for the cylinders over time for all the control lime water and deicer solution exposure tests.

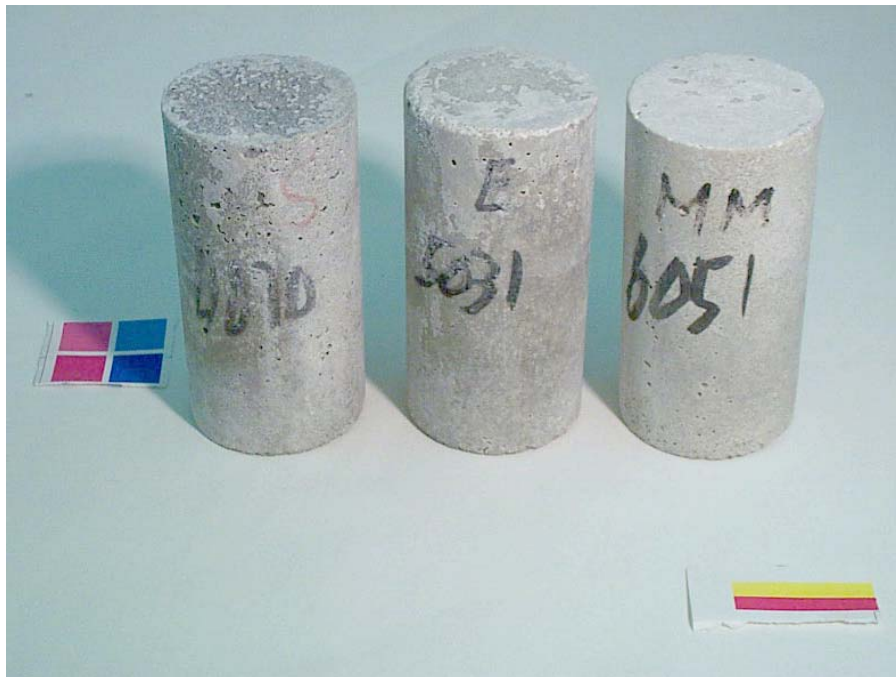
Figure 3.111. Cylinders exposed to  $CaCl_2$  solution after 84 days of constant high temperature test. From left to right: 0.40, 0.50, and 0.60 w/c mortar cylinders.
