## INTERIM REPORT

Investigation of the Long Term Effects of Magnesium Chloride and  
Other Concentrated Salt Solutions on Pavement and Structural  
Portland Cement Concrete

SD2002-01  
Submitted by:

January 2005

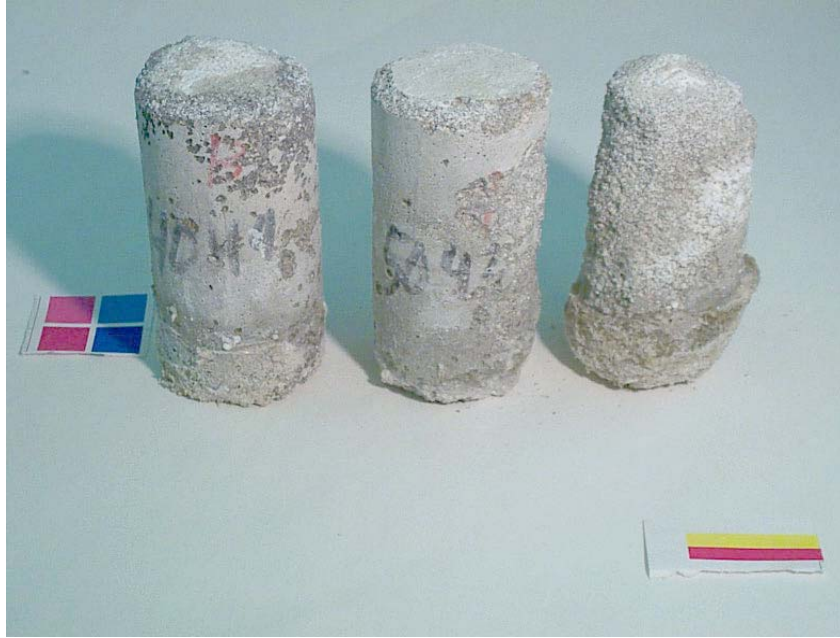
Figure 3.112. Cylinders exposed to CMA solution after 28 days of constant high temperature test. From left to right: 0.40, 0.50, and 0.60 w/c mortar cylinders.

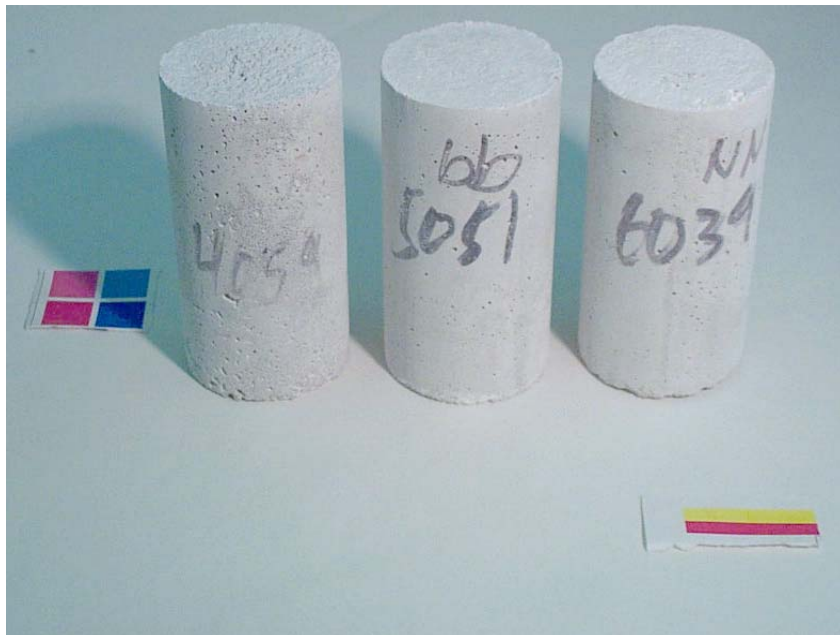
Figure 3.113. Control cylinders exposed to lime solution after 84 days of constant high temperature test. From left to right: 0.40, 0.50, and 0.60 w/c mortar cylinders.

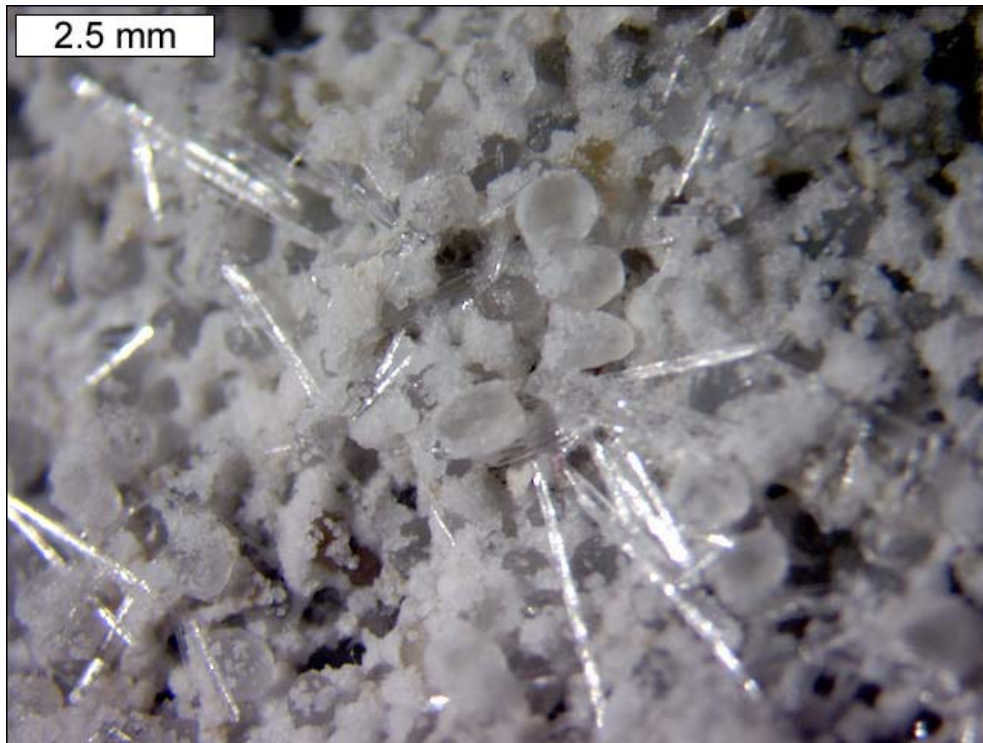
Figure 3.114: Stereomicroscope image of needles of translucent crystals on disintegrated mass of mortar.

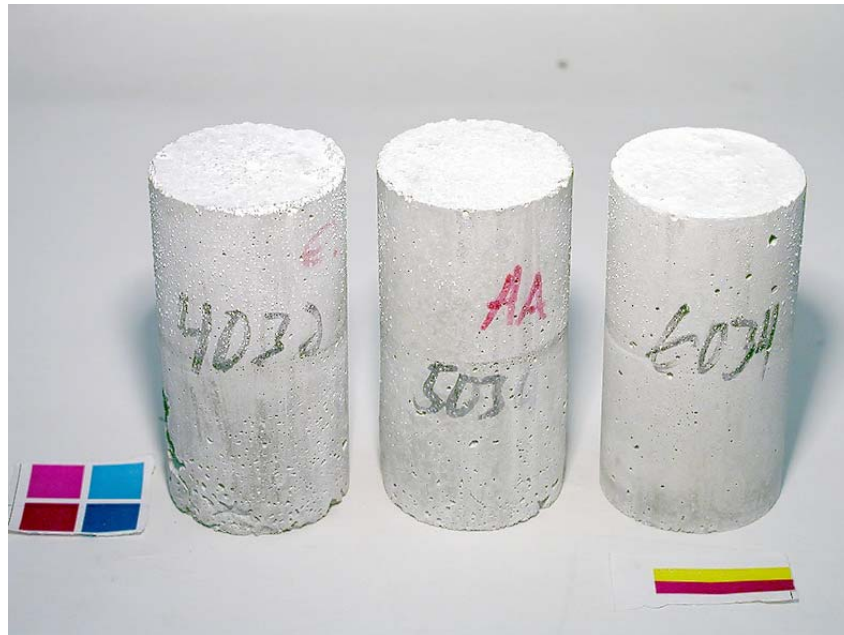
Figure 3.121. Cylinders exposed to rock salt NaCl solution after 28 days of cyclic temperature test without the oven step. From left to right: 0.40, 0.50, and 0.60 w/c mortar cylinders.

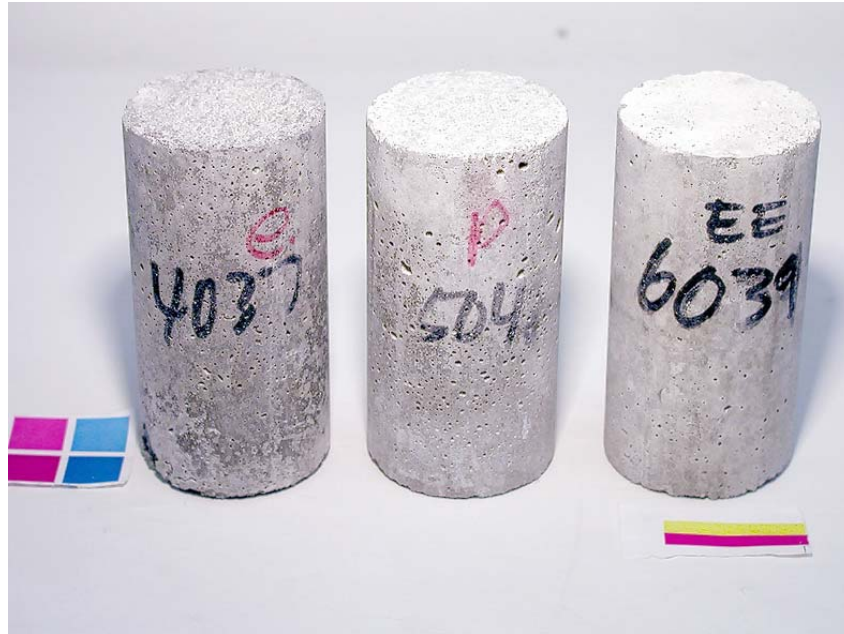
Figure 3.122. Cylinders exposed to rock salt NaCl solution after 28 days of cyclic temperature test without the oven step or the conditioning in lime water step. From left to right: 0.40, 0.50, and 0.60 w/c mortar cylinders.

As shown in Figures 3.121 and 3.122, eliminating the oven step eliminated the rapid failures seen in the original NaCl cyclic tests. However with extended testing, it was shown that distress would still manifest itself in 56 days as is shown in Figure 3.123.

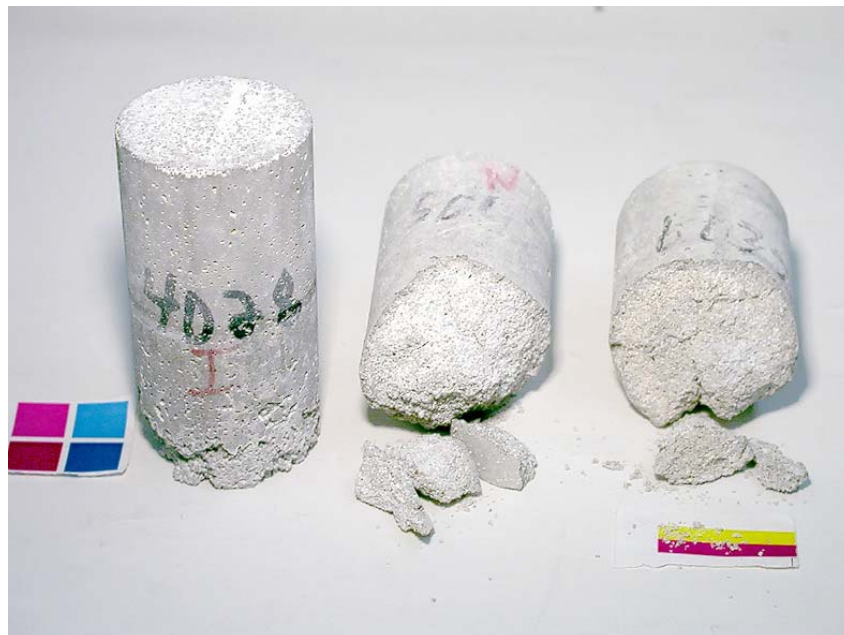
Figure 3.123. Cylinders exposed to rock salt NaCl solution after 56 days of cyclic temperature test without the oven step. From left to right: 0.40, 0.50, and 0.60 w/c mortar cylinders.

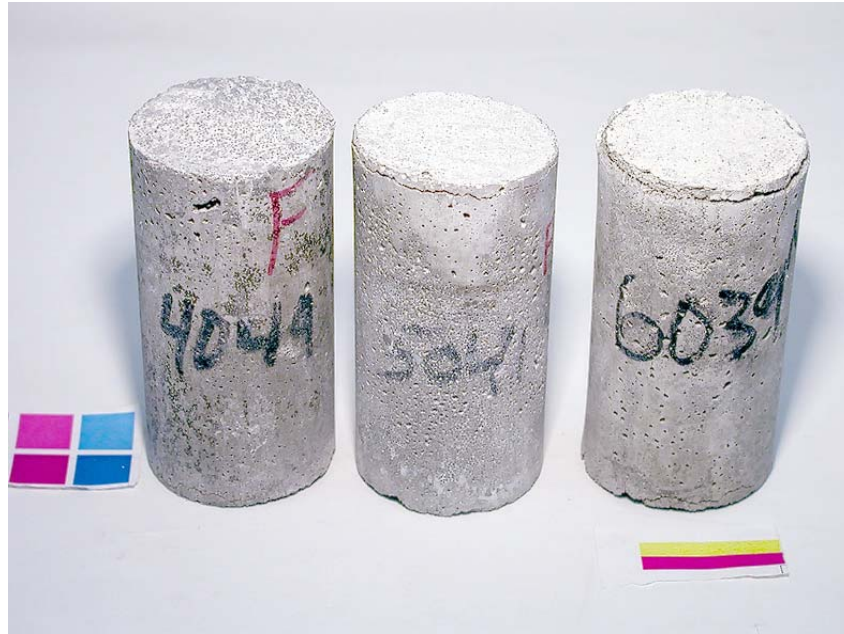
Figure 3.124. Cylinders exposed to rock salt NaCl solution after 56 days of cyclic temperature test without the oven step or the conditioning in lime water step. From left to right: 0.40, 0.50, and 0.60 *w/c* mortar cylinders.

Eliminating both the oven and the lime water steps greatly reduced the distress even further. However, as can be seen in Figure 3.124, distress did still appear. Therefore, it is postulated that either salt crystallization pressures or hydraulic pressures resulting from water evaporation were the cause of the rapid failures seen in the original experiment. However, no hard evidence of salt crystallization was found as a result of petrographic analysis and a specific mechanism was not identified as the cause of these failures. Further, these tests show that the temperature cycle from sub-freezing to room temperature is adequate to bring on distress and this temperature regime should be investigated further. The next phase of this research will use ASTM C 672, which utilizes a temperature cycle from sub-freezing to room temperature.

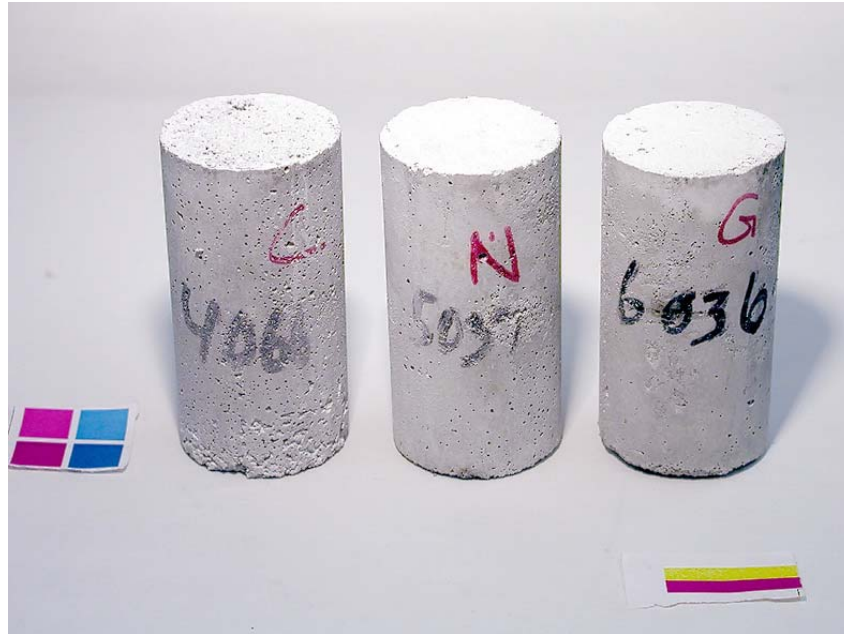
Figure 3.125. Cylinders exposed to  $\text{CaCl}_2$  solution after 56 days of constant low temperature test. From left to right: 0.40, 0.50, and 0.60 w/c mortar cylinders. Solution strength was 3%  $\text{CaCl}_2$ .

As can be seen clearly in Figures 3.125 through 3.129, concentration clearly has an affect on the observed damage at a given time for mortars exposed to the low temperature test.

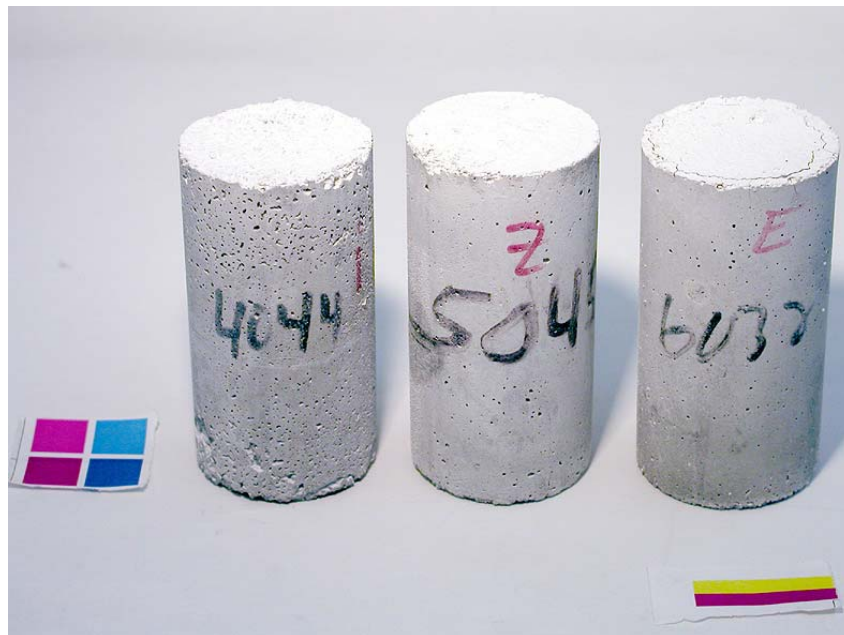
Figure 3.126. Cylinders exposed to  $\text{CaCl}_2$  solution after 56 days of constant low temperature test. From left to right: 0.40, 0.50, and 0.60 w/c mortar cylinders. Solution strength was 7%  $\text{CaCl}_2$ .

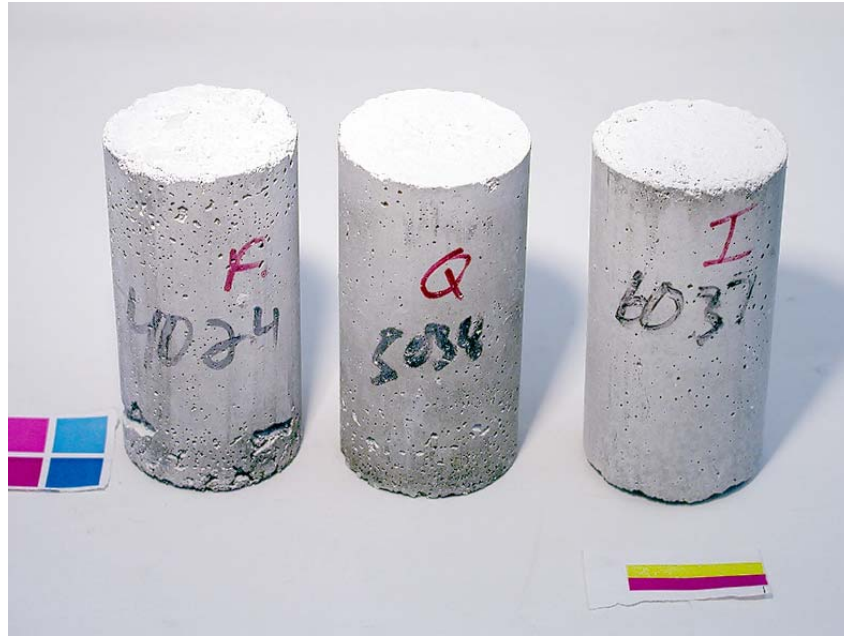
Figure 3.127. Cylinders exposed to  $\text{CaCl}_2$  solution after 56 days of constant low temperature test. From left to right: 0.40, 0.50, and 0.60 w/c mortar cylinders. Solution strength was 10%  $\text{CaCl}_2$ .

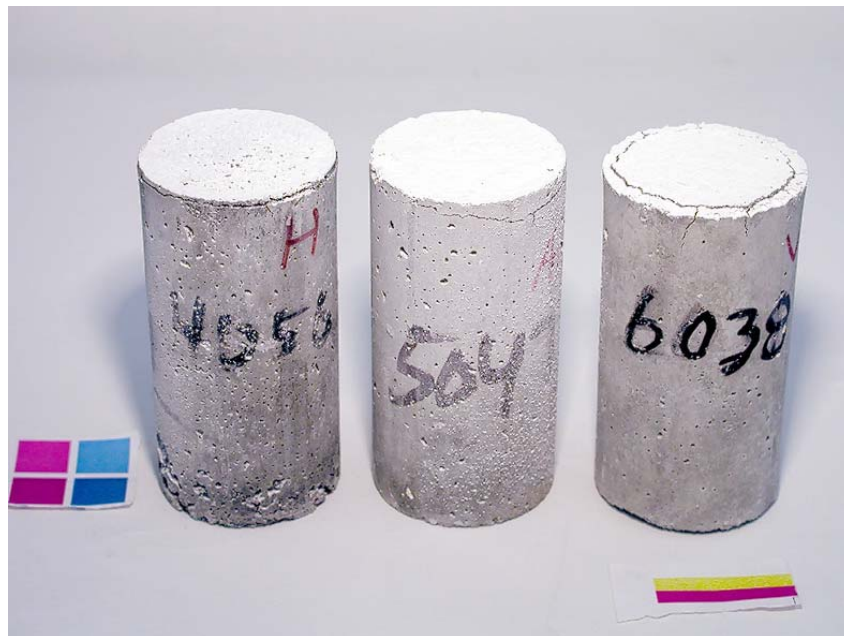
Figure 3.128. Cylinders exposed to  $\text{CaCl}_2$  solution after 56 days of constant low temperature test. From left to right: 0.40, 0.50, and 0.60 w/c mortar cylinders. Solution strength was 14%  $\text{CaCl}_2$ .

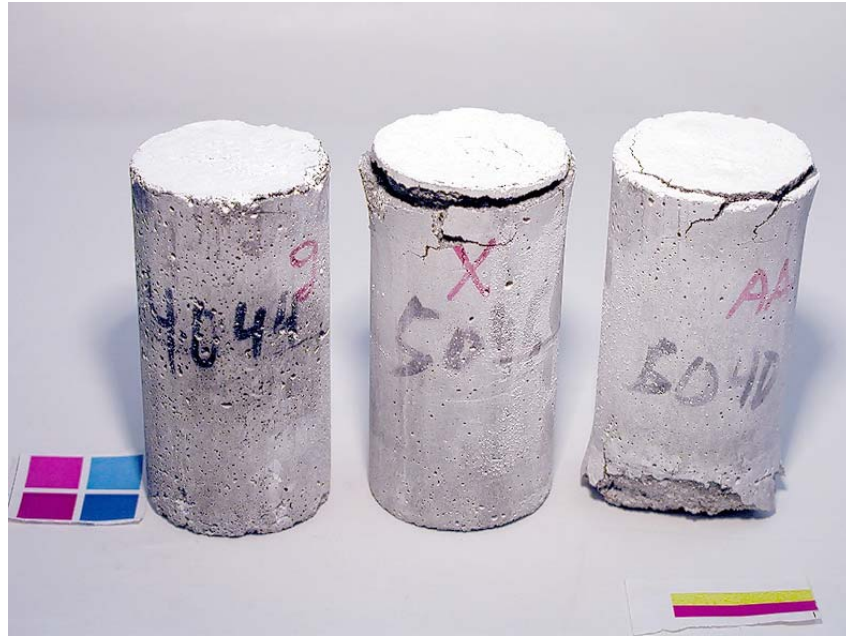
Figure 3.129. Cylinders exposed to  $\text{CaCl}_2$  solution after 56 days of constant low temperature test. From left to right: 0.40, 0.50, and 0.60 w/c mortar cylinders. Solution strength was 17%  $\text{CaCl}_2$ .
