## **Project Update Memo**

**Project Title:** Relative Operational Performance of Geosynthetics Used as Subgrade Stabilization

**Date Submitted:** December 14, 2012

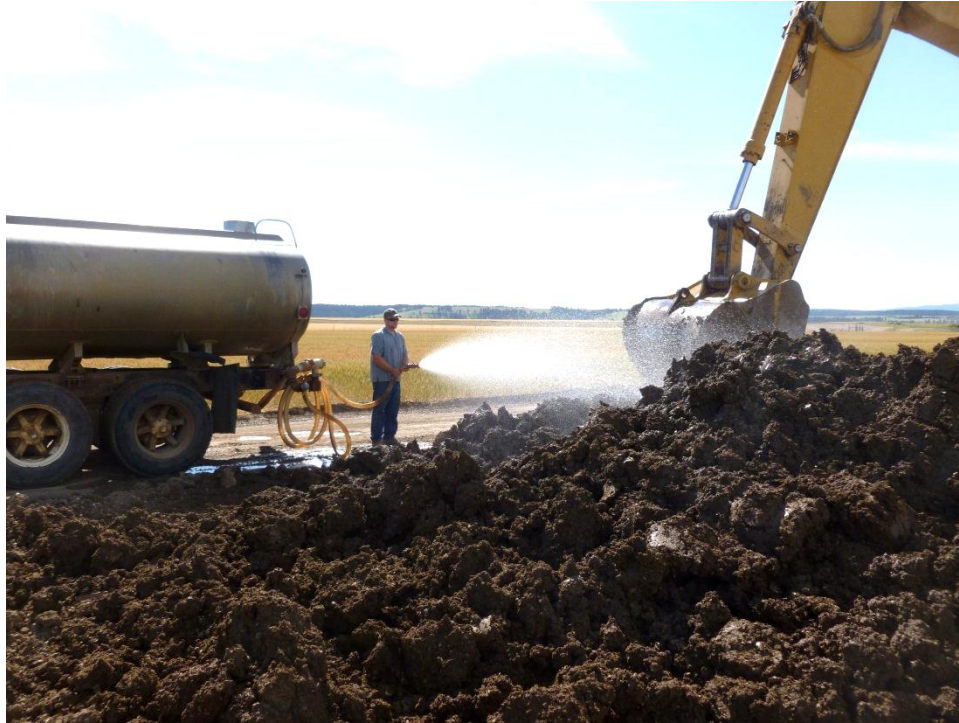
**Figure 1: Watering and mixing subgrade with excavator.**

The subgrade was built in 6 lifts that were approximately 6 inches deep for a total depth of about 3 feet. The subgrade was delivered adjacent to the test pit and was processed to reach the target strength by adding water from a water truck and fire hose (Figure 1). Water was added until the portion of the pile being prepared reached a predetermined moisture content (e.g., 23 percent for test Sections 3 through C3). Processing was accomplished using a large excavator (Caterpillar 345B). The operator used the bucket to move and mix the material as water was being added (Figure 1). Sufficient material was processed to construct a single 6-inch deep layer over two test sections at a time (about 30 yd<sup>3</sup>). The subgrade was then placed in the trench using the excavator and a track-mounted skid-steer tractor was used to level and initially consolidate the subgrade (Figure 2). A smooth, single-drum, vibratory roller (66-inch wide, 15,500 lb) was used to compact the subgrade by making two passes of the roller in three longitudinal paths of the freshly placed subgrade (Figure 3). The moisture in the top surface of the subgrade was maintained during construction by periodically wetting the surface and keeping it covered with plastic until the next layer of subgrade or the base course could be placed.

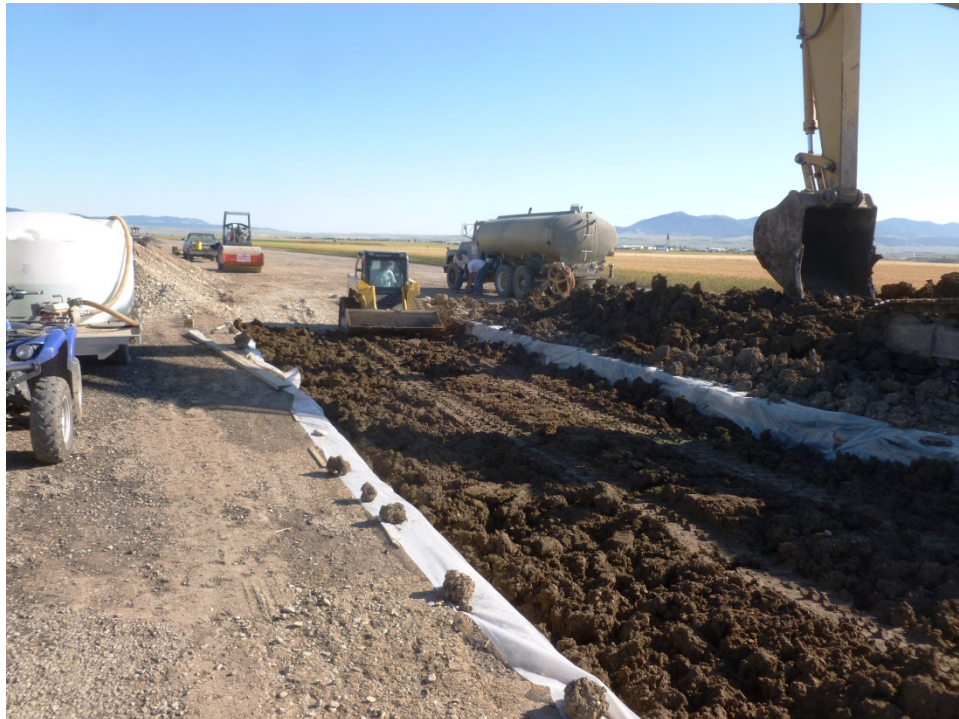
**Figure 2: Tracking freshly placed subgrade with track-mounted skid-steer.**

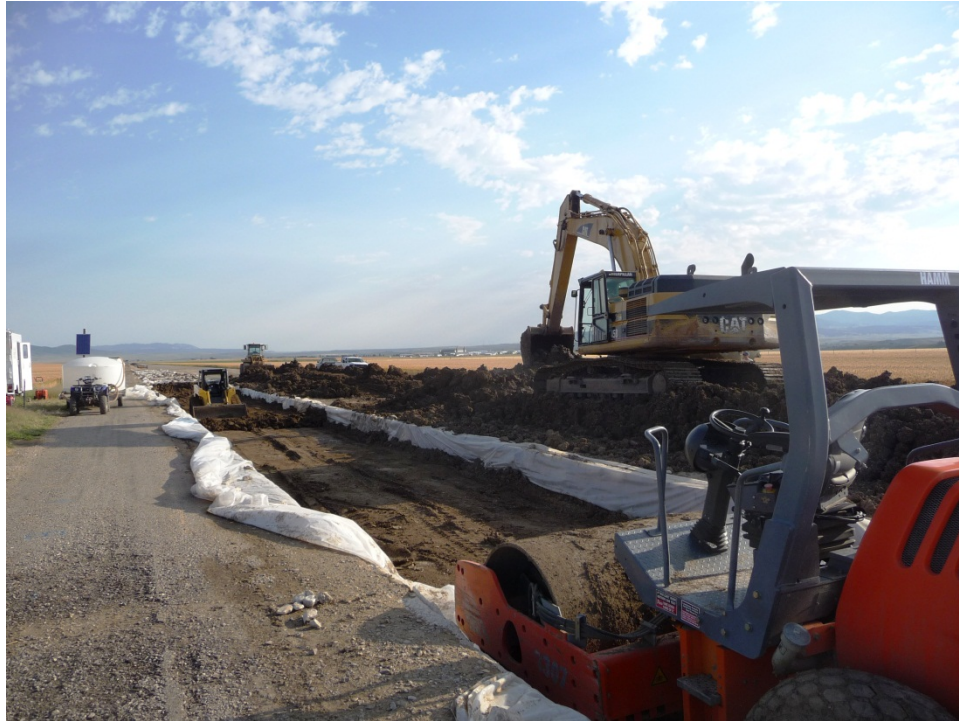
**Figure 3: Smooth-drum roller used to compact subgrade.**

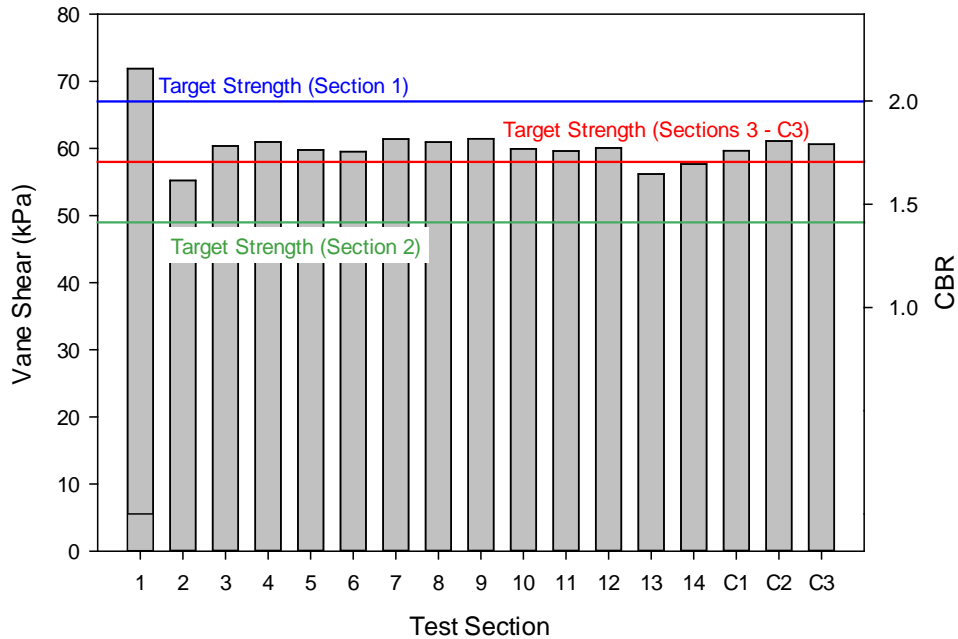
**Figure 4: Composite vane shear strength of the constructed subgrade.**

For quality control testing purposes, each 50-foot long test section was delineated into 14 subsections – seven in each wheel path, as outlined in the Task 1 report for this project. Four measurements of vane shear were made in each subsection for a total of 56 vane-shear measurements in each layer in each test section. A shear strength of 1,200 psf (58 kPa) was targeted, which corresponds to a CBR of 1.7. Shear strengths of 1,400 psf and 1,000 psf (67 kPa and 49 kPa, corresponding to CBRs of 2.0 and 1.4) were targeted for test sections 1 and 2, respectively. A plot of the composite shear strength of the subgrade for each of the constructed test sections, based on vane shear data, is shown in Figure 4. Measurements of dynamic modulus (using the light-weight deflectometer) were also made in six locations in each test section in each layer. Once construction of the subgrade was complete, dynamic cone penetrometer (DCP) readings were also made at these same six locations in each test section, in-field CBR was measured in one location in each test section, and density (using a nuclear densometer) was measured in two locations in each test section.

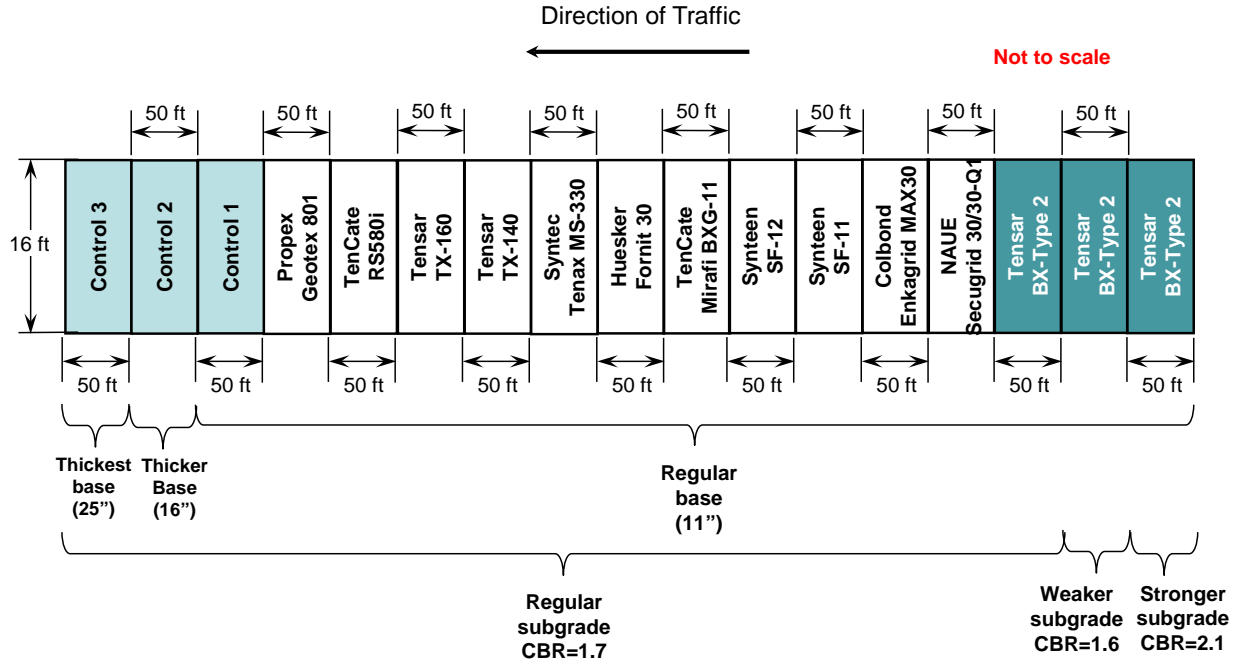
Figure 5: General layout of test sections.

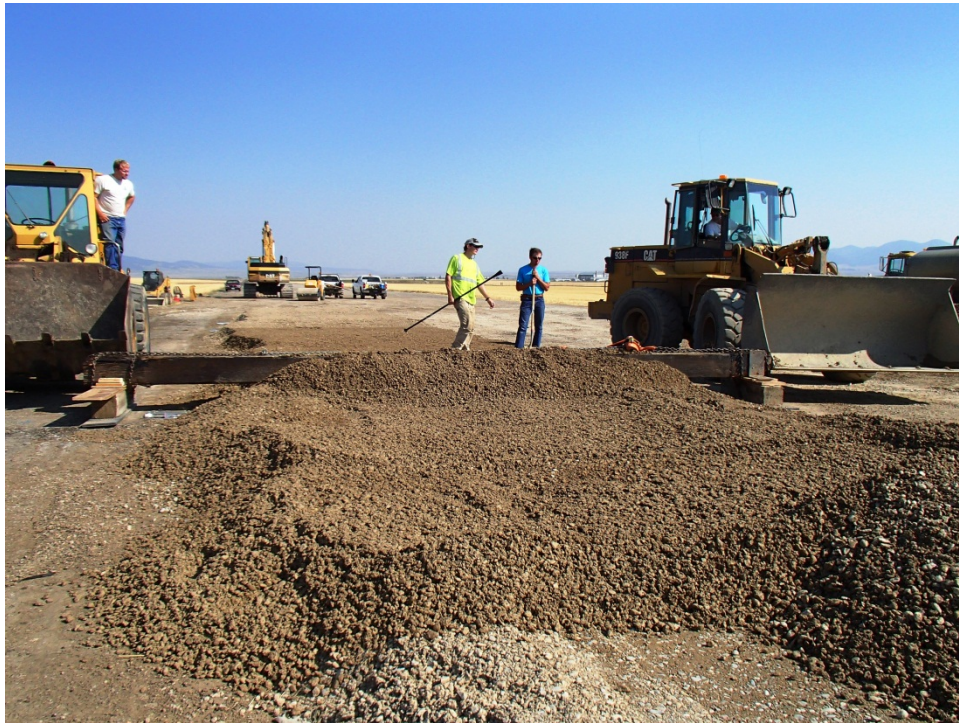
Figure 6: Screeding gravel surface.

The base course was prepared by adding water and mixing with an end loader until it reached optimum water content. Prior to placement of the base course, the top surface of the subgrade was smoothed and screeded to the height of the adjacent pavement surface. This was accomplished by tilling the top of the subgrade and pushing a large metal edge along the surface to remove excess material. The top surface was then compacted using a smaller single-drum, vibratory roller from the side to minimize ruts in the subgrade surface. Pore-pressure gages were then installed and the geosynthetics were placed. The final arrangement of the geosynthetics in the test sections is shown in Figure 5. A large screed that rested on the paved surface on both sides of the subgrade trench was used to level the surface of the gravel layer (Figure 6). The target gravel thickness was 12 inches, which was determined using data from the cyclic plate load test conducted as part of this project, as well as past cyclic plate load test data from other research projects. The base course was placed in two layers. The final thickness of the first layer of base course was about 8 inches when compacted and the second about 3 inches deep for a total of about 11 inches of gravel. The final thickness of the base course in each test section is shown in Figure 7. Compaction was achieved using a smooth, single-drum, vibratory roller (54-inch wide, 12,000 lb). In total, eight passes of the roller were made per lift at three transverse positions. In addition to a topographic survey, the final gravel surface was measured using DCP, LWD, CBR, and nuclear densometer.

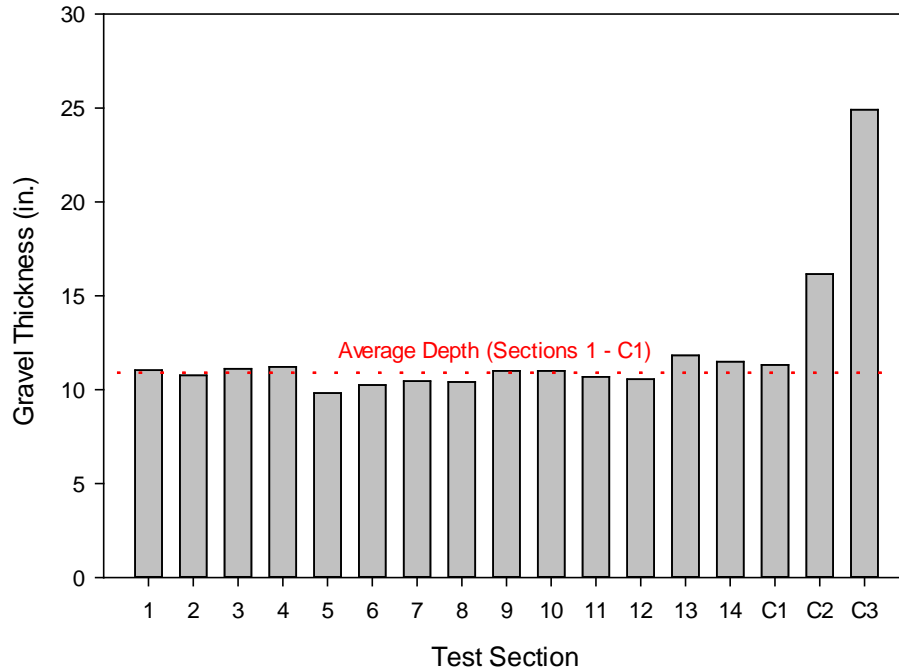
Figure 7: Gravel thickness.
