Application of Three-Dimensional Laser Scanning for the Identification, Evaluation, and Management of Unstable Highway Slopes

**Pooled Fund Study
Final Report TPF-5(166)
March 2015**

Prepared by:
John M. Kemeny, Ph.D.
Dept. of Mining and Geological Engineering
University of Arizona
1235 E. James E. Rogers Way, Room 229
Tucson, AZ 85721-0012

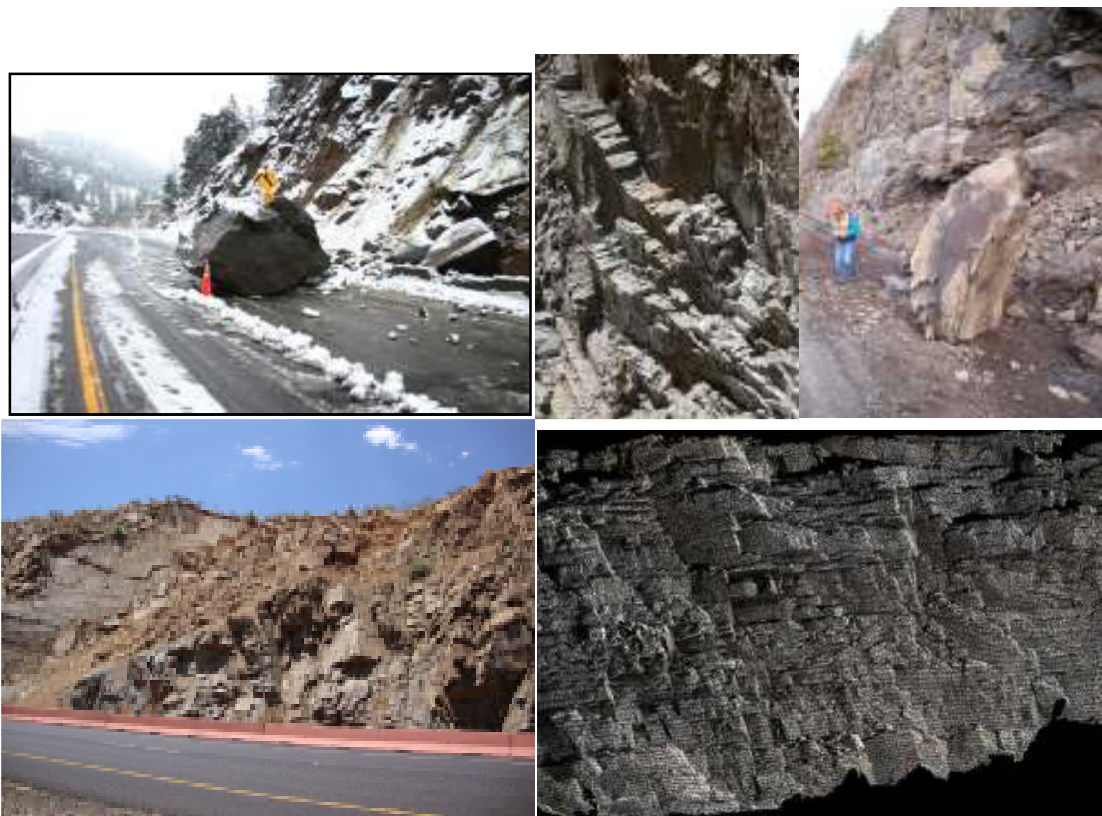
Figure 6. Images showing geotechnical issues associated with some of the pooled fund sites: top row, left to right, rockfall at one Colorado site, toppling at the California site, and rockfall at the Arizona site. Bottom left shows wedge failure at the Texas site, and bottom right shows overhangs at the New York site (Photos courtesy of CDOT).

Table 3 and Figure 5 show that eight of the nine sites are highway rock slopes, and one site is an artificial “slope” consisting of jersey and plastic barriers. The eight rock slopes cover a wide variety of rock types and slope conditions. In general, the rock slopes were selected because of geotechnical issues. Some of these issues are apparent in the photos in Figure 5. For example, the New Hampshire site shows wedge and plane failures that have occurred, and the Tennessee site shows overhanging sandstone slabs posing a hazard to the interstate highway below. The Colorado site is an ancient landslide deposit and the large boulders are prone to toppling, as shown in Figure 6a.

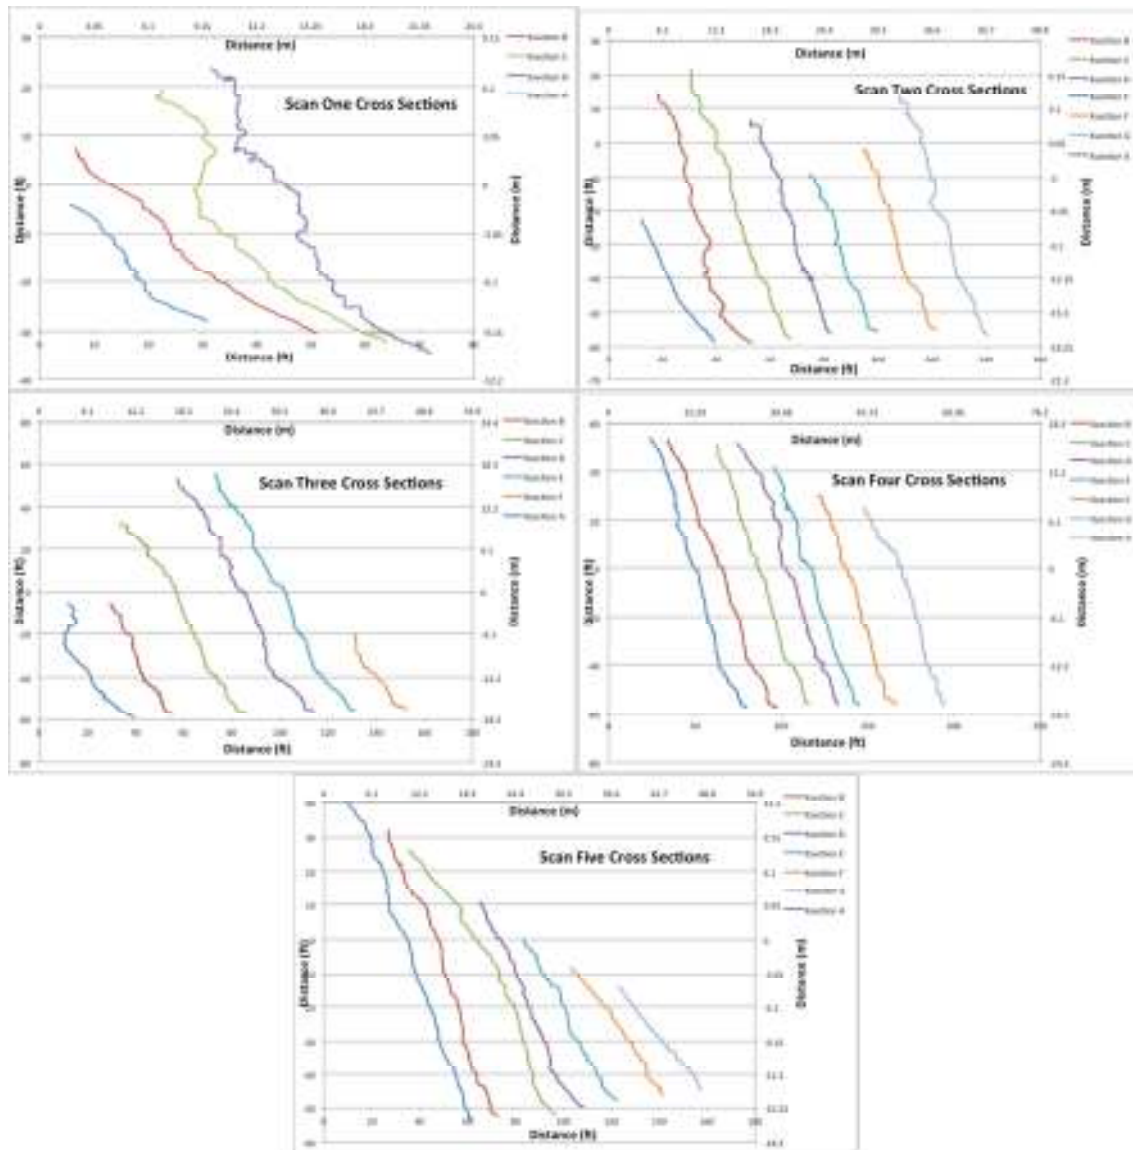
Figure 12. Slope profiles for Scans 1-5.

A number of cross sections were made in each of the five scans, as shown in Figure 12. Two types of analysis were made from the cross sections: an analysis of overhangs and an analysis of the trajectories of possible rockfall.

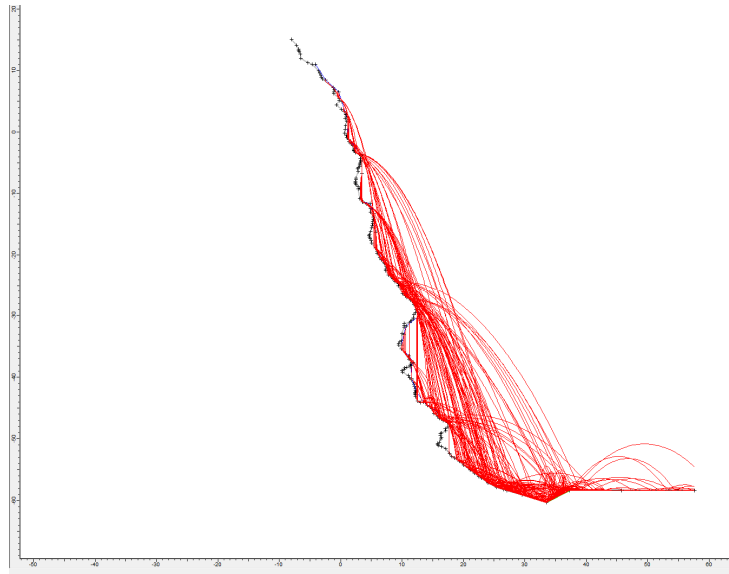
Figure 14. Trajectories of cross section B-B' in Scan 2.

Cross sections associated with potential rockfall can be identified by using the OHF. Using these cross sections, a trajectory analysis can then be conducted to determine if rockfall will be confined to the ditch or if a rockfall hazard exists. As an example, Figure 14 shows the rockfall trajectories calculated using the Rocscience RocFall program. A small block size was used to simulate loose rock crumbling along cross section B-B' of Scan 2, which has one of the highest OHFs. Impact and rebound properties of a weathered rock were used, with a talus cover at the bottom of the slope. A small ditch was also added between the slope and the highway. Based on these input parameters, 100 trials were simulated. The results indicate that of the 100 trials, over 10 of them ended up in the highway, indicating that a rockfall hazard does exist in the eastern part of the Arizona site.

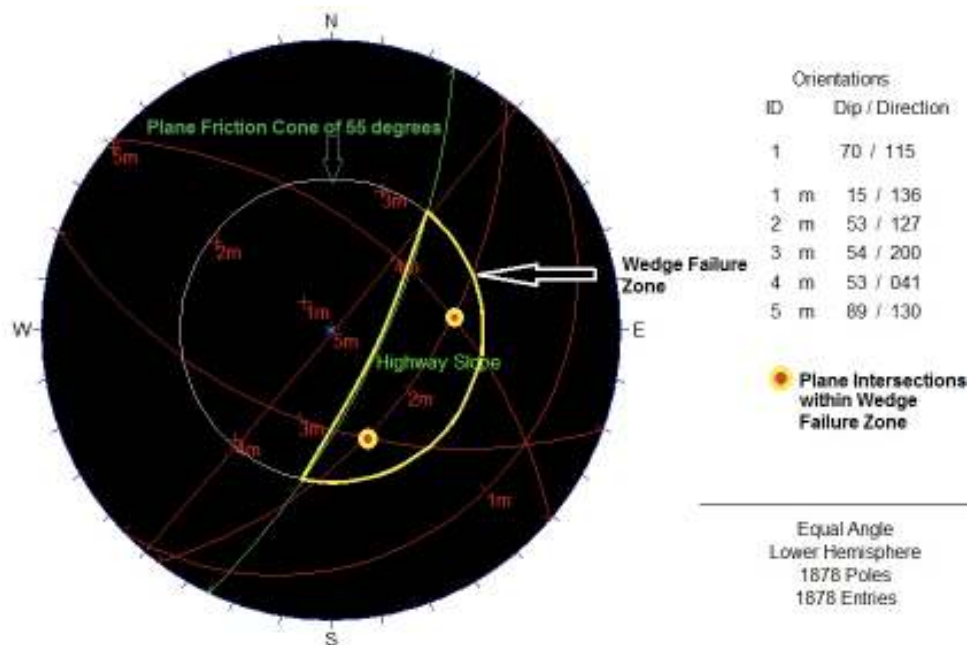
Figure 19. Rocscience Dips wedge failure kinematic analysis for the California site.

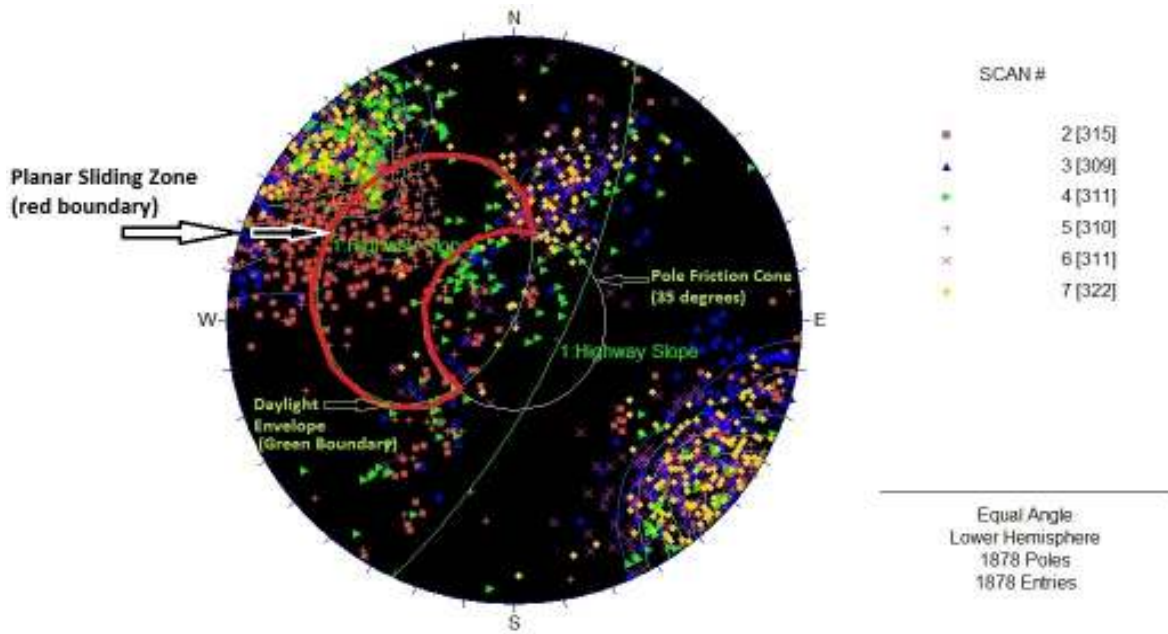
Figure 21. Rocscience Dips planar failure kinematic analysis for the California site.

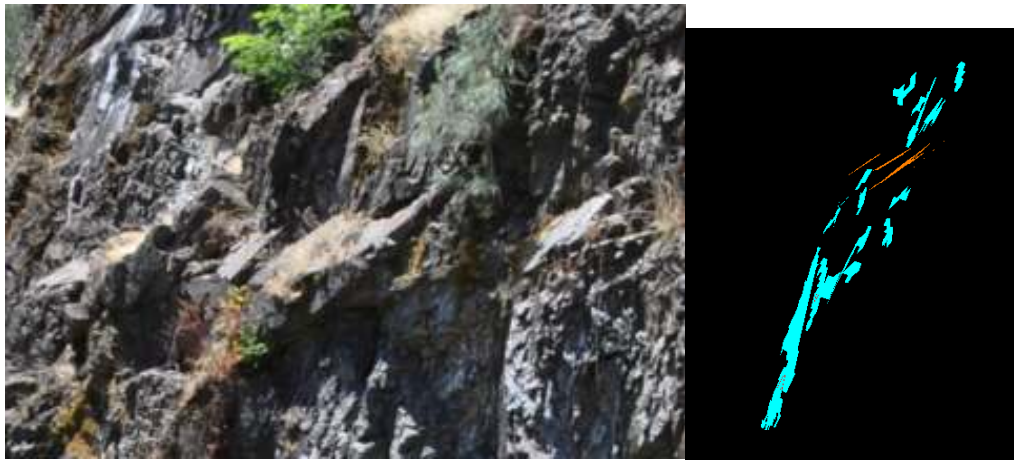
Figure 22. Left is an image of possible planar failure surfaces of approximately 50-degree dipping Joint Set 2 (light orange) with respect to the general rock face, while right shows a side view of Split-FX image of Joint Set 2 (orange) as compared to the main slope surface (teal).

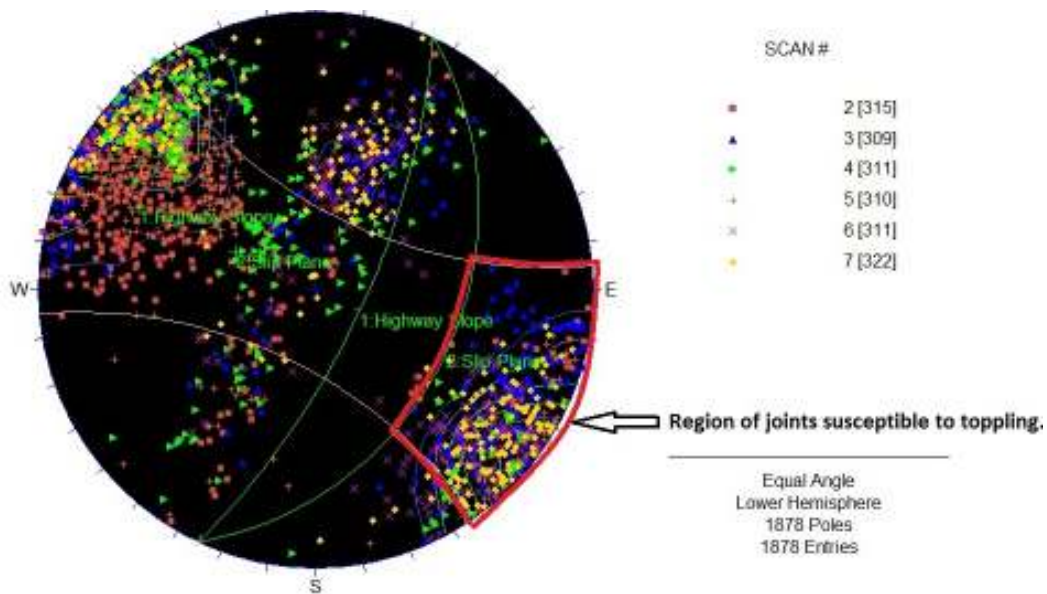
Figure 23. Rocscience Dips analysis for toppling failure at the California site.

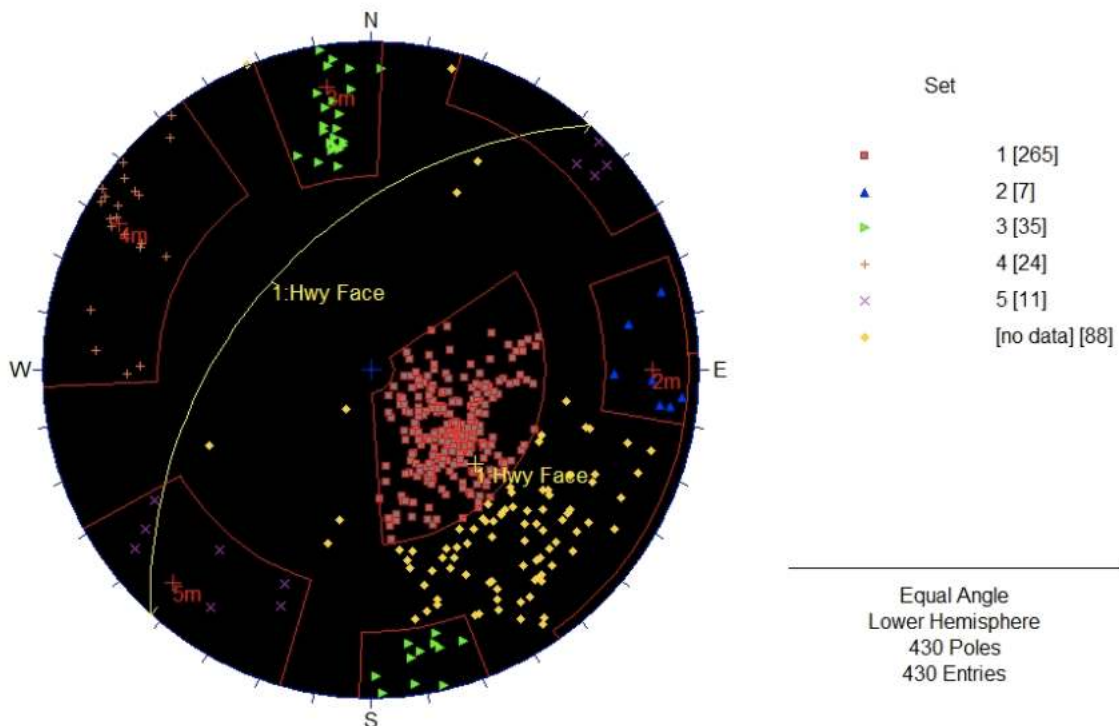
Figure 34a. Lower hemisphere stereonet plots for discontinuities at the New Hampshire site Woodstock1-Woodstock2 combined.

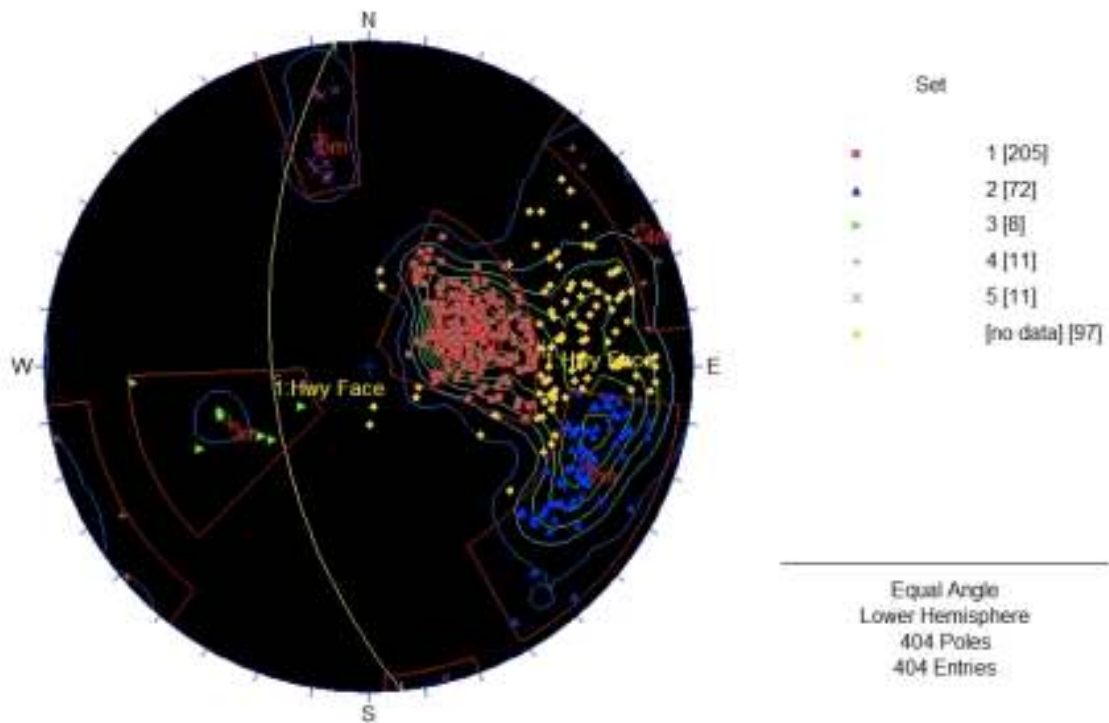
Figure 34c. Lower hemisphere stereonet plots for discontinuities at the New Hampshire site, Woodstock6-Woodstock7 combined.

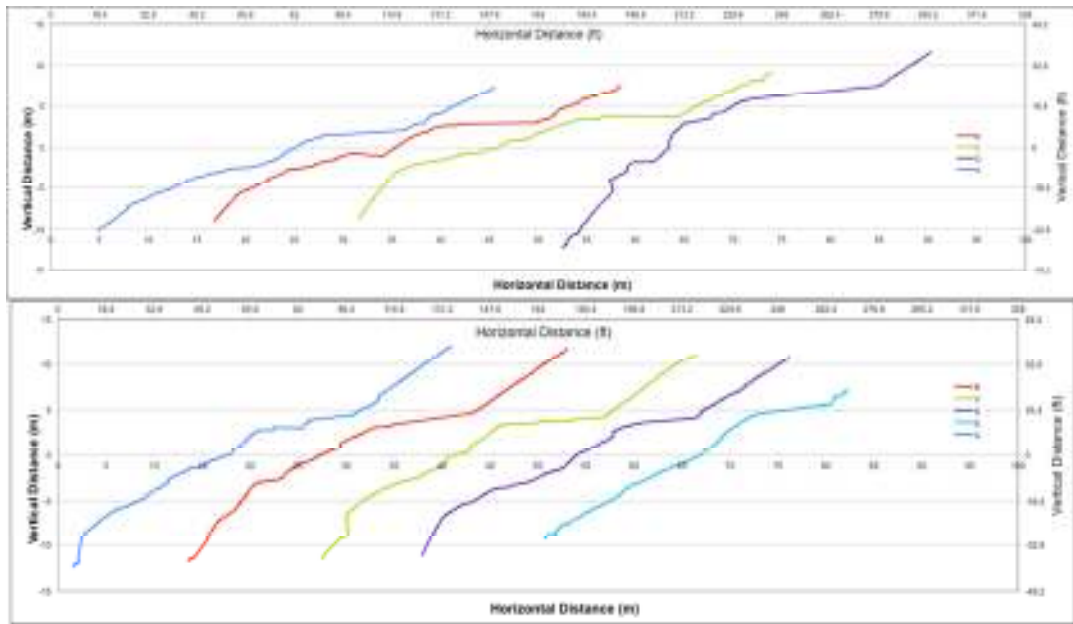
Figure 37c-d. Vertical cross sections for, top to bottom, c) Woodstock3 and d) Woodstock4.

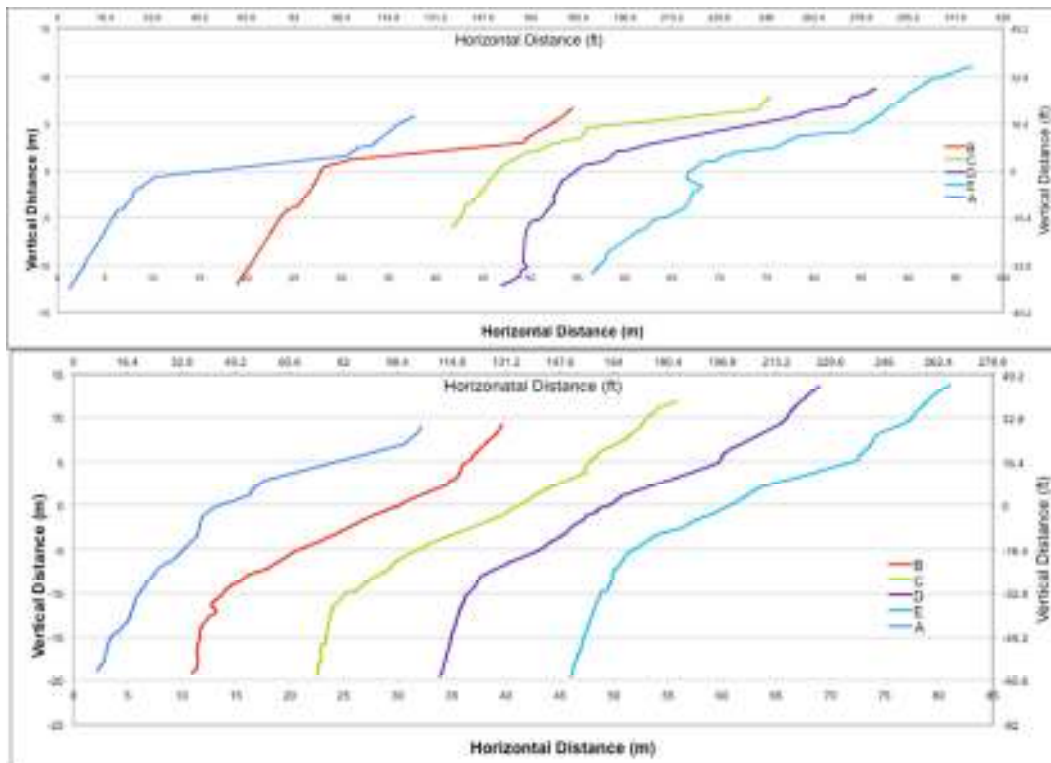
Figure 37e-f. Vertical cross sections for, top to bottom, e) Woodstock5 and f) Woodstock6.

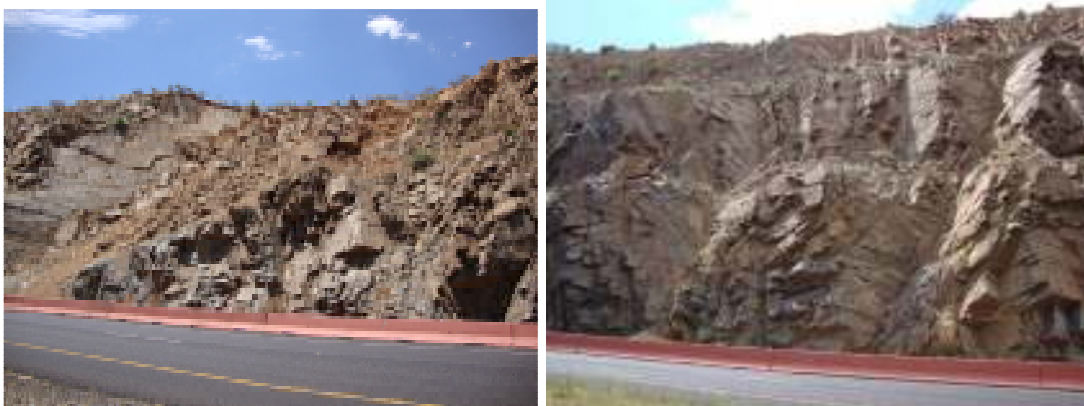
Figure 68. Wedge failures at the Texas site formed by discontinuity Sets 1 and 4 (see Figure 66b and Table 34).

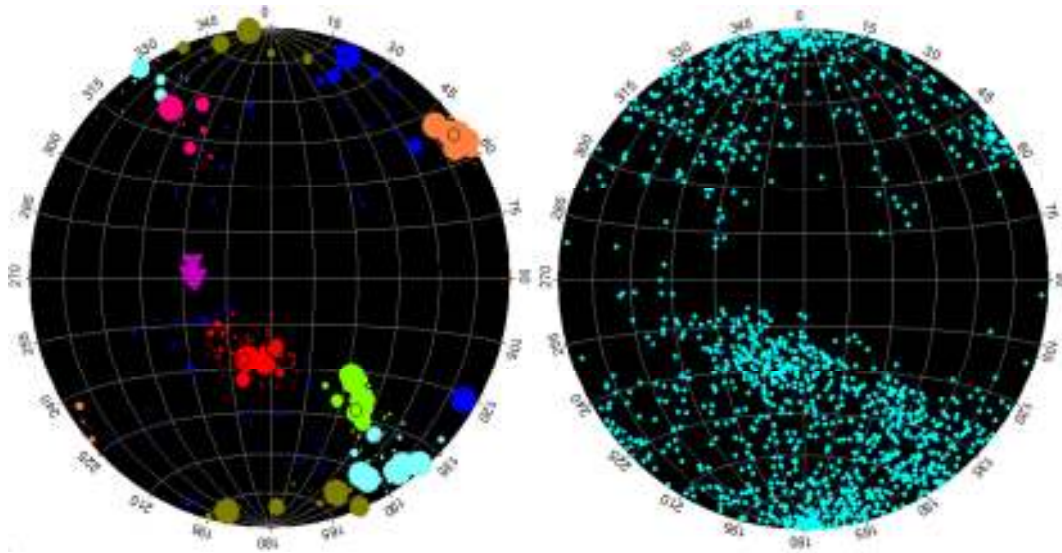
Figure 73. Stereonet plotting of the poles from the fractures shown in Figure 2b, at left, a) icon for delineated fracture surfaces (circles) plotted as a function of fracture area and some delineated fracture traces shown (triangles) and, at right, b) poles not plotted as a function of area for fracture surfaces and no fracture traces shown.
