Field Testing of Hand-Held Infrared Thermography, Phase II TPF-5(247) Interim Report

Interim Report

December 2015

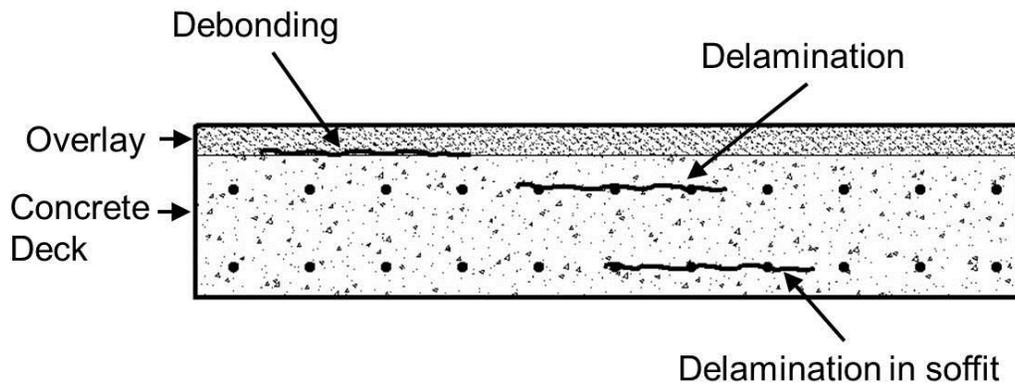
Figure 1. Schematic diagram of a bridge deck and overlay with debonding and delamination damage.

Infrared thermography is capable of detecting subsurface damage in concrete based on variations in thermal behavior of the concrete caused by the damage. Two types of subsurface damage are typically the focus of thermographic inspections – delamination in the concrete caused by corrosion and debonding between different materials, for example, debonding of a concrete overlay from the concrete substrate. Both subsurface delamination and debonding result in large planar flaws oriented parallel to the surface of the concrete, as shown in Figure 1.

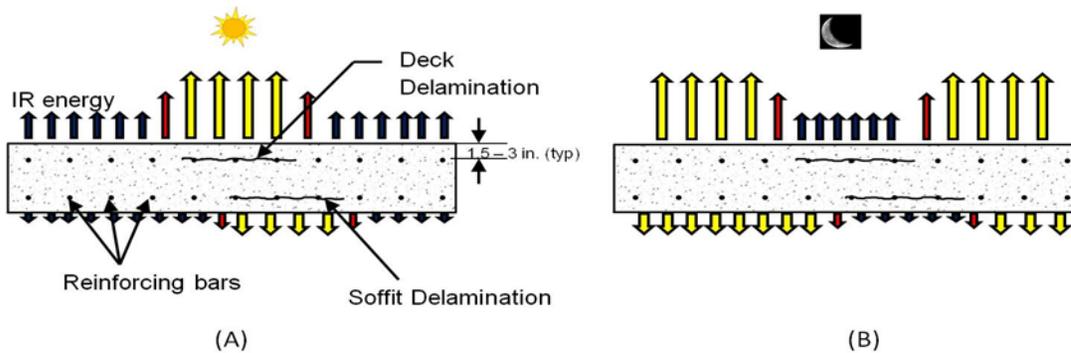
Figure 2. Schematic diagram of infrared energy emitted from damaged concrete during heating (A) and cooling (B) cycles.

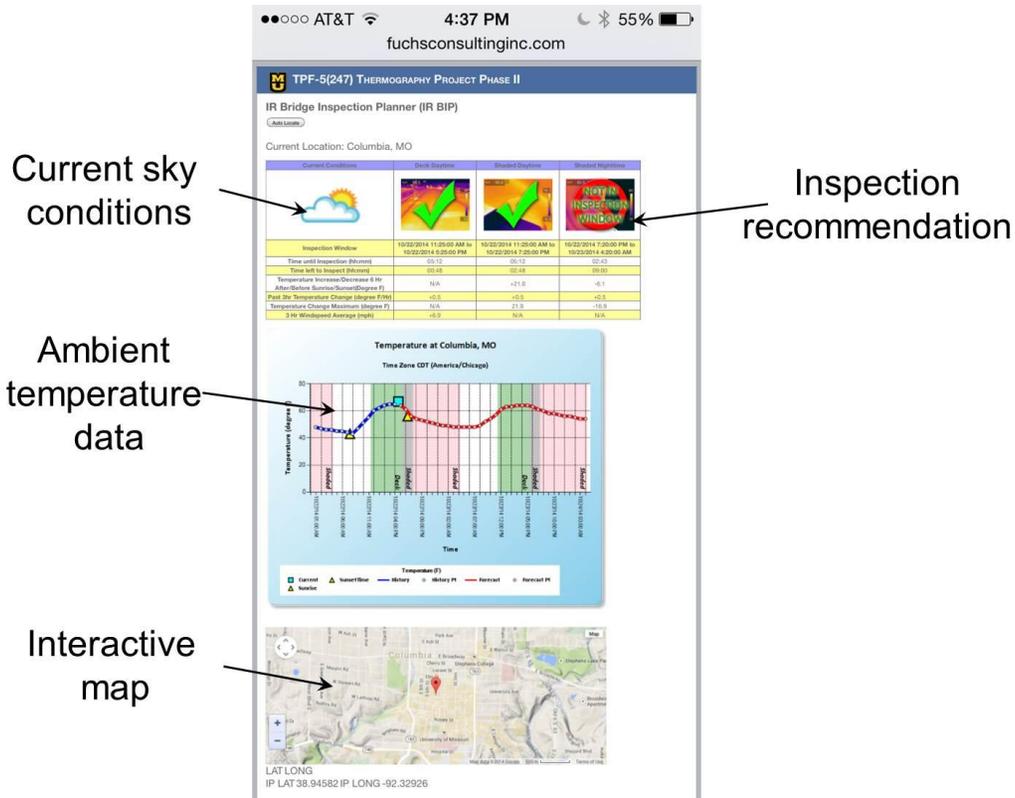
Figure 3. Screen capture of the BIP web tool showing thermal inspection recommendation.

These data are then utilized to compare the current conditions with the condition described in the Guidelines, including required temperature changes and wind speed. Time intervals for inspection described in the Guidelines, based on the delamination depth of two inches, are displayed as shaded regions on the ambient temperature graph. These data are analyzed to make a recommendation regarding the suitability of the weather conditions for thermal inspections for sunny and shaded conditions, as well as night time inspection. A recommendation is displayed as an icon on the screen, as shown in Figure 3. This figure shows a screen capture from a smartphone displaying the BIP, for the location of Columbia, MO. As shown in the figure, the current sky

conditions and an interactive map are also displayed. In the figure shown, check marks indicate that the weather conditions are suitable for inspections for both sunny and shaded daytime conditions. For nighttime inspections, conditions are not suitable because the current time was outside the required time interval for a nighttime inspection as described in the Guidelines. A circle and backslash icon is displayed for nighttime inspections.

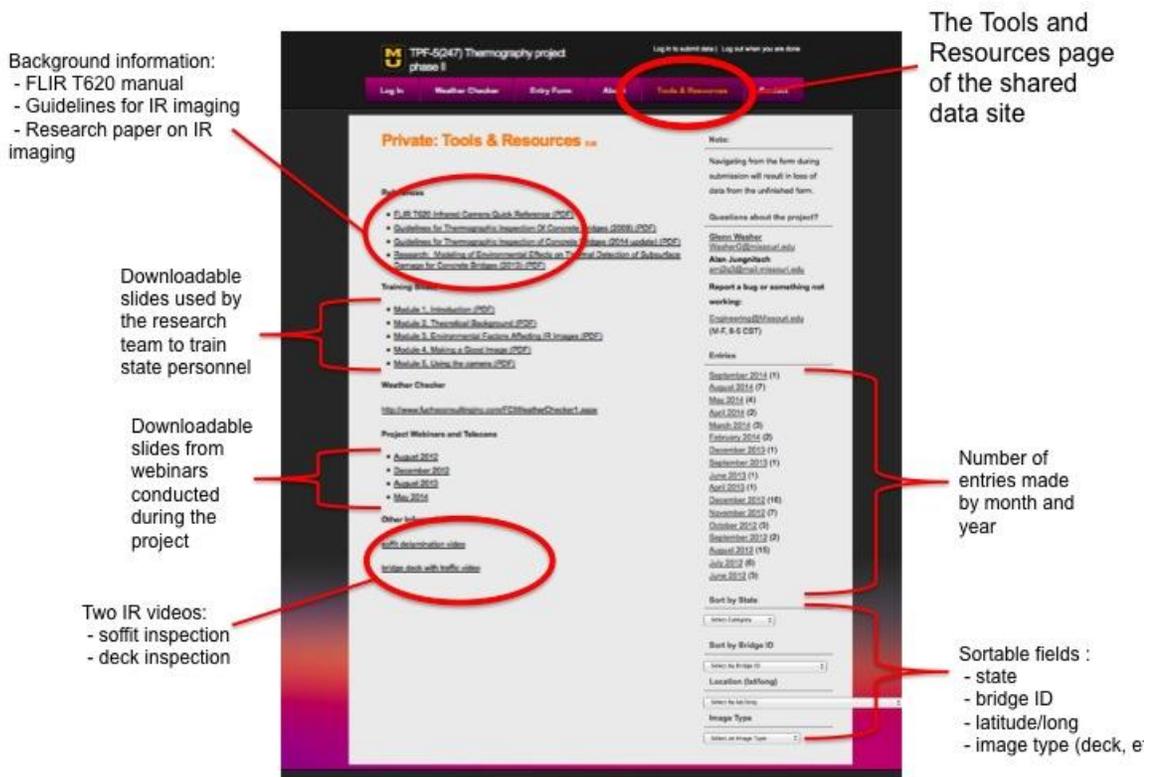
Figure 4. Screen capture of the "Tools and Resources" page of the project SDS.

The web site features a “Tools and Resources” page that contains key project information. Figure 4 shows a screen capture of the “Tools and Resources” page, illustrating the appearance of the page and noting key data located there. These data include the Guidelines for the thermal imaging and operational guidance on use of the T620 cameras used as part of the study. The slide presentations that were used for training can be downloaded from links located on this page for use by participants for further training or review. A link to the BIP planner is also available on this page, as shown in Figure 4.

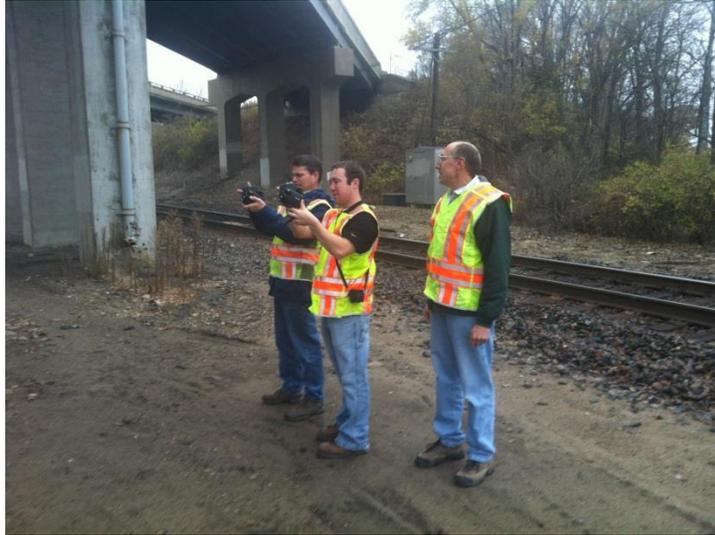
Figure 6. Photograph of typical training activity using IR cameras in the field.

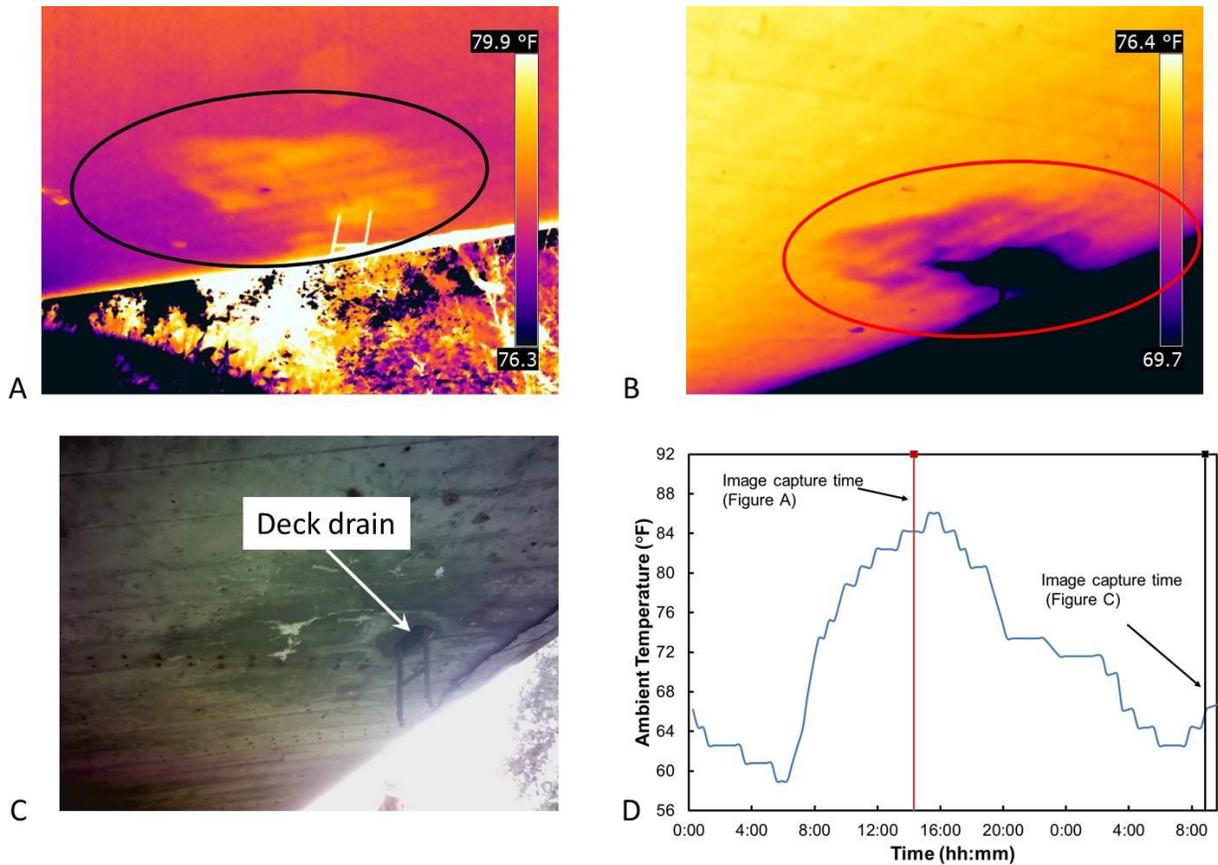
Figure 7. Thermal images of a delamination surrounding a deck drain, showing thermal images in the afternoon (A) and the following morning (B); photograph of the area (C) and ambient temperature conditions (D).

An example of visiting the same bridge in the afternoon and the following morning during the training is shown in Figure 7. The figure shows thermal images of the soffit of deck slab in the area of a deck drain (Figure 7 A and B), a photograph of the same area (Figure 7C), and a graph of the ambient temperature conditions at the bridge (Figure 7D). Figure 7A shows the thermal signature from a large delaminated area surrounding a deck drain in the afternoon, during the positive ambient heating cycle. Under these conditions, the thermal signature of the delamination appears warmer than the surrounding, intact concrete. As shown in Figure 7D, image 7A was captured at ~2 pm. Figure 7B was captured the following morning at ~9:00 am, following the cooling of ambient temperatures at the bridge. Under these conditions, the thermal signature of the delamination appears cooler than the surrounding, intact concrete. The damage in this area was confirmed using hammer sounding. Observing the same area during afternoon and morning conditions assists students with understanding the effect of ambient conditions on test results, and also helps confirm the results of the previous day's image interpretation.

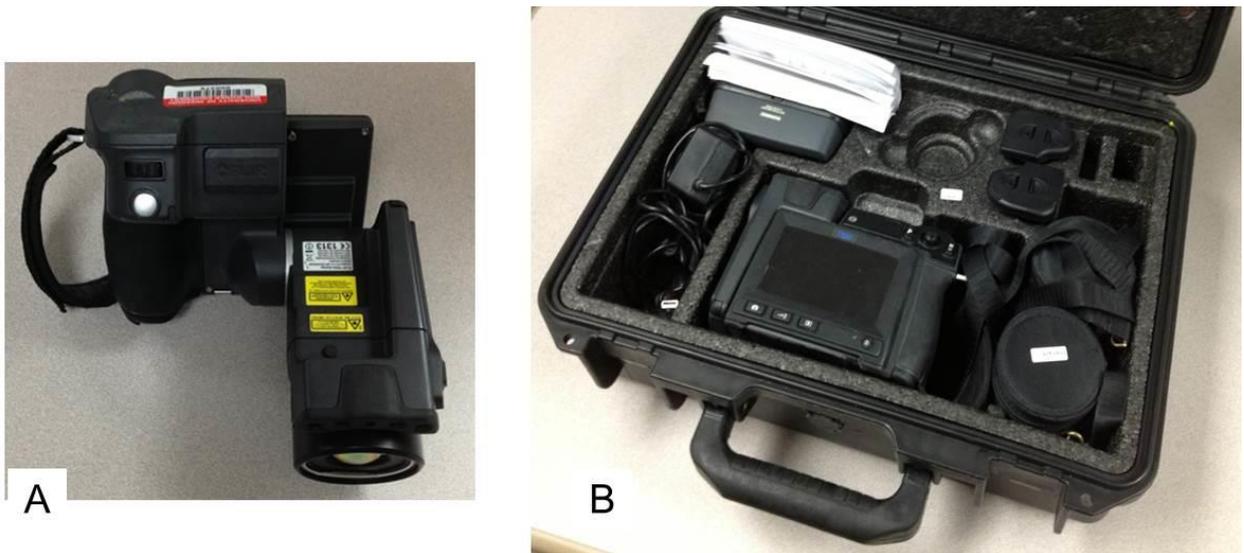
Figure 9. Photograph of the FLIR T620 infrared camera (A) and the camera in its carrying case, with additional batteries, lenses and accessories.

Each camera included a carrying case, two batteries, a charger, and a wide-angle lens. Figure 9 shows a photograph of the FLIR T620 camera (A) and the carrying case provided with the camera (B). This camera set has proven capable of meeting the needs of the project and has been well received by state DOT personnel.

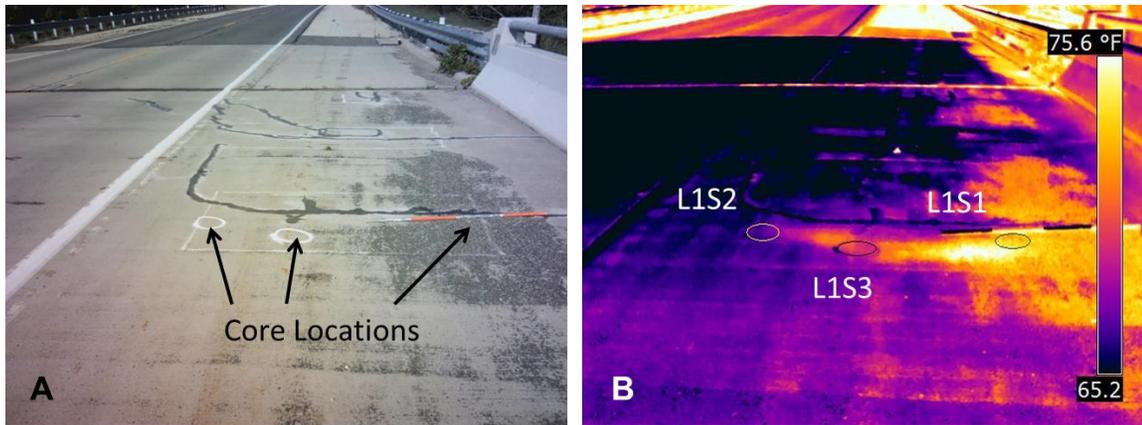
Figure 10: Photograph (A) and thermal image (B) showing locations of cores removed from a bridge deck.

A third sample (L1S3) was taken from an area that had a less distinct difference in thermal contrast from sample L1S1 and more distinct thermal contrast than sample L1S2. This shows up as mostly yellow with some pink in image B below.

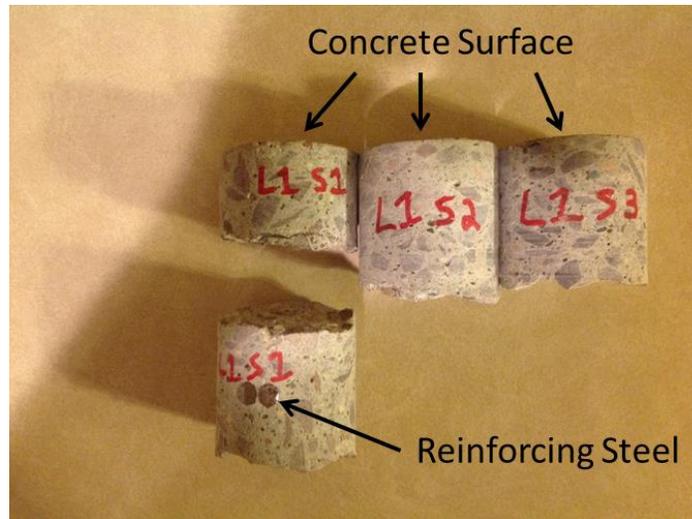
Figure 11: The cores taken from the delamination at L1

These thermal differences within the same delamination were due in part to the variation in cover above the delamination as shown in Figure 11, which shows a photograph of the three core samples. Sample L1S1 was taken just off the area that appears white in the IR image; in this area, the delamination was the closest to the surface, approximately 1.875 in. deep in the concrete as determined from the core sample. Sample two (L1S2) had the lowest thermal contrast of the three samples and the core had the largest amount of cover above the delamination, 2.625 in. This datum is consistent with the increased depth of the delamination, and the location of the core near the edge of the delamination where thermal contrasts are typically diminished regardless of depth. Core L1S3 indicated 2.375 in. of concrete cover, and is also near the edge of the delamination.

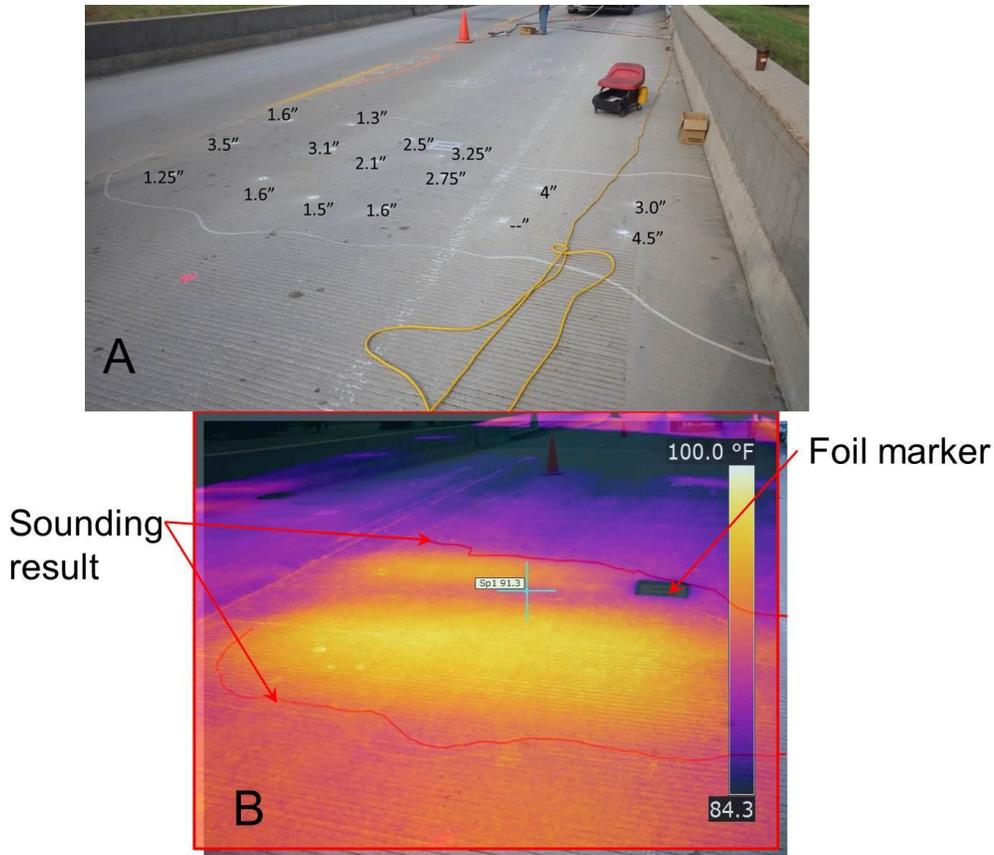
Figure 12. Photograph of delaminated area of bridge deck showing delamination depth measurements (A), and thermal image of the same area overlaid on a photograph showing sounding results (B).

The thermal image shown in Figure 12B appears to indicate two separate delaminations. However, the delamination is actually one large delamination of variable depth. According to the depth measurements shown in Figure 12A, the middle portion of the delamination has a depth of ~3.1 - 3.5 in. This area has different thermal contrast compared with the edge of the area where measured depths were ~1.25-1.6 in.

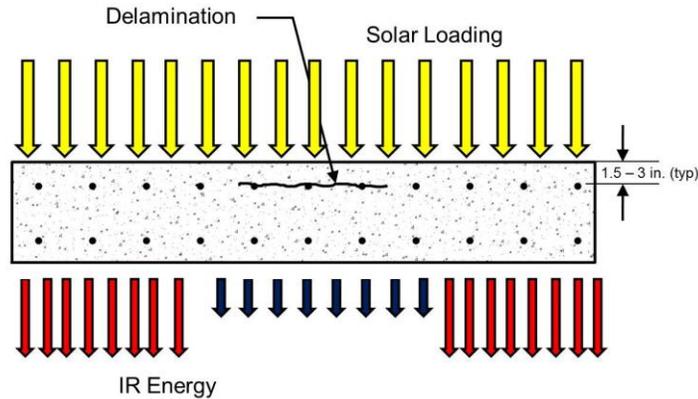
Figure 13. Schematic diagram of bridge deck exposed to solar loading, showing effect of IR energy emitted at the soffit.

a result, the heating from the sun affects the IR energy emitted from the soffit. When there is a discontinuity in the conduction path, the heating is interrupted, reducing the IR energy emitted from the soffit area, as illustrated in Figure 13. As a result, delamination in the soffit areas appear as cold spots, rather than hot-spots as envisioned by the Guidelines.

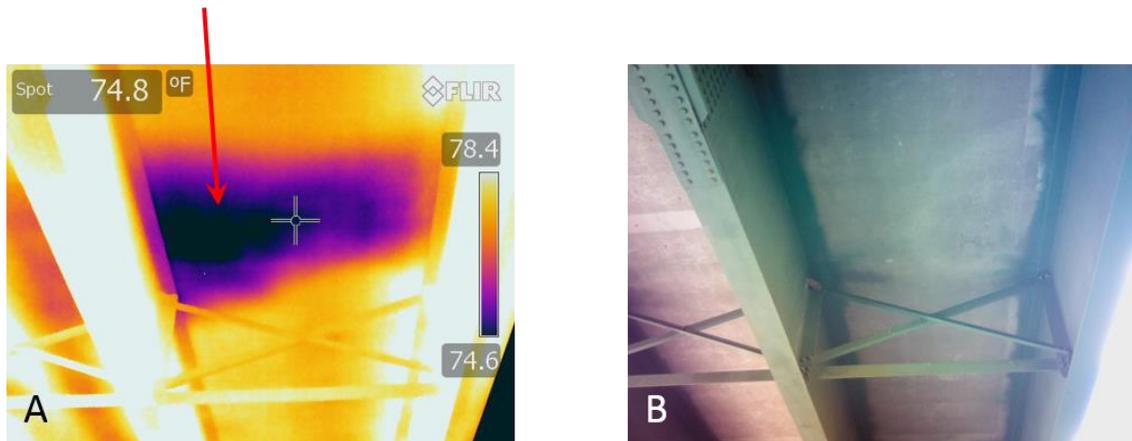
Figure 14. Thermal image showing deck delamination on the soffit of the deck appearing as a cold spot (A), and photograph of the same area of the soffit.

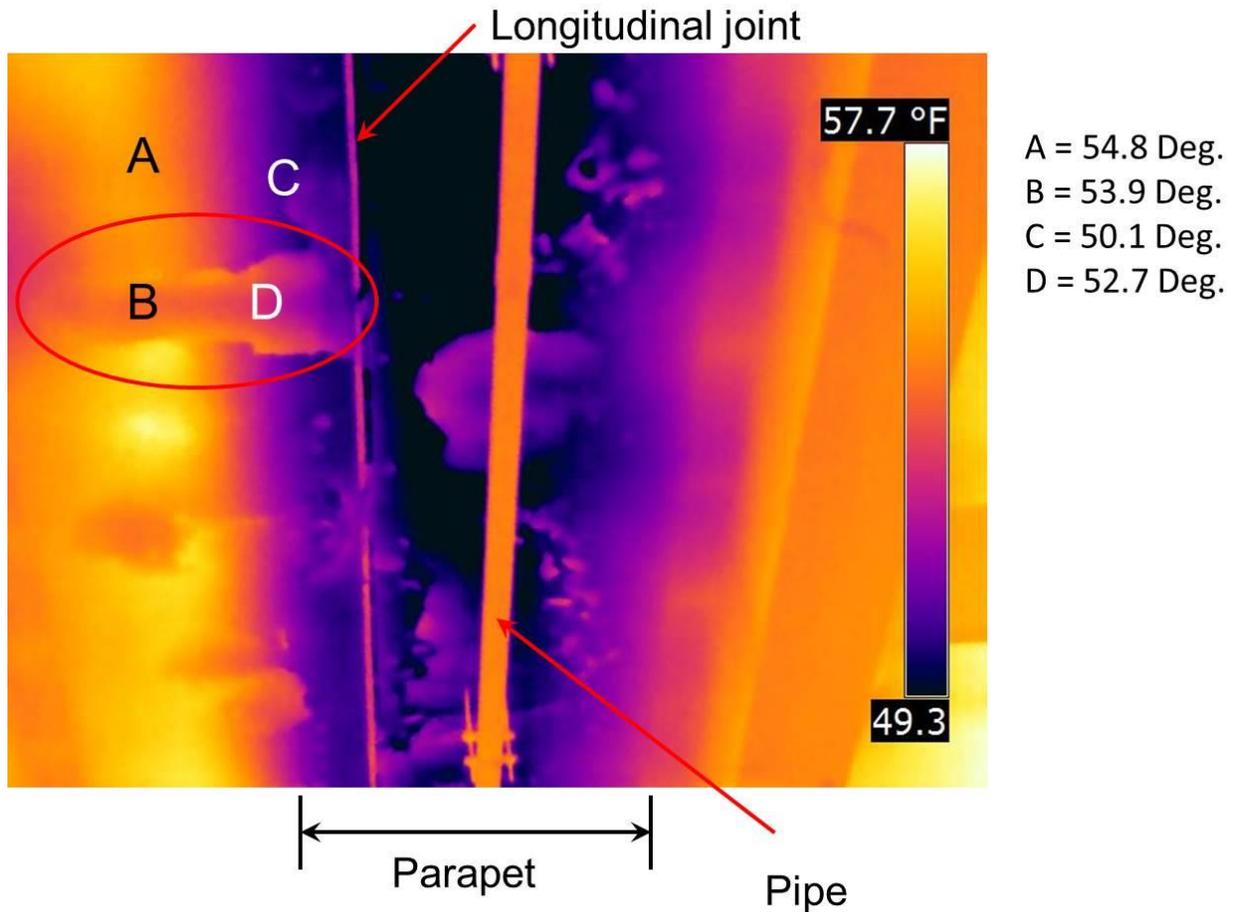
Figure 15. Thermal image of a deck soffit showing the conduction effect on the appearance of concrete delamination at the soffit.

A second example is shown in Figure 15. This figure shows a thermal image of the soffit area of a bridge in the area of a longitudinal joint. A parapet on the bridge deck (not shown in the image) creates an area in the soffit where temperatures are relatively cooler, due to the shadowing effect of the parapet and its thermal mass. In deck areas adjacent to the parapet, the heating from the sun has conducted through the deck. In the figure, a delamination in the soffit area of the deck is encircled. Four temperature measurements were made in this area and are labeled A, B, C and D. These data show that the nominal temperature of the deck at point A was 54.8°F, while the delaminated area labeled B was 53.9°F; this indicates that the delaminated area is cooler than the intact deck area, due to the conduction effect. Conversely, the delaminated area marked C displays a temperature of 50.1°F, while the delaminated area marked D displays a temperature of 52.7°F, warmer than the surrounding concrete. This figure illustrates the conduction effect very well because the same delamination appears both cooler than its surrounding where the conduction effect is warming the deck, and warmer than its surrounding where the parapet on the deck above creates a shadowing effect that eliminates the conduction effect.

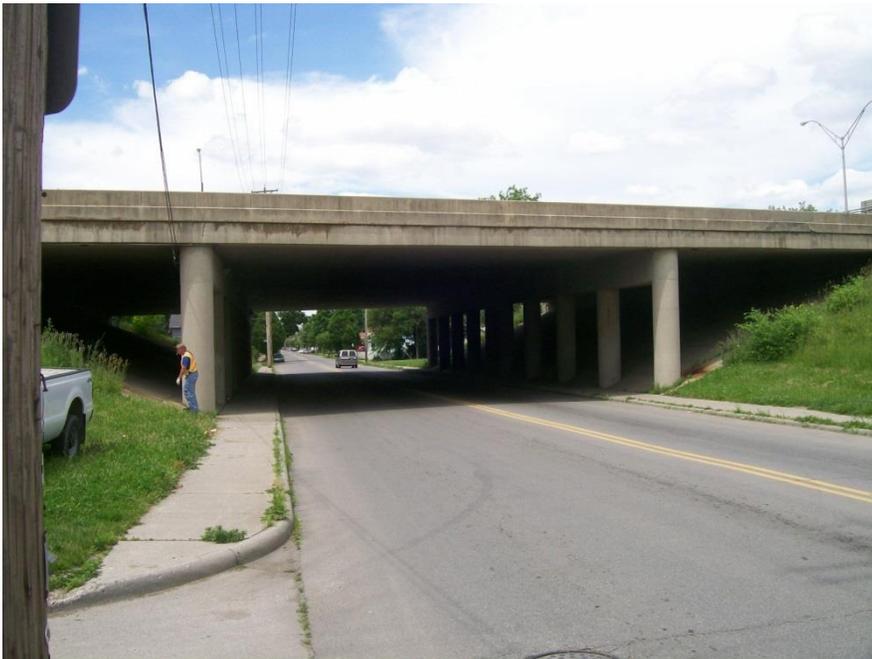
Figure 16. Slab bridge in Ohio where IR testing was conducted.

16. Members of Ohio Department of Transportation had reported some concerns about getting good infrared results of the soffit area of the bridge due to its width of 159 ft. The bridge was selected to evaluate if ambient temperature changes were sufficient to allow for effective thermographic inspections. Two other bridges were also inspected on the Ohio trip; their images can be seen on the pooled fund project website.

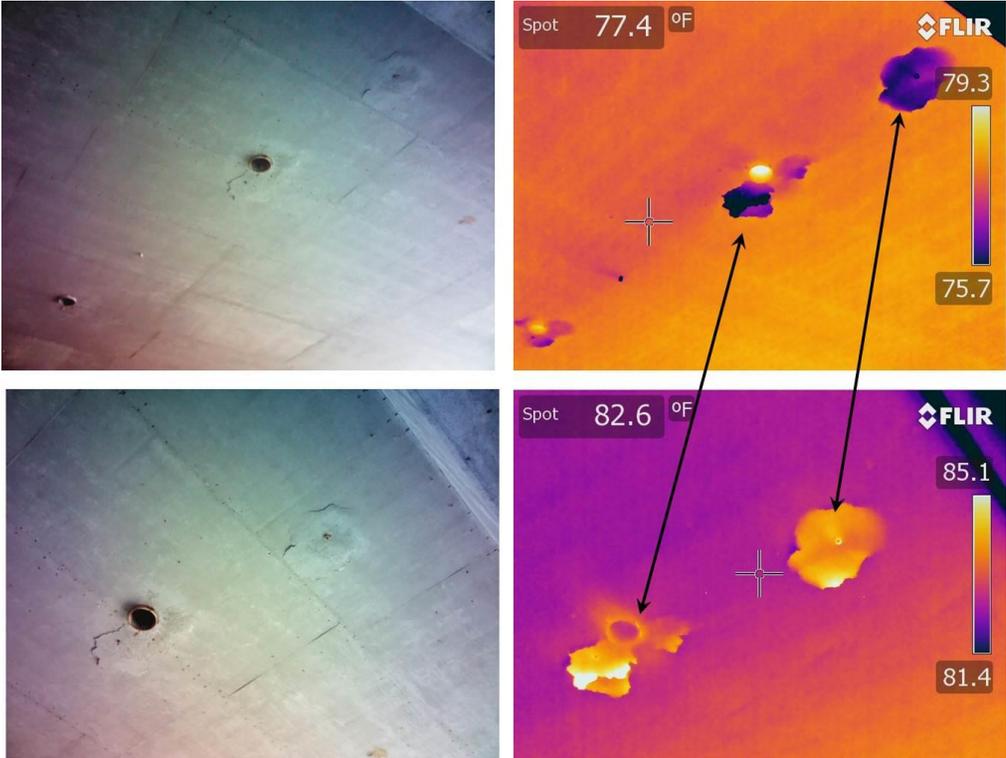
Figure 17 Thermal images of delaminations in the soffit of a wide slab bridge, showing morning (top) and afternoon (bottom) results.

afternoon. As shown in the images, the delaminations appear as cold spots during the morning hours and as hot spots during the afternoon.

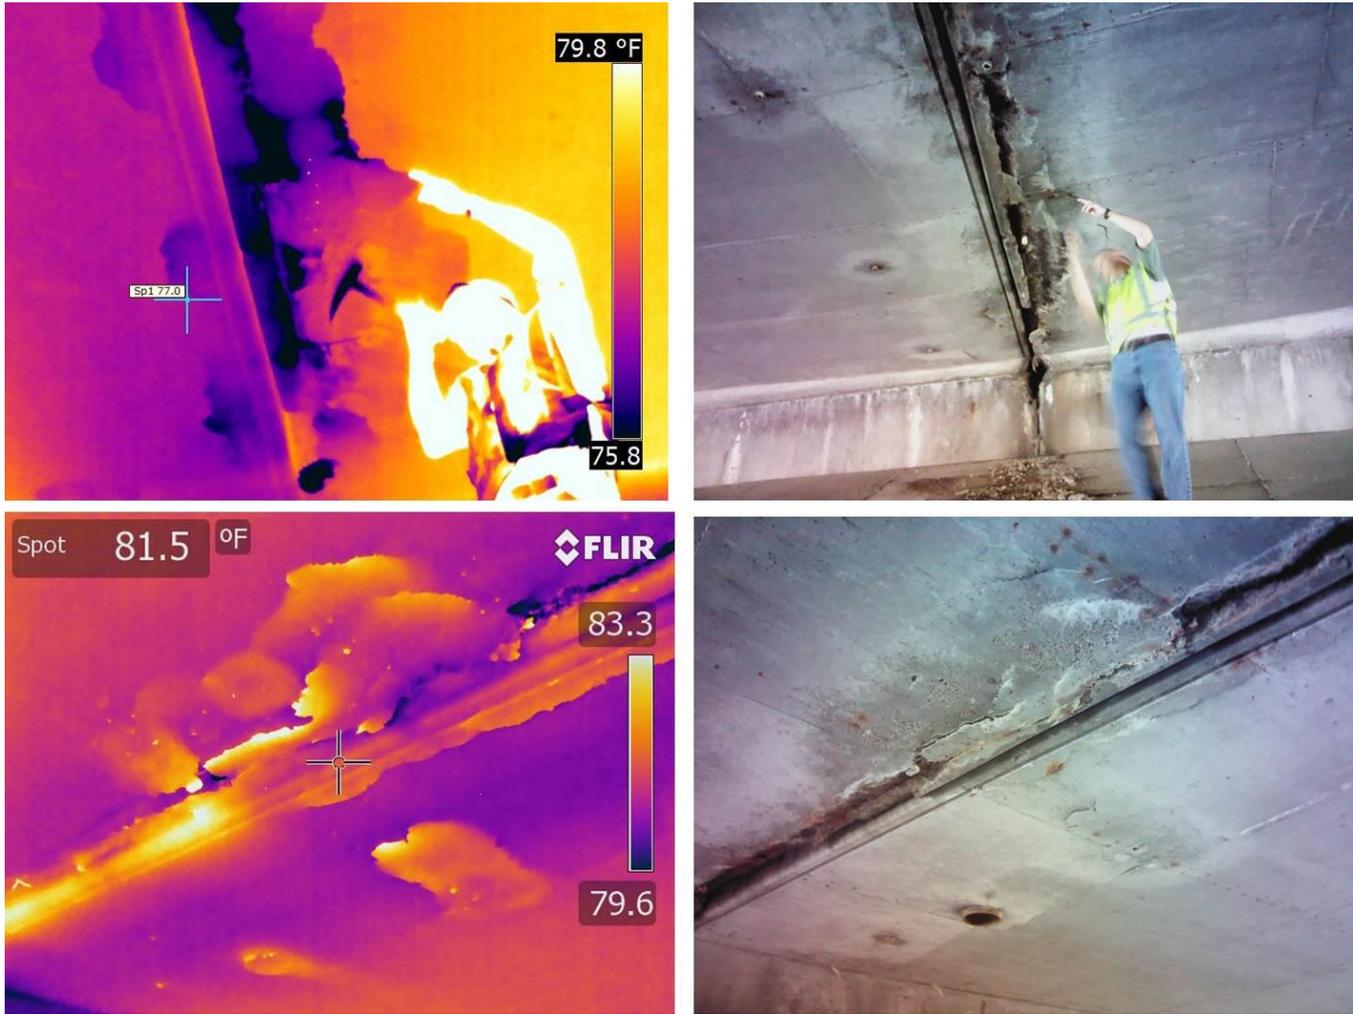
Figure 18. Thermal images showing damage along a longitudinal joint in a 159 ft wide slab bridge.

Images were also captured showing damage surrounding a longitudinal joint at the center of the bridge. Again, images are shown from the morning and the afternoon. As shown in Figure 18, damage surrounding the longitudinal joint could be imaged both in the morning (Figure 18, top) and in the afternoon (Figure 18, bottom).

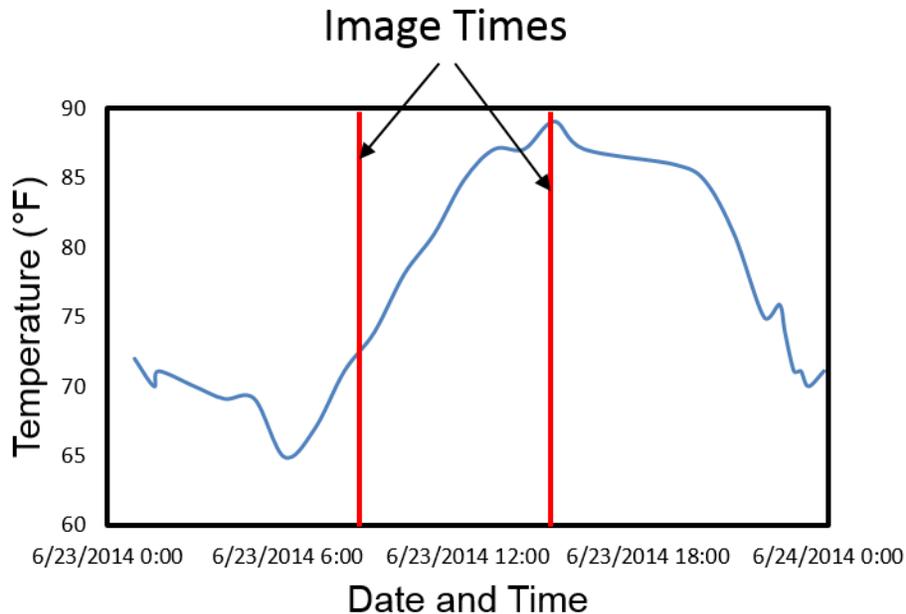
Figure 19: Ambient temperature for June 23, 2014 in Columbus Ohio

Figure 19 shows the ambient weather conditions on the day of the verification testing with the image capture times shown in the figure. The morning images were captured at ~7:00 am while the afternoon images were captured at ~2:00 pm.

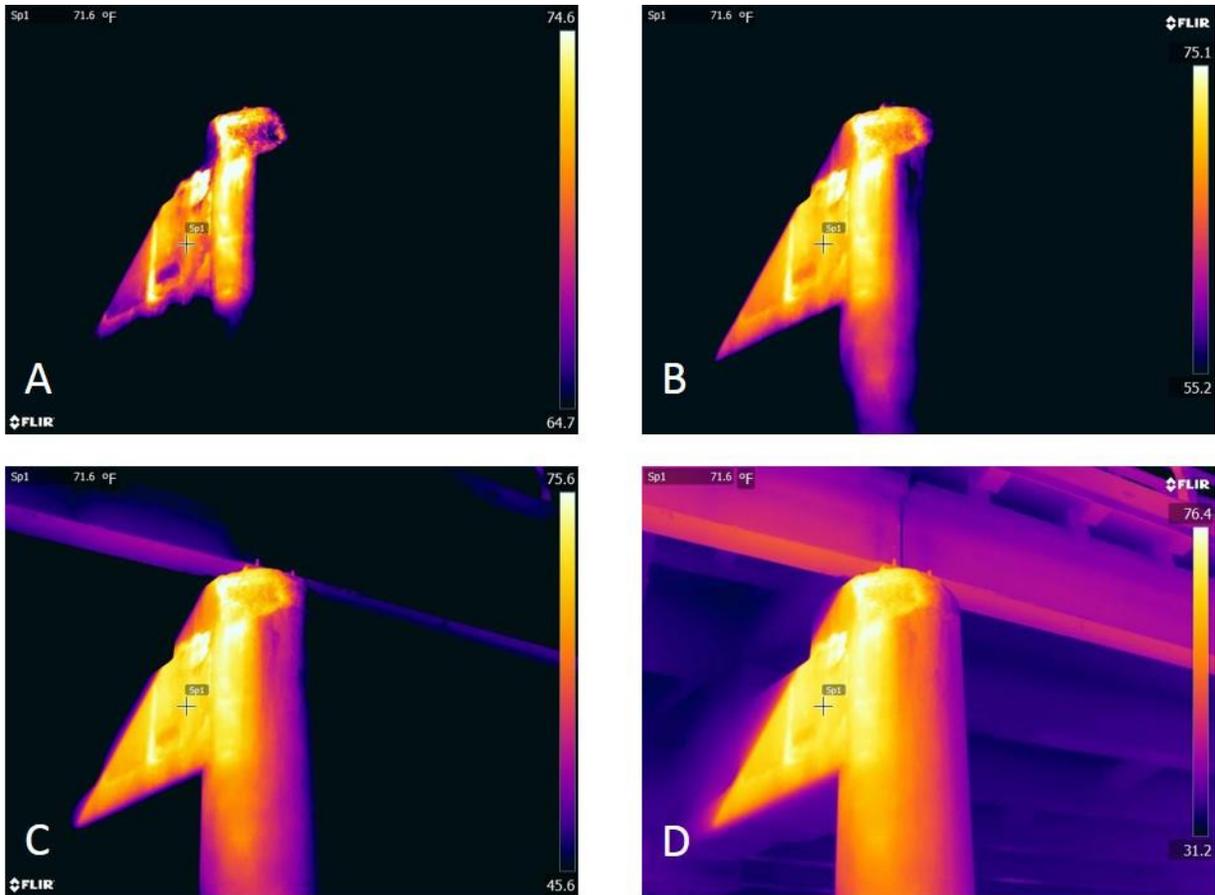
Figure 20: Illustration of how thermal gradient can affect a thermal image.

A third situation where thermal imaging was ineffective was for a bridge substructure partially exposed to solar loading. For example, the thermal gradient caused by a portion of a circular column being exposed to solar loading is illustrated in Figure 20. To demonstrate how a thermal gradient across a surface can affect an image, Figure 20 shows four versions of the same image, each with different temperature span applied to the image. The temperature span used for each image were as follows: (A)10°F, (B)20°F, (C)30°F and (D)40°F. A typical span for capturing a good image in the field is 4-8°F to provide sufficient image contrast to allow for the detection of the small thermal contrast that result from subsurface damage. As shown in Figure 20A, a small span setting results in much of the area being assessed appearing as black in the image, because its temperature is outside the span range. Small thermal contrasts associated with subsurface damage are difficult to detect under these conditions because only portions of the object being imaged can be observed in the IR image. In contrast, Figure 20D shows a large temperature span (40°F), for which much more of the object can be observed in the thermal image. However, small temperature contrasts resulting from damage may not appear in the image as a noticeably different color when the temperature span is large. In general, conditions where large thermal gradients exist due to environmental conditions such as direct sunlight on only a portion the area being assessed make interpretation of IR images very difficult.

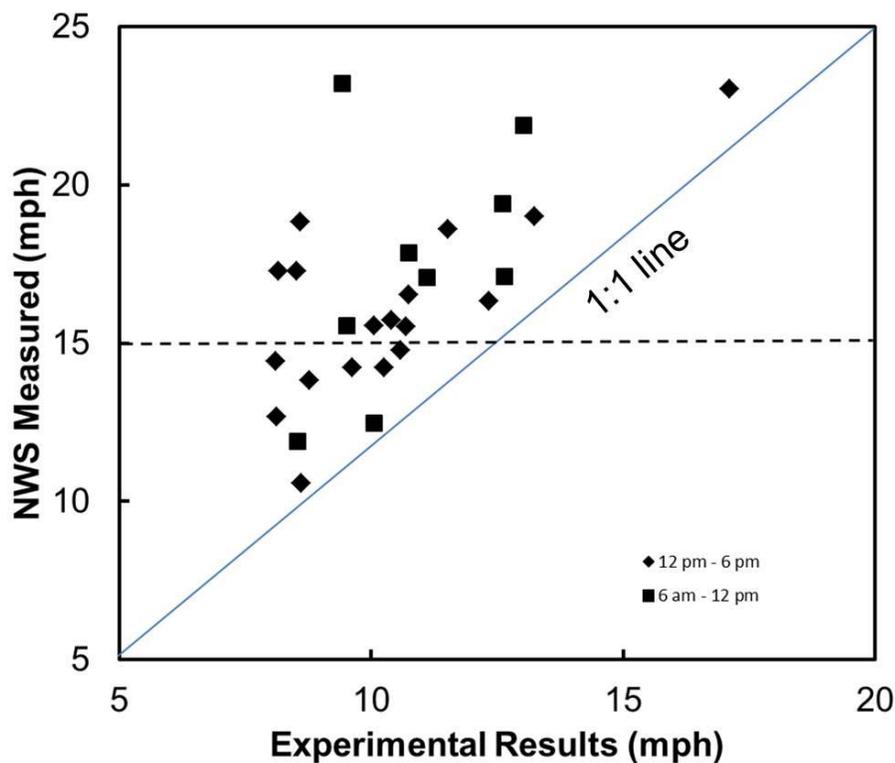
Figure 21. Graph showing correlation between experimental and NWS-reported wind speed data for high wind speed conditions.

The relationships between the site-measured wind speed recorded by MU research and the weather service reported wind speed are shown in Figure 21. This figure shows the correlation between the site-measured data and coincident NWS data for high wind-speed conditions determined in Phase I of the research. As shown in the figure, the NWS data typically results in a larger value than the site-measured data from phase I; this can be observed by the 1:1 correlation line that bisects Figure 21.

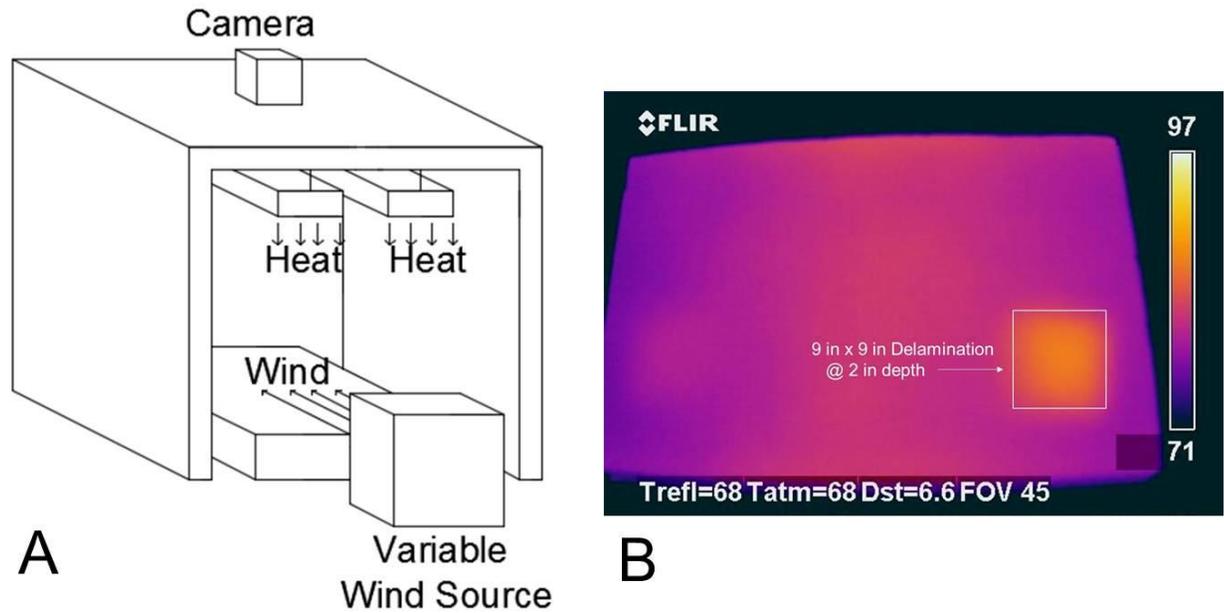
Figure 22. Schematic diagram of the test arrangement for evaluating wind effects (A), and thermal image of the concrete test block showing subsurface target (B).

The effect of wind speed was analyzed by monitoring the surface temperatures on the specimen during heating and cooling with under different air speed varying from 0 to 20 mph. Surface temperatures were determined using a FLIR S65 thermal camera. The duration of each test was 60 minutes; the IR heating source was energized for the first 30 minute interval, then turned off while the cooling of the specimen was monitored. The thermal contrasts, i.e. the apparent temperature difference between the surface above intact concrete and the surface above the target, was determined from thermal images captured at 1 minute time intervals

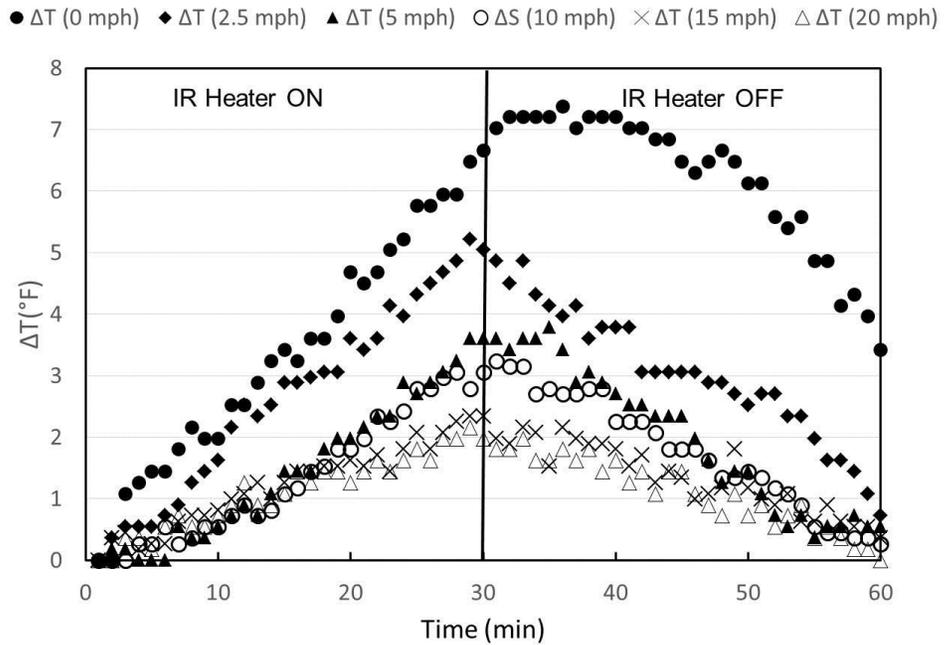
Figure 23. Graph showing thermal contrast developed for subsurface targets with varying air speed.

Figure 23 shows the thermal contrast developed under air speeds of 0, 2.5, 5, 10, 15 and 20 mph over a 1 hour time interval. These results show that the thermal contrast developed was significantly larger ($\sim 7^{\circ}$ F) without wind, but diminished significantly under high wind speeds, for example, at 20 mph the thermal contrast was only $\sim 2^{\circ}$ F. During the first 30 minutes of the test, when the IR heaters were energized, the thermal contrast develops much more rapidly when there is no wind blowing on the deck. When the IR heaters are turned off, at the 30 minute mark shown in the figure, thermal contrast diminishes much more rapidly with the presence of wind, even for relatively modest velocities of 2.5 mph.

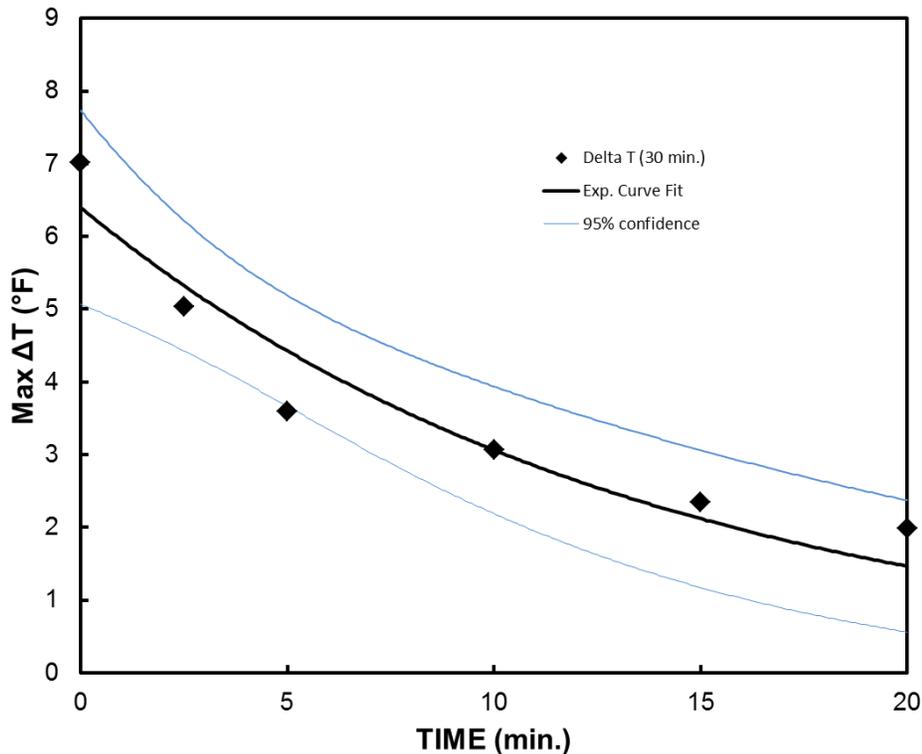
Figure 24. Maximum temperature differentials at 30 min. showing exponential curve fit.

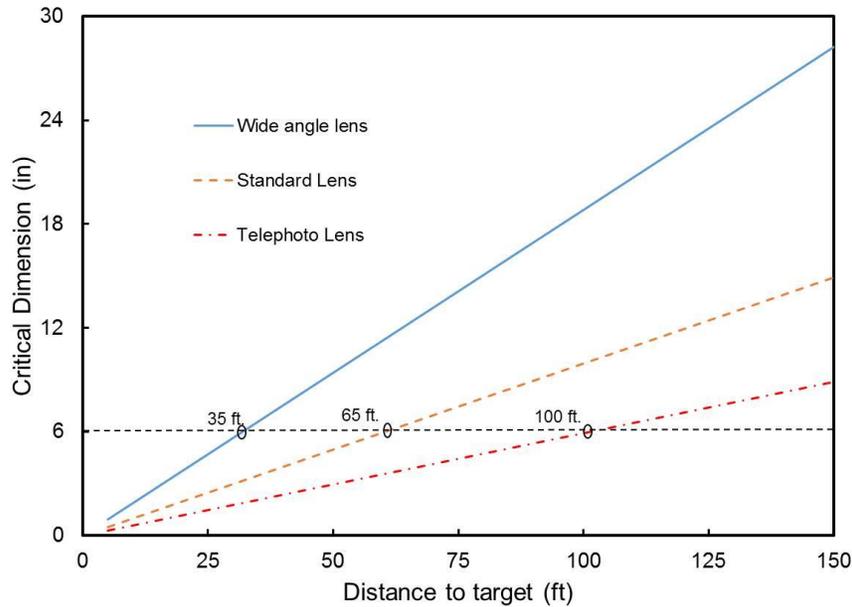
Figure 25. Graph showing critical dimension as a function of observation distance.

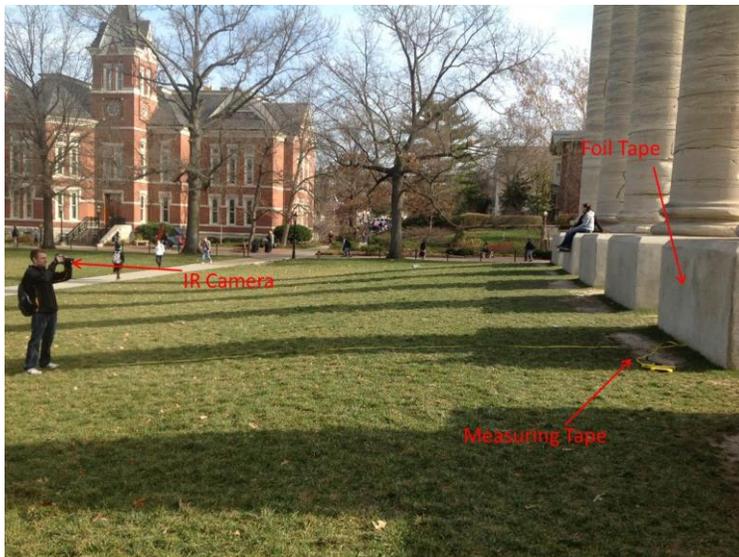
Figure 26. Photograph of test set-up for pixel resolution evaluation.

A simple test was conducted to demonstrate the effect of distance on the imaging and identification of an area of thermal contrast using different lenses. To provide an area of uniform thermal contrast, a 2 in. by 2 in. piece of metallic tape was utilized which provided a thermal contrast area greater than one pixel in dimension at a distance of 100 ft. Metals typically have much lower emissivity than concrete, resulting in an apparent thermal contrast when the metal and concrete are at the same temperature. The metallic tape was fastened to the surface of a concrete foundation of the columns at MU, as shown in Figure 26.

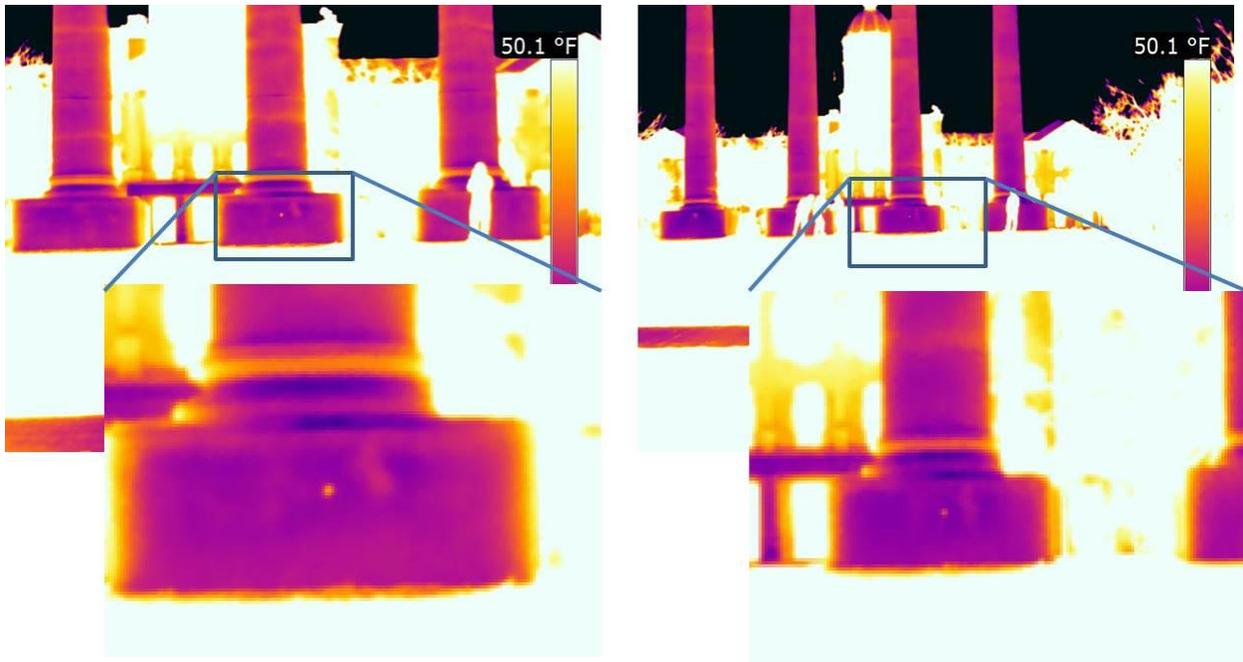
Figure 27. Thermal images for the standard lens (A) and wide angle lens (B) at a distance of 100 feet from the test specimen

The weather conditions at the time of the test were sunny with a temperature of 60° F and average wind speeds were 11 miles per hour. The critical dimension of the tape used in this test was 2 inches. Using Equation 1, the object distances for detection, recognition, and identification for the wide angle lens (45°) were 85 feet, 21.2 feet and 10.6 feet, respectively. For the regular lens the object distances for detection, recognition and identification were 161 feet, 40.2 feet and 20.1 feet, respectively. The thermal images captured by each lens at a distance of 100 feet are shown in Figure 27. The images illustrate the effect of distance on the detectability of the 2 x 2 in. metallic tape fixed to the structure. As shown in Figure 27, the tape can be easily observed using a standard lens (detection distance > 100 ft.) but is very difficult to observe in using the wide-angle lens (detection distance <100 ft.). The figure includes a digital zoom (4x zoom) for each lens in the area of the metallic tape, which demonstrates that the metallic tape can be detected by the camera by each lens. However, using the wide angle lens, the thermal contrast resulting from the metallic tape is too small to be observed in the image without the use of the zooming function.

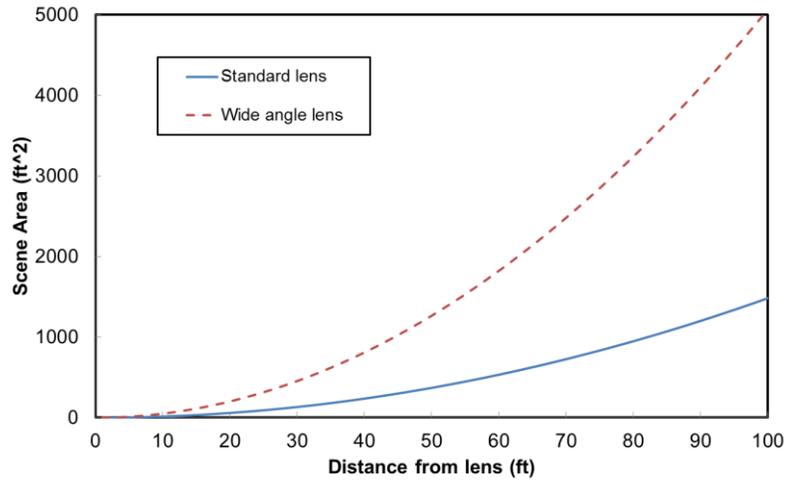
Figure 28. Scene size in relation to distance from the camera lens.

To assess the relationship between the total area being imaged, the area imaged within each pixel, camera lenses, and the distance to target, the field of view of the lenses was calculated using a tools provided by the camera manufacturer. Figure 28 shows the relationship between the distance and the physical (spatial) size of the image captured by the IR camera. This figure can be used to estimate the total spatial area that will be imaged from a certain distance, and to compare the area imaged between a wide-angle and standard lens. Figure 29 shows the relationship between the distance to target and the area imaged by each pixel. This figure can be used to estimate the area over which the temperature measurement provided by each pixel will be averaged. In other words, the output for a given pixel is produced from the average input from the spatial area being imaged by that pixel. Were a thermal contrast to exist across an area smaller than the area image by that pixel, this contrast would be averaged and thereby diminished in magnitude. These figures can be utilized for general guidance in the field to estimate the areas that will be included in an image and the spatial extent represented in each pixel in the image.

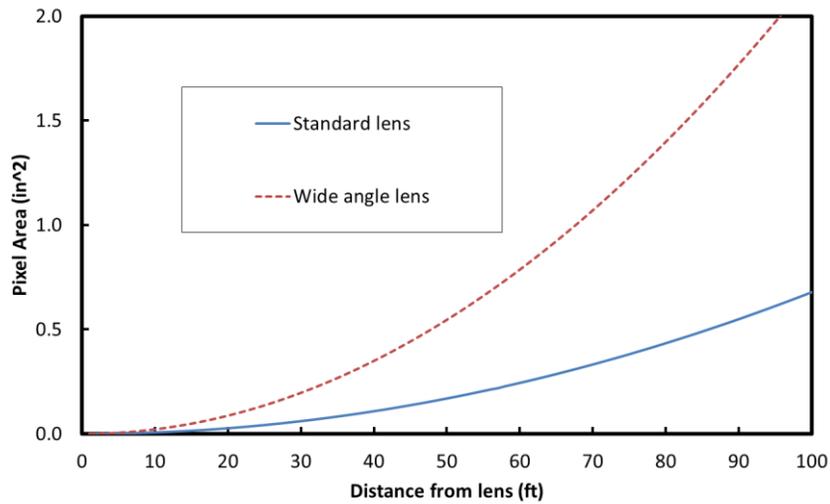
Figure 29. Area of one pixel in relation to distance from the camera lens.
