Field Testing of Hand-Held Infrared Thermography, Phase II TPF-5(247) Interim Report

Interim Report

December 2015

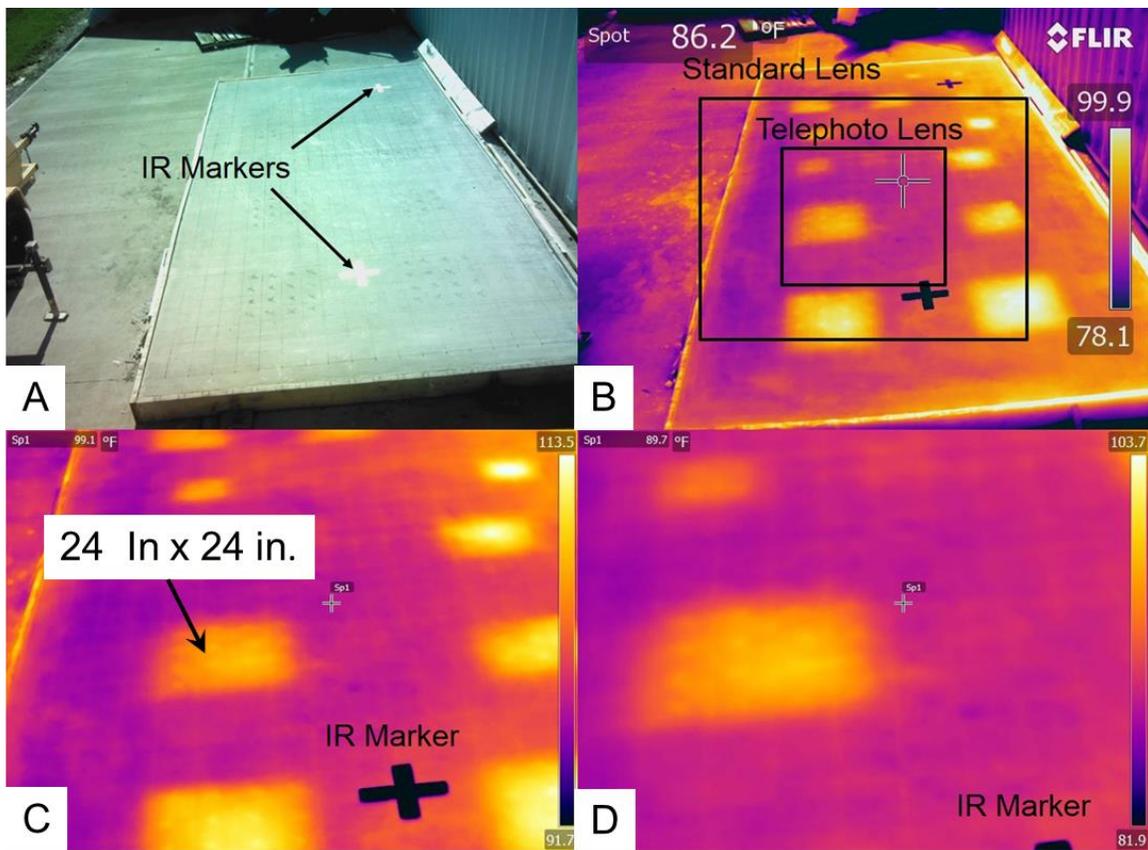
Figure 30. Images of a concrete test deck showing photograph (A) and thermal images captured using (B) wide angle, (C) standard and (D) telephoto lenses.

markers consisting of 2 in wide foil tape in a cross pattern were placed on the deck as spatial markers. Subsurface Styrofoam targets were cast into the deck at a depth of 2 in.. The dimensions of the Styrofoam targets were 24 in x 24 in., 18 in. x 18 in., 12 in. x 12 in. and 6 in. x 6 in.. All images in the figure were captured from a distance of 25 ft. Figure 30B shows a thermal image of the test deck captured with a wide angle lens, Figure 30C shows the thermal image captured with a standard lens and Figure 30D shows a thermal image captured with a telephoto lens. The data in these figures provide a practical illustration of the effect of using different lenses from a uniform distance from the target.

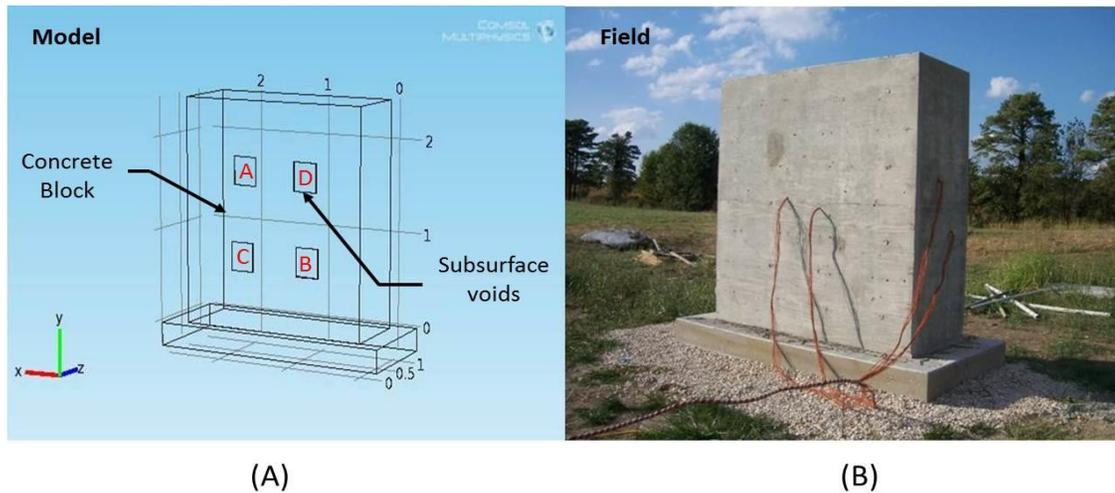
Figure 31. Schematic diagram of concrete block modeled by FEM (A), photograph of concrete test block in the field (B).

Figure 31A shows the three dimensional geometry of the concrete block that was simulated using the FEM. The concrete block modeled had the same geometry as the block constructed for the experimental study, which is shown in Figure 31B. The constructed block is a 2.4m x 2.4m by 0.9m in thickness and included Styrofoam targets (305 x 305 x 13 mm in dimension) at depths of 25, 51, 76, and 127 mm on each side. These Styrofoam targets have thermal conductivity close to that of air, such as would be present at a subsurface delamination in concrete.

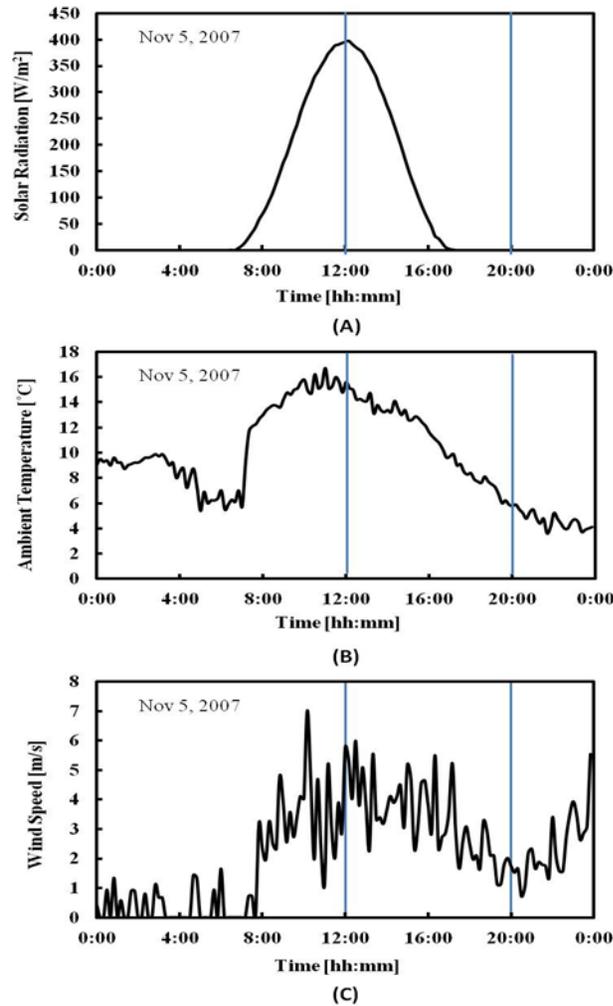
Figure 32. Environmental parameters as boundary condition in simulation on November 5, 2007: (A) solar radiation; (B) ambient temperature; and (C) wind speed.

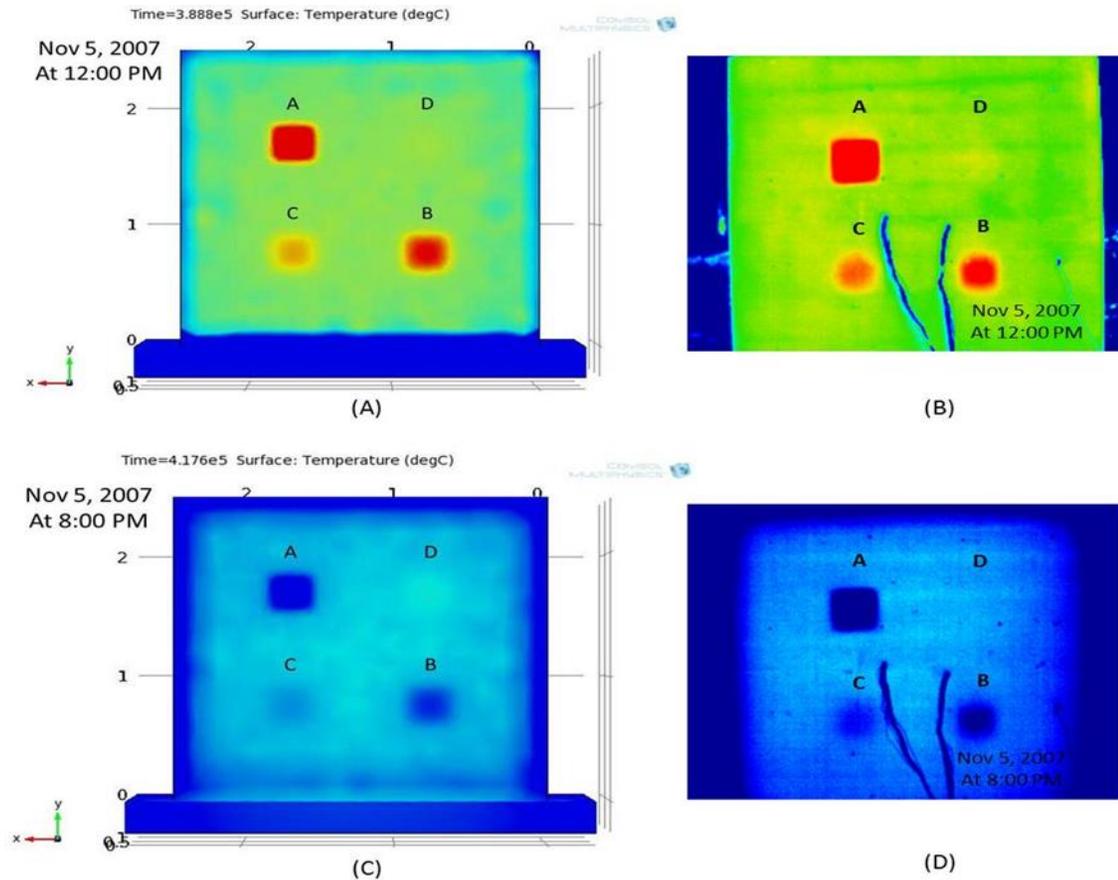
Figure 33. Typical thermal images of the thermal behavior for the South side of the concrete block: (A) the model result at noon; (B) the field test result at noon; (C) the model result at 8:00 p.m.; and (D) the field test result at 8:00 p.m.

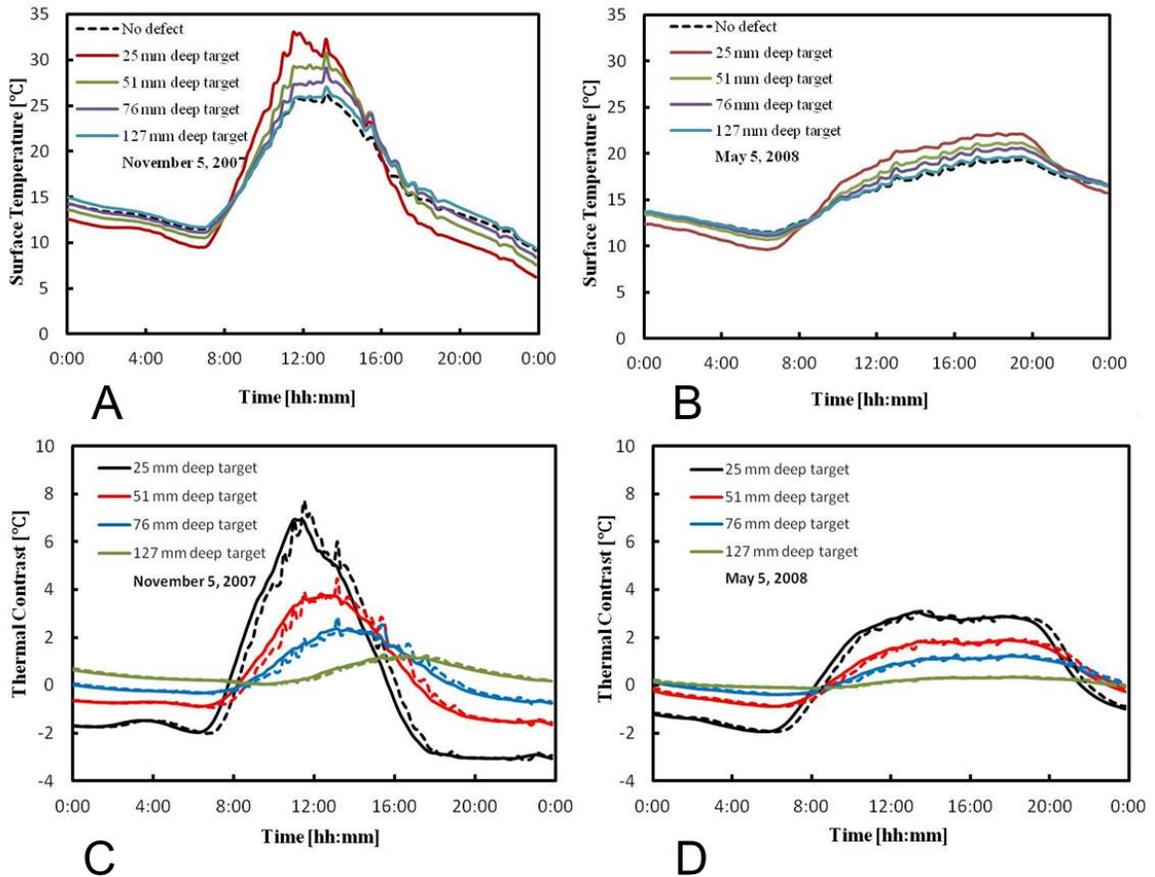
Figure 34. FEM model results for the north and south sides of the test block, showing typical results for surface temperature (A and B) and thermal contrasts (C and D)

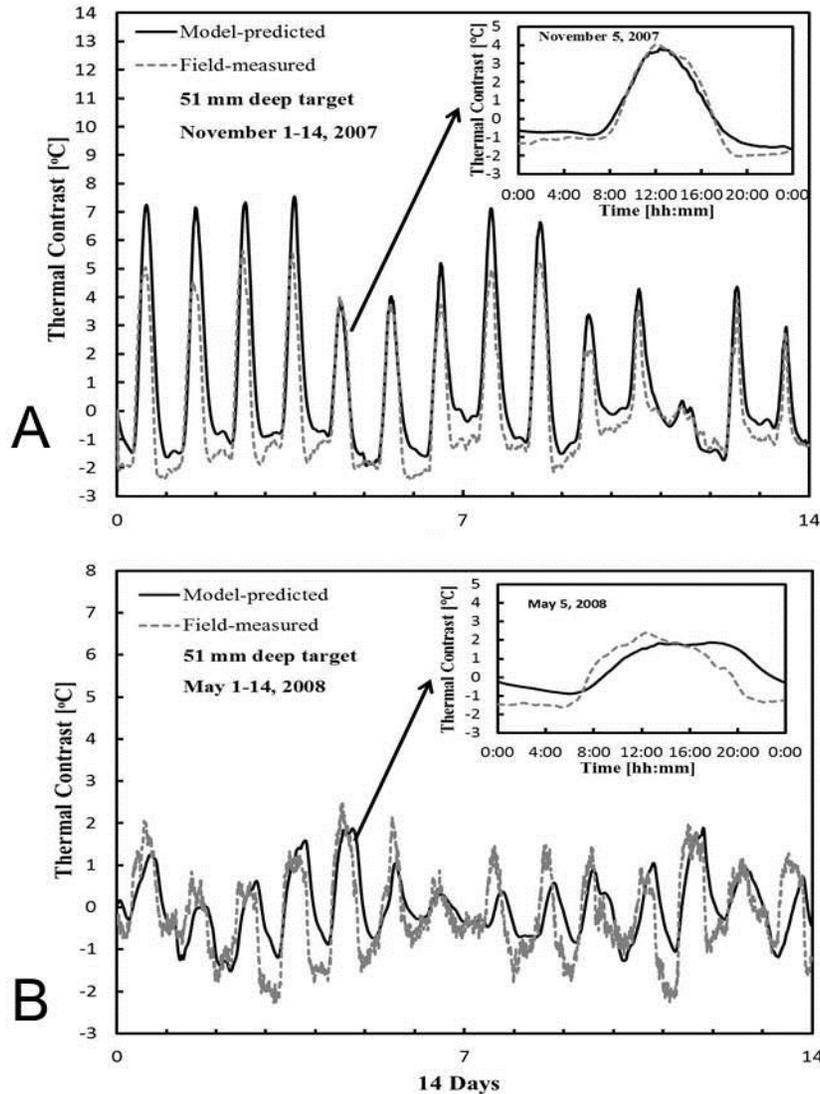
Figure 35. Thermal contrast determined from the numerical model and measured in the field for A) solar loaded conditions and B) shady conditions.

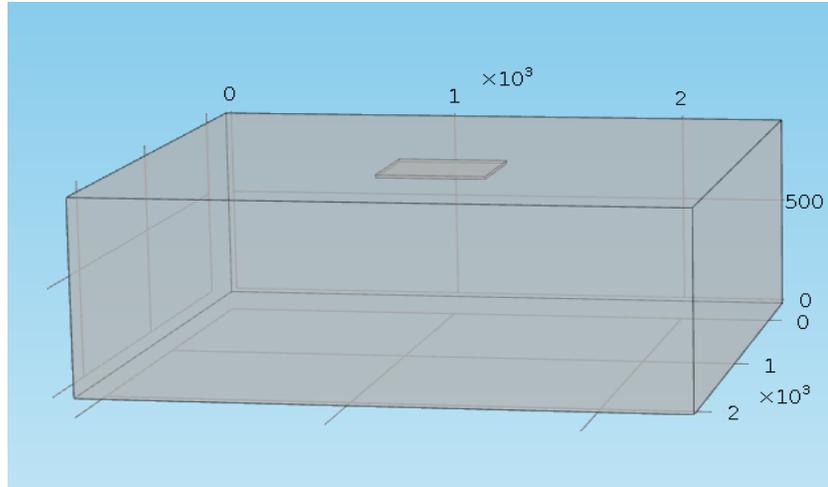
Figure 36. The basic geometry of the concrete model (geometry view in COMSOL)

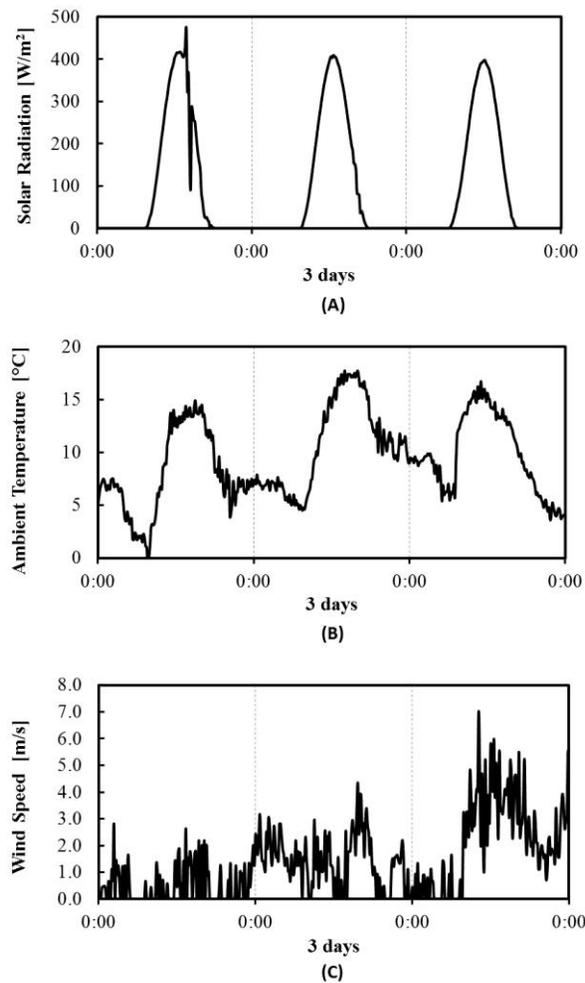
Figure 37. Three consecutive days of environmental parameters as a boundary condition in simulation: (A) solar radiation; (B) ambient temperature; and (C) wind speed

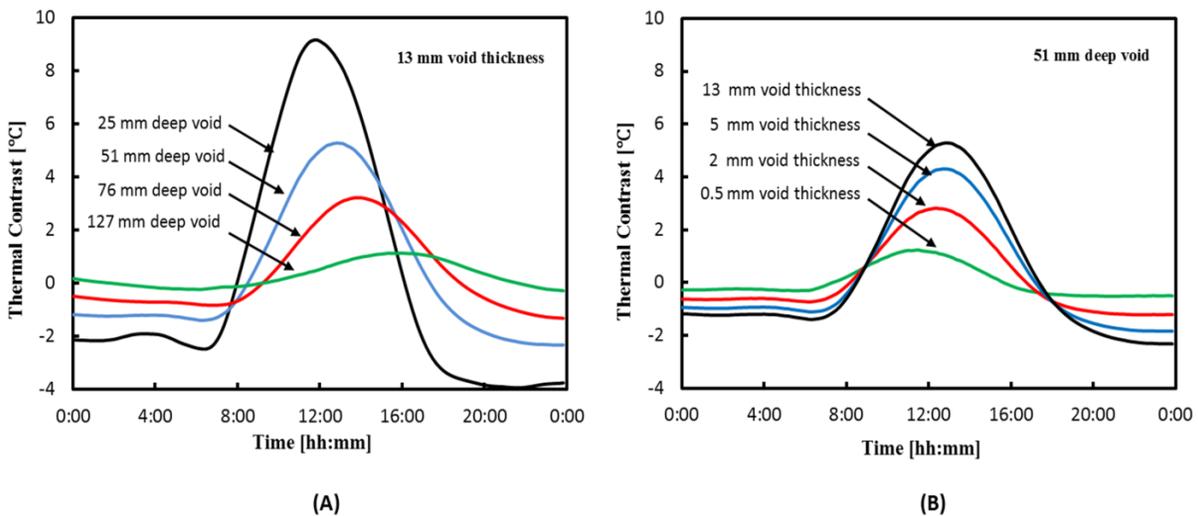
Figure 38. The time varying thermal contrast: (A) as a function of void depth, and (B) as a function of void thickness

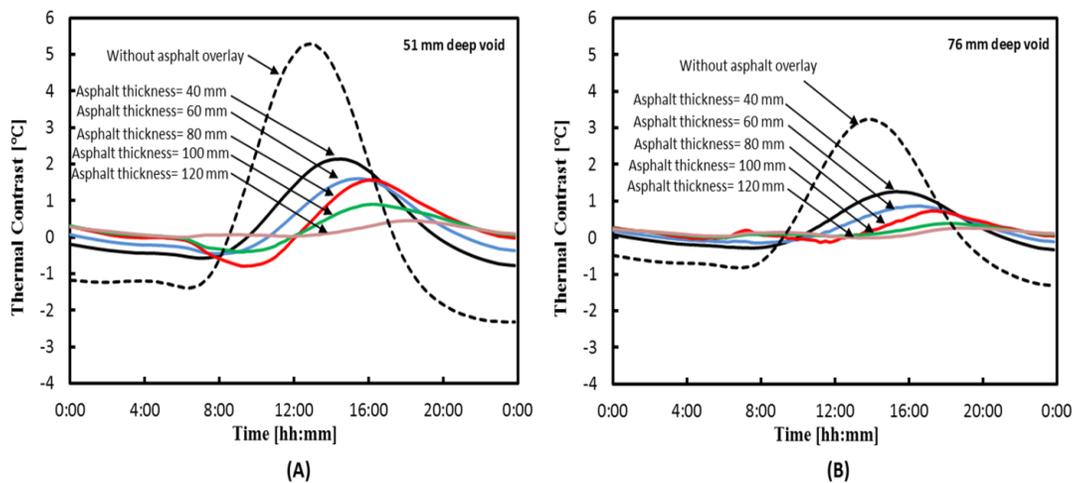
Figure 40. The time varying thermal contrast as a function of asphalt thickness: (A) 51 mm deep void (B) 76 mm deep void.

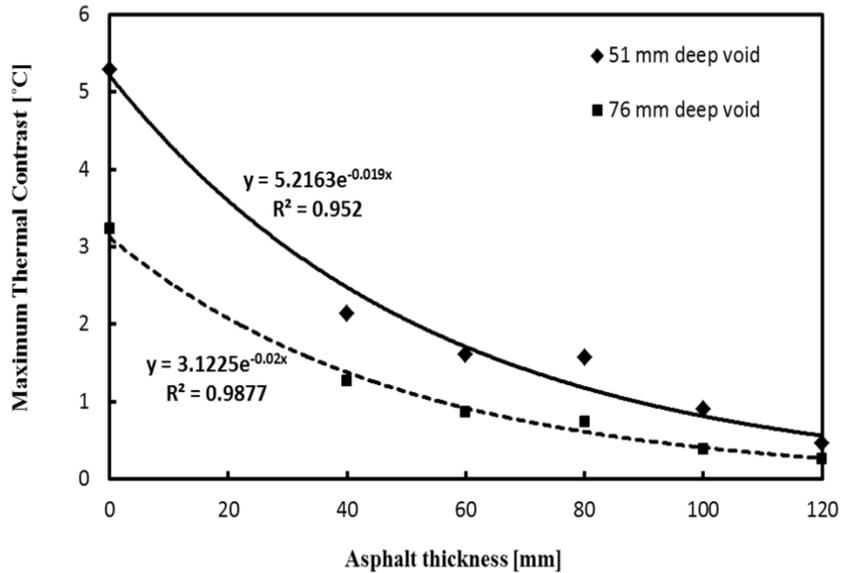
Figure 41. Effect of asphalt thickness on the maximum thermal contrast.

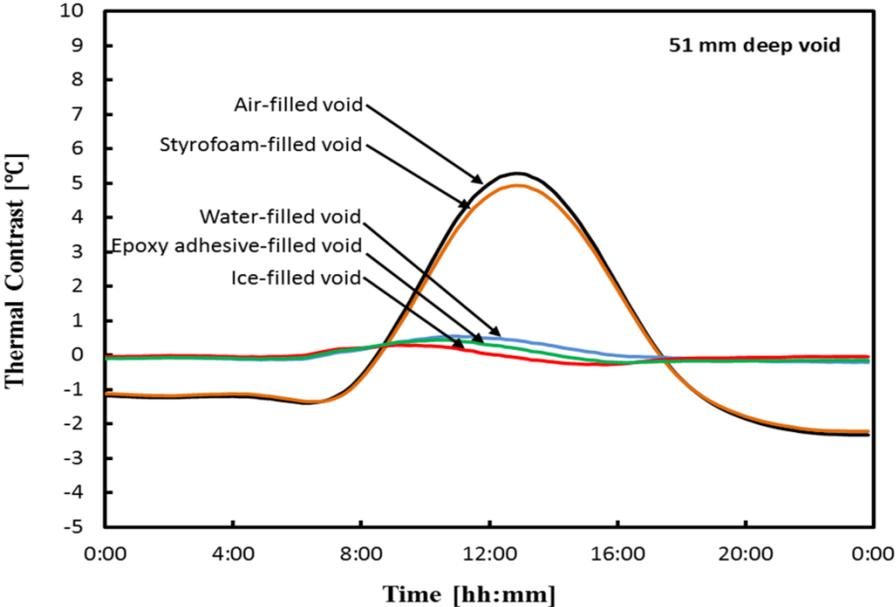
Figure 42. The time varying thermal contrast as a function of the materials present in the void

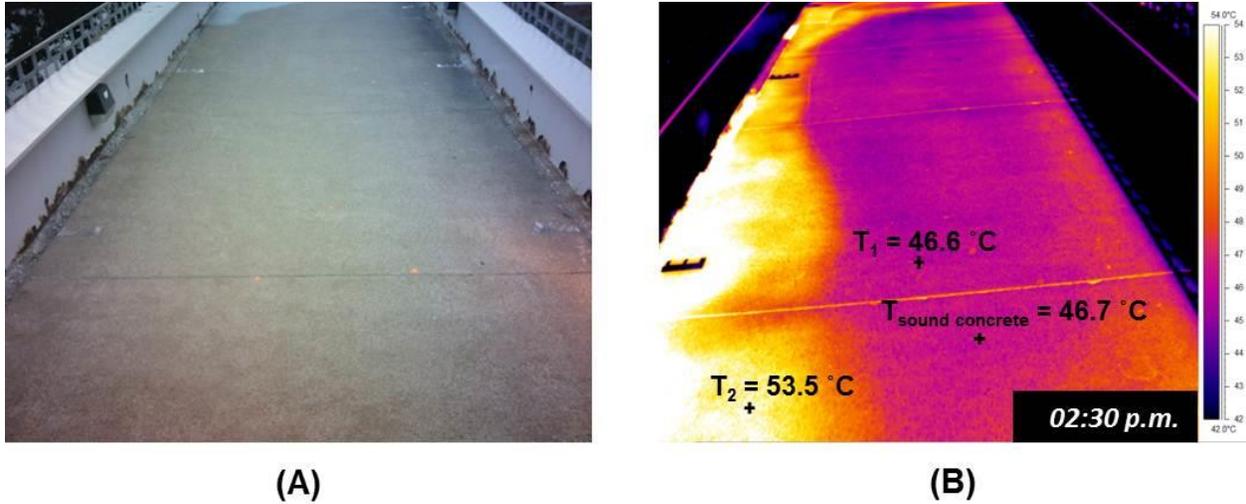
Figure 43. The digital image and the thermal image at 2:30 p.m. (obtained from the field IR thermography testing)

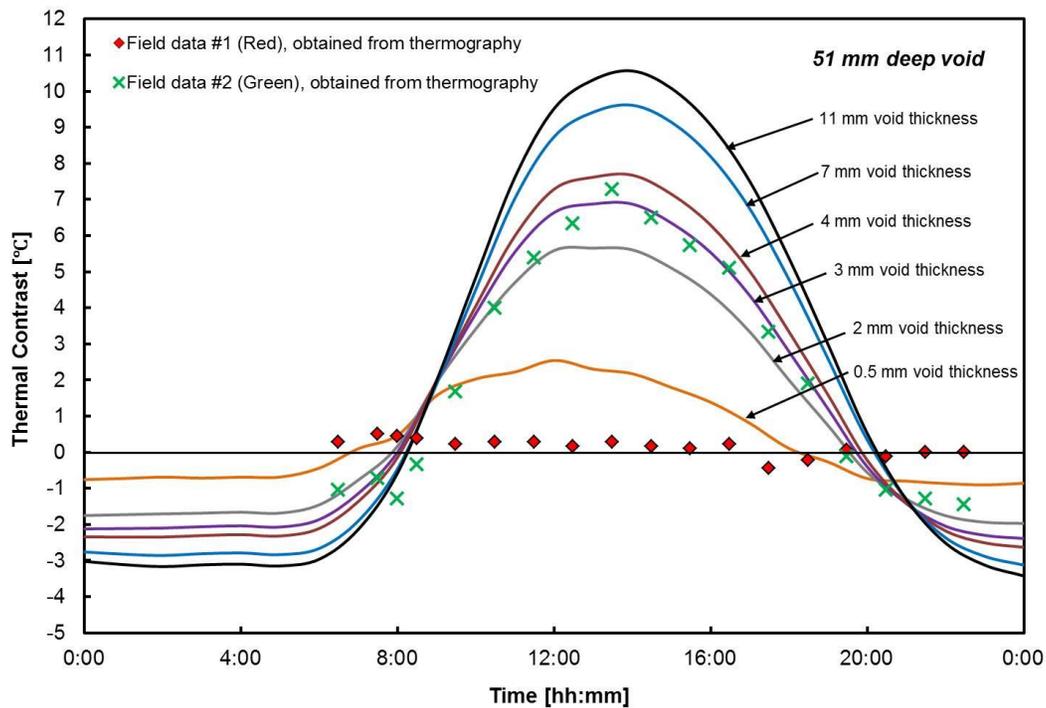
Figure 44. Thermal contrast as a function of void thickness for 51 mm deep void
