Research Project 9-1526 / TPF-5(116)
“Investigation of the Fatigue Life of Steel Base Plate to Pole
Connections for Traffic Structures”
A Pooled Fund Study

Project Update
January 2007

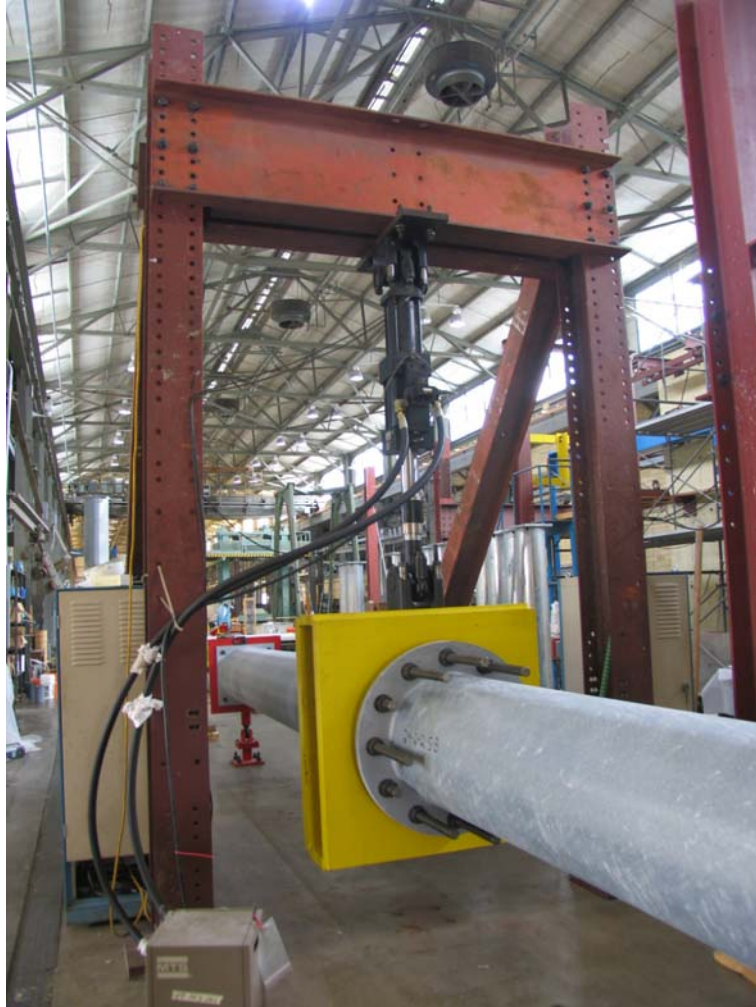
Figure 2: Test Setup for 24" high mast poles

The test setup for the 24" high mast lighting poles is almost identical to the one used for the 10" mast arms; only on a much larger scale. The small test setup has a total length of 16' from one reaction support to the other while the large setup has a total length of 32'. One of the few differences between the two setups was the way in which the specimens were bolted to the loading box. For the small test setup, washers were placed in between the base plate and the loading box to eliminate the possibility of a warped base plate from introducing unwanted stresses. For this same reason, leveling nuts were used for the 24" high masts in the large test setup. The leveling nuts can be seen in Figure 3 below. Note that this picture was taken during installation and the specimen is not yet bolted to the loading box.

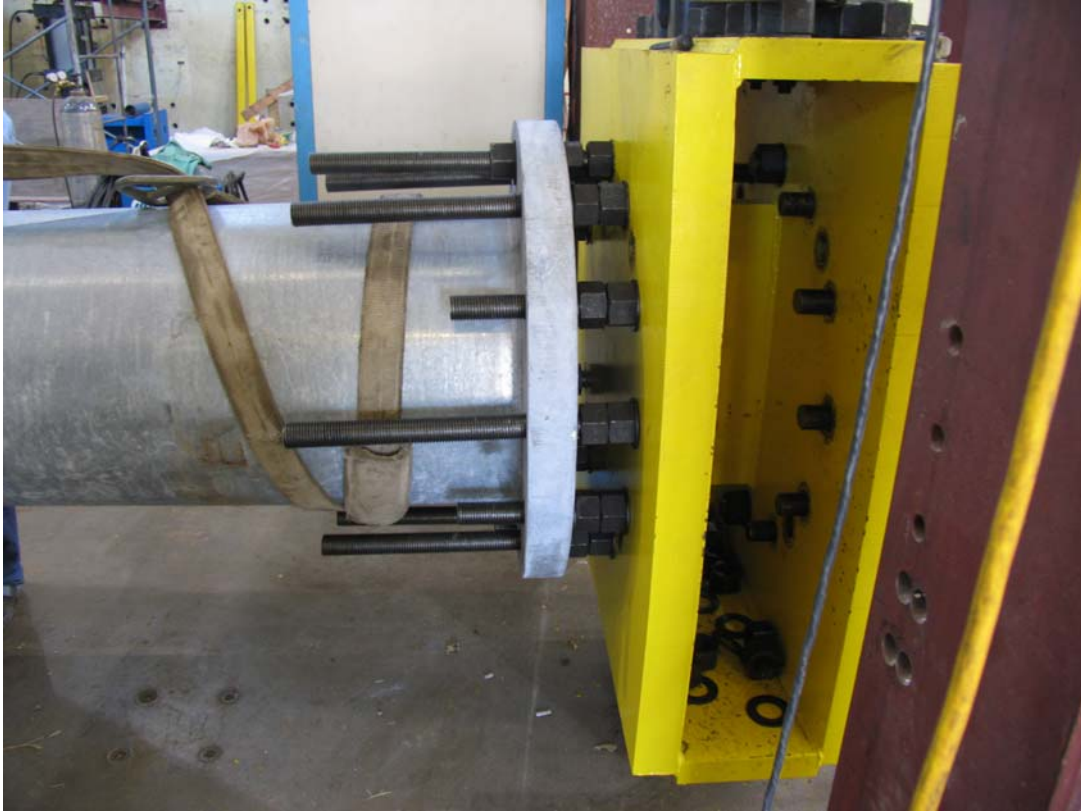
Figure 3: Leveling nuts used for base plate to loading box connection in large test setup

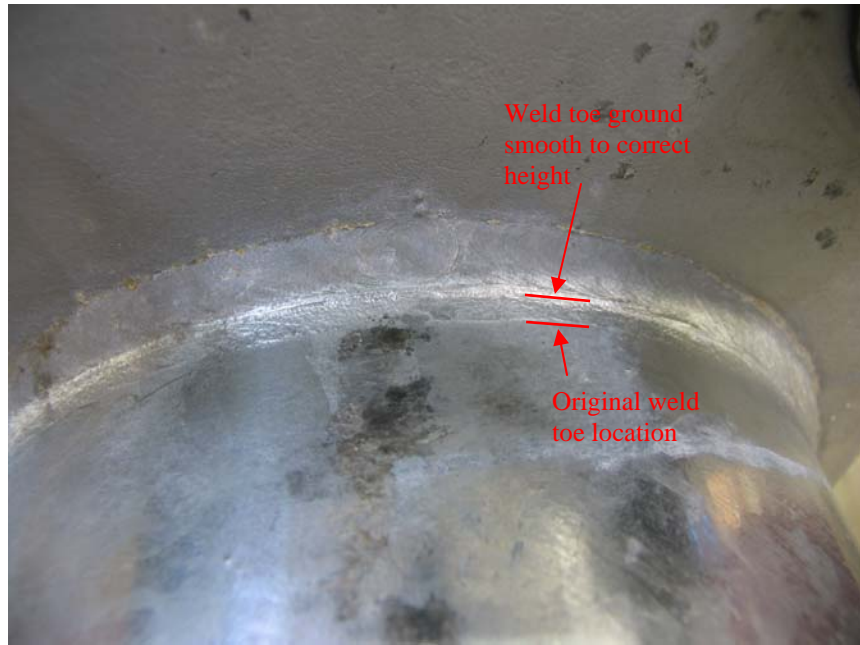
Figure 4: Grinding of the weld toe

One will notice that for three of the specimens, the fatigue life states that the specimens were “Unable to Test to Failure.” Two of these specimens had one thing in common: the weld toe seemed to have been ground smooth during manufacturing. Grinding the weld toe reduces the angle with which the weld comes into contact with the pole wall. This has a significant effect on fatigue performance since it reduces the stress concentration at the critical location of the weld toe. Figure 4 below shows a weld from one of these specimens.
