PAVEMENT SUBGRADE PERFORMANCE STUDY

Test Section 711

Subgrade AASHTO soil type A-7-5 at 25 percent gravimetric moisture content

Edel R. Cortez⁽¹⁾

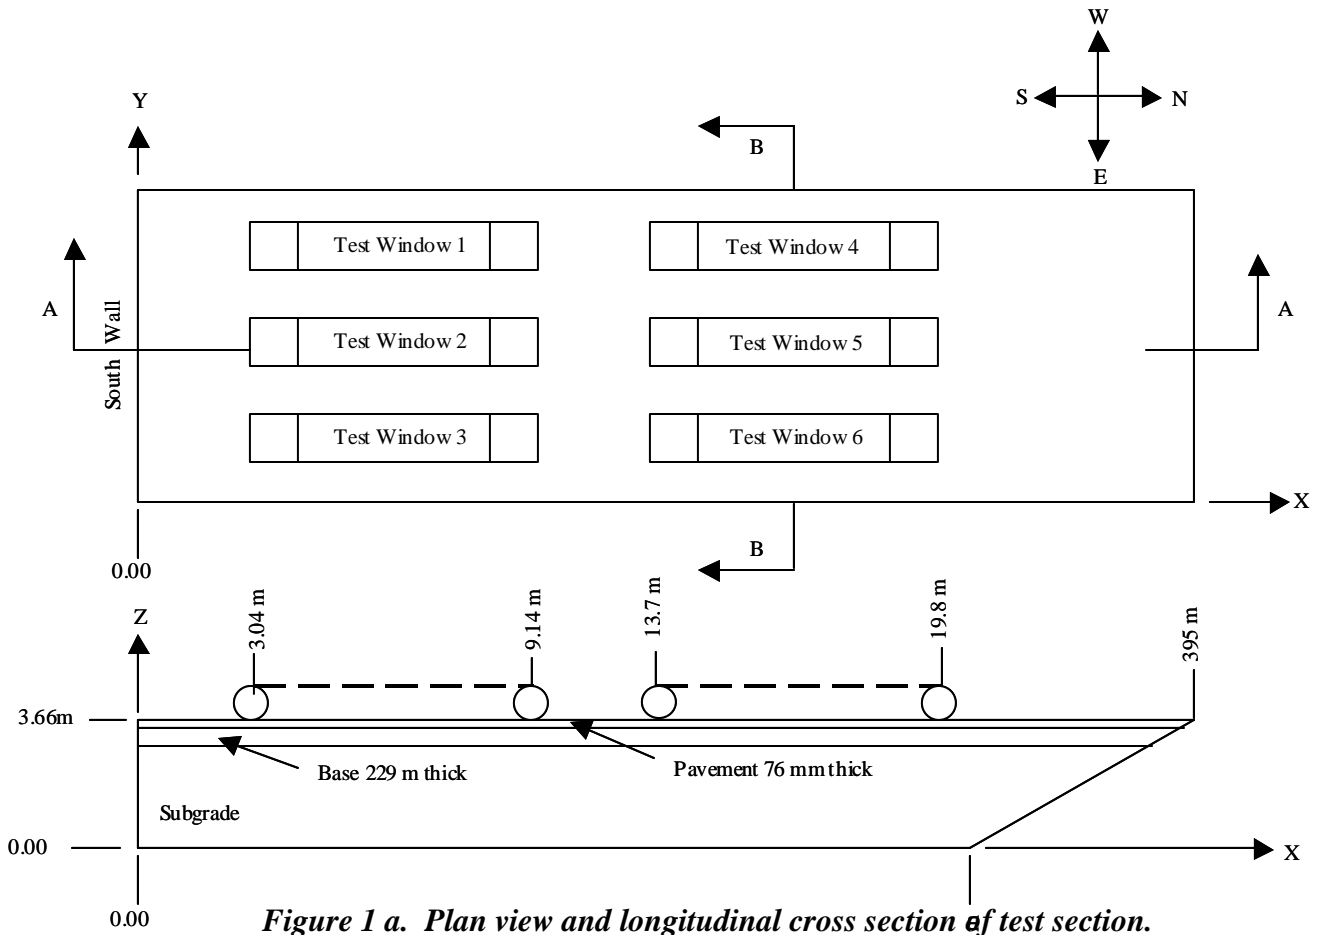
Figure 1 a. Plan view and longitudinal cross section of test section.

The pavement structure consisted of a 76-mm (3-in) hot mixed asphalt (HMA) layer, a 229-mm (9-in) crushed gravel base course, and 3 m (10 ft) of subgrade soil.

The test section was divided into six test windows. A test window is an area where traffic is applied. An effective test window was 0.91 m (3 ft) wide by 6.08 m (20 ft.) long, excluding acceleration and deceleration areas. The thickness and material properties for all test windows were designed to be constant, but the traffic load intensity was designed to vary from one test section to another.

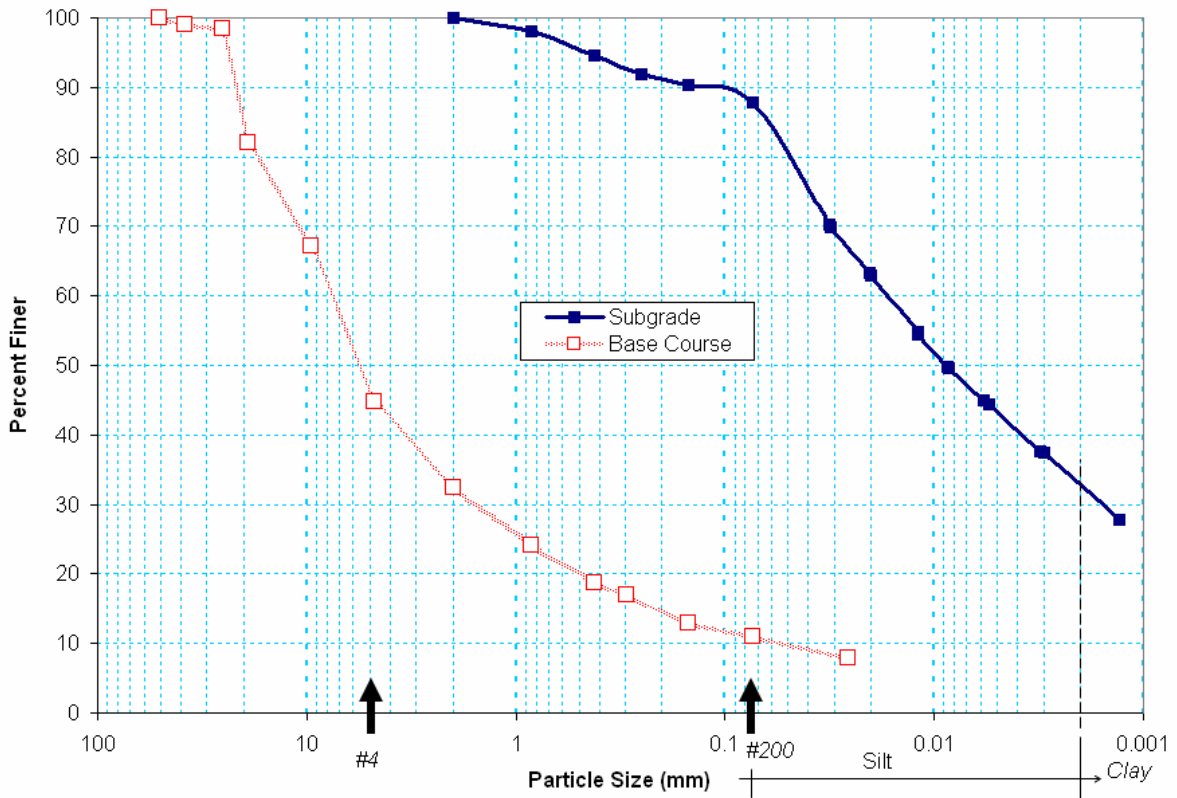
Figure 2. Grain size distribution for the subgrade soil and base course soils.

Figure 1 shows grain size distributions for the subgrade soil and for the base course soil. The subgrade soil has approximately 88 percent passing the 0.074-mm (#200) sieve and 33 percent finer than 0.002 mm (clay content). The average liquid limit (LL) and plasticity index (PI) of the soil were 55 percent and 20 percent respectively. According to the American Association of Highway and Transportation Officials (AASHTO) soil classification system, this soil falls within the A-7-5 region, but near the boundary of the A-7-6 region. According to the Unified Soil Classification System, the subgrade soil was a MH soil (High liquid limit silt). The average specific gravity of the subgrade soil was 2.71.

The base course material was made of unbound crushed stone. It was classified as an AASHTO type A-1 soil. According to the Unified Soil Classification System, the base course soil was type GP-GM (mix of poorly graded gravel and silty gravel). About 11 percent by weight of the base course soil particles passed through the sieve 0.074-mm (#200) sieve. The fines were classified as non-plastic.

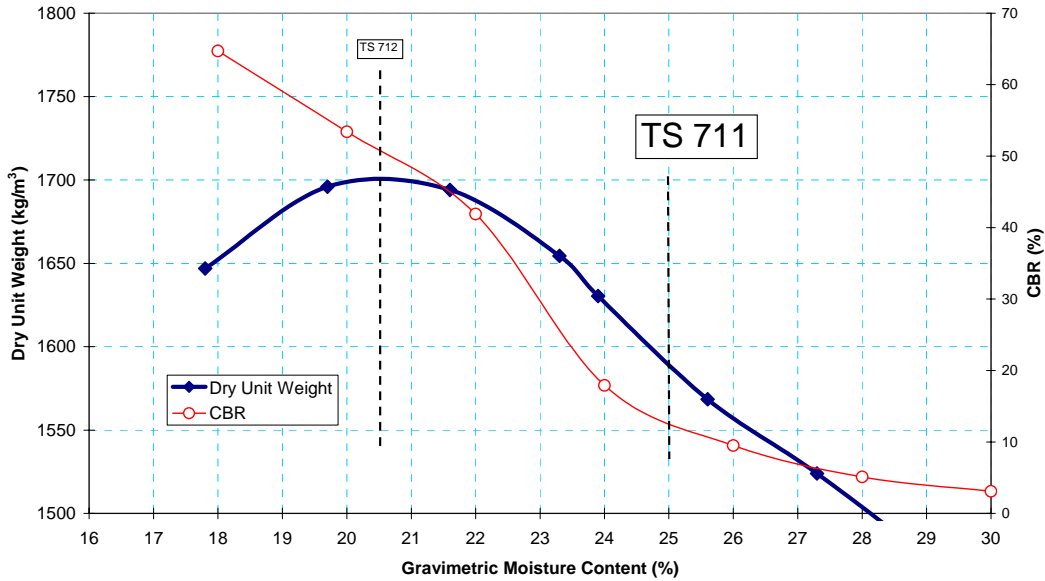
Figure 3. Subgrade modified Proctor and laboratory CBR test results.

The maximum density and optimum gravimetric moisture content for the subgrade soil were 1700 kg/m³ (106.1 pcf) and 20.5 percent respectively. The design moisture content for this test section was 26 percent, but the average as-built subgrade moisture content was 25 percent. The laboratory CBR for this moisture content was approximately 13 percent.

Figure 3 shows that, for this subgrade soil at 25 percent moisture content, the laboratory CBR value is approximately 13 percent. Figure 19 shows that this is equivalent to a resilient modulus (M_r) of 96.5 MPa (14 ksi). If the moisture content increases to 26 percent as originally intended for this test section, the laboratory CBR would be reduced to 9 percent, corresponding to an M_r value of 75.8 MPa (11 ksi).

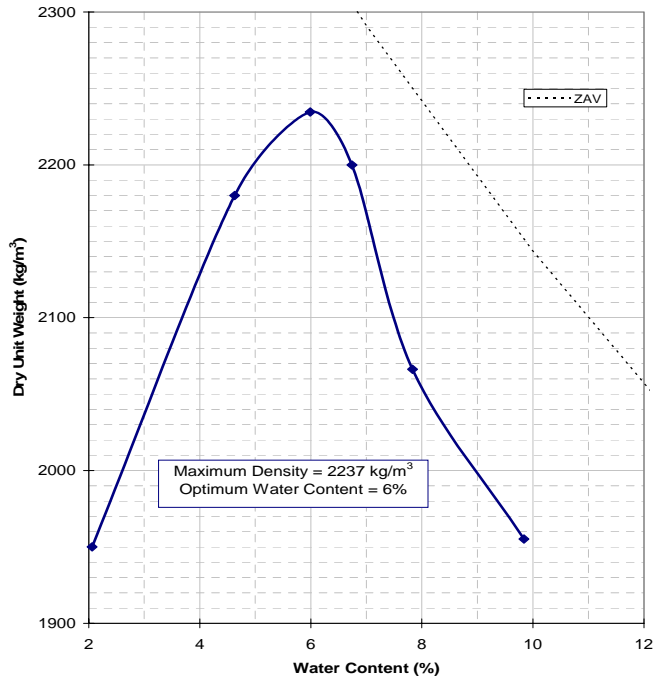
Figure 4. Base course modified Proctor test results.

The modified Proctor test results shown in Figure 4 indicate that the optimum gravimetric moisture content of the base course material was 6 percent and the maximum density was 2237 kg/m³ (139.5 pcf). Obtaining this moisture content with high hydraulic conductivity materials is difficult in practice. The average moisture content of the base course material during construction was 5.9 percent.

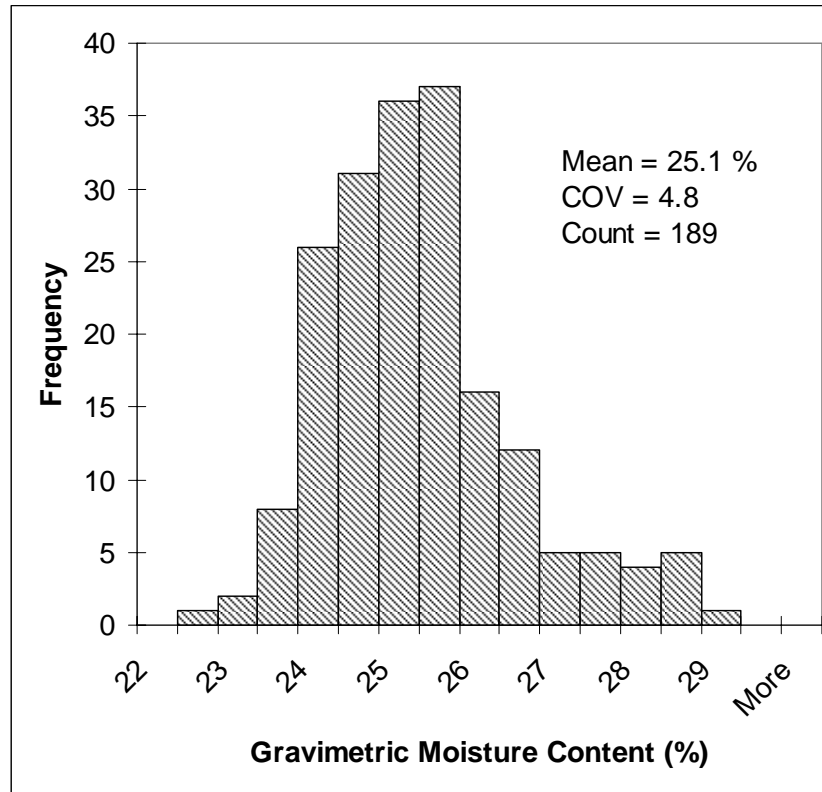
Figure 5. Subgrade moisture content.

The mean moisture content of the subgrade was 25.1 percent. The average moisture content of the base course during construction was 5.9 percent.

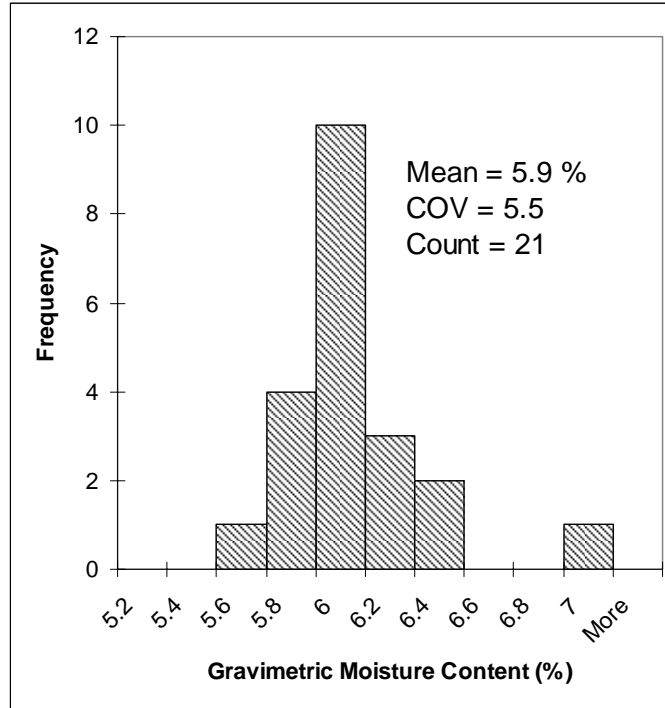
Figure 6. Base course gravimetric moisture content.

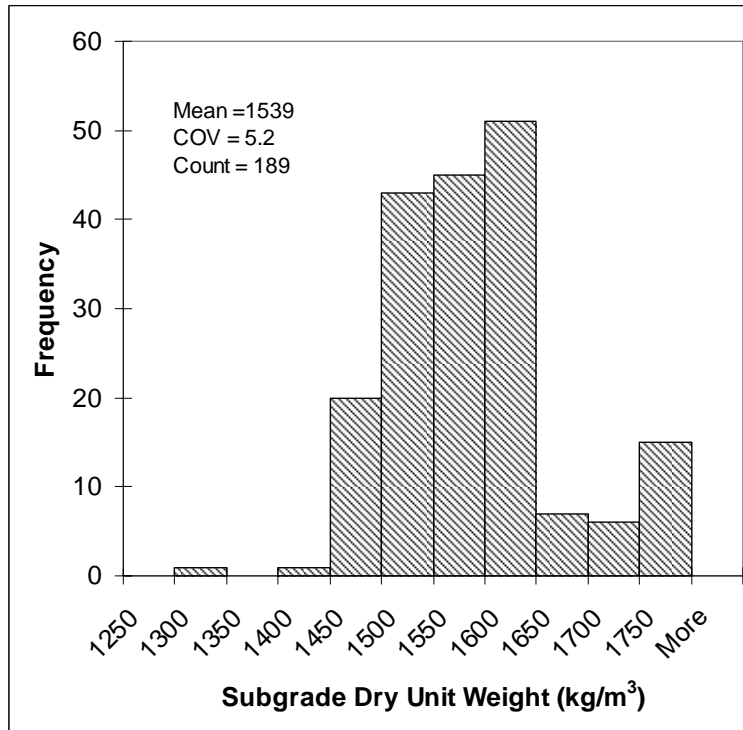
Figure 7. Subgrade dry unit weight.

The mean dry density of the subgrade was 1539 kg/m^3 (96.1 pcf). The mean dry density of the base course was 2350 kg/m^3 (146.7 pcf). The mean density of the AC was 2300 kg/m^3 (143.6 pcf).

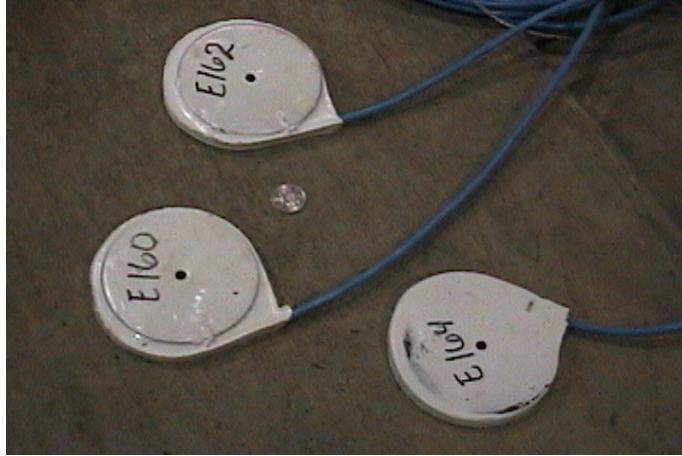
Figure 9. Emu coils in a co-planar arrangement to measure longitudinal and transversal displacements. A US 25-cent coin is included for scale reference.

Displacement measurements were made in the base and subgrade by means of ϵ mu coils. Strain can be deduced from displacement measurements between coil pairs in either coaxial or co-planar arrangements. The sensors were placed 150 mm center to center. Displacements were measured in the longitudinal (x), transversal to traffic (y), and vertical (z) direction of loading. Displacements in the vertical direction were measured in a series of layers down to a depth of 1.52 m.

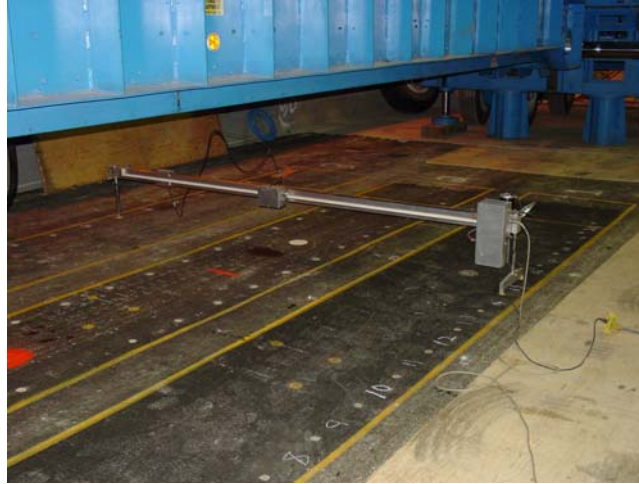
Figure 13. Laser profilometer.

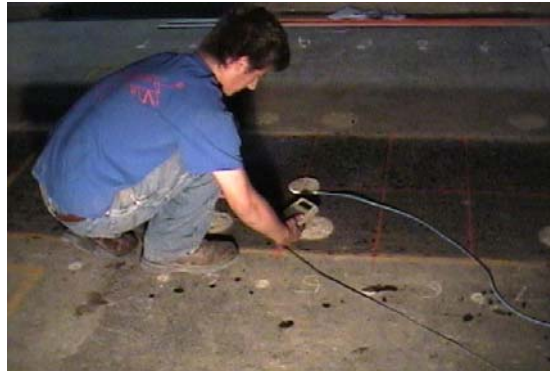
Figure 16. Measuring displacement between the AC surface and the top of the base course.

4. Subsurface stress and displacement measurements conducted in the vertical, longitudinal, and transversal directions relative to the direction of traffic. The measurements were conducted at various pass levels to define their progression throughout the traffic tests. The displacement measurements were conducted dynamically upon the passing of tire traffic, and also statically when no traffic was occurring. The dynamic displacements measured the resilient deformation during traffic load events. The static measurements provided a way to measure permanent deformation.
5. In addition to the ϵ mu coils embedded in the pavement, a mobile coil was placed on top of the asphalt over a vertical stack of embedded ϵ mu coils as shown in Figure 16. This provided a means to measure the vertical permanent deformation in the asphalt layer.

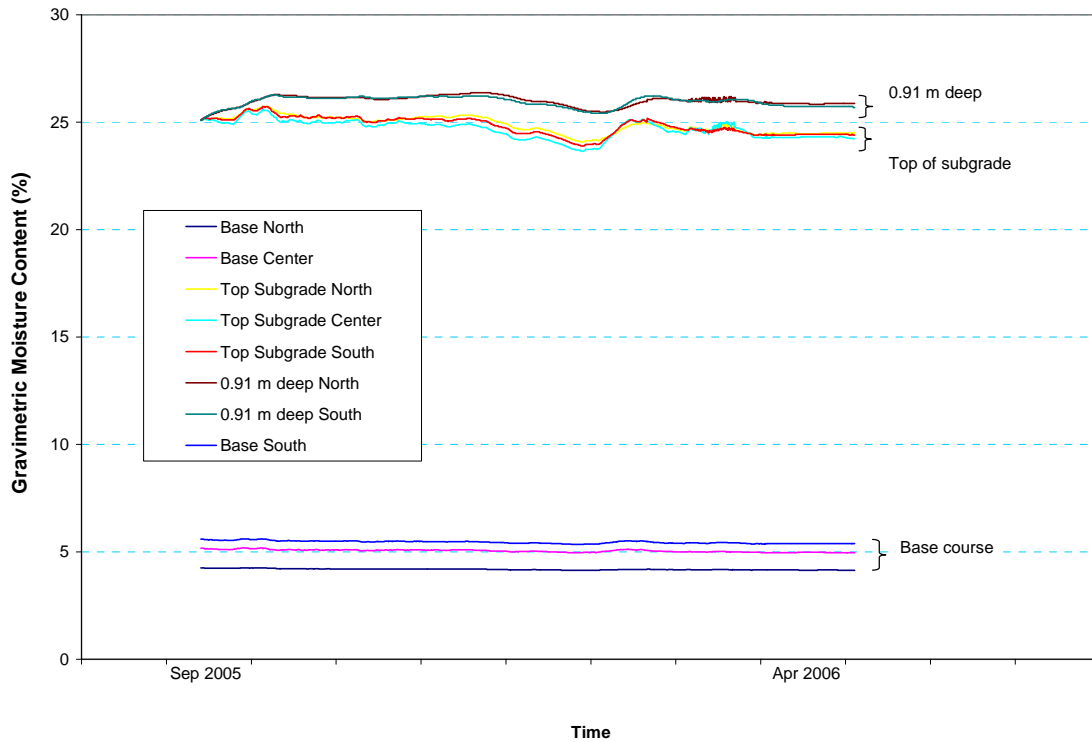
Figure 18. Moisture measurements in the base and subgrade during testing.

oscillation frequency between two rods embedded in the moist soil. The oscillation frequency is related to the dielectric constant that changes with moisture content, and to a lesser degree with temperature. The sensor readings are also affected by salinity, mineralogy and presence of organic materials. Volumetric moisture content is converted to gravimetric moisture content through weight-volume relationships and soil specific gravity. Figure 18 shows the oven-dry corrected gravimetric moisture measurements in the base course, at 15 cm (6 in.) below the top of the subgrade and at 61 cm (2 ft.) below the top of the subgrade. The moisture sensor data suggest that a small decrease in moisture content at the top of the subgrade, and a small increase in moisture at the lower subgrade location. The test section is built above a concrete floor, and it is surrounded by concrete wall and covered by 76 mm (3 in.) of asphalt concrete. Neglecting vapor diffusion through these very low permeability materials, one can consider the subgrade and base course system as a practically sealed system. Therefore, the small decrease in moisture content near the top of the subgrade must come as a result of moisture migration within the test section.

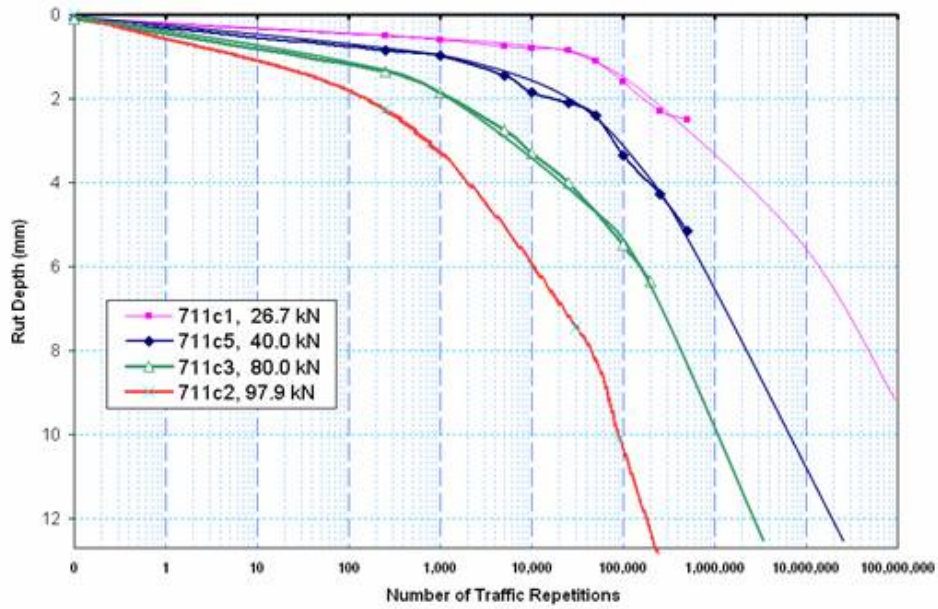
Figure 20. Average rut depth as function of traffic load repetitions and semi-axial load intensity.

as a function of traffic repetitions for test windows subjected to various load intensities. The axial load intensity applied to each test window is also indicated in this figure. As expected, test windows tested with heavier loads deformed faster than those tested with lighter loads. The gravimetric moisture content of the subgrade soil in Test Section 711 was 25 percent. The modified Proctor optimum moisture content was 20.5 percent. Despite the higher moisture content Test Section 711 was relatively strong. Producing the desired rut depth of 12.7 mm (0.5 inch) became time and cost prohibitive. For example, Test Window 711c5 was tested with the standard axial load of 80 kN (18 kips). After 500,000 traffic repetitions, the rut depth was 5.2 mm. Therefore, for each test window, the number of traffic repetitions needed to produce 12.7 mm of rut depth had to be estimated by projecting the experimental curve. For Test Window 711c5 with the standard axial load, failure was estimated to occur at approximately 25 million traffic repetitions.

As shown in Figure 20, approximately 25 million ESALs were needed to fail this test section. Considering the thin asphalt concrete in the pavement structure, this indicates a relatively strong subgrade. The number of ESALs needed to fail Test Section 712 (the control test section with subgrade soil at optimum moisture content) was 60 million. Although the pavement life was reduced in Test Section 711 due to the higher subgrade moisture content, both test sections were relatively strong compared to test sections built with other soils. However, with this AASHTO A-7-5 soil, if excessive moisture is allowed to enter the subgrade, the soil loses strength rapidly. When building roads over this subgrade soil type, special care must be exercised to provide drainage that reduces exposure to bulk water for significant periods of time. Concerns on the dry side are limited to shrinking cracking that can be dissipated by a granular sub-base, a drainage layer or the base course. Due to the very low hydraulic conductivity of soils with high clay content, they tend to have an equilibrium moisture content that depends on the long-term mean relative humidity of the geographic location.

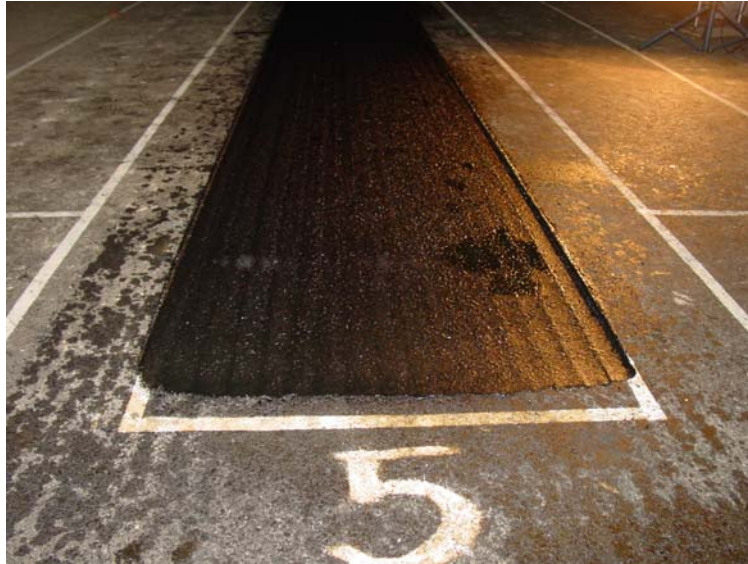
Figure 28. Test Window 711c5 at the end of HVS traffic.

During traffic testing of Test Window 711c5, a slowly dripping oil leak developed. The leak was repaired but the surface of the effective test window had a sticky appearance. However, there was no evidence of asphalt softening beyond a very thin surface layer.

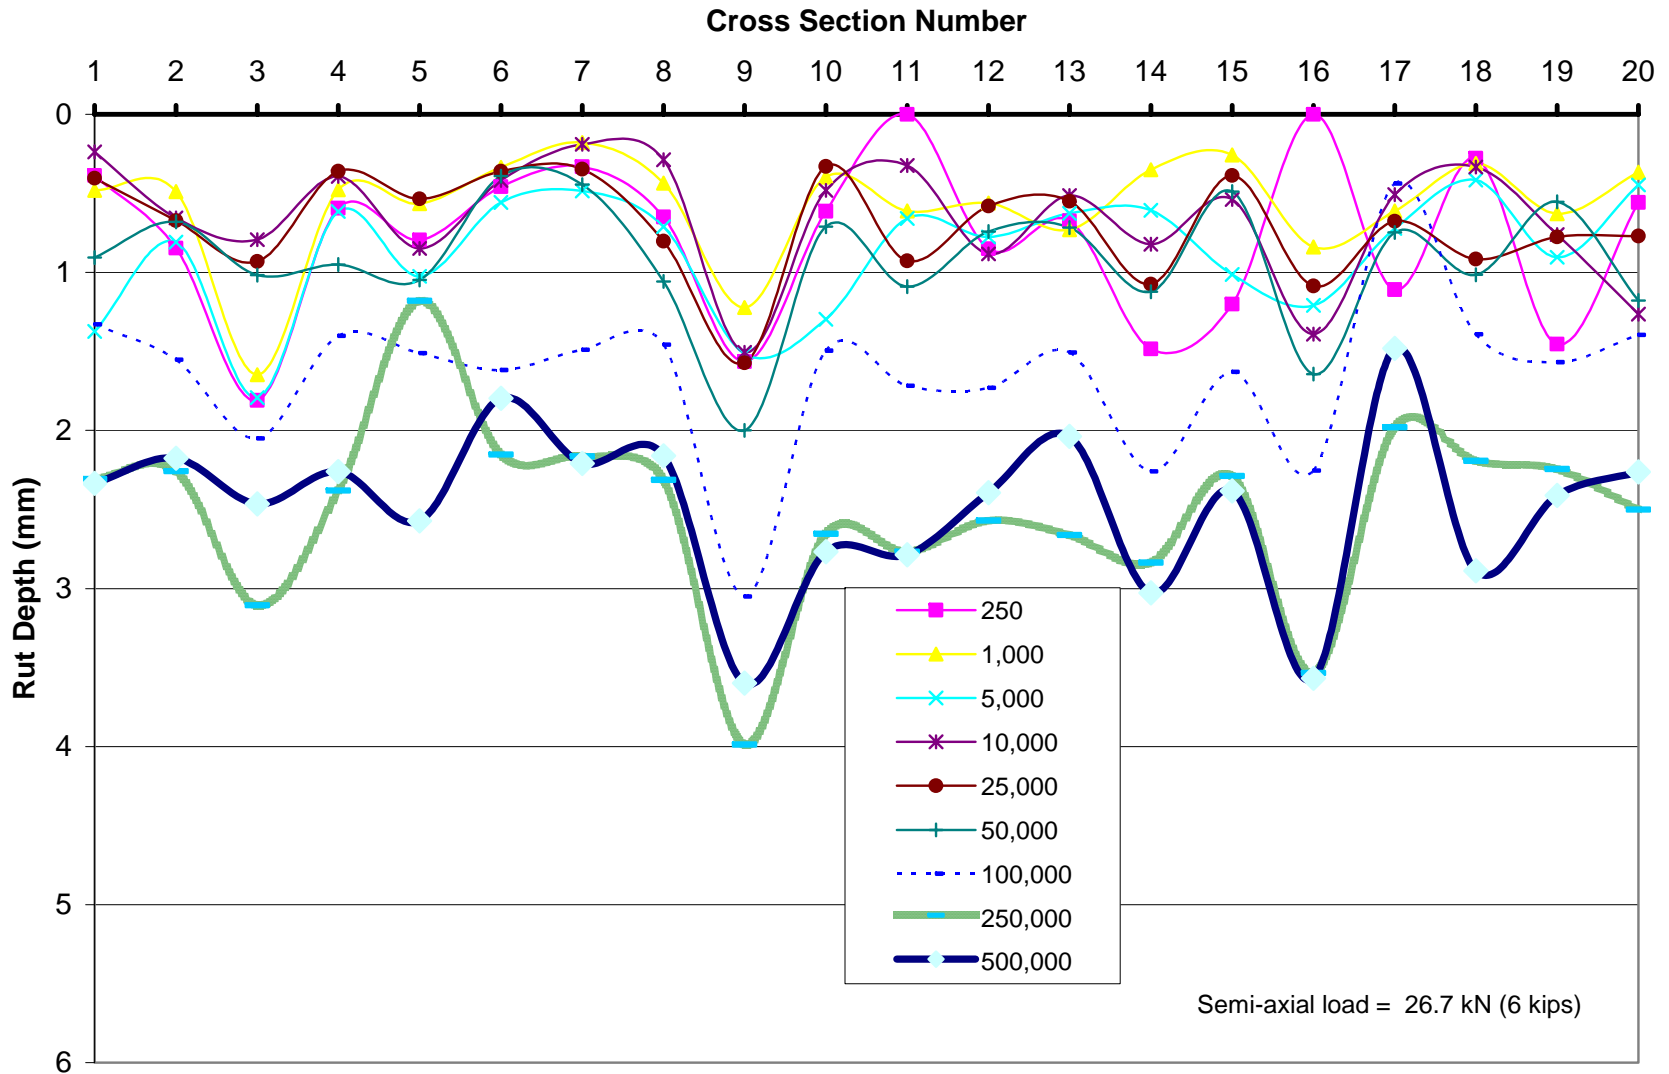
Figure 30. Progression of surface rutting along the center of the tire path in Test Window 711c1.

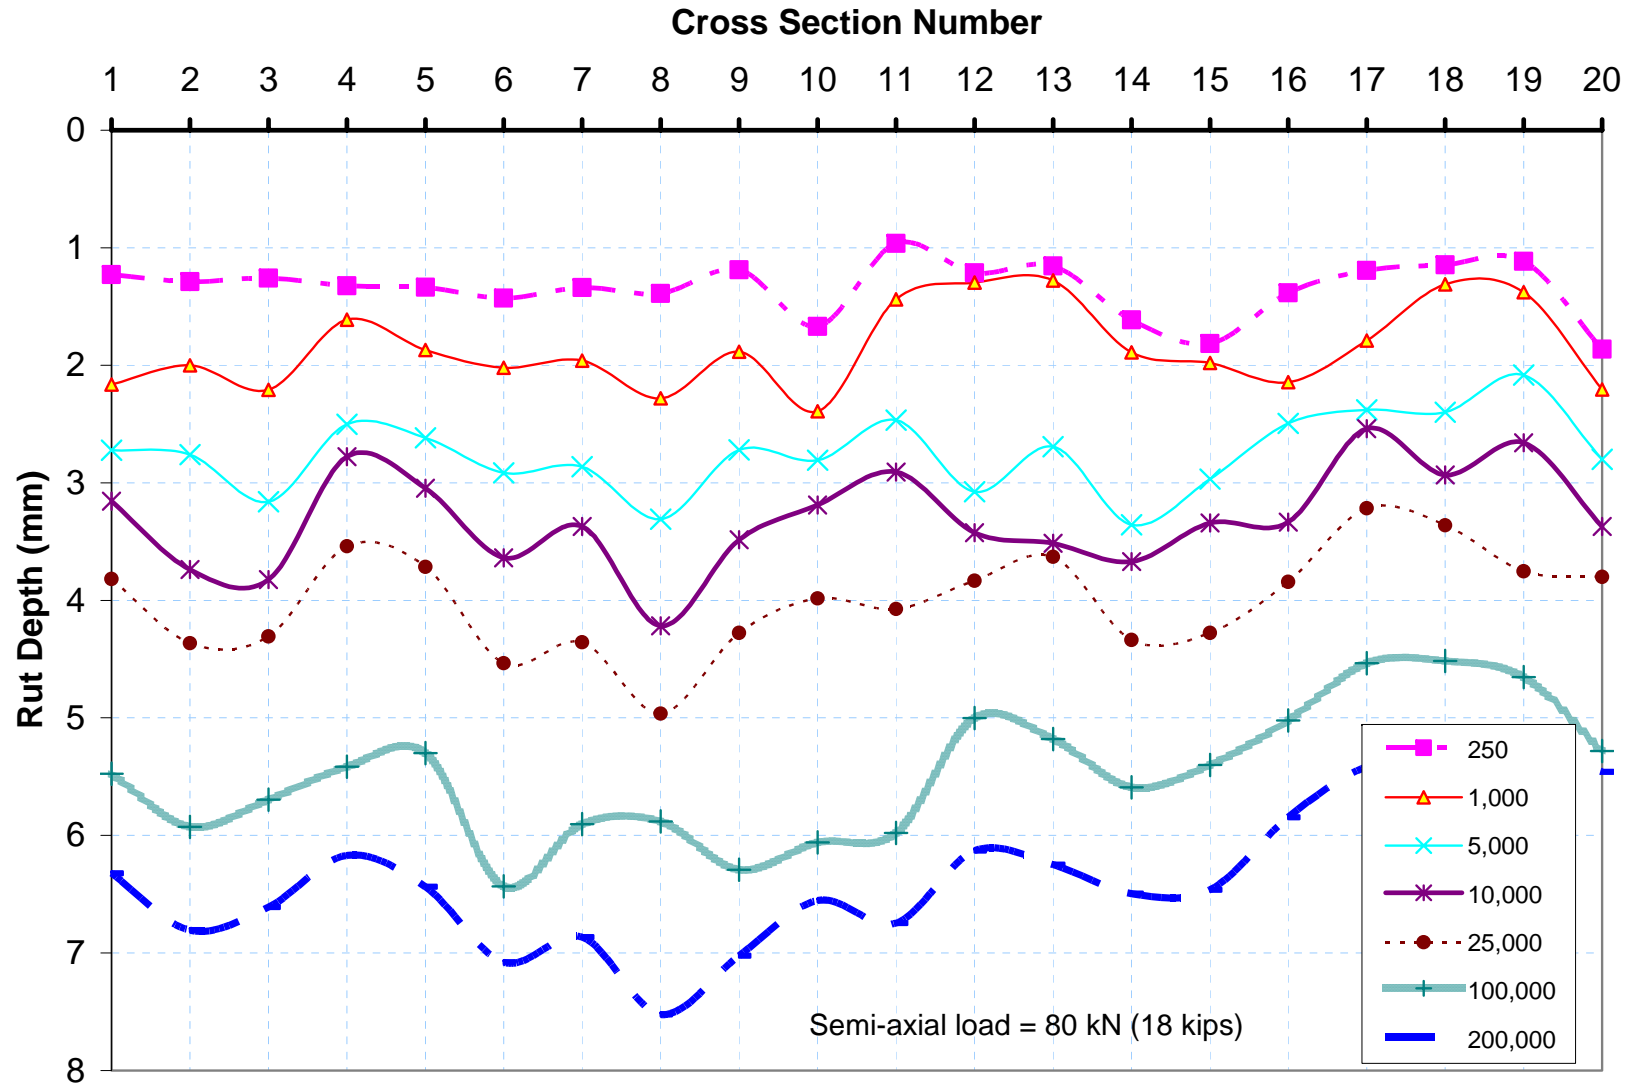
Figure 32. Progression of surface rutting along the center of the tire path in Test Window 711c3.

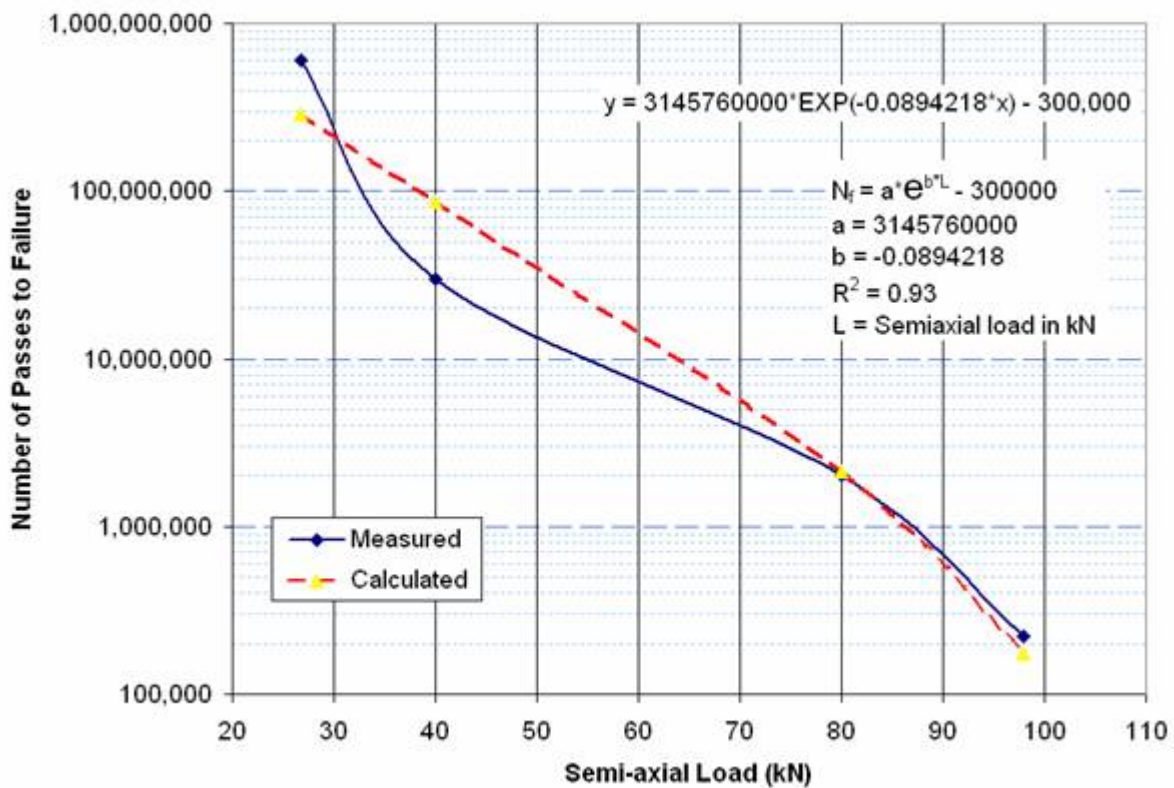
Figure 34 Load repetitions to failure as a function of load intensity.

Table 8 shows the number of traffic passes required to cause a rut depth of 12.7 mm (0.5 in) estimated from the projections of the experimental data. Figure 34 graphically shows the relationship between load intensity and number of traffic passes to failure, and also a power function that fits the experimental data with an R^2 value of 0.93.

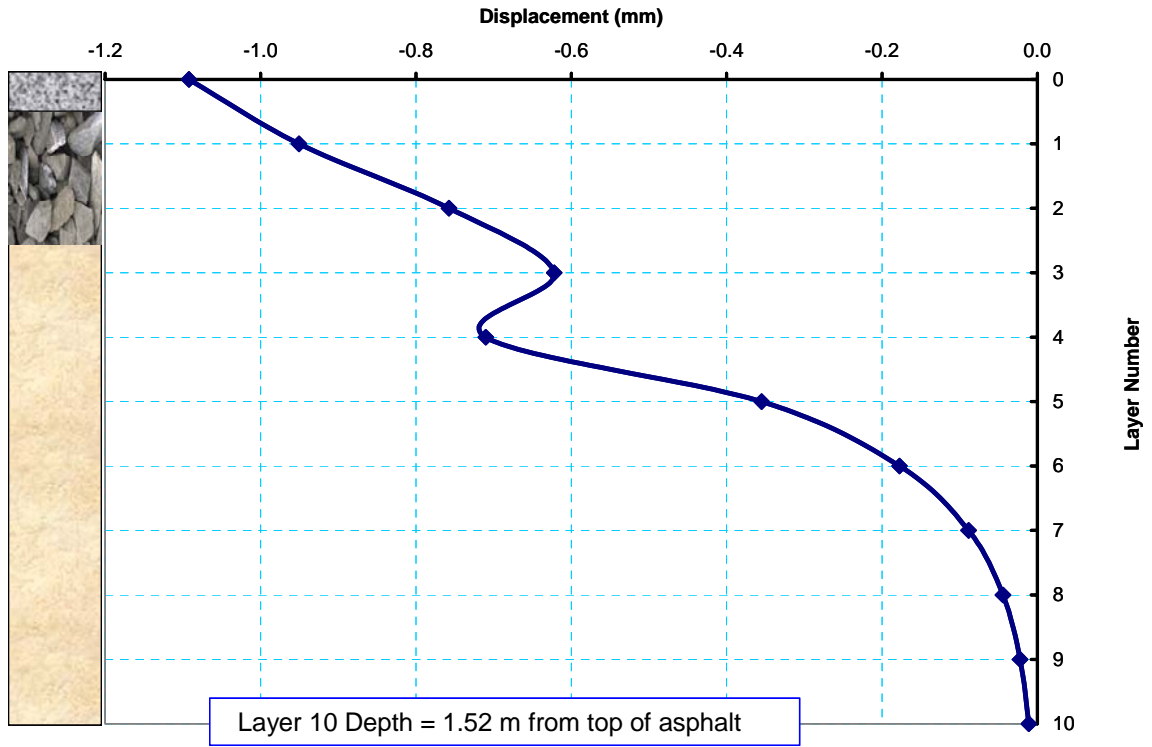
Figure 35a. Layer by layer vertical permanent deformation in Test Window 711c1 with 26.7 kN semi-axial load.

Figure 35b. Layer by layer vertical permanent deformation at failure in Test Window 711c1 with 26.7 kN semi-axial load.

Permanent deformation measurements were collected from ϵ mu coils embedded in the base and the subgrade. Measurements were conducted before traffic began and at various stages throughout the traffic tests. An additional mobile ϵ mu coil was placed at the asphalt surface and paired with a coil embedded just below the bottom of the asphalt concrete (AC) to measure the vertical deformation that occurred in the asphalt layer. Three stacks of ϵ mu coils were embedded to form triaxial arrangements in the base and subgrade. Vertical pairs of ϵ mu coils were embedded down to a depth of 1.52 m (5 ft) from the asphalt surface. Previous experiments have shown that, at this depth, the strains are normally small compared to electronic noise.

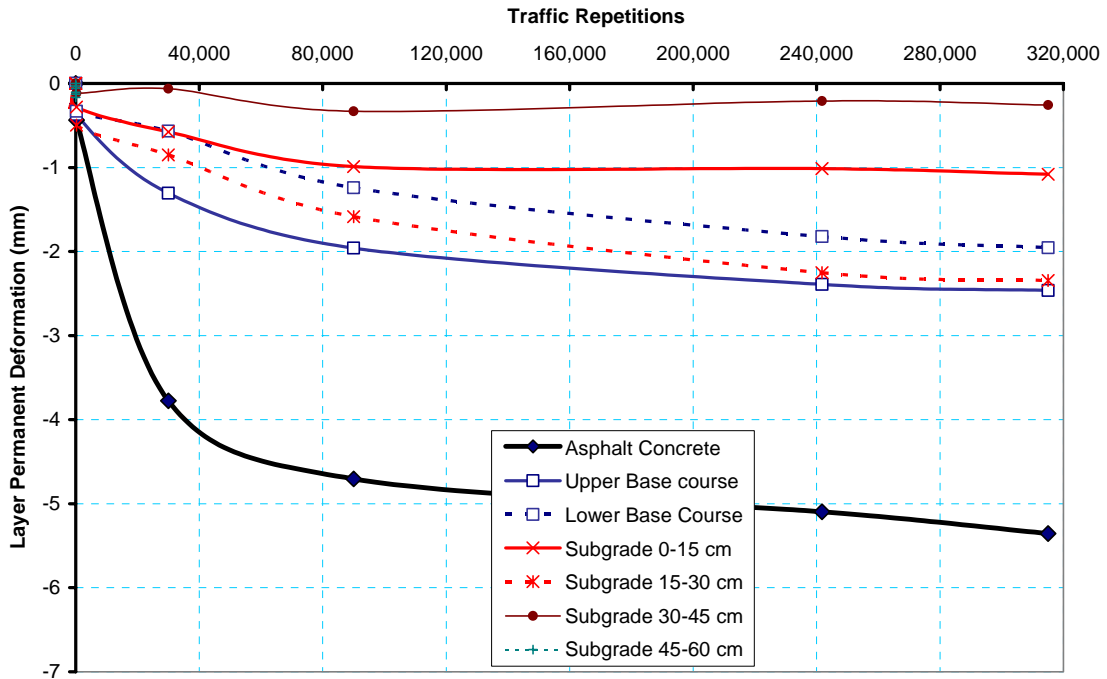
Figure 36a. Layer by layer vertical permanent deformation in Test Window 711c2 with 97.9 kN semi-axial load.

Figure 36b. Layer by layer vertical permanent deformation at failure in Test Window 711c2 with 97.9 kN semi-axial load.

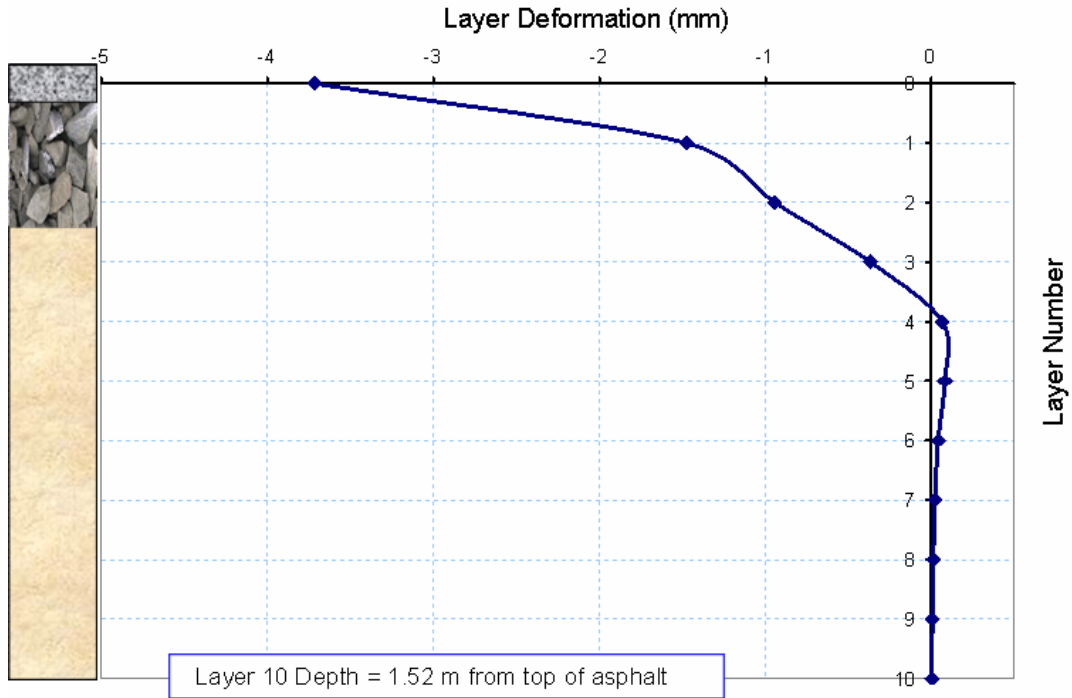
Figure 37a. Layer by layer vertical permanent deformation in Test Window 711c3 with 80 kN semi-axial load.

Figure 37b. Layer by layer vertical permanent deformation at failure in Test Window 711c3 with 53.4 kN semi-axial load.

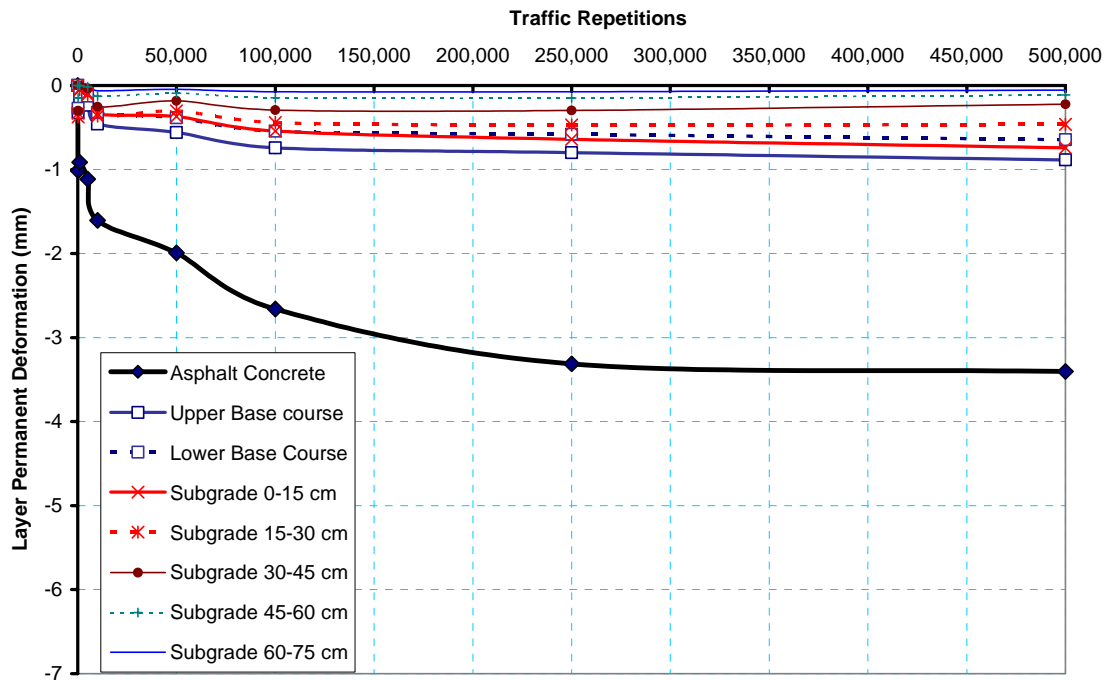
Figure 38a. Layer by layer vertical permanent deformation in Test Window 711c5 with 40 kN semi-axial load.

Figure 38b. Layer by layer vertical permanent deformation at 500,000 traffic repetitions in Test Window 711c5 with 40 kN semi-axial load.

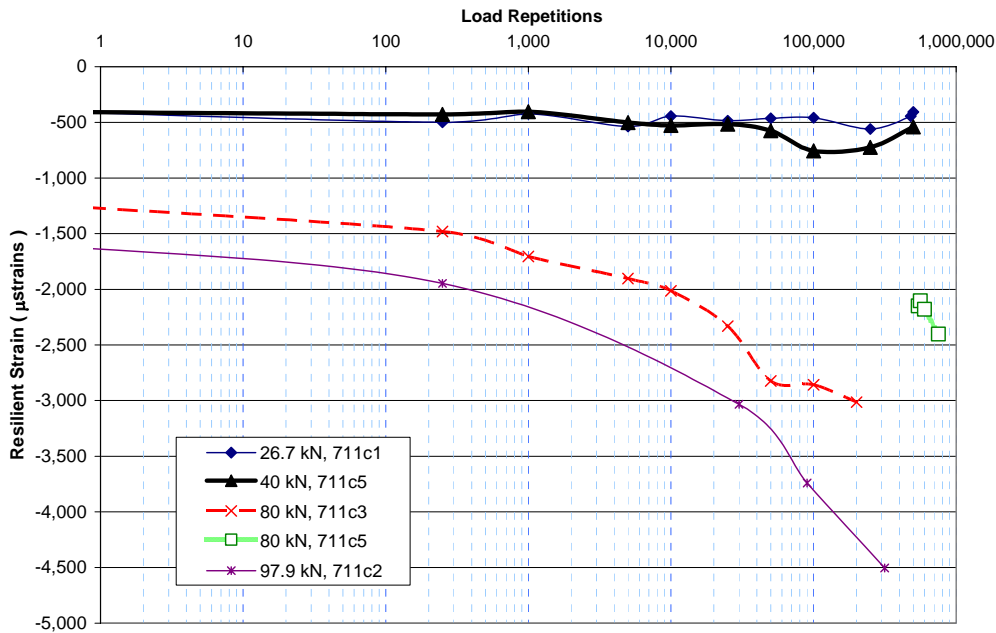
Figure 39. Resilient vertical strains 76 mm (3 in) below the top of subgrade for various semi-axial traffic loads.

In general, resilient deformation and strain increased in proportion to the traffic load intensity. Resilient strains as a function of load repetition at 76 mm (3 in.) below the top of the subgrade are presented in Figure 39. It can be seen that the resilient strains increased with the number of traffic repetitions (strain hardening). This trend was more clearly observed in the test windows with higher load intensities.

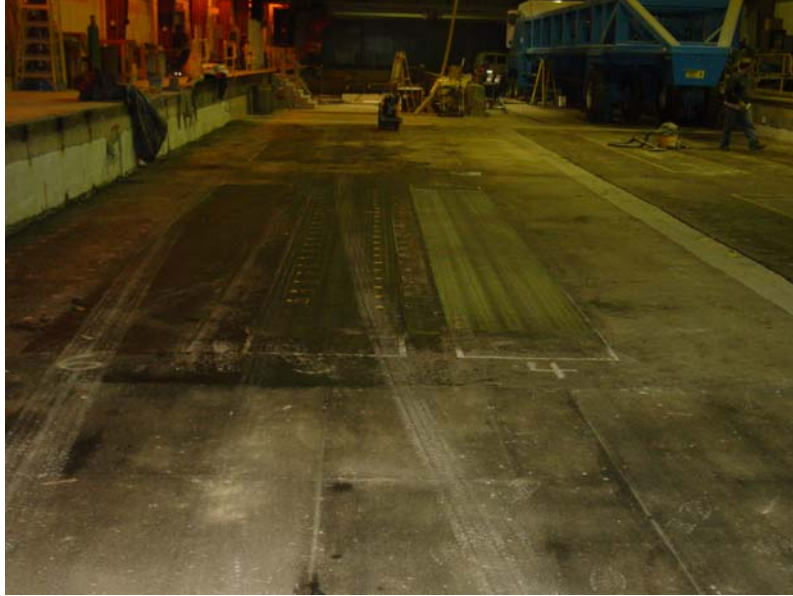
Figure 44. View of test section at the end of traffic tests.

Figure 44 shows a view of the test section at the end of traffic. Except for Test Window 711c6, the only noticeable distress mode in all the test windows was smooth rutting. Test Window 711c6 experienced accelerated rutting at its south end. The asphalt on the sides of the traffic area bulged as shown in Figure 45.

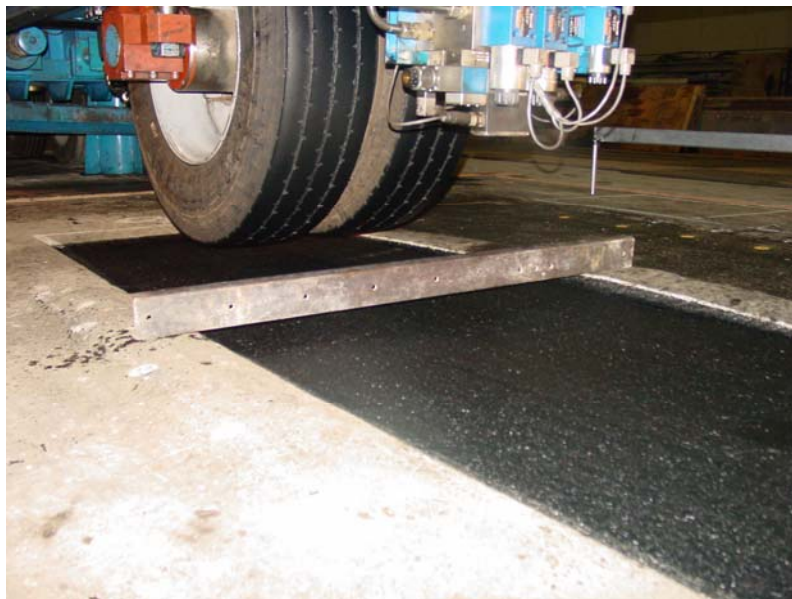
Figure 45. Soft spot and premature rutting in Test Window 711c6.

Test Window 712c6 had the largest deviations from design thickness for both the asphalt and the base layers. This fact must be considered in the data analysis. The irregular thickness may have contributes to a premature failure seen at the pavement surface as localized rutting and bulging of the sides of the traffic area. Rutting was relatively uneven in this test window.

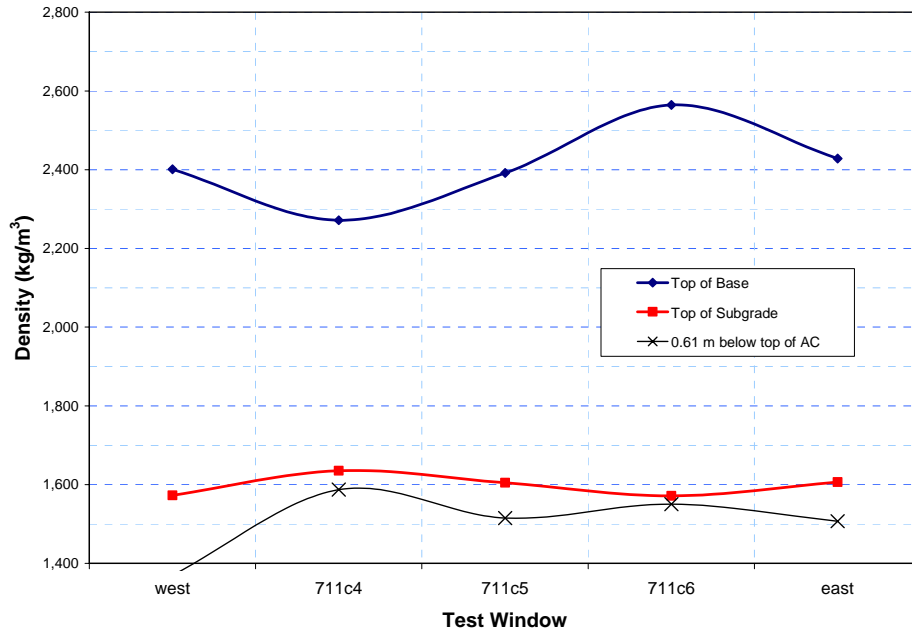
Figure 48. Density measurements in the base and subgrade in the south trench.

Figure 49. Density measurements in the base and subgrade in the north trench.

Moisture and density measurements were conducted inside the trenches in the base course and in the upper subgrade down to a depth of 0.91 m (3 ft.) below the top of the asphalt concrete. Figure 46 and 47 show the gravimetric moisture contents in the south and north trenches respectively. The measured values are consistent with those obtained during the construction, but the moisture content in the zone near the top of the subgrade experienced a drop of 2 to 3 percent in moisture content from the values measured during the construction. Figures 48 and 49 show density measurements for the south and north trenches at each test window and also at locations outside the traffic areas at the east and west sides of the test windows. Most measured values are above 90 percent of modified Proctor density.

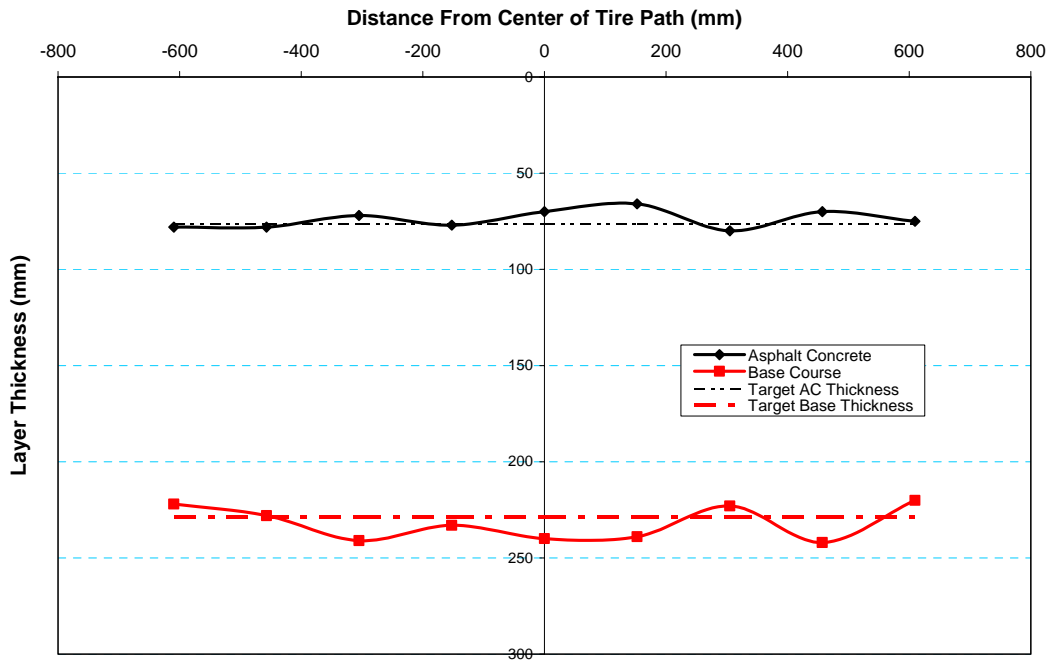
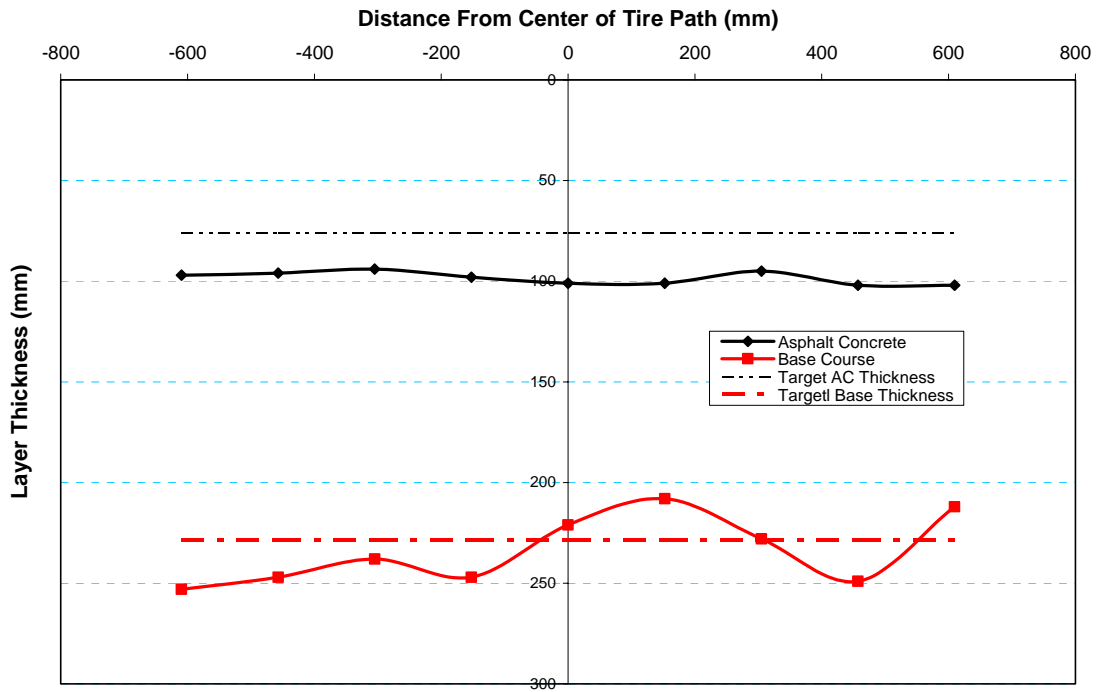
Figure 50. Layer thickness measurements across Test Window C1.

Figure 51. Layer thickness measurements across Test Window C2.

Figure 52. Layer thickness measurements across Test Window C3.

Figure 53. Layer thickness measurements across Test Window C4.

Figure 54. Layer thickness measurements across Test Window C5.

Figure 55. Layer thickness measurements across Test Window C6.
