## PAVEMENT SUBGRADE PERFORMANCE STUDY

### Test Section 708

Subgrade AASHTO soil type A-6 at wet of optimum (19%)

Dr. Vincent Janoo<sup>(1)</sup>  
Mr. Edel Cortez<sup>(1)</sup>

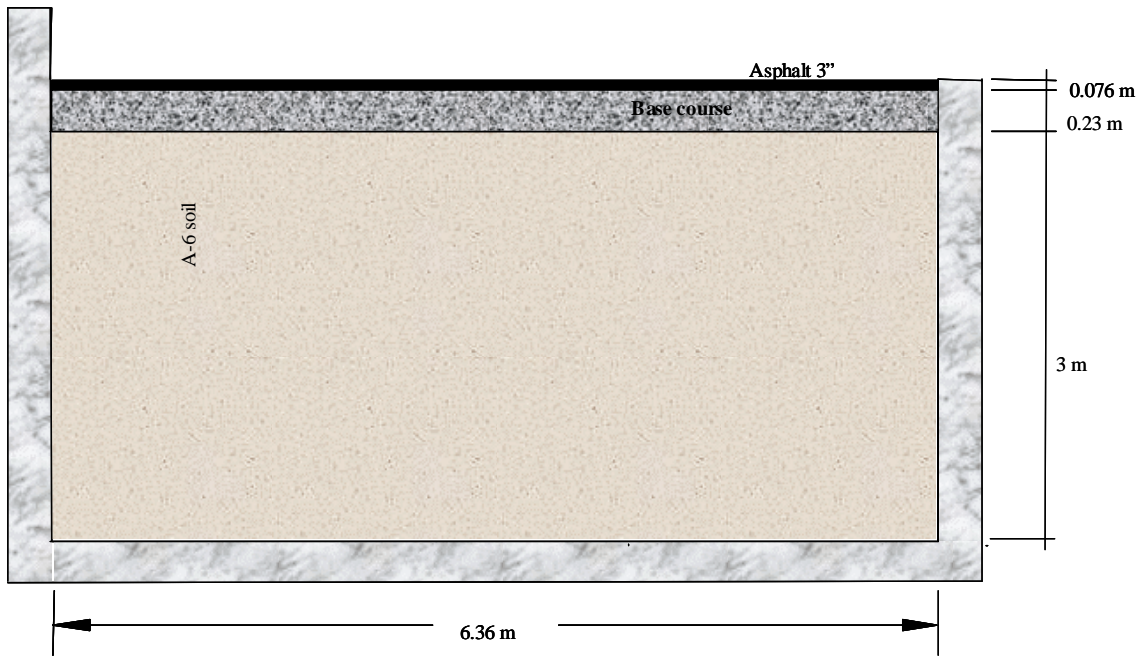
Figure 1. Test section.

The test section (Fig. 1) consists of a 76-mm (3-in.) asphalt concrete (AC) layer, a 229-mm (9-in) crushed gravel base course, and 3 m of AASHTO type A-6 subgrade soil conditioned to a gravimetric moisture content of 19%.

a. Plan view and longitudinal cross section.

b. Transversal cross section.

The test section was divided into six test windows. A test window is the area where traffic is applied. An effective test window was 0.91 m (3 ft) wide by 6.08 m (20 ft) long, excluding acceleration and deceleration areas. The thickness and material properties for all test windows were intended to be constant, but the traffic load was designed to vary for different test windows.

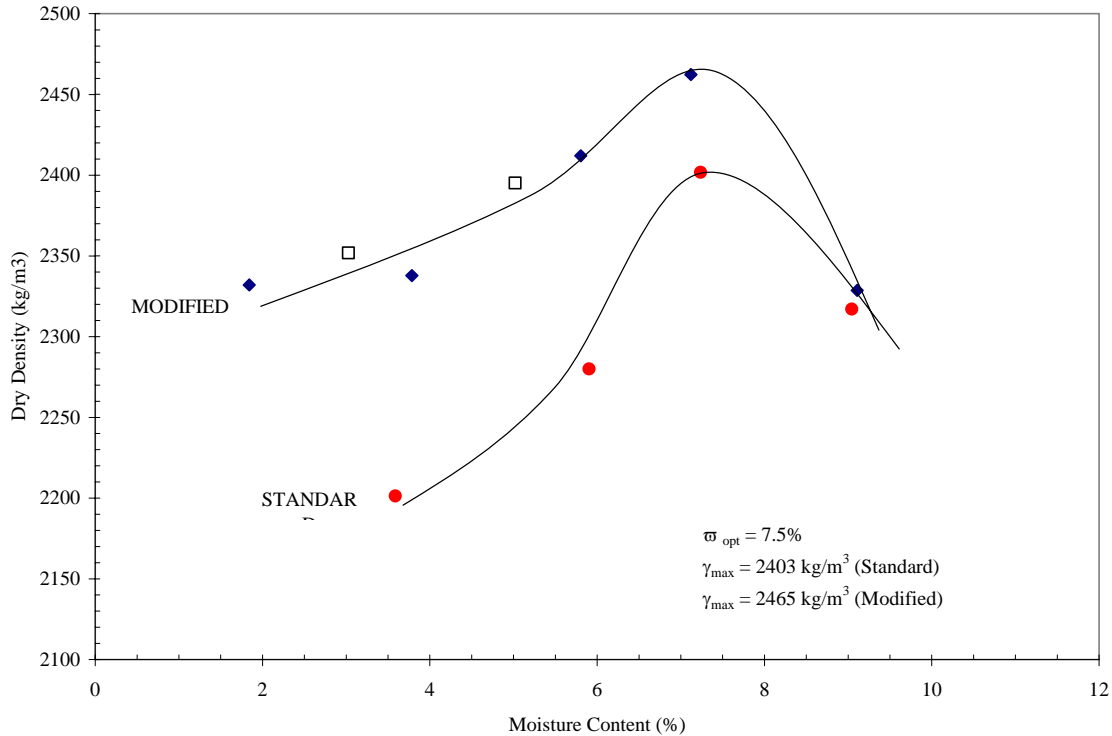
The standard and modified moisture density relationships for the base material are presented in Figure 4 and maximum densities and optimum gravimetric moisture content are 2403 kg/m<sup>3</sup> (150 pcf), 2465 kg/m<sup>3</sup> and 7.5%, respectively.

**Figure 4. Moisture-density relationships for the base course soil.**

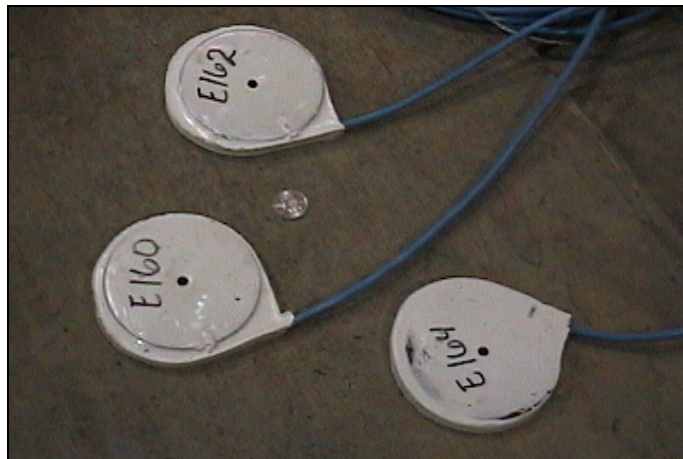
Displacement measurements were made in the base and subgrade by means of  $\epsilon$ mu coils (Fig. 5). Strain can be deduced from displacement between a pair of coils. The sensors were placed 150 mm center to center. Displacements were measured in the longitudinal (x), transverse (y), and vertical (z) direction of loading. Displacements in the vertical direction were measured to a depth of 1.52 m.

Figure 5. Emu coils. A US 25-cent coin is included for scale reference.

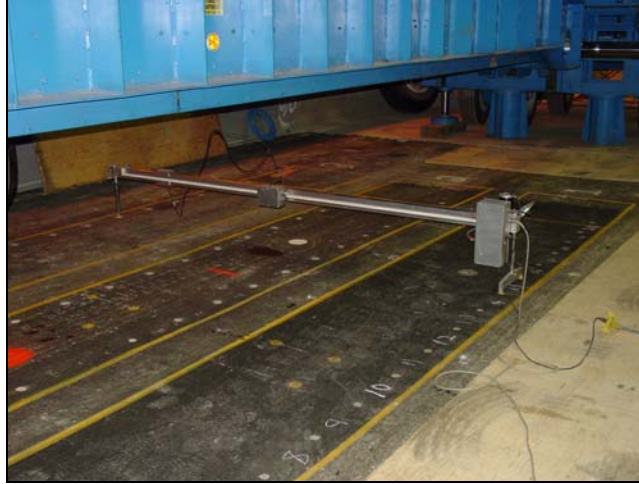
Figure 9. Laser profilometer.

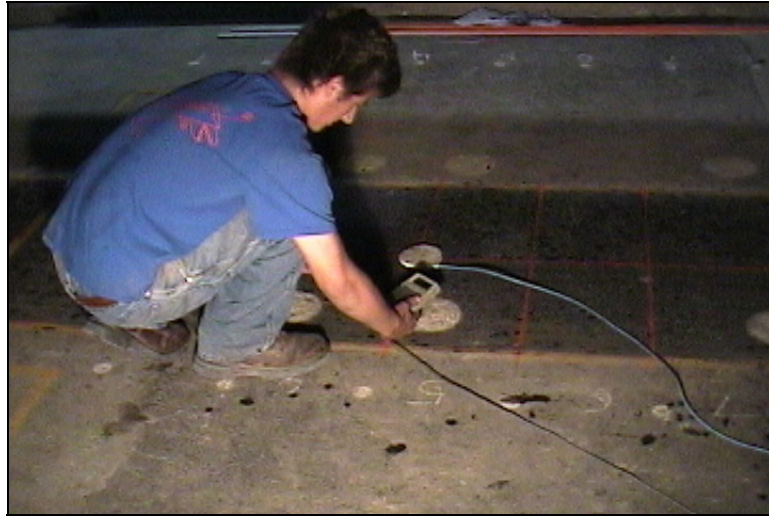
5. At the end of the dynamic stress-strain measurements, permanent deformation measurements were taken using the emu coils (Fig. 12). A loose coil gage on the surface was used to measure the permanent deformation between the AC surface and the first coil in the base course.

Figure 12. Measuring displacement between the AC surface and the top of the base course.

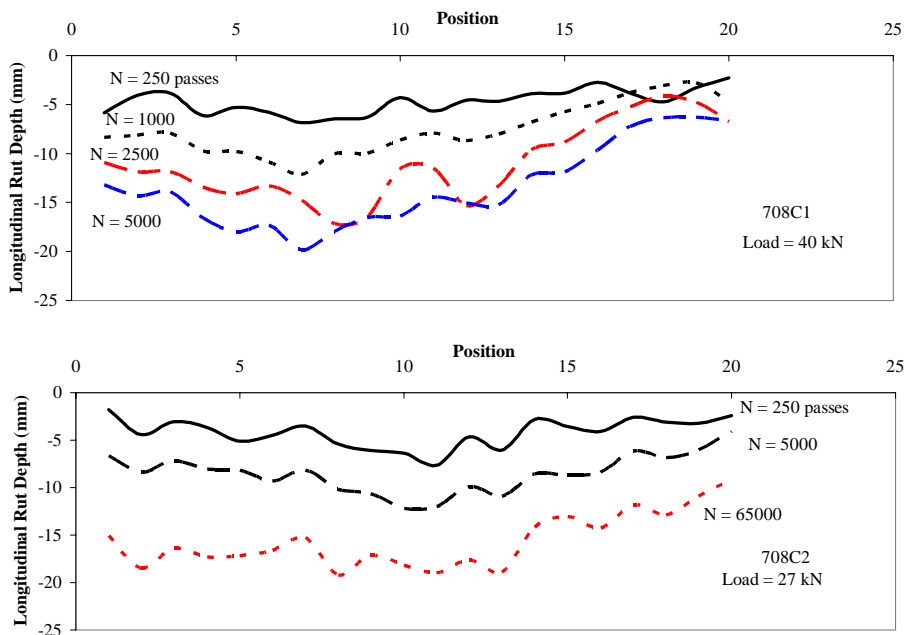
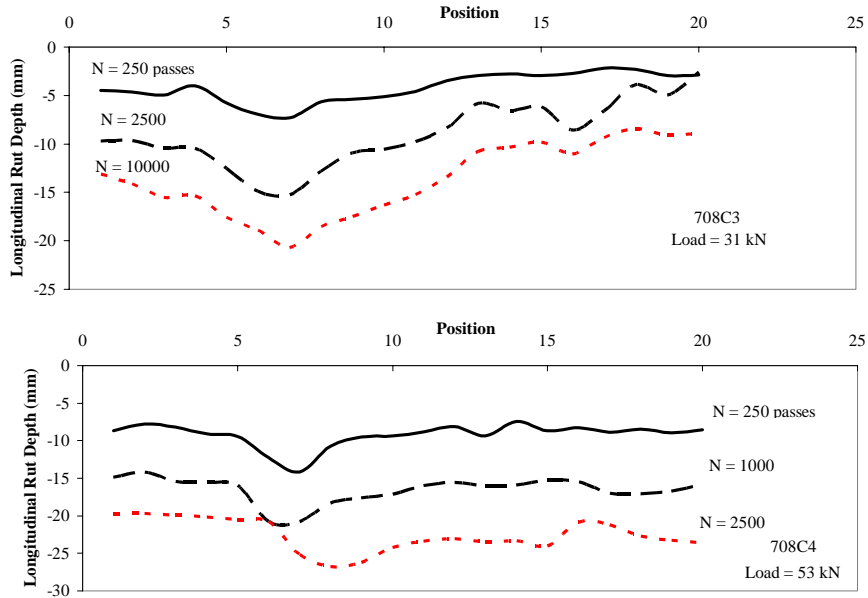
**Figure 13. Longitudinal rut formation.**

The maximum rut depths from transverse profile measurements were used to develop the longitudinal profile. The longitudinal rut depth in various test windows as a function of load repetitions are presented in Figure 13. First, it can be seen that it did not take many passes to exceed a surface rut of 12.5 mm (1/2 in.). Second, the longitudinal ruts are fairly uniform across the test window.

**a. In TS708C1 and TS708C2.**

**b. In TS708C3 and TS708C4.**

**c. In TS708C5 and TS708C6.**

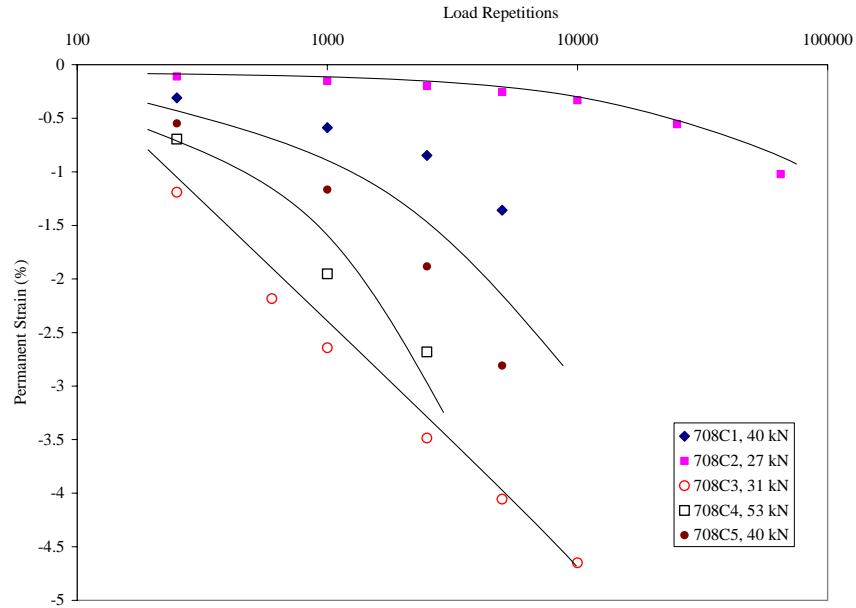
to be correlation between applied load and permanent deformation with the exception of 708C3 and 708C6 (not shown in Fig. 15). Cortez reported that prior to the testing of 708C6, he found that the surface of the pavement showed an upheaval. This he thought was from the rutting in 708C2. A similar situation may have happened to 708C3. Although shown in Figure 15, the permanent deformation in 708C3 and 708C6 were not used in any future analysis. Power curves were fitted to the strain data (combined the results from 708C1 and 708C5) and the results are presented in Figure 16 and in Table 8.

**Figure 15. Permanent strains at 76 mm below the top of subgrade layer.**

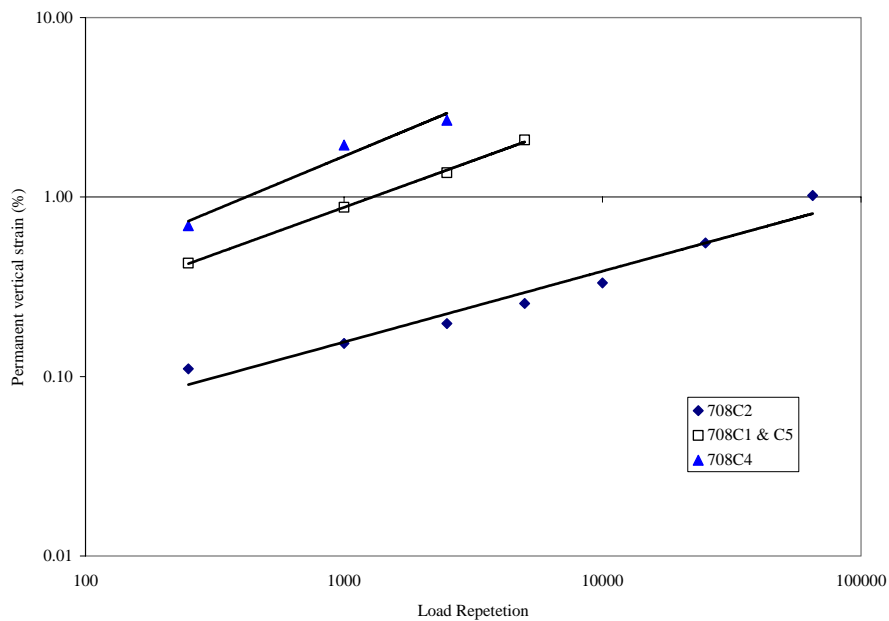
**Figure 16. Permanent strains at 76 mm below the top of subgrade layer as a function of load repetitions**

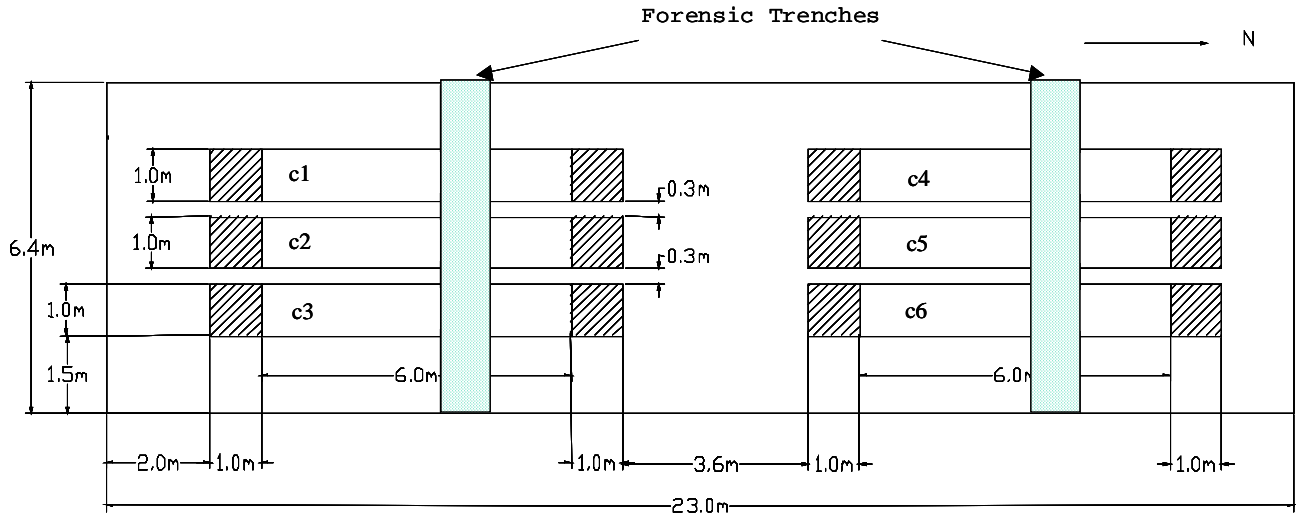
A forensic exploration was conducted to establish the condition of the pavement structure at the end of the traffic tests (Fig. 20 and 21).

Figure 20. Location of the forensic trenches in Test Section 710.

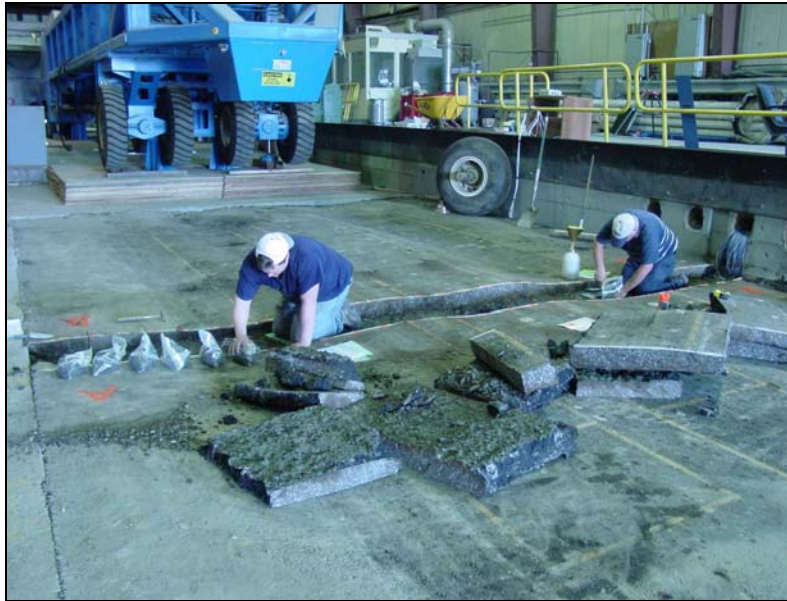
The areas of the trenches were marked with paint over the asphalt pavement. A dry saw was used to neatly cut the asphalt concrete layers so that reliable layer thickness measurements could be made. Rod and level elevation measurements were taken at 0.20-m (8-in.) spacing along the edge of the trenches.

Figure 21. Forensic trench.

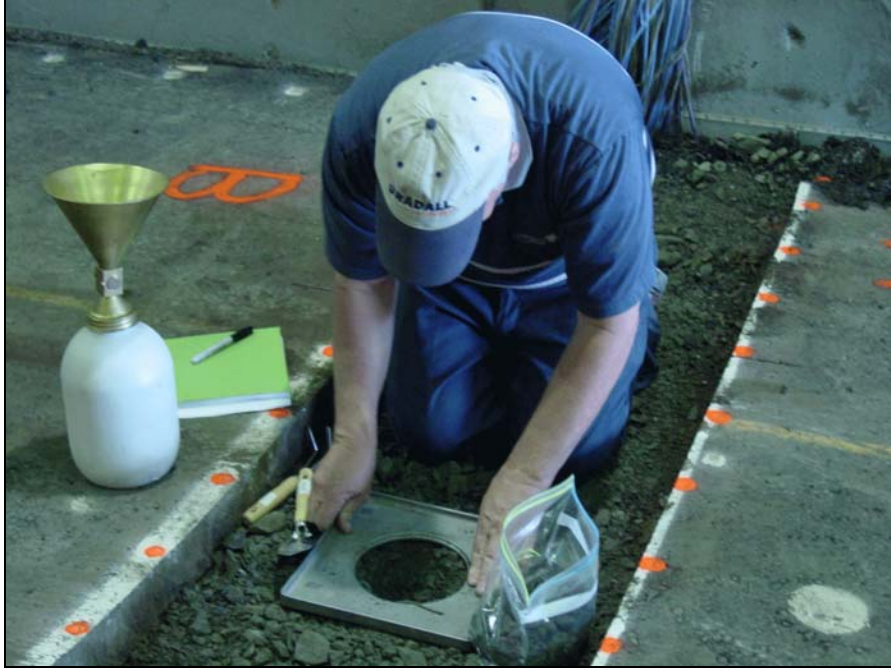
Sand cone measurements were conducted in the base course in the trench areas (Fig. 22–24). One test location represented the center of the tire path for each test window. In addition, sand cone measurements were conducted outside the test windows.

Figure 22. Sand cone density measurements in the base course.

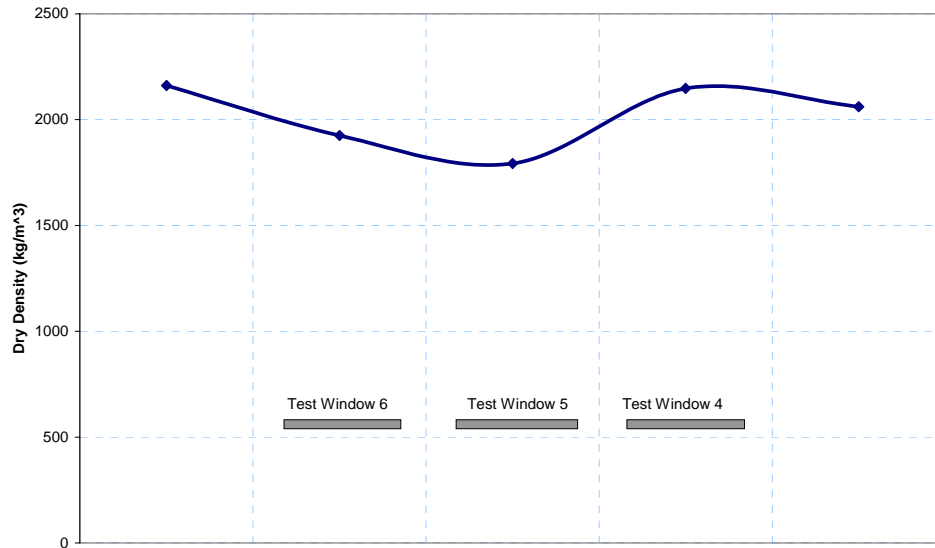
**Figure 24. Base course density measured by the sand cone method in the north trench.**

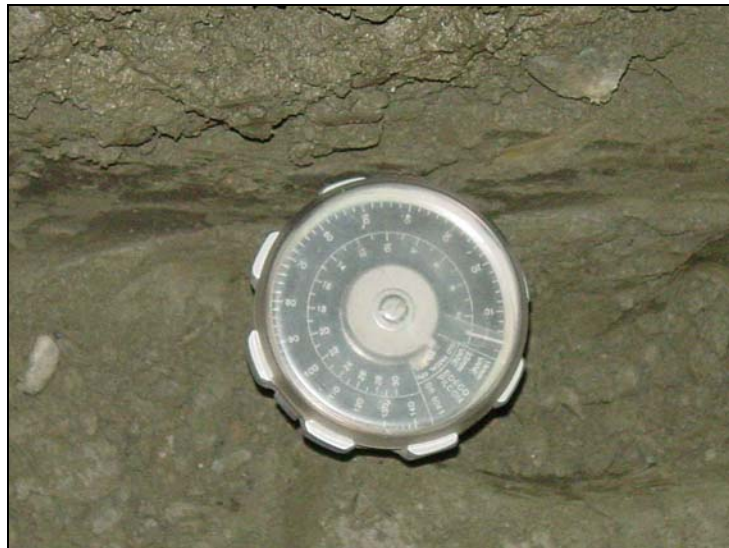
Vane shear tests were conducted at various depths in the subgrade at 33 locations along each trench (Fig. 25–27).

**Figure 25. Vane shear measurement in the subgrade.**

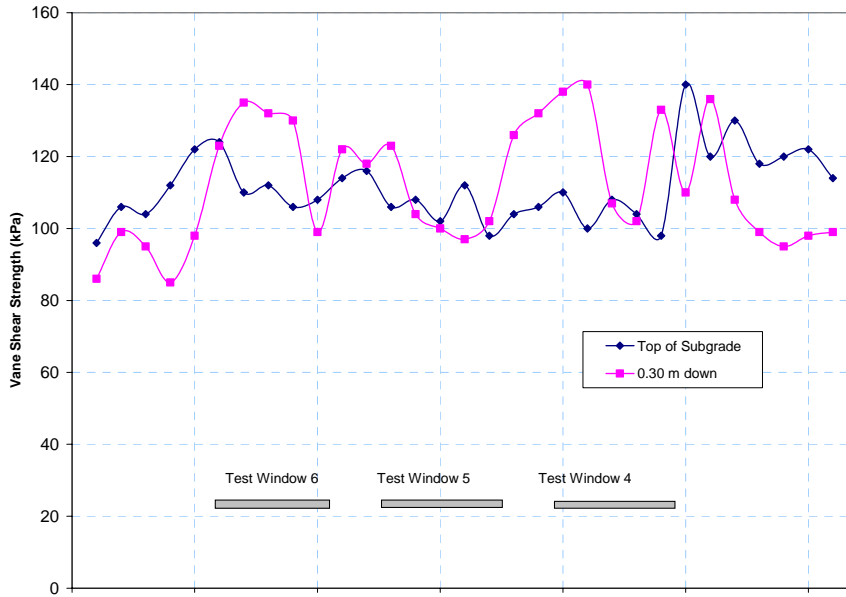
Figure 27. Vane shear strength measurements in the north trench across Test Windows 4, 5, and 6.

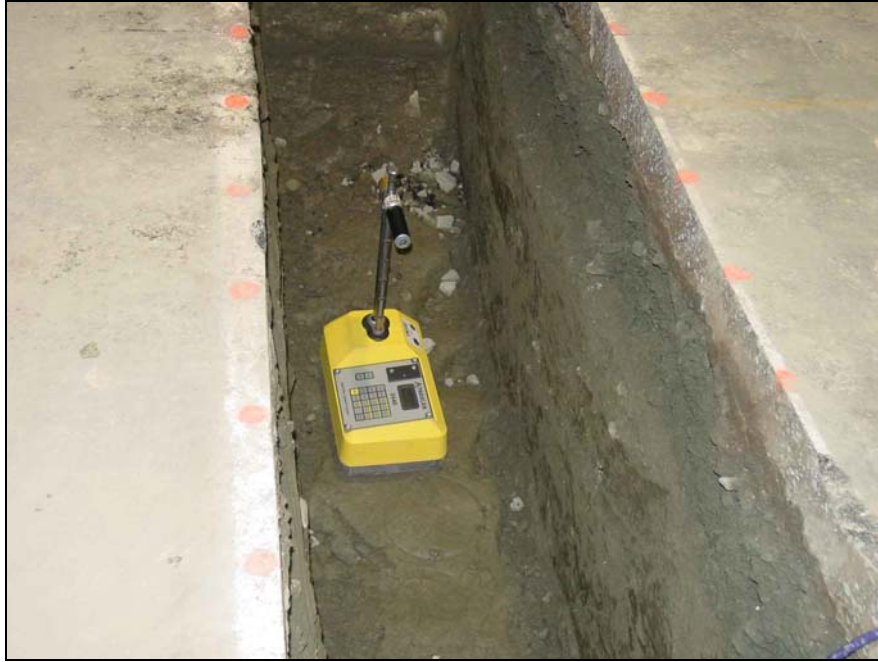
Nuclear moisture and density measurements were taken in the trenches at each layer. The measurements were conducted in the direct mode, i.e., the probe was inserted 0.15 m (6 in.) into the soil. The measurement represents the region of soil between the inserted nuclear source and the receiver in the box of the apparatus. Drive cylinder tests samples

Figure 28. Nuclear gauge density measurement in a trench.

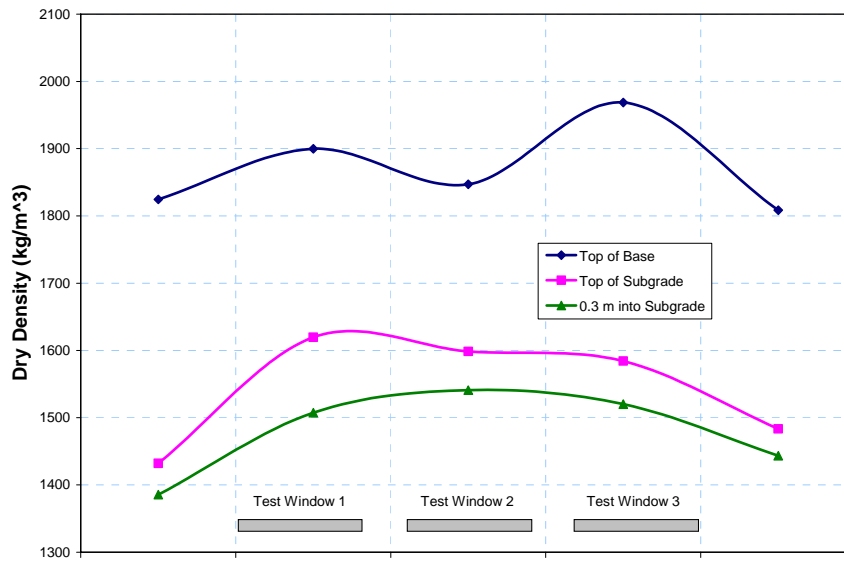
Figure 29. Soil densities in the base course and in the upper subgrade in Test Windows 1, 2, and 3, and at the sides of the test windows.

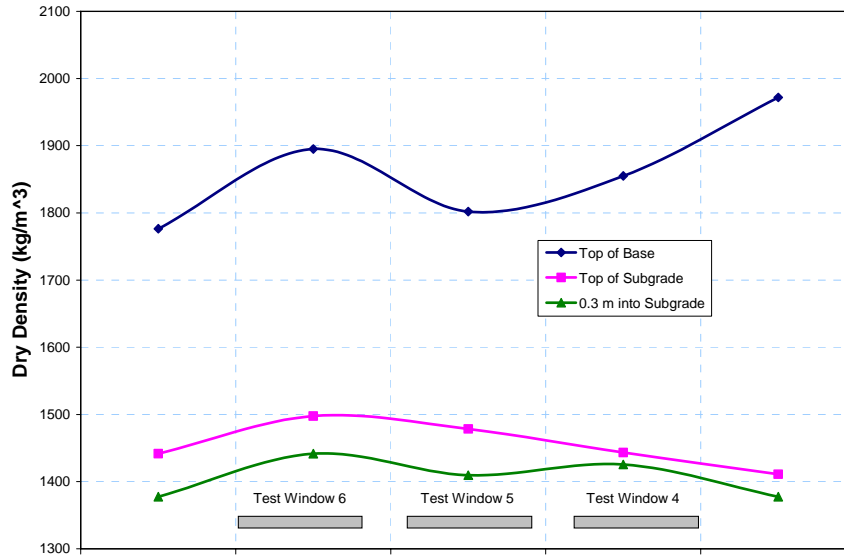
**Figure 30. Soil densities in the base course and in the subgrade in Test Windows 4, 5, and 6, and at the sides of the test windows.**

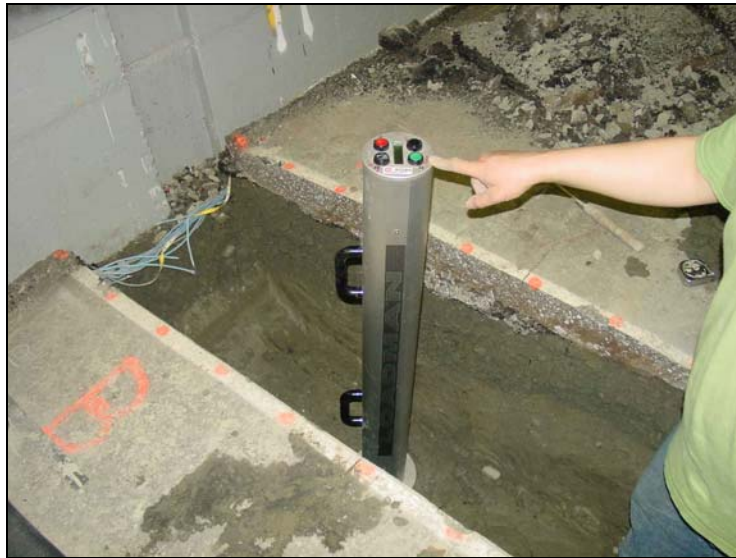
A portable falling weight deflectometer was used to measure the composite soil modulus at various layers in the subgrade at the trenches (Fig. 31–33).

**Figure 31. Portable falling-weight deflectometer measurements in the trenches.**

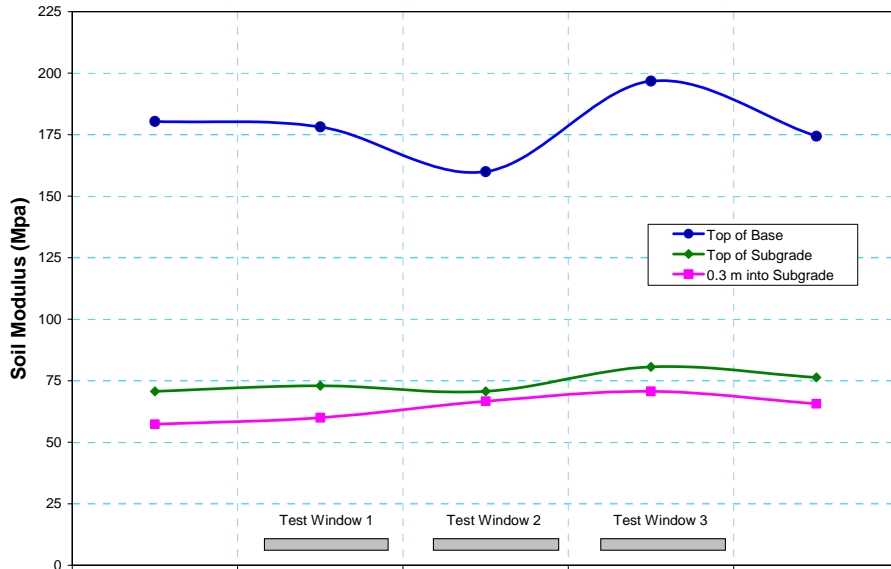
**Figure 32. Soil modulus measured with the portable falling-weight deflectometer in the south trench.**

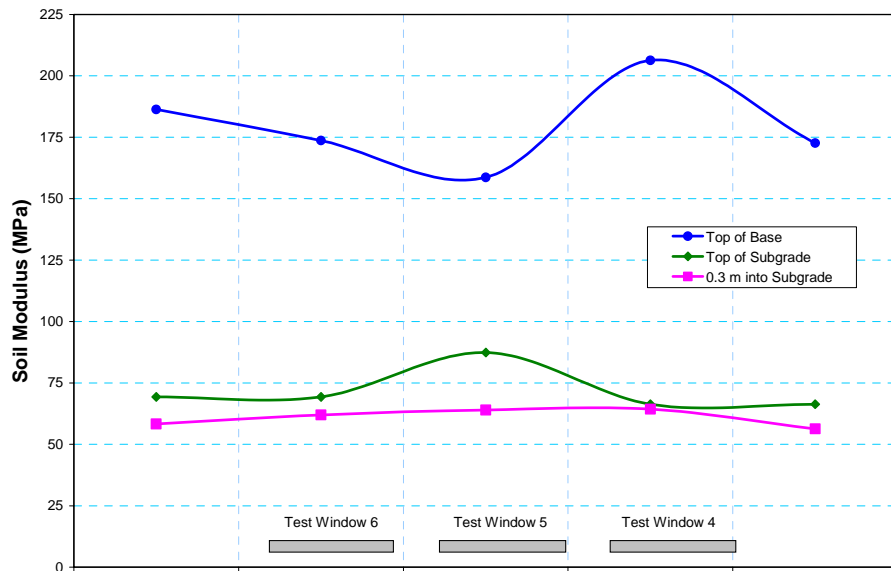
**Figure 33. Soil modulus as measured with the portable falling-weight deflectometer in the north trench.**

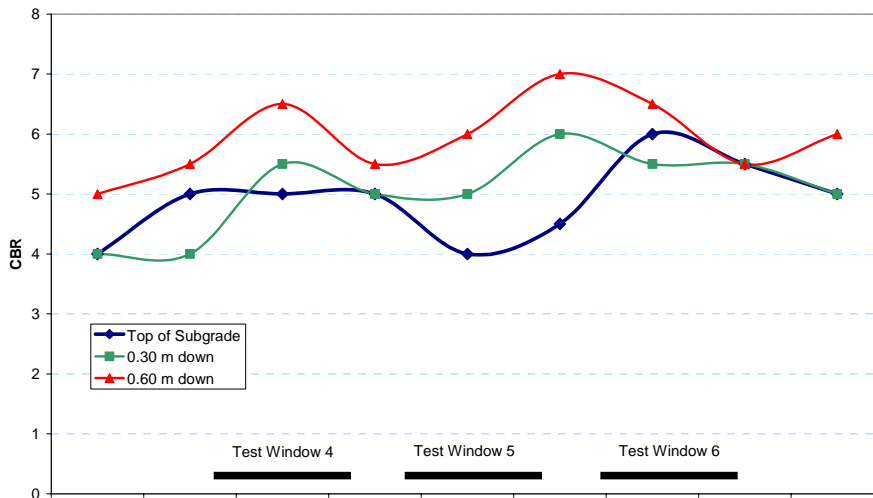
Figure 35. CBR values obtained from DCP measurements in the south trench.

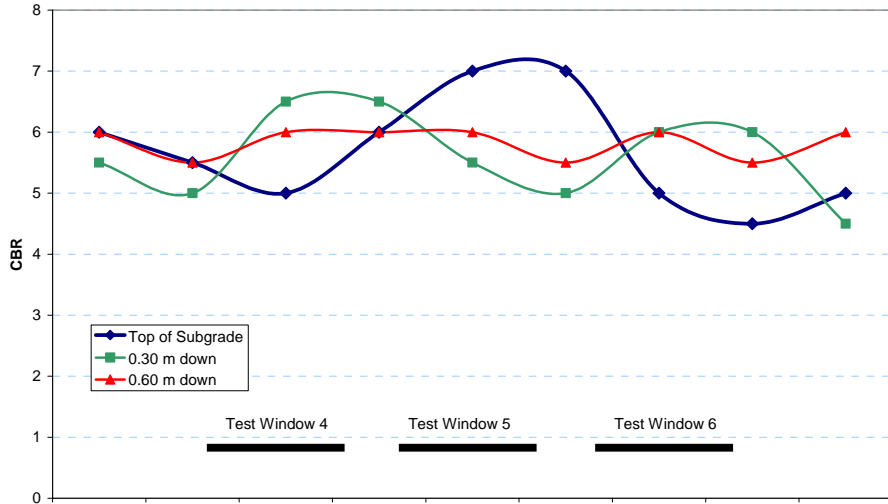
**Figure 36. CBR values obtained from DCP measurements in the north trench.**

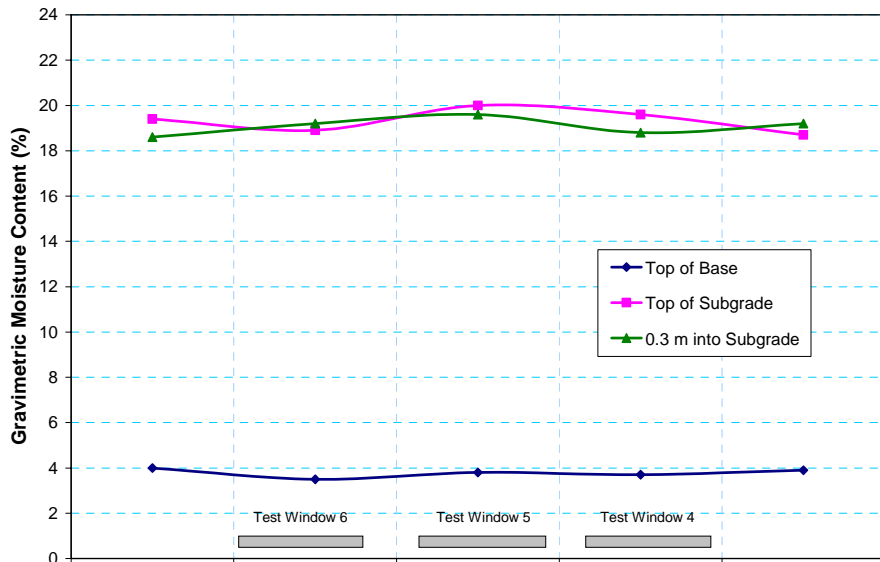
Figure 38. Gravimetric moisture content in the base course and subgrade in the north trench.

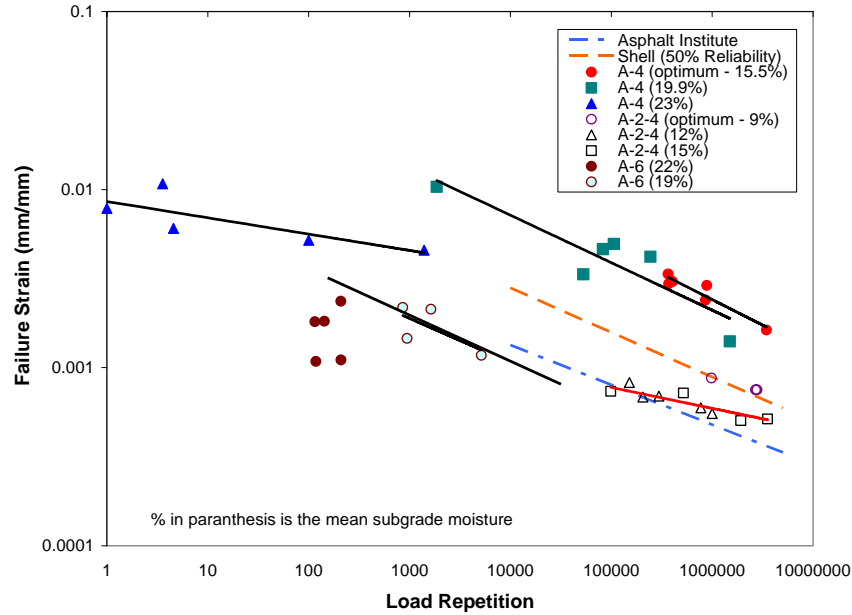
The dynamic strains at failure are compared with the current Asphalt Institute and Shell subgrade failure criterions (Fig. 39). In additions the strains at failure from the other subgrades are shown in Figure 39. Note that these results were measured at 12 km/hr. To be able to compare with the results from the AASHTO Road tests, where the test speed was 48 km/hr, a correction factor was applied to the strain data. The correction factors were developed based on results from MnRoad (Dai and Van Deusen 1998, Janoo et al. 2002). The test results were multiplied by factors of 0.63 and 0.48 for speeds of 48 km/hour (AASHTO Road Test) and 88 km/hour (highway) respectively.

Figure 39. Effect of soil type on the subgrade failure criterion.
