PAVEMENT SUBGRADE PERFORMANCE STUDY

## Test Section 705

Subgrade soil type A-4 at extreme wet of optimum

Edel R. Cortez and Vincent C. Janoo

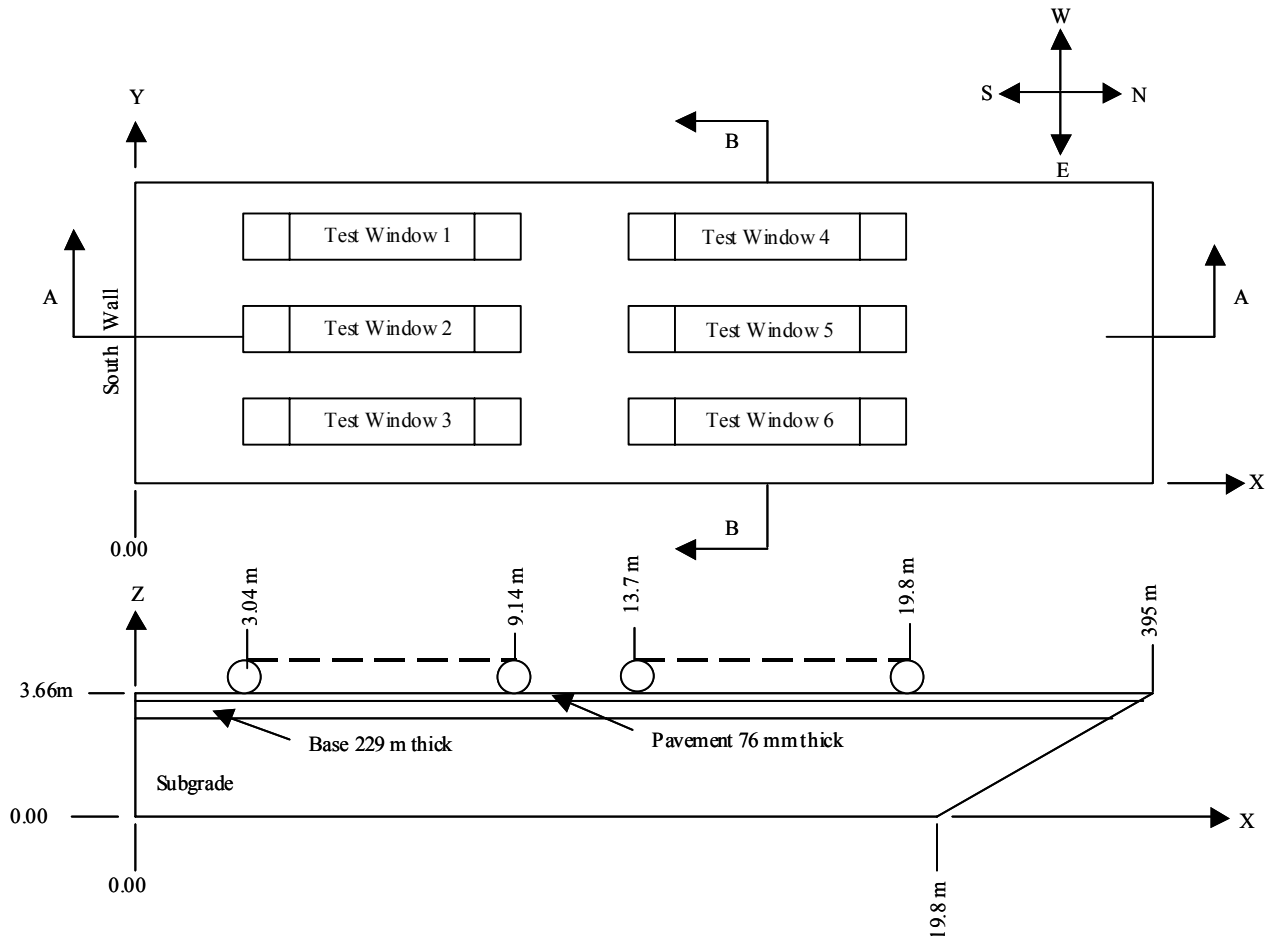
The test section consists of a 76-mm (3 in) asphalt concrete (AC) layer, a 229-mm (9 in) crushed gravel base course, and 3 m of AASHTO A-6 subgrade soil conditioned to a gravimetric moisture content of 23 percent.

Figure 1.a. Plan view and longitudinal cross section of test section.

Each test window was instrumented with embedded sensors to measure in-situ stress, strain, moisture and temperature at various locations within the pavement structure. Dynatest® stress cells were used to measure stress in the subgrade soil. Geokon® stress cells were embedded in the unbound base course. Strain was deducted from displacement measurements obtained by means of emu coil pairs. Vitel Hydra® sensors were used to record volumetric soil moisture content and temperature. Additionally, strings of thermocouples were used to record subgrade temperatures.

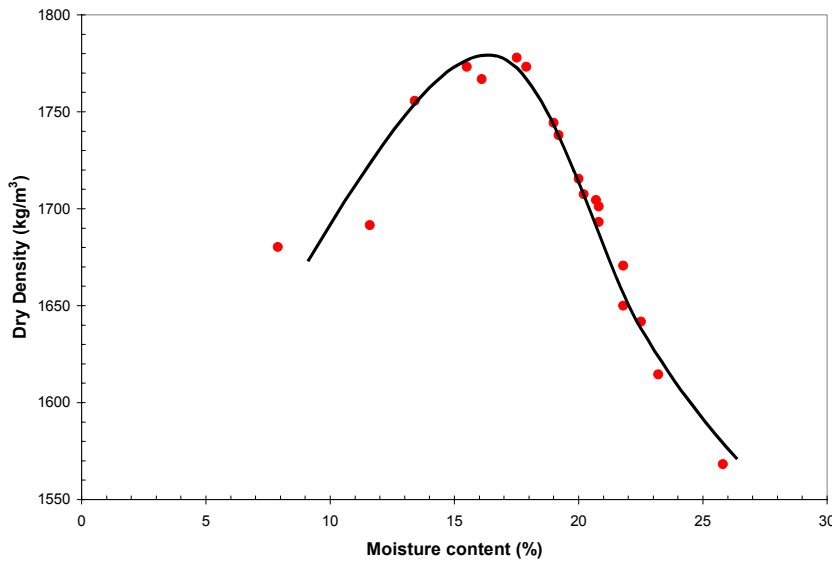
Optimum moisture content and maximum density tests were conducted on the subgrade material in the test section using the AASHTO test procedure, “*The Moisture-Density Relations of Soils Using a 5.5 lb (2.5 kg) Rammer and a 12 in. (305 mm) Drop (T 99-90)*”. Samples were collected from various parts of the stockpile for the test and the results from these tests are shown in Figure 3. The optimum density and moisture content was 1778 kg/cm<sup>3</sup> and 16.5% respectively.

**Figure 3. Moisture-Density relationship for A-4 subgrade soil**

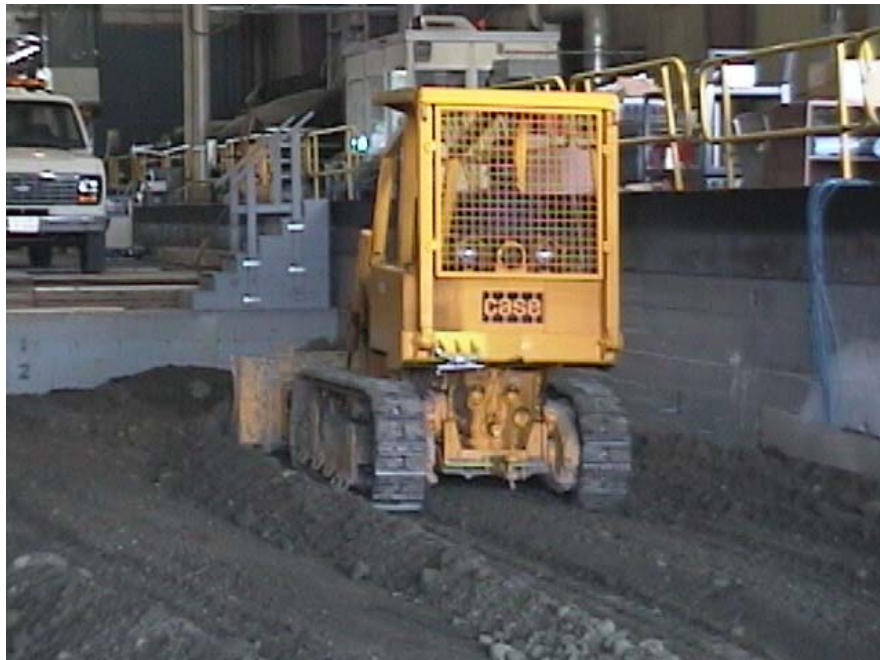
The subgrade material was preprocessed to remove stones and to mix it well in a dry condition. The dry soil was brought into the test basin by means of a front loader. It was spread with a bulldozer in separate layers each about 0.15 m (6 inches) thick. Water was sprinkled onto the soil and sampled periodically. If the moisture content of the subgrade soil was found to be too dry, the soil was roto-tilled, and more water was added. When the target moisture content was achieved, the exiting subgrade surface was roller compacted with two passes of a 10-Ton (9,072-kg) steel roller in static mode.

Figure 5. Bulldozer spreading and grading the subgrade soil.

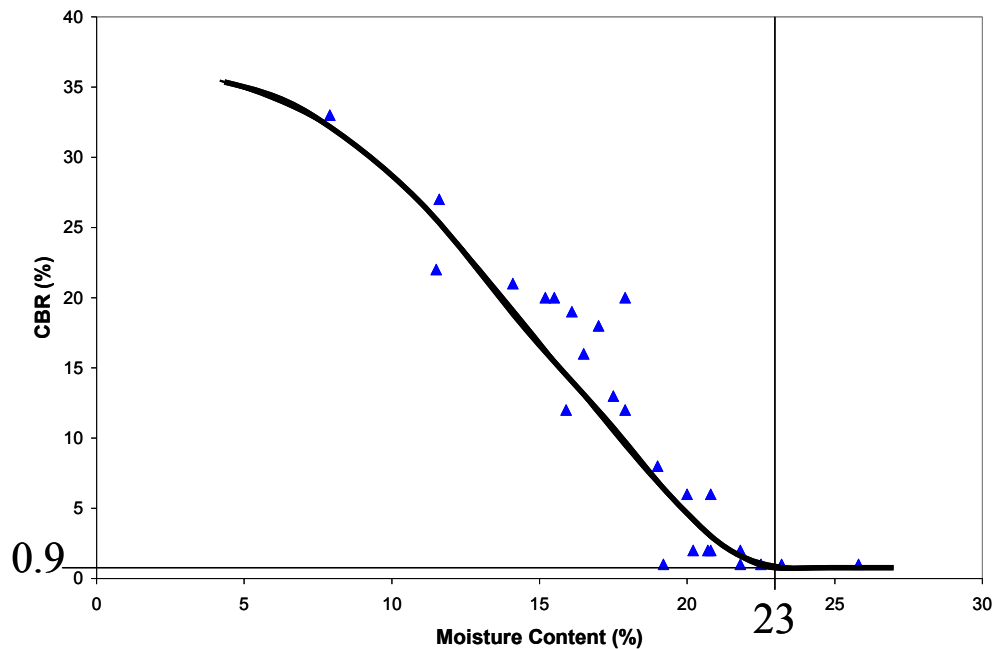
Laboratory CBR tests were conducted to build a correlation between CBR and moisture content for the subgrade soil. This correlation provided a means to indirectly monitor CBR values during construction by monitoring the soil moisture content.

**Figure 6. CBR-moisture correlation for the A-4 test soil.**

The subgrade soil was conditioned to gravimetric moisture content of about 23 percent. For this subgrade soil, this moisture content was as high as it could be built. Figure 6 shows that, for the target moisture content of the subgrade soil, the CBR value is about 1. The constructed subgrade was noticeably soft and it deformed easily under construction traffic.

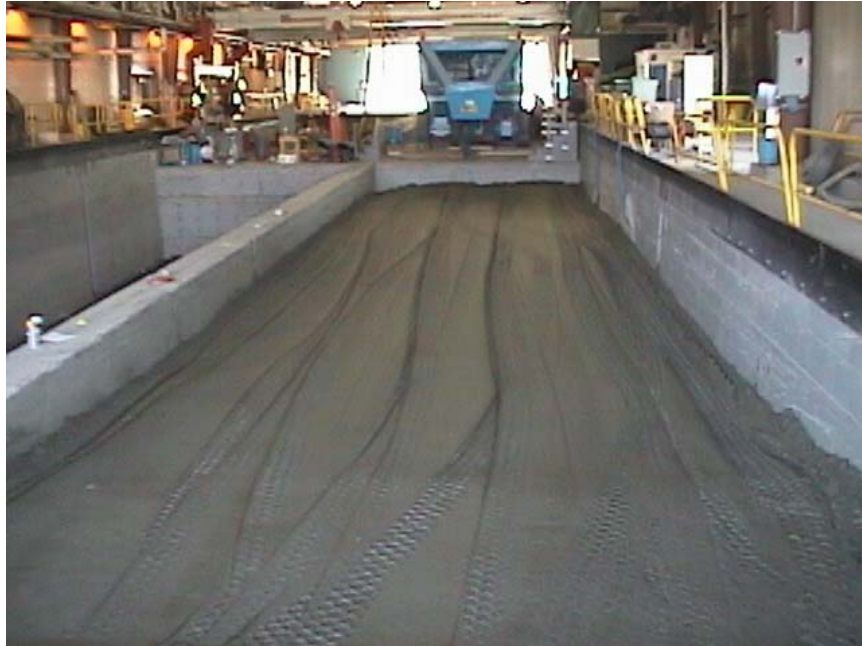
The A-4 subgrade soil at the designed moisture content for this test section was extremely soft. It was difficult to produce a flat finished surface because the construction traffic would easily indent the soil as shown in Figure 7a and 7b. Even after placing and compacting the base course, significant deformations under construction traffic were easily noticeable.

**Figure 7a. Soft subgrade soil surface after rolling.**

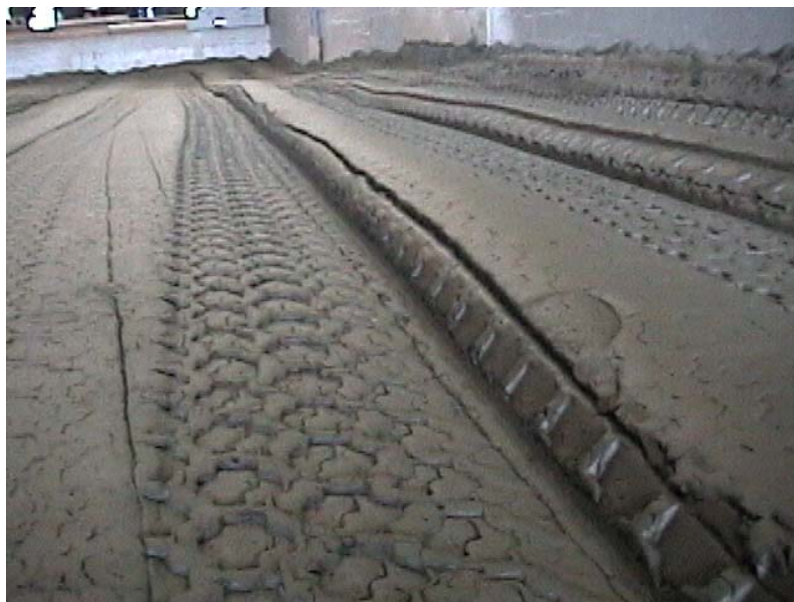
**Figure 7b. Construction equipment tire marks on subgrade soil.**

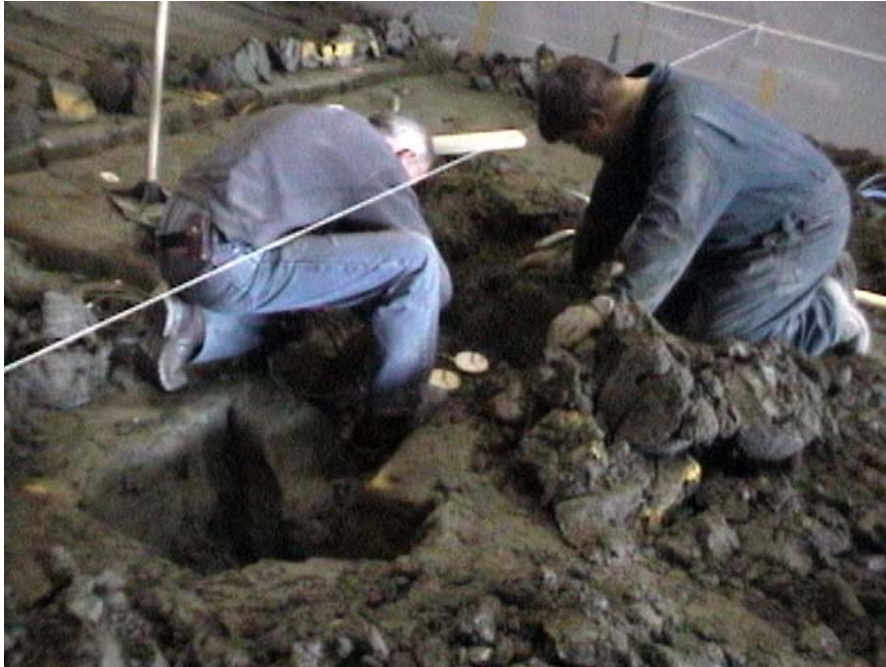
At various depths, sensors were embedded into the soil and wires routed through recorded paths to reach the inlets leading to the instrumentation tunnel.

**Figure 8. Installing sensors into the subgrade.**

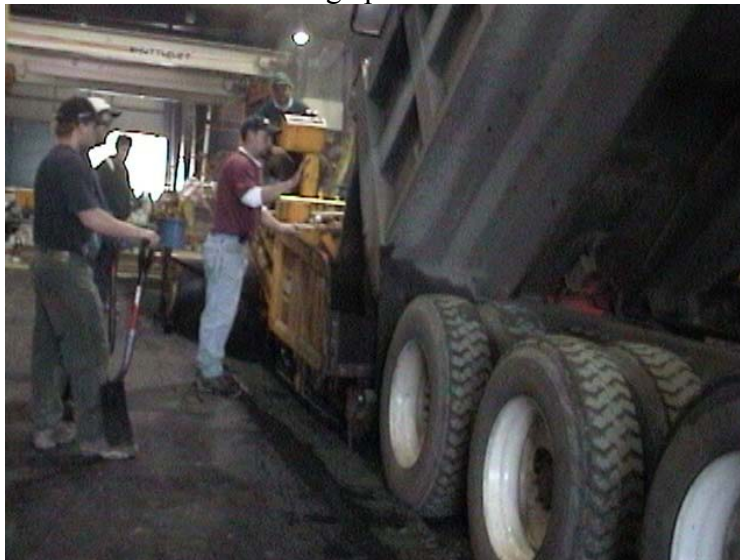
A single layer of asphalt concrete was placed on top of the base course material. The hot mix asphalt (HMA) was produced at a local asphalt plant about 7 miles from the test sections site. The asphalt concrete mix was transported in dump trucks. A Black Knox® paver model PF-400A was used to place the asphalt in a single layer over 2 lanes. A single layer was chosen instead of the traditional 2-layer system to avoid the possibility of interlayer delamination. Recent experience with pavement test sections built with similarly soft soils indicated that a 2-layer asphalt system is prone to delamination and premature asphalt shear failure due to large pavement deflections.

**Figure 9. Construction loads caused significant ruts during the asphalt paving operation.**

The soft subgrade soil impacted the stability of the base course. The paver tracks and the dump truck tires caused the development of ruts on top of the base course. These ruts were filled with asphalt concrete during paving. This resulted in large variations of the asphalt layer thickness. From the records of the total volume of asphalt concrete transported into the test sections, it could be established that the average thickness of the asphalt layer was 100 mm (3.9 inches). The planned thickness was 76 mm (3 inches).

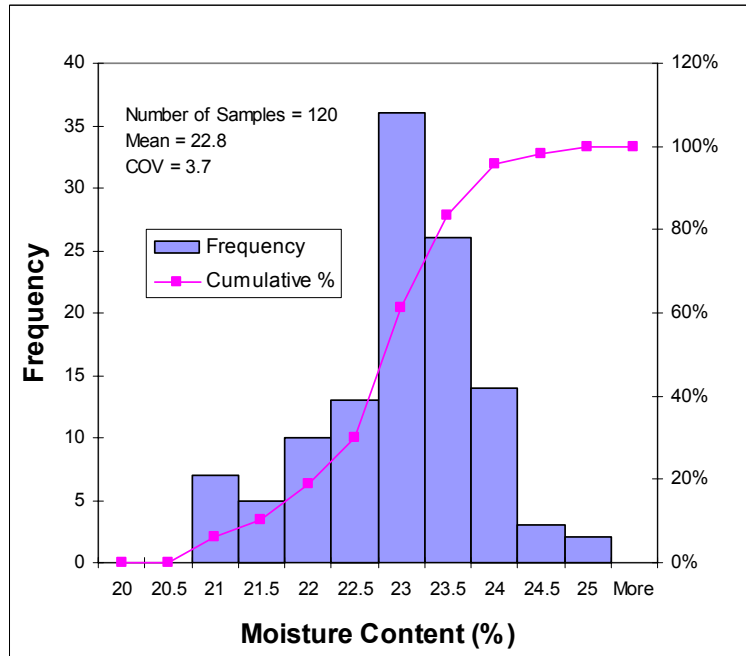
In addition to the nuclear moisture and density tests, oven dry verifications were conducted. Figure 12a shows a histogram of 120 moisture content measurements conducted at various locations within the subgrade. Figure 12b shows a histogram of 18 oven dry verifications.

Figure 12a. Histogram of gravimetric subgrade soil moisture measurements by means of a nuclear gage.

The average moisture content of the subgrade soil during construction was 23 percent. At this moisture content, the soil was very soft. When construction traffic was applied, the soil yielded in a visco-plastic manner. Significant ruts developed on the base course.

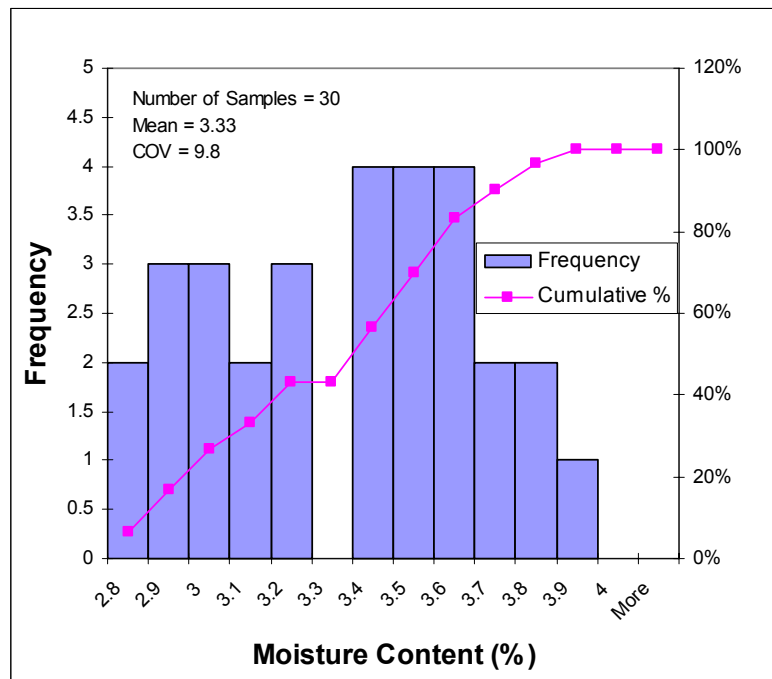
Nuclear gage moisture and density measurements were taken at 30 locations on the base course. The test locations are the shown in Figure 11. A histogram of the test results is presented in Figure 13. The mean moisture content in the base course obtained with the nuclear gauge coincided with the optimum moisture content established through oven dry laboratory tests, i.e., 3.3 percent. However, the dispersion of the data was larger with the nuclear gauge. This data dispersion is typical of nuclear gage measurements on granular materials.

**Figure 13. Histogram of gravimetric moisture measurements on the base course by means of a nuclear gage.**

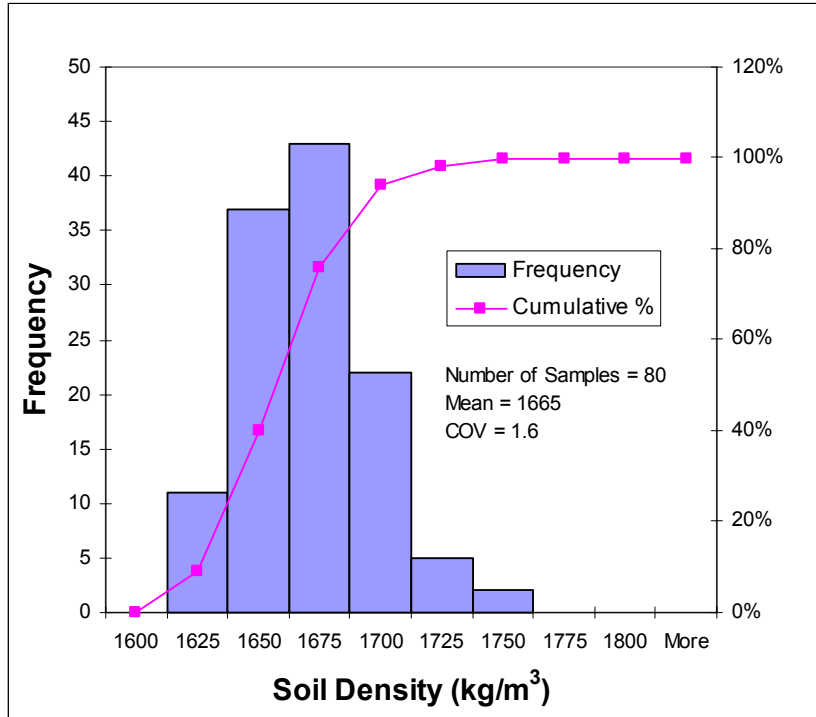
Density tests were conducted in the subgrade soil and on the base course using a nuclear gage. For the subgrade layers, the direct method was used, i.e, the radioactive source inserted into the soil about 0.15 m. For the base course, the backscattered method was followed.

Figure 14. Subgrade soil density measurements at 120 locations.

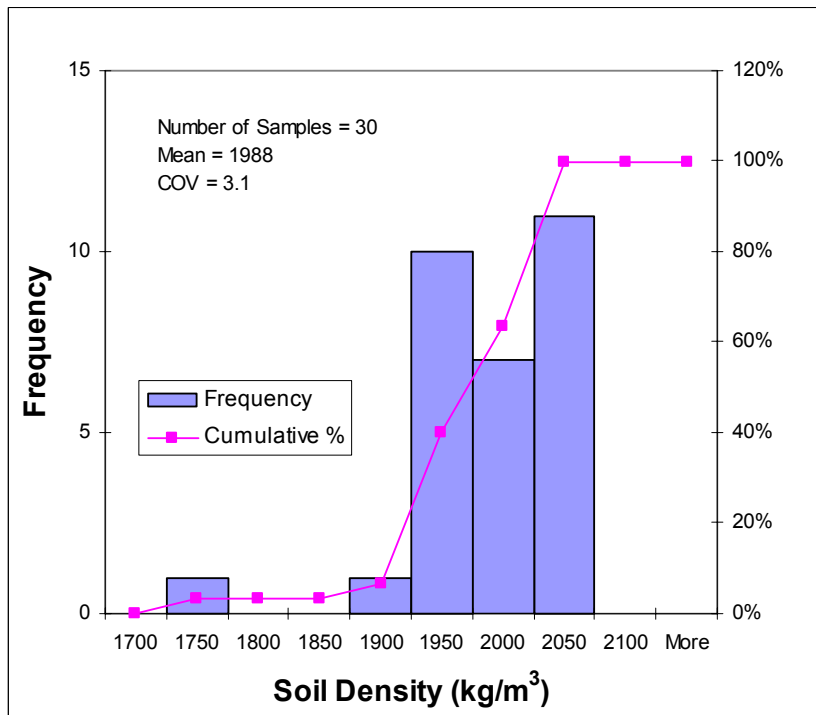
Figure 15. Base course density measurements at 30 locations.

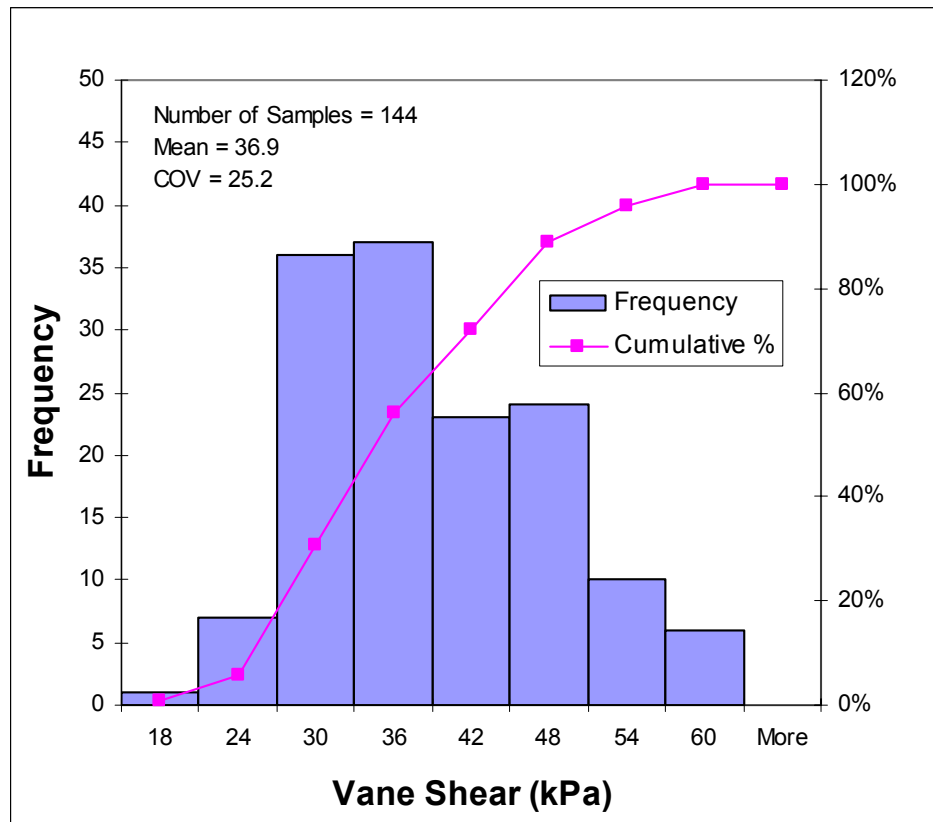
Vane shear tests were conducted at 36 locations at the top of the subgrade and at depths 0.08 m, 0.39 m, 0.69 m and 0.99 m from the top of the subgrade. This resulted in 144 measurements. Figure 16 shows the location of the shear tests on a soil layer. Figure 17 presents a histogram of the Vane shear readings at all 144 test points.

**Figure 17. Histogram of Vane shear measurements in the subgrade.**

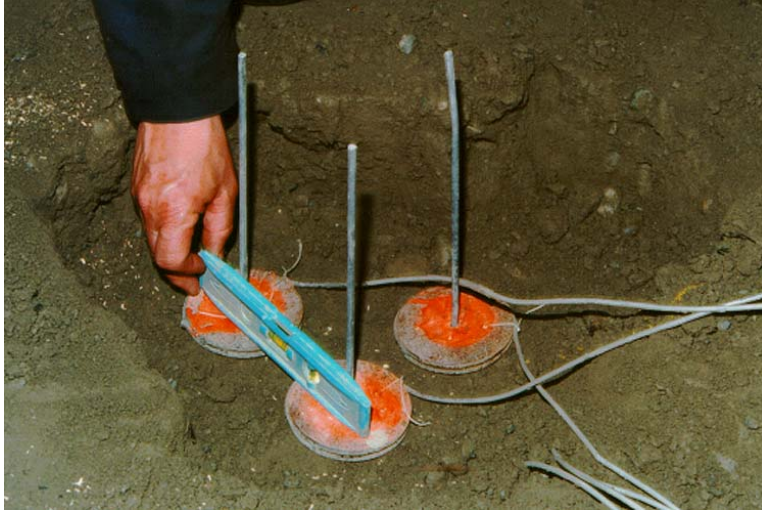
$\epsilon$ mu coils were installed to measure deformation between pairs of coils. This enables calculation of the strains in the vertical (z), longitudinal (x), and transverse (y) directions at various locations within the pavement structure. Figure 18 shows a set of  $\epsilon$ mu coils that enables triaxial measurements. Each  $\epsilon$ mu coil is 100 mm in diameter. During measurements,  $\epsilon$ mu coils work in pairs: one transmitter and one receiver. Their transmit-receive function can be alternated. The timing and order of measurement of each pair must be carefully designed to avoid interference among coil pairs.

**Figure 18. Emu coils**

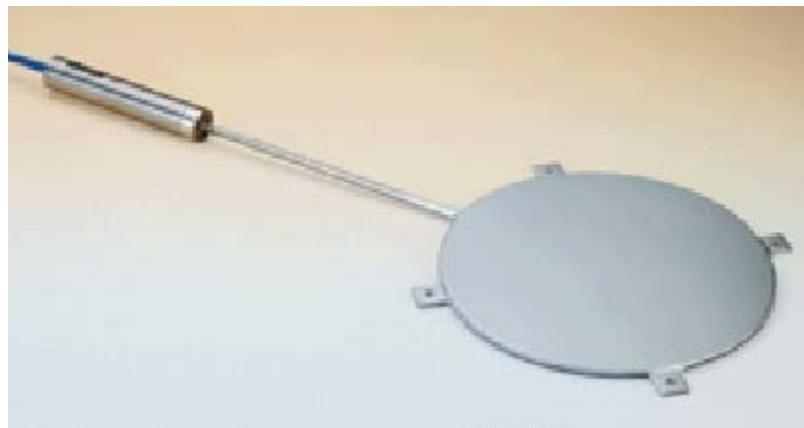
**Figure 20. Geokon® stress cell.**

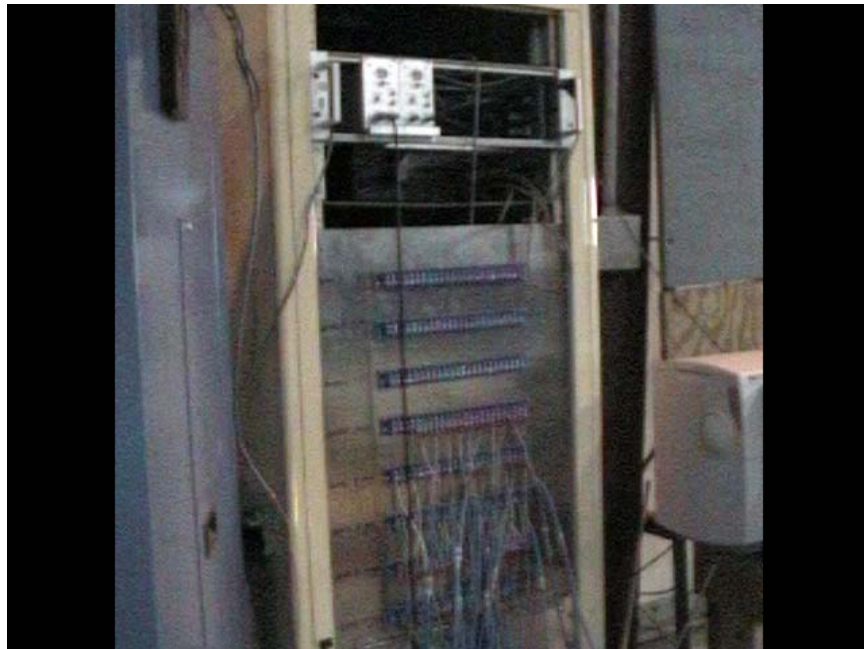
The primary data acquisition system for this experiment was engineering specifically for this project because no suitable system was commercially available. This system was used to measure the response of stress and strain sensors. In order to avoid interference, the  $\epsilon$ mu coil pairs had to be read at different times than their neighboring sensors. The data acquisition system includes a set of relays to time the various measurements.

Figure 22.  $\epsilon$ mu relays and custom-made electronic hardware.

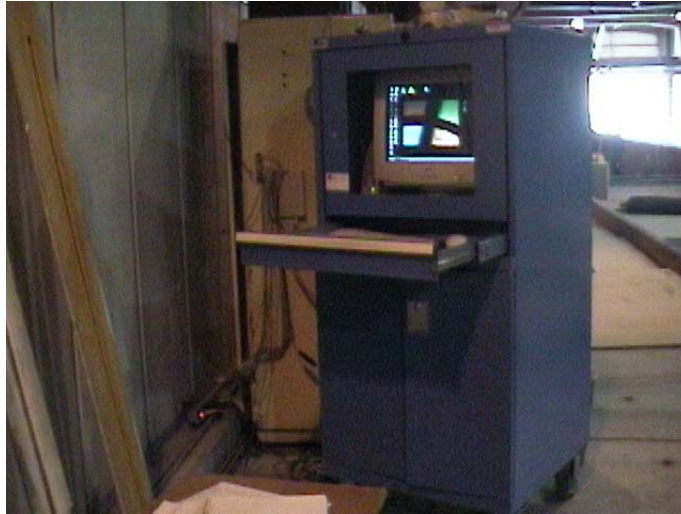
The primary data acquisition system was controlled by a dedicated personal computer that also stored the data. A computer program written in LabView® language was developed specially for the current instrumentation.

**Figure 23. Computer that controlled the primary data acquisition system.**

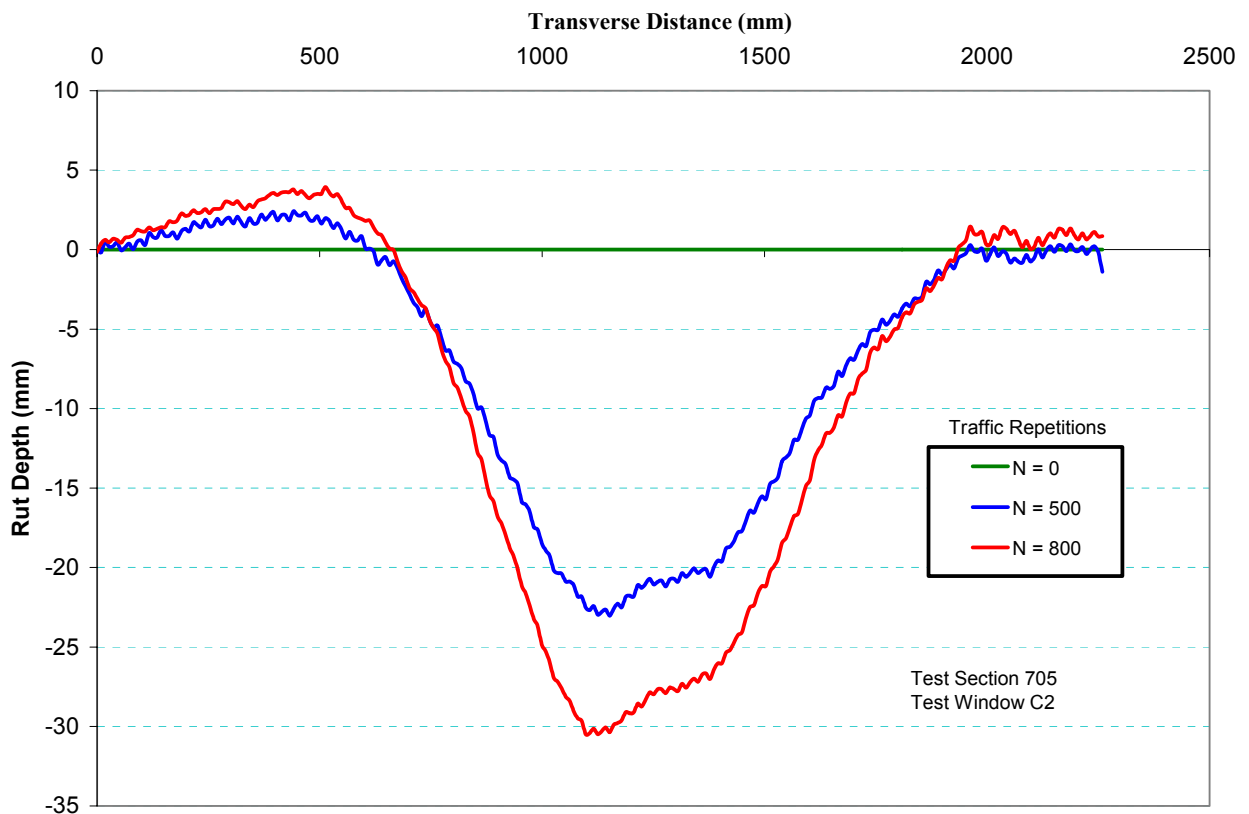
The maximum rut depths from transverse profile measurements were used to develop the longitudinal profile. The longitudinal rut depth in various test windows as a function of load repetitions are presented in Figures 31 to 33. The ruts developed in this test section were quite irregular. Very large deformations occurred quickly upon application of traffic loads.

Figure 30. Typical transverse rut measurements in test section.

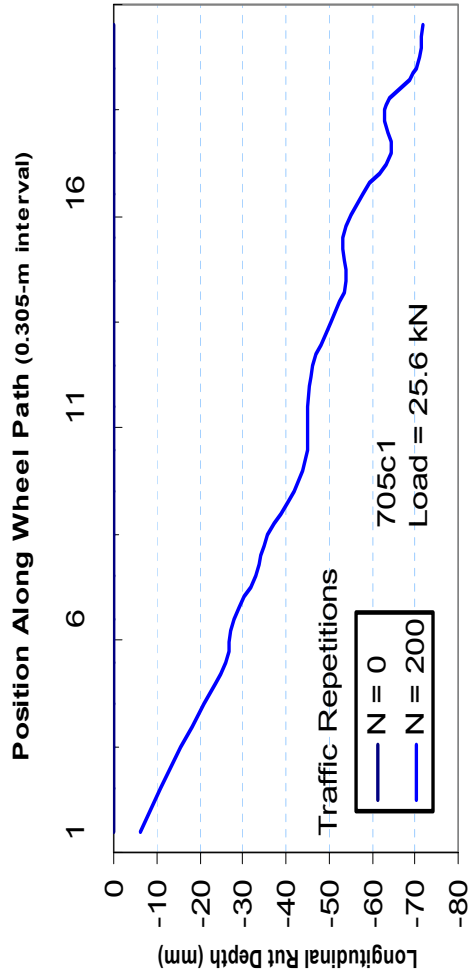
Figure 31. Longitudinal rut formation in TS705C1 and TS705C2

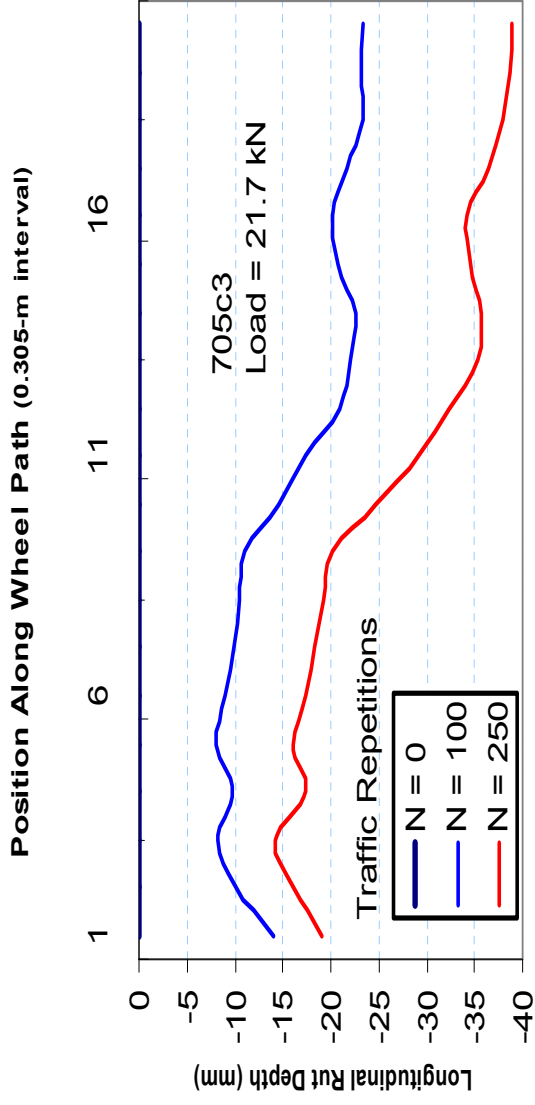
Figure 32. Longitudinal rut formation in TS705C3 and TS705C4.

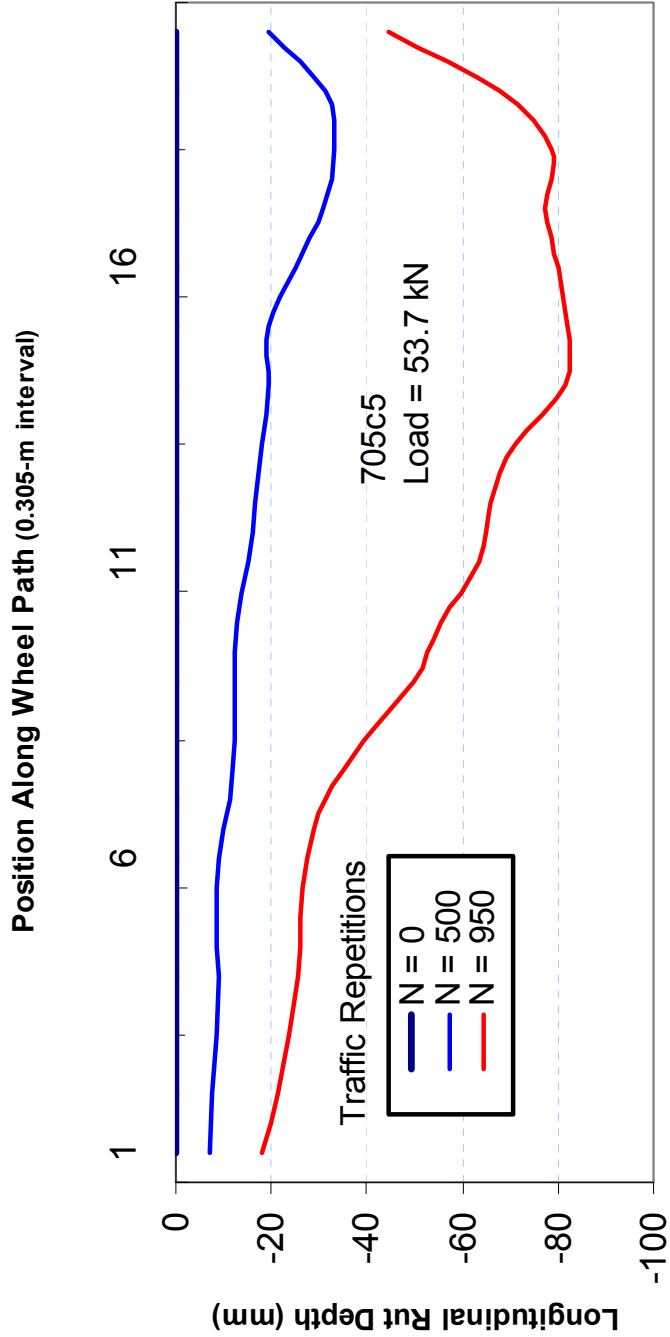
Figure 33. Longitudinal rut formation in TS704C5.

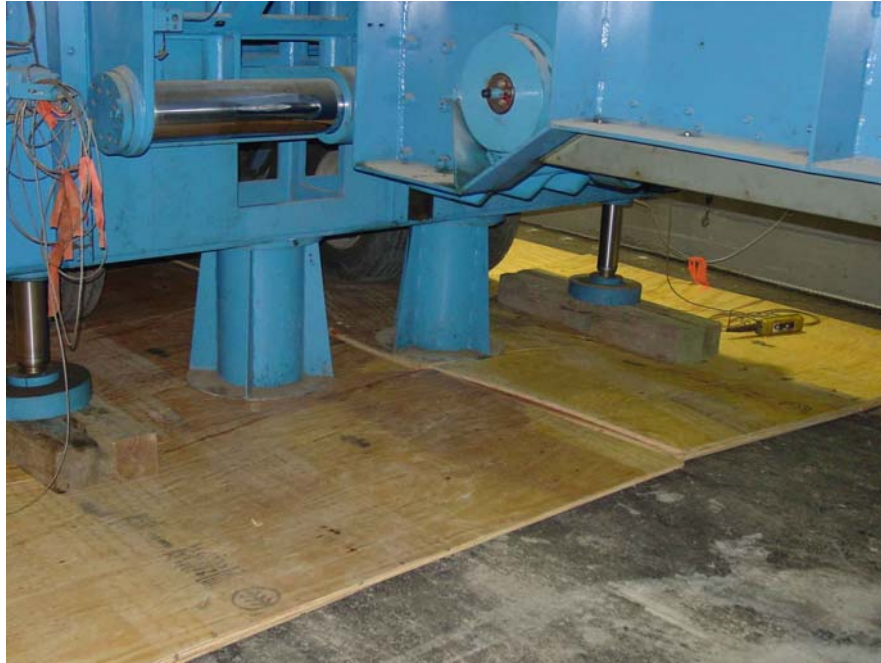
Upon setting of the HVS over the test area, the pavement surface deformed significantly despite the precaution of covering the area with plywood boards. The maximum pavement deformation occurred at the HVS supports despite placing several layers of wood to help spread the loads. The HVS supports continued to sink into the pavement slowly and gradually. The deformation appeared to be time-dependent. Rod and level measurements were conducted to monitor changes in elevation at various points in the test windows.

**Figure 35. Pavement deformation at the HVS supports.**

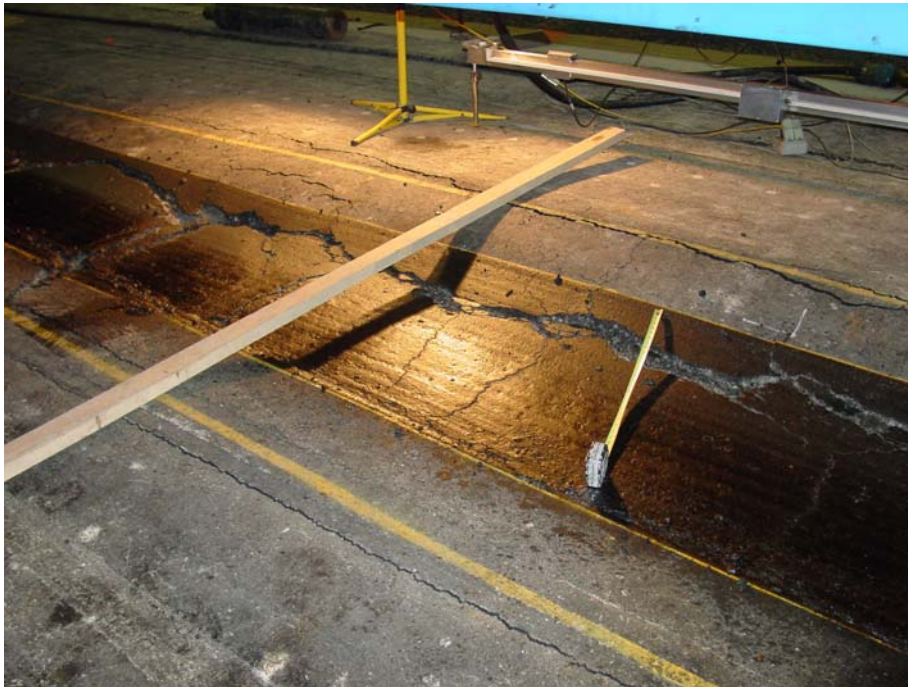
Only few traffic passes were required to cause rutting beyond failure. Both the resilient and the permanent deformations were large even with loads as light as 17.8 kN (4 kips). Figure 36 shows dramatic rutting and cracking at the end of 1000 passes with a load of 53.7 kN (12 kips).

**Figure 36. Pavement rutting and cracking at the end of HVS traffic on Test Window 5.**

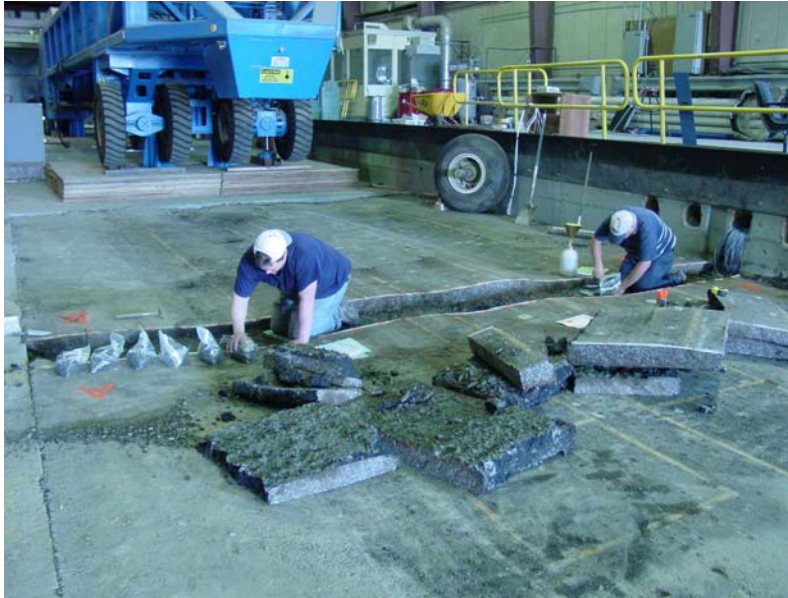
**Figure 38. Forensic trenches across Test Windows 1, 2, and 3.**

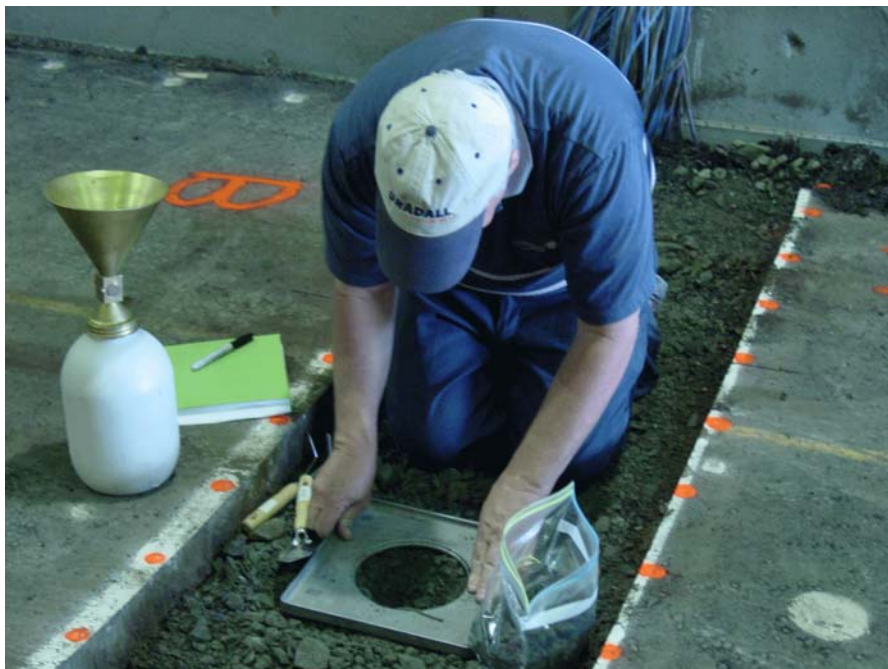
Sand cone measurements were conducted at each base and subgrade layer in the trenches. One test location represented the center of the tire path for each test window. In addition, sand cone measurements were conducted outside the test windows.

**Figure 39a. Sand cone density measurements in the base course.**

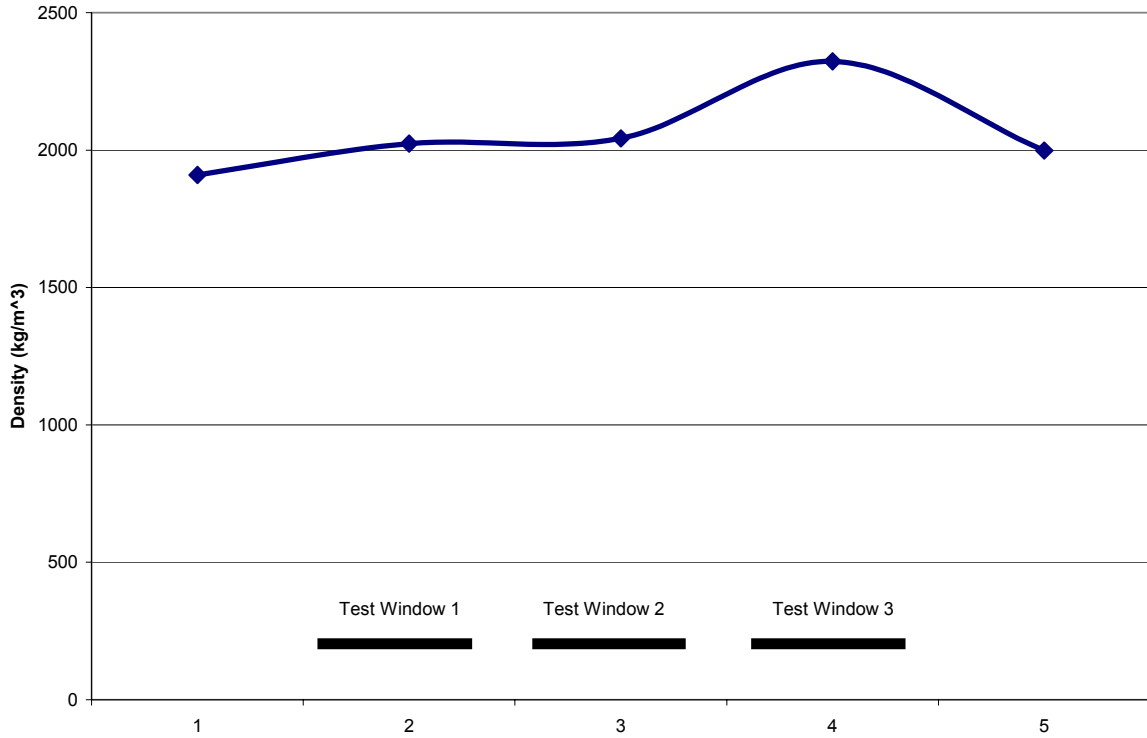
Figure 39b. Base course density measured by the sand cone method in the south trench.

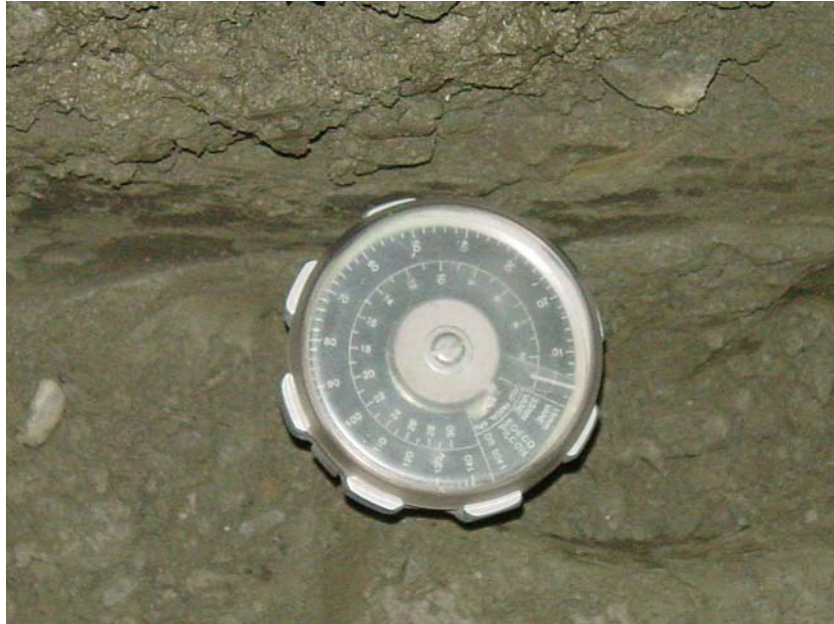
Vane shear tests were conducted at various depths in the subgrade at 33 locations along each trench.

Figure 40a. Vane shear measurements in the subgrade at various depths.

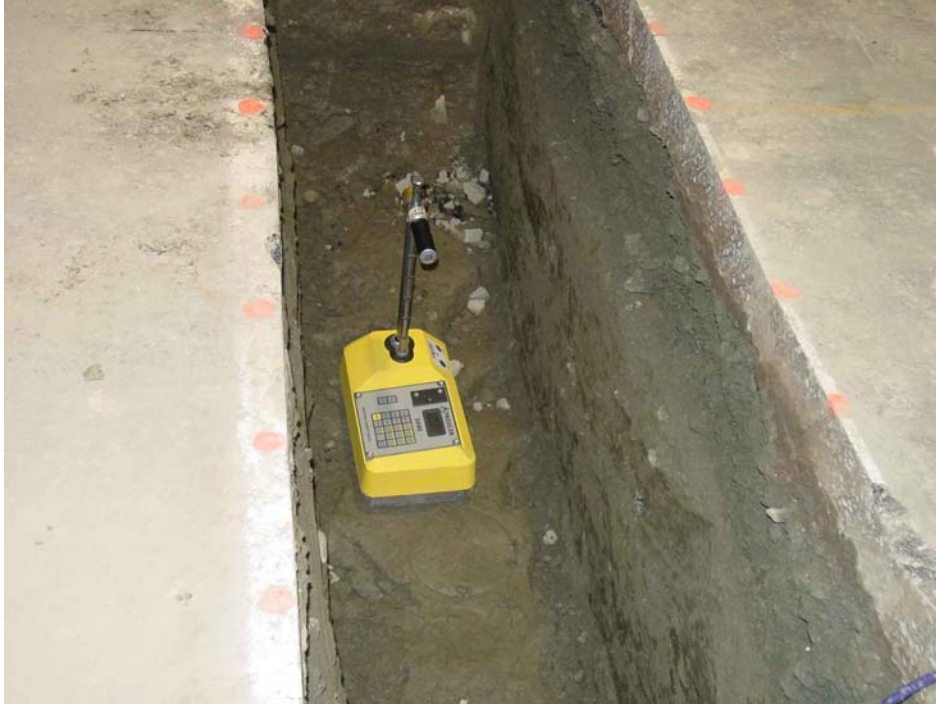
Nuclear moisture and density measurements were taken in the trenches at each layer. The measurements were conducted in the direct mode, i.e., the probe was inserted 0.15 m into the soil. The measurement represents the region of soil between the inserted nuclear source and the receiver in the box of the apparatus. Drive cylinder tests samples were taken in the same volume where the nuclear gauge measurements were taken.

Figure 41a. Nuclear gauge density measurements in the trenches.

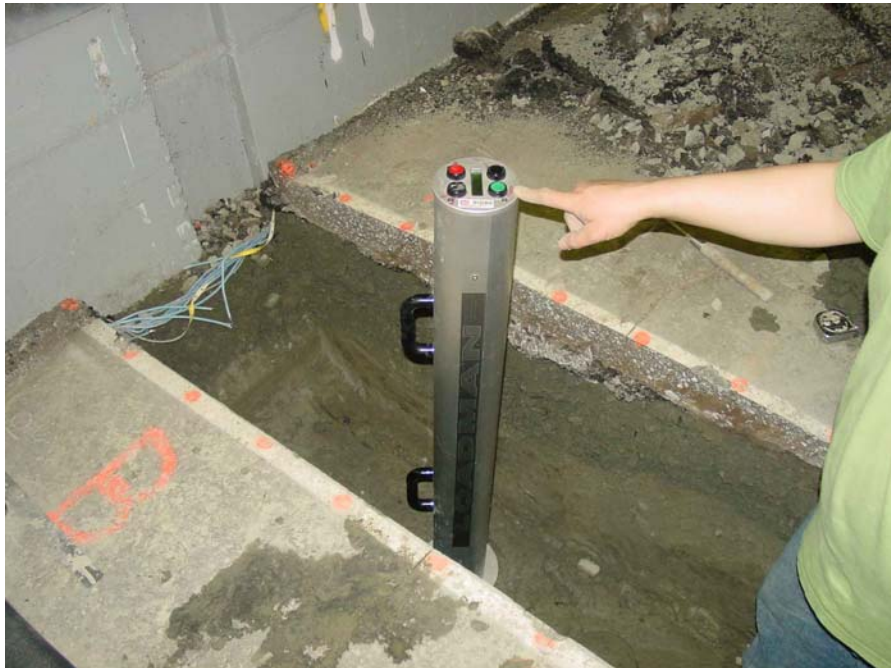
**Figure 42a. Portable falling-weight deflectometer measurements in the trenches.**

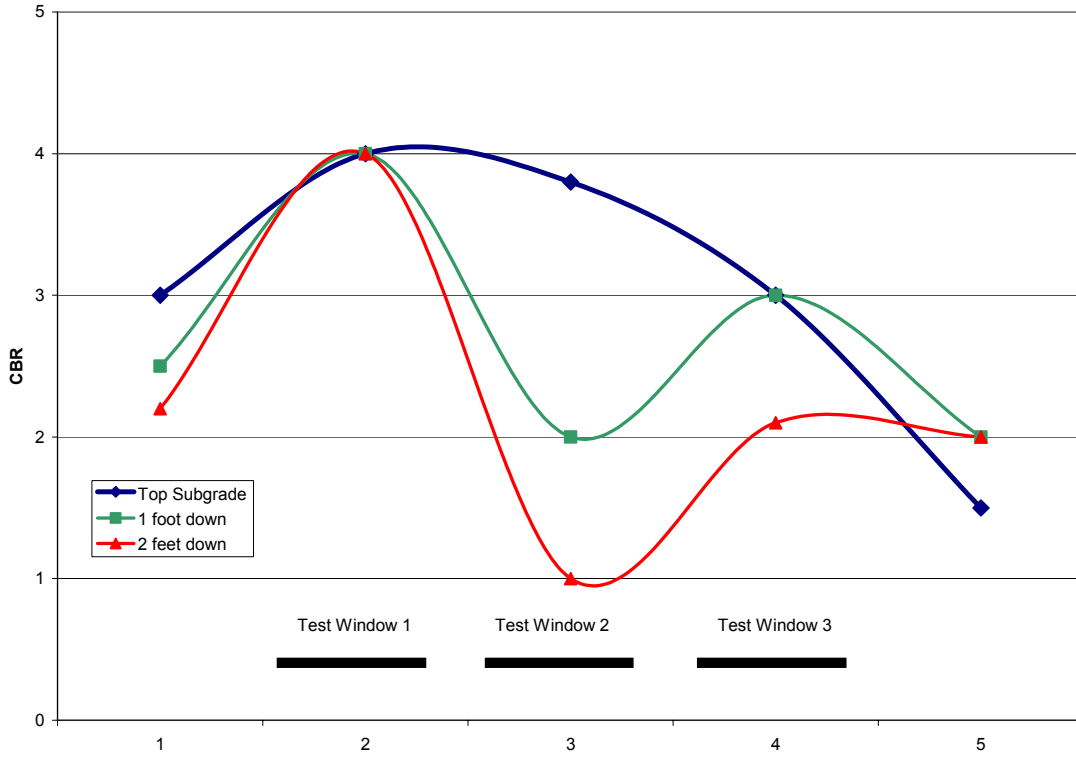
Figure 43b. CBR values obtained from DCP measurements in the south trench.

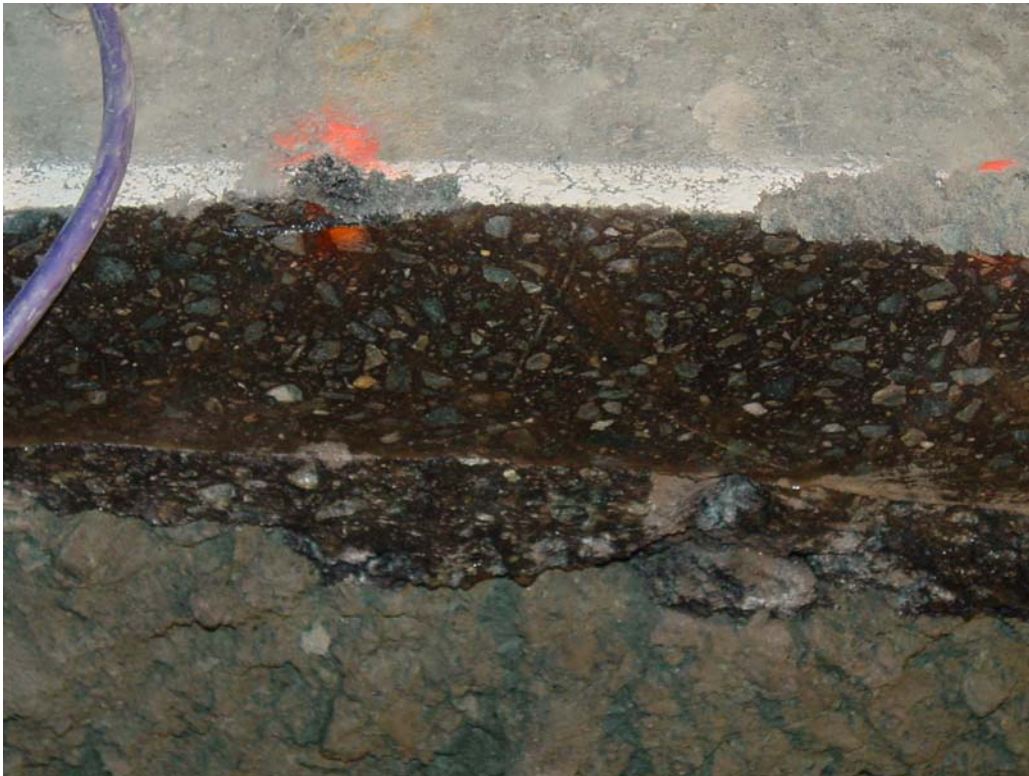
**Figure 44. Cross section of the asphalt concrete showing asphalt material filling ruts created by construction traffic.**

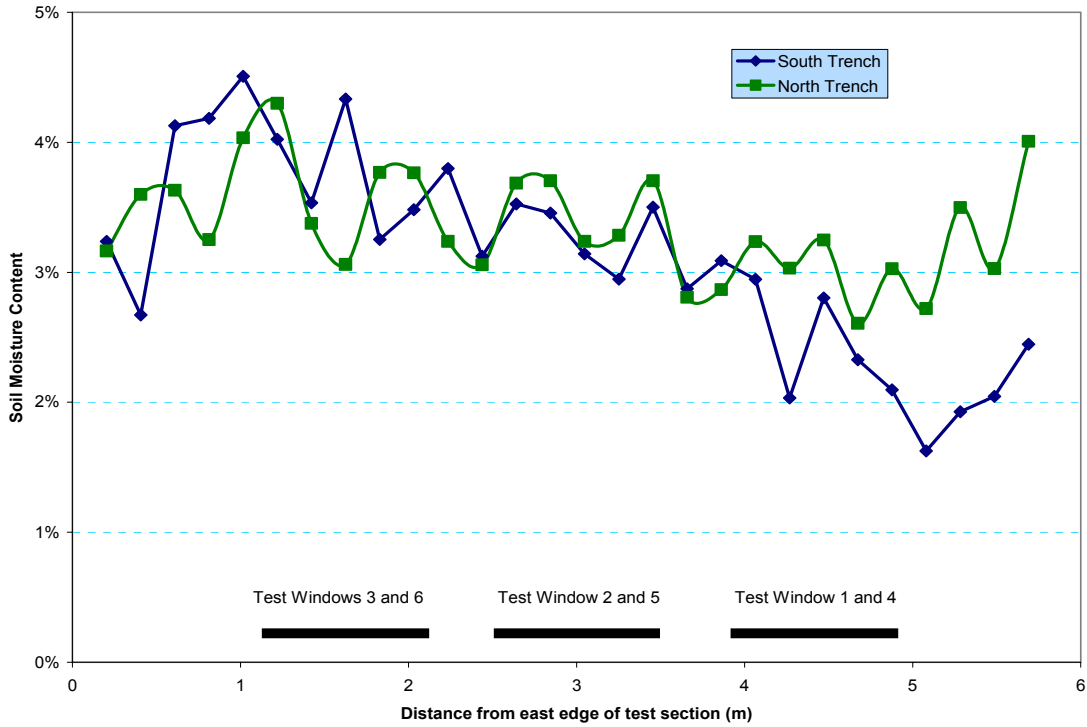
Figure 45. Gravimetric moisture content in the base course.
