PAVEMENT SUBGRADE PERFORMANCE STUDY

## Test Section 705

Subgrade soil type A-4 at extreme wet of optimum

Edel R. Cortez and Vincent C. Janoo

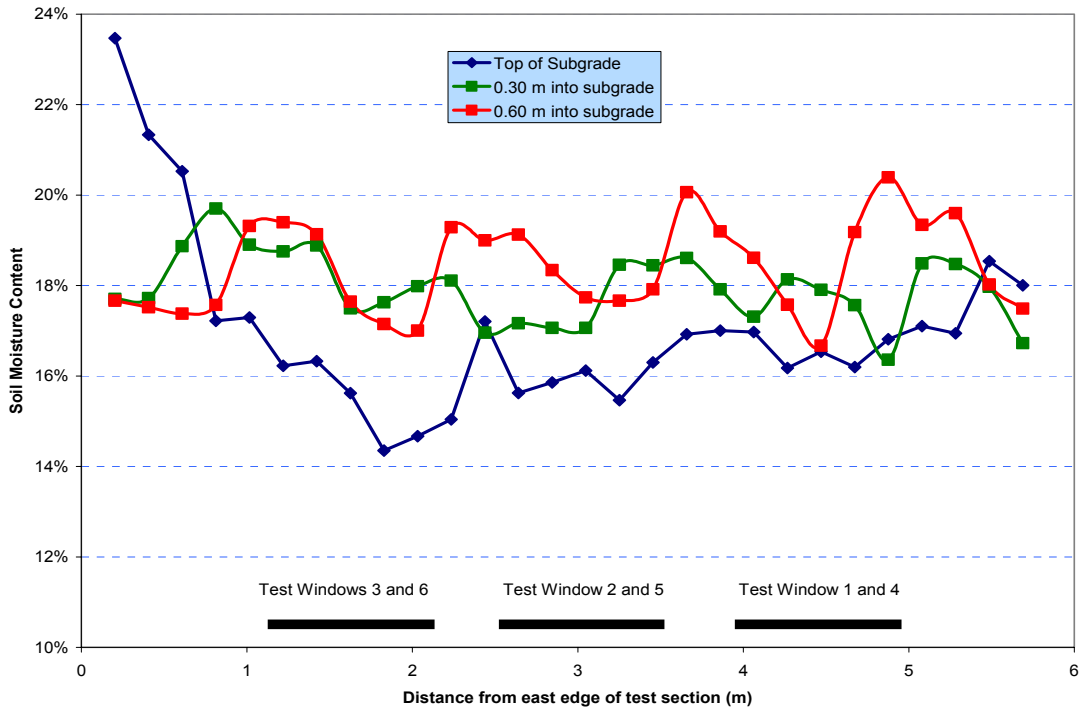
Figure 46a. Gravimetric moisture content in subgrade in the south trench.

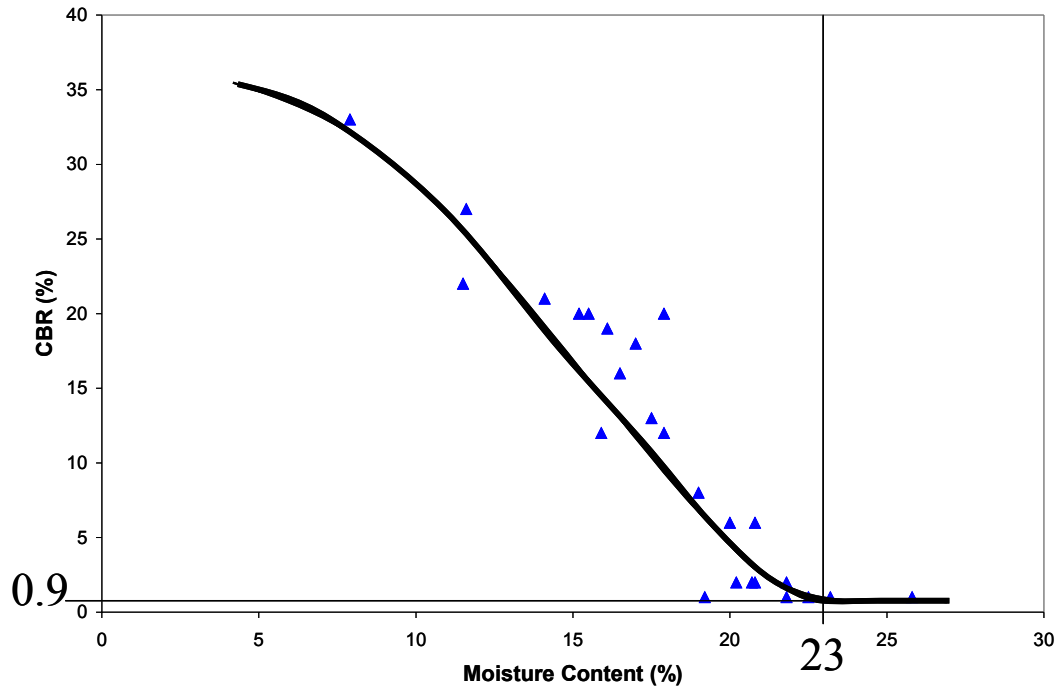
Figure 47. Moisture-CBR relationship for the A-4 subgrade soil

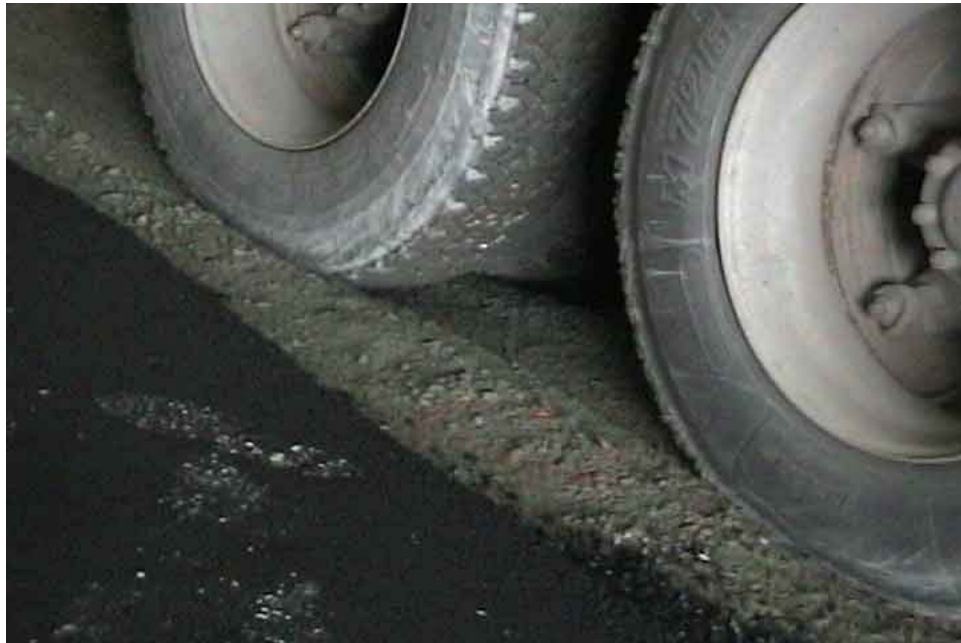
Figure 48. Ruts observed on top of the base course during the paving operation.
