TRANSPORTATION POOLED FUND PROGRAM QUARTERLY PROGRESS REPORT

| Project Title: Strain-based Fatigue Crack Monitoring of Steel Bridges using Wireless Elastomeric Skin Sensors | | |
| Lead Agency Project ID: RE-0699-01 | Other Project ID (i.e., contract #): | Project Start Date: 9/2015 |

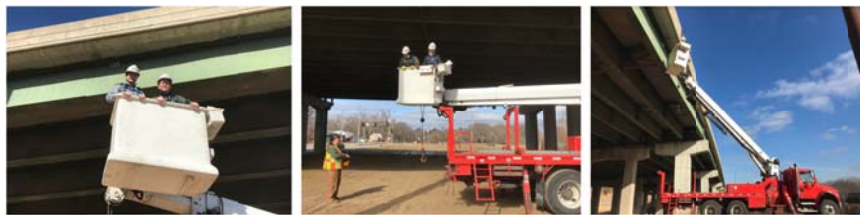
The KU team also performed a field deployment of the SECs on a steel highway bridge in this quarter. The tested bridge was a part of the I-70 highway near Kansas City, Kansas. The bridge was named 70-105-41731-(127) and 70-105-417.32(128) according to the inspection report provided by the Kansas department of transportation (KDOT). The KU team visited the tested bridge twice on 01/23/2018 and 01/25/2018. Fig. 6 shows some photos taken from the field.

Figure 6. Field visit to the I-70 highway steel bridge.

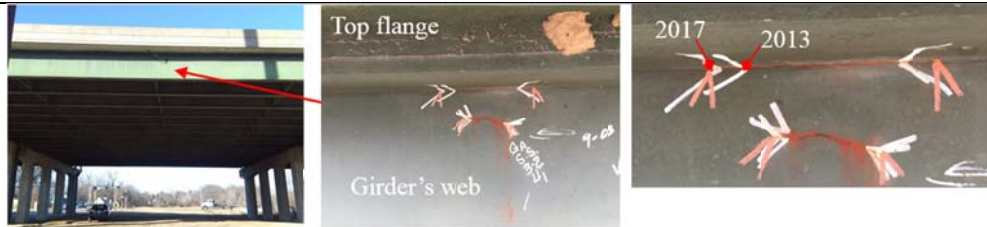
As shown in Fig.7, the web gap region at the fascia side of an external steel girder was selected for installing the SECs. This bridge was inspected in 2013 and 2017, respectively. Based on the inspection reports and the marks of fatigue cracks on the structural surface, two fatigue cracks can be found in this region including: 1) a horizontal crack developed between the top flange and the web; and 2) a horizontal crack in the web. Both cracks propagated during the past 4-year inspection interval.

Figure 7. Detail views of the fatigue-susceptible region prior to sensor installation.

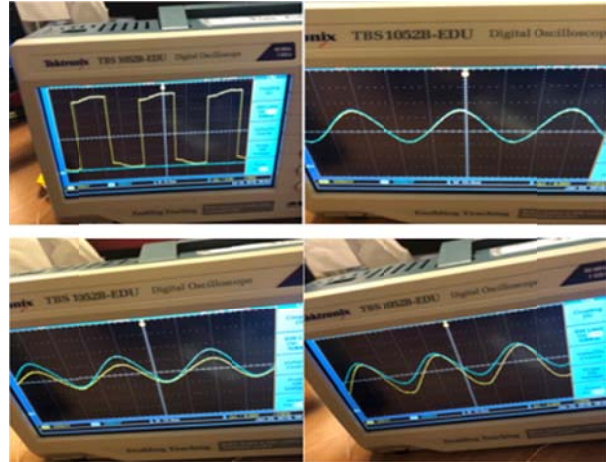
board is designed to measure the capacitance of SEC sensors by converting the capacitance change to voltage change. At KU, we have been trying to balance the sensor board based on the instructions provided by Arizona team. For this purpose, there are two steps to be taken. Firstly, the potentiometers on the sensor board need to be adjusted to match the signals of different jumpers monitored by the oscilloscope. There are two types of balancing for the sensor board including coarse balance and fine balance. Coarse balance is easier to achieve; however, it causes more errors in the measurements of the sensor board. To achieve high quality data, fine balance is necessary for field tests. The second step is to perform shunt calibration to calculate the coefficient to convert the measured voltage to capacitance. To perform these steps, the Xnode is used as the power source for data acquisition. Fig. 11 presents the configuration of the connections between the sensor board, SEC sensor, and Xnode. We have succeeded to finish the balancing step. Fig. 12 shows different stages of the balancing step displayed on the oscilloscope. Our next step is to perform shunt calibration.

Figure 12. Balancing steps
