Project Description:

The main objective of this proposed research is to *provide state DOTs a practical and cost-effective long-term fatigue crack monitoring methodology using a **wireless elastomeric skin sensor network***. This research is intended to demonstrate the value-added of fatigue crack monitoring of steel bridges using wireless skin sensors over the traditional bridge inspection.

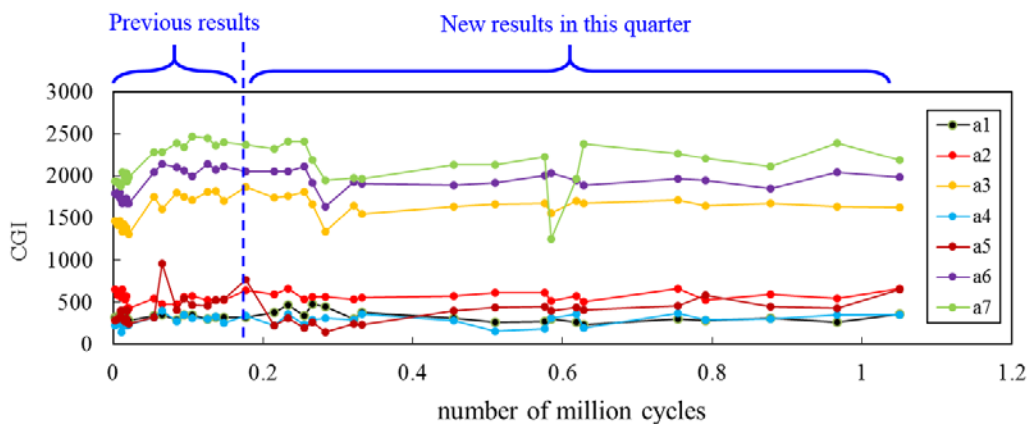
Utilizing the previously established data processing method, the crack growth index (CGI) was computed from each individual SECs in the SEC array and the results are shown in Fig. 2. As shown in the figure, all SECs demonstrate relatively stable CGI responses, except for the slight drop around 0.3 million cycles. The drop was due to the fact that a fatigue crack was generated at a cross frame member (see Fig. 3), leading to decrease of the CGIs at SEC a3, a6, and a7.

Figure 2. The CGI responses from the SEC array.

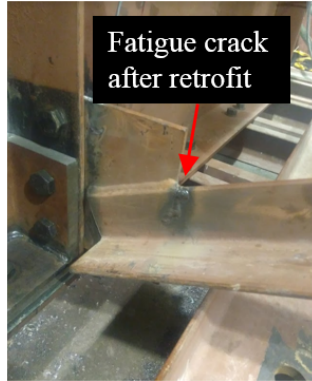
Figure 3. A fatigue crack was found at the diagonal member of the cross frame. The crack in the photo was later retrofitted by welding.

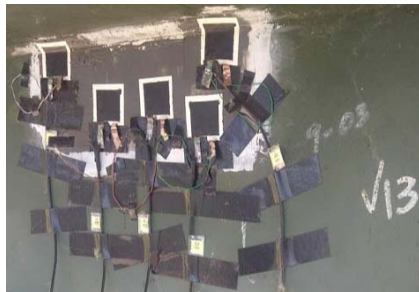
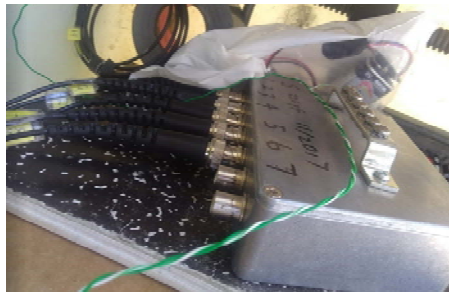
The third field test was performed on the mid-span. Fig. 4 shows the setup of the field deployment where measurements of 5 SECs were collected through PCAP02 data acquisition system. The data acquisition system is shown in Fig. 4b, while the SECs are shown in Fig. 4a. The 5 SECs are named a1, a2, a7, a4, and a5 starting from left.

Figure 4. (a) The SECs deployed on the bridge; and (b) the wired data acquisition system.

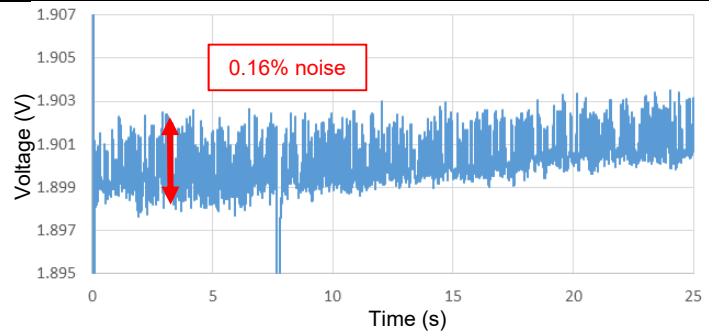
To further validate this idea, we also tested the pre-balanced sensor boards on the I-70 bridge. During our field visit to the bridge abutment span on 05/04/2018, we checked the balancing of a pre-balanced sensor board with a SEC sensor with the same nominal capacitance which was attached on the bridge near the abutment. Several data sets were collected using the pre-balanced SEC sensor, and the noise level was also investigated. It was observed that the noise level was about twice as in the lab. However, this noise level allows collection of meaningful measurements from the bridge. Figure 7 presents a picture of our test setup, while Figure 8 shows one sample measurement in the field on 05/04/2018.

Figure 8. A sample measurement from abutment span

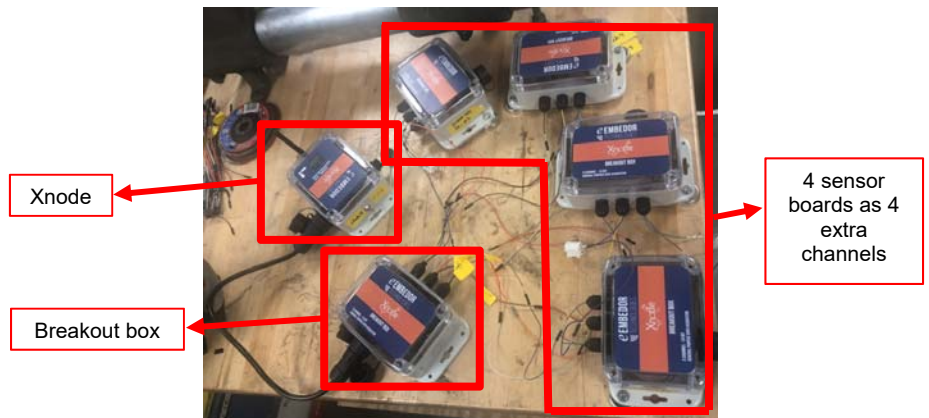
Figure 10. Connection of sensor boards to Xnode through breakout box

Our final task was to incorporate the breakout box which is an interface between the Xnode and the SEC boards for power supply and data collection. Figure 9 present the board inside the breakout box. This board allows us to integrate the connections of all 5 extra channels to the sensor boards and SEC sensors. Figure 10 shows how we used the breakout box to make all the connection required between the Xnode, the sensor boards, and the SEC sensors.
