## **Progress Report**

**March 5, 2007**

**FOR THE DEVELOPMENT OF  
GUIDE SPECIFICATIONS FOR BRIDGES VULNERABLE TO COASTAL STORMS  
AND  
HANDBOOK OF RETROFIT OPTIONS FOR BRIDGES VULNERABLE TO  
COASTAL STORMS**

Modjeski and Masters, Inc.

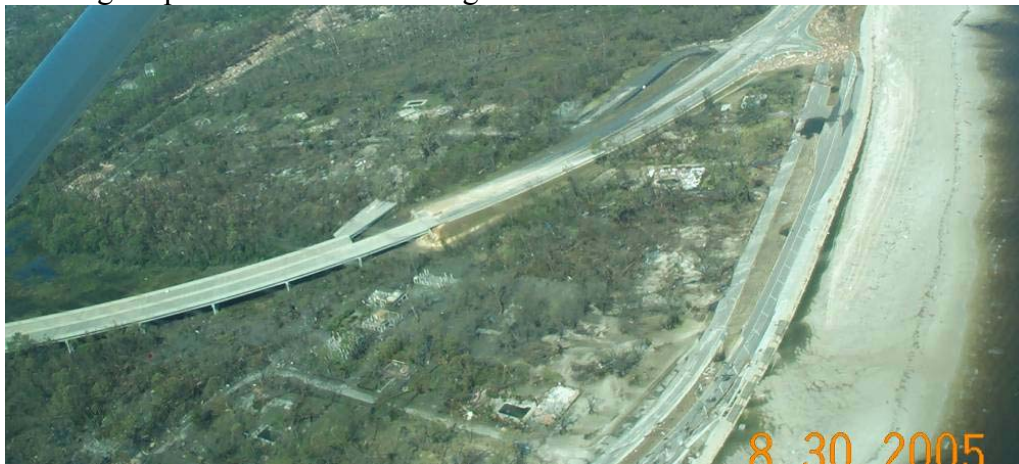
- Side by side chorded multi-span prestressed bulb-T girder bridges
- Bridge Drawings dated 1996
- Elastomeric bearing pads at free end
- Full depth doweled diaphragms at fixed ends
- One span of bridge dislodged completely, others shifted
- Dislodged span was where bridge met grade (lowest elevation/most submersion)
- Dislodged span was about 123' long and 48' wide

- Because there was no vertical restraint (assuming dowels ineffective) it is likely that the superstructure was lifted up and off of the dowels then was pushed laterally by waves, current, and/or wind.

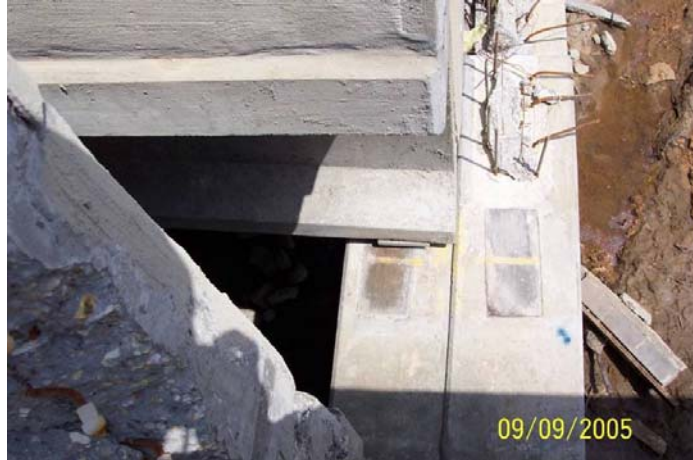
- Dowel bars still intact (not sheared)
- Some dowels bent (from beams landing on them)
- Others still upright (at edge, where span moved away from them)
- Dowels in fixed diaphragm are double leg #5's at 12" (See bridge plan sheets 16 to 19, and 23)

- Some States use bond breakers between the steel dowel bars and the diaphragm concrete to enable jacking of the beams for bearing replacement and other maintenance
- No bond breaker details given in plans
- Did dowel bars provide any vertical restraint for this bridge?

- Concrete in end diaphragm is damaged (due to rotation of span about fixed end or dropping of the span?)

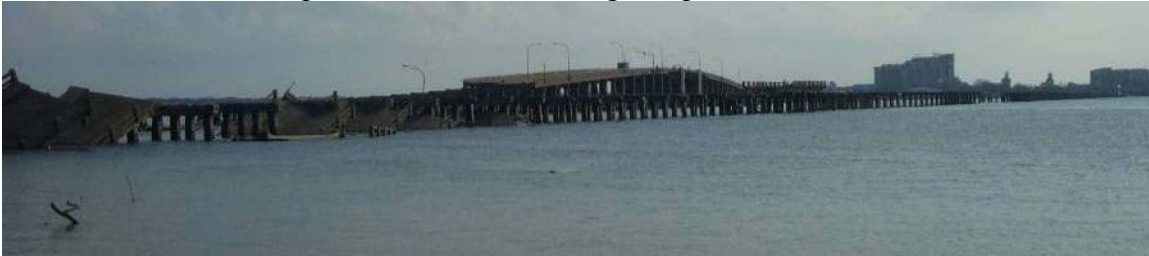
- Bridge contained concrete girder spans, steel girder spans, and a bascule span
- Bridge plans dated 1959
- Concrete girder spans
  - Prestressed girders
  - 52' typical span length
  - 33' 5" typical span width
  - Used on lower elevation spans
  - Majority of bridge was concrete spans
- Steel girder spans
  - Wide flange sections
  - 76' typical span length
  - Used on higher elevation spans adjacent to bascule
- Low elevation spans were lost, while higher spans were left intact

- Conditions that failed the bridge obviously did not involve static water
- Is it possible that the sections were displaced prior to complete submersion? (i.e. wave forces failed the bridge before the above-mentioned buoyancy calculations materialized)
- Likely superstructure was lifted (above the small angles or other features, such as stepped beam seats, that might have provided lateral or longitudinal restraint), then lateral and or longitudinal forces due to waves, tides, and/or wind pushed sections off of piers

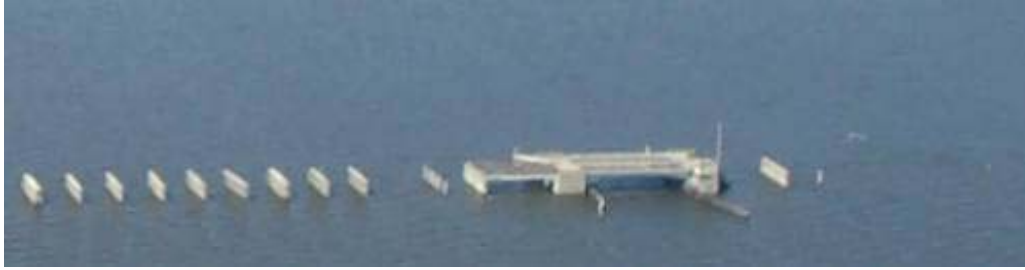
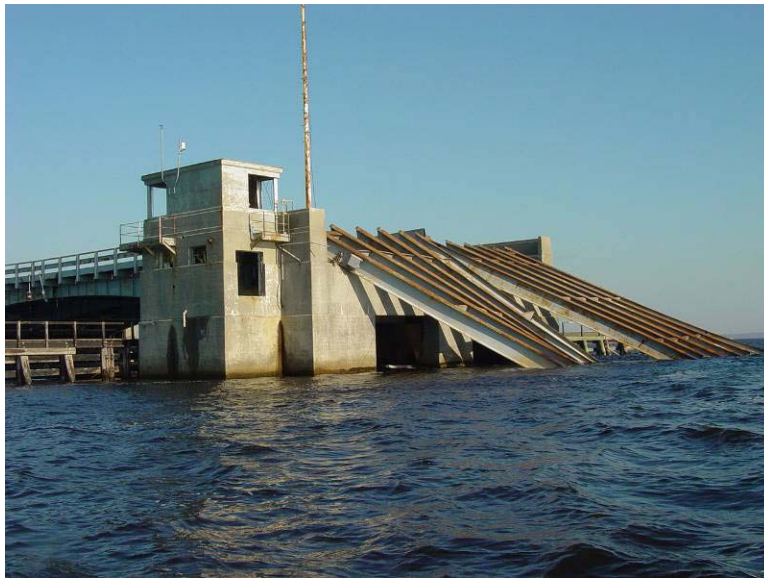
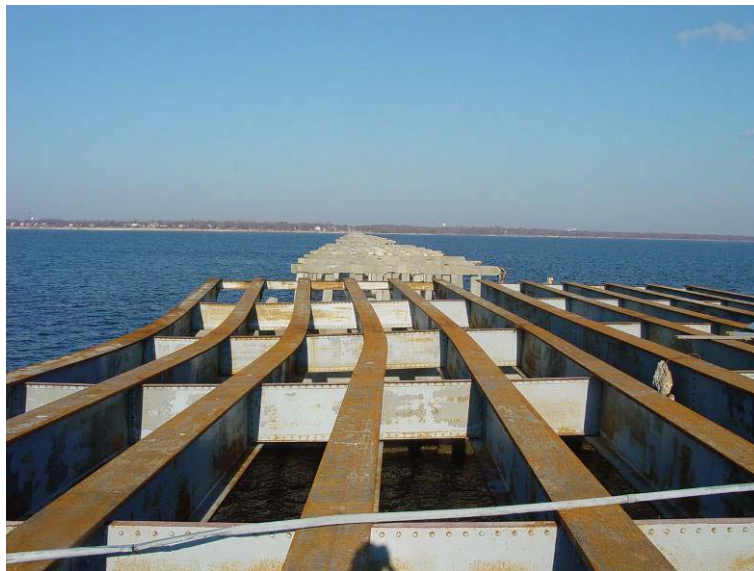
- Bearings provide no positive connection that would resist uplift
- Bearing details shown below are from sheet 12 of the bridge plans
- Pintles should project  $\frac{3}{4}$ " from the rocker or sole plate

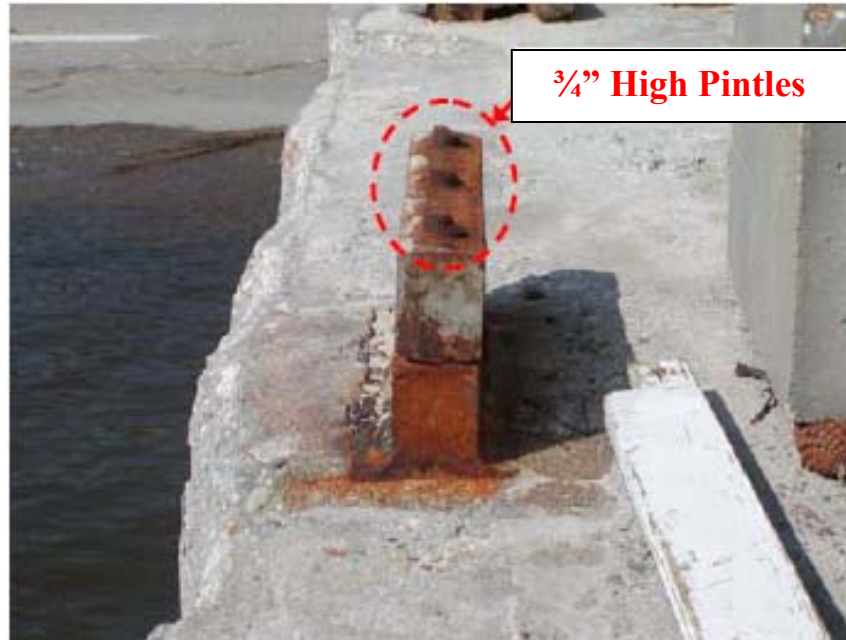
- 3" diameter drains through deck at 10' increments
- Drains would permit air to escape from one of the three air-spaces between girders
- Diaphragms were only slightly more than half of the beam depth below the deck
- Comparatively small volume of trapped air

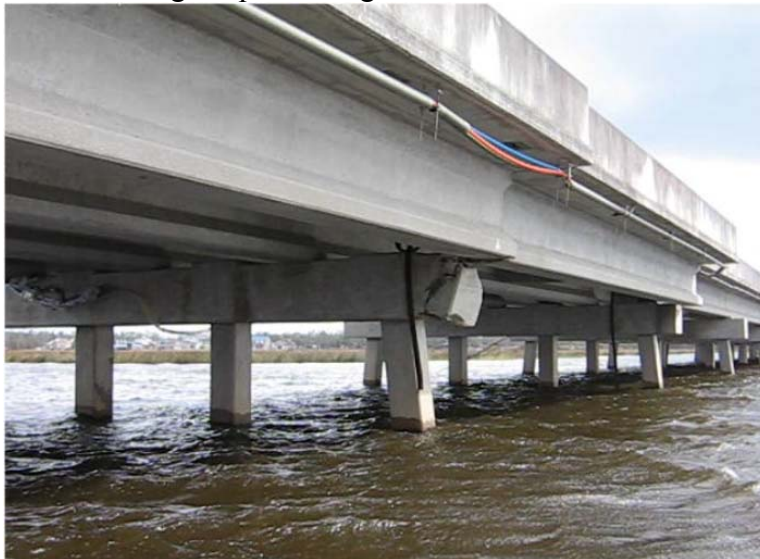
- Cracked pier cap ends
  - Beams came to rest at the end of pier caps
  - The pier cap of pier 52 looks like it sheared where reinforcement started (i.e. beam came to rest with 2" or 3" of bearing on end of pier cap and the cap failed in direct vertical shear along the plane where the first tie/stirrup was)
  - Shallow member beam theory is not applicable to the pier cap overhang due to the large depth to length ratio.

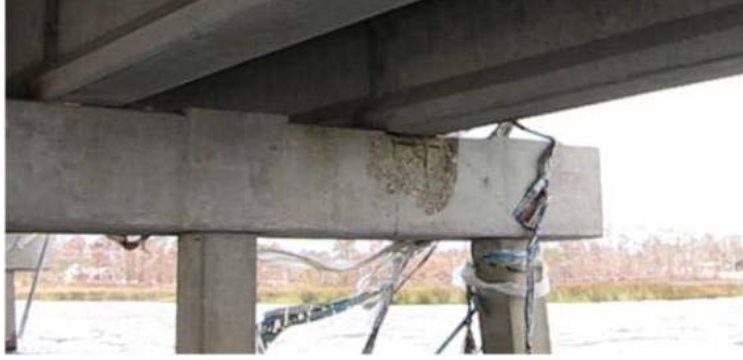
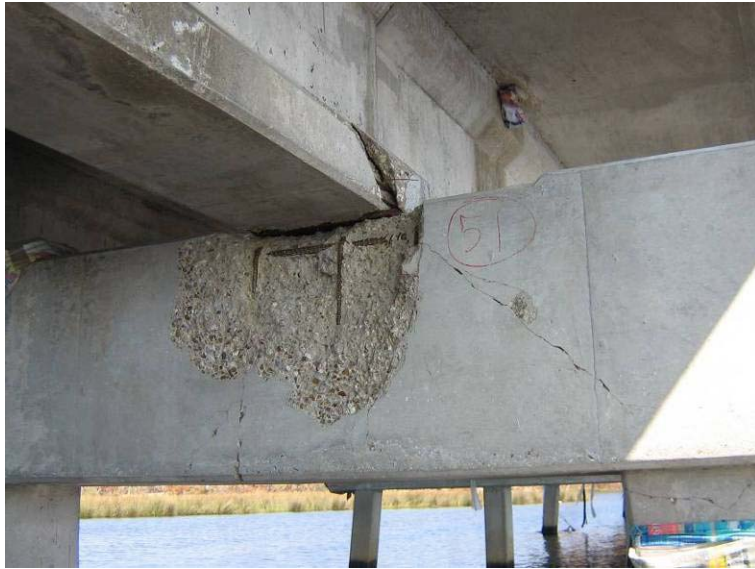
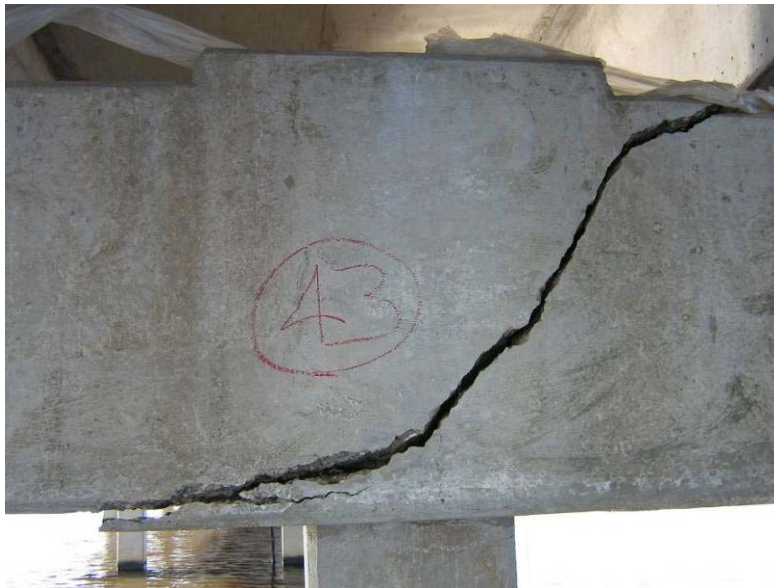
- Pier cap beam cracked between columns
  - Superstructure beams came to rest midway between columns
  - Pier cap beam shows inclined shear crack from face of column
  - Flexure cracks observed directly below some of the shifted superstructure beams.
  - Spalling under superstructure beam, insufficient bearing / bearing on corner???
  - Pier cap beam likely not designed to take superstructure reactions at these locations – beams supposed to sit directly over the columns

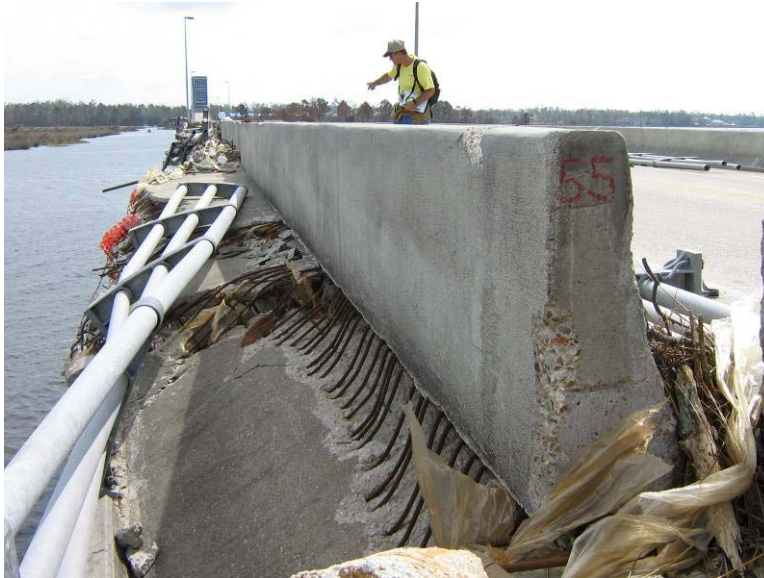
Deck/sidewalk failed

- Context of the picture is unclear

- Cantilevered section?
- Failed due to uplift on cantilever?

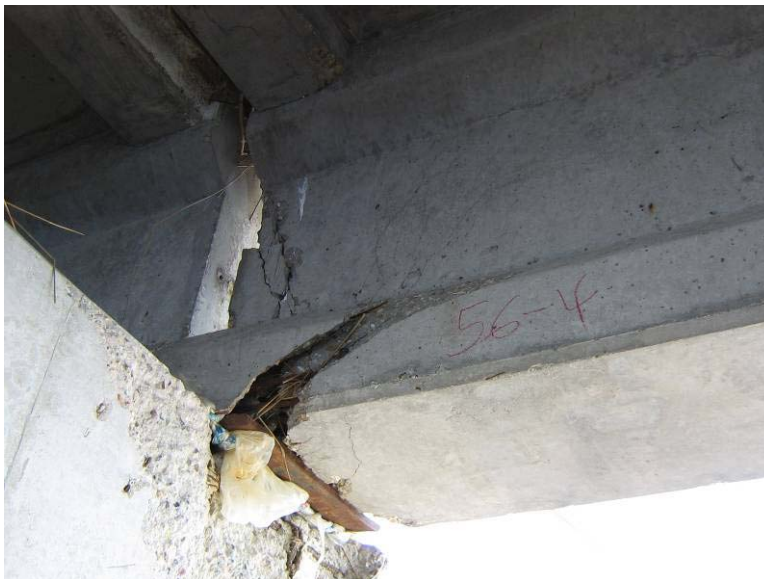
- Cracked beam end in area of sole plate
  - Due to shortened bearing length after span shifted?
  - Due to dropping of the span?

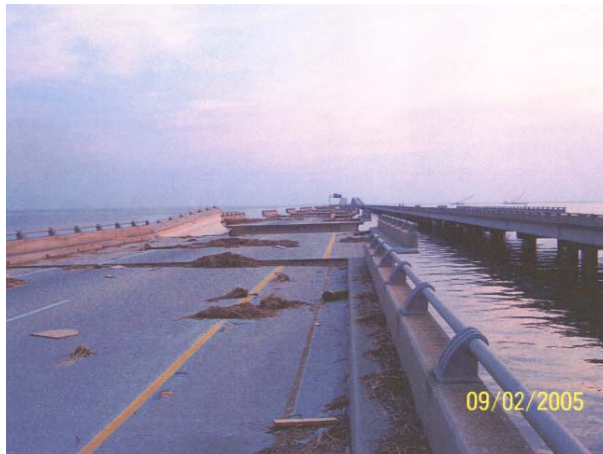
- Bridge consisted of concrete spans and steel spans
- Concrete spans
  - Precast prestressed monolithic concrete girder/deck units
  - Typical span length 65 ft
  - Used steel and bronze bearings
- Steel Spans
  - Used at higher elevation, not impacted by surge
- Low lying spans impacted by surge while higher elevation spans largely undamaged
- Some spans completely dislodged while others shifted laterally

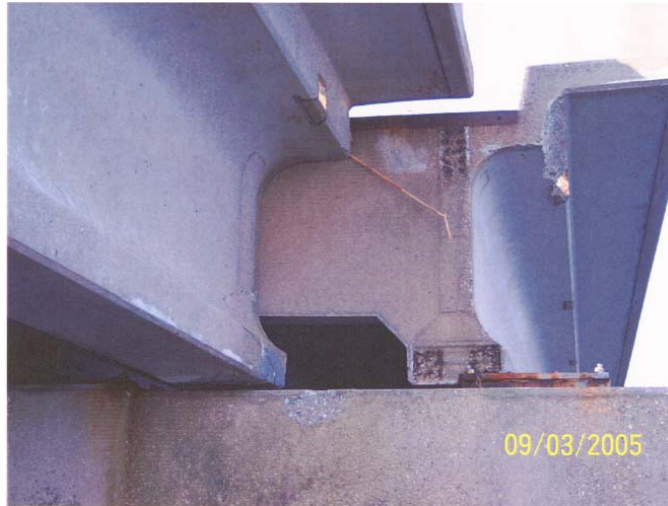
Fixed bearing at an exterior beam - Bronze plate still attached to pier  
Straps holding the bronze plate to the beam failed while the anchor bolts remain intact

- Connections inadequate to prevent uplift of spans
  - Vertical restraint provided only at one end of each span
  - In some cases bolts connecting bronze plate to pier broke while in other cases the straps connecting the bronze plate to the beam broke

- Area of bolts and straps about the same (steel strengths unknown)
  - About 3 square inches of steel to anchor each span
  - Provided area of steel reduced by corrosion?

- It is unclear if the connections failed in shear, tension, or a combination of shear or tension
- Once spans were lifted (above any existing features that might provide lateral or longitudinal restraint), they moved laterally or longitudinally causing most of the damage pictured above, if spans could be anchored most damage would be avoided.

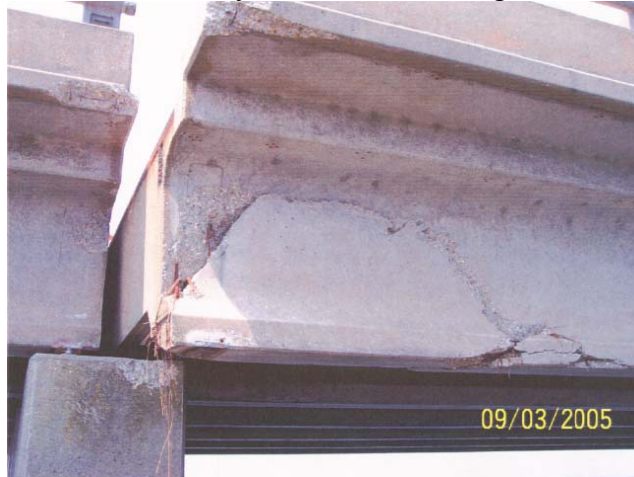
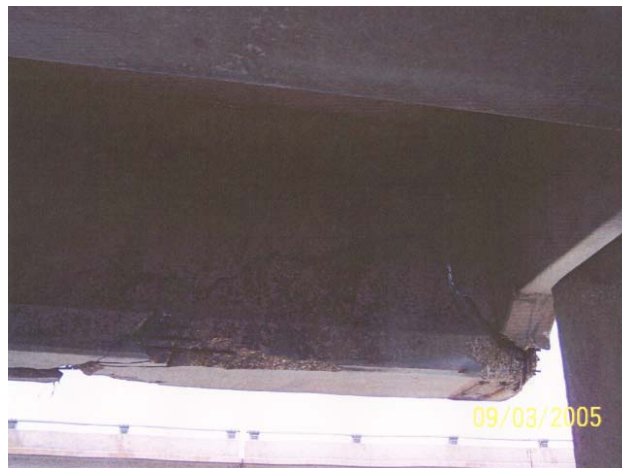
#### Cracks and spalls at beam ends

- Could some of this damage be repairs to damage from previous events?
- Beams banging on pier?
- Shifted beams being supported with insufficient bearing area/surface?
- At locations where the bronze plates were anchored to both the beam and the pier, the beam to plate connection may have caused damage to the concrete?

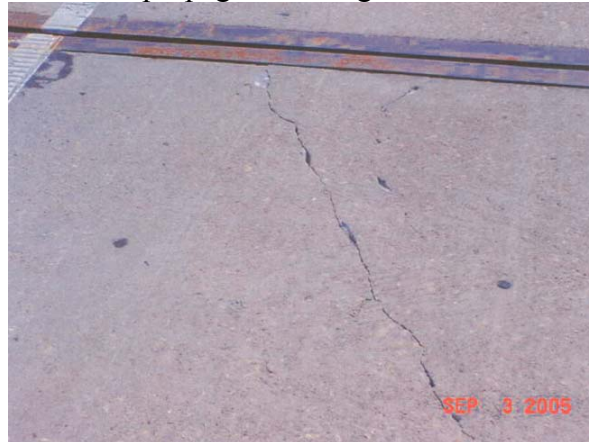
45 degree cracks at ends of decks

- Initiated through end diaphragms

- Beams gets caught on a stepped bearing seat as it moves sideways, halts sideways movement, tension transferred through diaphragm, cracks initiate and propagate into deck??
- Span shifts so that fascia beam is no longer supported by pier, weight of unsupported beam is now transferred through diaphragm which develops an inclined shear crack that propagates through the deck??

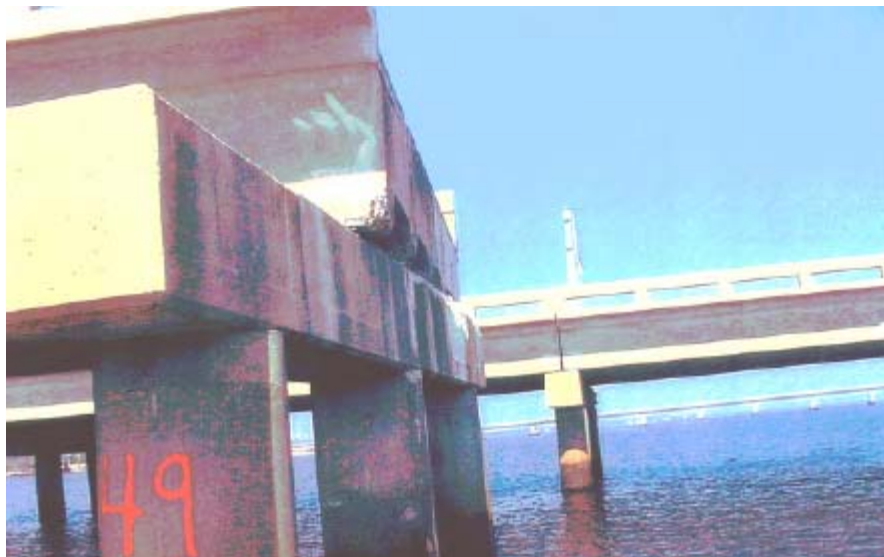
Span displaced laterally and longitudinally

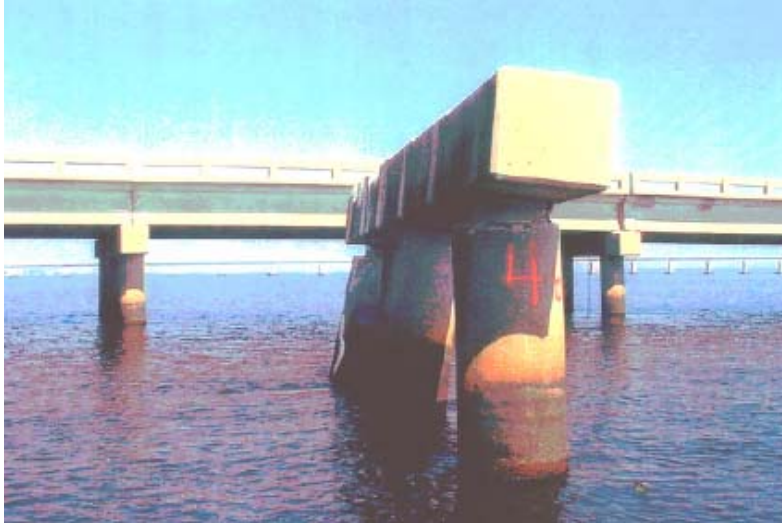
Bent deformed longitudinally

- Bent damage indicates that securing the superstructure to the substructure may lead to destruction of the substructure. This is a serious limitation on retrofits.

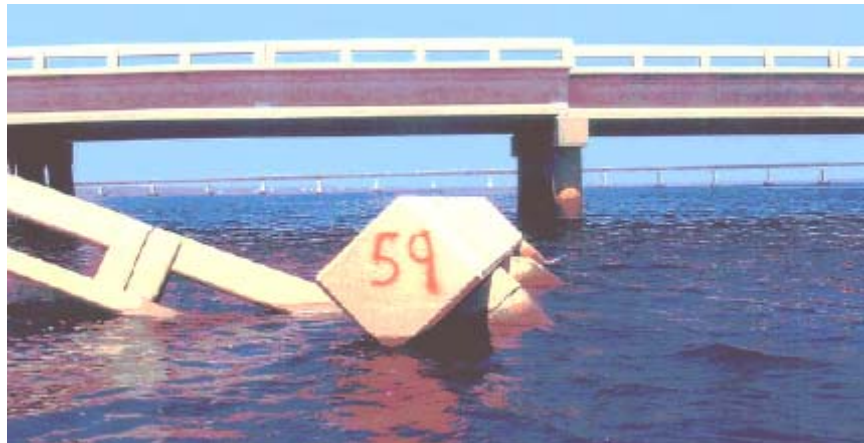
Bent failed longitudinally

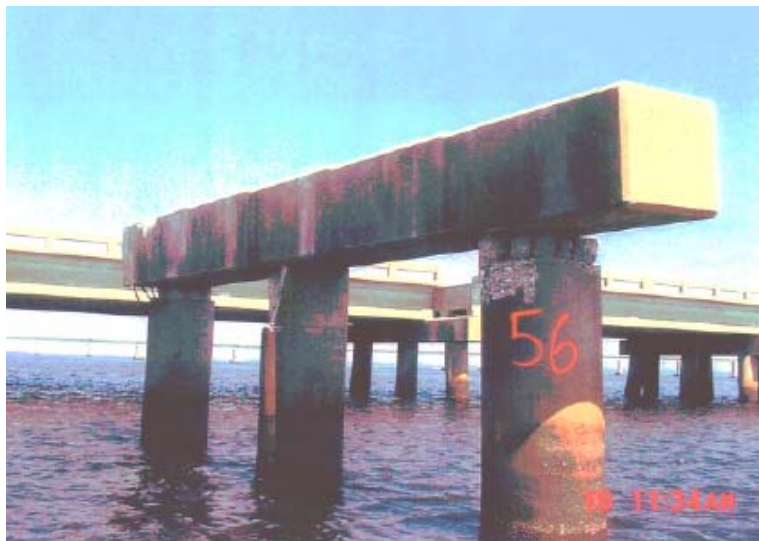
Bent with damaged pile to bent cap connection

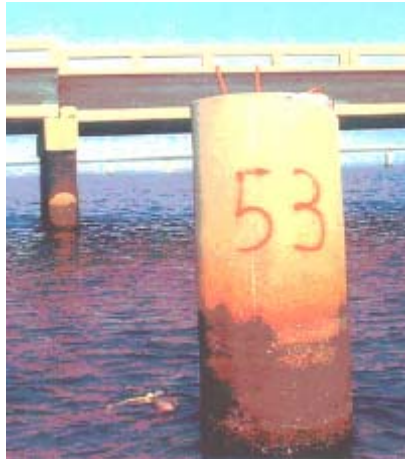
As built reinforcement?

- It is unknown if the as-built conditions of the pile to bent cap connections were in agreement with the bridge plans shown above.
- Pile to bent cap connection used on this bridge was also used on other bridges of this era including I-10 Lake Ponchartrain, the Ponchartrain Causeway, and possibly the Pensacola Bay Bridge. These bridges were constructed using precast elements such as monolithic superstructure units and post tensioned Raymond piles. The I-10 Lake Ponchartrain Bridge, the Ponchartrain Causeway, and the Pensacola Bridge are known to have been manufactured at the Mandeville plant on Lake Ponchartrain. It is suspected, but has not been verified, that the Escambia Bay Bridge was also manufactured at this plant.

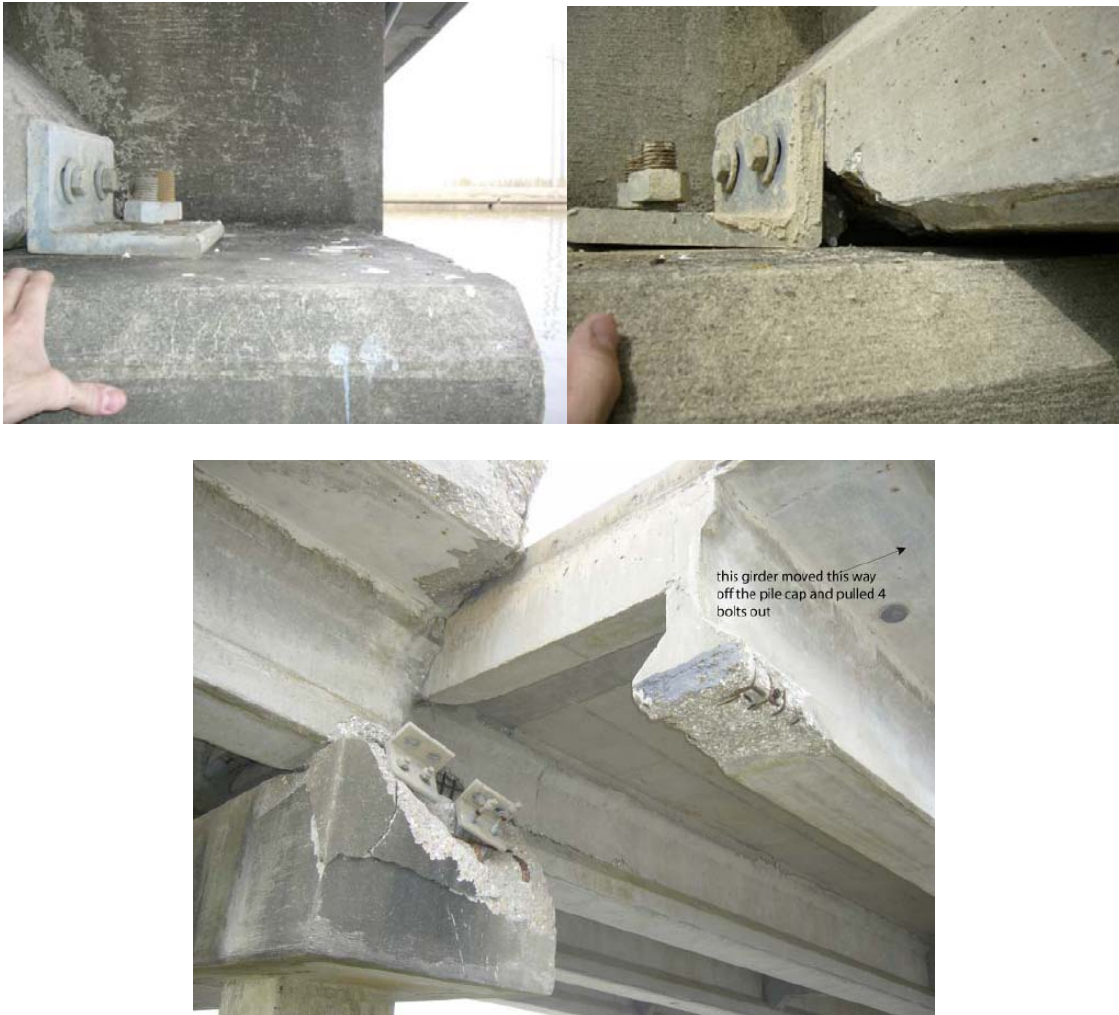
- Prestressed concrete simple spans 45' in length
- Built in 1970's
- Beams anchored using 1" diameter anchor bolts and 6" x 9" x 1" steel angles (ASCE)
- Concrete around bolts broke (Douglass et al.)
- Broken anchor bolts (ASCE)
- Some spans on curve were pushed toward center of the curve, so this may have prevented them from being fully dislodged

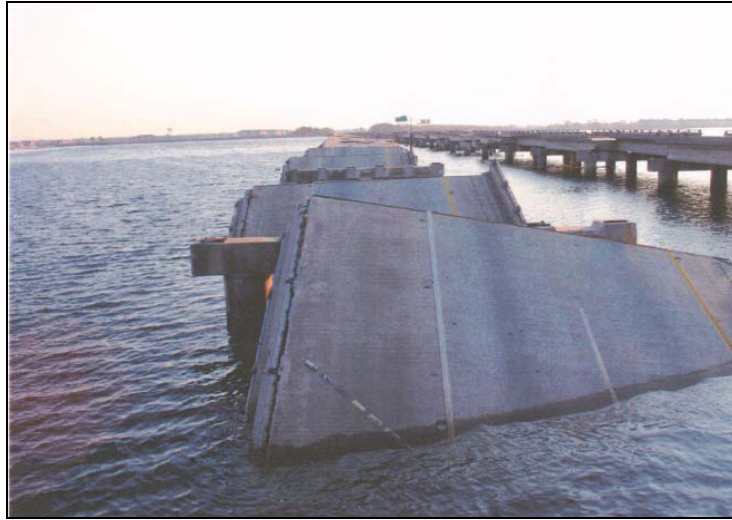
remained on the bents while 64 ended up in the lake. Figure 2.1 shows spans of the I-10 Lake Ponchartrain Bridge that were displaced longitudinally.

Figure 2.1 – I-10 Lake Ponchartrain Bridge after Hurricane Katrina  
Source: Volkert and Associates Damage Assessment

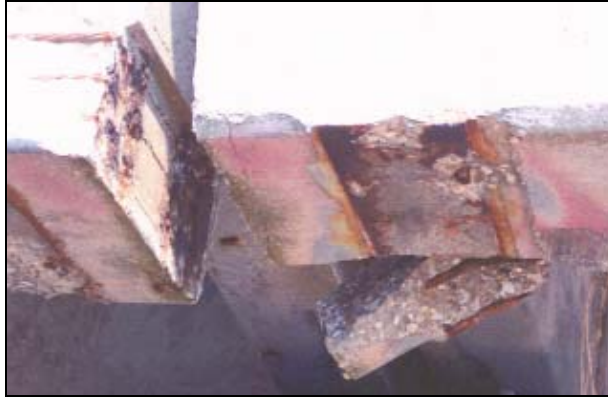
Figure 2.2 – Beams with Missing Bearing Plates on I-10 Lake Ponchartrain Bridge  
Source: Volkert and Associates Damage Assessment

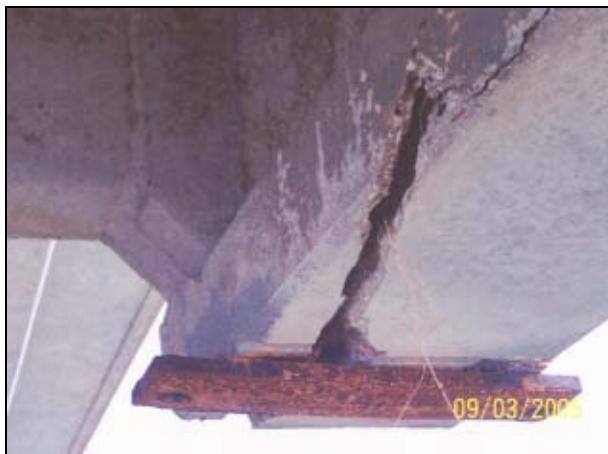
Figure 2.3 – Beam with Intact Bearing Plate on I-10 Lake Ponchartrain Bridge  
Source: Volkert and Associates Damage Assessment

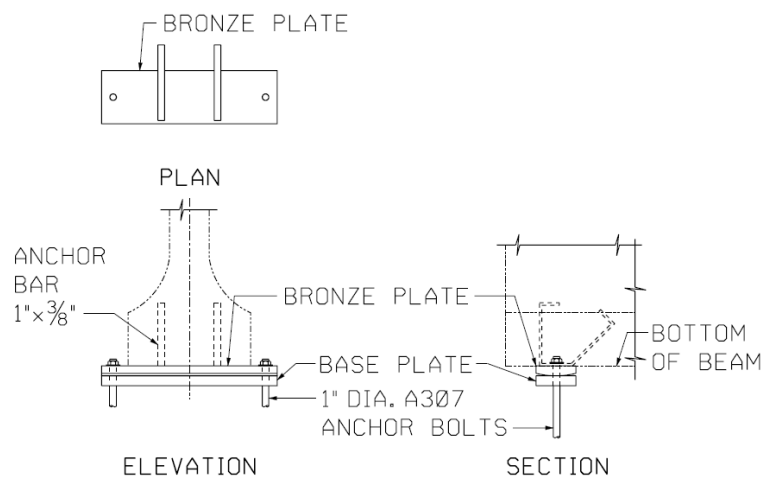
Figure 2.4 – Bearings at Fixed End Exterior Girders

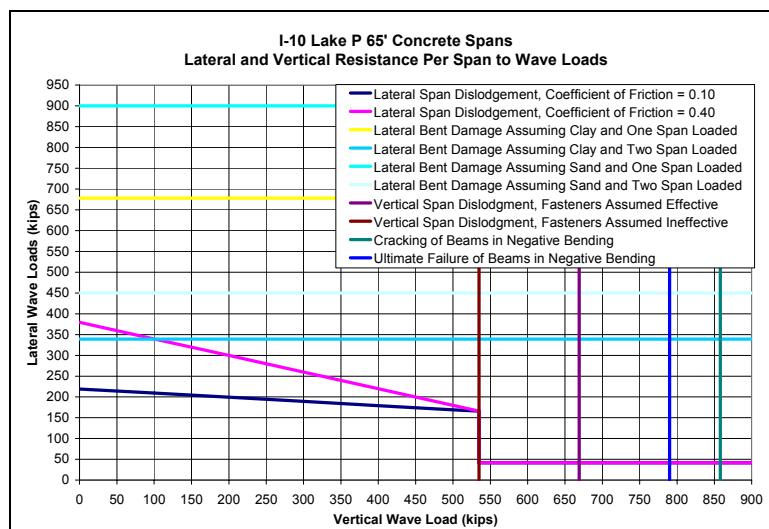
With respect to lateral and longitudinal loading, strictly comparing the capacity values above does not allow a failure mode to be easily determined. This is due to the dependency of span dislodgment resistance on vertical load, uncertainty relating to simultaneous loading of adjacent spans, and uncertainty in soil conditions at the site. To better assess the ranges above, a linear programming approach was selected. The approach seeks to examine known boundary conditions to find a range of acceptable solutions. Figure 2.10 is a plot of the examined lateral and longitudinal failure mechanisms. Horizontal lines represent lateral load resistances that are relatively independent of uplift loads, vertical lines represent vertical resistances that are relatively independent of lateral loads, and sloped lines represent lateral resistances that are dependent on vertical loads.

Figure 2.10 – Plot of Lateral and Vertical Resistances for I-10 Lake Ponchartrain Bridge

Examination of the chart reveals that several failure modes may be removed completely from consideration because other failure modes would occur first. For example, negative bending damage to the beams would be preceded by span dislodgment. Three of the four bent damage scenarios would also be preceded by span dislodgment. Other failure modes may be seen to control over only a small range of loads. For example, “Lateral Bent Damage Assuming Clay and Two Spans Loaded” will control over “Lateral Span Dislodgement, Coefficient of Friction = 0.40” when vertical loads are less than about 100 kips. Removal of failure modes that will not occur (because other failure modes occur first) in the above graph will lead to Figure 2.11.

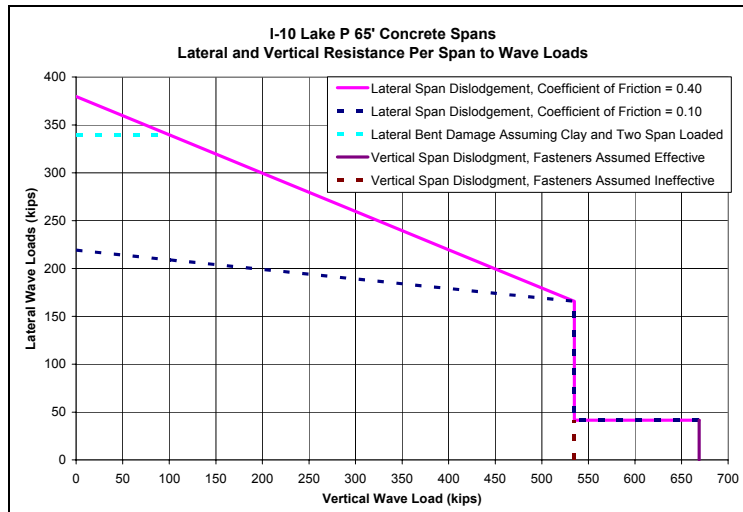
Figure 2.11 – Failure Envelope for Lateral and Vertical Loads

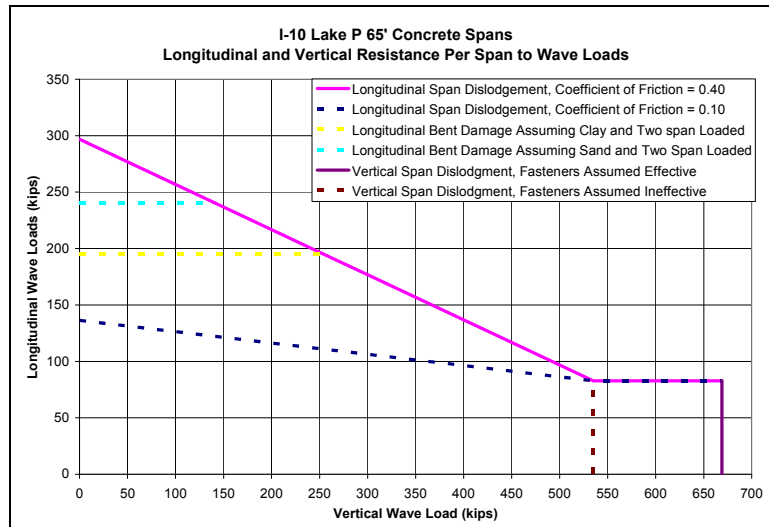
A similar linear programming process was conducted for lateral and vertical loads. The results are shown in Figure 2.12. In this figure horizontal lines are longitudinal load resistances that are relatively independent of uplift loads, vertical lines are vertical resistances that are relatively independent of longitudinal loads, and sloped lines are longitudinal resistances that are dependent on vertical loads

Figure 2.12 - Failure Envelope for Longitudinal and Vertical Loads

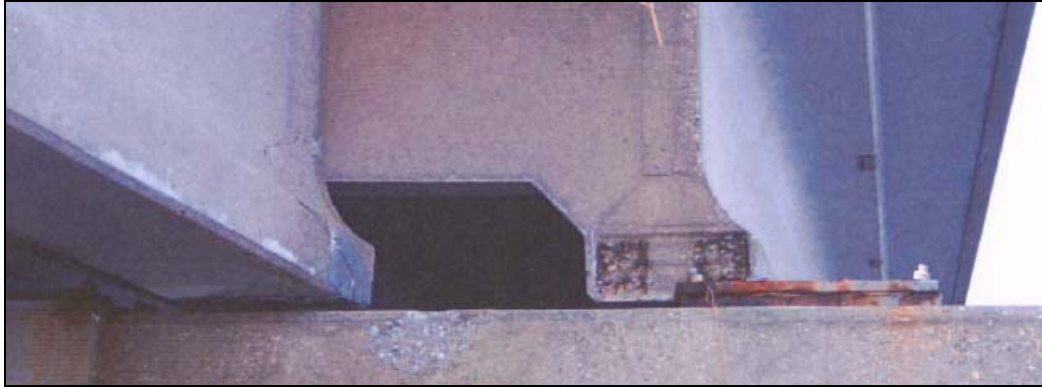
The minimum magnitude of vertical wave loads may be estimated as 535 k to 669 k. This estimate is based on the displacement of spans. Although the spans could have been displaced by lateral loads, several bents appeared to have had damage from beams being dropped or slammed onto the bent cap, suggesting the girders were lifted. Also, as shown in Figure 2.13, some bents had obstacles such as stepped beam seats or anchor bolts, which would exhibit damage if the spans were pushed across the bent cap without being lifted. Evidence indicates that many spans were lifted by vertical forces. The non-occurrence of negative bending failures does not exclude the possibility that the seastate could cause vertical loads in excess of the negative bending capacity of the beams. This is because the beams were not vertically restrained at both ends, thus span dislodgment would occur before sufficient negative bending could not have occurred. When comparing the linear programming results to bound a solution, it should be recognized that the direction of the waves that caused the damage is not entirely known. It is likely that the actual direction of waves was not perpendicular to or parallel to the bridge, but somewhere in between. This may be confirmed by the fact that both longitudinal and lateral span displacement occurred.

Figure 2.13 – Undamaged Bolt where Beam was Displaced Laterally  
Source: Volkert and Associates Damage Assessment

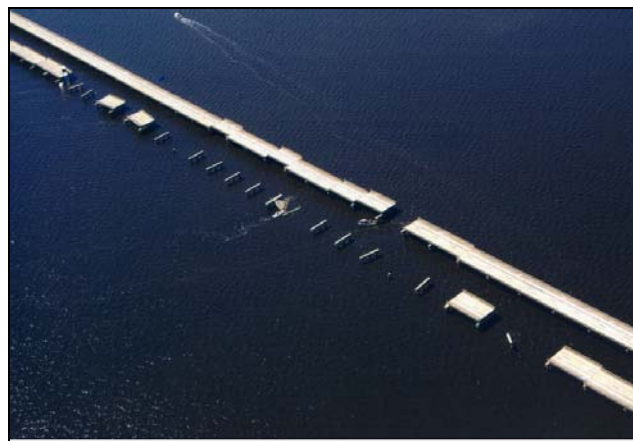
The second structure examined was the I-10 Bridge over Escambia Bay. The 2.6 mile bridge, which was built in the mid 1960's, consisted of two side by side spans, each carrying two lanes of traffic. The majority of the bridge was constructed using 60' precast spans supported on intermediate or tower bents. Intermediate bents used a single row of three piles, while tower bents used two rows of three piles. Tower bents were used every seventh bent. The exception to this was around the shipping channel where longer spans and higher bents with more or larger piles were used. The 60' spans consisted of six girders and a deck which were cast monolithically. The intermediate and tower bents were constructed using 36" diameter post-tensioned cylinder piles and reinforced concrete bent caps. The majority of the bridge was at a profile grade elevation of 16.0'. The FDOT damage report performed after Hurricane Ivan lists 46 spans as "gone" and photographs contained in the report showed that numerous spans were shifted. The damage report also lists 8 bents as "gone", "destroyed", or "1 pile remaining." Less severe damage to 11 other bents is also listed. Figure 3.1 shows lost and shifted spans as well as damaged and missing bents of the I-10 Escambia Bay Bridge.

Figure 3.1 – I-10 Escambia Bay Bridge after Hurricane Ivan  
Source: FDOT

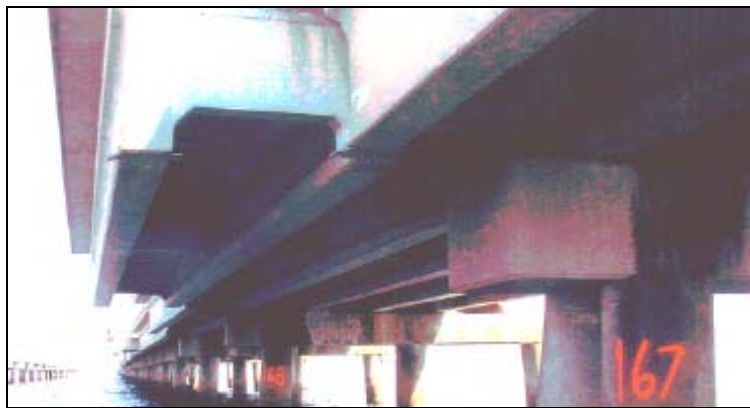
Figure 3.2 – Girders with Bearing Plates Intact on Escambia Bay Bridge  
Source: FDOT Damage Report

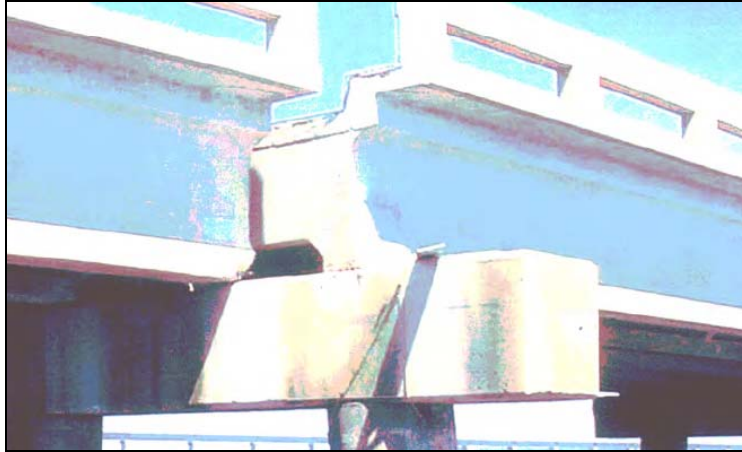
Figure 3.3 – Bent Cap with Bearing Plate Partially Attached on Escambia Bay Bridge  
Source: FDOT Damage Report

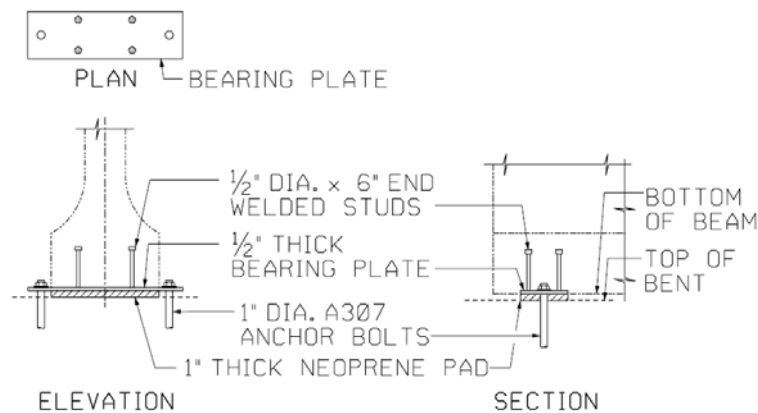
Figure 3.4 – Fascia Girder Bearings

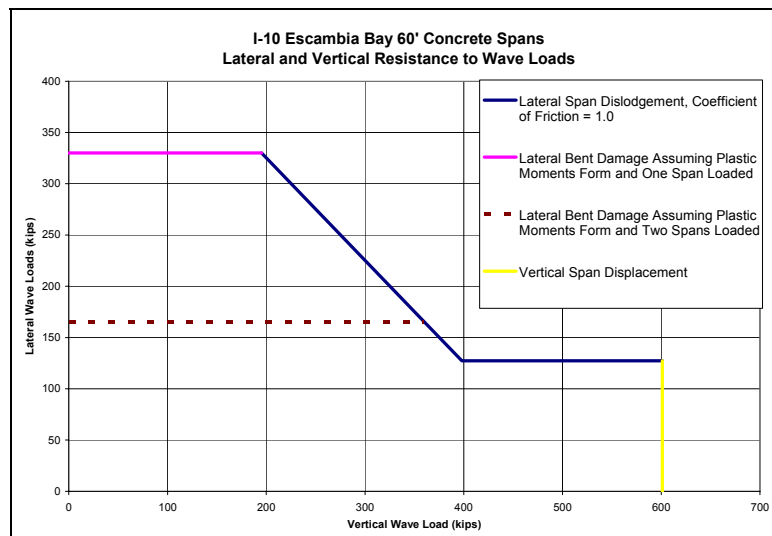
Figure 3.8 shows the failure envelope for lateral and vertical loads that was developed using linear programming.

Figure 3.8 – Failure Envelope for Lateral and Vertical Load

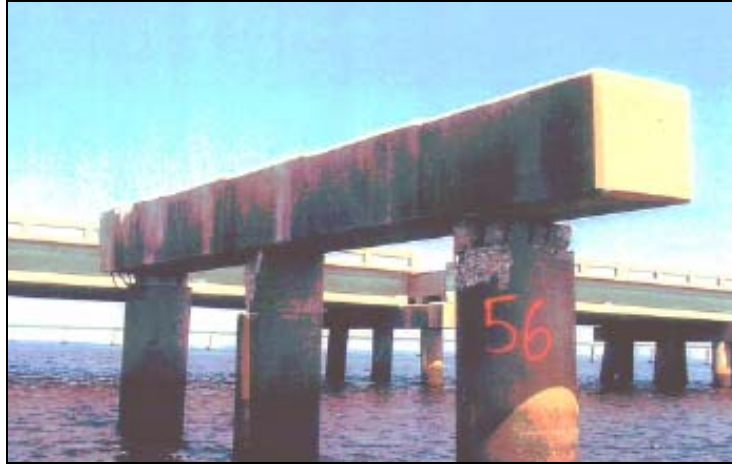
Observations of damage reveal that both span dislodgment and bent failure occurred. As seen in Figure 3.9, many failed bents exhibited distress at the pile to bent cap connection in the area where the first plastic moments were expected to form. It is probable that this connection did not develop the full plastic capacity of the piles. If this is true, the horizontal lines in Figure 3.8 would be lower because the calculations, which did not account for this failure mode, overestimated the lateral capacity of the piers.

Figure 3.9 – Damage to a Pile to Bent Cap Connection on Escambia Bay Bridge  
Source: FDOT Damage Report

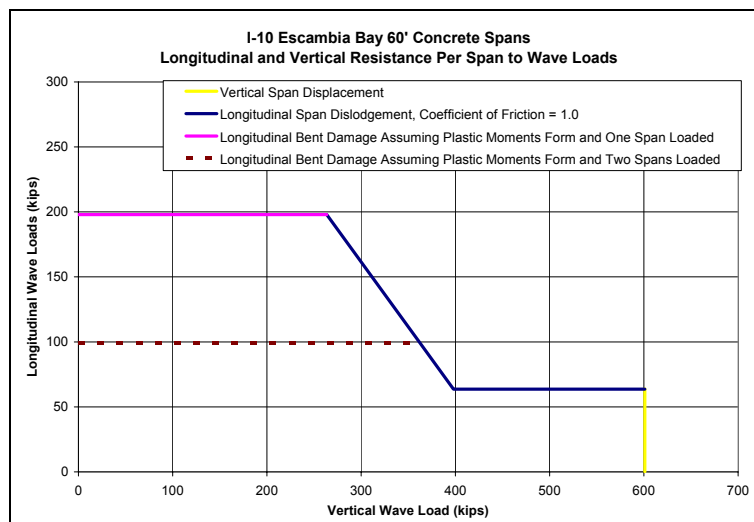
Figure 3.10 shows the failure envelope for longitudinal and vertical loads that was developed using linear programming.

Figure 3.10 – Failure Envelope for Lateral and Vertical Load

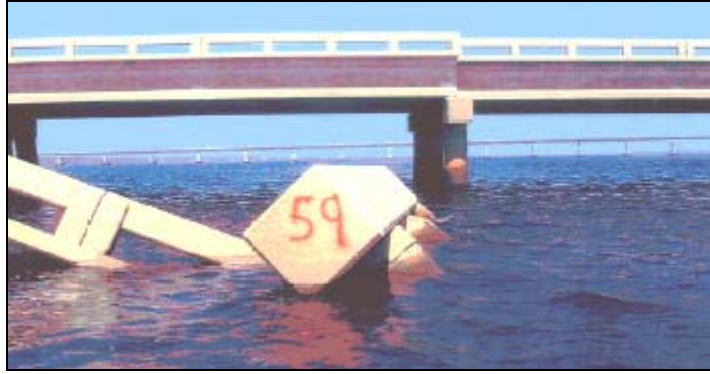
Available photographs of damage, such as Figure 3.11 and Figure 3.12, show longitudinal damage to bents and longitudinal displacement of spans. However, it is possible that the observed longitudinal bent damage occurred after the spans were displaced. It is also possible that the fasteners were failed by uplift loading prior to longitudinal displacement of the spans.

Figure 3.11 –Bent Exhibiting Longitudinal Damage on Escambia Bay Bridge  
Source: FDOT Damage Report

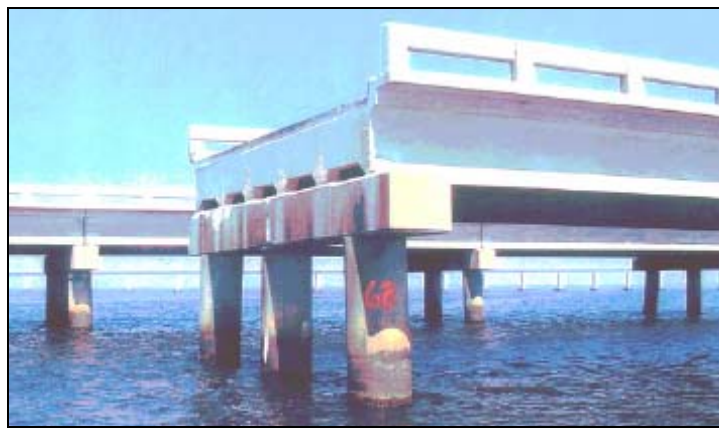
Figure 3.12 – Longitudinally Displaced Span on Escambia Bay Bridge  
Source: FDOT Damage Report
