Technical Memorandum

Re. Forensic Desktop Study Report: Mississippi LTPP Test Section 28_5025

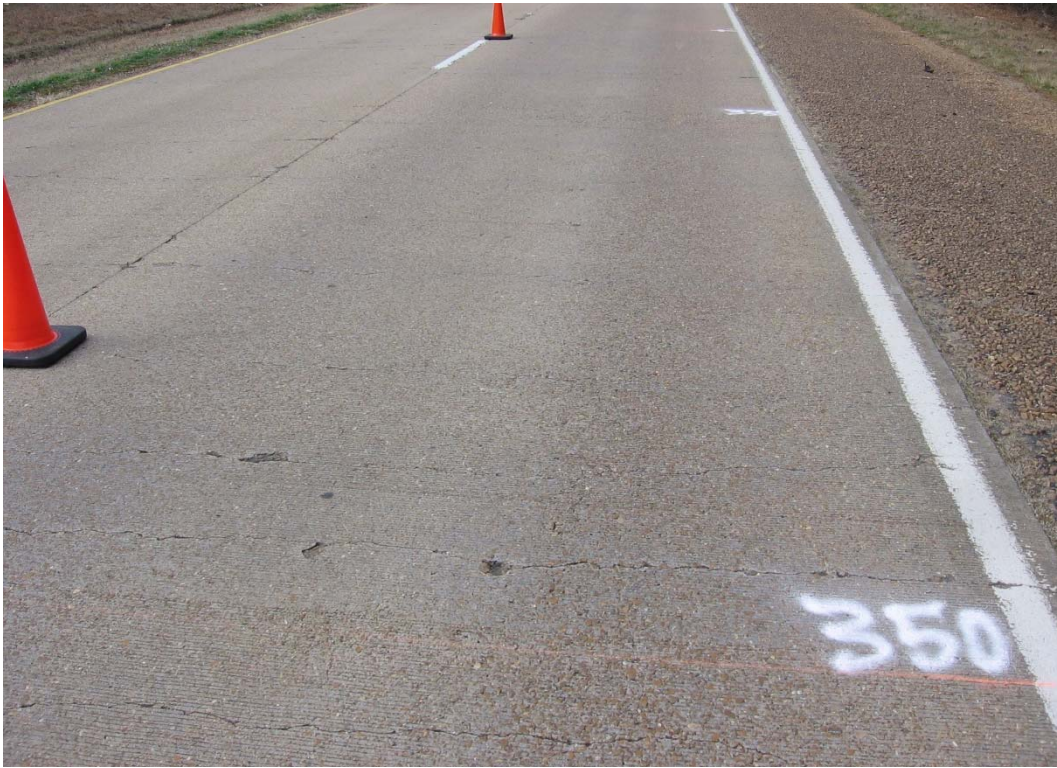
Photograph 1. Picture of test section 28_5025 in 2014 (Station 3+50 looking westbound).

LTPP test section 28_5025 is located on US Route 84, westbound, in Lincoln County, Mississippi. US Route 84 is a rural principal arterial with two lanes in the direction of traffic. It is classified as being in a Wet—No Freeze climate zone with an average annual precipitation ranging between 43.6 inches (2000) and 78.9 inches (2012) and an annual average air freezing index ranging between 0 Deg-F degree-days (multiple years) and 85 Deg-F degree-days (1989 and 1996) during the performance period in question (1978 to 2017). The coordinates of the test section are 3 31.54636, -90.44317. Photograph 1 shows the test section at Station 3+50 looking westbound in 2014 (last distress survey), while Map 1 shows the geographical location of the test section relative to Jackson, Mississippi and to Baton Rouge and New Orleans, Louisiana.

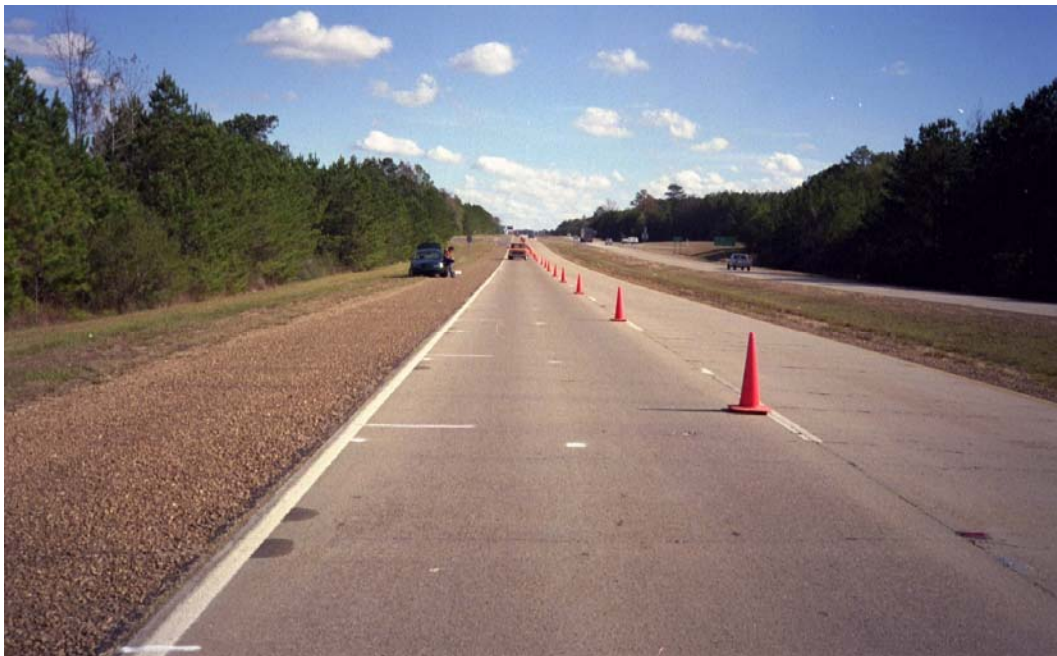
in Figure 10 taken during the distress survey performed in 1999, which was rated as the most severe pumping event, this appears to be water seeping to the pavement surface at cracks on the outside edge of the pavement and not eroding of the unbound subsurface layers typically associated the typical pumping mechanism on CRCP.

Figure 10. Photograph of test section 28_5025 taken during 1999 manual distress survey.

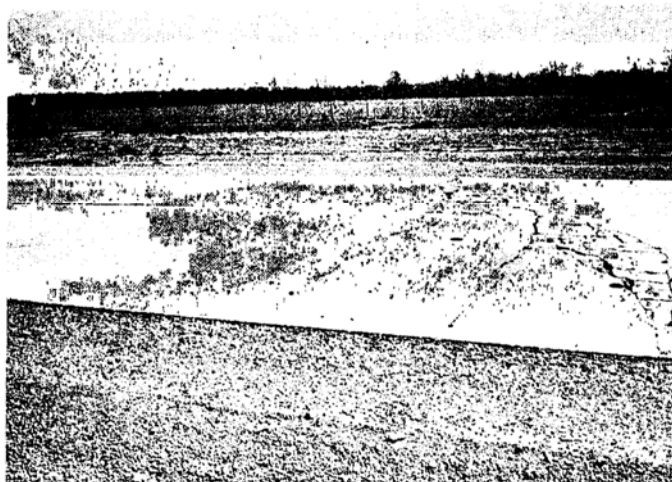
Slide 1

of the adjacent project that would be constructed later. As shown on slide 2, the contractor for the adjacent project has to bend the splicing steel in order to construct the base, subbase and subgrade. Under this condition, the construction joint for the sublayers can not be properly constructed to provide continuity and very often provides a weak plane when high stresses develop.

It is recommended that when a continuously reinforced concrete pavement project is to be continued with another project, special end construction arrangement be made to allow continuity of all base structure layers. This can be accomplished by requiring the first contractor to extend the base layers 30 to 50 feet beyond the termination station of the project.
