TPF-5(433) Behavior of Reinforced and Unreinforced Lightweight Cellular
Concrete (LCC) For Retaining Walls

**Interim Report on Test 3 of MSE Wall with Lightweight Cellular Concrete
Backfill**

May 2022

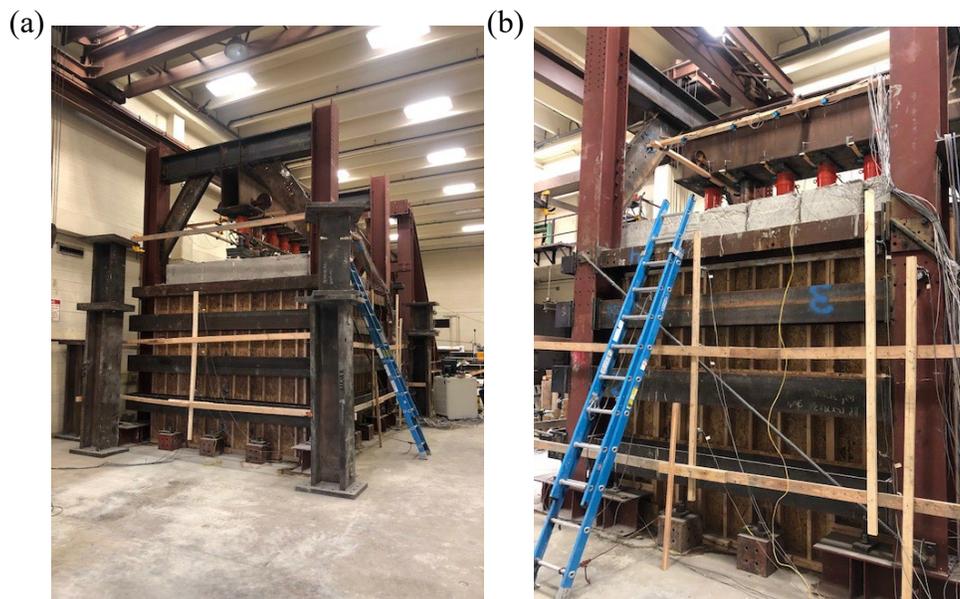
Photographs of the test box are provided in Fig. 2. For each test, we applied the surcharge load incrementally at 25,000 lbs to 50,000 lbs load increments or 2.8 psi to 5.5 psi pressure increments. For the test on the MSE retaining wall, load was applied to the first three surcharge blocks (6 ft) adjacent to the MSE wall as illustrated schematically in Fig. 3(a). For the test against the free face, with no retaining wall, load was applied to the first three surcharge blocks (6 ft) adjacent to the free face as illustrated schematically in Fig. 3(b). The load was quite uniformly distributed over the three blocks in each case, but settlement under each block could be different. Displacement of each block was monitored with three string potentiometers attached to an independent reference frame.

Fig. 2 Photographs showing: (a) the test box from the short side opposite from the retaining wall and (b) the test box from the long side with the concrete surcharge blocks and hydraulic jacks reacting against a longitudinal beam consisting of two deep beams.

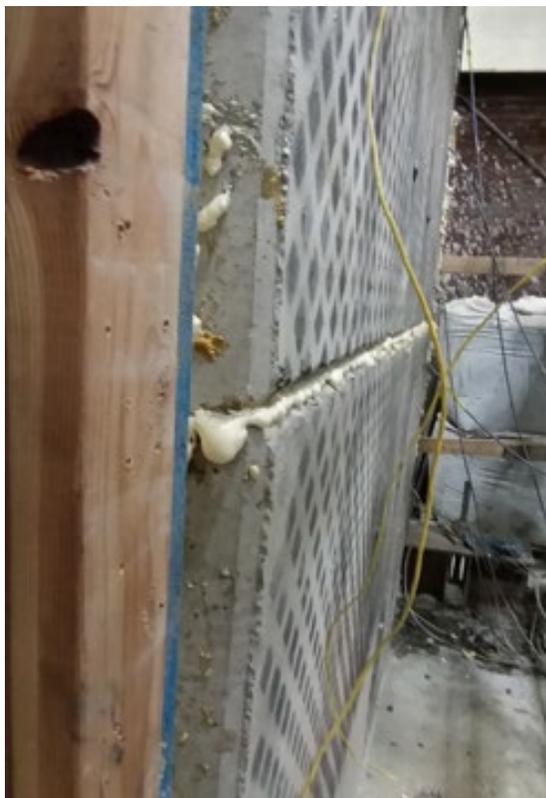
Based on the string potentiometer measurements on the front face of the MSE wall panels, horizontal wall deflection has been plotted as a function of height above the base of the wall for selected surcharge pressures in Fig. 10. The string pots were located at the height of the MSE reinforcement connections. All displacement were less than about 0.1 inch for surcharge pressures up to 53 psi. At the peak surcharge pressure of 67 psi, wall deflection exceeded 0.40 inch at the top of the wall with deflection of about 0.1 inch at the bottom. As the strength decreased post-peak, the displacement of the MSE wall panels accelerated with the maximum value ultimately occurring at the joint between the two wall panels (5 ft height). Overall, displacements of the top panel were greater than those on the bottom panel.

Fig. 10 Photograph of (a) MSE wall panel deflection after the test, and (b) measured horizontal deflection of the wall versus height above the base of the wall for selected surcharge pressures.

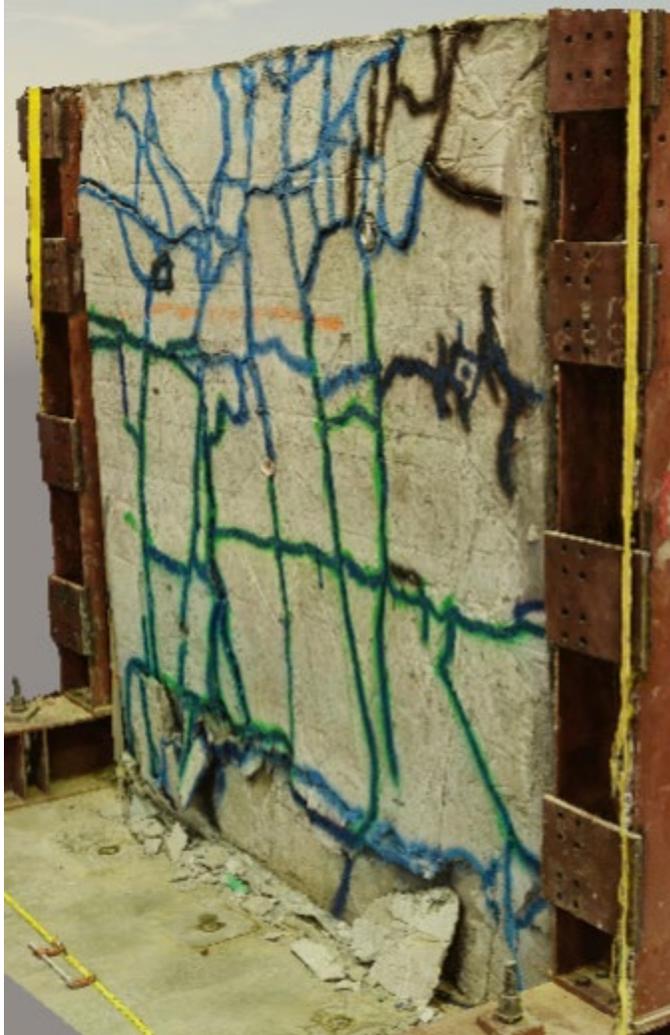
A photograph of the free face at the completion of the surcharge loading adjacent to the free face is shown in Fig. 13. All the cracks were spray painted to highlight their location, and all the paint was intended to be blue. The cracks consist of both vertical, horizontal, and inclined cracks. The large horizontal crack 1 ft to 1.5 ft above the bottom of the free face appears to be where the log spiral failure plane surfaced. Surcharge loading was halted to prevent the failing LCC from damaging the instrumentation and steel box.

Fig. 13. Photograph of the crack pattern in the LCC on the free face opposite to the MSE wall side.
