Test and Evaluation Report

Project: DTFH61-C-98-00050

Testing and Evaluation of the PERES II Bridge Inspector

Wiss, Janney, Elstner Associates, Inc.

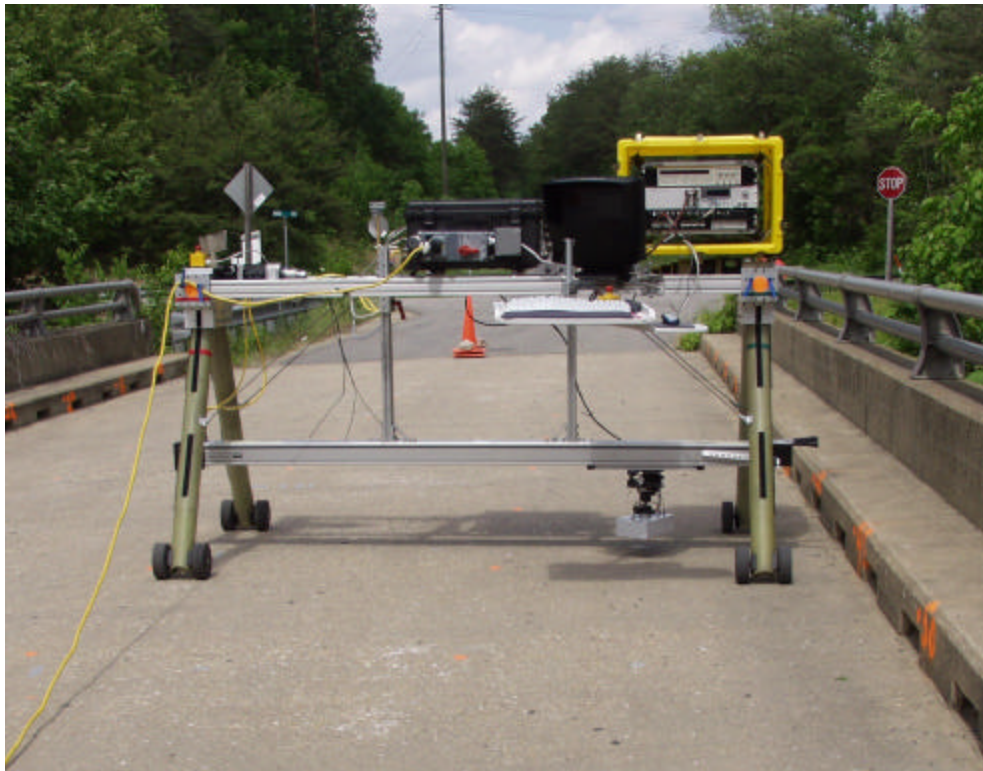
Figure 1. PERES II cart collecting data on the Van Buren Road Bridge.

The configuration of the PERES II prototype provides a logical technical approach to addressing the needs identified in Section 1.3. In addition, knowledge gained through experiences reported on in the original HERMES project [4] has been applied to the practical and technical design of the new system. A photograph of the new PERES II system is presented in Figure 1.

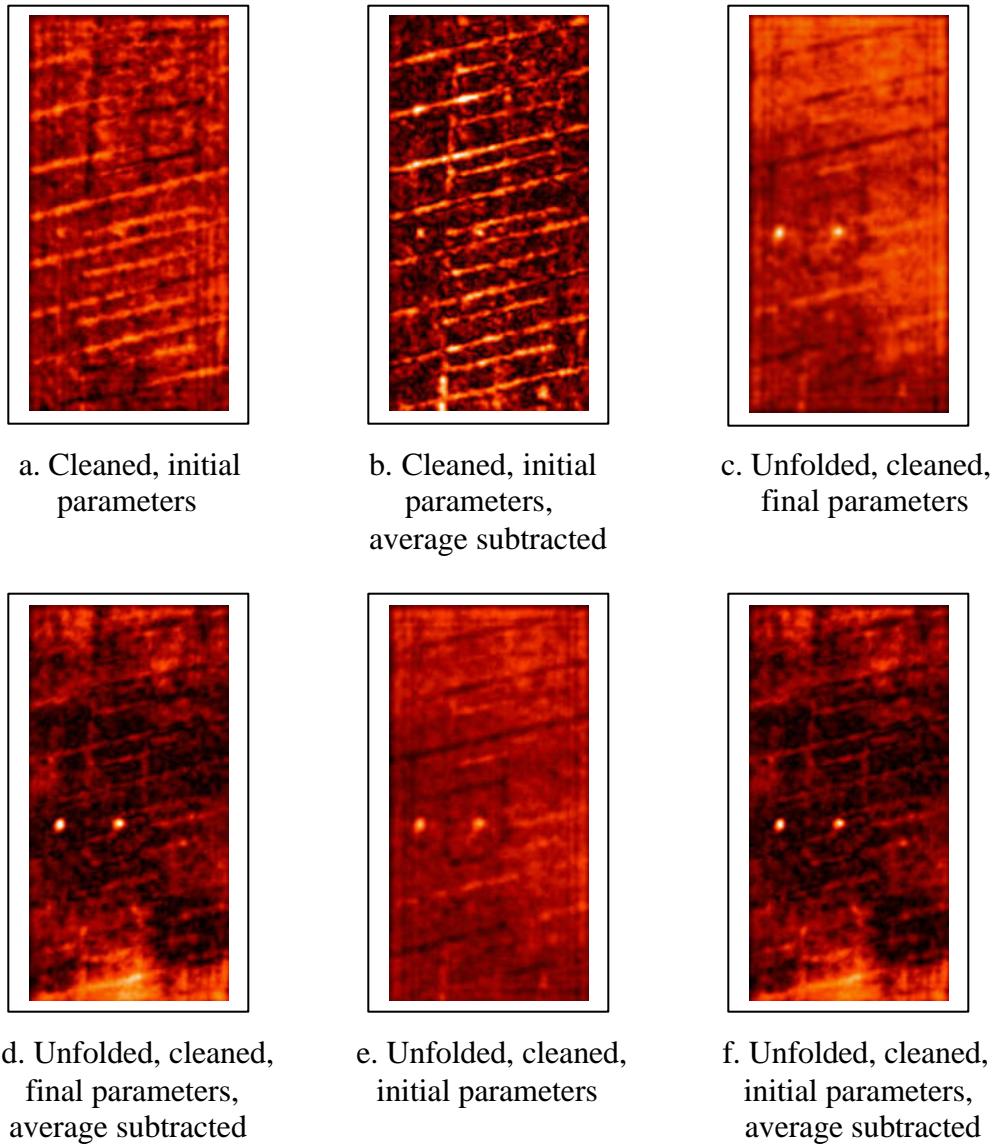
Figure 6. Data reconstruction results for a 3 m x 1.5 m area of the Van Buren Road Bridge deck for a variety of data processing methods.

All six of the images in Figure 6 were produced using the same data, collected using PERES II on the Van Buren Road Bridge deck. The only differences between these images are

the methods that were used to process the data. All of the images present reconstructed data from the top mat of reinforcing steel inside the deck. Although useful information can be obtained from all of these images, the image in Figure 6b provides the highest contrast, the most accurate focus and has the fewest indications of clutter. The clear, precise imaging of the reinforcing steel below the deck illustrates the quality of this image. This discussion clarifies how important appropriate processing parameters and procedures are for effective data

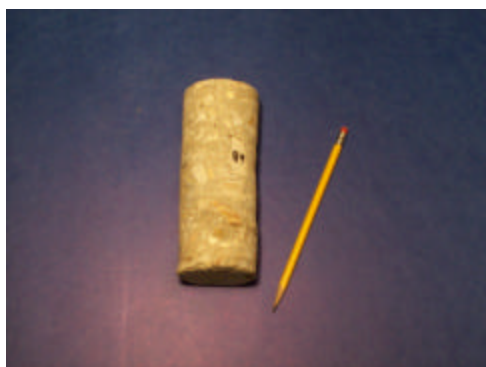
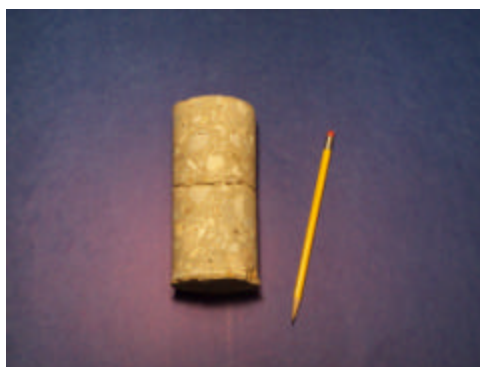
Figure 15. (a) Core #8 (solid) and (b) core #6 (delaminated) from Van Buren Road Bridge.

Core	Result
1	Delaminated
2	Delaminated
3	Solid
4	Solid
5	Solid
6	Delaminated
7	Delaminated
8	Solid
9	Delaminated
10	Solid

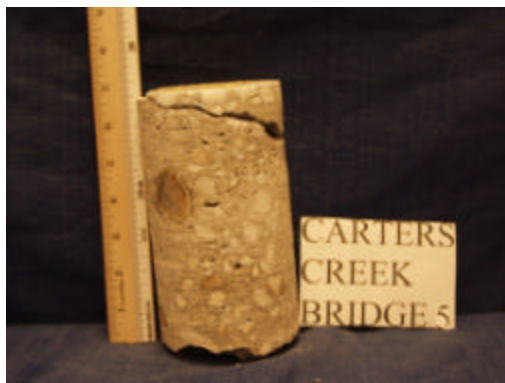
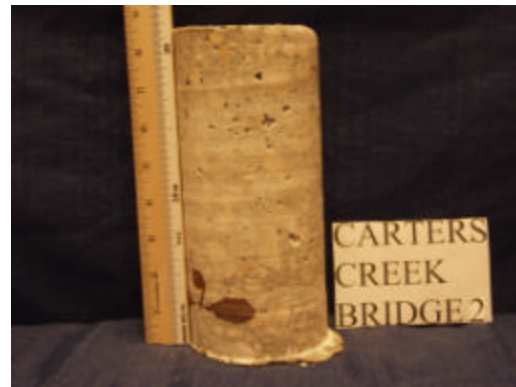
Figure 16. (a) Core #5 (delaminated) and (b) core #2 (solid) from Carter's Creek Bridge.

Core	Result
1	Solid
2	Solid
3	Solid
4	Solid
5	Delaminated
6	Solid
7	Solid

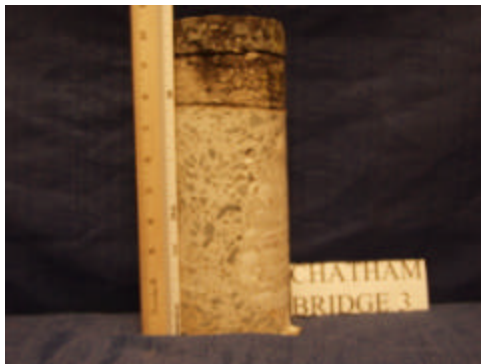
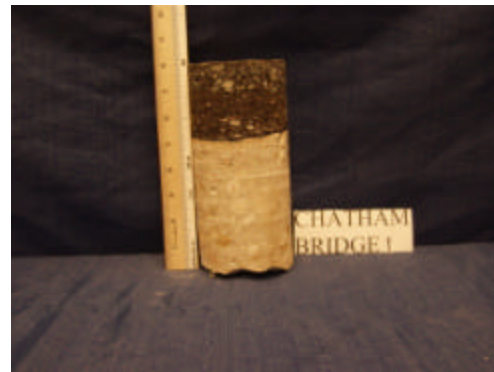
Figure 17. (a) Core #3 (concrete patch) and (b) core #1 (solid) from Chatham Bridge.

Core	Result
1	Solid
2	Delaminated
3	Subsurface Concrete Patch
4	Subsurface Concrete Patch
5	Solid
6	Solid
7	Solid

PERES II test results from the Chatham Bridge indicate that PERES II can image basic bridge deck features effectively through asphalt, such as a concrete patch or reinforcing steel. The quality of the PERES II images is illustrated by data presented in Figure D5. Here, two relatively short sections of data are presented for review. Technical difficulties with PERES II precluded more data from being collected at this bridge. Even though a relatively short section of data was obtained from Chatham Bridge, some interesting results were produced. For example, cores 3 and 4 were both observed to contain concrete patch material, which appears to be indicated by an increased magnitude response in the lower left corner of the PERES II data,

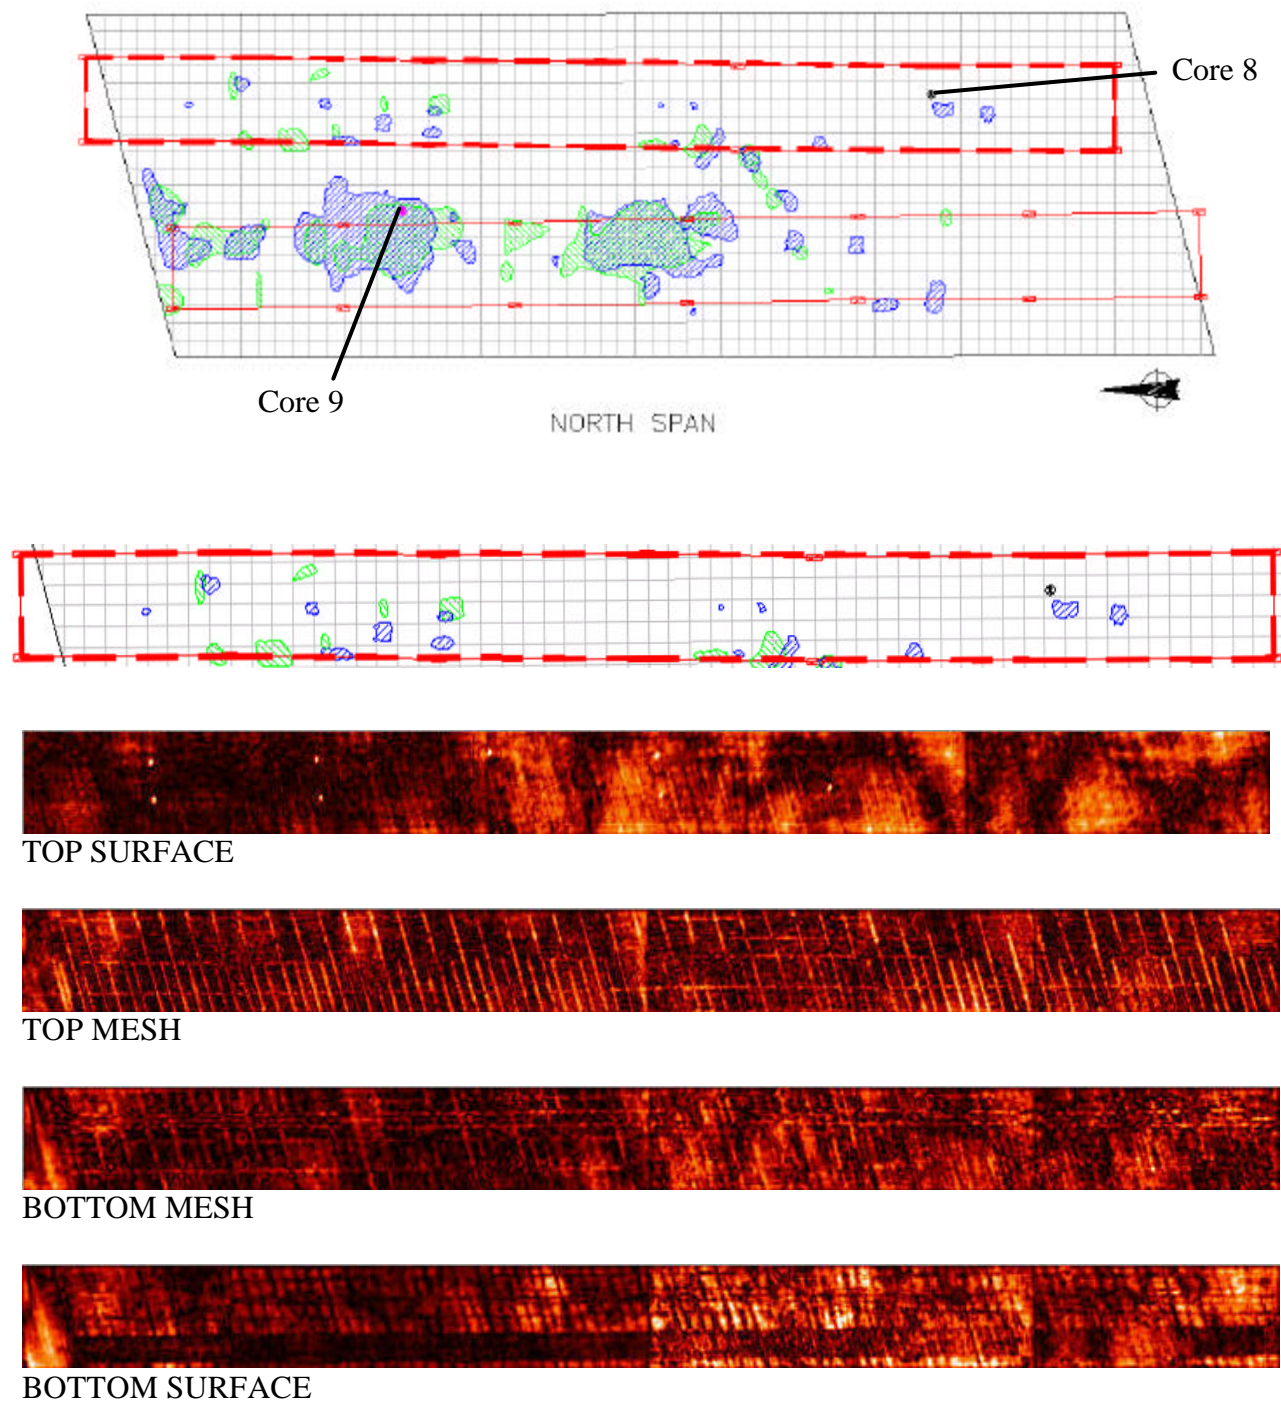
Figure D1. Van Buren Bridge north span, north bound data.

The middle two images, labeled as the top and bottom reinforcing steel mesh layers, illustrate typical PERES II responses to reinforcing steel. The top mesh clearly captures the skew of the reinforcing steel and the locations toward the bottom of the image where additional reinforcing steel appears. This additional steel reduces the spacing of the steel in the transverse direction to half that observed in the upper half of the image. This section of data does not present many opportunities for comparison to delaminated areas detected by sounding, and the areas that do offer a comparison between ground truth and PERES II data do not demonstrate an any significant correlation between them. However, it is significant that the reinforcing steel and solid concrete in this illustrated section is effectively imaged. The bottom reinforcing steel mesh is not clearly imaged, particularly relative to the top mesh.

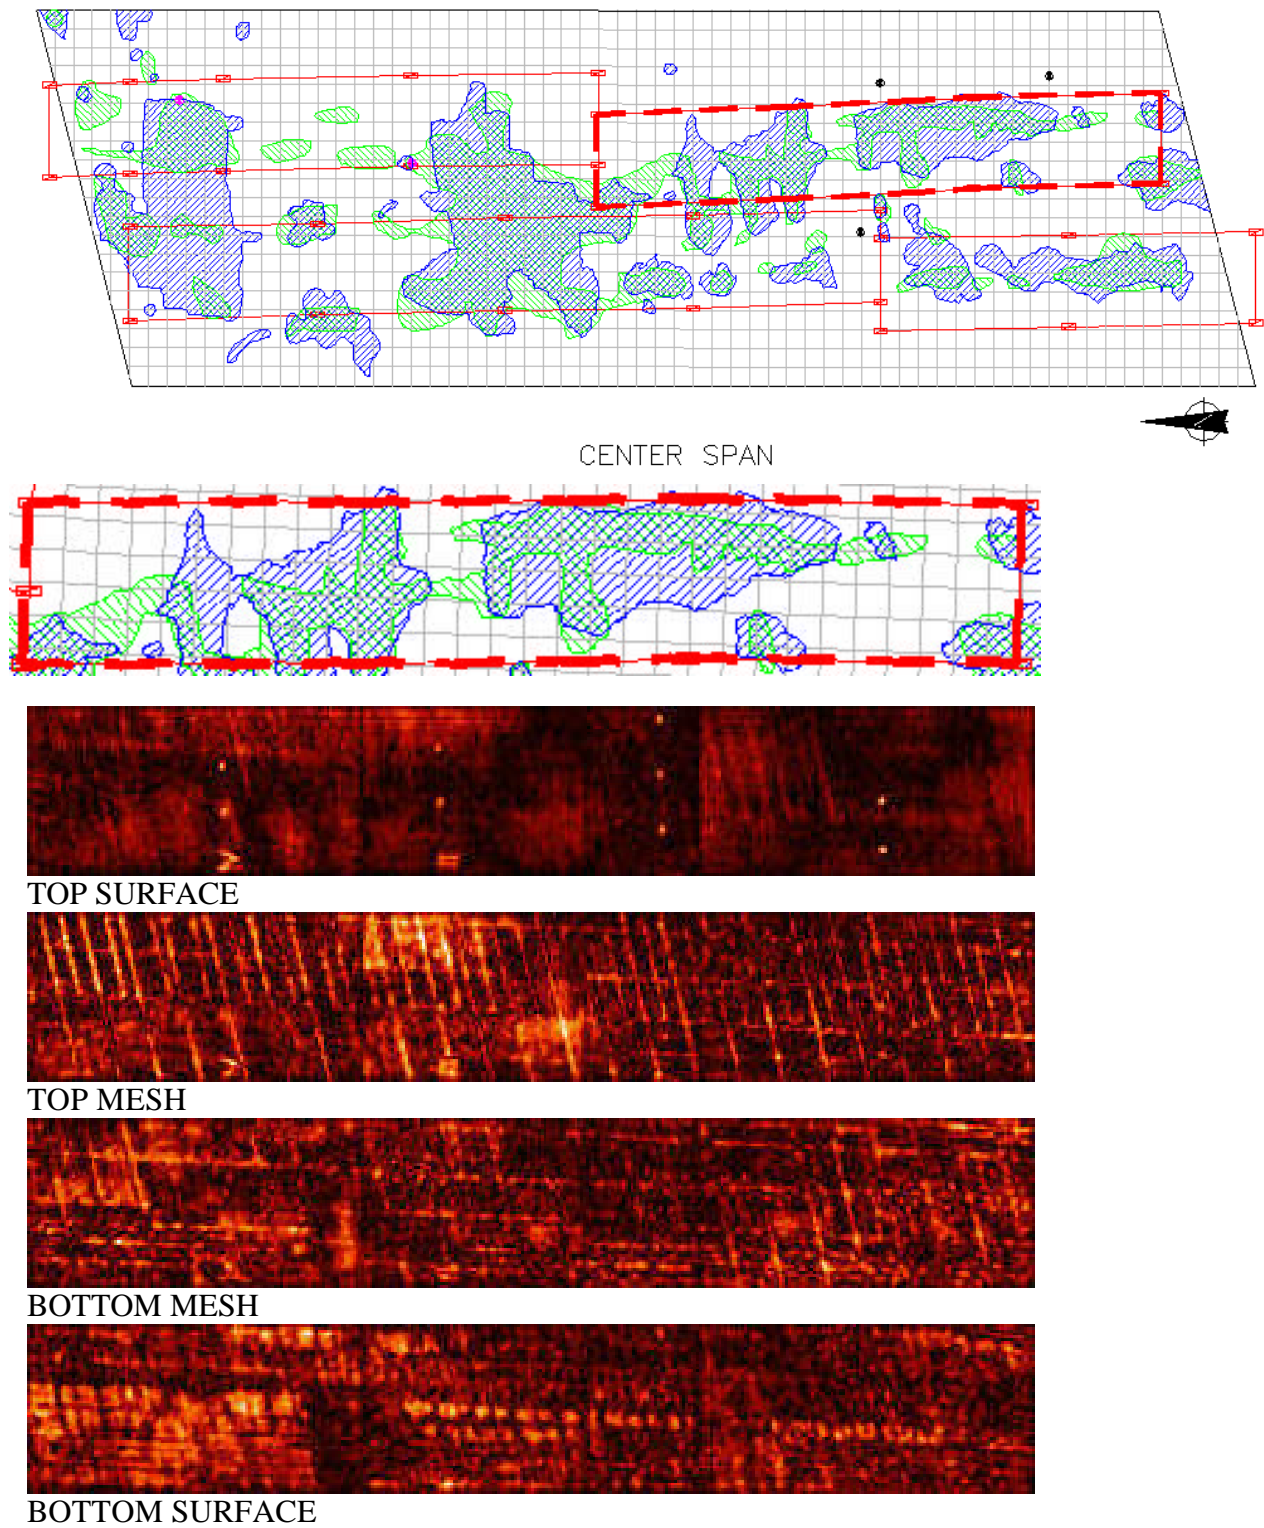
Figure D3. Van Buren Bridge center span, north bound data set 2.
