The Deleterious Chemical Effects of Concentrated Deicing Solutions on Portland Cement Concrete

Study SD2002-01
Final Report

Prepared by
Michigan Tech Transportation Institute
1400 Townsend Drive
Houghton, MI

April 2008

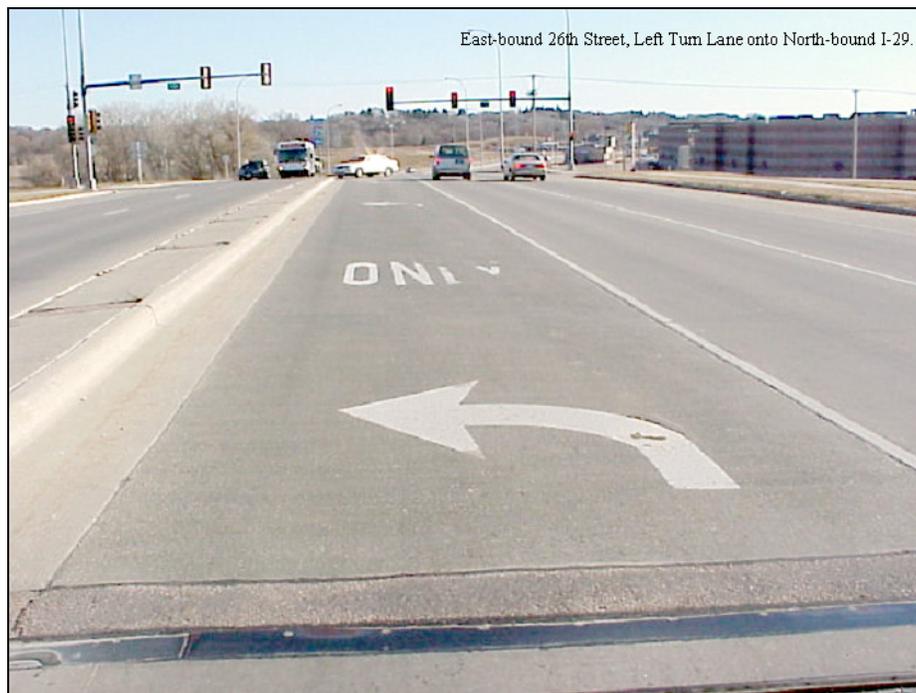
Figure 4.2. Photograph of core site.

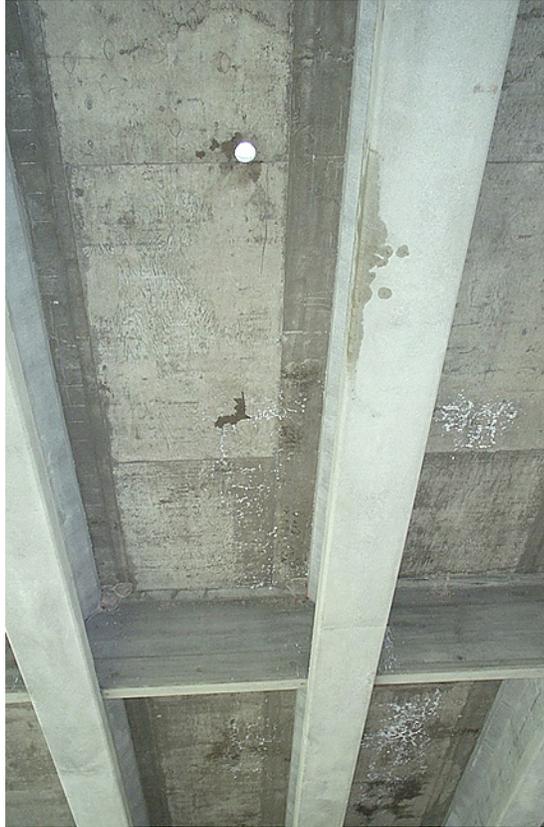
Figure 4.28. Photograph from beneath bridge deck after coring operation. Hole from core T-2 is visible. Dampness permeating through cracks visible beneath the area of core T-1. White efflorescence common in areas directly below regions covered with cold patch material.

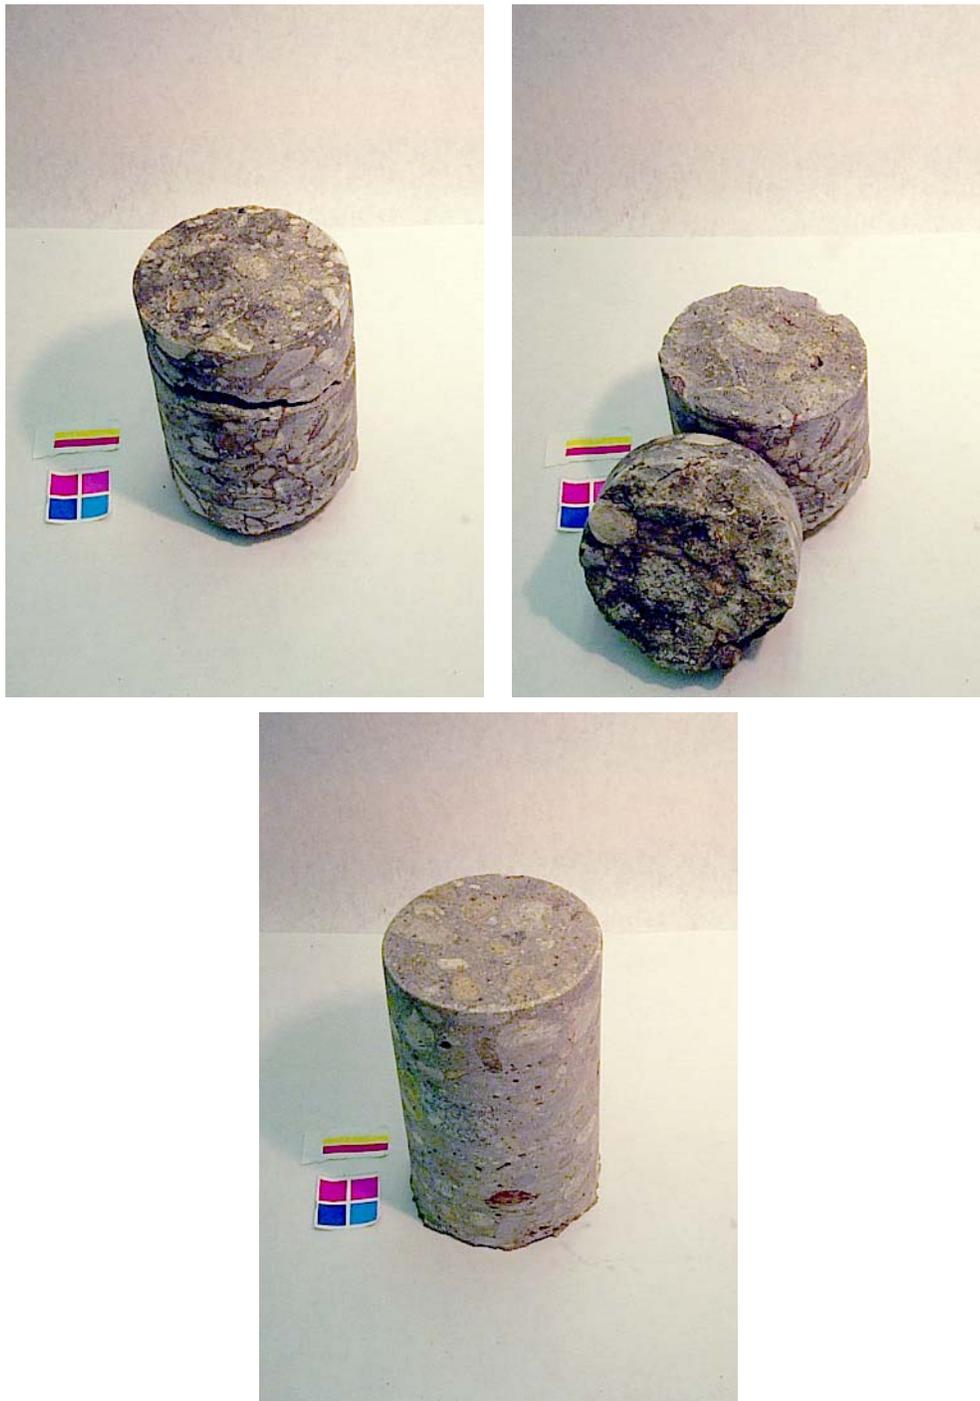
Figure 4.29. Cores retrieved from site, core T-1 (top), core T-2 (bottom).

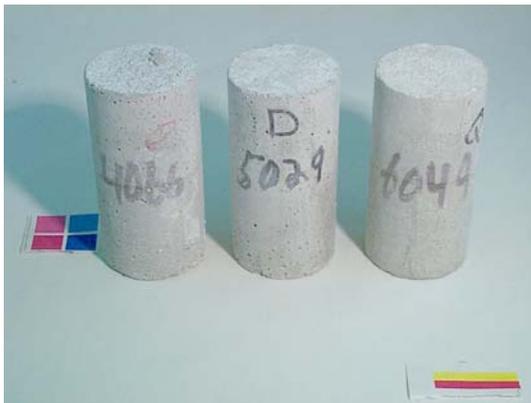
Figure 5.1. Cylinders exposed to NaCl solution after 84 days of constant low temperature test. From left to right: 0.40, 0.50, and 0.60 w/c mortar cylinders.

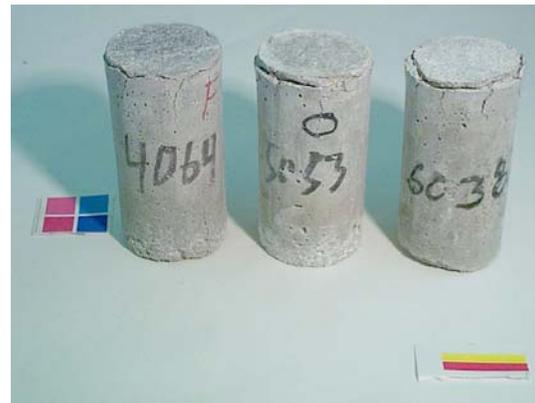
Figure 5.2. Cylinders exposed to MgCl₂ solution after 84 days of constant low temperature test. From left to right: 0.40, 0.50, and 0.60 w/c mortar cylinders.

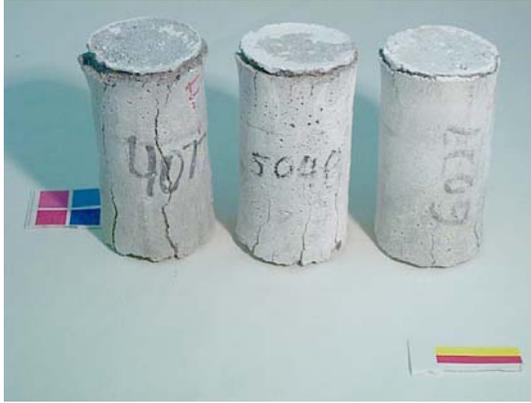
Figure 5.3. Cylinders exposed to CaCl_2 solution after 84 days of constant low temperature test. From left to right: 0.40, 0.50, and 0.60 w/c mortar cylinders.

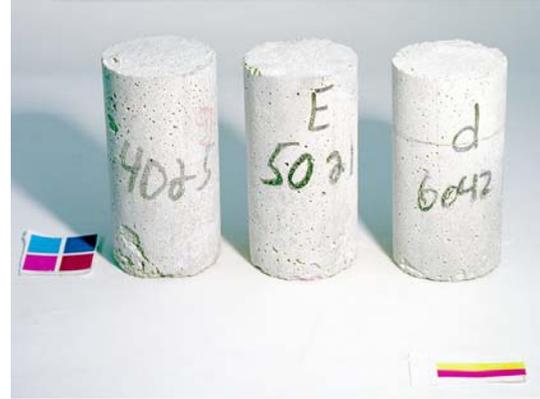
Figure 5.4. Cylinders exposed to CMA solution after 84 days of constant low temperature test. From left to right: 0.40, 0.50, and 0.60 w/c mortar cylinders.

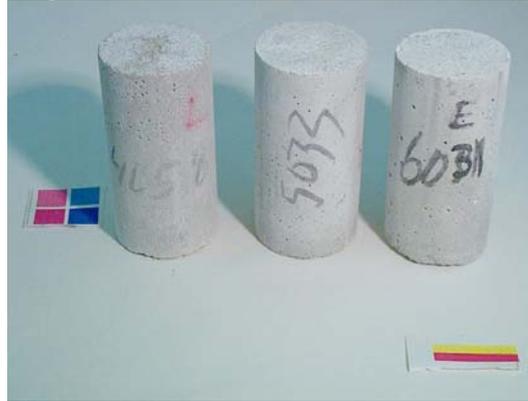
Figure 5.5. Control cylinders exposed to limewater solution after 84 days of constant low temperature test. From left to right: 0.40, 0.50, and 0.60 w/c mortar cylinders.

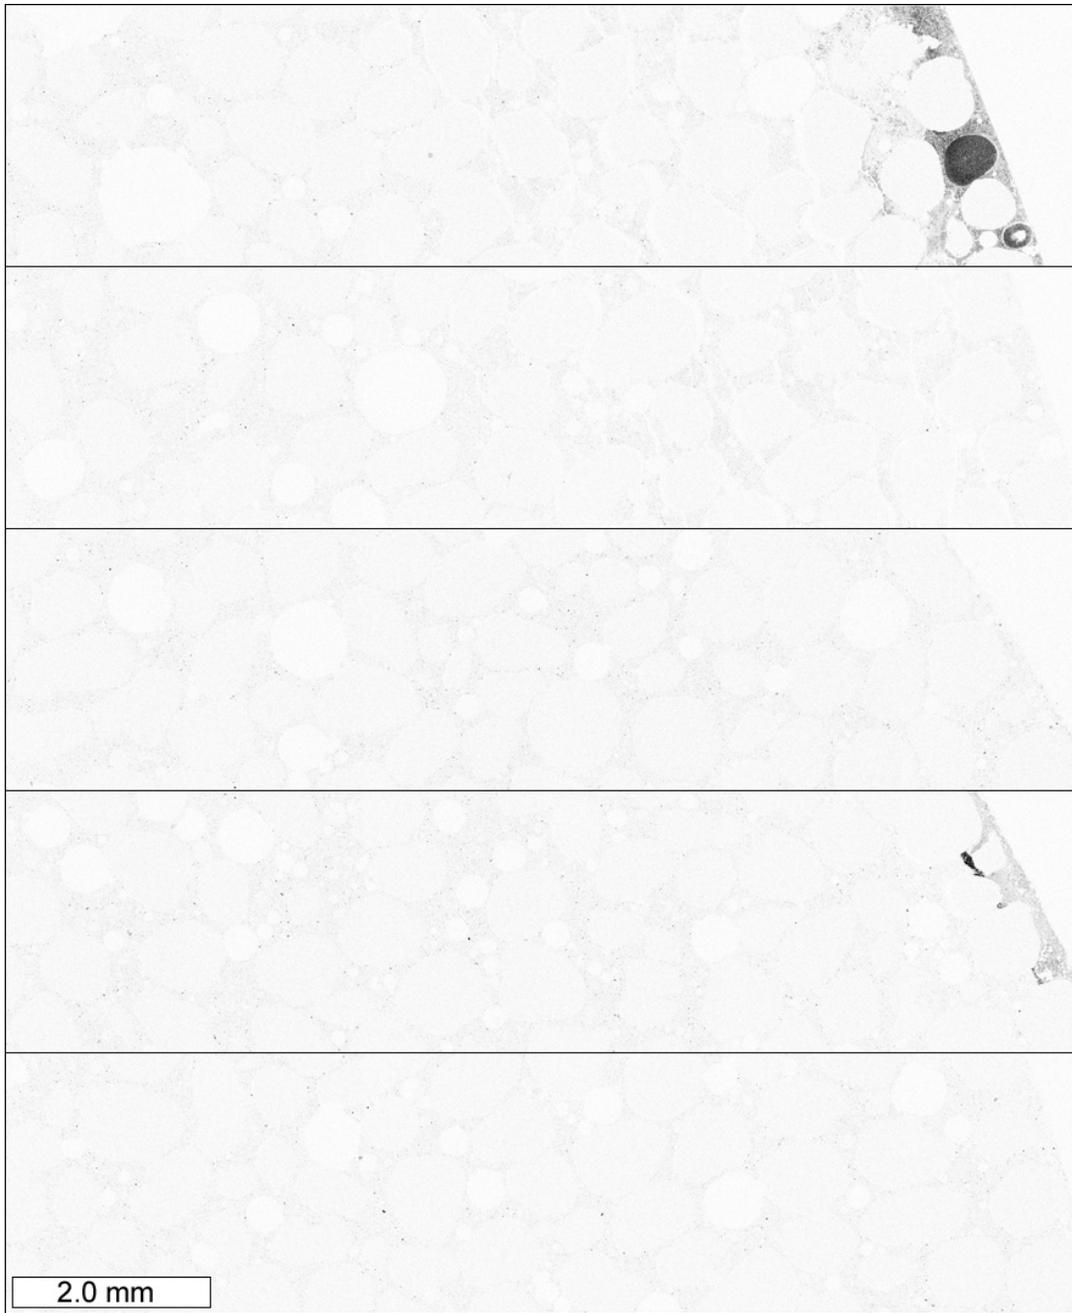
Figure 5.11. Elemental map for magnesium collected from thin sections prepared from mortar cylinders immersed in chemical solutions.

From top to bottom: magnesium chloride, calcium chloride, sodium chloride, calcium magnesium acetate, and limewater. Darker areas indicate a higher concentration.

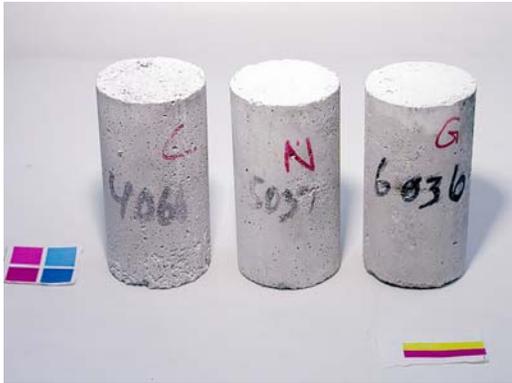
Figure 5.25. Cylinders exposed to 3% CaCl_2 solution after 56 days of constant low temperature test.
From left to right: 0.40, 0.50, and 0.60 w/c.

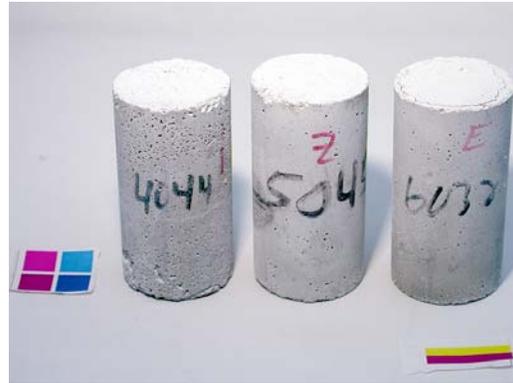
Figure 5.26. Cylinders exposed to 7% CaCl_2 solution after 56 days of constant low temperature test.
From left to right: 0.40, 0.50, and 0.60 w/c.

As can be seen clearly in Figures 5.25 through 5.29, concentration clearly has an affect on the observed damage at a given time for mortars exposed to the low temperature test.

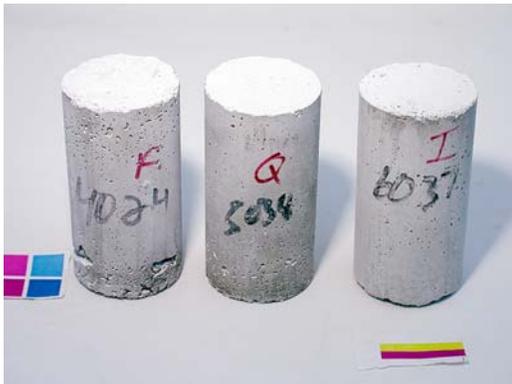
Figure 5.27. Cylinders exposed to 10% CaCl_2 solution after 56 days of constant low temperature test.
From left to right: 0.40, 0.50, and 0.60 w/c.

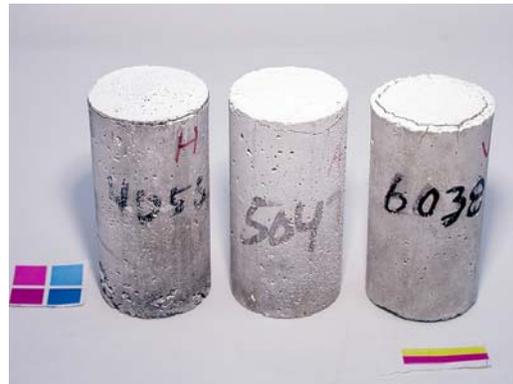
Figure 5.28. Cylinders exposed to 14% CaCl_2 solution after 56 days of constant low temperature test.
From left to right: 0.40, 0.50, and 0.60 w/c.

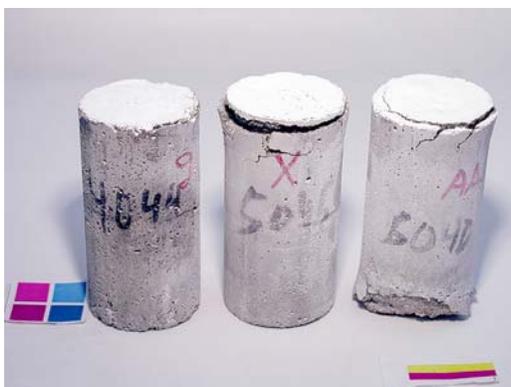
Figure 5.29. Cylinders exposed to 17% CaCl_2 solution after 56 days of constant low temperature test. From left to right: 0.40, 0.50, and 0.60 w/c.

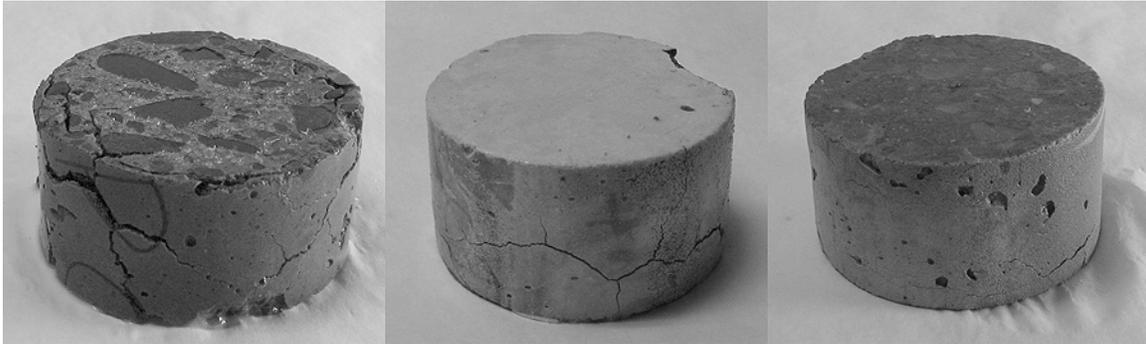
Figure 5.50. Photographs of 4 inch [100 mm] diameter 0.45 w/c ordinary portland cement (OPC) concrete specimens after 500 days in high concentration brines. From left to right: CaCl_2 , MgCl_2 , and MBAP brines.

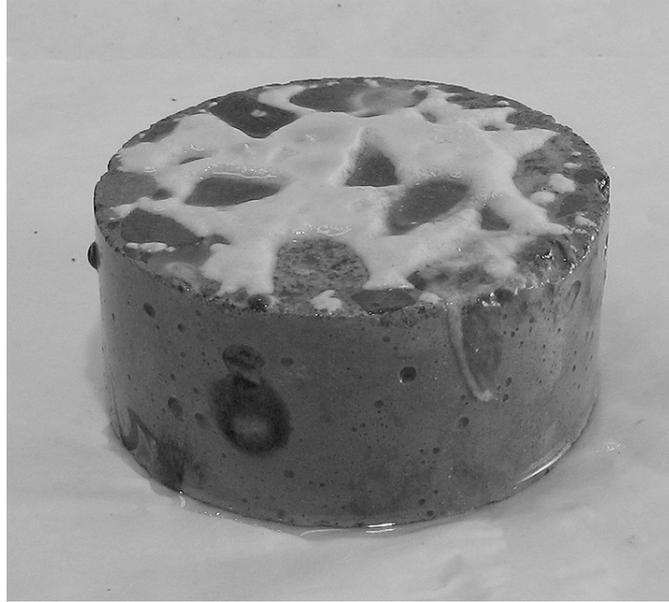
Figure 5.52. White precipitate on exterior of 4 inch [100 mm] diameter concrete specimen after 500 days immersion in low-concentration CMA solution.

A coating of mineral precipitates can be seen on the specimens in Figure 5.50. Mineral coatings were typically observed on specimens from the CaCl_2 , MgCl_2 , and MBAP brines. The mineral precipitates on the specimens from the MgCl_2 brine were white and very fine grained. Similar white precipitates were present on the specimens from the MBAP brine, but to a lesser degree. The mineral precipitates on the specimens from the CaCl_2 brine consisted of slender translucent crystals, examples of which are shown in Figure 5.51. External precipitates were not observed on specimens from the other brines, with the exception of specimens immersed in the low-concentration CMA brine. Figure 5.52 illustrates the white very fine-grained precipitate present on the surface of a specimen from the low-concentration CMA brine. Several circular deposits of black mold can also be observed along the sides of the specimen in Figure 5.52.

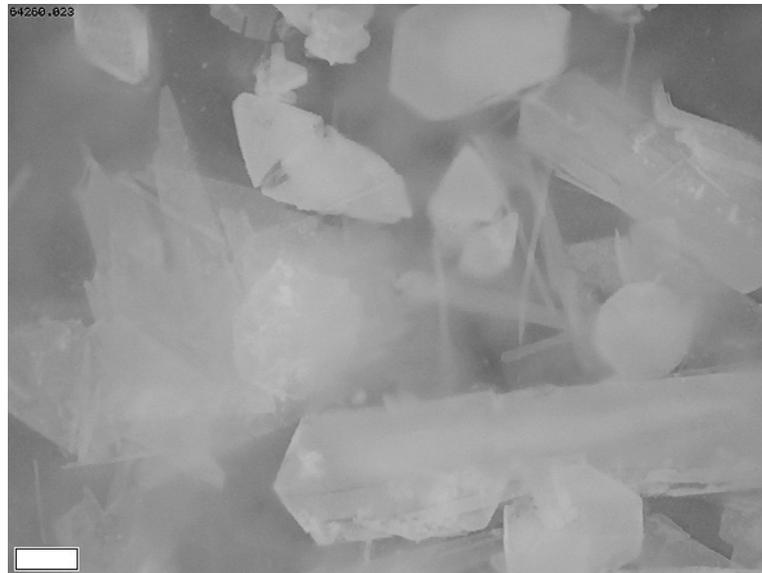
**Figure 5.70. $\text{CaCl}_2 \cdot \text{Ca}(\text{OH})_2 \cdot 2\text{H}_2\text{O}$ crystals before, (top) and after immersion in distilled water in atmospheric equilibrium with CO_2 at room temperature and subsequent alteration.
(Bottom) scale bar = 1 mm.**

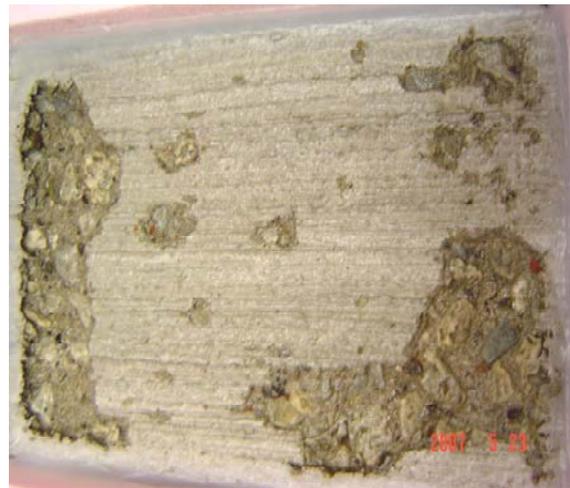
Figure 5.119. Photographs of concrete surfaces at cycle 50 (a) pretreated with 23% NaCl and tested with 3% NaCl and (b) pretreated with 22% CaCl₂ and tested with 4% CaCl₂.

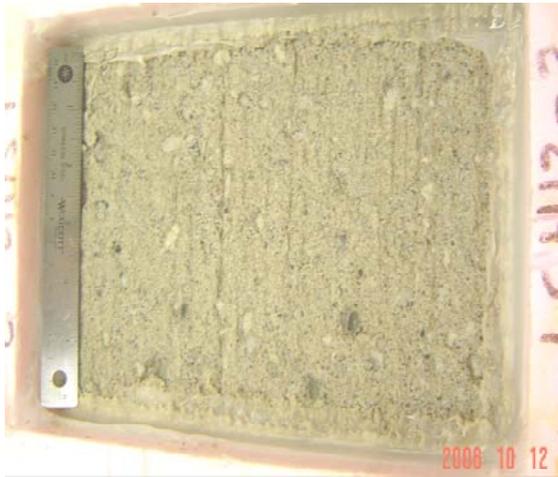
Figure 5.120. Photographs of concrete surfaces at cycle 100 (a) pretreated with 23% NaCl and tested with 3% NaCl and (b) pretreated with 22% CaCl₂ and tested with 4% CaCl₂.
