**Report No.
CVEEN-02/02**

**FATIGUE TESTS OF CRACKED AND
REPAIRED ALUMINUM CONNECTIONS
OF OVERHEAD SIGN STRUCTURES –
INTERIM REPORT**

**New York State Department of Transportation
Utah Department of Transportation**

June 2002

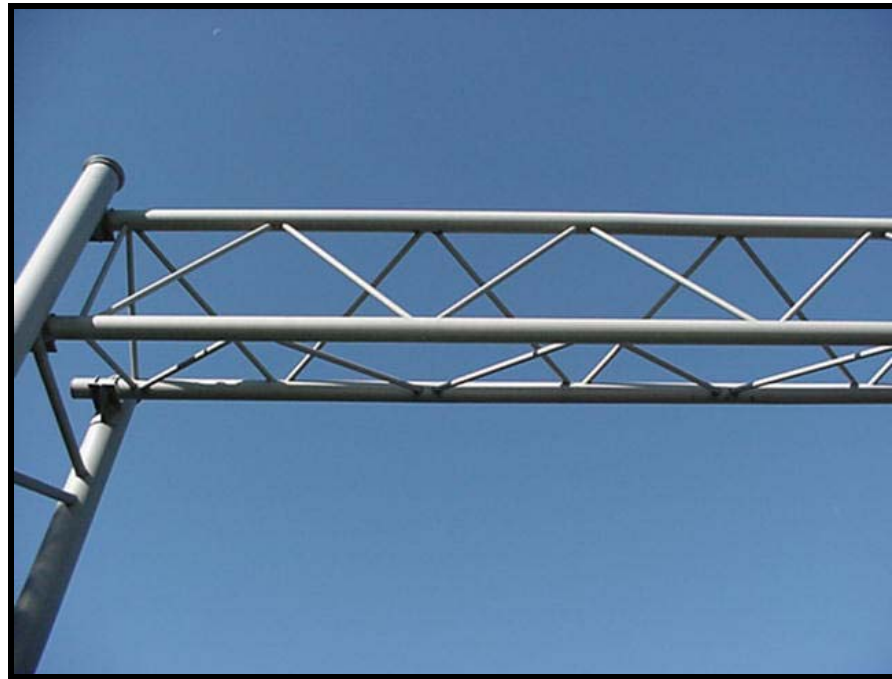
Fig. 1. Tri-truss aluminum overhead sign support structure

Cracks in the welds of aluminum overhead sign structures can propagate to complete failure of members, which can cause signs to fall and cause injuries. The truss considered here is a 3D truss, or tri-truss system, as shown in Fig. 1. Figure 2 shows a typical crack in a welded aluminum connection, which typically occurs due to thermal and fatigue stresses.

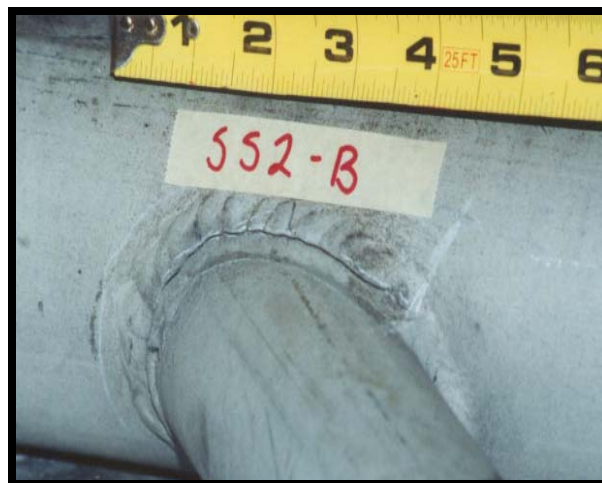
Fig. 2. Crack through aluminum-welded joint of overhead sign structure

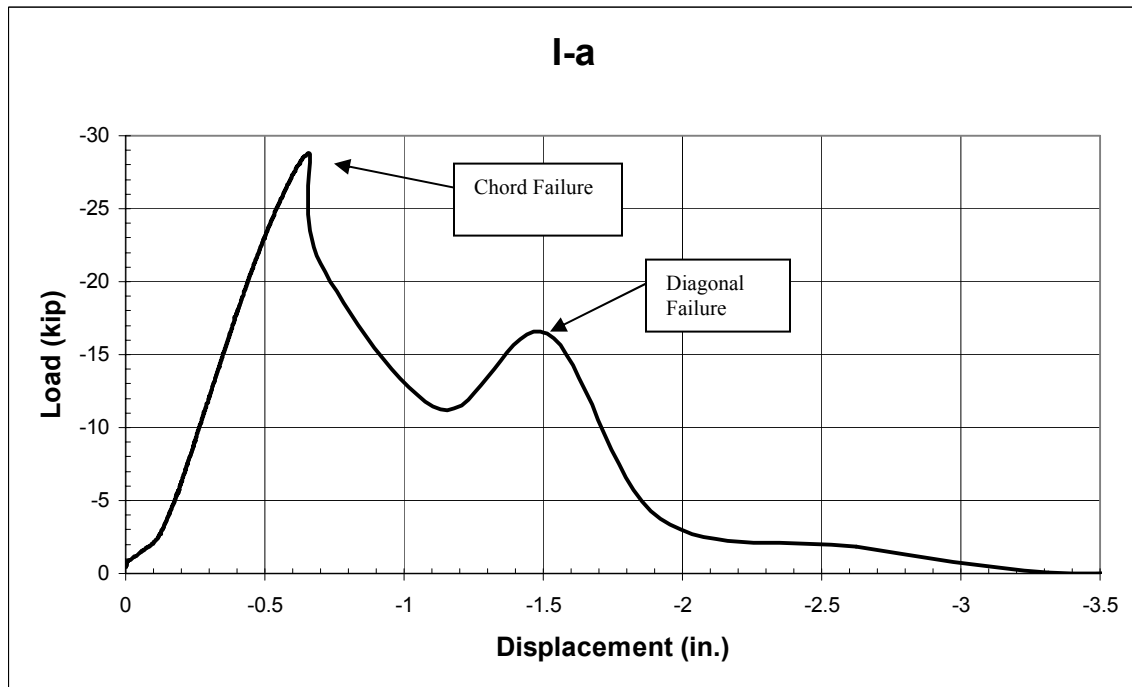
Fig. 6. Test I-a Load vs. Displacement curve

Static tests I-a and I-b had a similar failure mode and load/displacement curve. Failure occurred at the toe of the weld and continued almost entirely around the chord, as can be seen in Fig. 5. Immediately following failure of the chord the diagonal was subjected to combined tensile and bending stress, due to the large deflection of the chord, which subsequently caused the diagonal to fail as seen in Fig. 6. This failure of the diagonal was secondary to the failure of the chord.

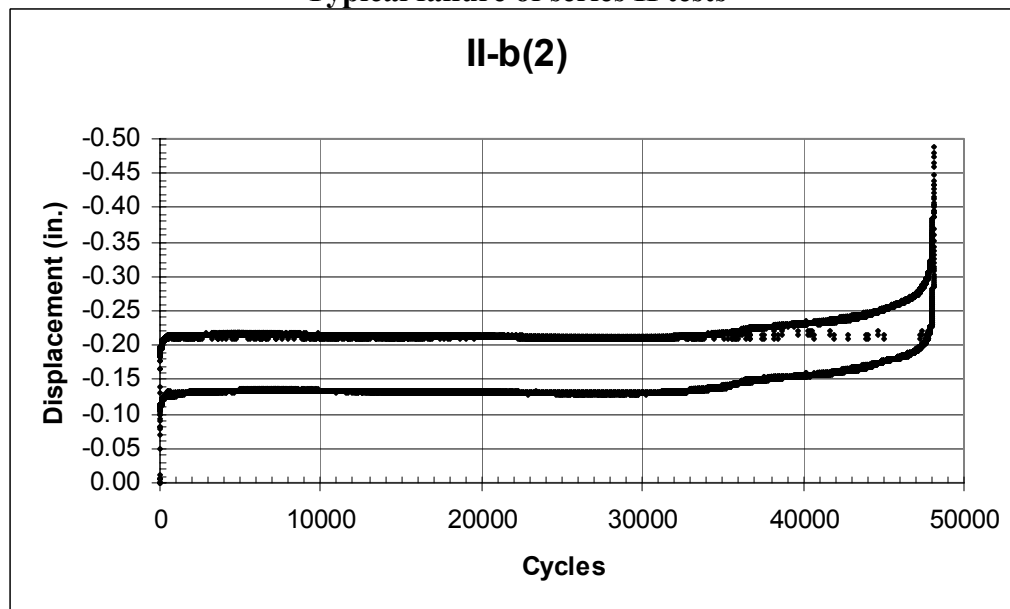
Fig. 8. Typical displacement of series II tests, test II-b is shown

Series (II) tests all had a similar failure mode and displacement/cycle curve. The typical failure is seen in Figs.7 and 8. The failure started with a crack at the toe of the weld; the crack propagated into the base material, and would have continued around the chord – similar to the failure of the series I tests. However, the steel pipe inside the chord forced the crack to propagate through the base material outside the weld, a distance of $\frac{1}{2}$ " to 1" following the weld contour, as shown in Fig. 7(b). Figure 8 shows the typical displacement vs. number of cycles curve for the Series (II) tests. The top line shows the displacement at the maximum stress (0.22in.) and the bottom line shows the displacement at the minimum stress (0.13in.). At approximately 31,000 cycles the displacements start to increase indicating gradual degradation to failure.

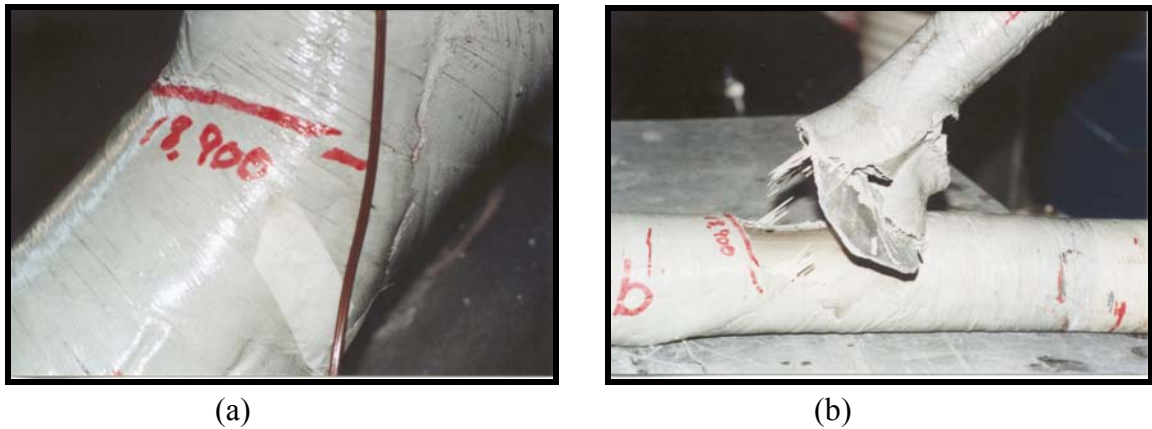
Fig. 11. (a) Initial cracking of FRP composite, (b) Failure of Base Material, Weld, and FRP composite

The second failure mode seen in the Series (III) tests is shown in Fig. 11 and Fig. 12. This failure was seen in tests III-b and III-c. In this failure mode cracking was seen on the FRP first. This cracking was directly above the initial crack of the aluminum induced during the test at the toe of the weld; this failure was not through the throat of the weld. This crack at the toe of the weld propagated around the chord, similar to the failure mode of Series (II) tests. As can be seen in Fig. 12, this occurred between 8,000 and 12,000 cycles. Next the weld was slowly fatigued, this occurred in the throat of the weld, until the weld completely fractured. This was followed by tensile failure of the FRP composite.

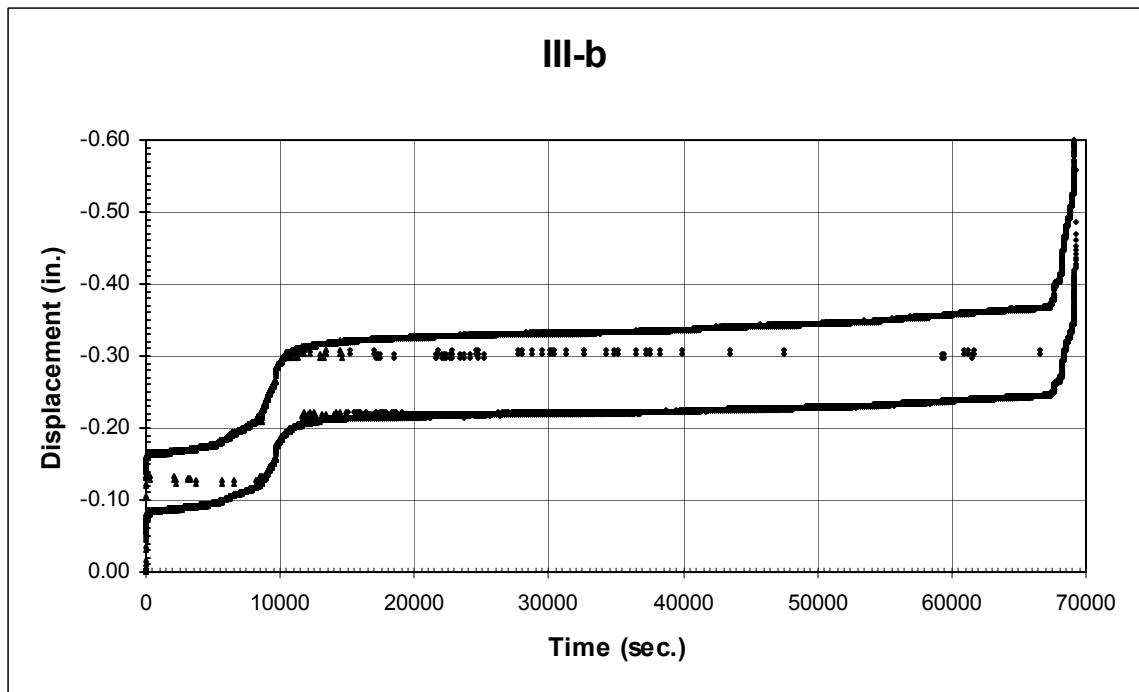
Fig. 12. Displacement vs. Cycles curve for test III-b

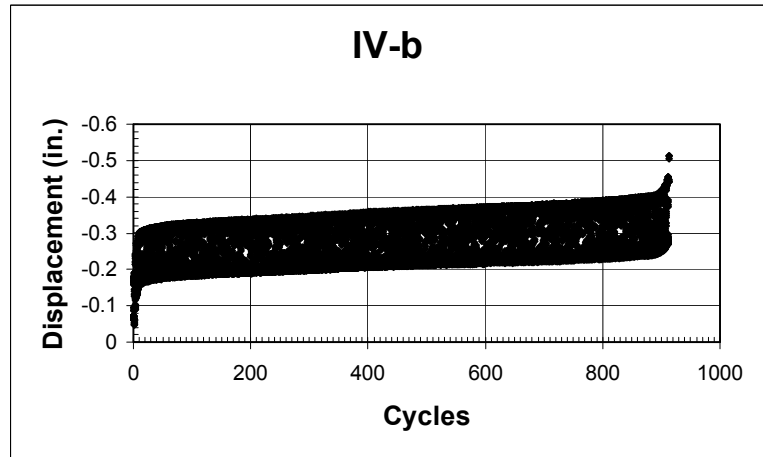
Fig. 16. Displacement vs. Cycles curve for test IV-b

Series (IV) tests had two failure modes, adhesive and FRP composite tensile failure. The adhesive failure occurred in tests IV-a (1) and IV-c. The adhesive failure of test IV-c is shown in Fig. 15. This failure is identical to the adhesive failure described in a previous report regarding static tests of similar joints (Pantelides and Nadauld 2001). Test IV-a was repeated to determine if the adhesive failure was due to quality control issues. This second test, IV-a (2), had an FRP composite tensile failure even though the test unit and loading program were identical to test IV-a (1). The maximum strain in the GFRP composite for test IV-a (1) was 0.55% whereas the maximum measured strain for test IV-a (2) was 1.55%. Fig. 16 shows the small number of fatigue cycles reached in test IV-b.
