Report No. UT-11.16

NON-DESTRUCTIVE AND DESTRUCTIVE INVESTIGATION OF AGED-IN-THE-FIELD CARBON FRP-WRAPPED COLUMNS

Utah Department of Transportation and
New York State Department of
Transportation

University of Utah
Department of Civil & Environmental
Engineering

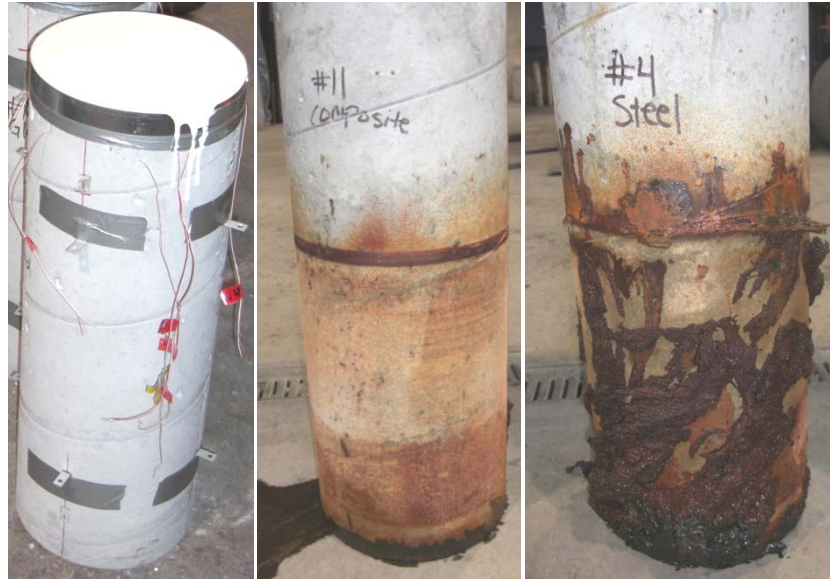
Figure 2.6: Condition comparison: (a) Typical control specimen (b) Typical hybrid corrosion specimen (c) Typical steel corrosion specimens

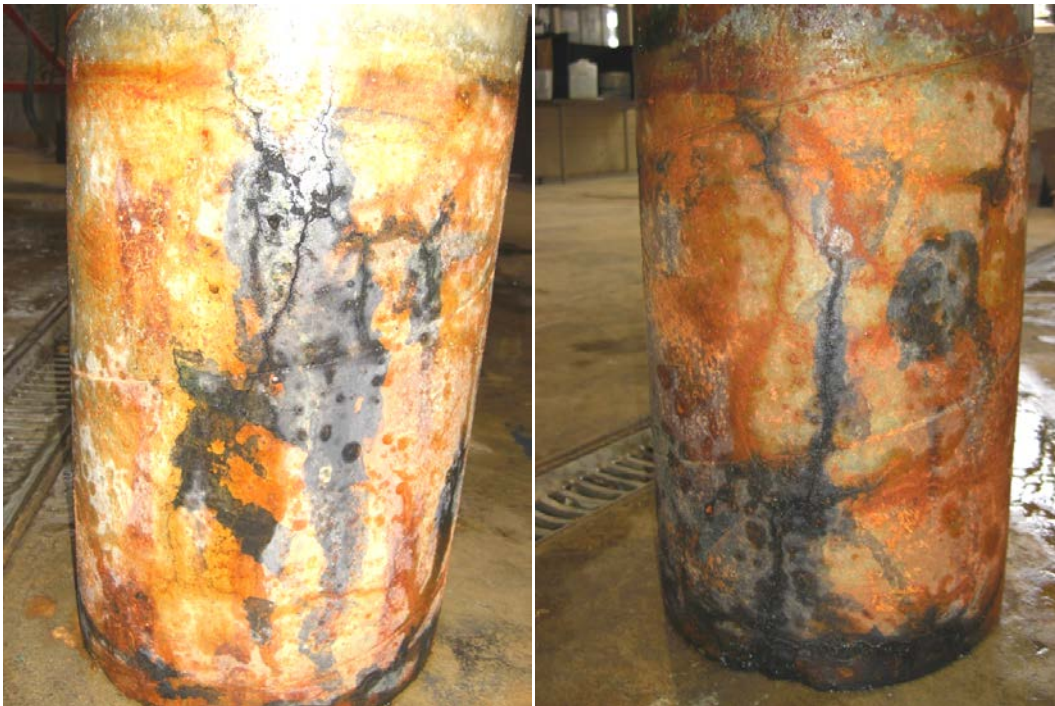
Figure 2.7: Trial corrosion specimen comparison (a) #7SCOREX after 5 weeks of corrosion (b) #8SCOREX after 10 weeks of corrosion

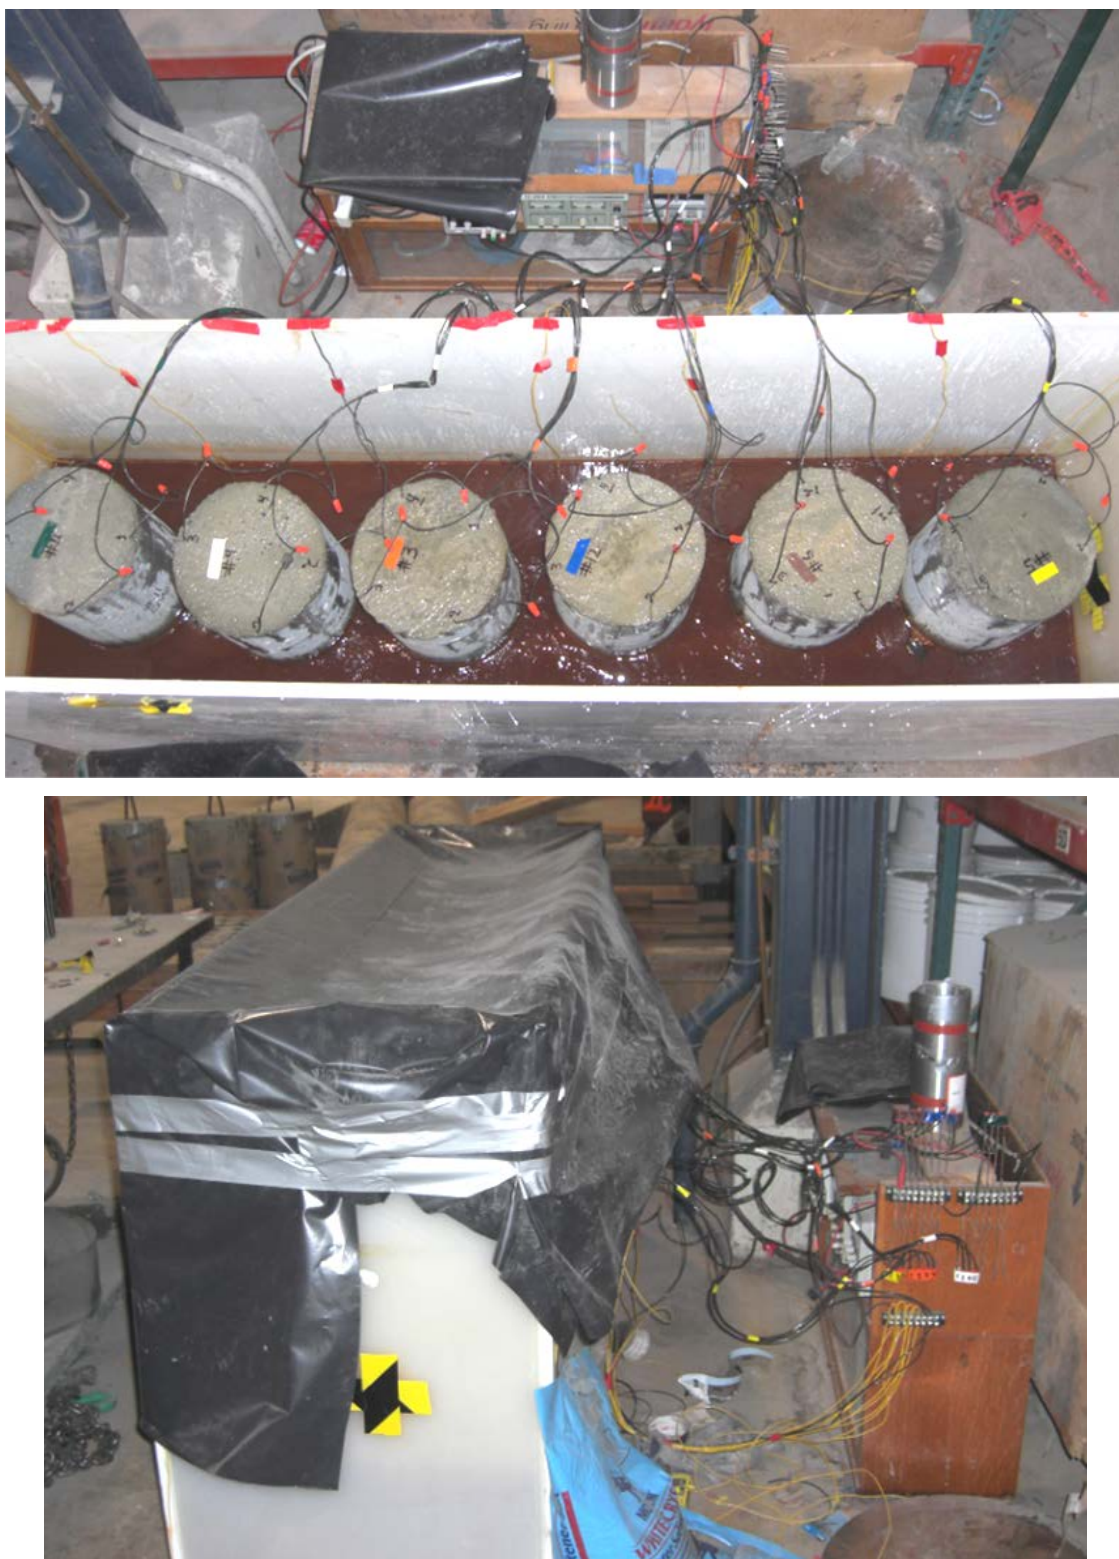
Figure 2.8: Corrosion system for medium-scale RC columns

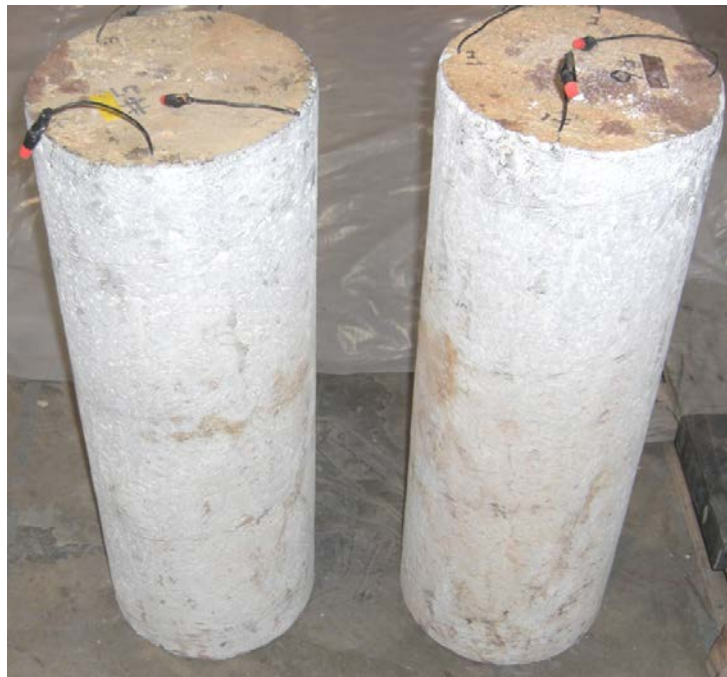
Figure 2.9: Roughened surface of Columns #5SCORW and #6SCORW

Columns #5SCORW and #6SCORW were wrapped with *SikaWrap Hex 103C*, a high-strength unidirectional carbon fiber fabric with epoxy resin after being subjected to corrosion. This CFRP wrap has a tensile strength of 177 ksi, tensile modulus of 12.6 Msi, and an ultimate tensile strain of 0.014 in./in. The surface of the columns was roughened using a grinder with a metal diamond embedded grinding disc before being wrapped as shown in Figure 2.9. Roughening the surface of the columns removes any loose concrete cover and laitance and provides a better surface for the resin to bond. After being roughened, the columns were coated with epoxy resin and then wrapped with resin impregnated CFRP sheets. The entire column was wrapped with two layers of CFRP made up of two separate sheets with approximately 8 in. lap splices. The top and bottom 6 in. were then wrapped with an additional two layers to prevent premature end crushing during loading. The final product is shown in Figure 2.10.

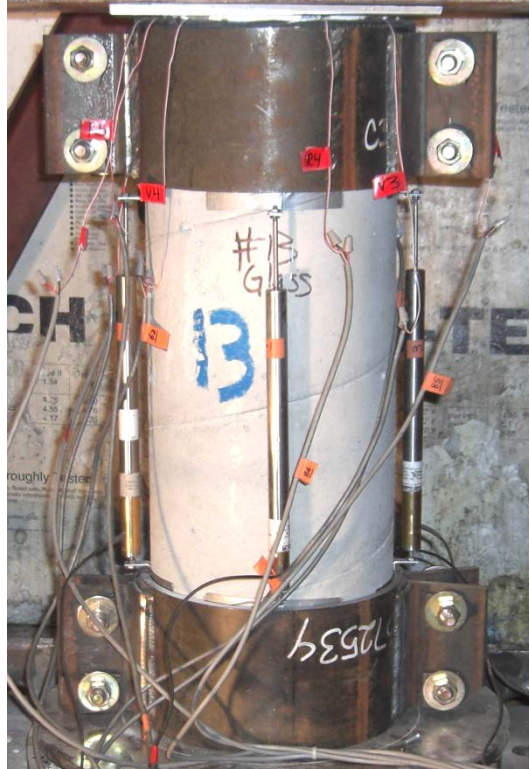
Figure 2.11: LVDT placement and steel confinement collars

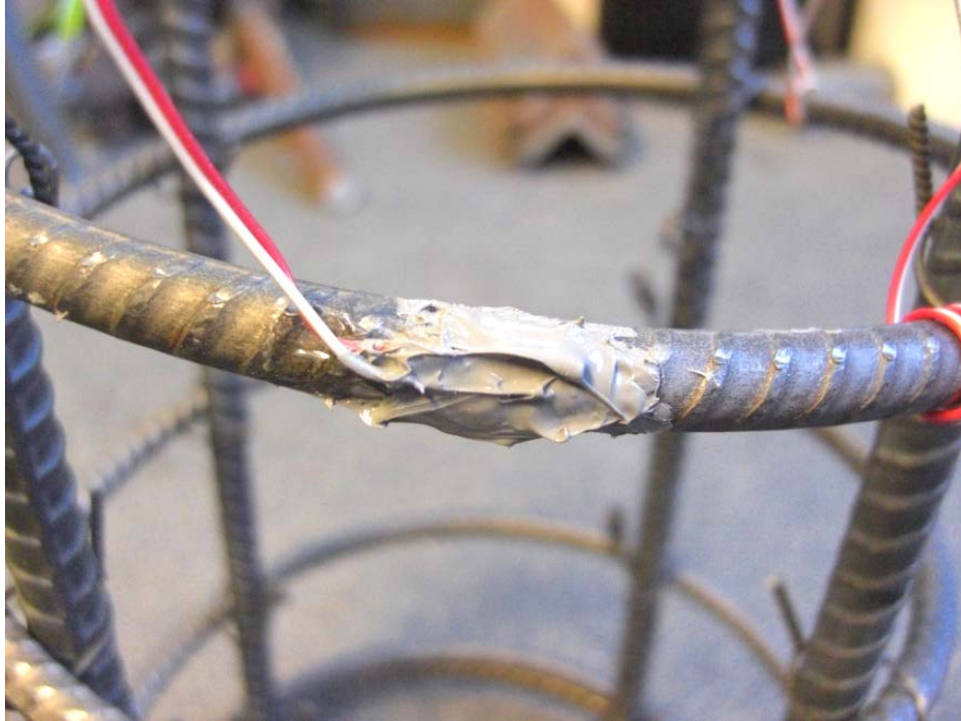
Figure 2.13: Internal strain gauge protective coating

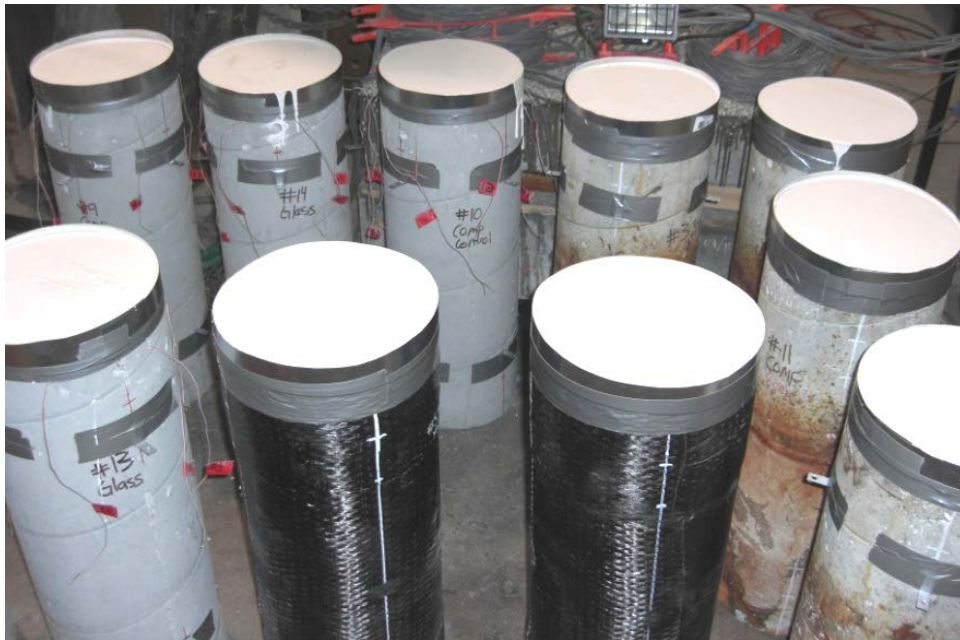
Figure 2.15: Hydrostone caps

Hydrostone, a high strength plaster, was used to cap the columns to provide a level and smooth top surface. The plaster mix used a 32% water to Hydrostone ratio by weight. This was fluid enough to self level and leave a smooth surface, but also had a compressive strength at least 2,000 psi higher than the concrete. Figure 2.15 shows the columns after Hydrostone was applied.

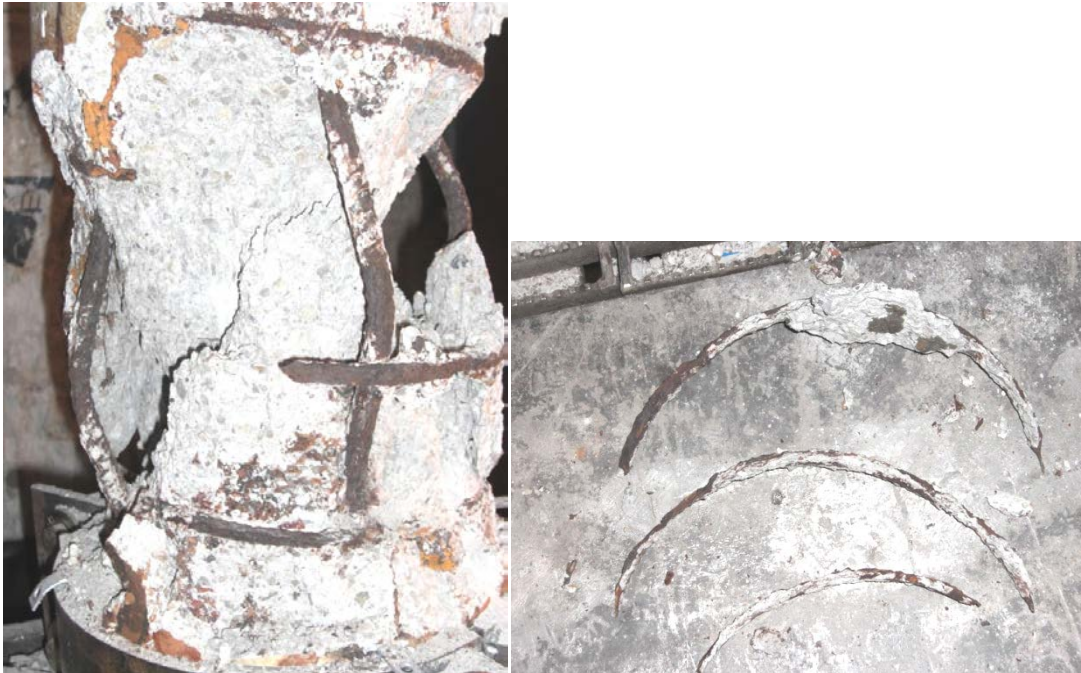
Figure 3.1: Effects of corrosion on steel spiral

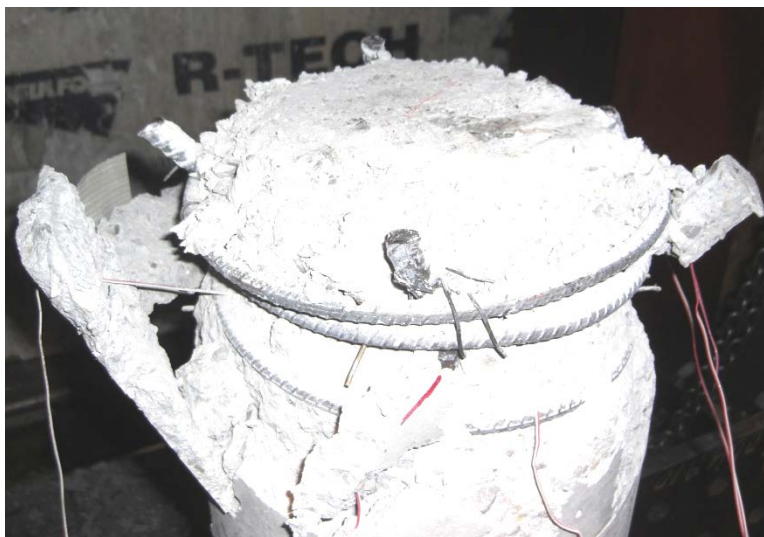
Figure 3.5: #1SCTL premature end crushing

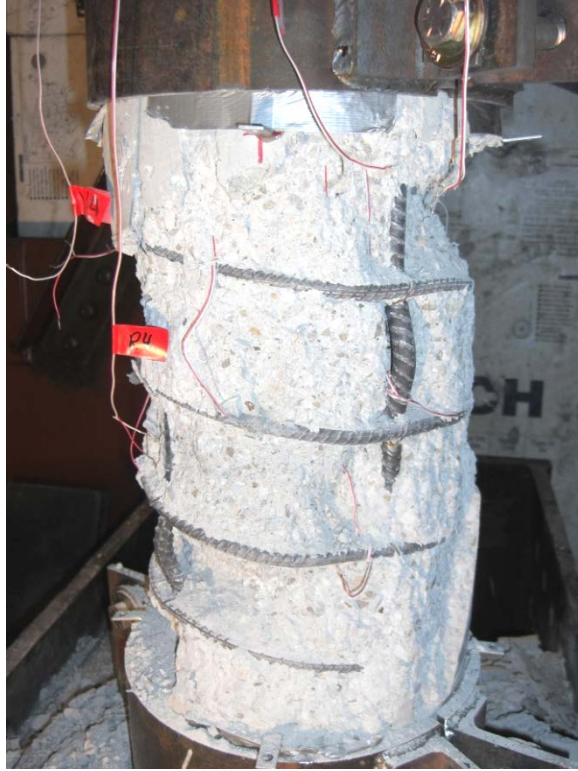
Figure 3.6: #2SCTL proper failure

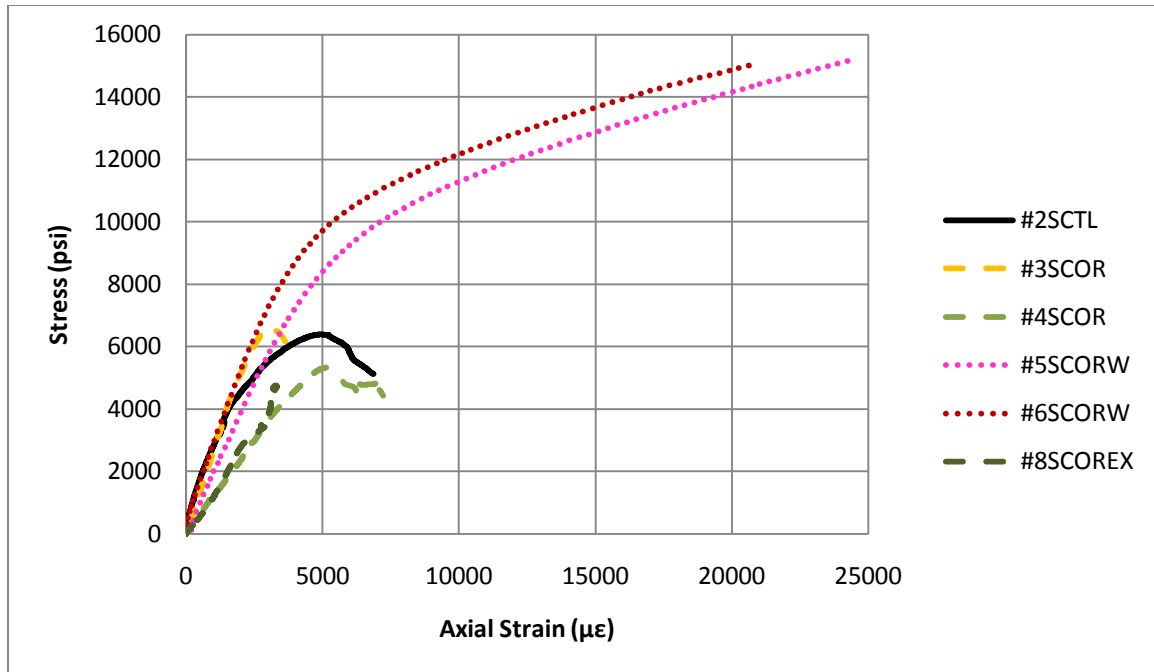
Figure 3.20: Stress-strain curves of specimens with all-steel reinforcement

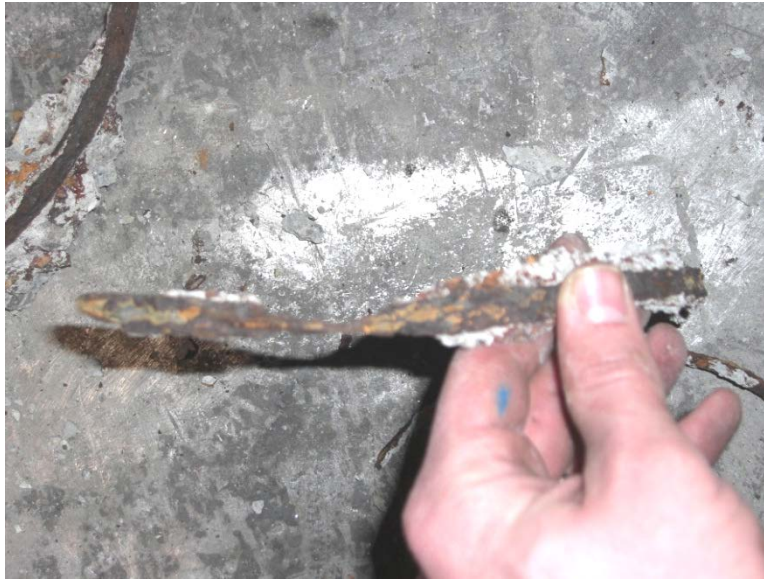
Figure 3.25: Section of spiral with more than 75% steel loss

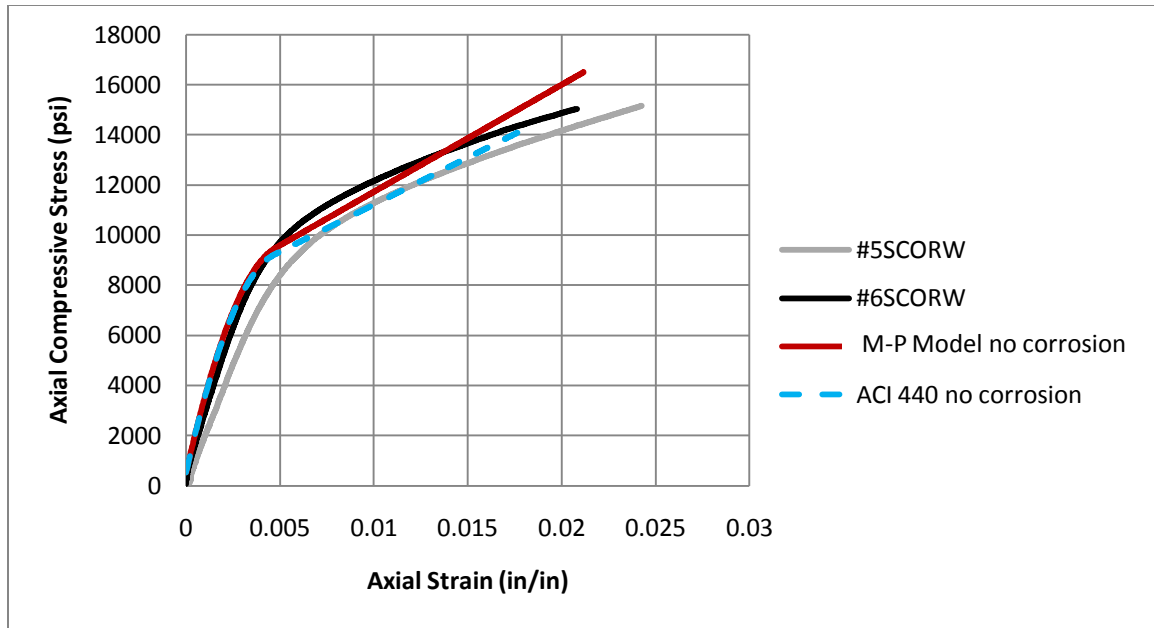
Figure 3.27: Stress-strain models assuming no spiral steel loss

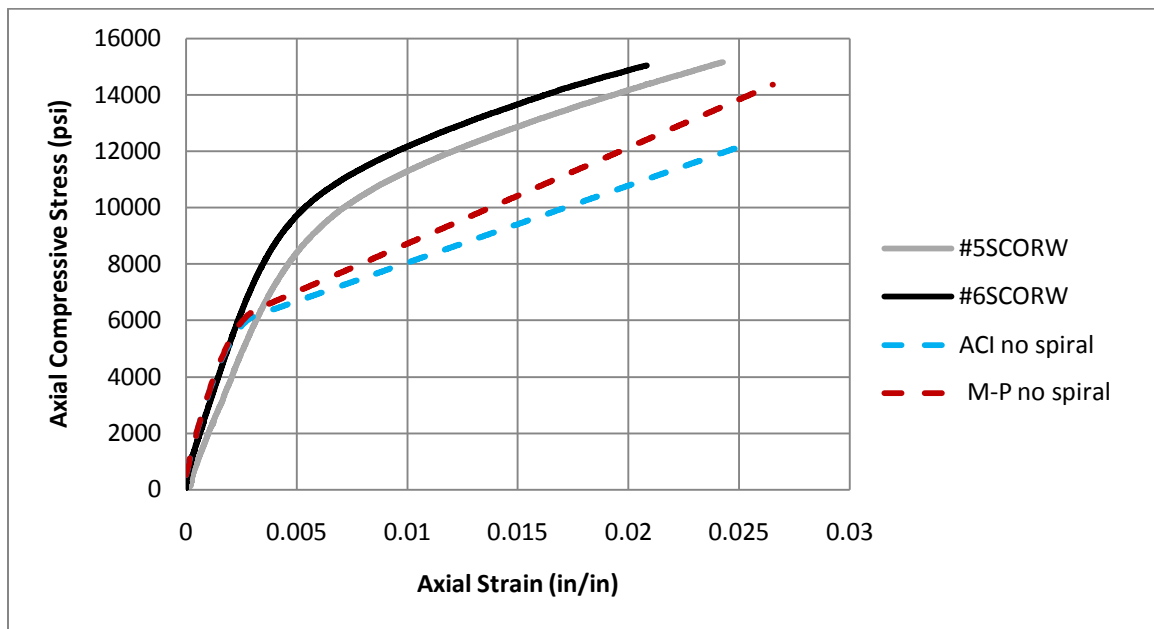
Figure 3.28: Stress-strain models not accounting for steel spiral

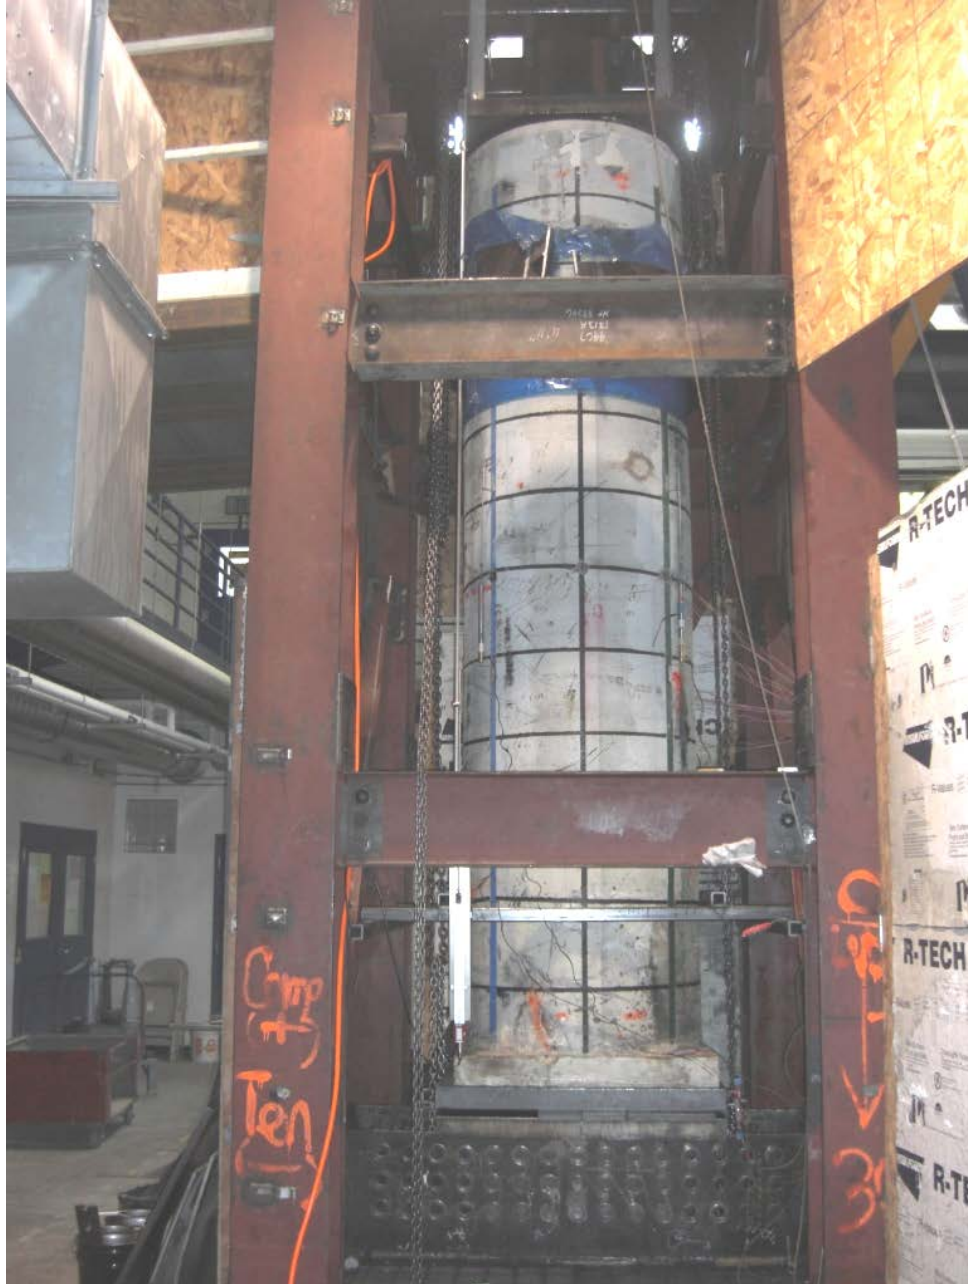
Figure 4.1: Column in load frame

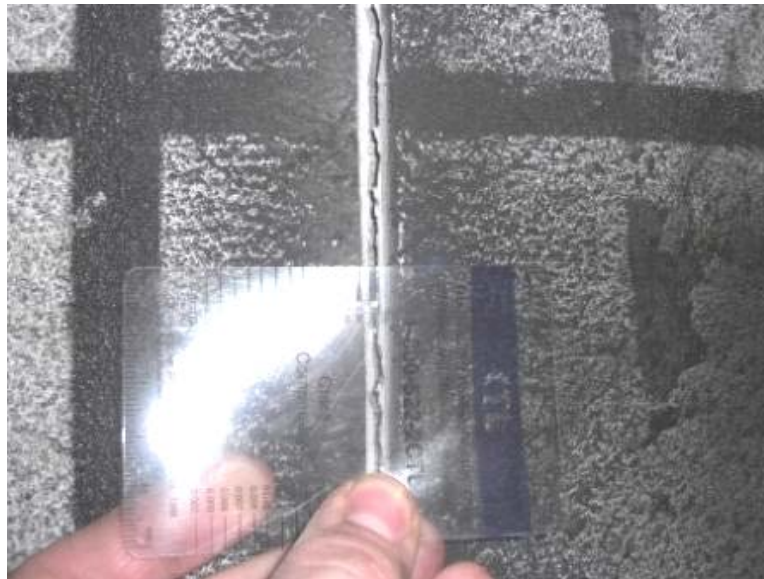
Figure 4.5: Original crack after jacket was cut

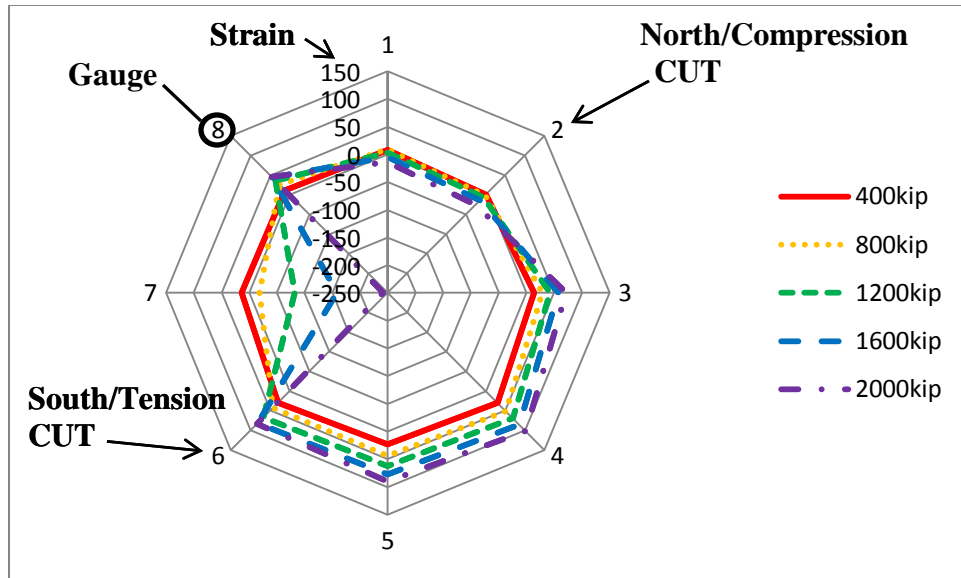
Figure 4.6: Radial micro-strain for column LG2 during CUT concentric test

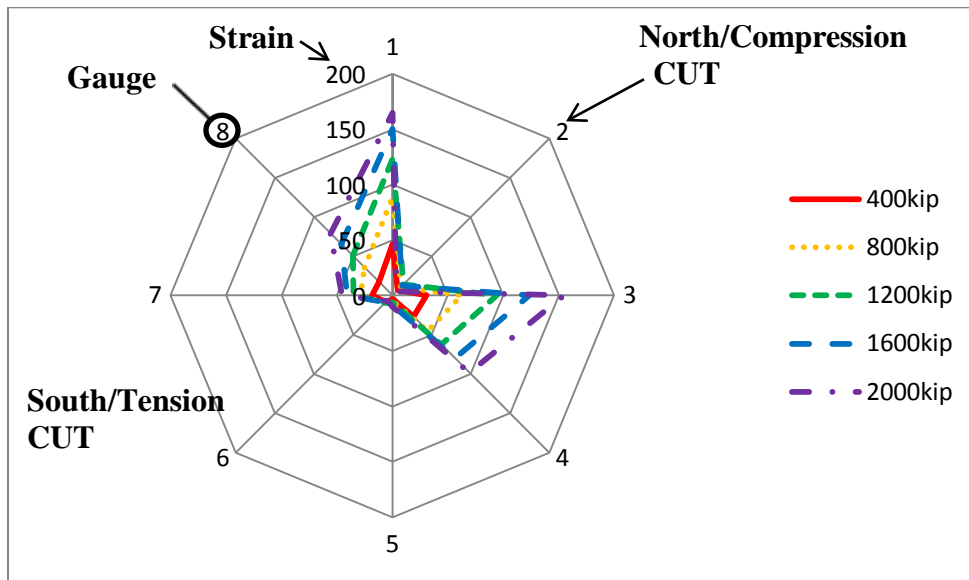
Figure 4.7: Radial micro-strain for column LG2 during CUT eccentric 3 test

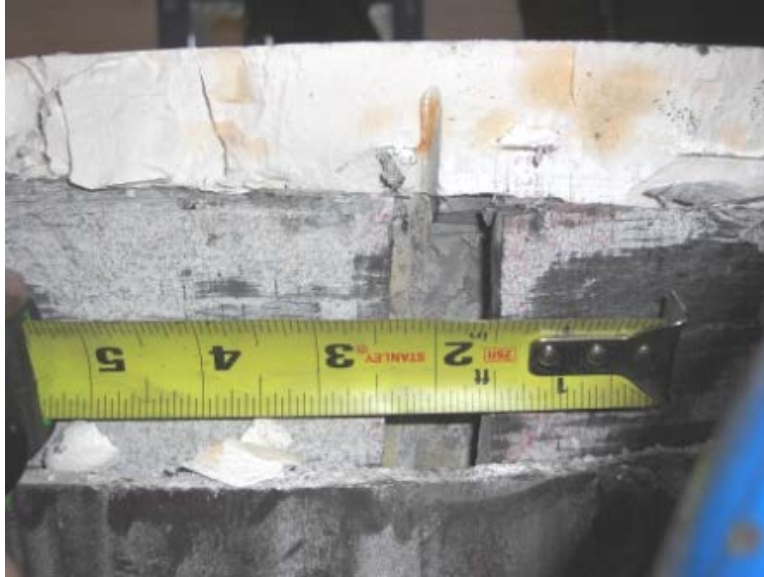
Figure 4.8: Delamination cracking at end of LG1 CUT eccentric 3 test

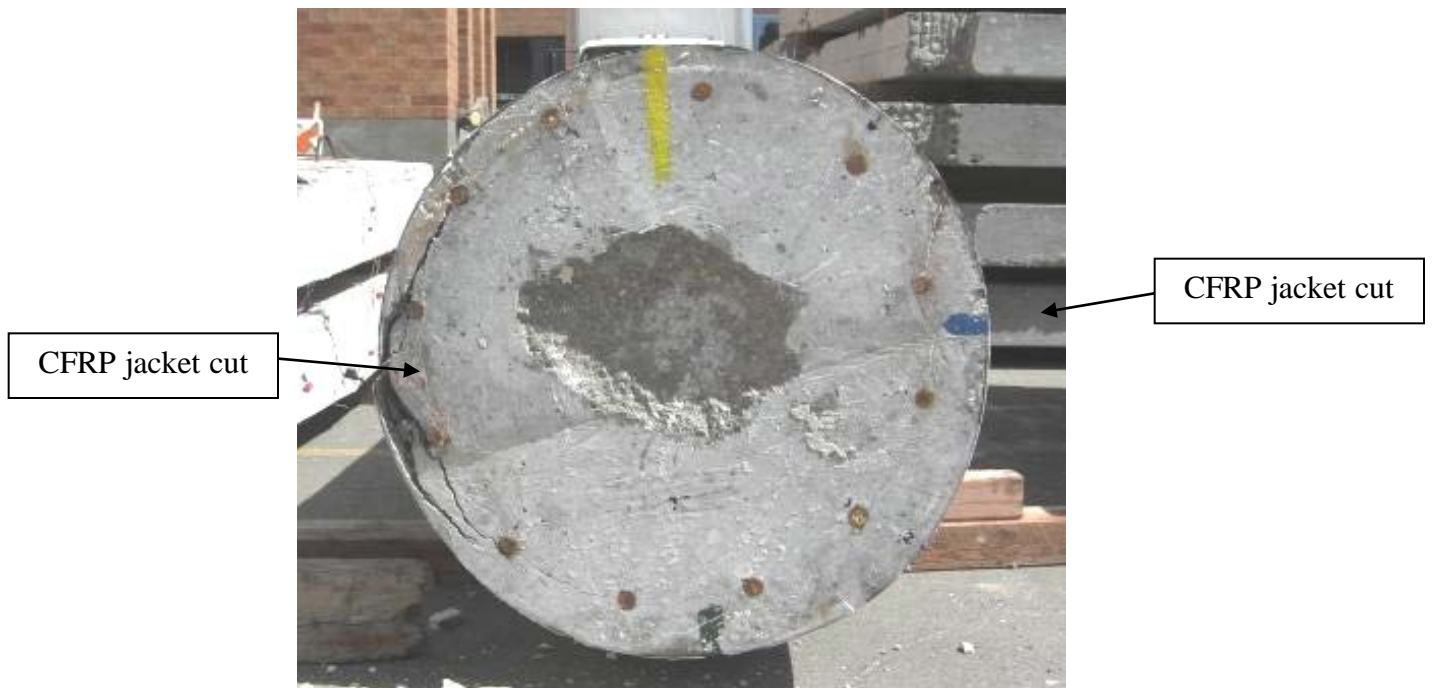
Figure 4.9: Picture of delamination of LG1 after testing

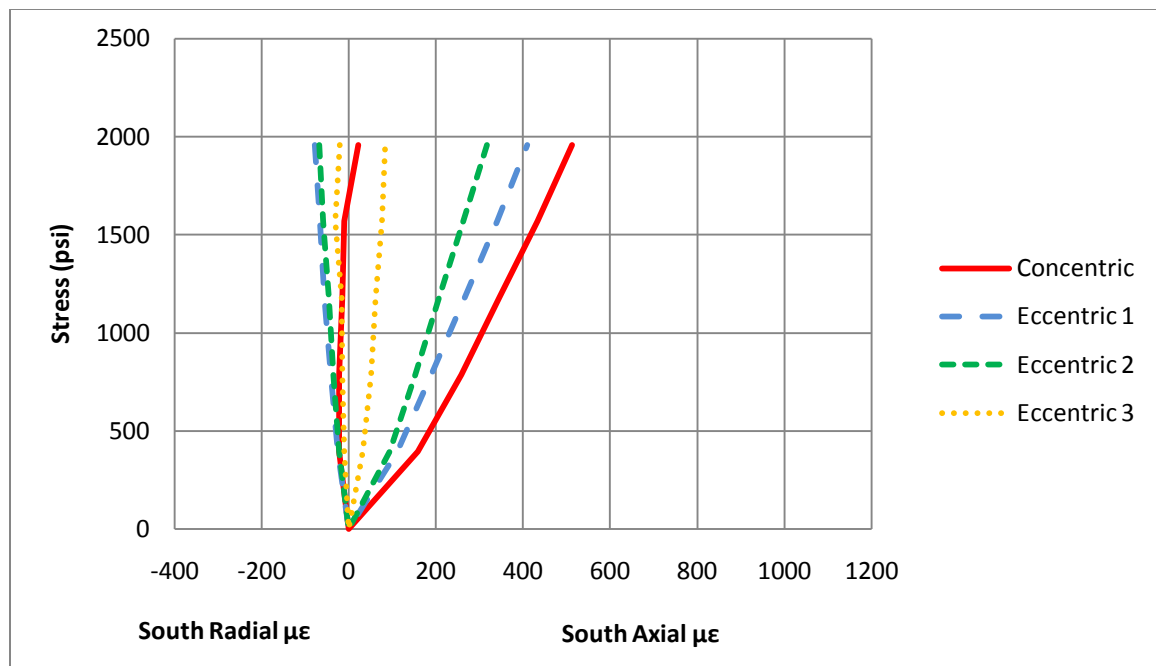
Figure 4.17: CUT LG2 south/tensile side axial stress versus strain

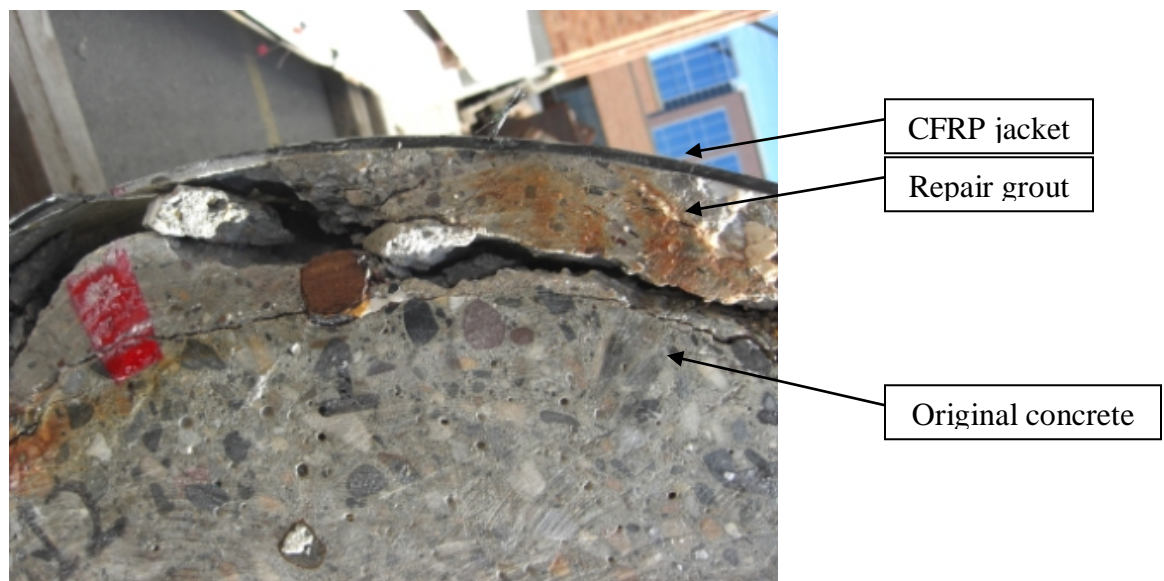
Figure 4.18: Debonding of repair grout and original concrete
