Second Quarter 2004 Progress Report
Midwest Roadside Safety Facility
Mid-States Regional Pooled Fund
July 23, 2004

Pooled Fund Consulting Summary

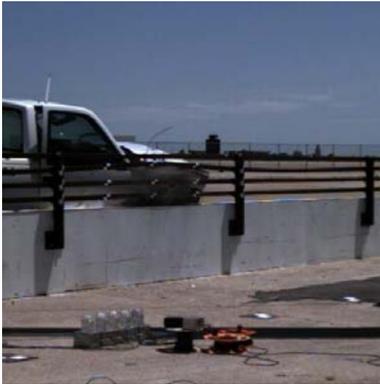
A second full-scale TL-3 test of a modified rail system, as shown below, was performed on May 28, 2004. As shown, the hood of the vehicle again interacted with the railing elements and the vehicle subsequently rolled. Currently there is not additional funding for further development so our plan is to report on these two tests and look for recommendations during the next year's annual meeting.

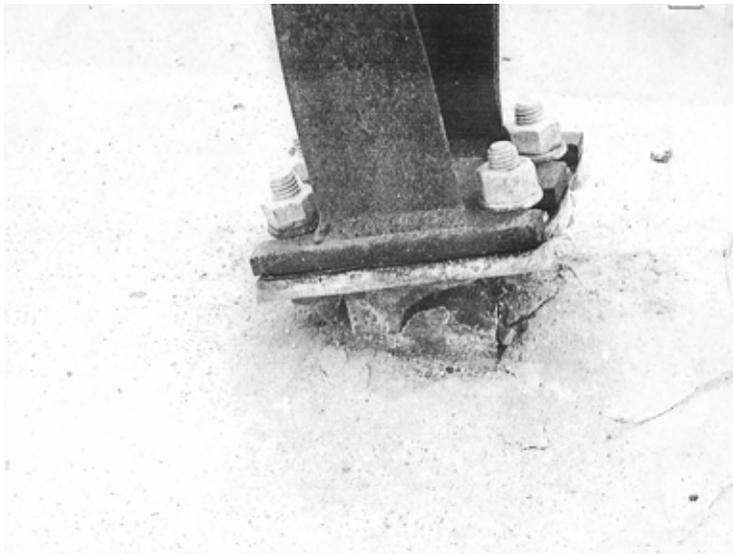
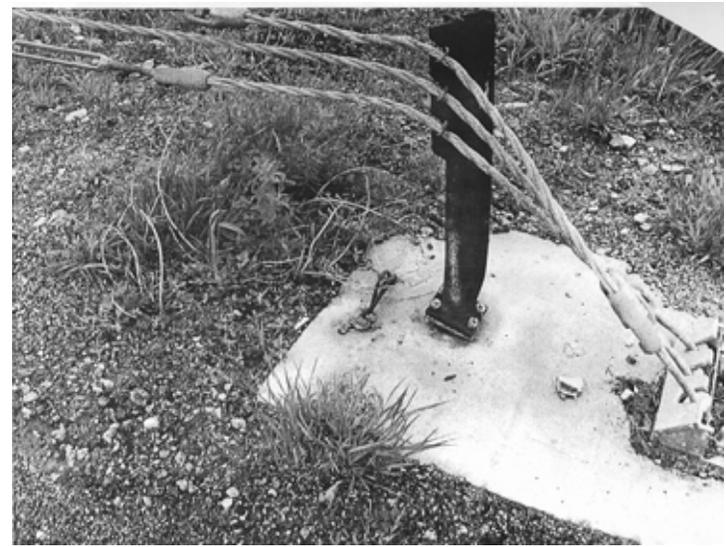
Figure 1. NY Cable Anchorage Damage

The NY cable anchorage consists of an end anchor and first post embedded into a concrete foundation. The first post, post no. 1, employs a slip base to disengage the top of the post during an impact on the end of the system. Performance of the system has been satisfactory, but the bottom of post no. 1, which is set in a concrete foundation, tends to get damaged during impacts. Repair of this damage requires full replacement of the concrete anchorage at an approximate cost of \$1,100.00. If the system could be modified so only post no. 1 need be replaced, the cost of repair would be reduced to approximately \$10.00 - \$15.00.
