Report No. UT-14.09

## **SEISMIC EVALUATION OF GROUTED SPLICE SLEEVE CONNECTIONS FOR PRECAST RC BRIDGE PIERS IN ABC**

Utah Department of Transportation  
Research Division

**Final Report  
October 2014**

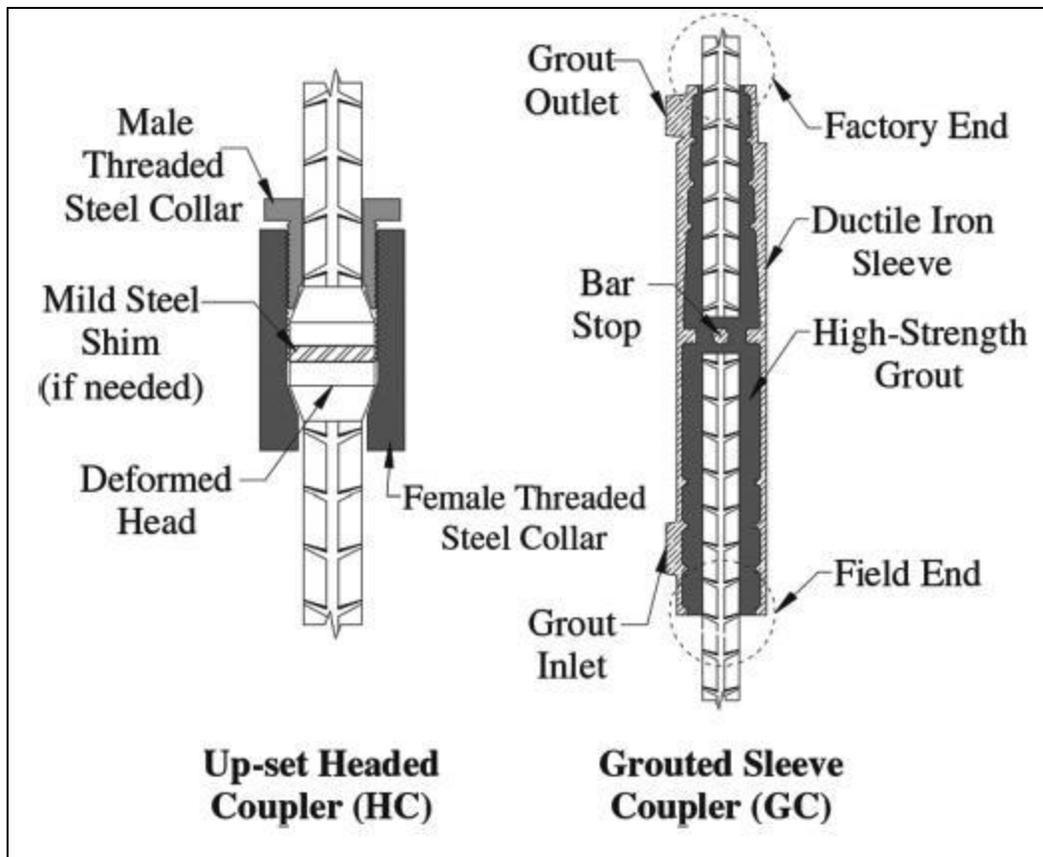
Figure 1-2. Two types of Coupler used in the research [7].

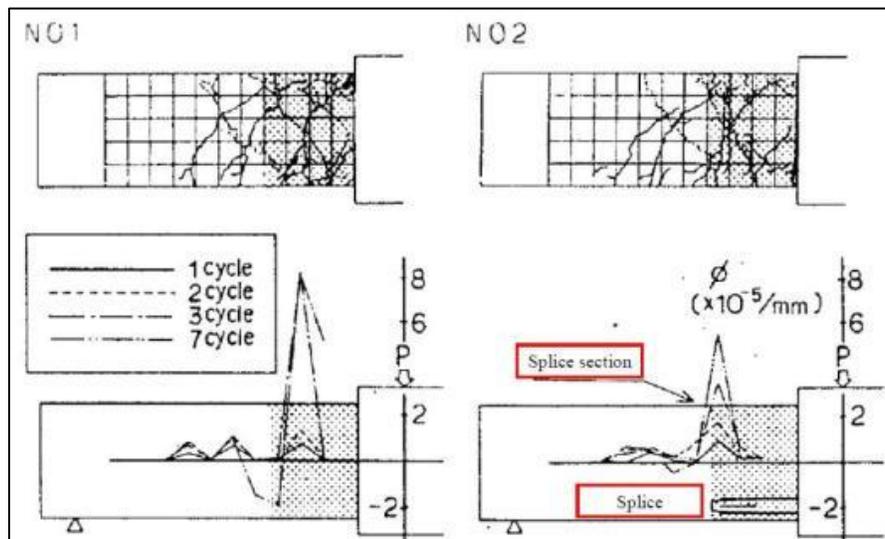
Figure 1-4. Damage state for two test specimens at failure [15].

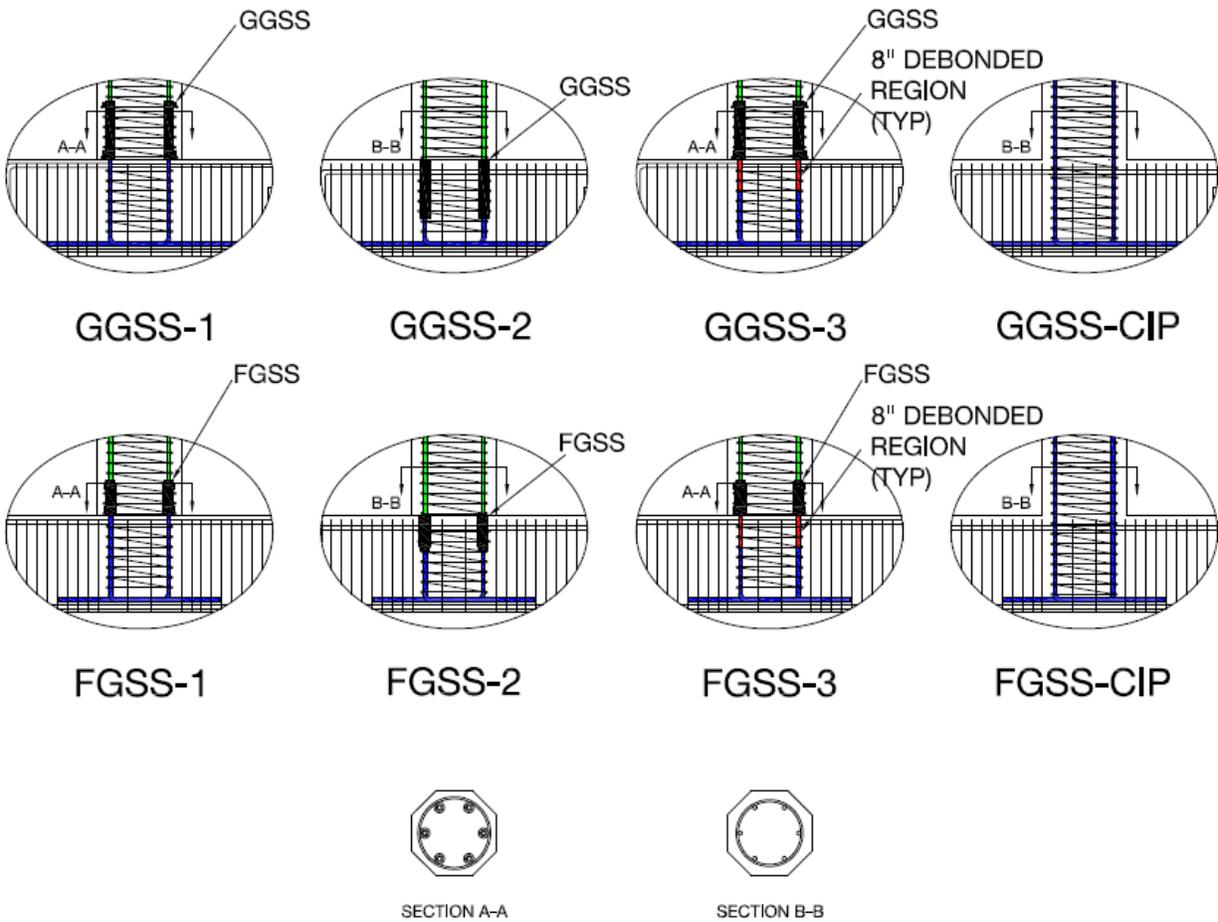
Figure 1-7. Configuration of test specimen alternatives.

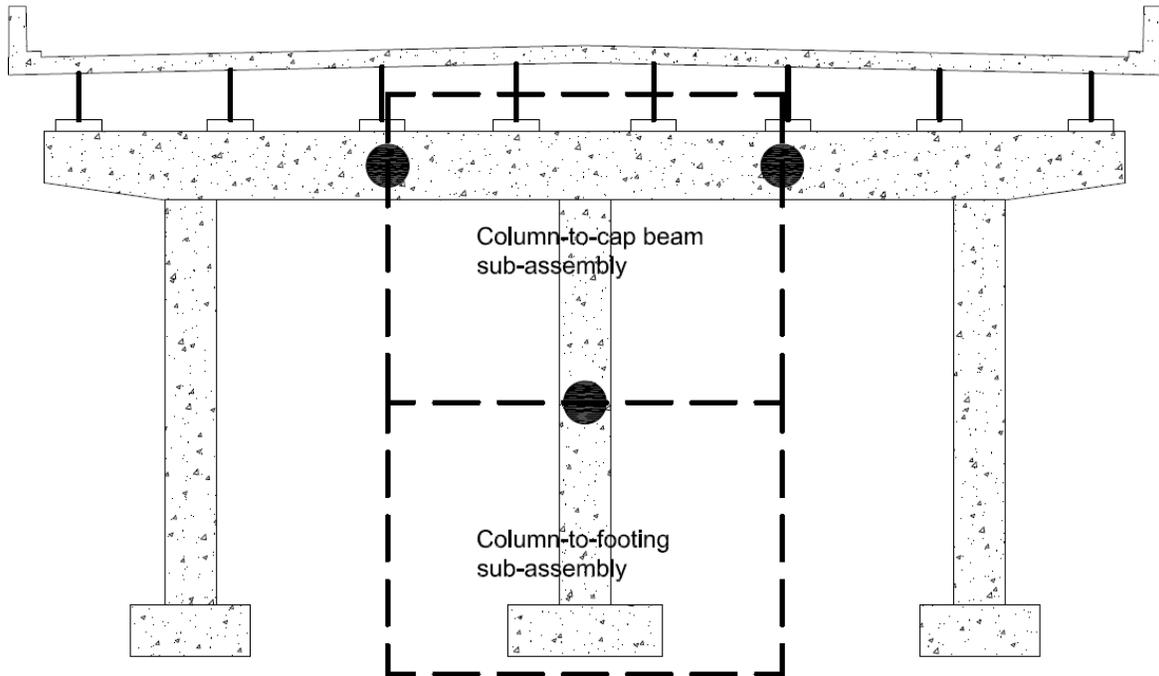
The final column height for all specimens was selected to be 8 ft-6 in. with a 21-in. square column head in the top 1 ft-6 in. portion. The lateral load, however, was intended to be applied at a height of 8 ft from the column end. The cross section changed to an octagon along the remainder of column height to facilitate casting of concrete. Six No. 8 bars in a circular arrangement, in addition to a No. 4 spiral with a pitch of 2½ in., made up the column cage. The longitudinal and volumetric transverse reinforcement ratios were 1.3% and 1.9% respectively.

Figure 2-1. Prototype bridge with highlighted portions representing specimen design.

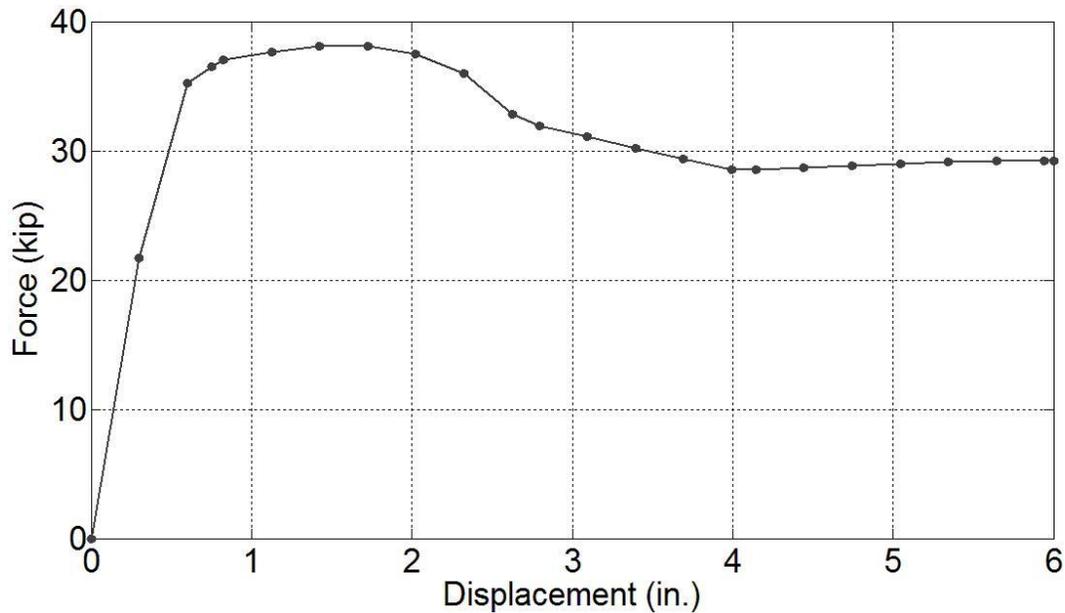
Figure 2-2. Preliminary pushover analysis on monolithic test specimen (prediction).

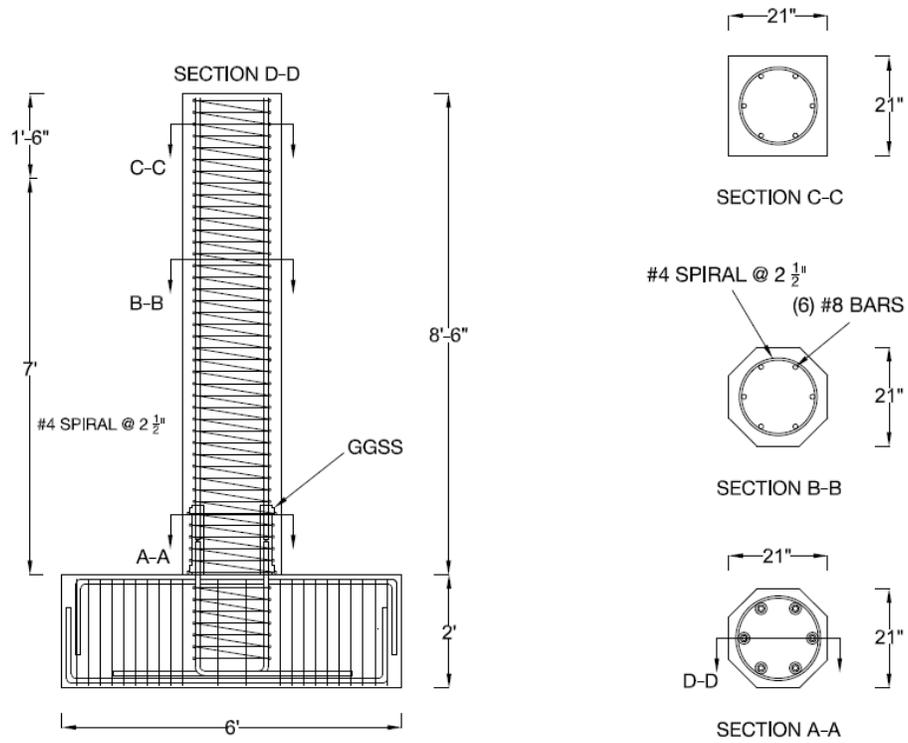
(a) Details of GGSS-1.

Figure 2-5. GGSS-1 specimen details and rebar cages.

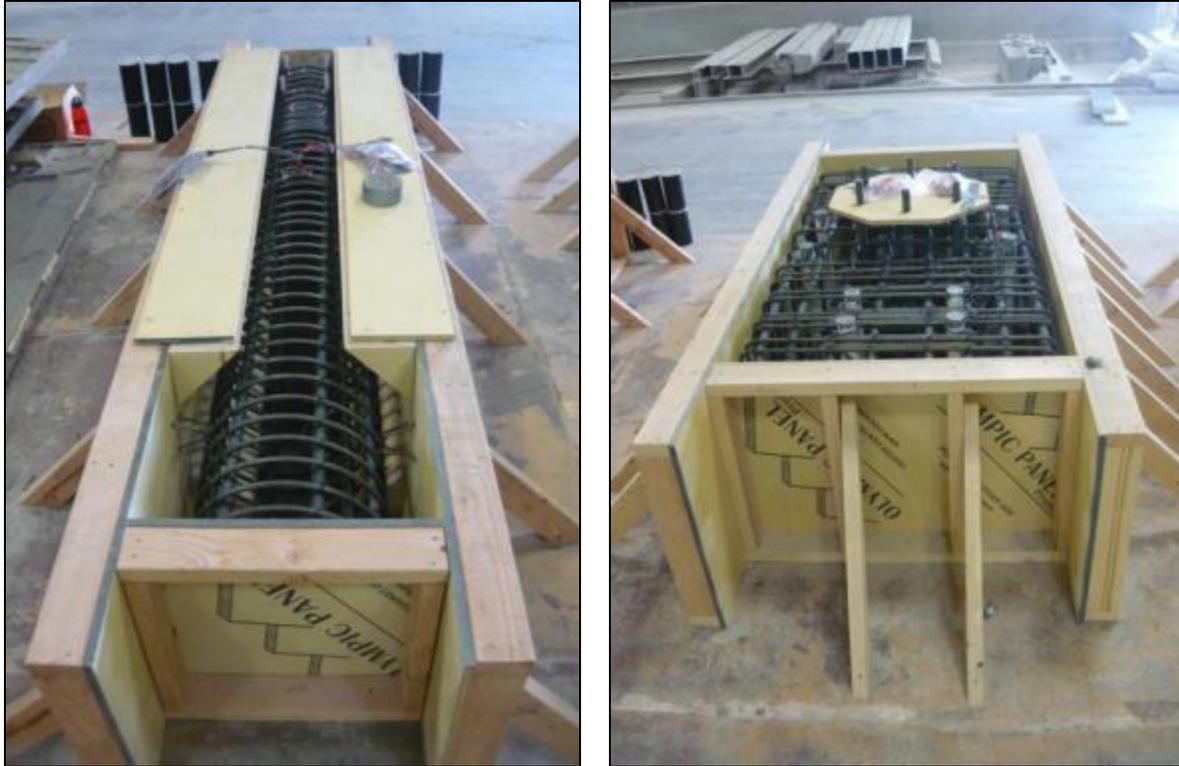
**Figure 2-6** shows the GGSS-1 column and footing reinforcement inside the forms at the precast plant. Concrete casting was performed with great care to avoid damage to instrumentation wires. 4 in. x 8 in. cylinders were made according to ASTM C39 [18], to perform compression tests before removing the specimens from the forms, at 28 days after casting, and on test day. 1 ½” PVC pipes were inserted inside the footing cage to provide room for anchors that would clamp the specimen down to the testing frame. The average concrete compressive strength at 28 days for this specimen was 5.3 ksi.

Figure 2-6. GGSS-1 precast components inside concrete forms.

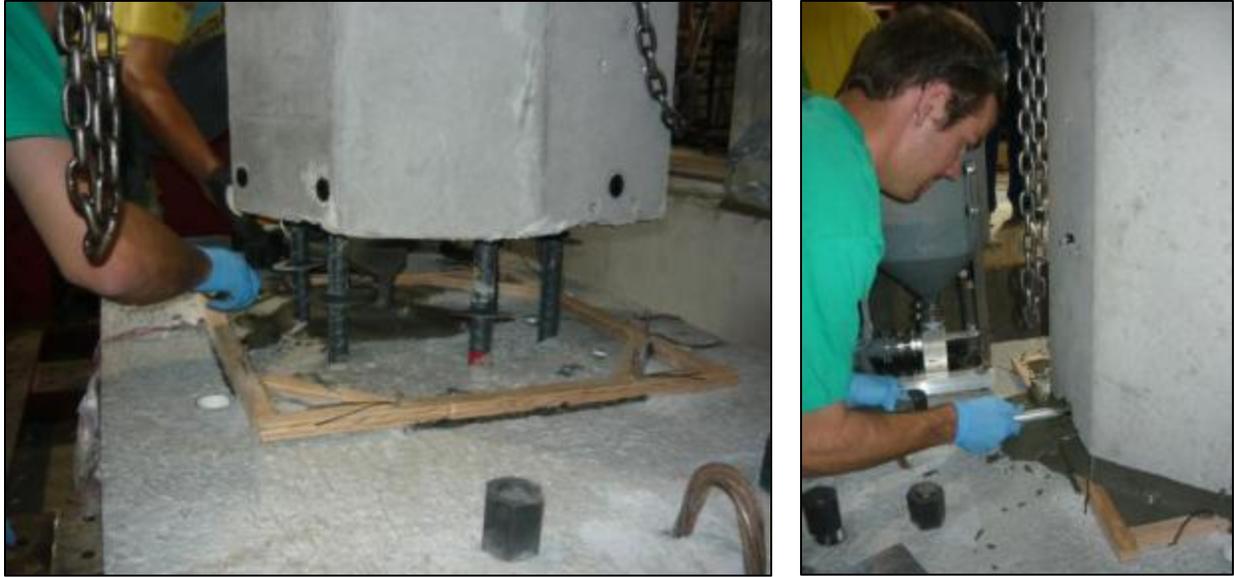
This specimen remained attached to the testing frame for a minimum of 28 days before testing, for the grout to cure completely. In the meantime, test preparation and external instrumentation were carried out. The average compressive strength of the grout at 28 days was found to be 14.4 ksi. **Figure 2-8** displays specimen GGSS-1 in the final testing position, at the end of the grouting operation.

Figure 2-7. Grouting operation for GGSS-1.

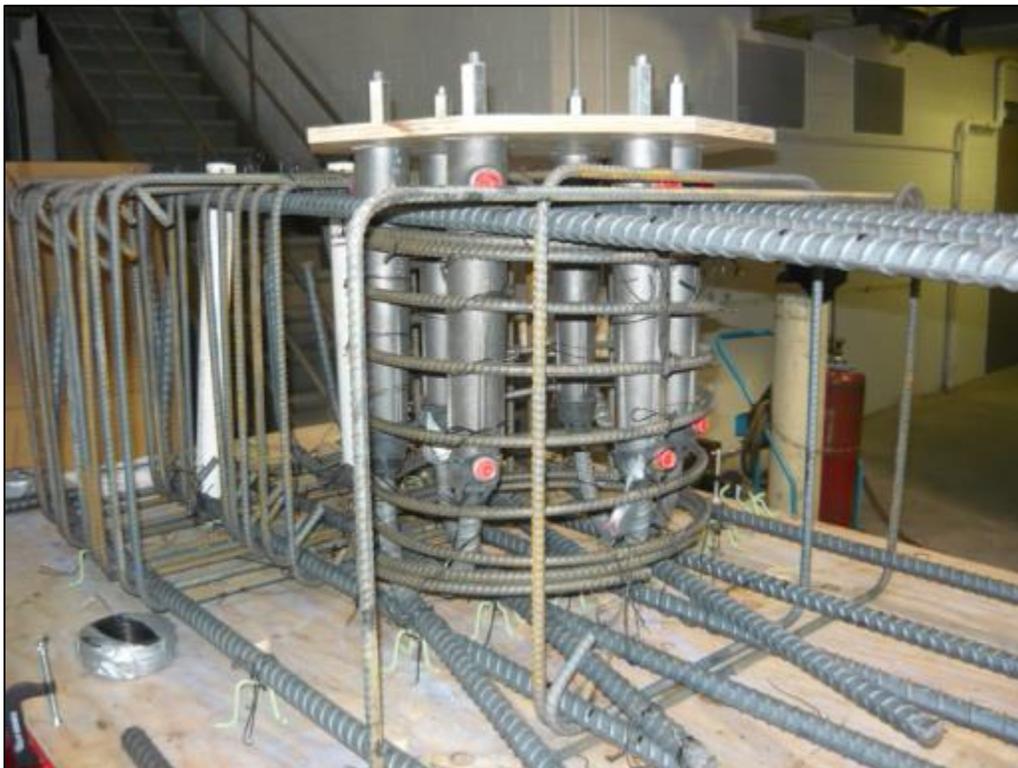
Figure 2-10. GGSS-2 precast footing core rebar cage.

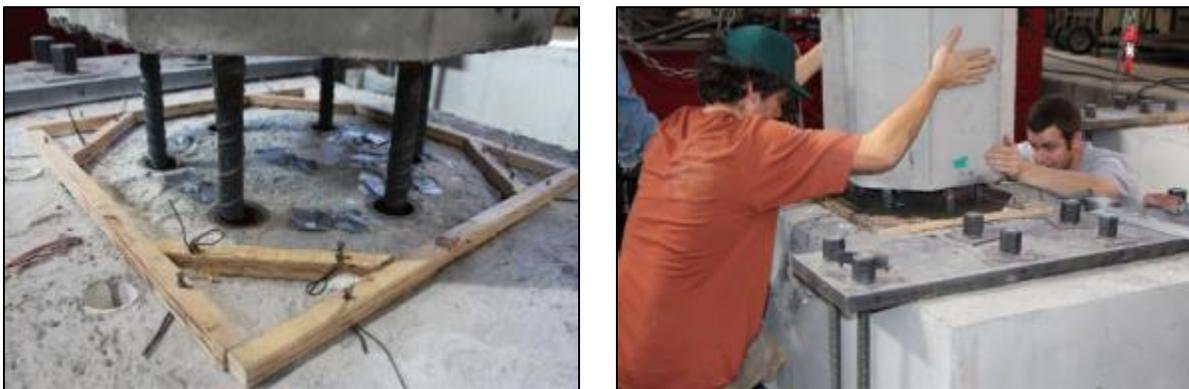
Temporary wood bracing was used to prevent movement of the GGSS-2 column until the grout developed sufficient strength. This specimen remained attached to the testing frame for a minimum of 28 days before testing, for the grout to cure completely. In the meantime, test preparation and external instrumentation were carried out. The average compressive strength of the grout at 28 days was found to be 11.1 ksi. **Figure 2-15** displays specimen GGSS-2 in the final testing position, at the end of the grouting operation.

Figure 2-14. Grouting operation for GGSS-2.

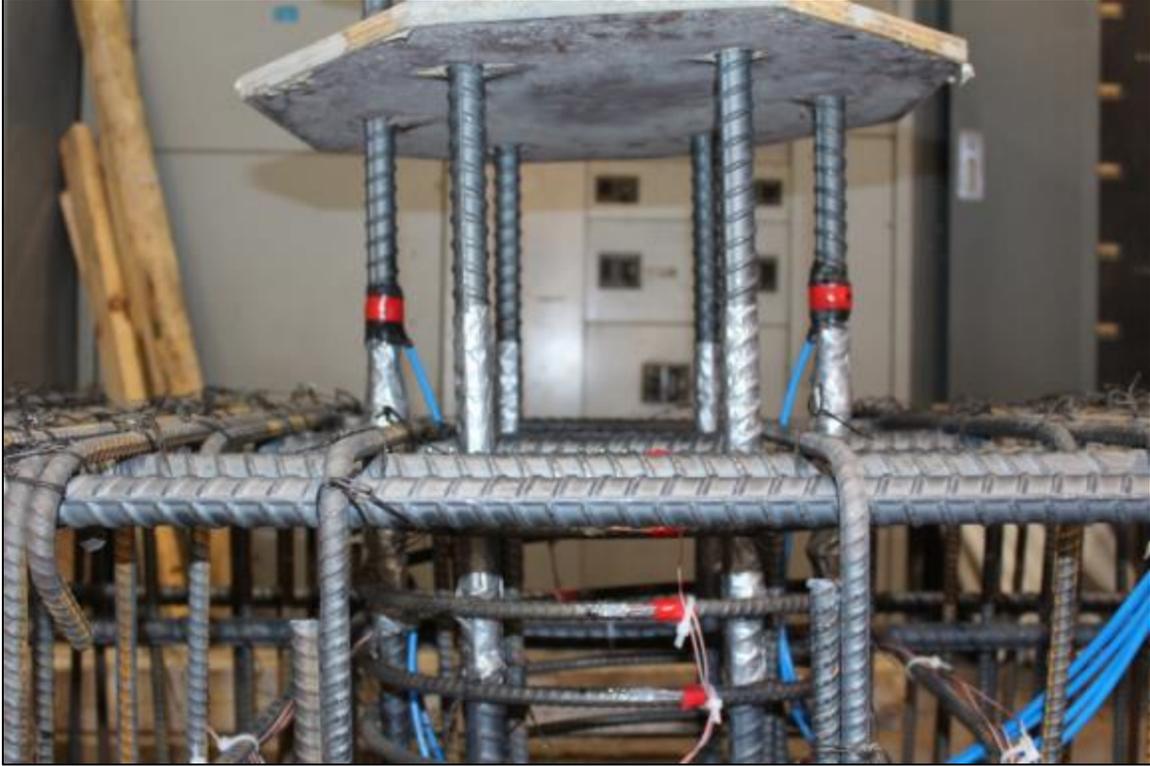
The main objective of the intentional debonding of rebar was to provide a better strain distribution along the critical region of the steel bars which was outside the GGSS, within the footing. This would reduce the strain concentration over the short length around the column-to-footing interface and hence, any premature rebar fracture would be delayed.

Figure 2-16. Debonded region of the dowel bars for GGSS-3.

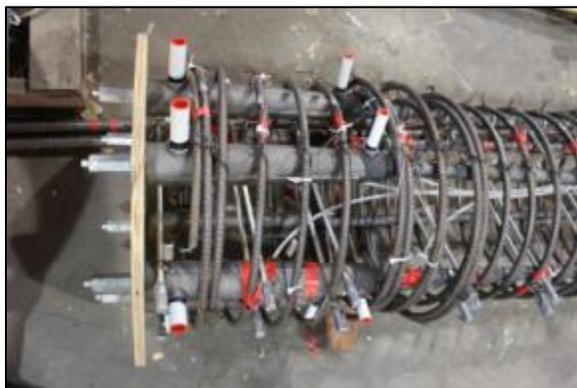
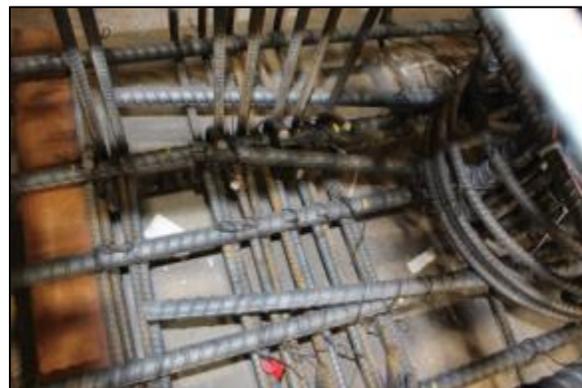
(a) Column end GGSS and overlapping spiral. (b) Footing dowel bars tied to rebar cage.

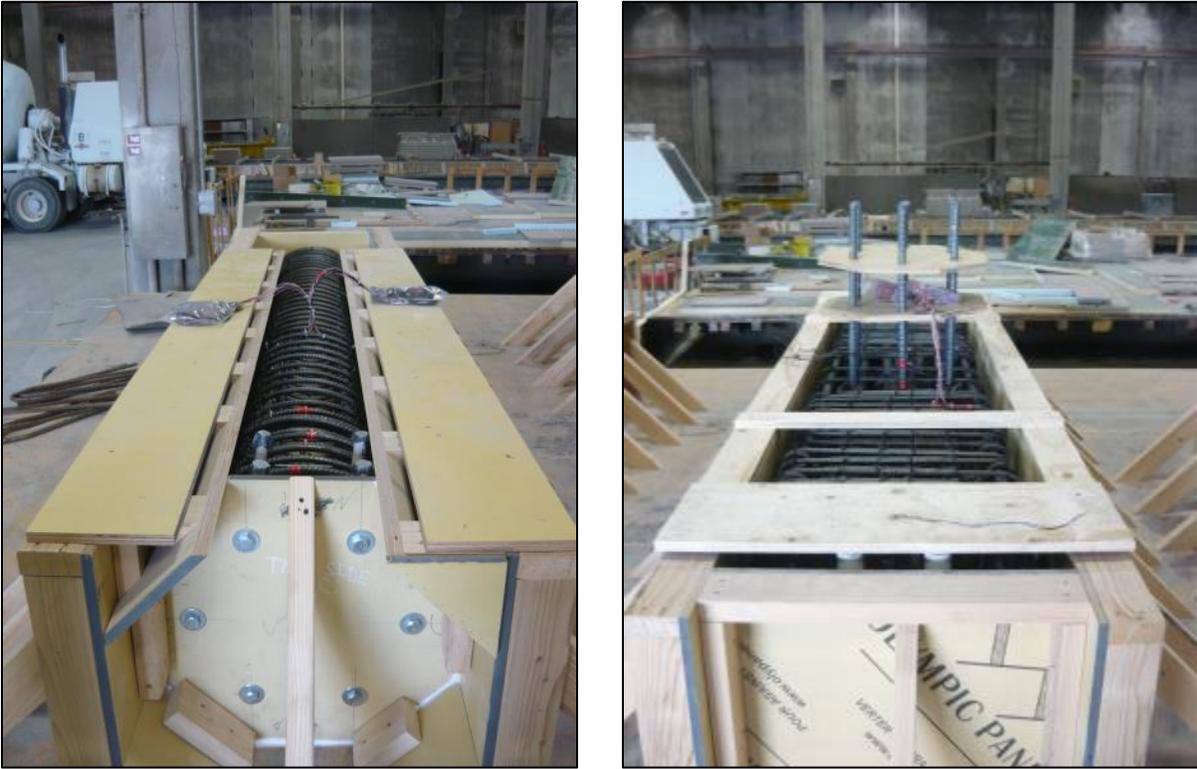
Figure 2-30. FGSS-1 precast components inside concrete forms.

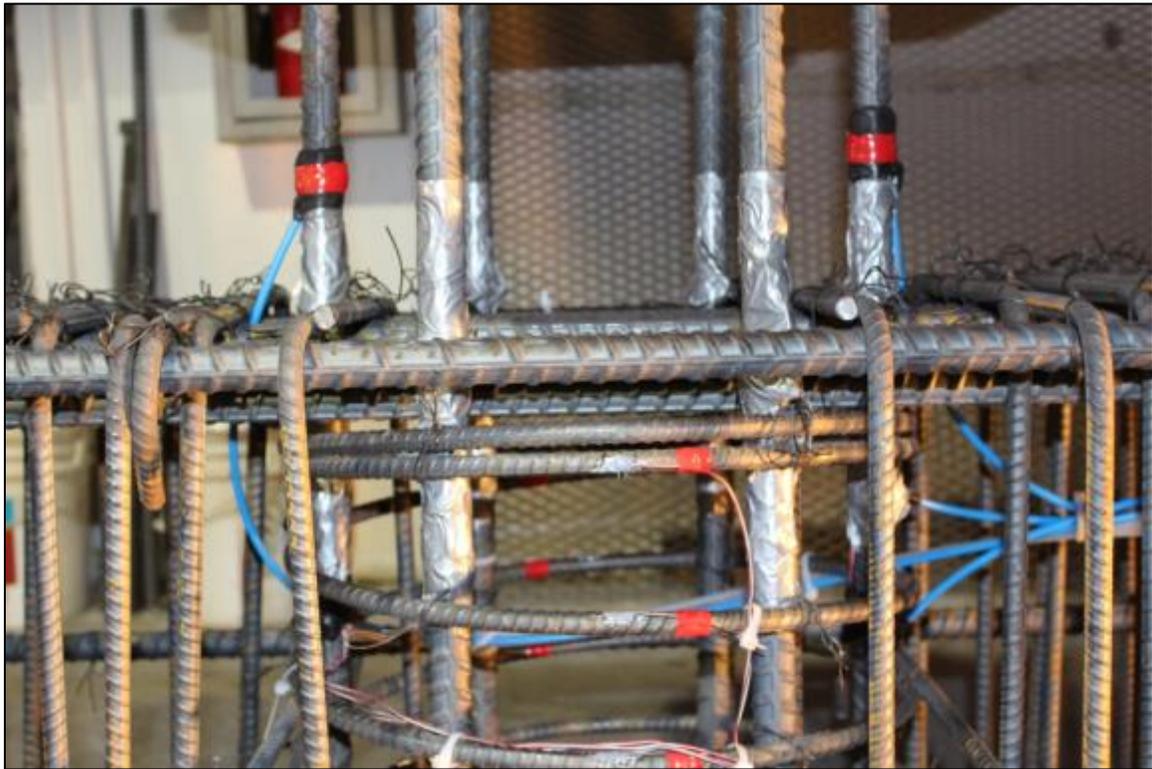
The main objective of the intentional rebar debonding was to provide a better strain distribution along the critical region which was outside the FGSS, within the cap beam. This would reduce the strain concentration over the short length around the column-to-cap beam interface, thus premature rebar fracture would be delayed. The 8-in. debonded length was obtained by subtracting the required development length of a hooked rebar from the available depth in the cap beam. This was carried out in accordance with the AASHTO LRFD Bridge

Figure 2-39. Debonded region of the dowel bars for FGSS-3.

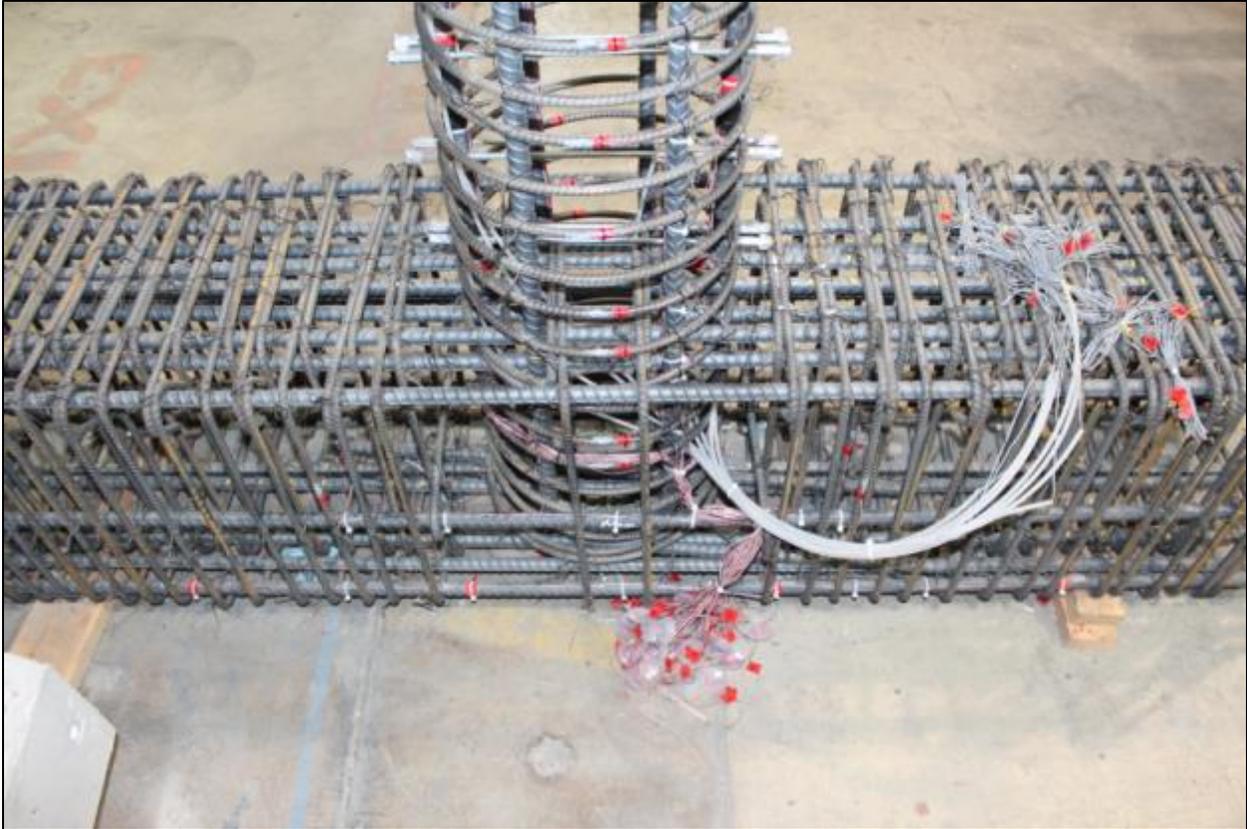
Figure 2-46. FGSS-CIP joint area.

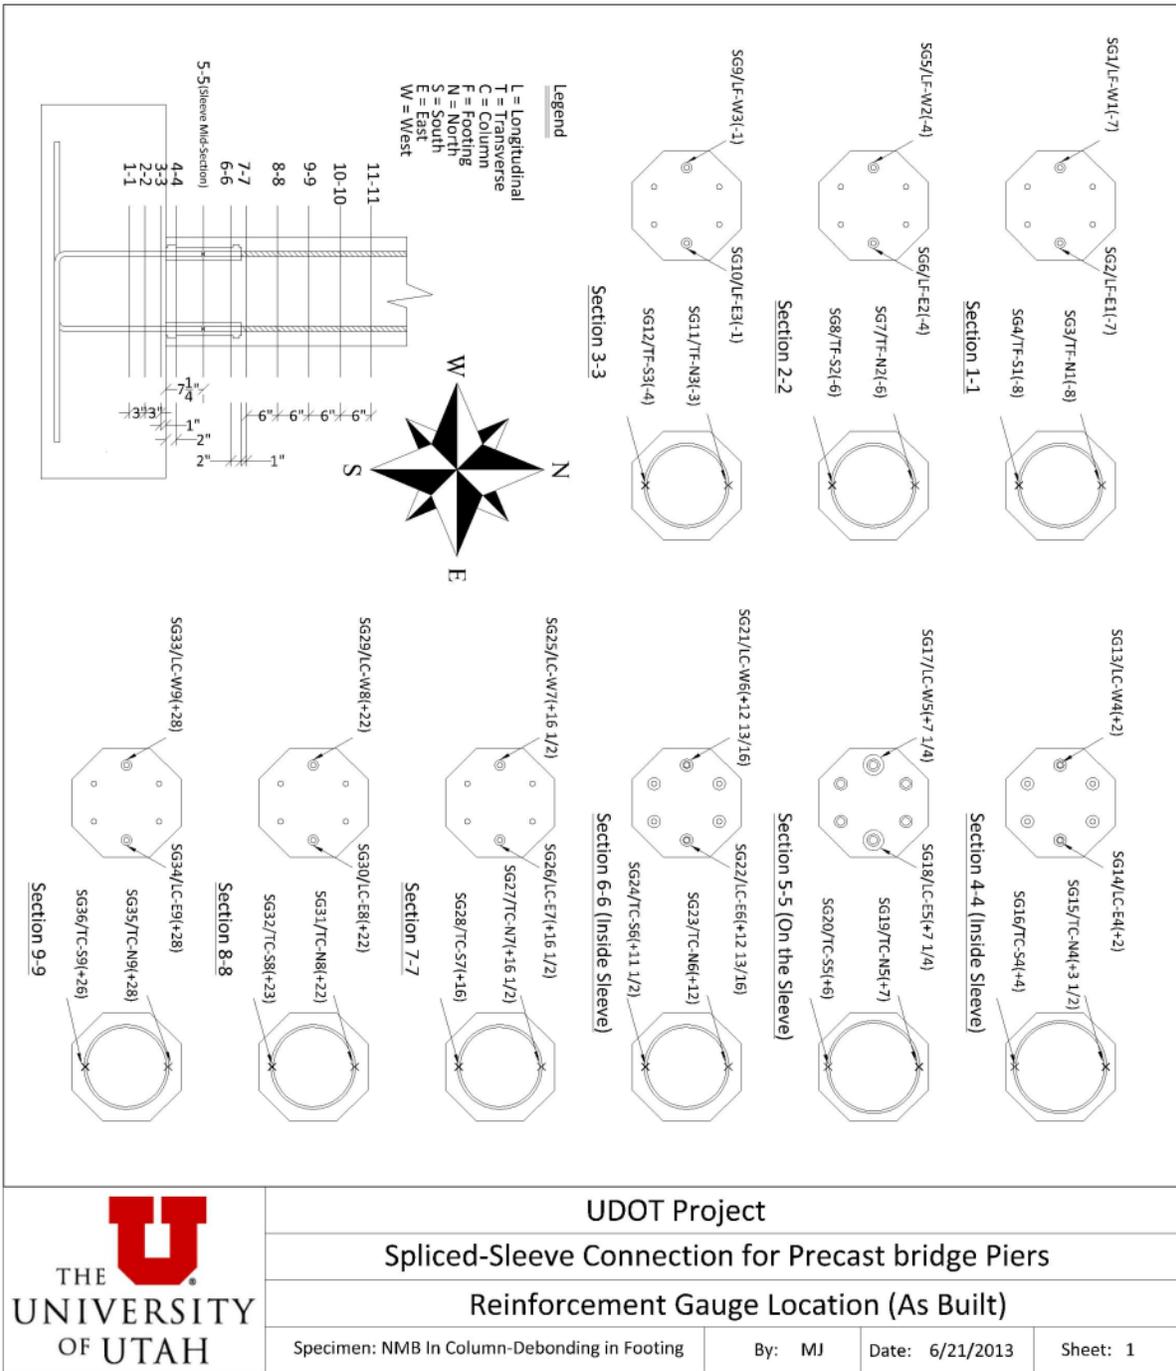
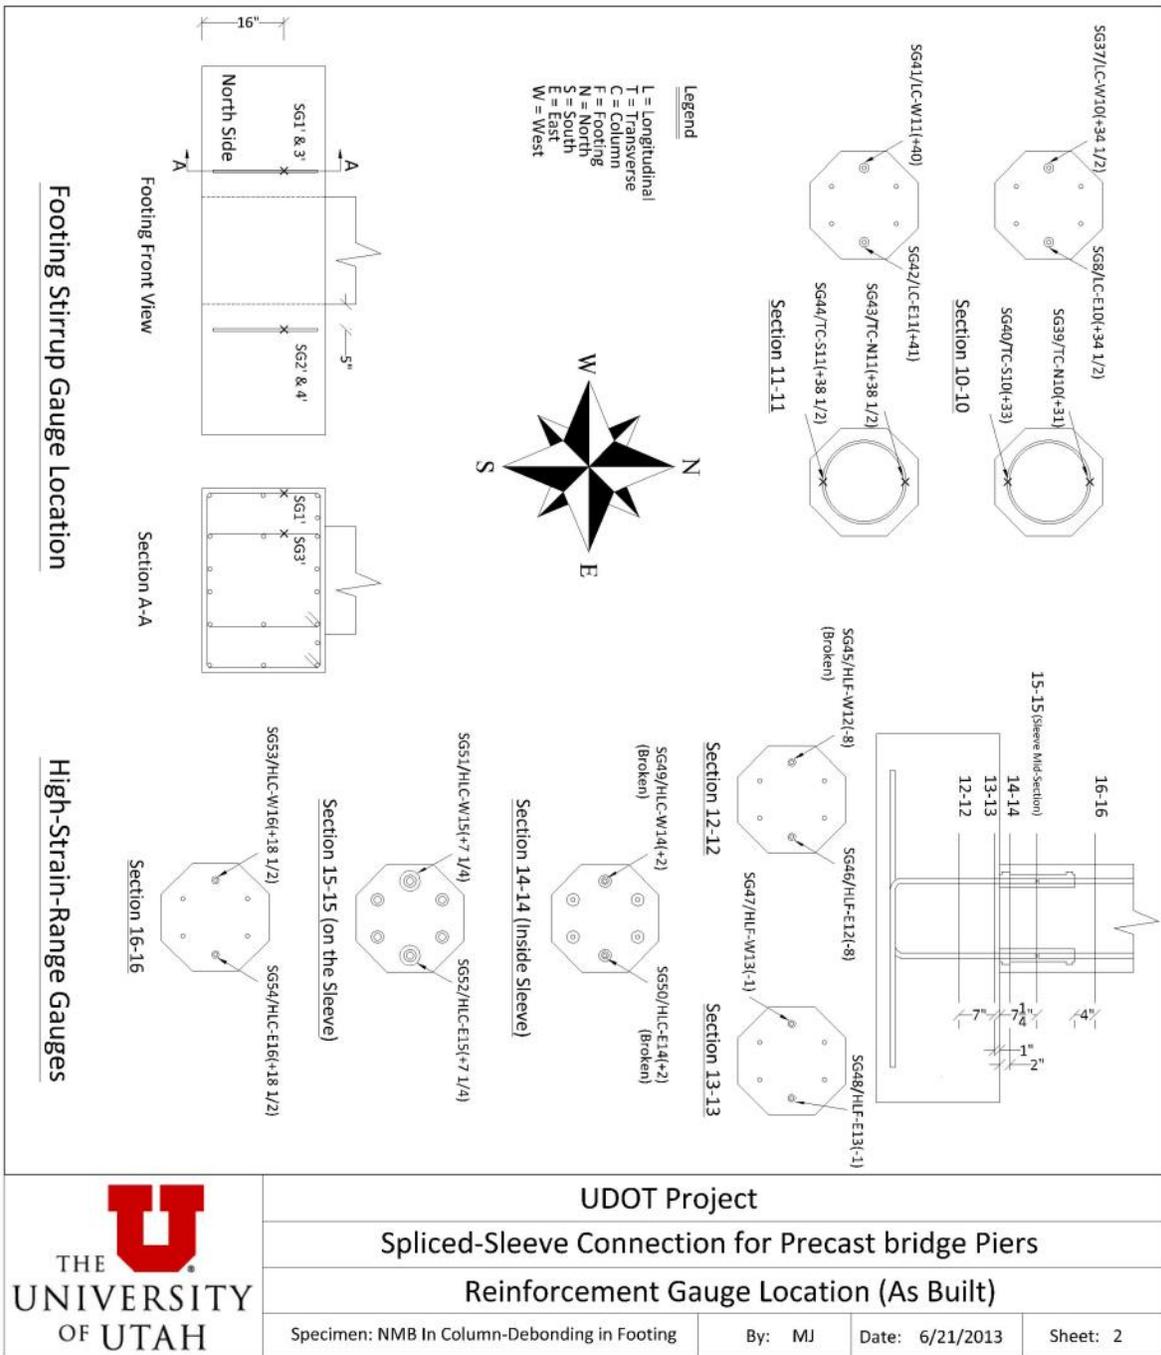
A sample of a typical strain gauge layout is shown in **Figure 3-1**. This layout includes the location, designation, and type of strain gauge used at each specific section. It is noted that only the two extreme longitudinal reinforcing bars were gauged in each section and only two strain gauges were placed on the corresponding spiral section, for specimen GGSS-3.

(a) Sample strain gauge layout-part 1.

(b) Sample strain gauge layout-part 2.

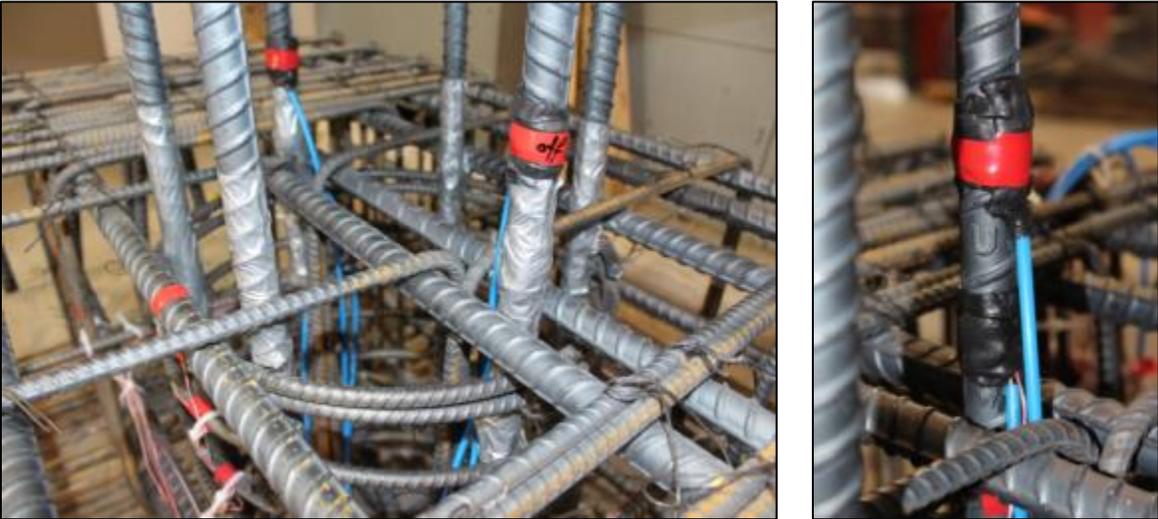
A detailed step-by-step procedure was followed for surface preparation, attachment of strain gauges, and protection from debris and further damage that was likely to be caused by the surrounding concrete. **Figure 3-2** displays the strain gauges placed on the spiral and longitudinal rebar during the last phase of construction for GGSS-3. Wires were carefully routed towards a point in the middle of the footing where significant damage was unlikely to occur. **Figure 3-3** shows the strain gauges on the joint spiral and longitudinal rebar for FGSS-3. Strain gauge wires were protected inside the hollow flexible plastic blue tubes.

Figure 3-2. Strain gauges on GGSS-3.

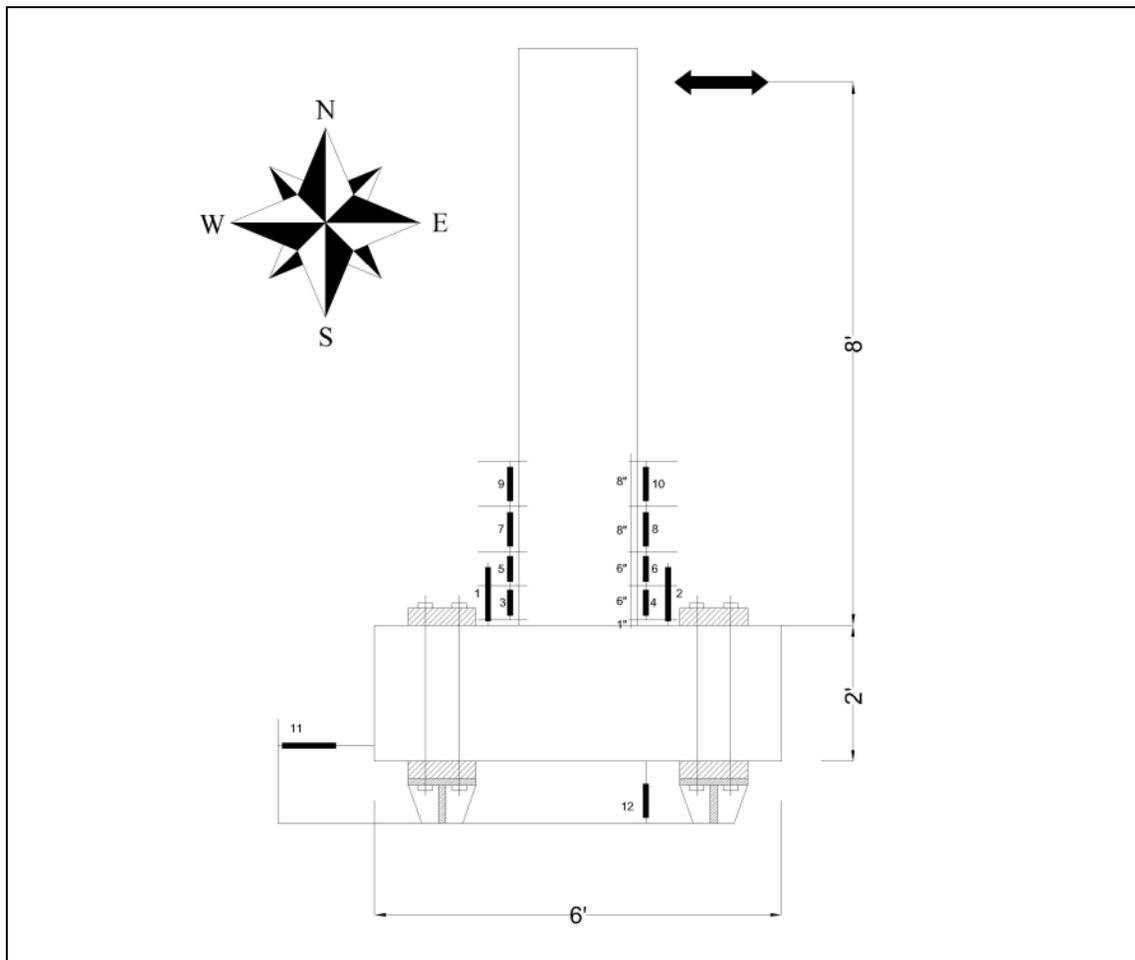
Ten LVDTs were mounted to the column end, over an approximately 30-in. region, to measure the relative vertical displacements between the sections and provide data for curvature analysis. Column base rotation and subsequent bond-slip rotation were studied using the lowest pair of LVDTs on the column end, or LVDT 1 and 2 as illustrated in **Figure 3-5** for the column-to-footing connections. Other LVDTs were used to compute the curvature capacity along the column end. The LVDT configuration was similar for the column-to-cap beam connections.

Figure 3-5. LVDT configuration for column-to-footing connections

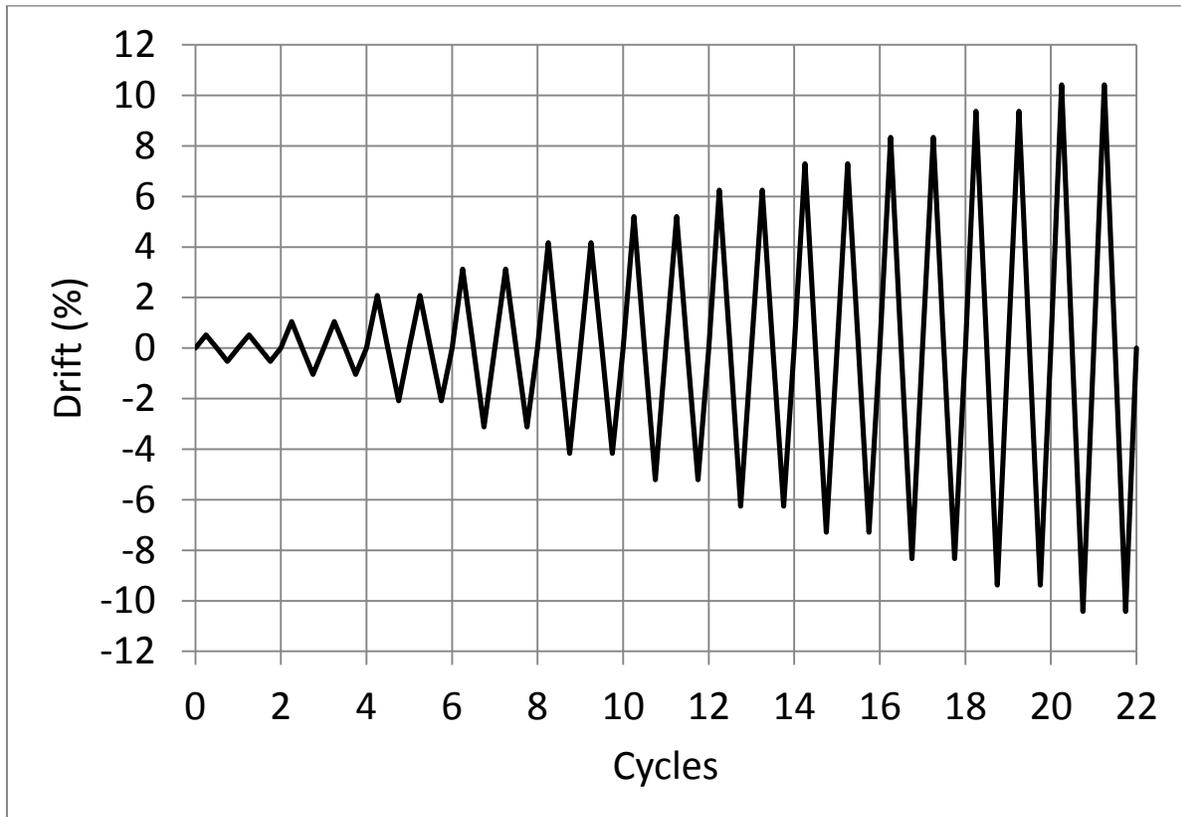
A reversed cyclic quasi-static displacement-control protocol was applied to the column at an elevation 8 ft above the footing or cap beam, as shown in **Figure 3-7** and **Figure 3-8**. This displacement history was comprised of increasing amplitudes as multiples of the predicted yield displacement of the column [20]. Two cycles were employed for each drift ratio as depicted in **Figure 3-9**. A 5-minute pause was introduced after the completion of each drift ratio, to examine the test specimen and make observations regarding the visible aspects of the response. The displacement rate was set to 1.2 in./min up to the end of the 3-in. drift ratio, after which it was changed to 4 in./min and was kept constant until completion of the test.

Figure 3-9. Displacement history.

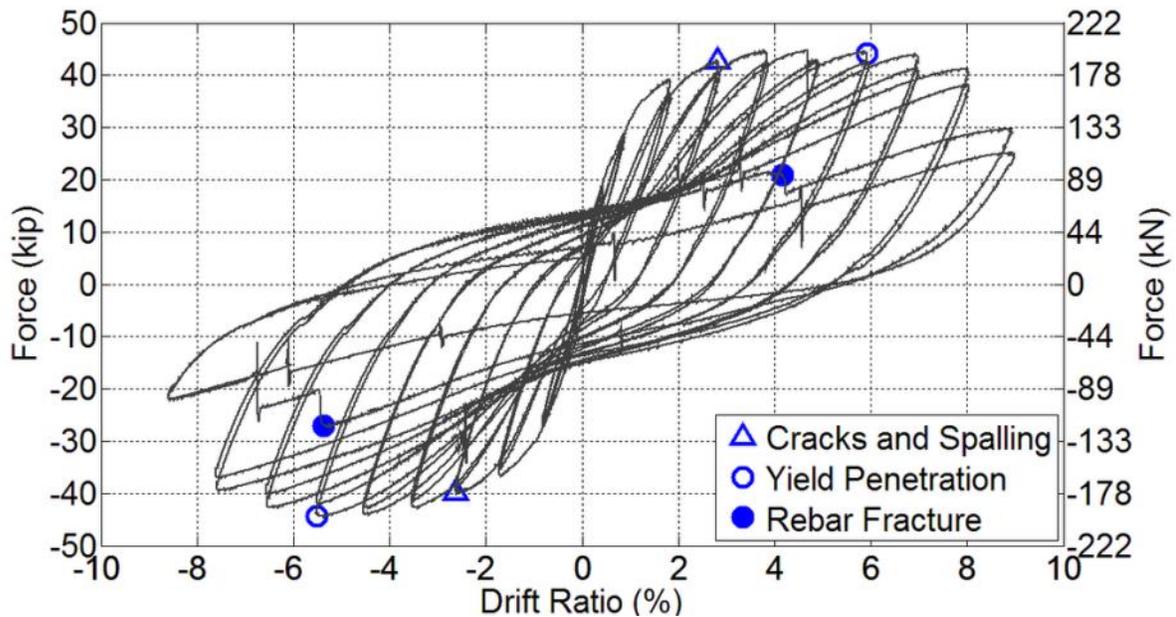
**Figure 4-2** shows the lateral force-displacement curve in addition to the major damage states including end of crack formation and initiation of spalling, yield penetration, and rebar fracture. Hysteresis loops were wide and stable for this specimen without strength degradation up to a 7% drift ratio. A slight reduction in strength is noted at the 8% drift ratio. The test was terminated at the end of the 9% drift ratio due to a drop larger than 20% in lateral force. The overall hysteresis response was symmetric in terms of strength and residual drift.

Figure 4-2. Hysteresis response of GGSS-1 with damage states.

A hairline minor crack developed at the bed grout, located at the column-to-footing interface, during the 0.5% drift ratio. This crack became wider and was accompanied by another crack forming right above the GGSS during the first cycle of the 1% drift ratio. By the end of the 3% drift ratio, all major cracks had developed including a relatively large crack at the bed grout, another one at a section close to the top of the GGSS, and a third crack at the end of the spiral-overlapping zone about 30 in. above the column base, as shown in **Figure 4-3(a)**. Spalling initiated during the first cycle of the 3% drift ratio and progressed near the corners of the octagonal column. The spalled area had a height of 4in. on both sides of the column and a crack width of 0.009 in. above the GGSS. Cracks widened and spalling progressed at higher drift ratios. The aforementioned select crack had a width of 0.013 in. at a drift ratio of 4%, 0.02 in. at a drift ratio of 5%, and 0.03 in. at the 6% drift ratio. Yield penetration was noted at the end of the 6% drift ratio with a depth of 1.5 in. and 1 in. on the west and east side of the column, respectively. The height of the spalled region was 8 in. and 14 in. on the west and east side of the column, respectively. **Figure 4-3(b)** shows the damage state at the end of the 6% drift ratio. The column spiral became visible during the 7% drift ratio and a few hairline cracks were spotted on the north and south side of the footing. The bed grout deteriorated around the perimeter of the column end, while the spalled region over the GGSS became deeper and the GGSS was visible at the end of the 8% drift ratio.

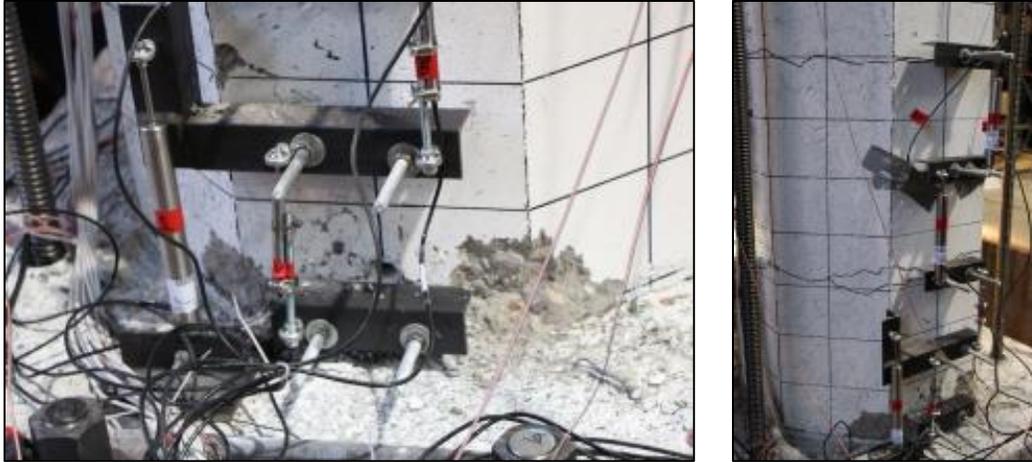
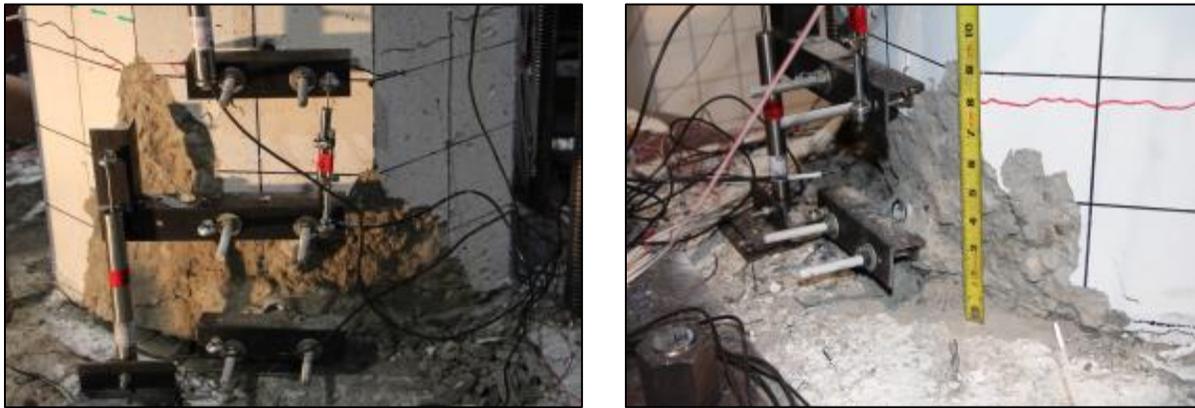
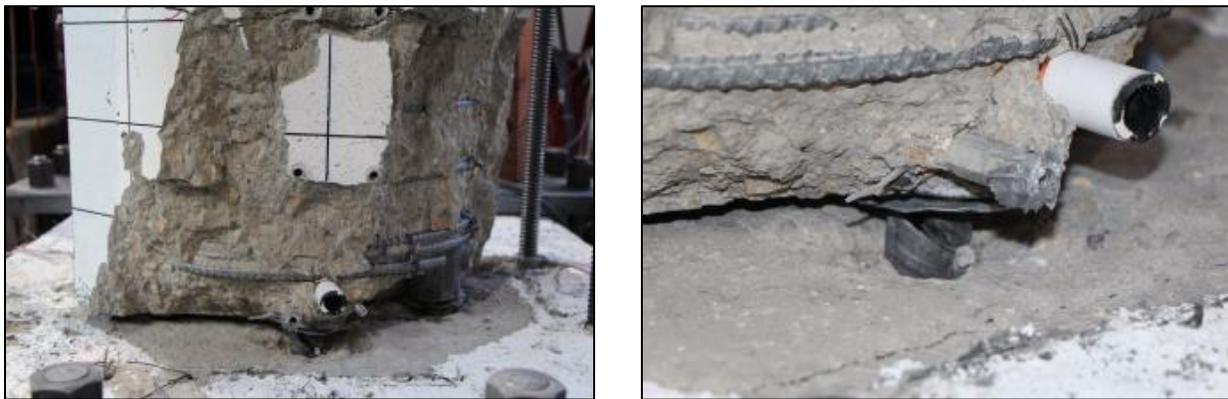
(a) Damage state at 3% drift ratio: cracks and spalling.

(b) Damage state at 6% drift ratio: cracks, spalling, and yield penetration.

(c) Damage state at 9% drift ratio: spalling, exposed rebar cage, and fractured bar.

During the last drift ratio of 9% for GGSS-1, all six longitudinal column bars had buckled. Concrete spalling grew larger in terms of area and depth, and the spiral and GGSSs were exposed, as shown in **Figure 4-3(c)**. The two extreme bars fractured in the first cycle of the push and pull directions of the 9% drift ratio, due to low cycle fatigue. Rebar fracture occurred 1in. to 1.5 in. below the surface of the footing, where there was no confining transverse reinforcement. Post-test investigations ascertained that the confined concrete core remained undamaged and the GGSSs themselves did not slip inside the column. The footing remained perfectly elastic as a capacity-protected member with minor hairline cracks in the joint region. Compression test results on concrete cylinders and grout cubes indicated that the compressive strength of the concrete and grout were 5.9 ksi and 14.4 ksi, respectively, on the day of the test.
