Report No. UT-14.09

## **SEISMIC EVALUATION OF GROUTED SPLICE SLEEVE CONNECTIONS FOR PRECAST RC BRIDGE PIERS IN ABC**

Utah Department of Transportation  
Research Division

**Final Report  
October 2014**

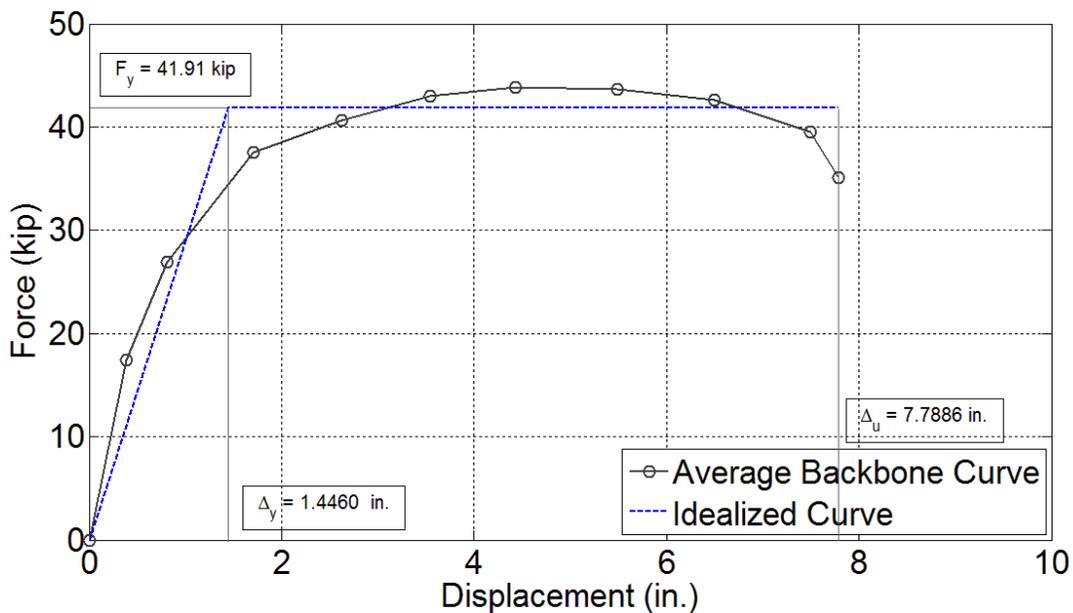
The average backbone curve was constructed in accordance with the method described in **Section 4.1.2**, along with the idealized elasto-plastic curve. **Figure 4-4** depicts the plots in addition to the parameters required to obtain the displacement ductility. The effective yield displacement and force for GGSS-1 were found to be 1.45 in. and 41.91 kip, respectively. The ultimate displacement, corresponding to a 20% strength drop, was 7.79 in., resulting in a displacement ductility of 5.4.

Figure 4-4. Average backbone curve and displacement ductility for GGSS-1.

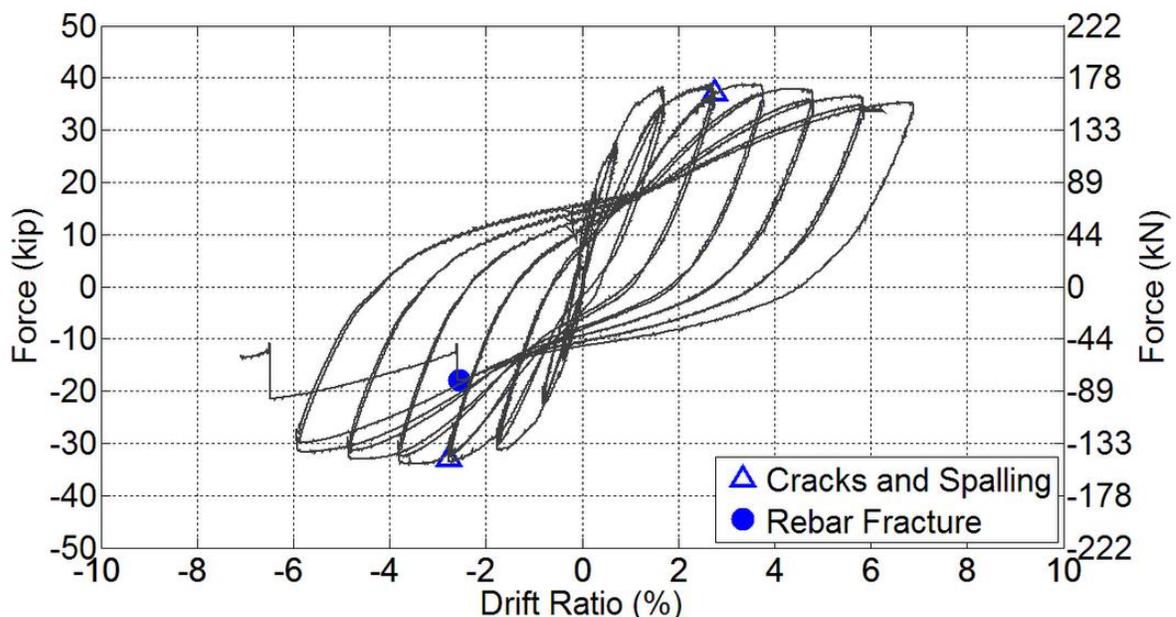
**Figure 4-8** shows the hysteresis response of this specimen in addition to the major damage states including end of crack formation and initiation of spalling, and rebar fracture. Hysteresis loops were wide and stable for this specimen without strength degradation up to the 7% drift ratio, when the extreme east column bar fractured during the first pull cycle. The test was terminated at this point due to a drop larger than 20% in the lateral force. The overall hysteresis response was considered satisfactory, although there was a slight difference between the peak lateral forces in the push and pull directions.

Figure 4-8. Hysteresis response of GGSS-2 with damage states.

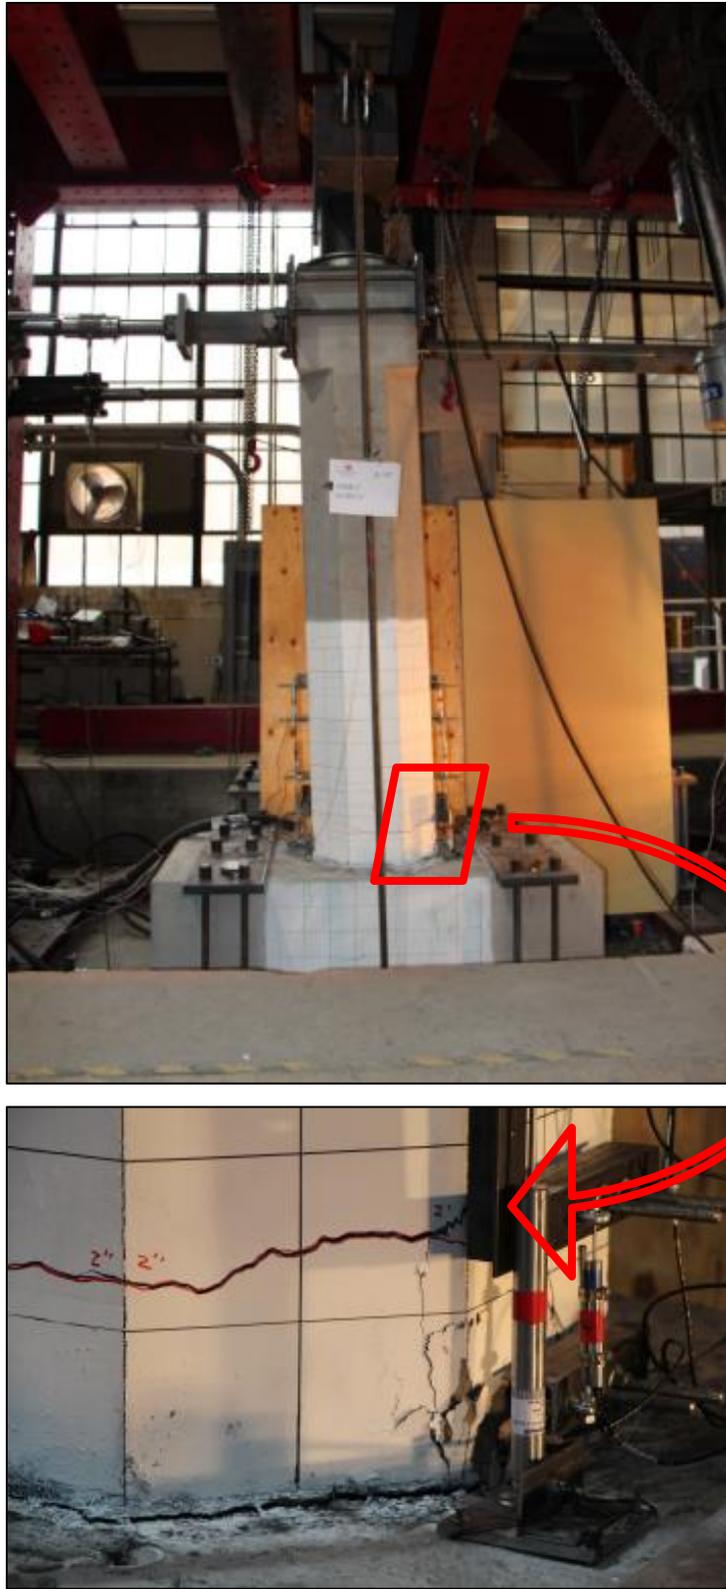
Figure 4-9. GGSS-2 at maximum displacement during the 3% drift ratio—Largest crack.

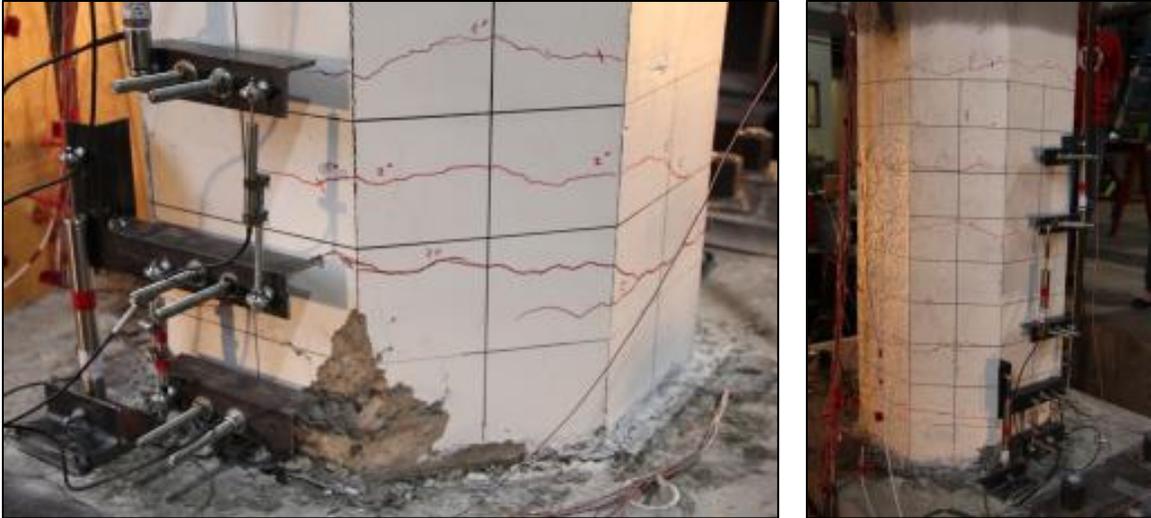
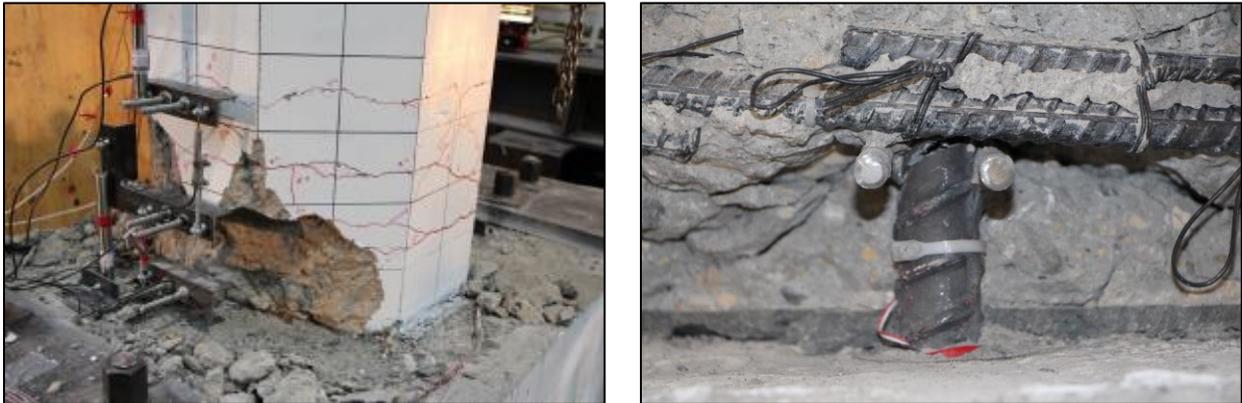
of spalling at the south-east corner of the octagonal column is also visible with a vertical dimension of 4 in. The state of damage to the column plastic hinge region is shown in **Figure 4-10(a)** in addition to the spalled region and major flexural cracks that formed along the column height. It was noted that flexural cracks occurred at approximately 8-in. increments.

The crack developed at the column-to-footing interface during the previous drift ratios became a 0.0625-in. permanent gap, when the test was terminated. **Figure 4-10(b)** depicts the damaged area at the column base including major cracks, spalled region, and the fractured column bar.

(a) Damage state at 3% drift ratio: cracks and spalling.

(b) Damage state at 7% drift ratio: cracks, spalling, fractured bar, and exposed rebar cage.

The column plastic hinge region became deteriorated with an increase in the drift ratio. Cracks opened further and spalling intensified during the 4% drift ratio. The select crack located 6 in. above the column base had a width of 0.05 in. at the end of this drift ratio, and another crack at 10 in. from the column base had a width of 0.02 in. A few inclined cracks, known as flexure-shear cracks, developed during the 4% and 5% drift ratios on the north and south sides of the column base, due to an increased tensile demand. A large piece of concrete cover with a dimension of 7 in. split from the column base during the 5% drift ratio. Smaller concrete cover pieces, measured 4 in. and 6 in., became separated from the surface of the column base during the 6% drift ratio.

During the first pull of the 7% drift ratio, the extreme column reinforcing bar fractured at a section 2 in. above the interface, and the test was terminated as the column strength dropped below 80% of the maximum reached. Fracture of the rebar was attributed to low cycle fatigue as a result of successive bending and re-straightening of the extreme reinforcing column bar. Post-test investigation revealed that the cover concrete was crushed completely around the column end, after removing the loose material. Thus, spiral hoops together with extreme column bars were evident at the end of the test.

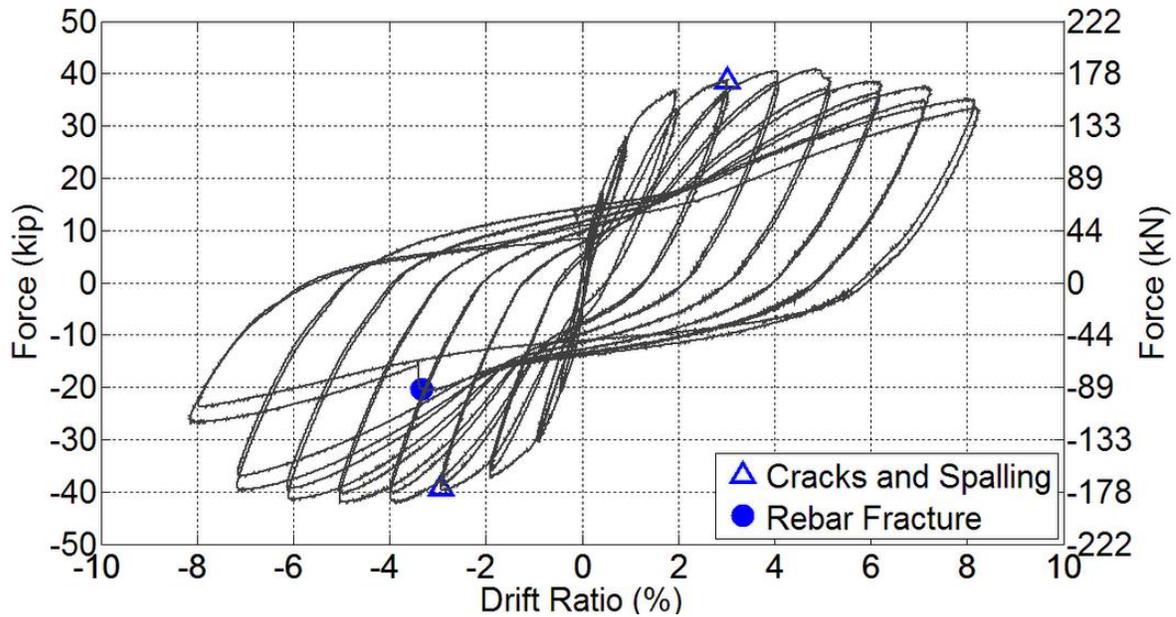
Figure 4-15. Hysteresis response of GGSS-3 with damage states.

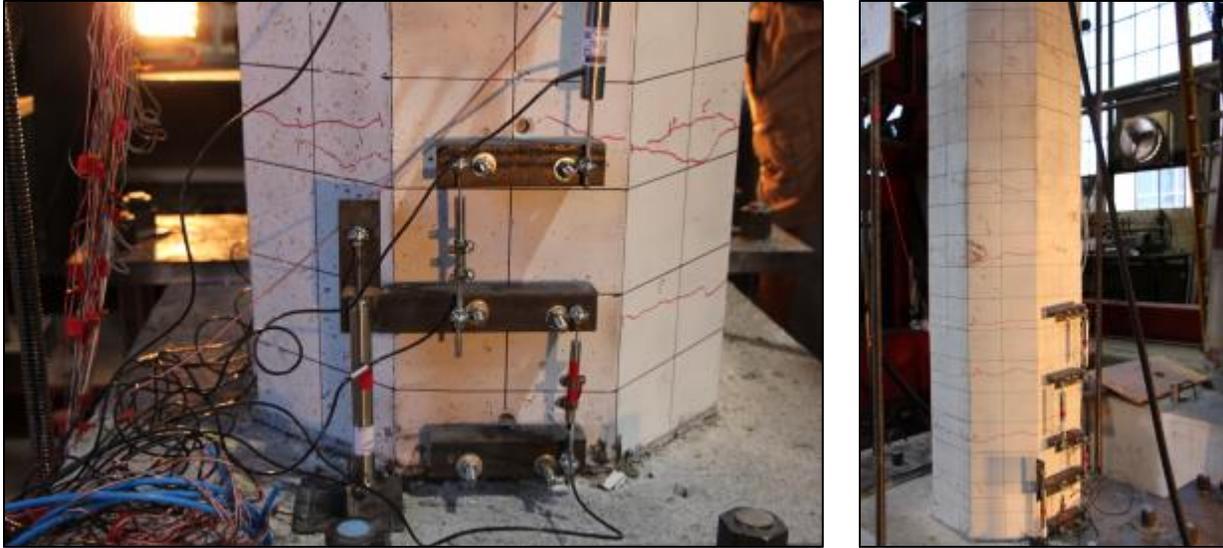
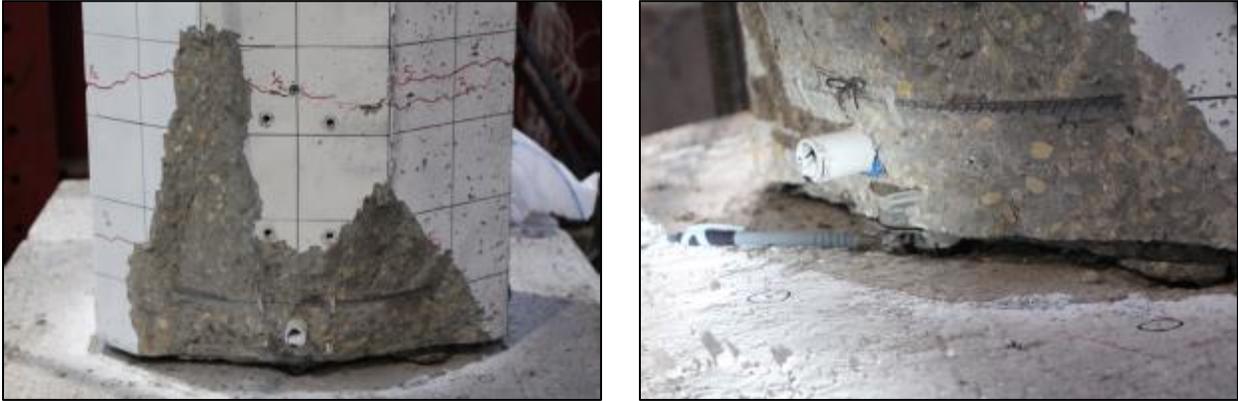
(a) Damage state at 3% drift ratio: cracks and spalling.

(b) Damage state at 8% drift ratio: cracks and spalling, fractured bar, and exposed rebar cage.

Figure 4-16. GGSS-3 visual observations.

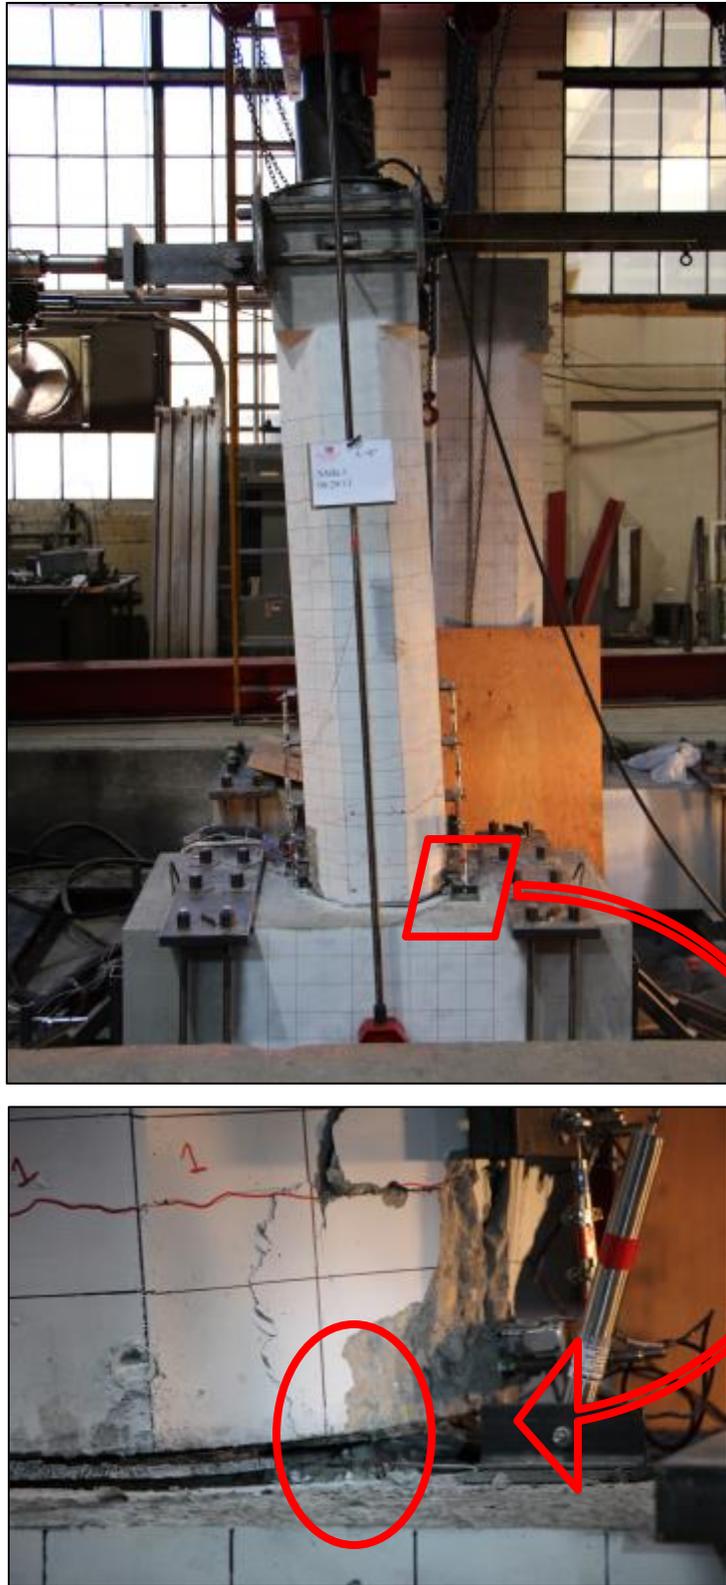
Figure 4-17. GGSS-3 footing dowel became visible at the 7% drift ratio.

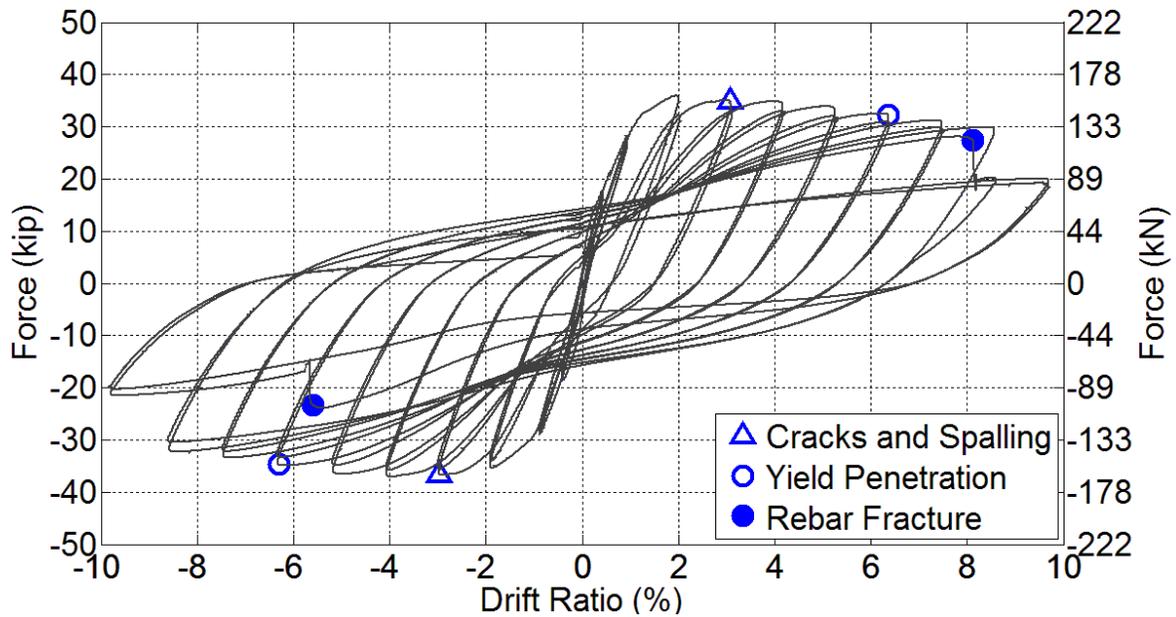
Figure 4-22. Hysteresis response of GGSS-CIP with damage states.

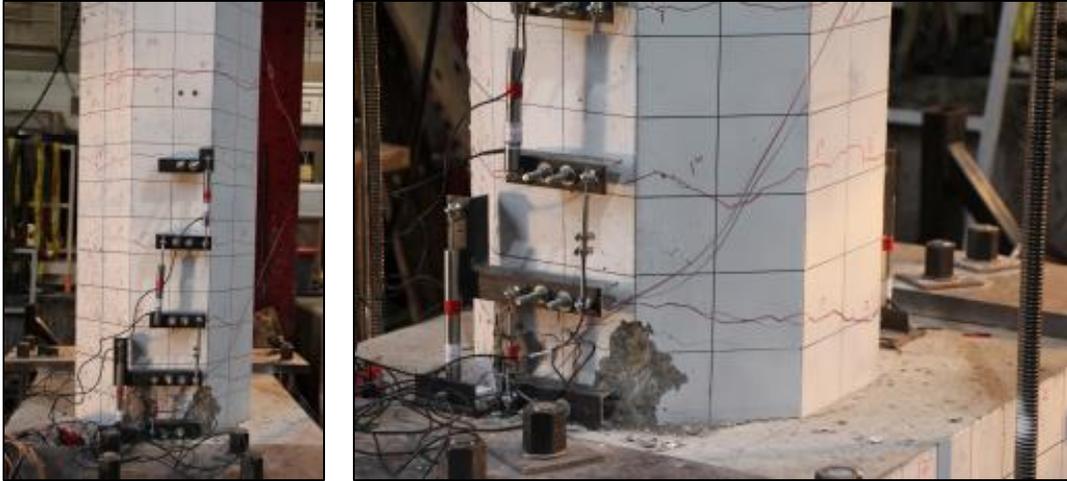
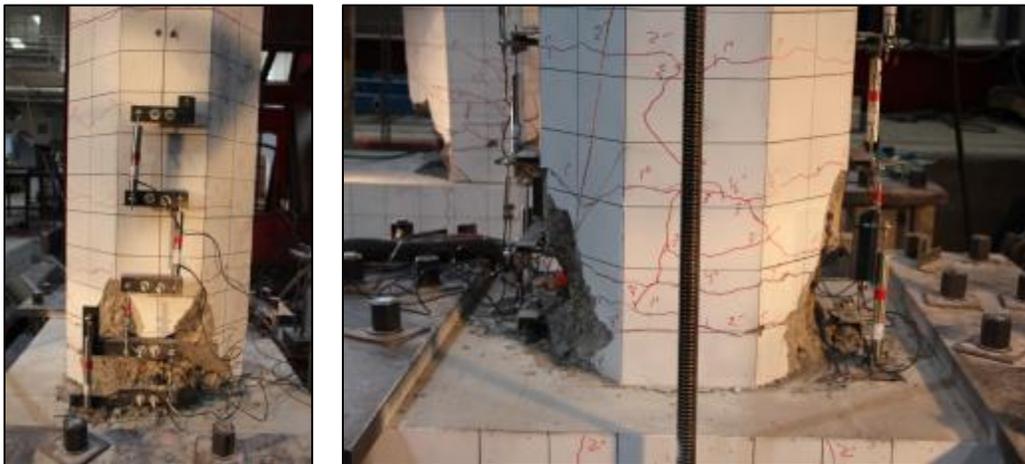
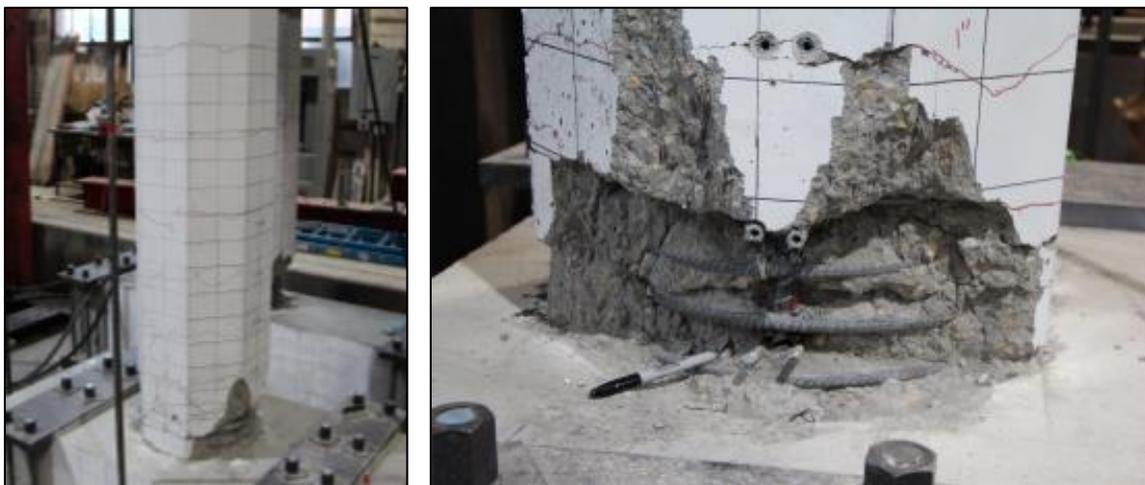
(a) Damage state at 3% drift ratio: cracks and spalling.

(b) Damage state at 6% drift ratio: spalling and inclined cracks.

(c) Damage state at end of test: cracks, spalling, concrete delamination, and fractured rebar.

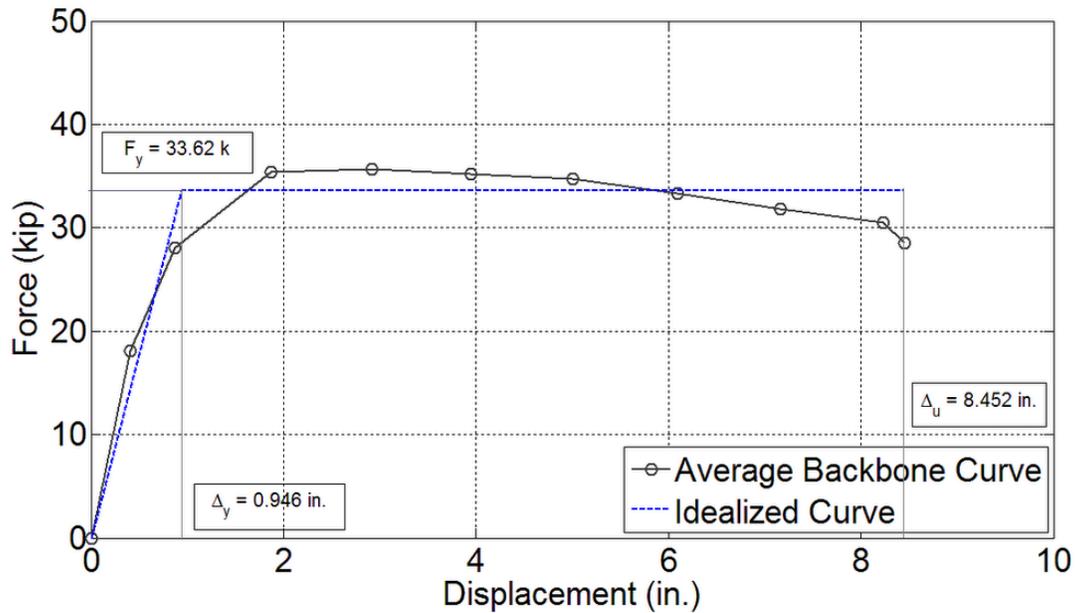
Figure 4-24. Average backbone curve and displacement ductility of GGSS-CIP.

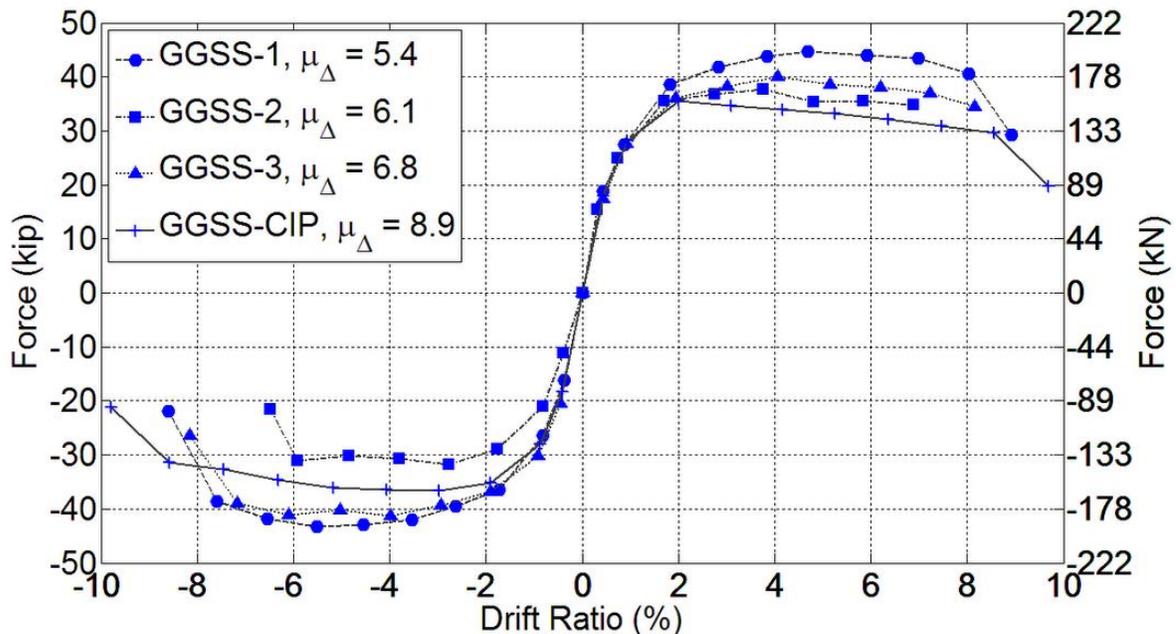
Figure 4-28. Force-displacement response of column-to-footing test specimens.

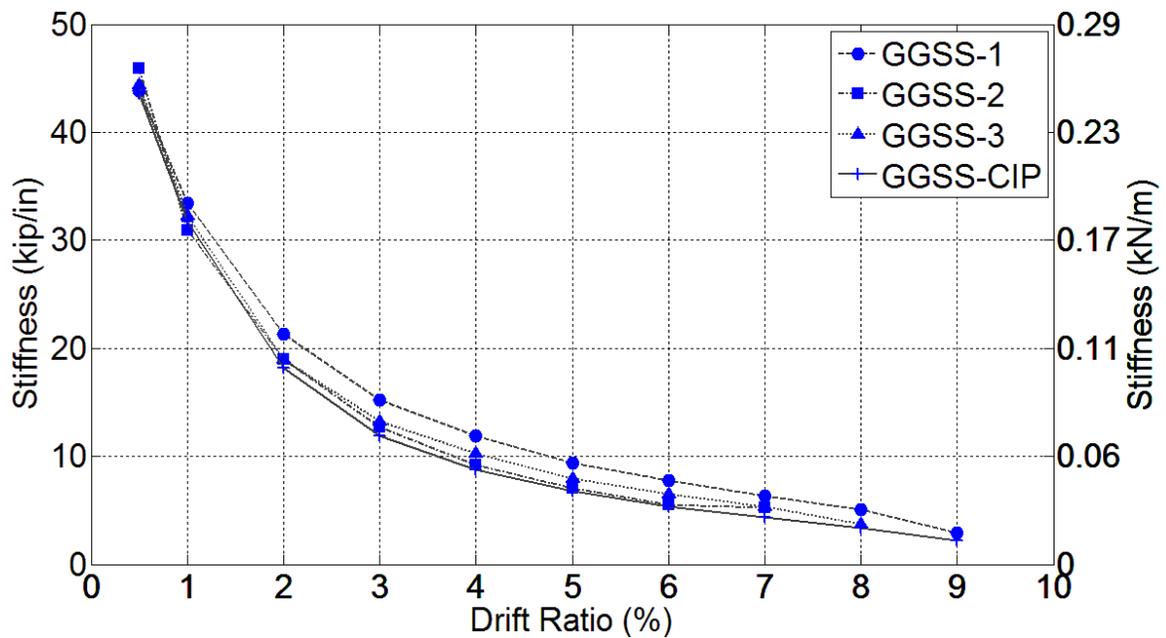
Figure 4-29. Stiffness degradation for column-to-footing test specimens.

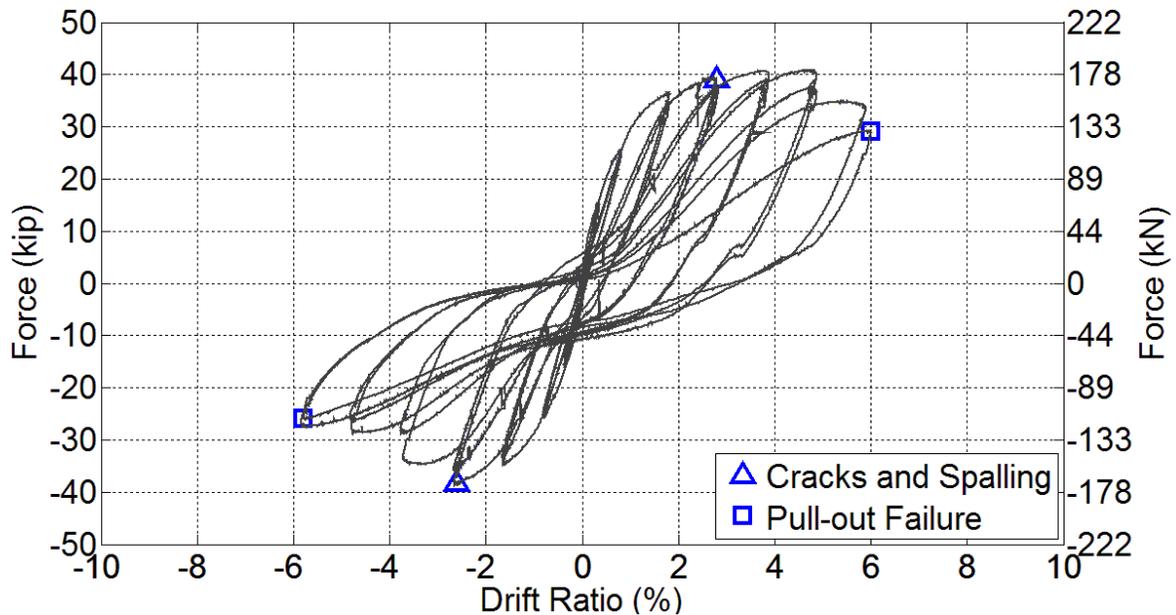
Figure 4-32. Hysteresis response of FGSS-1 with damage states.

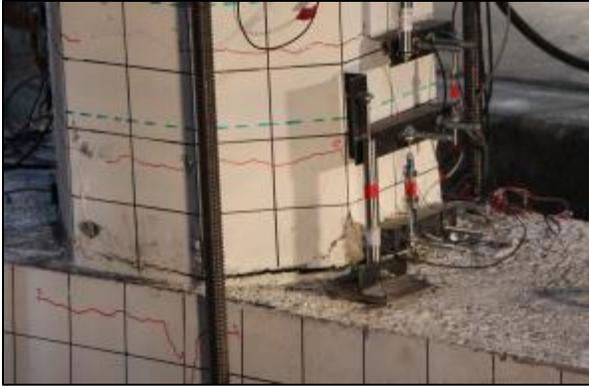
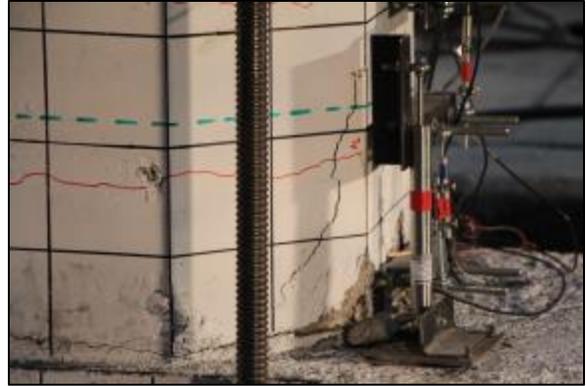
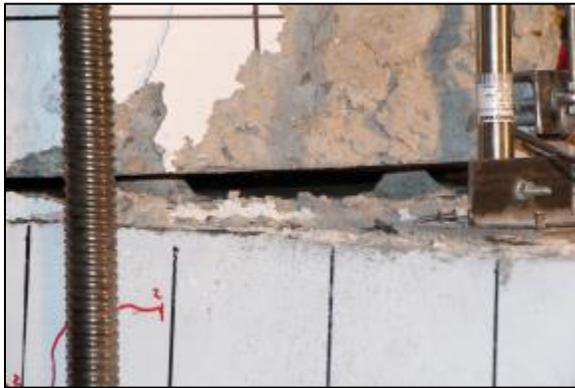
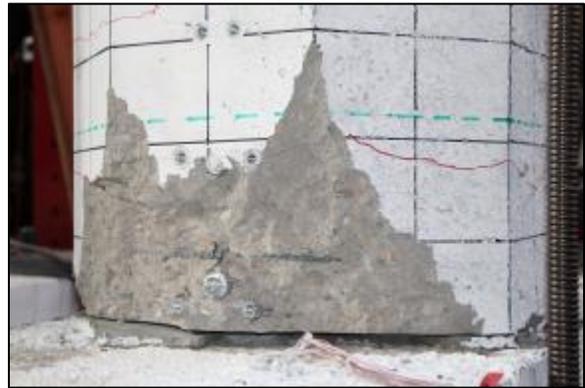
(a) Bed grout opening at 3% drift ratio (peak).

(b) Damage state at 3% drift ratio.

(c) Bar pull-out during 6% drift ratio.

(d) Damage state at end of test.

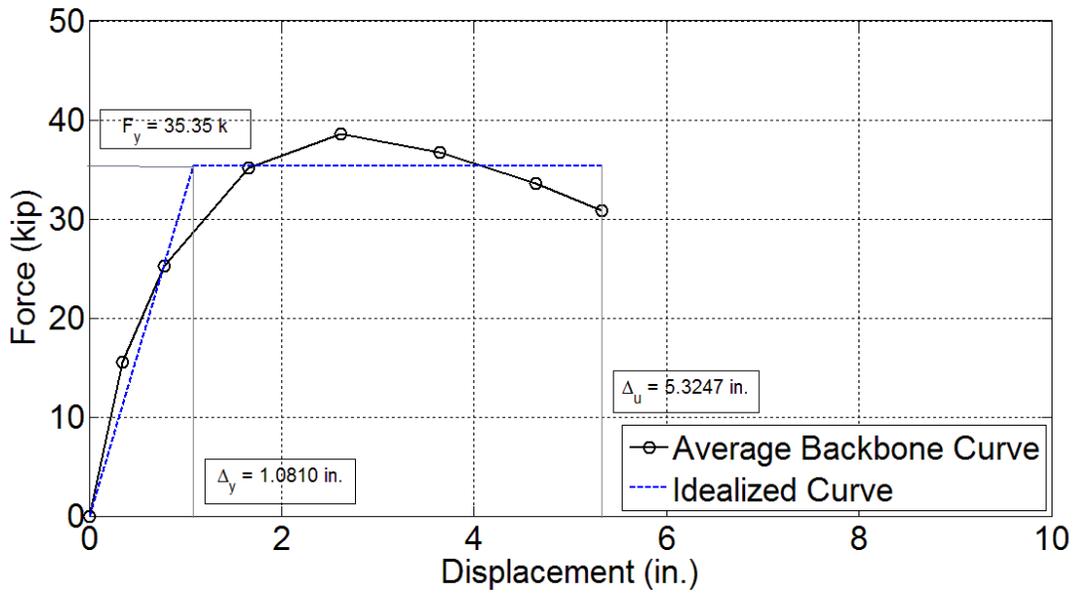
Figure 4-34. Average backbone curve and displacement ductility for FGSS-1.

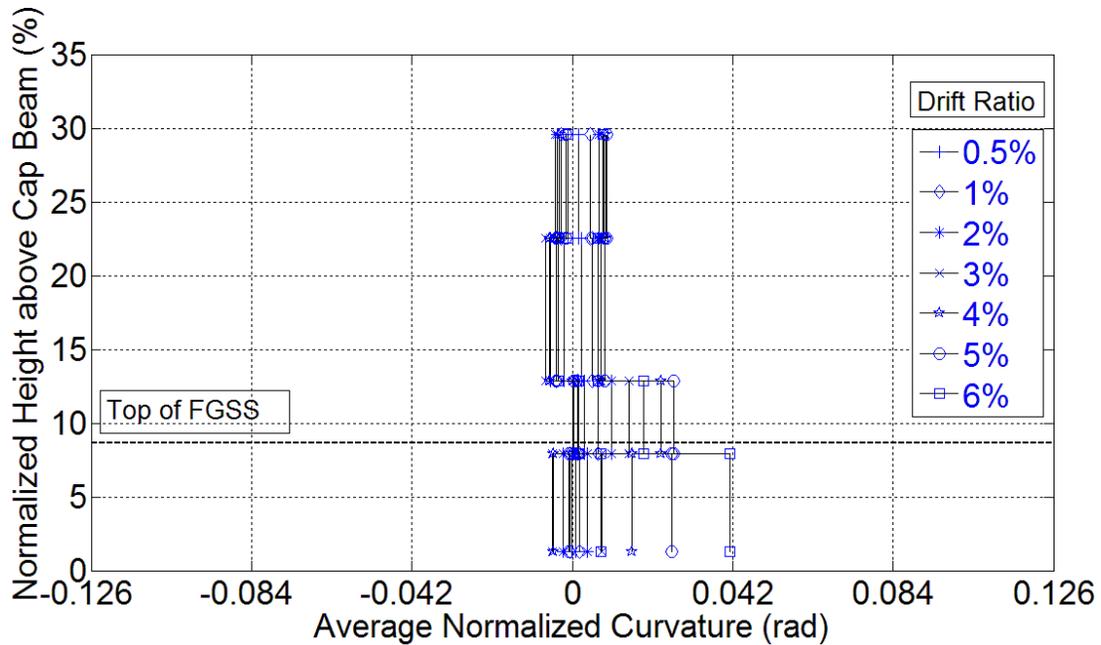
Figure 4-37. Normalized curvature distribution for FGSS-1.

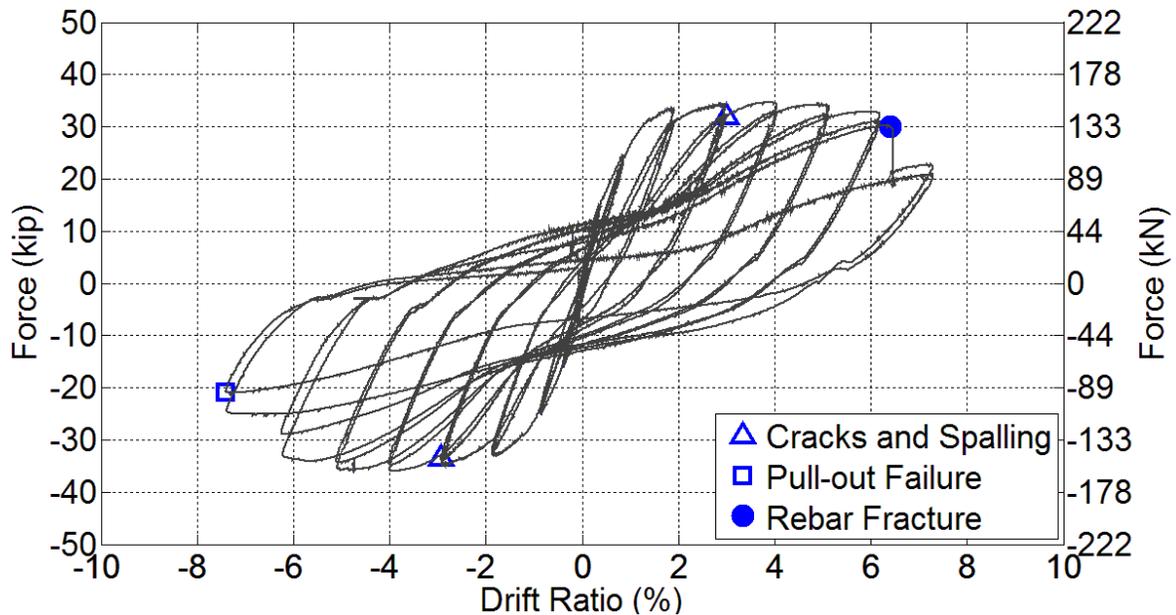
Figure 4-38. Hysteresis response of FGSS-2 with damage states.

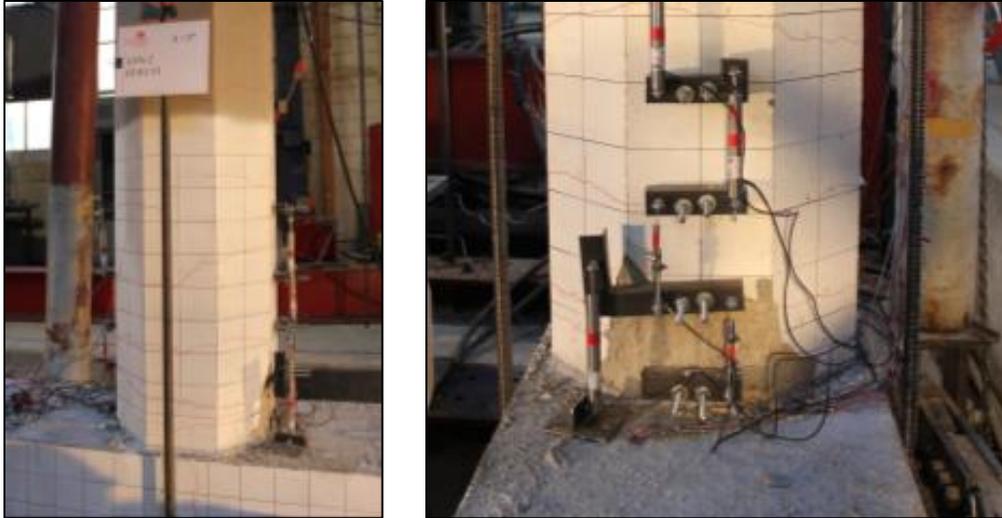
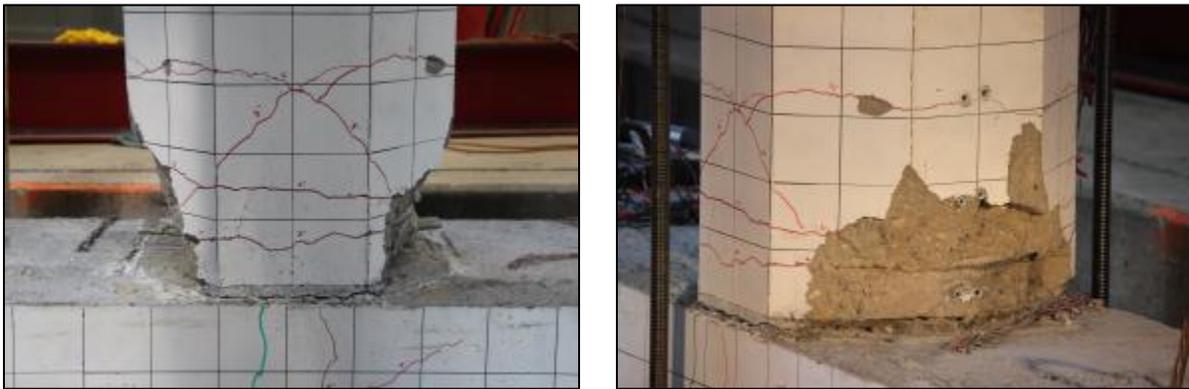
(a) Damage state at 3% drift ratio: cracks and spalling.

(b) Damage state at 7% drift ratio: cracks, spalling, and exposed spiral.

Figure 4-39. FGSS-2 visual observations.

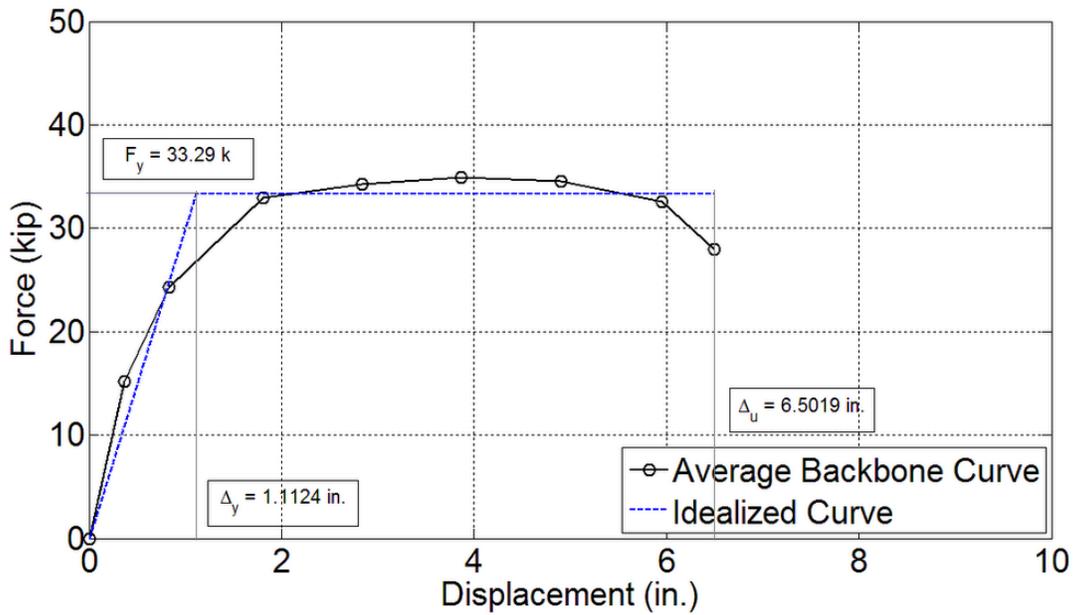
Figure 4-40. Average backbone curve and displacement ductility of FGSS-2.

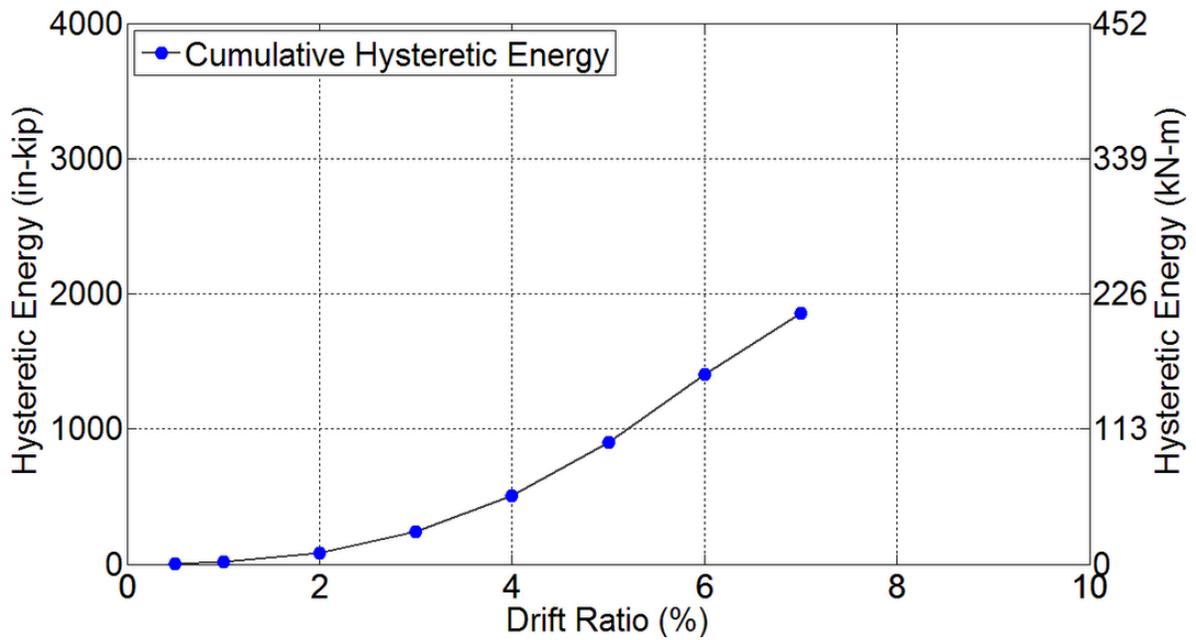
Figure 4-42. Energy dissipation capacity of FGSS-2.

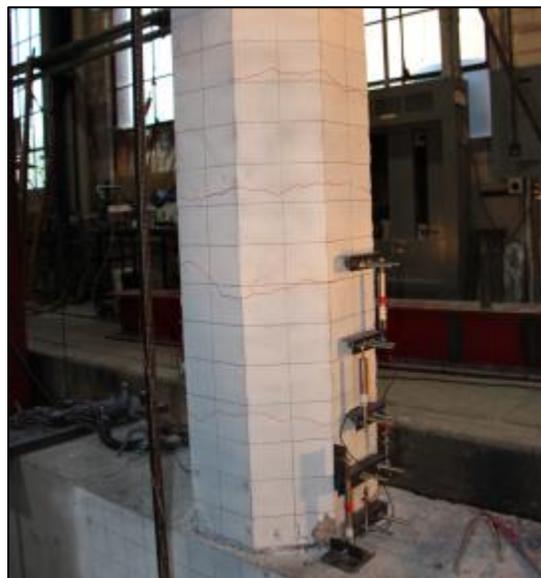
Figure 4-44. Pre-test condition of FGSS-3.

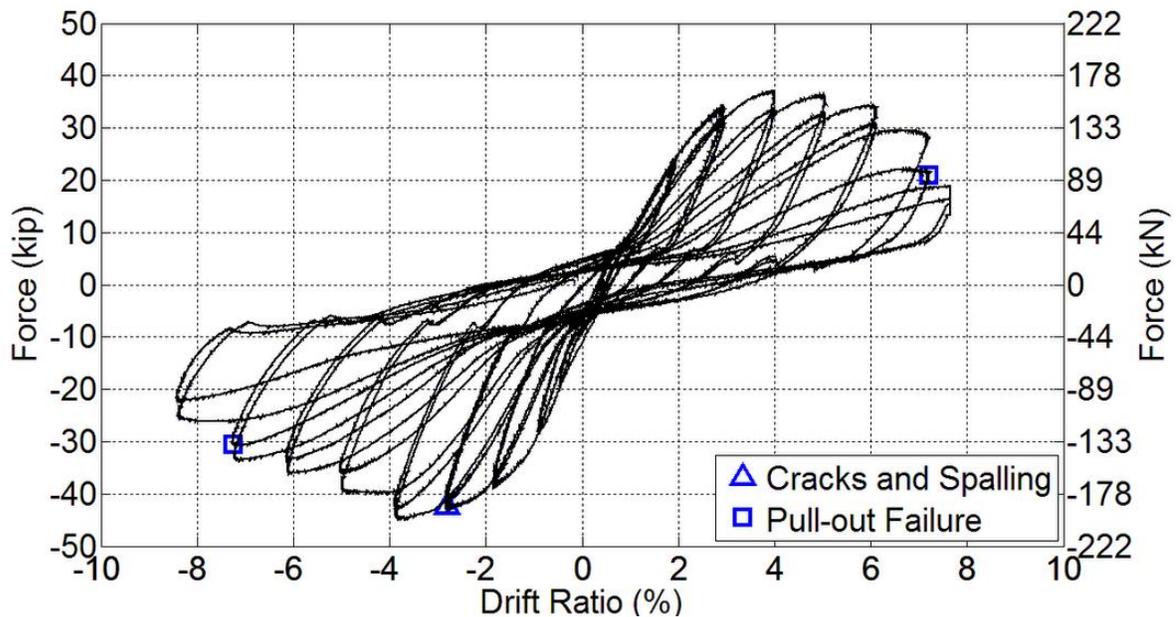
Figure 4-45. Hysteresis response of FGSS-3 with damage states.

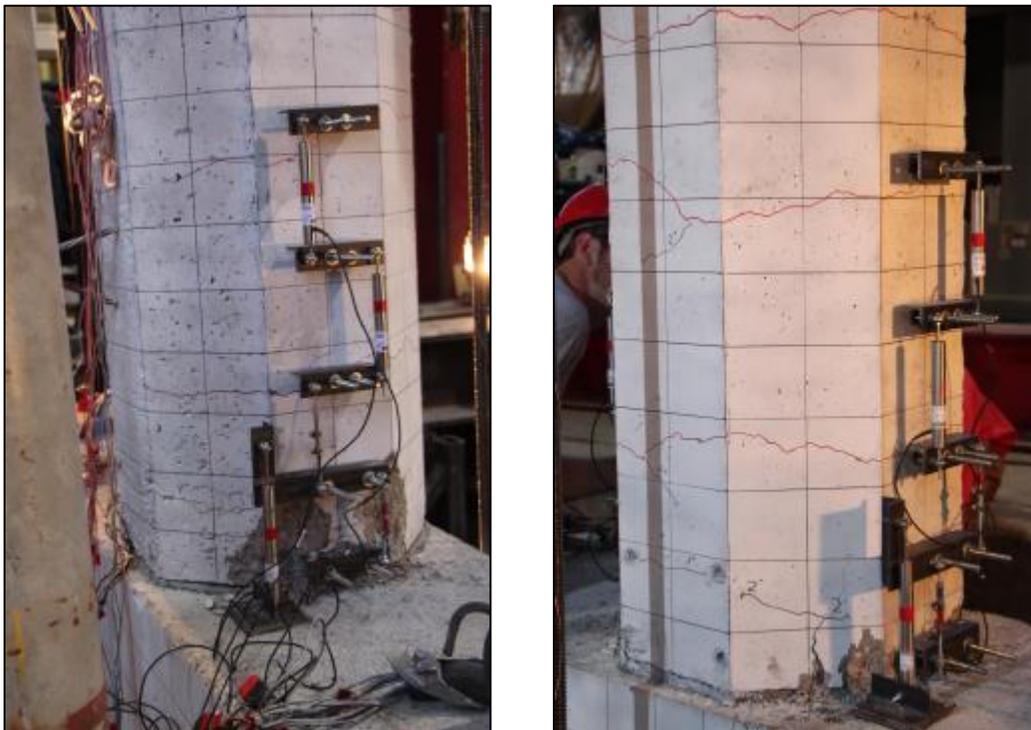
Figure 4-46. Damage state for FGSS-3 at 4% drift ratio.

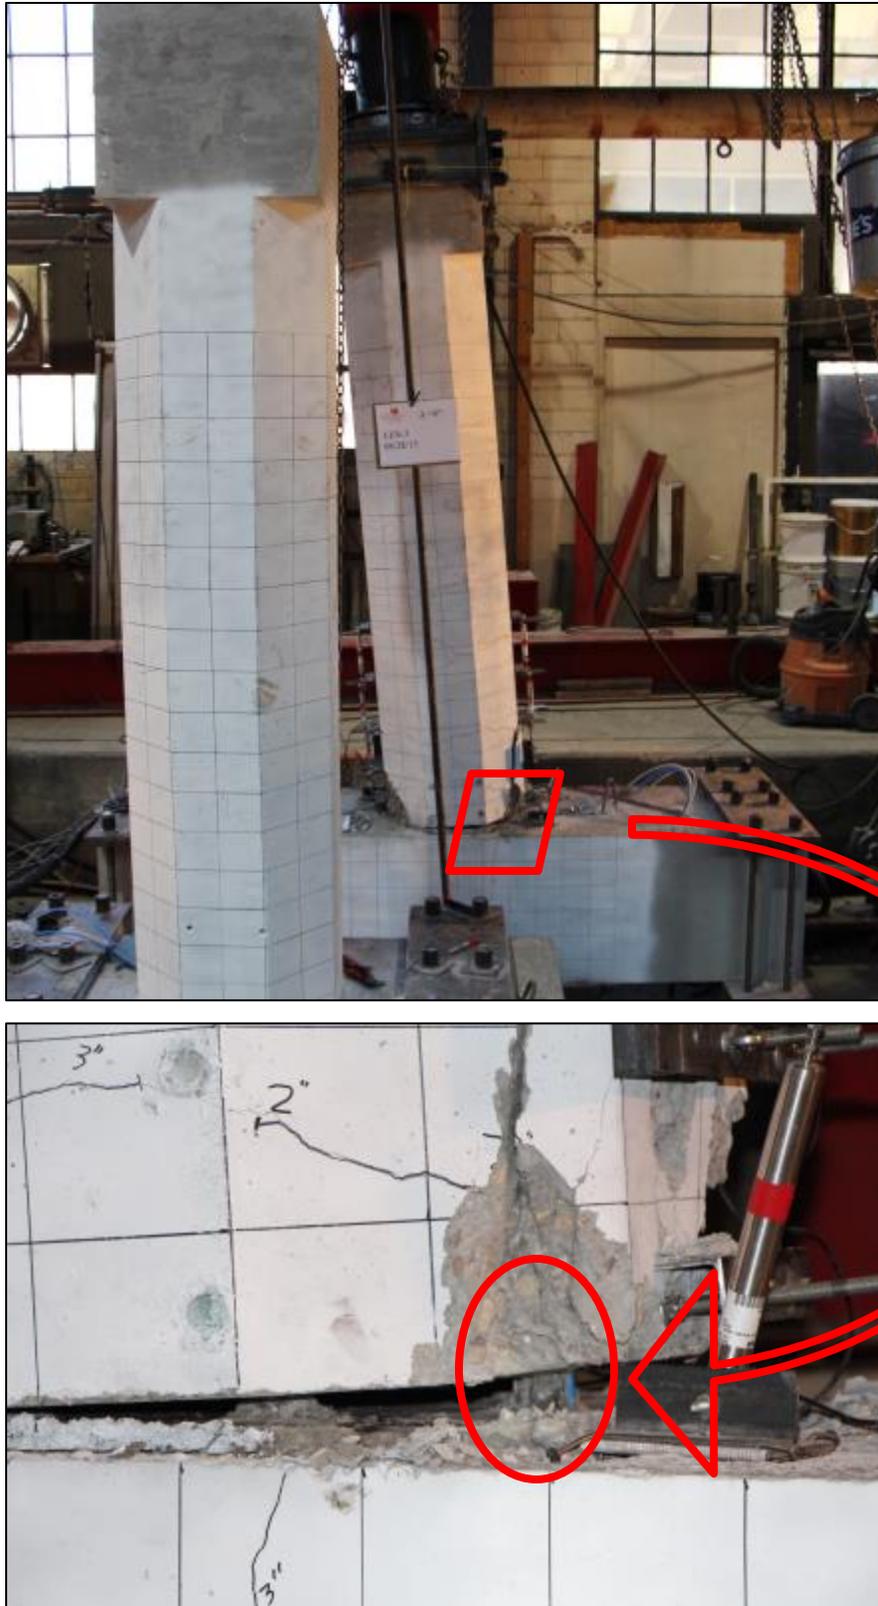
Figure 4-47. FGSS-3 cap beam dowel pull-out at 8% drift ratio.

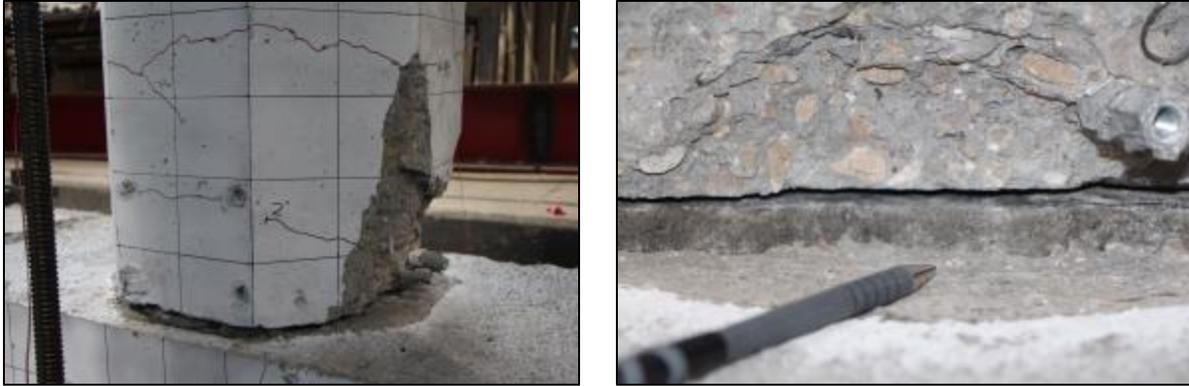
Figure 4-48. Damage state for FGSS-3 at end of test: cracks and spalling, permanent gap.

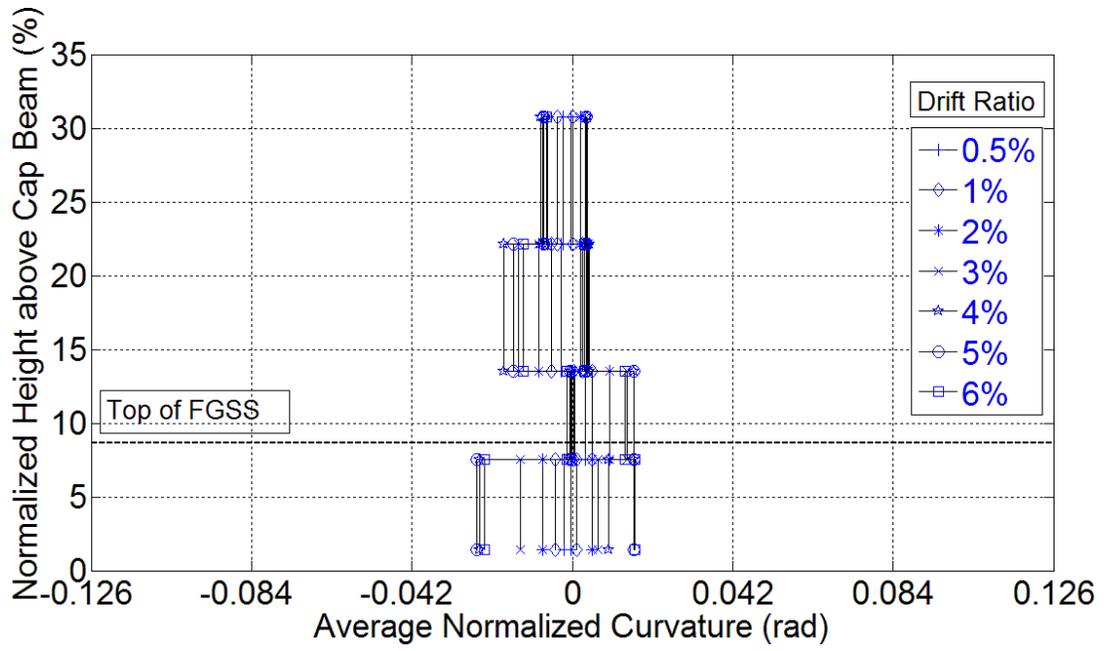
Figure 4-52. Normalized curvature distribution for FGSS-3.
